**EMALAHLENI – VULINDLELA BRIDGE – BASIC ASSESSMENT
ANNEXURE D AND F IN SUPPORT OF THE BASIC ASSESSMENT REPORT
FOR THE PROPOSED VULINDLELA BRIDGE REPAIRS, IN OGIES,
MPUMALANGA PROVINCE**

Date: 16 September 2019

VULINDLELA BRIDGE REPAIRS

ENVIRONMENTAL
MANAGEMENT PROGRAMME

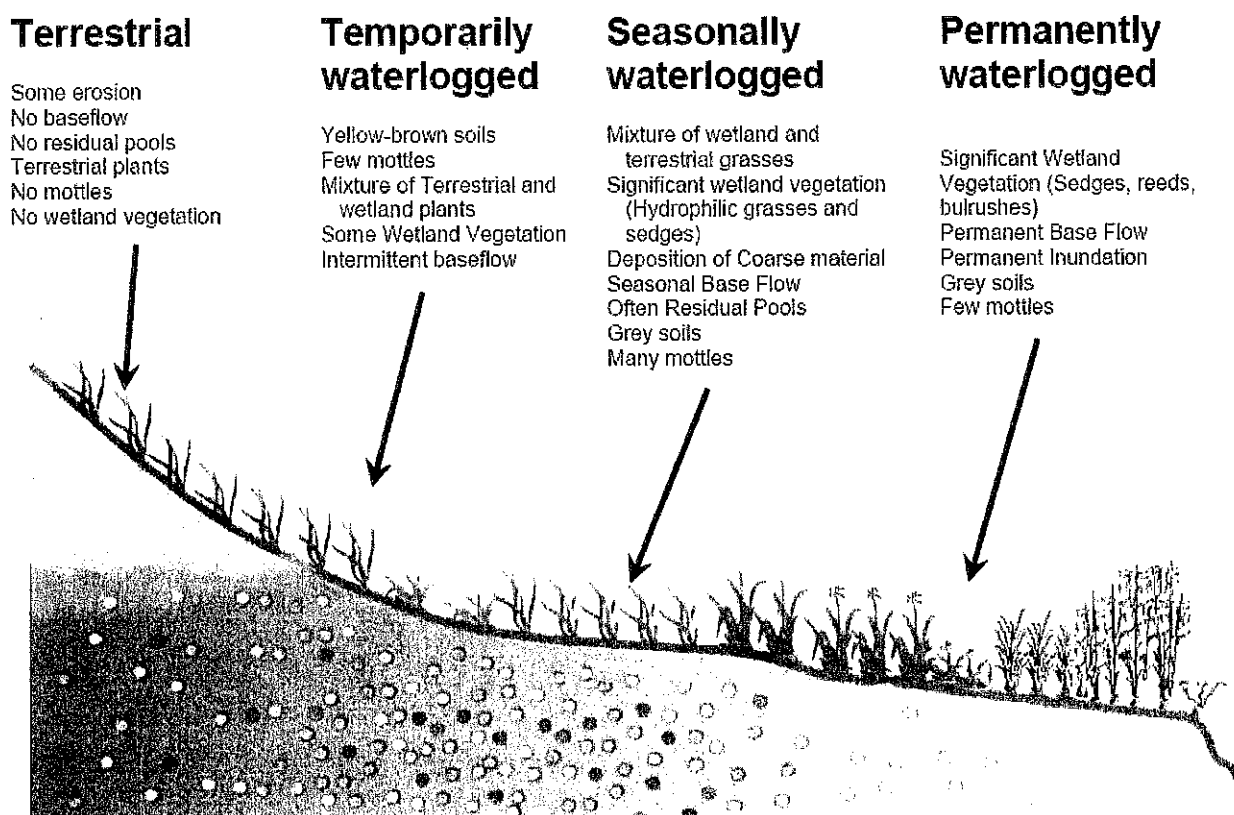
Figure 3-1: Cross section through a wetland, indicating how the soil wetness and vegetation indicators change along a gradient of decreasing wetness, from the middle to the edge of the wetland. (Reproduced by Sivest from Kotze (1996), DWAF Guidelines)

such circumstances, vegetation provides the best indication of the distribution of wetlands as it best reflects current hydrological conditions (Figure 3-1).
