# PRELIMINARY ECOLOGICAL HABITAT ASSESSMENT FOR THE PROPOSED REPLACEMENT OF THE NSELENI RIVER BRIDGE, KWAZULU-NATAL

Compiled for **Triplo 4 Sustainable Solutions** by:  
Mr. C.L.COOK (MSc. Zool.) *Pr.Sci.Nat.* 400084/08  
Specialist Faunal/Ecological Consultant  
Cell No. 082 688 9585  
[Giant.bullfrog@gmail.com](mailto:Giant.bullfrog@gmail.com)

SUBMITTED: 30<sup>th</sup> MARCH 2013

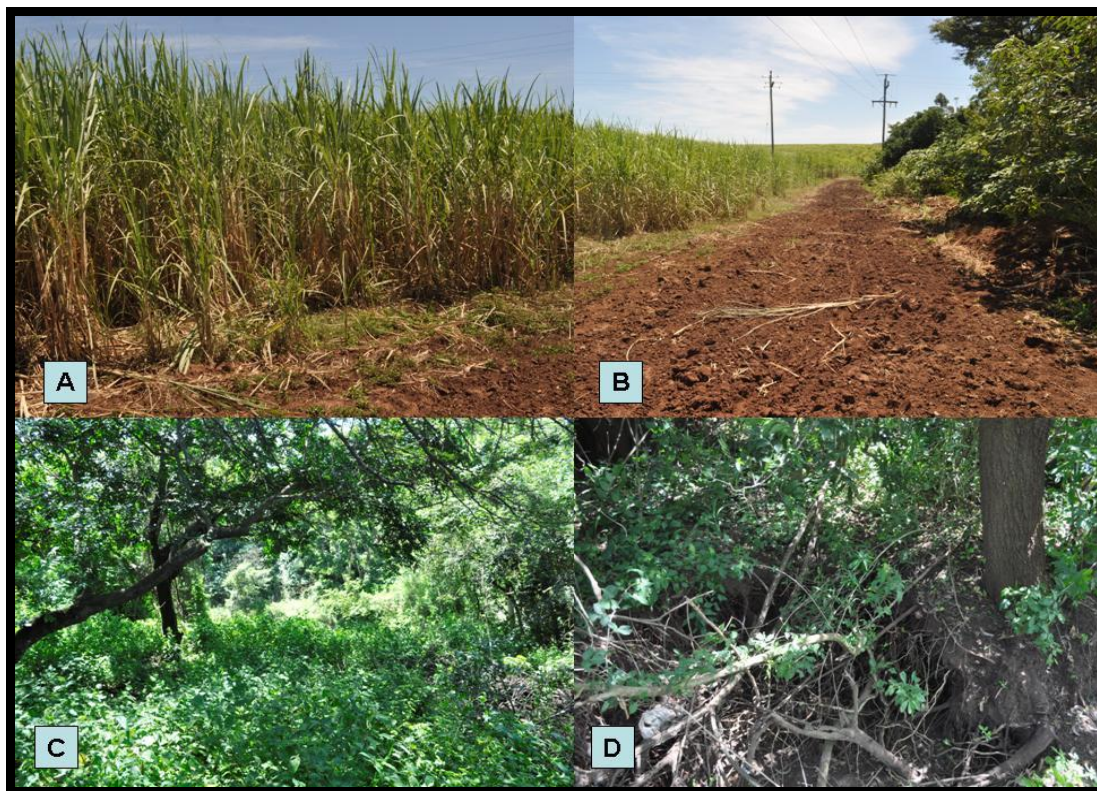
**Figure3.** A collage of photographs displaying the current impacts on the vegetation surrounding the Nseleni Bride site. **A:** The site is situated adjacent to large scale agricultural activities (sugar-cane plantations) which have completely transformed the vegetation. **B:** The scraping of roads as well as clearing of power line servitudes restricts the riparian zone to the macro-channel banks. **C:** The understory vegetation has been transformed during the recent borehole exploration activities. The vegetation is dominated by pioneer weedy plant species as well as alien invasive vegetation. **D:** Macro-channel bank erosion and slumping occurs within the disturbed areas; especially on the southern banks of the Nseleni River.

- Wood harvesting and tree clear-felling was observed along the riparian zone of the Nseleni River.
- Thicket formation and severe bush encroachment occurs in the old agricultural lands as well as old livestock enclosures as well as in certain areas along the Nseleni River by *Dichrostachys cinerea*

- Illegal poaching and hunting (dogs, catapults and snares) within the riparian zone of the Nseleni River,
- Riparian zone degradation due to removal of majority of hardwood tree species for wood harvesting. Several tree species were coppicing.

- Bank erosion from vegetation removal as well as sheet and rill erosion.
- Extensive littering especially adjacent to the current bridge.
- Deterioration in water quality due to presence of pit-latrines as well as washing and bathing activities within the adjacent wetlands and streams.

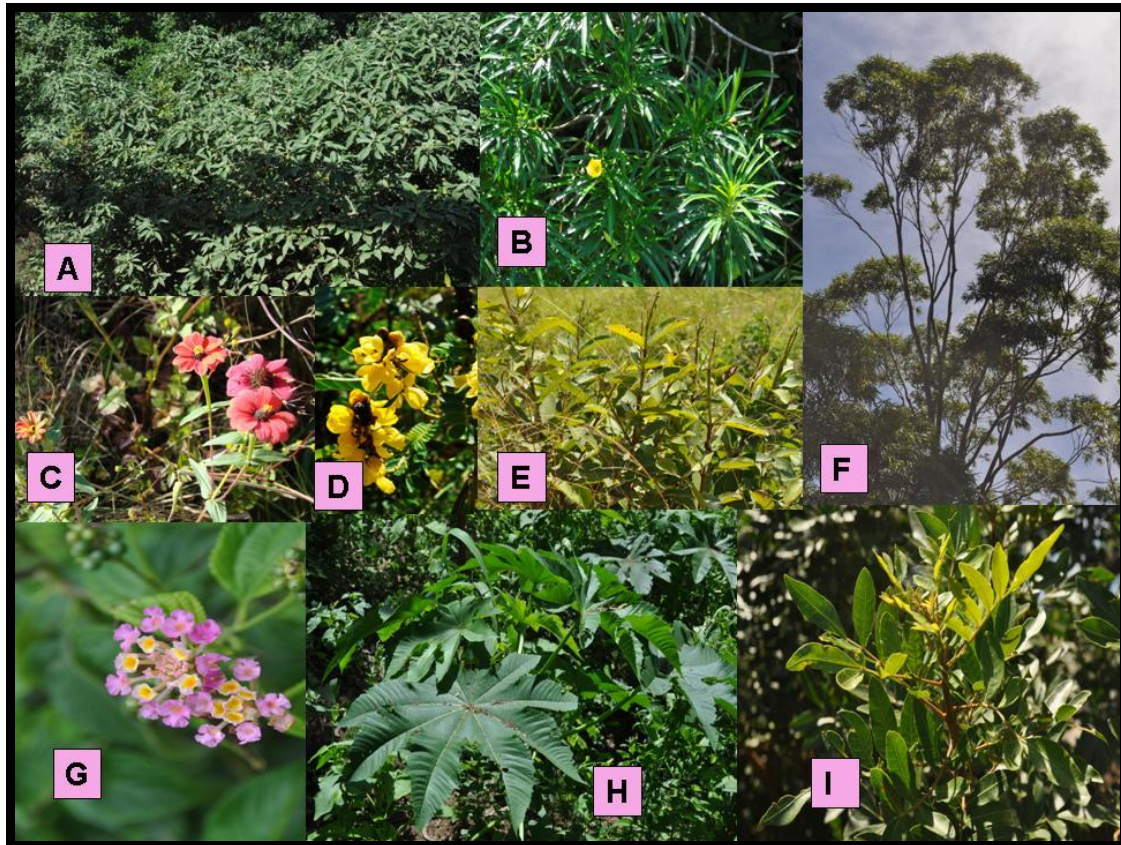
**Figure 5.** A conglomerate of photographs displaying the dominant alien invasive vegetation observed within and immediately adjacent to the proposed Nseleni Bridge site. **A:** Bugweed (*Solanum mauritianum*\*) Category 1b Weed, **B:** Yellow Oleander (*Thevetia peruviana*\*) Category 1b Weed; **C:** Redstar Zinnia (*Zinnia peruviana*\*) Weed; **D:** Peanut Butter Cassia (*Senna didymobotrya*\*) Category 1b Invader; **E:** Guava (*Psidium guajava*\*) Category 2 Invader; **F:** Saligna Gum (*Eucalyptus grandis*\*) Category 1b/2 Invader; **G:** Lantana (*Lantana camara*\*) Category 1b Weed; **H:** Castor-oil Plant (*Ricinus communis*\*) Category 1b Weed and **I:** Brazilian Peppercorn Tree (*Schinus terebithifolius*\*) Category 1b Weed.

Exotic and invasive plant species were categorised according to the framework laid out by The Conservation of Agricultural Resources Act (CARA) (Act 43 of 1983). CARA defines weeds as alien plants, with no known useful economic purpose that should be eradicated. Invader plants, also considered by the Act, can also be of alien origin but may serve useful purposes as ornamentals, as sources of timber, or may have other benefits (Henderson, 2001). These plants need to be managed and prevented from spreading.

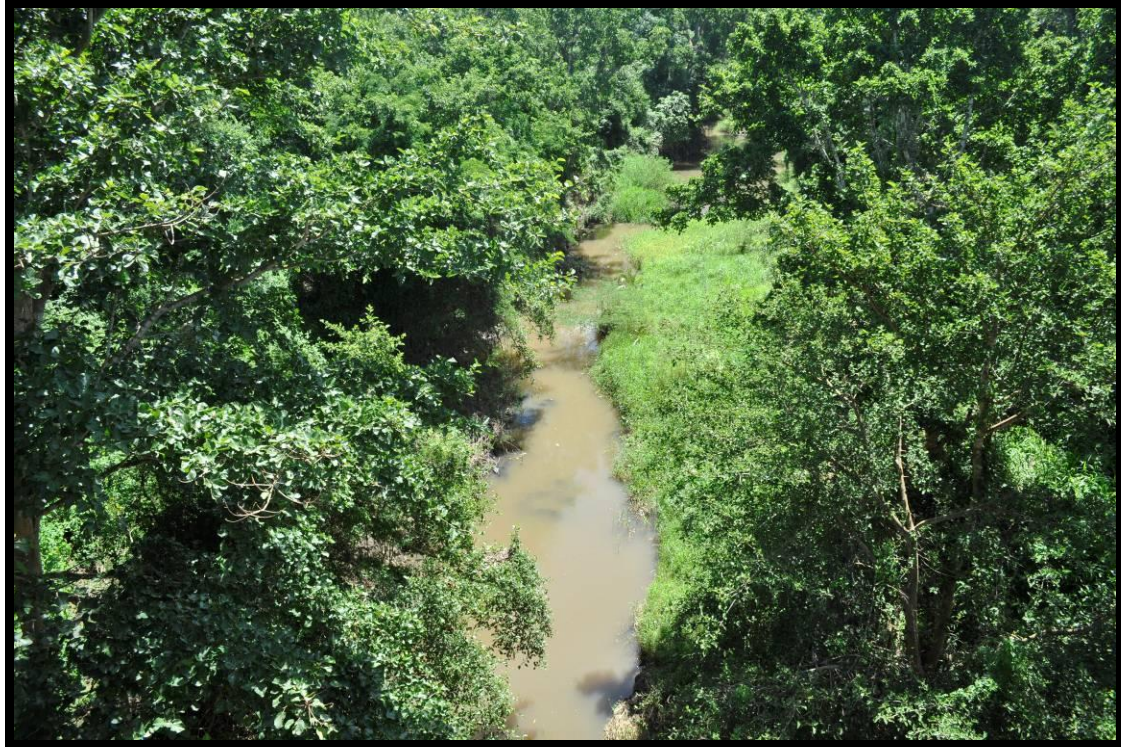
**The rivers and associated Subtropical Alluvial riparian zone are considered to be of conservation importance for the following reasons:**

- The indigenous riparian vegetation along rivers within Kwazulu-Natal, and rivers in general throughout the Kwazulu-Natal coast, are in danger of being completely replaced by alien invasive species. Any remaining areas of indigenous riparian vegetation within Kwazulu-Natal must therefore be regarded as sensitive and of high conservation importance.

- Rivers and drainage lines are longitudinal ecosystems, and their condition at any point is a reflection of not only upstream activities, but also of those within adjacent and upstream parts of the catchment (O'Keefe 1986). Any impact on the riverine area within the study area is therefore also likely to impact on upstream and downstream areas.
