## **PROGRESS REPORT**

### **Archaeological Monitoring of Tower 204 and Previously Unidentified Site at Tower 205**

### **PROPOSED 400KV TABOR-WITKOP TRANSMISSION LINE, LIMPOPO PROVINCE**

March 29, 2012

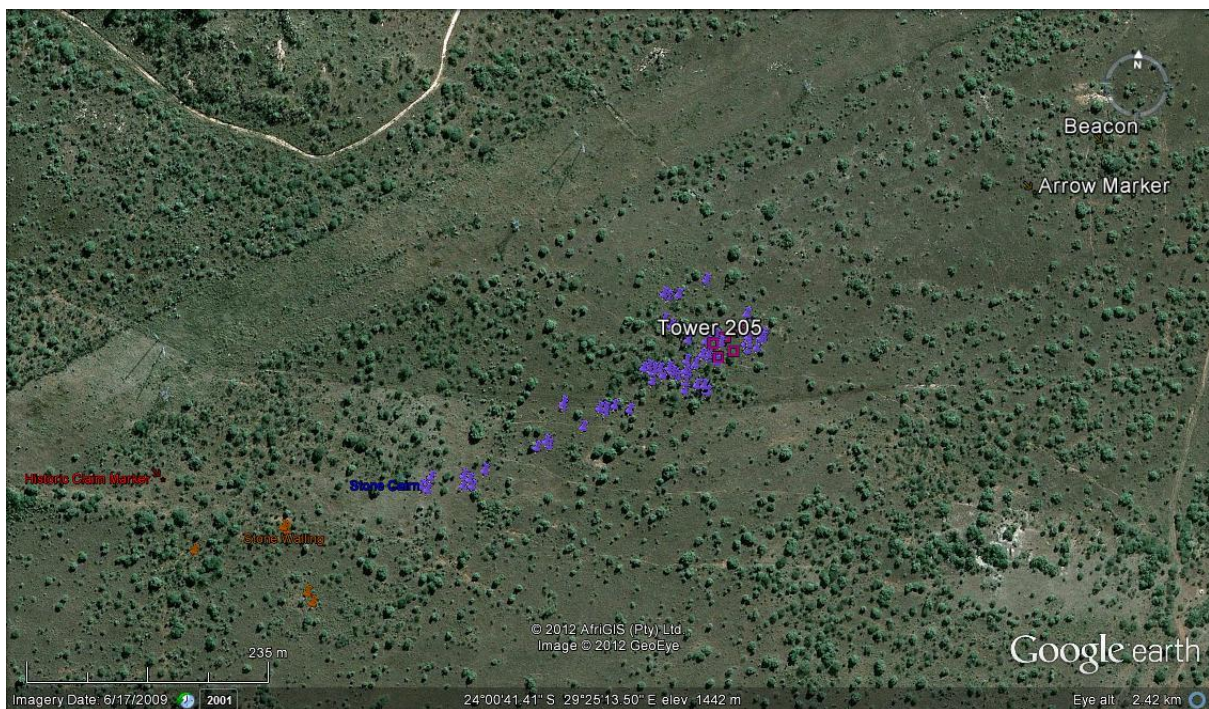
**Fig 1.** A general view of the archaeological sites discovered in close proximity to Towers 204 and 205. The red marker indicates the site identified by J van Schalkwyk in 2010, while the rest of the markers indicate the location of new sites identified between 19 & 28 March 2012. The foundations of Tower 205 are indicated with pink squares.

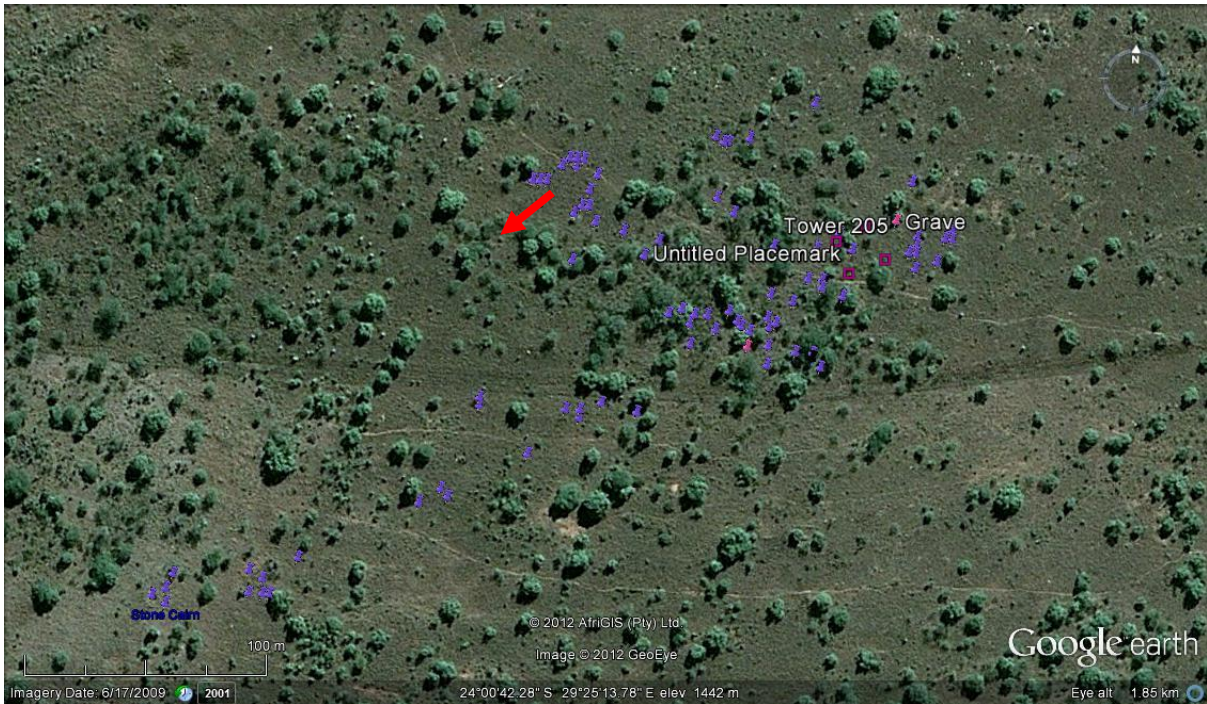
**Fig 2.** A closer view of the burials. The lowermost grave indicated by a pink pin was accidentally excavated, which led to the discovery of the cemetery. The grave that was to be excavated and relocated at request of the Eskom representative is indicated with a pink pin. The excavation was, however, not completed and closed up when it was decided to move the tower in a more south-westerly position. It is quite clear that the north-western foundation (Leg C) is positioned almost on top of another burial, less than a metre from the grave. On March 28 and 29, 2012, the archaeologist also documented more graves which will not necessarily be affected by the power line, but since it forms part of the same component under investigation, this was a necessary precaution. This task was however not completed due to dense shrubbery. It is, however, clear that more graves are present in the area; the general area and direction of these other graves are indicated by a red arrow.

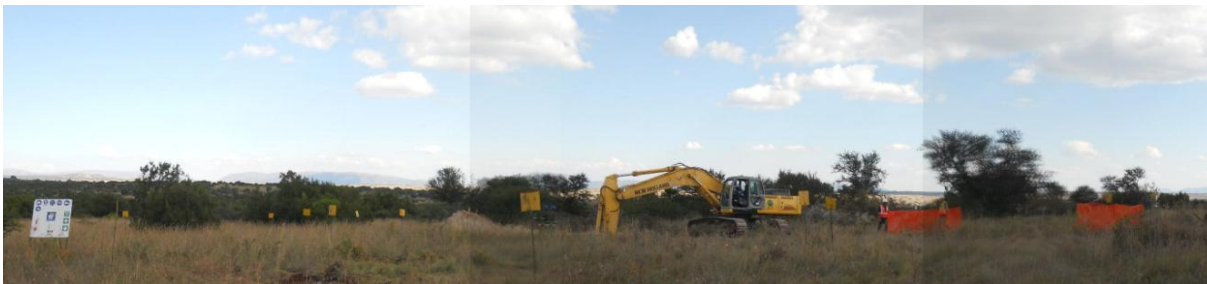
**Fig 3.** The distribution of some of the graves at Tower 205 at ground level. Some of the graves in danger to be overlooked by traffic are temporarily indicated by the yellow markers, while the orange netting mark two graves which are either close to the thoroughfare for the excavator and other traffic or one leg of the tower.

- All graves should be left intact and not be disturbed in any way, at any time;
- an entrance road to the tower should be clearly marked;
- it should be permanently isolated by demarcating a buffer zone of at least 10 metre around it, starting from the outermost graves that can be located. Standard fencing material should be used to permanently remain in place; and
- no ground clearing machinery or vehicle traffic is to be allowed onto the site at any time.
- It is further advised that an archaeologist be present when the area is demarcated and during the construction of the tower, should more cultural remains be uncovered to prevent accidental damage of it;
- Reconnaissance of the immediate area should also be undertaken in an attempt to contextualise the burials.

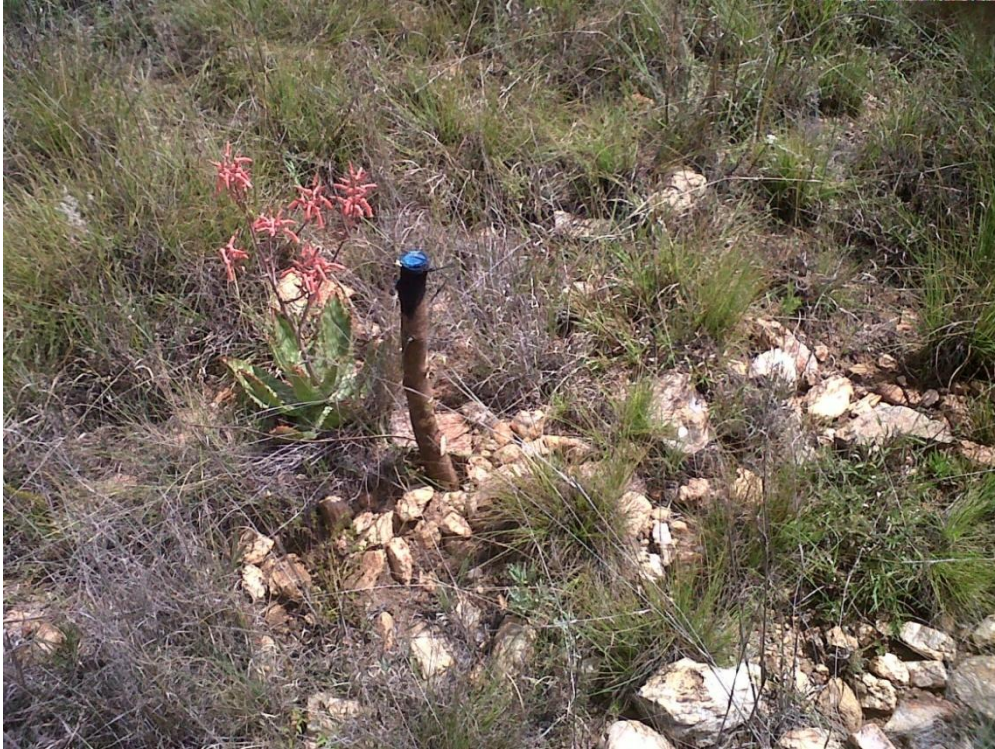
**Fig 4.** Grave 1 (March 19, 2012). Location:  $24^{\circ}00'39.05''S$   $29^{\circ}25'16.49''E$ . The graves were identified by stacked rocks and pebbles of various sizes. For better visibility of these graves each was marked with a wooden stake dipped in blue paint. This effort was, however, not very successful: it was difficult to drive the stakes into the soil, they were often shorter than the surrounding plant growth and the blue colour didn't stand out well.

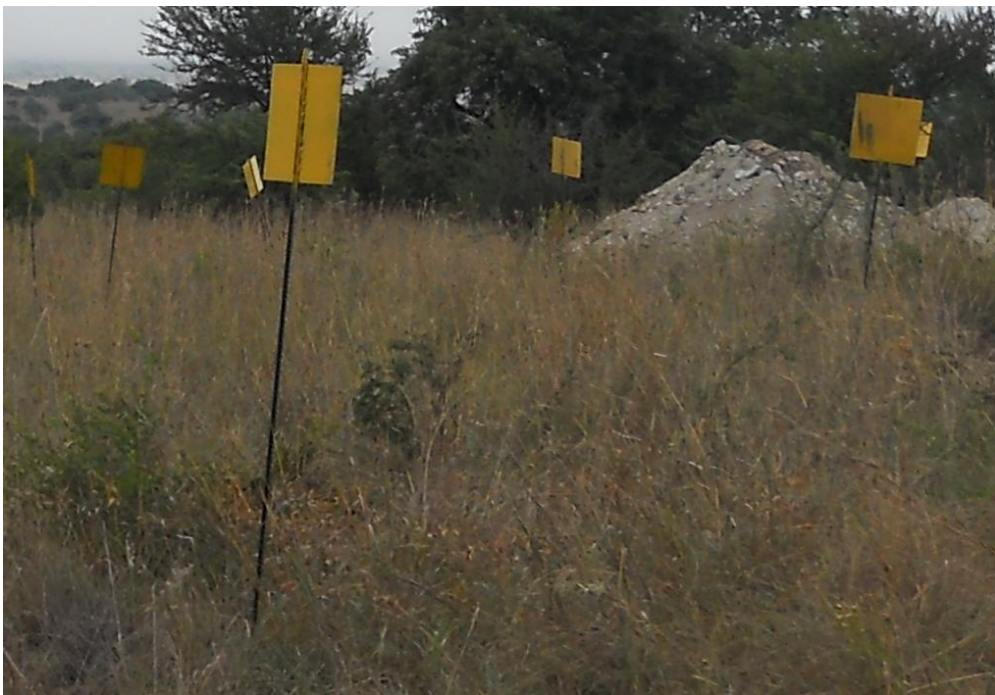
**Fig 5.** It was decided to use the longer, yellow markers to indicate the position of the graves. These were much more successful and grave locations were visible from a distance. Since there were not enough markers, they were mainly used where there was a possibility that the graves could be damaged by vehicle or excavator traffic.

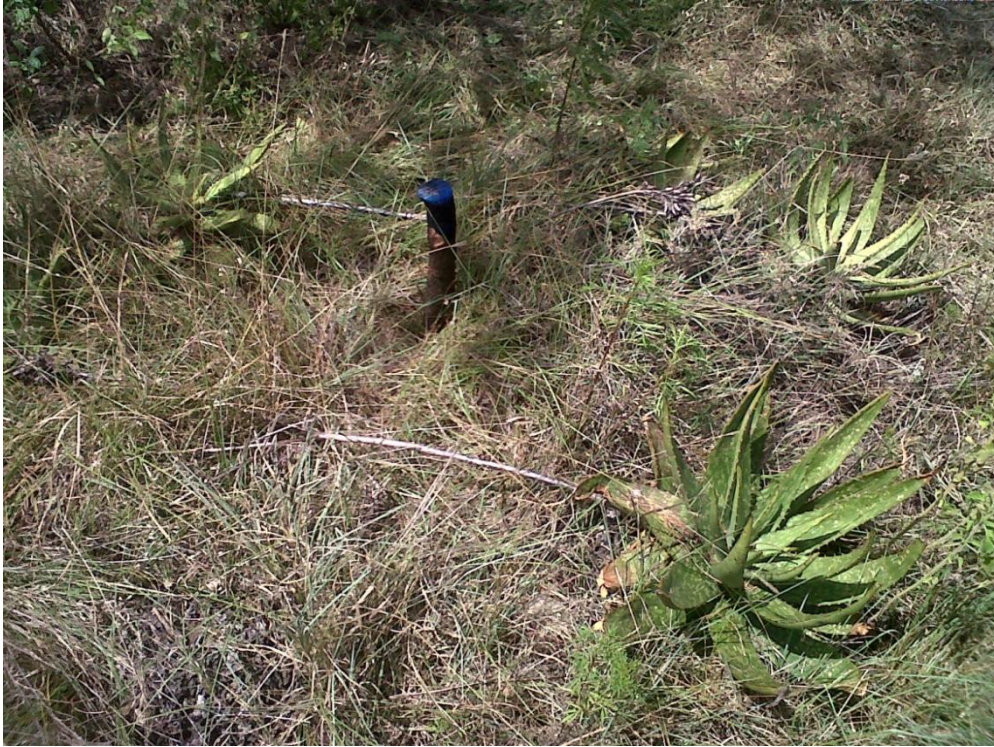
**Fig 6.** Grave 8 (March 19, 2012). Prior to bush clearing, most of the graves were covered in thick vegetation and were totally invisible. In the example above it is clear that, even after clearing had commenced, some of the graves were only detected by their raised surfaces. More than one hundred graves were detected, yet there still may be the same amount covered by the vegetation.

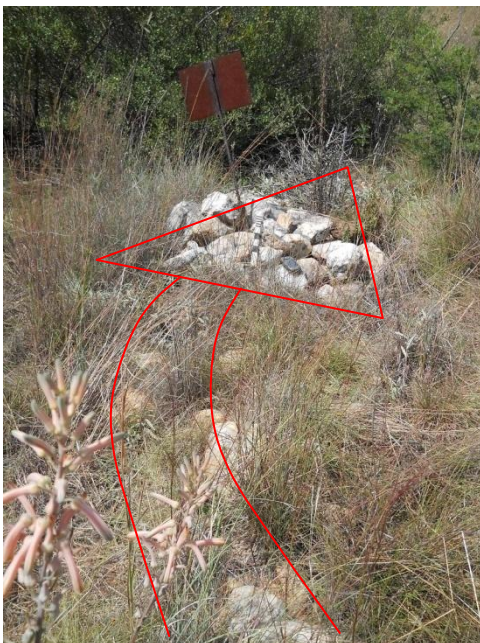
**Fig 7.** Arrow shaped feature.

Location: 24°00'35.60"S 29°25'27.40"E. A (gold?) claim marker is located close to Tower 204. It consists of white quartz and other light coloured rock roughly arranged in the shape of an arrow. A rusted nameplate welded onto a steel rod is placed in an upright position almost at the centre of the arrow tip. This feature has a low significance; its purpose can only be speculated about. It is possible that it could be a claim marker, but more and similar examples will reinforce this argument. Further research could be undertaken.

- In the absence of more information the arrow feature (Figure 7) might seem not be of any great cultural significance. It is clear, however, that the feature was intentionally built and without doubt had relevance to some action that took place in the past. It is advised that it should be clearly demarcated for the duration of the tower construction in order for it to be avoided and should not be removed or damaged in any way.
- The beacon in Figure 8 is safe due to its location next to the well marked access road to Tower 204. It is, however, advised not to remove or damage it (or any of the other and similar beacons) in any way.

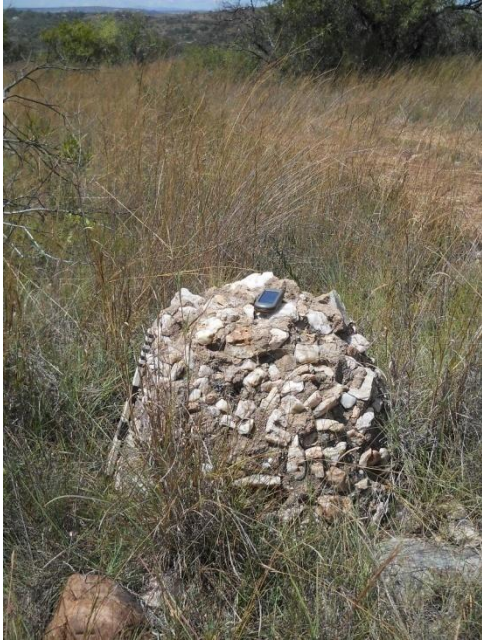
**Fig 8.** Stone and cement beacon.

Location: 24°00'34.00"S 29°25'20.80"E. This stone and concrete feature stands next to the access route to Tower 204. There are more further into the field. The age and purpose of it is unknown, but it is clearly meant to be a beacon of some sorts. Similar structures were used in the recent past (60 years +) to demarcate an area destined for building or marking of a garden/farm border. In order to assess its value, further research will have to be undertaken.

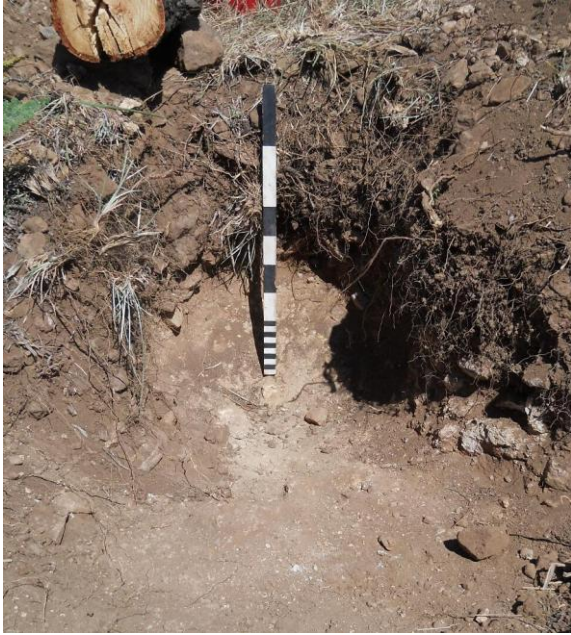
**Fig 9.** The excavation which was initiated before final decision about the position of Tower 205. It was excavated to approximately 45 cm before it was halted. Some pottery sherds and undiagnostic fragmented bone were retrieved from just below surface (see the image below).

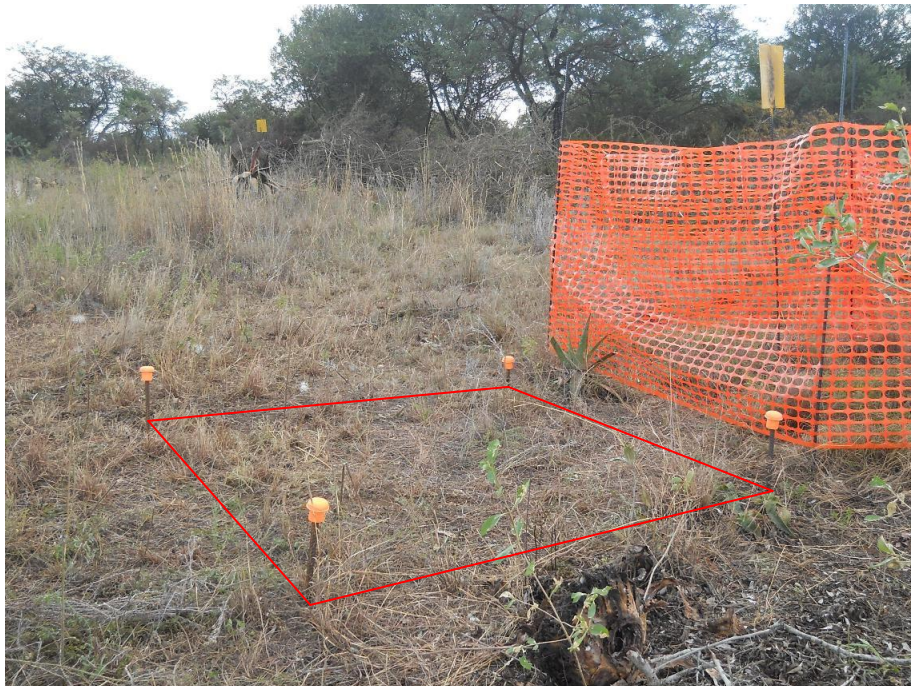
**Fig 10.** The position of Leg C of Tower 205 is marked with steel rods and yellow caps (indicated with a red square). The burial is temporarily demarcated with the orange netting.

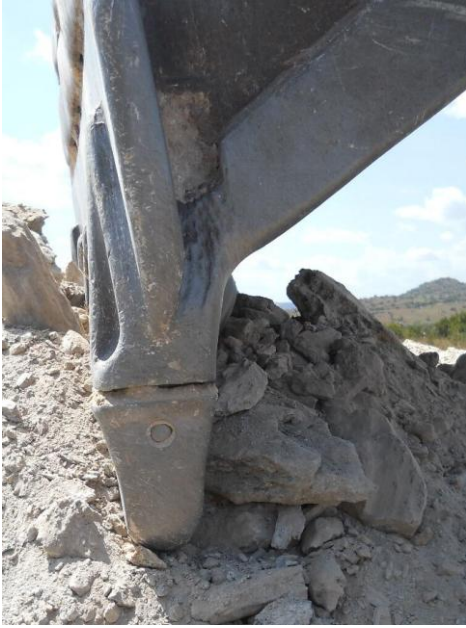
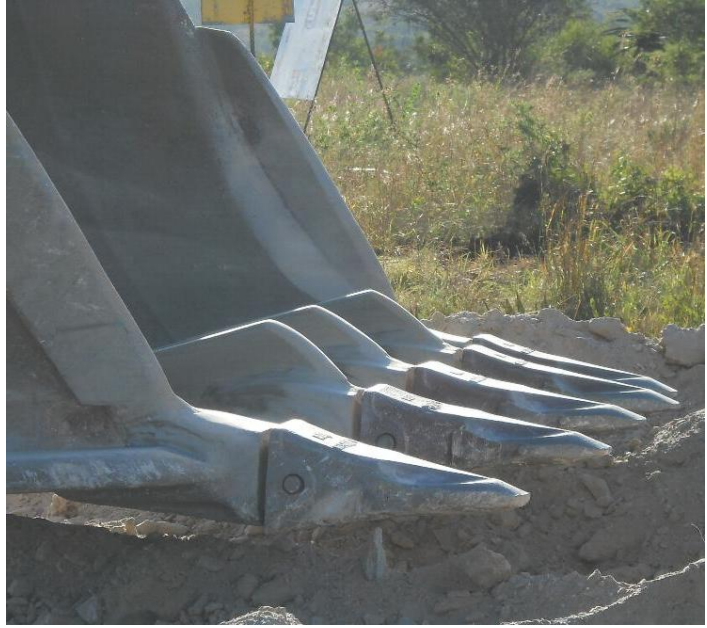
Excavation commenced of Legs A, B and D (keeping Leg C, the most sensitive area, for the last), but during the progress it became clear that the excavator's bucket teeth were too blunt to excavate; the operator had to slew it to break through the rock. The archaeologist prohibited any further excavation until the bucket teeth were replaced. Apparently an order had already been placed for the replacement three weeks prior. Excavation continued the next morning with a smaller excavator from Fred's Towing being brought in, which was assisted by the larger one used previously.

**Fig 11.** Clearly visible in the image at left are the bucket teeth before replacement the next day (at right).

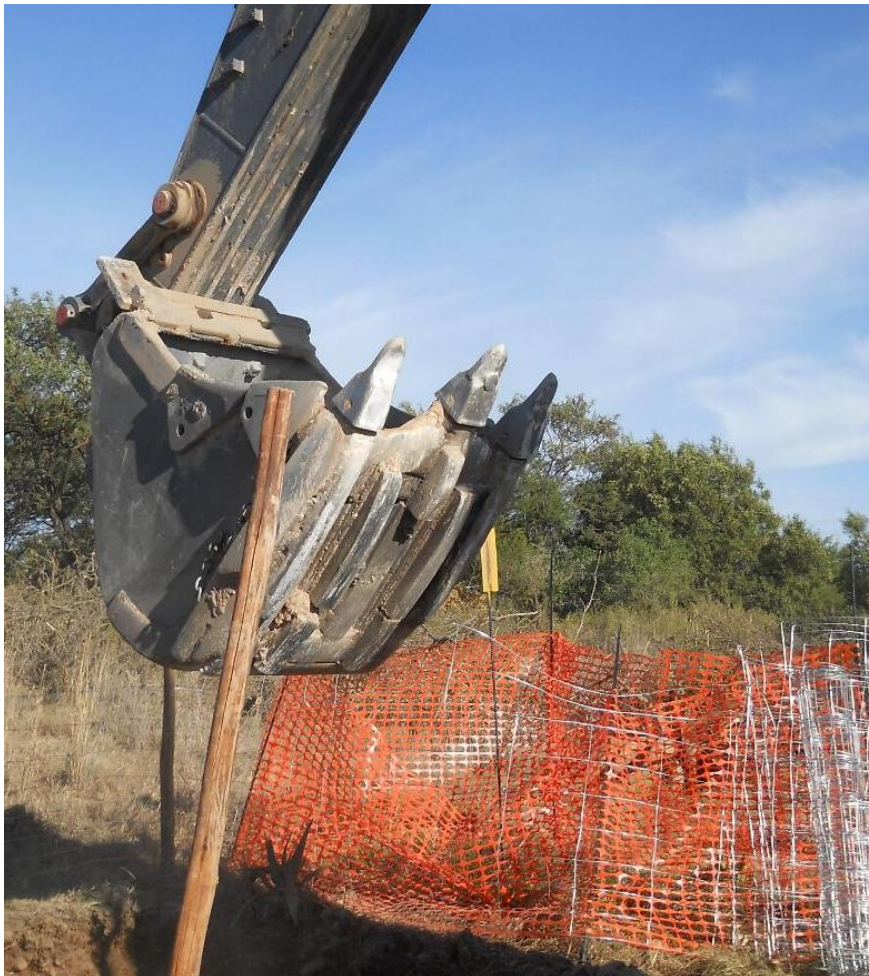
**Fig 12.** The close proximity to the burial, and the actual danger of it being damaged, is clearly expressed in this image.

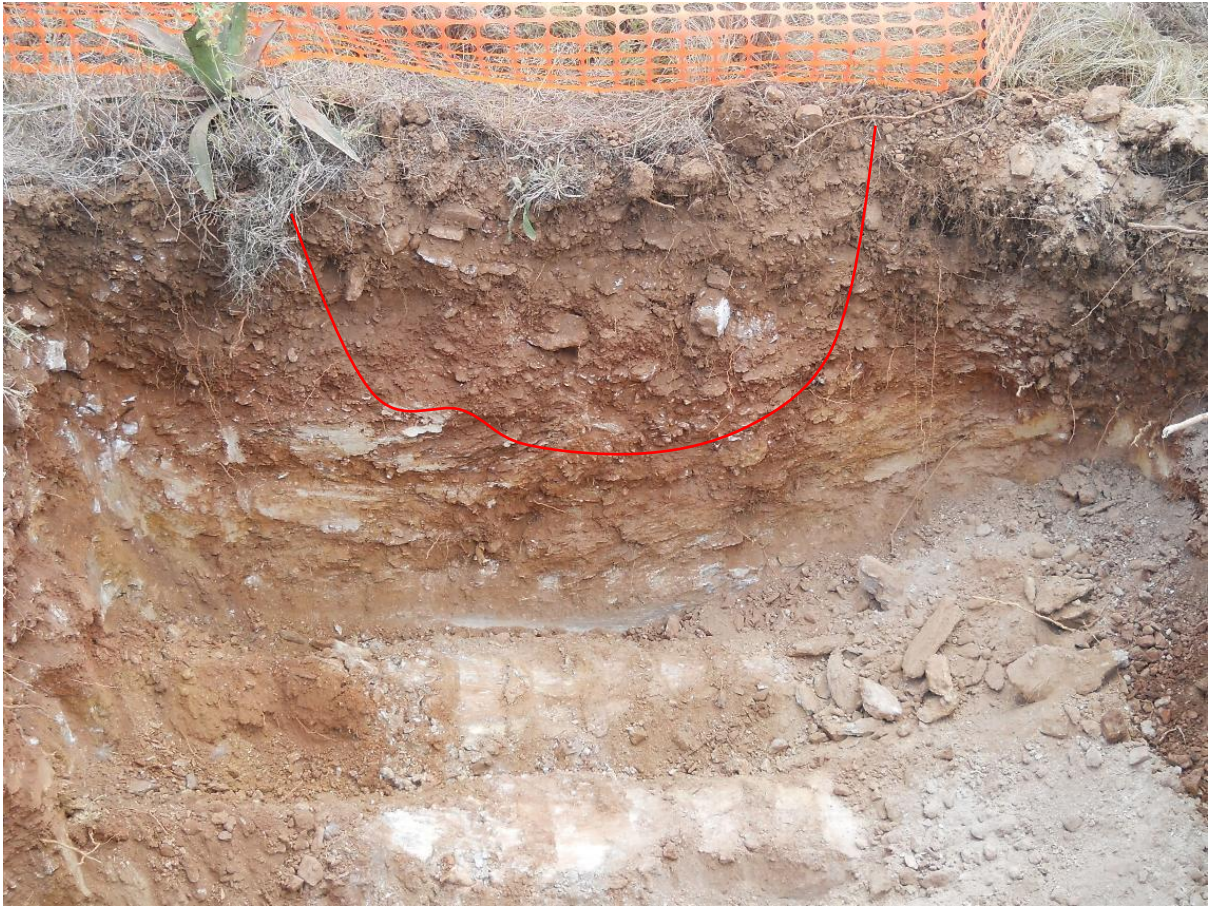
**Fig 13.** The disturbance of soil from the dug grave is visible (delineated in red). It is clear that the excavation cut through a small part of the grave. No skeletal material, however, was visible or was removed. The excavation was completed without any further damage to the burial.

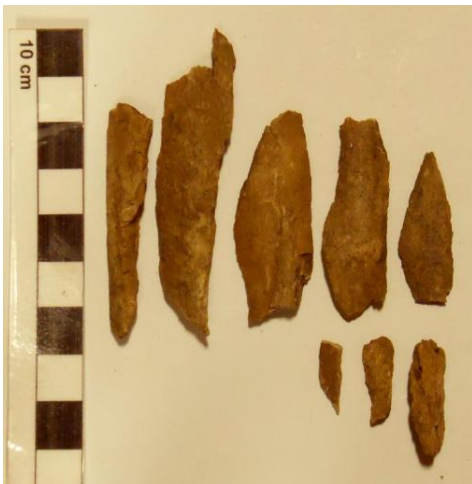
The animal bone is undiagnostic due to the severe fragmentation. It is clear, however, that it was intentionally broken or cut, probably during slaughtering. Its presence in the cemetery could be indicative of a ritual performed there to appease the ancestral spirits.

**Fig 16.** Fragmented bone of animal origin. These were also located under the cairn among the pottery sherds.

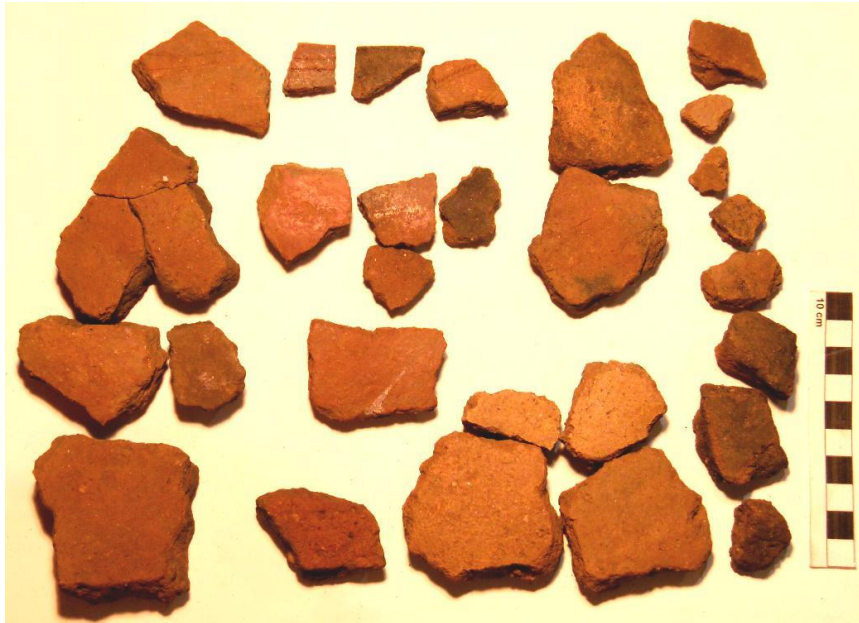
**Fig 14.** Partially excavated grave (No. 12, March 26, 2012, 24°00'40.50"S 29°25'17.70"E). Pottery sherds of various thicknesses, texture and colour were discovered on the site. A few decorated pieces and pot lips are among these, as well as some sherds indicating the use of red oxide and graphite as part of the decoration.

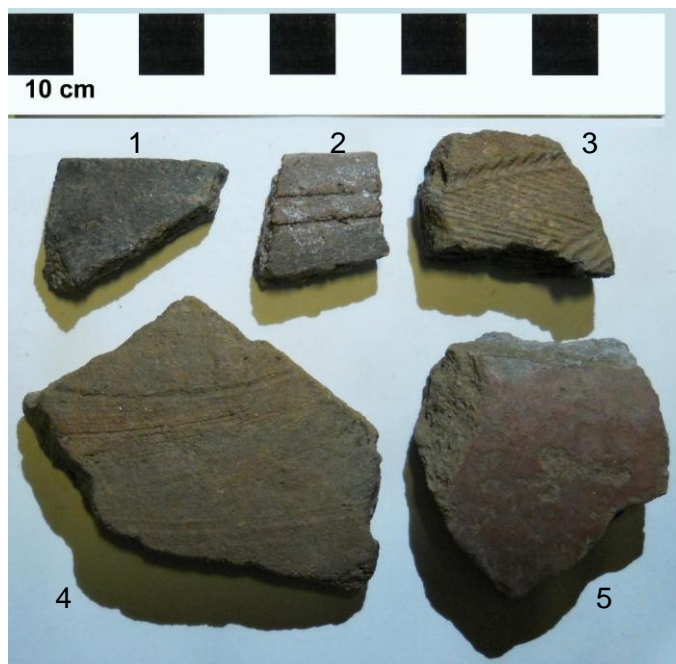
**Fig 15.** The decorated pottery sherds found under the cairn.

- Sherd 3 is characteristic of the Eiland facies which dates to AD 1000 to 1300. Its main distribution area is along the Limpopo and Crocodile rivers in the Blouberg and Waterberg areas, but a small distribution has been identified in the Polokwane area. Eiland pottery has a characteristic herringbone design (Huffman, p 229).

- The other sherds include two lips, one with multiple incised bands separated by colour. Sherd 2 is an example of this with red ochre (not clear in the image) above the two bands and graphite below it. Other sherds, such as Sherd 5, shows an area decorated with red ochre. These are characteristic of the Icon facies of the Moloko branch from the Urewe Tradition. The distribution of this type of pottery covers a large area particularly in the Limpopo province from Musina, Bloubaai and Phalaborwa, inclusive of Polokwane, and stretch southwards to just north of Lydenburg in Mpumalanga. The most likely date for this pottery is AD 1300 – 1500 (Huffman, pp 183, 185). Icon is the earliest recorded facies of Moloko. In some places Icon incorporated earlier Eiland elements (Huffman, p 429).

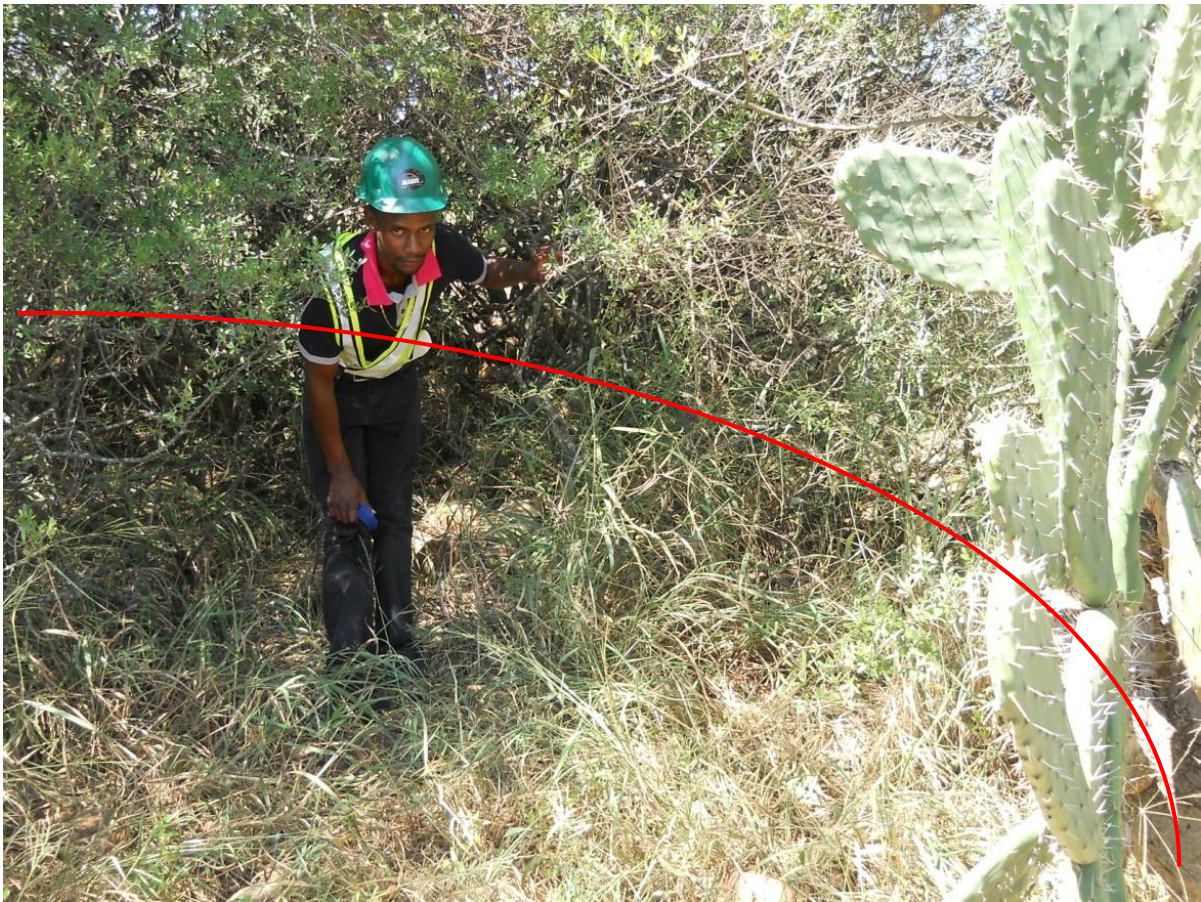
In the vicinity of Tower 206 the remains of stone walling were located which are indicative of permanent settlement. Although covered in thick vegetation, it is clear that these are circular structures. In most places the walls were apparently robbed by later inhabitants since only the foundation stones are still visible.

**Fig 17.** One of the better preserved stone wall structures passes behind the person which was used to indicate scale. The red line indicates the rounded shape, and although it is clearly visible on site, it is difficult to distinguish in the photograph due to the thick vegetation.

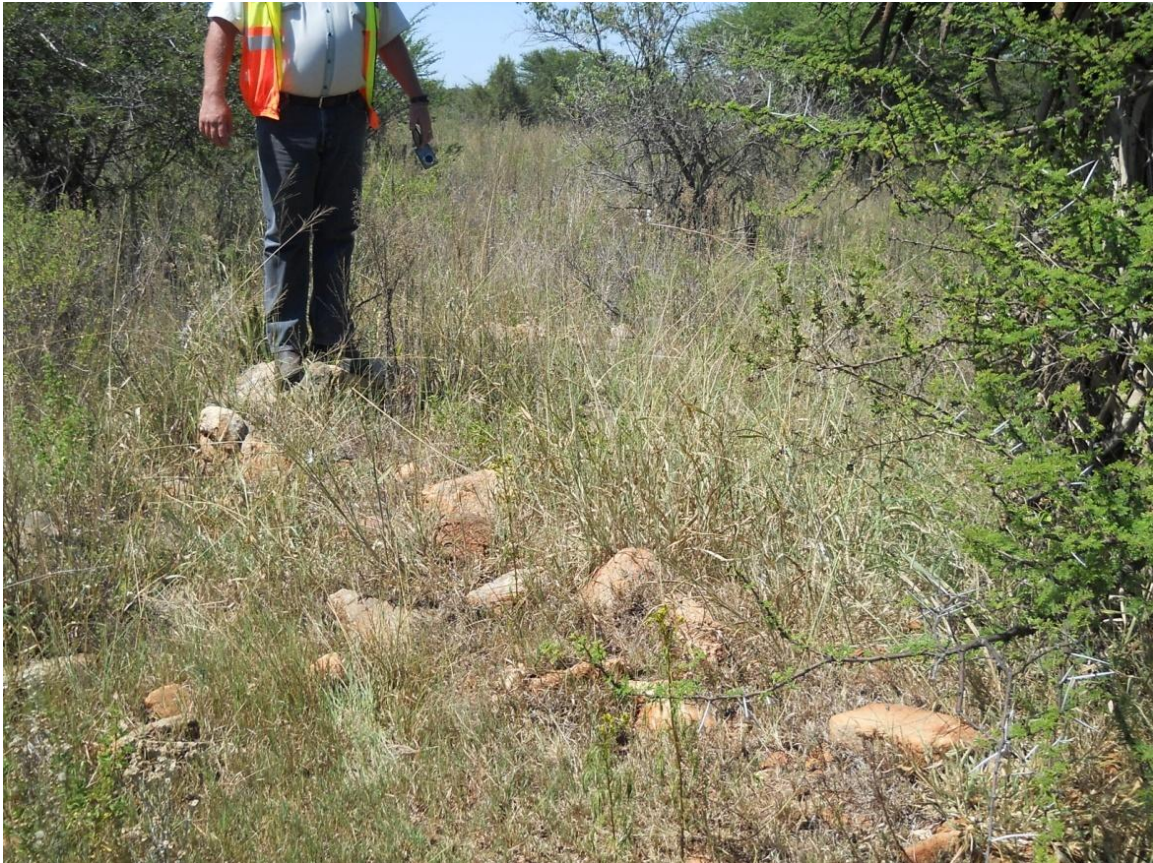
**Fig 18.** One of the robbed walls which are part of the same structure photographed in Figure 17.

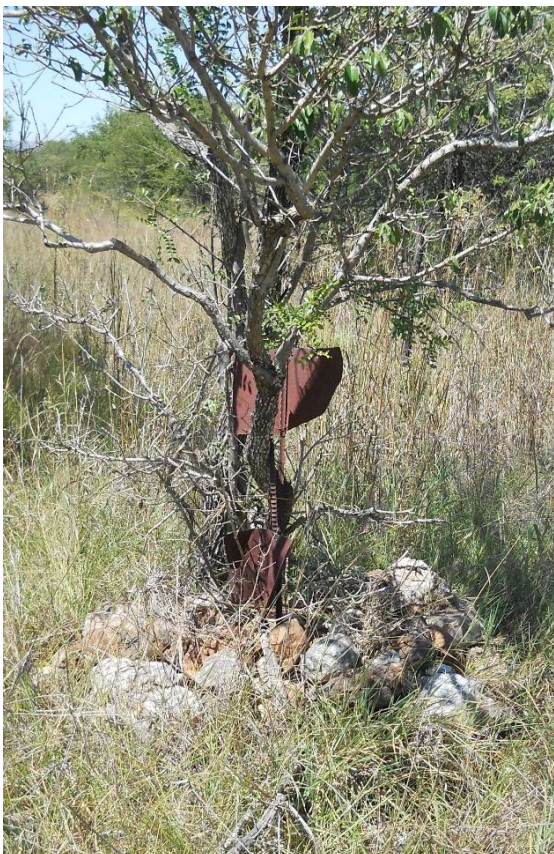
**Fig 19.** This feature was identified by J van Schalkwyk in 2010 as an “historic claim marker” ( $24^{\circ}00'45.94''S$   $29^{\circ}25'58.57''$ ).

Like the arrow marker in Figure 7, this could also be a claim marker, since it also consists of packed quartzite rocks and is also provided with a rusted nameplate welded onto a steel rod.

This feature could be linked to the similar feature in the vicinity of Tower 204, and should be treated likewise. It is advised that it should be clearly demarcated for the duration of the tower construction in order for it to be avoided and should not be removed or damaged in any way.
