PROGRESS REPORT 03 – April 10, 2012

Assessment of Archaeological Site at Tower 146

**PROPOSED 400KV TABOR-WITKOP
TRANSMISSION LINE, LIMPOPO PROVINCE**

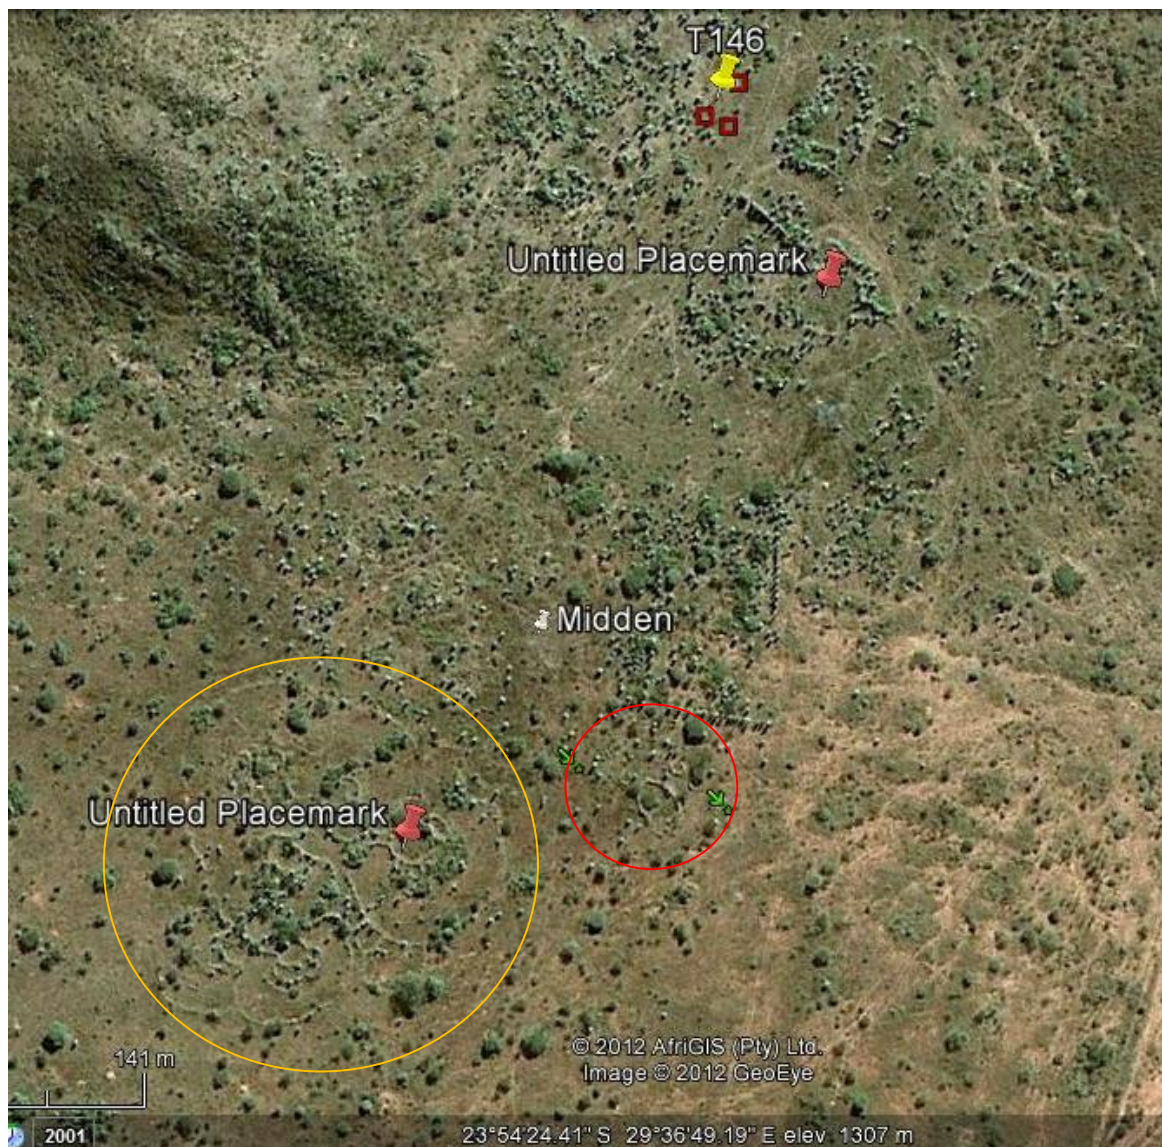
Fig 1. Three of the foundation markers for Tower 146 could be located. The one foundation at the bottom, right hand corner will afflict damage to a wall. Not visible on the Google map are many of the robbed foundations of the pre-colonial habitation, however, in some areas it is still visible, such as the one in the bottom left hand corner, roughly delineated in yellow. The red encircled area is another similar but smaller area. The green arrows indicate its borders.

- The tower should be moved outside the sensitive area. If necessary, one tower (self-supporting) could be erected on each side outside of the archaeological area.
- The area where the tower is to be placed should be excavated at the expense of the developer. This would include, inter alia, analyses such as radio-carbon dating, pottery, faunal and floral analysis, and if any human remains is recovered, human skeletal analysis. Eskom / Stefanutti Stocks Power could thus contribute to scientific research into the history of South Africa and set a good example for other similar companies.

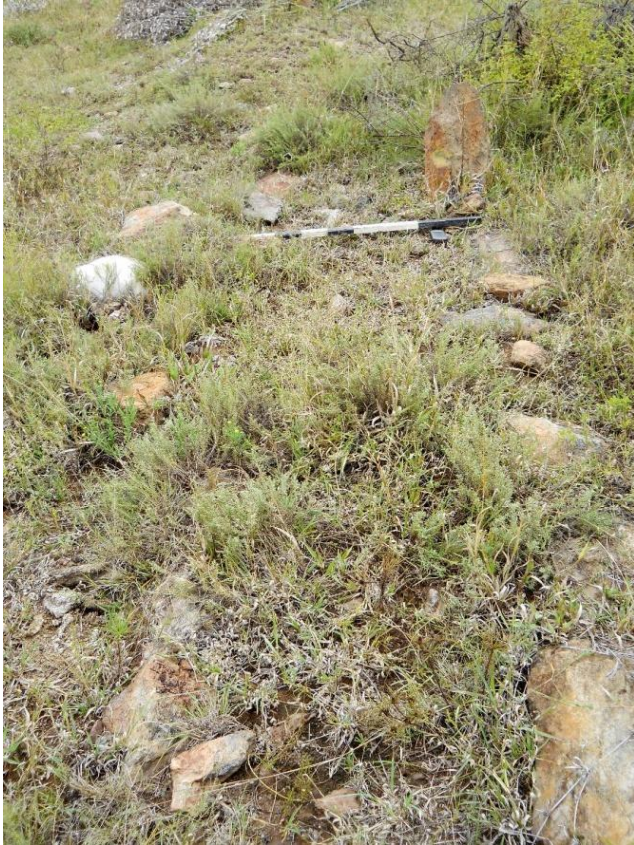
Fig 2. The foundation stones of a pre-colonial occupation are still visible in this image. Although it is clearly seen in this image as well as on the site, it is not visible in the Google Earth imagery. It was customary for later occupants of an area to rob the stones for their own dwellings. Proof of later occupation is seen elsewhere on the site.

The wall is approximately a metre wide, and was possibly a perimeter wall. Construction of such walls encompasses large stones for the outer facing, the core being filled in with rubble. Upright stones, such as the one behind the gauge, usually mark an entrance.

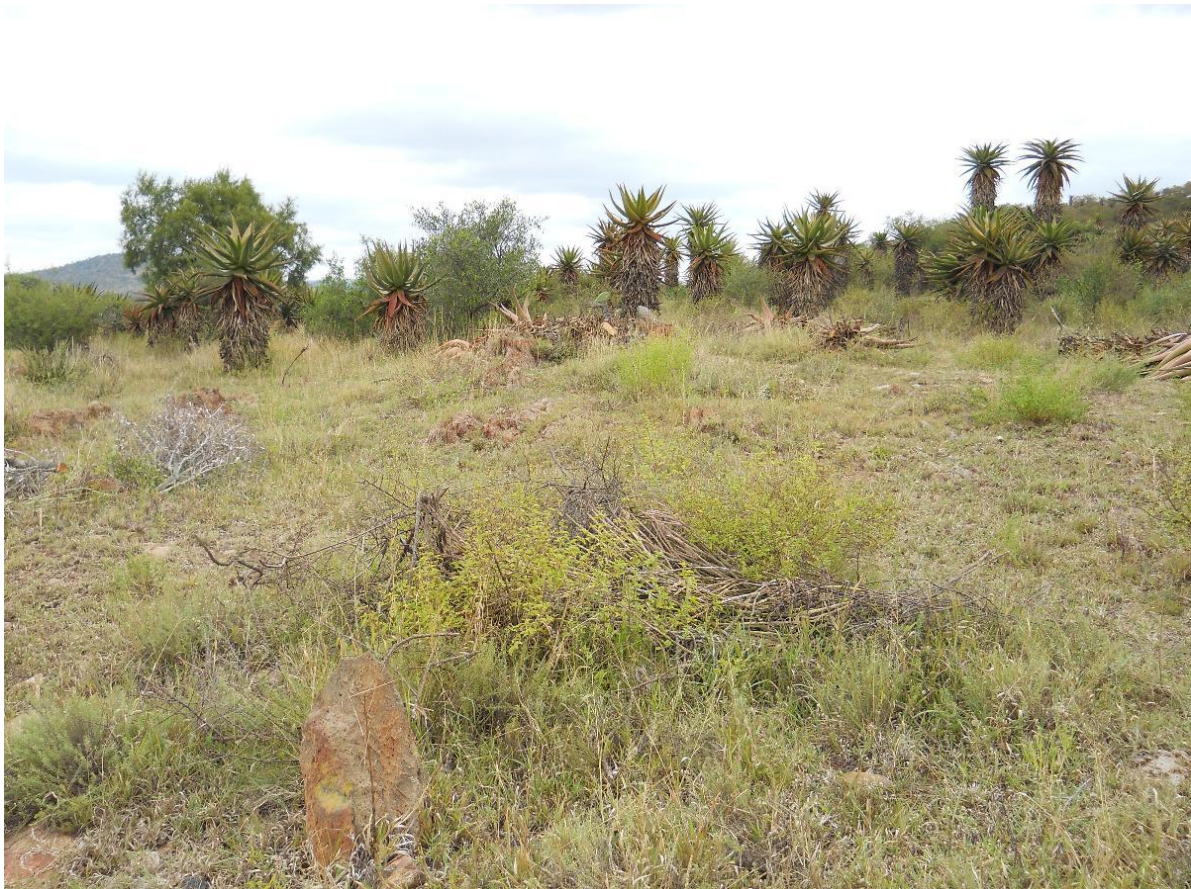
Fig 3. In the image below, the continuation of the wall is seen by the slightly raised surface.

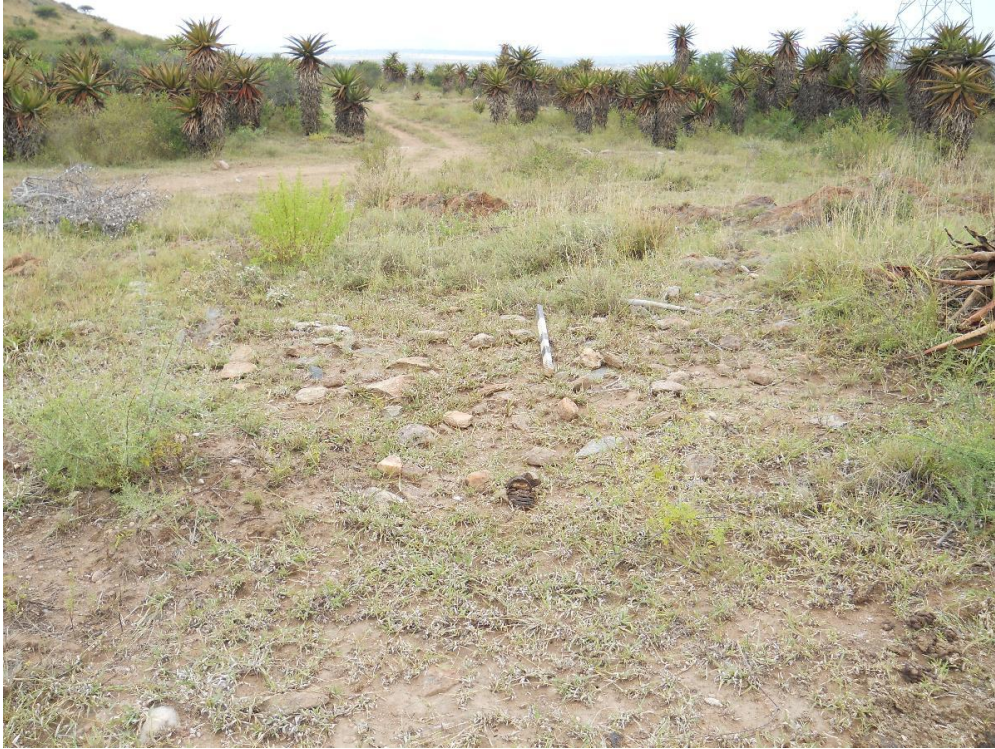
Fig. 4. Stone rubble, as seen in this image, could indicate the presence of a structure or was left behind by the wall robbers. This apparent featureless section of the settlement could have contained thatched huts during pre-colonial times. No evidence of such structures would be recovered unless it had burnt down: the floors consisted of clay and dung and would have been fired; charcoal around the perimeter of a hut would indicate the withes used for the supporting structure. Unless excavated, the use of this particular space is speculative.

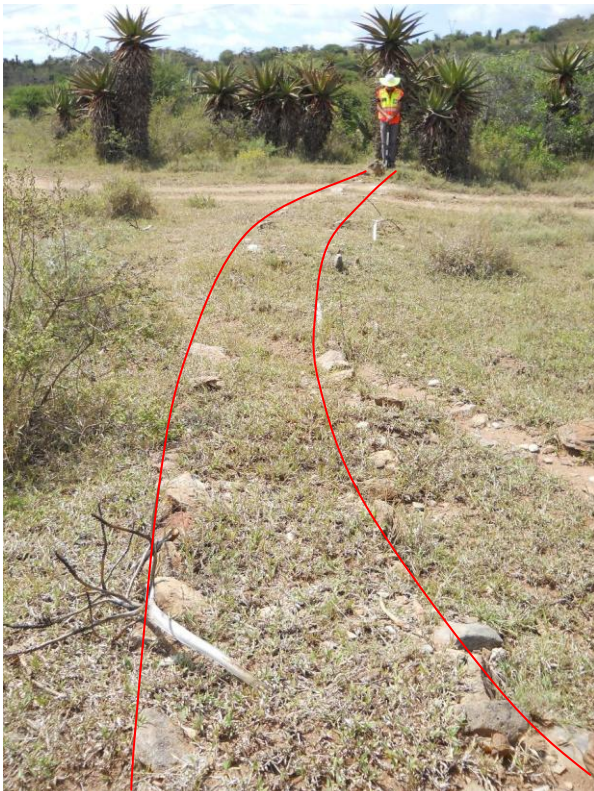
Fig 5. The access road ($23^{\circ}54'19.70''S$ $29^{\circ}36'49.90''E$) intrudes on the perimeter wall in at least two places. This image was taken in the vicinity of the planned Tower 146.

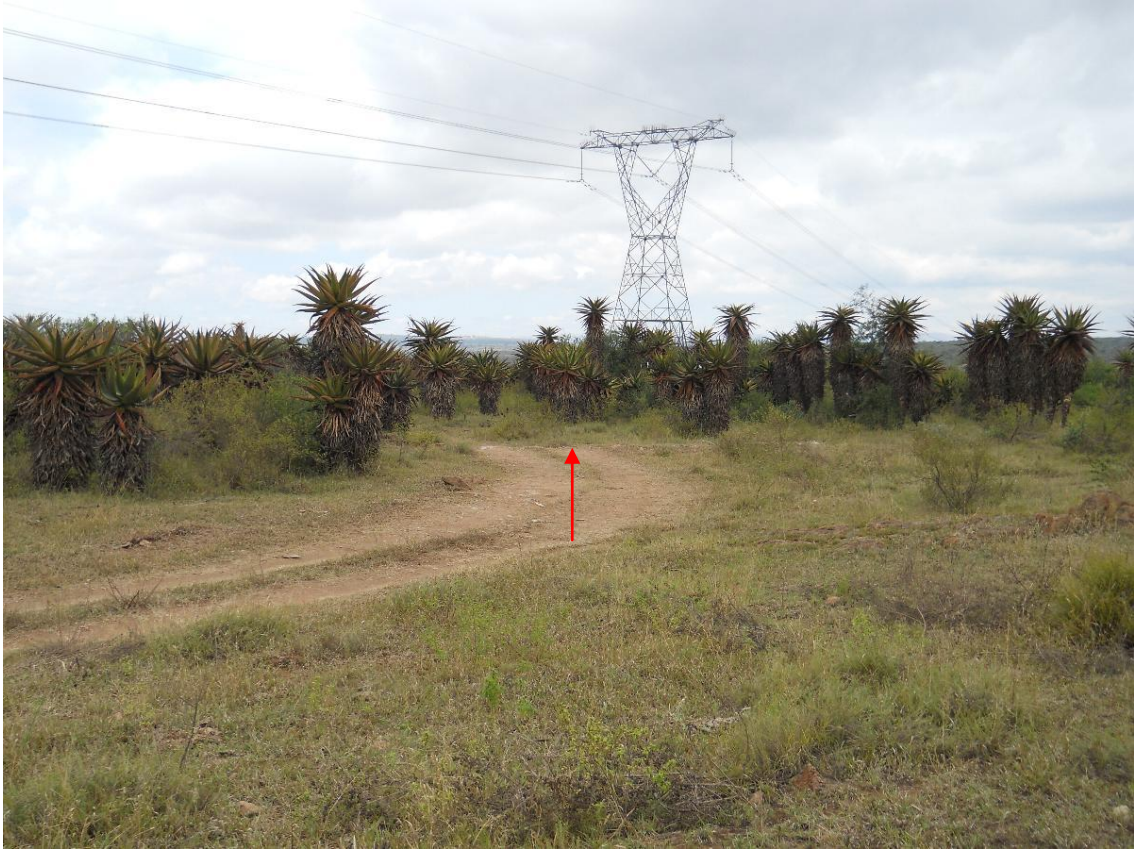
Fig 6. Another viewpoint of the intrusion of the access road. It is easily seen by the slight raise of the soil on the surface.

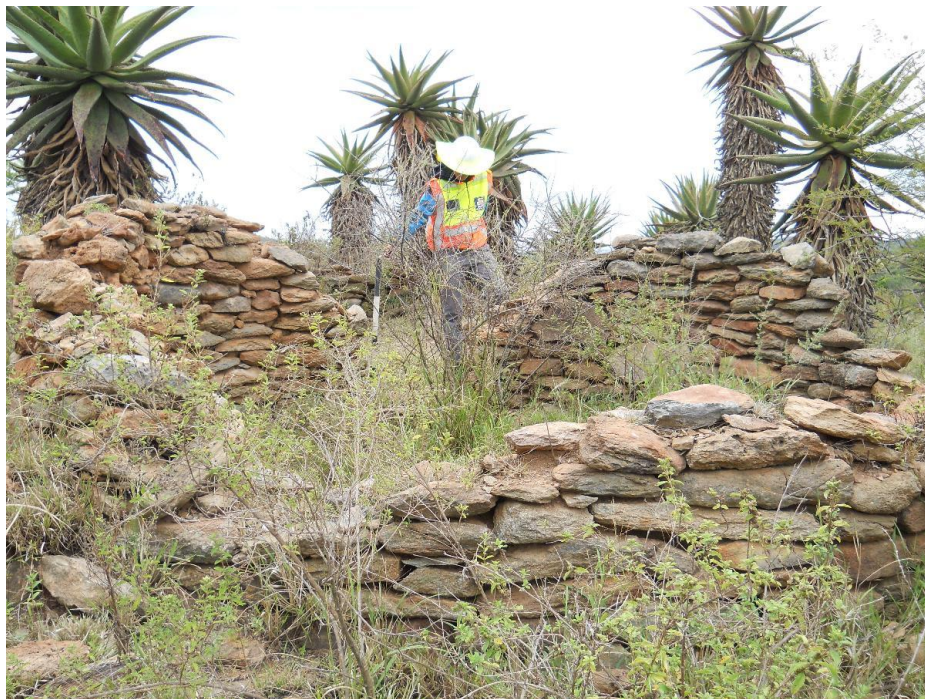
Fig 7. Visually more striking than the remains representing the occupation during pre-colonial times, are the stone structures a bit higher up the slope of this hillock. These not only represent the later inhabitants, but would also contain the stone robbed from the older site.

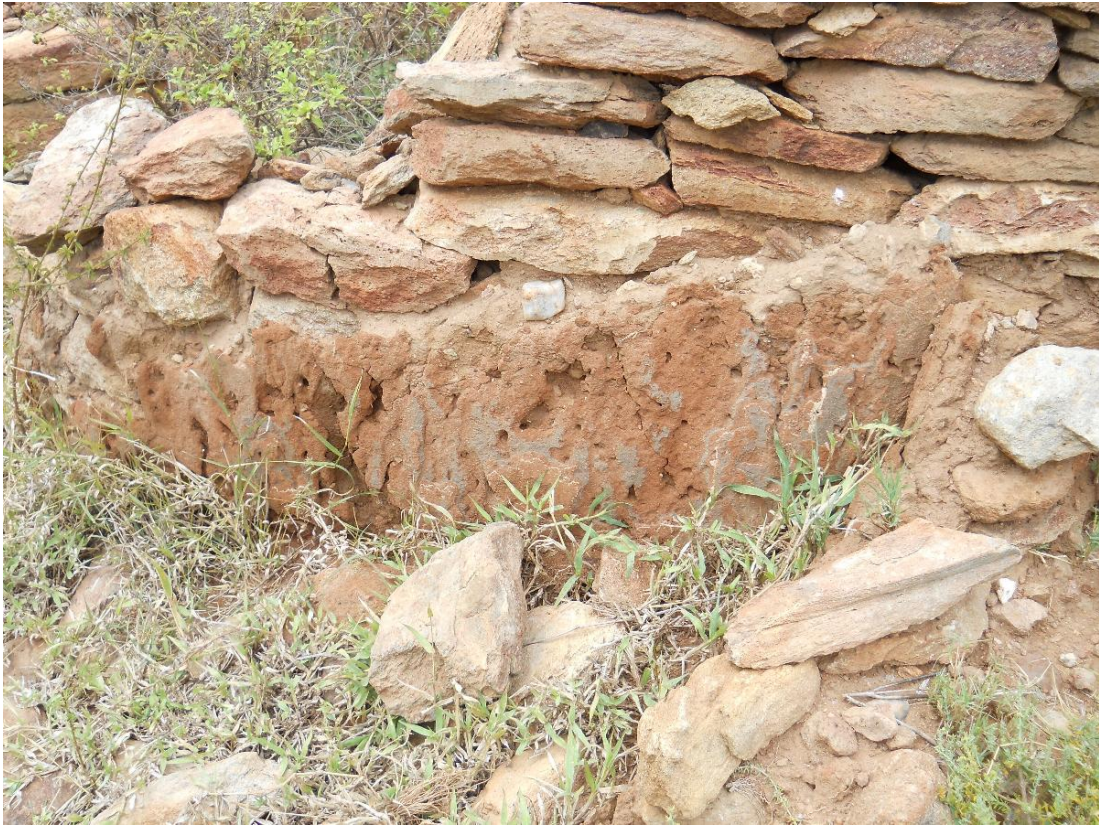
Fig 8. Some of the units still contain clay plastering on the external as well as internal surfaces. The approximate co-ordinates for this structure are 23°54'18.80"S 29°36'46.80"E.

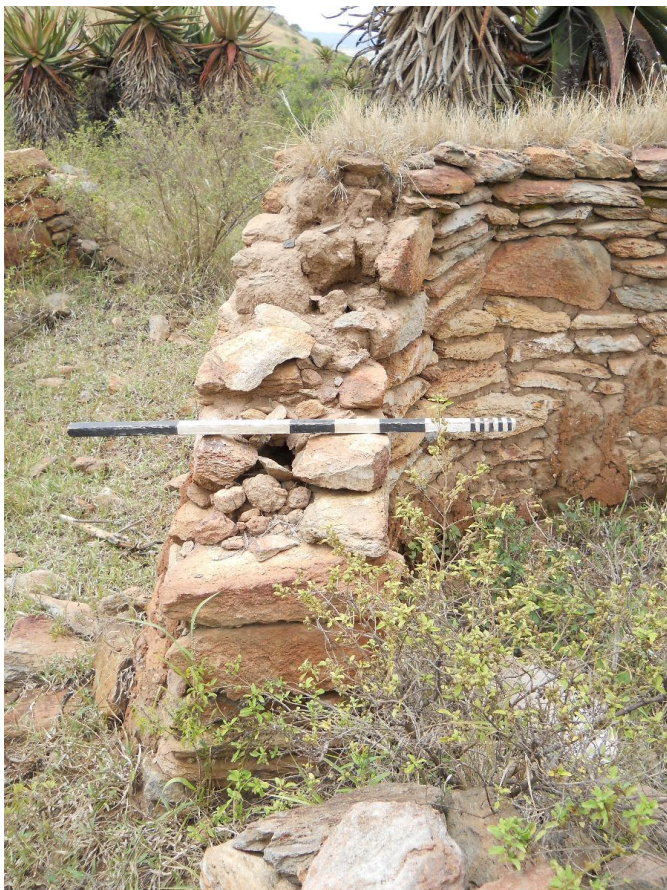
Fig 9. Another characteristic of this later occupation is the mud/clay used in between the stone coursing.

These structures were possibly houses. In the earlier structures, stone walls would indicate a sheep/goat/calf enclosure or the demarcation of a living unit, but not a house. The fact that these walls were plastered also indicates that these were houses.

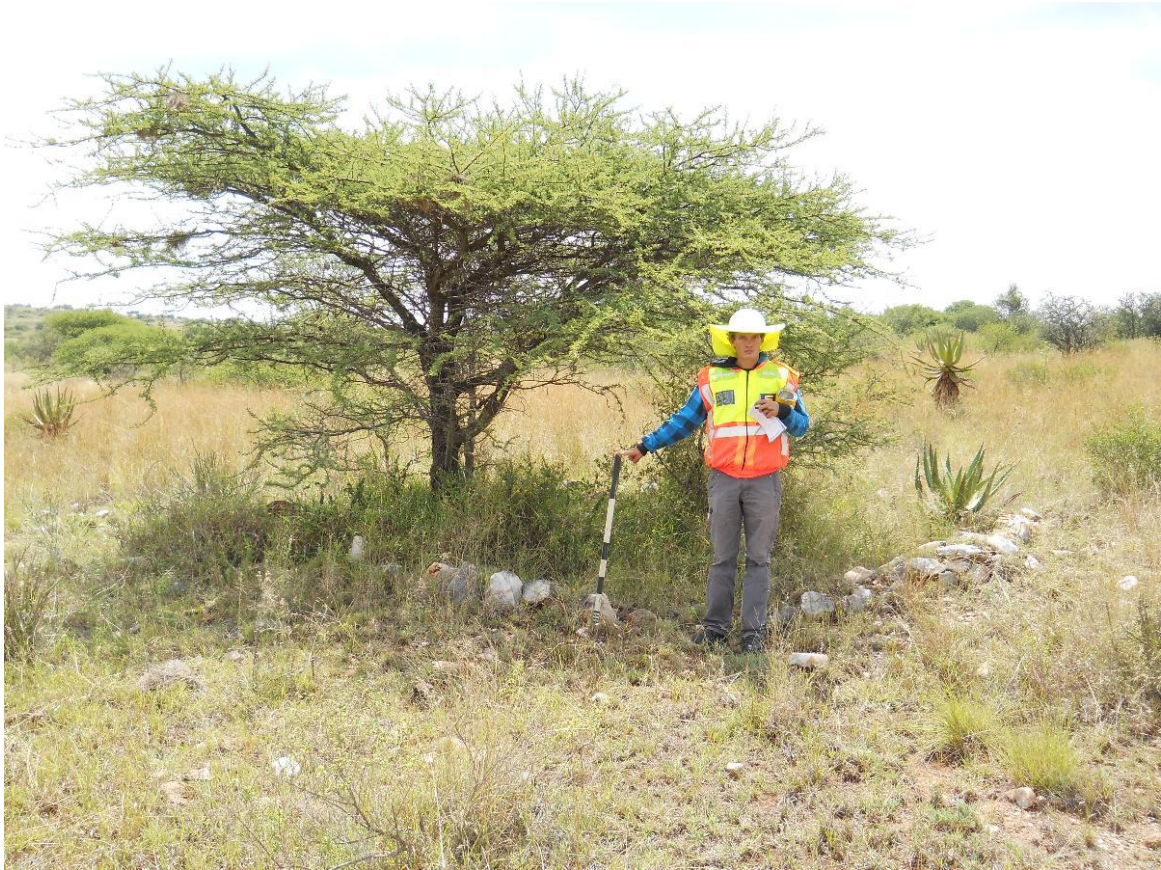
Fig 10. This cylindrical structure ($23^{\circ}54'11.10''S$ $29^{\circ}36'47.30''E$) apparently stood on its own. It is mainly built with quartzite. Except for a possible ritual purpose, its function remains speculative unless excavated.

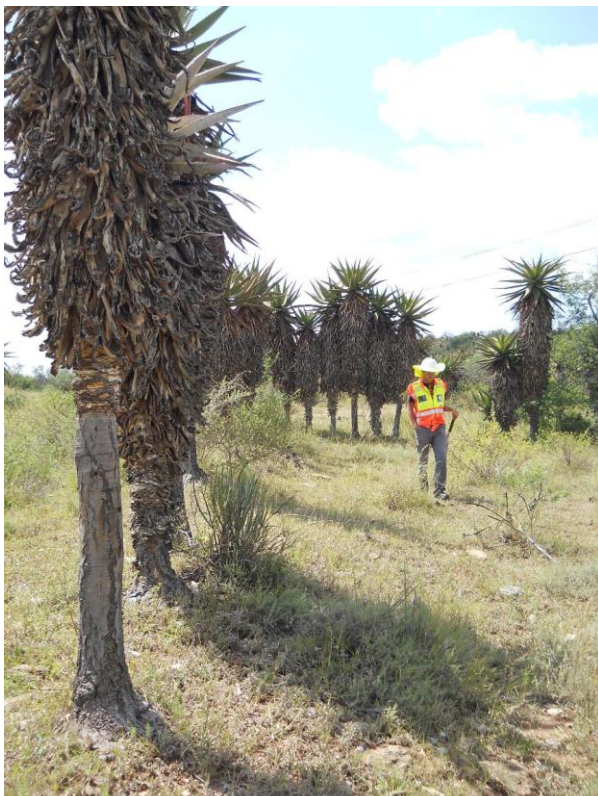
Fig 11. Straight rows of aloes are located in a few areas on the site. The aloes mainly grow from the foundations of the stone walling. The remains of some circular houses are located close by ($23^{\circ}54'21.00''S$ $29^{\circ}36'49.50''E$). Similar aloe growth ($23^{\circ}53'55.40''S$ $29^{\circ}36'59.00''E$) on straight walls also occurs close to Tower 145.

Straight walling is also characteristic of the historical period after contact with the white settlers had occurred.

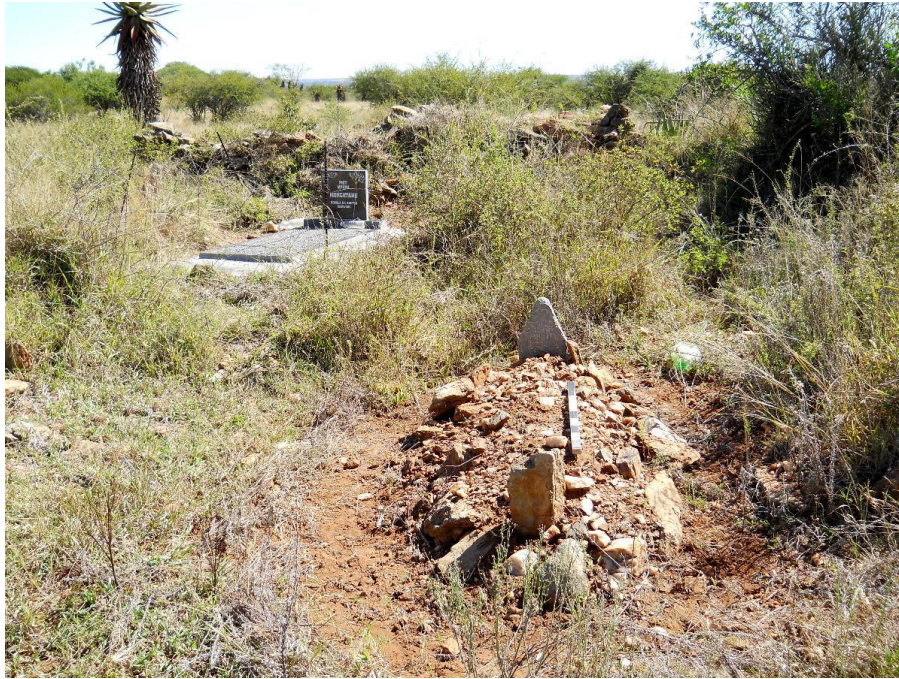
Fig 12. Two graves, one with a modern headstone, are located within one of the original complexes ($23^{\circ}54'27.00''S$ $29^{\circ}36'43.90''E$) closer to Tower 147. It is not endangered by the transmission line or a tower. Important though is that this place probably has some relevance to the history of the site. It is, however, also evidence of intrusion on a historical site older than 60 years.

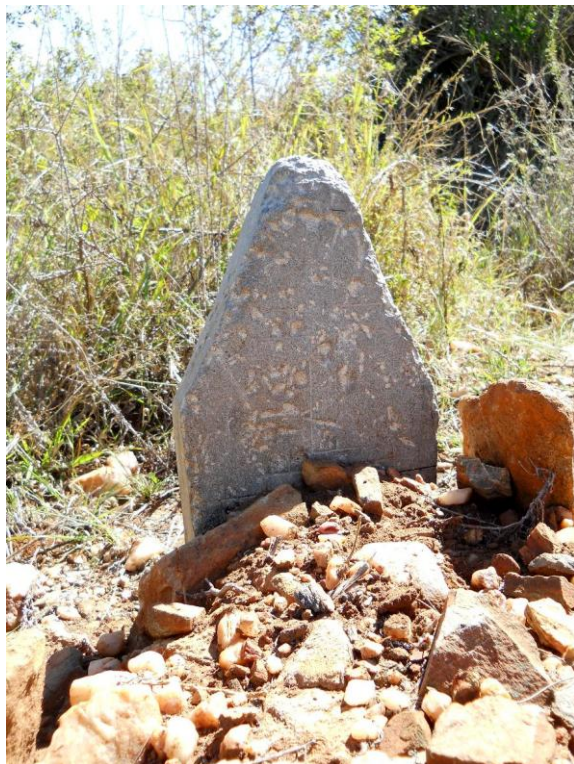
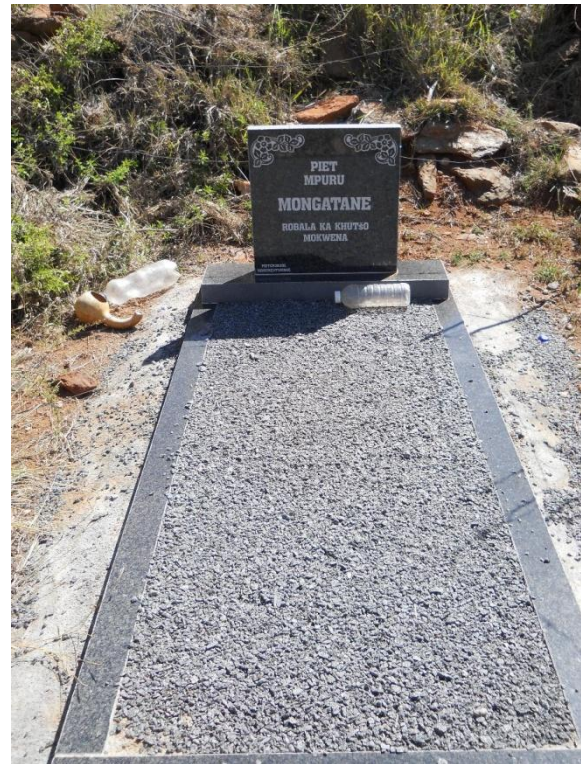
Fig 13. The one headstone is totally illegible, although some engraving is still visible on its surface. The more modern looking gravestone has the name of Piet Mpuru Mongatane on it, without any dates of birth and death. The calabash next to the headstone indicates that the person is still honoured as an ancestor and would have contained beer as a libation.

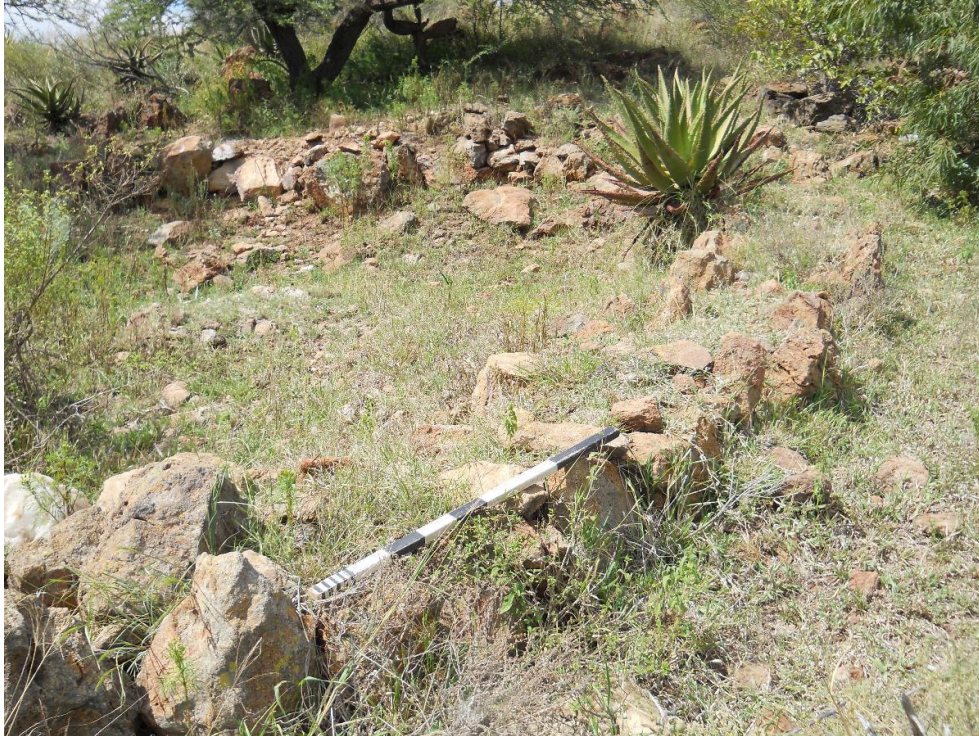
Fig 14. This historical homestead ($23^{\circ}54'08.2''S$ $29^{\circ}36'53.00''E$) consists of a lapa, circular houses and a cattle kraal (in the image above). It is possible that the inhabitants' graves will also be located here.

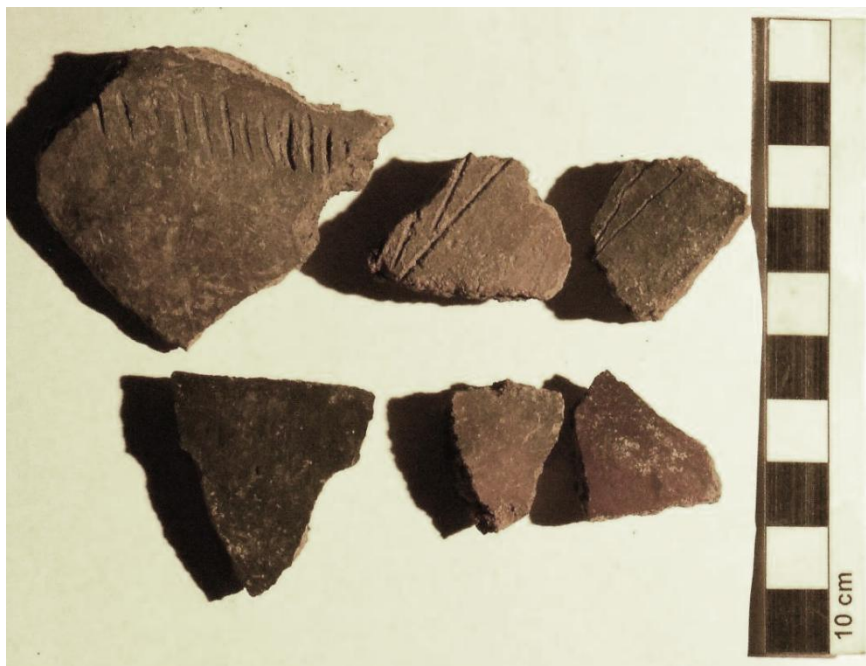
Fig. 15. A small surface collection of pottery sherds from the communal midden ($23^{\circ}54'25.10''S$ $29^{\circ}36'47.20''E$). Typical of the Letaba pottery is the burnished, red ochre colour and/or graphite; this doesn't show up well in the image. Incised bands on the shoulder (see the example top left) and diagonal incisions forming triangles in a band are key features.
