PROGRESS REPORT 06: May 11, 2012

Tower 28

PROPOSED 400KV TABOR-WITKOP TRANSMISSION LINE, LIMPOPO PROVINCE

For: Stefanutti Stocks Power

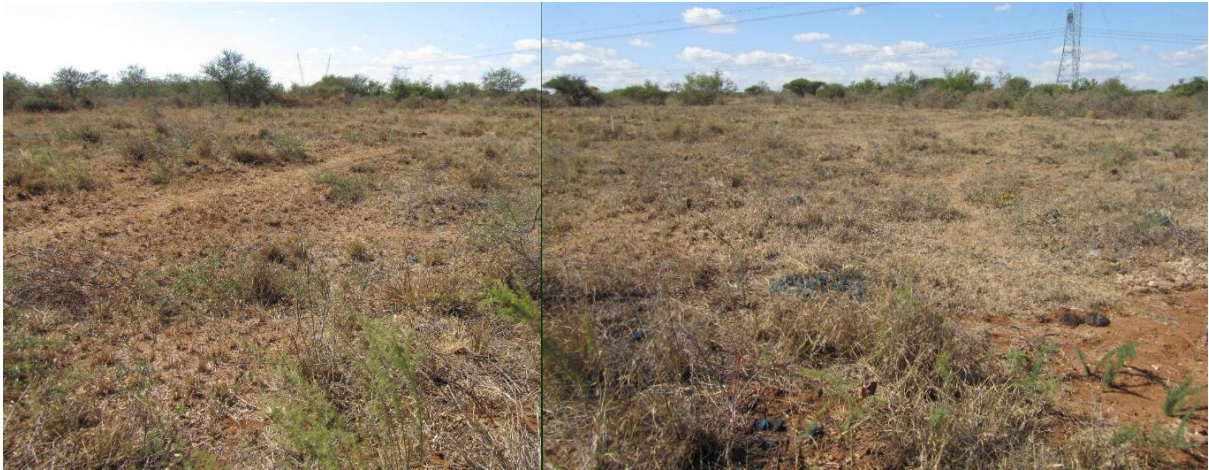
No graves or any other archaeological material were located. A few possible stone flakes, indicating human activity during the Late Stone Age, were seen. But the area is riddled with ant heaps and the remains of abandoned ant heaps. The roots of shrubs and clusters of vegetation growth such as aloes and acacias also create raised surfaces which could be mistaken for graves. Some of the soil heaps were created when the access road for the older Eskom lines were prepared, some even containing stones, thus resembling more recent graves.

Figure 2. A general view of the debushed area around Tower 28. The unevenness of the terrain is clearly seen by the cast shadows.

Recommendations: No further action is required. However, should any cultural material be located during excavation of the tower foundations, an archaeologist should be immediately notified.

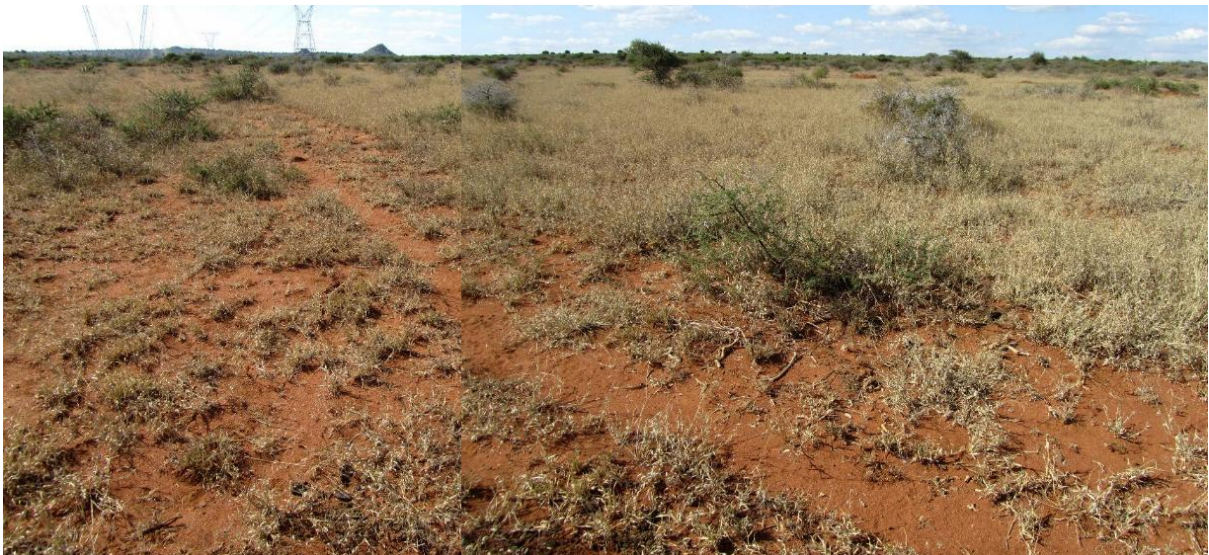
Figure 3. A general view of the terrain with its natural vegetation cover. The open area in the foreground is the access road of the previous Eskom line.

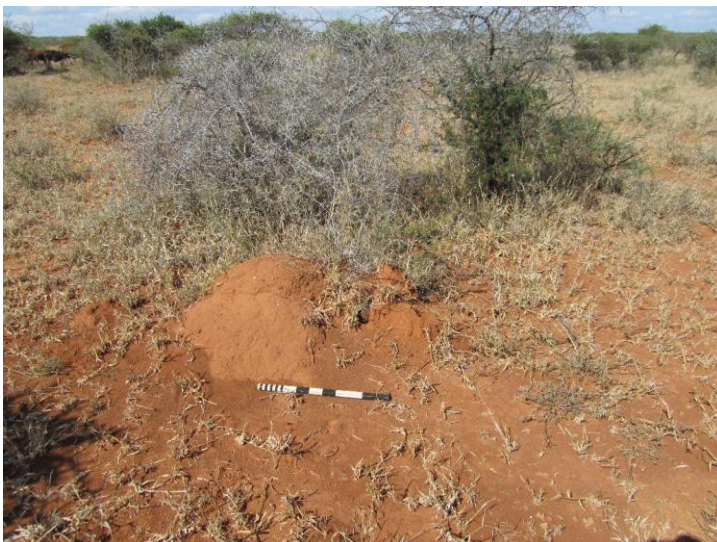
Figure 4. One of the more recent ant heaps. This could be mistaken for being a burial.

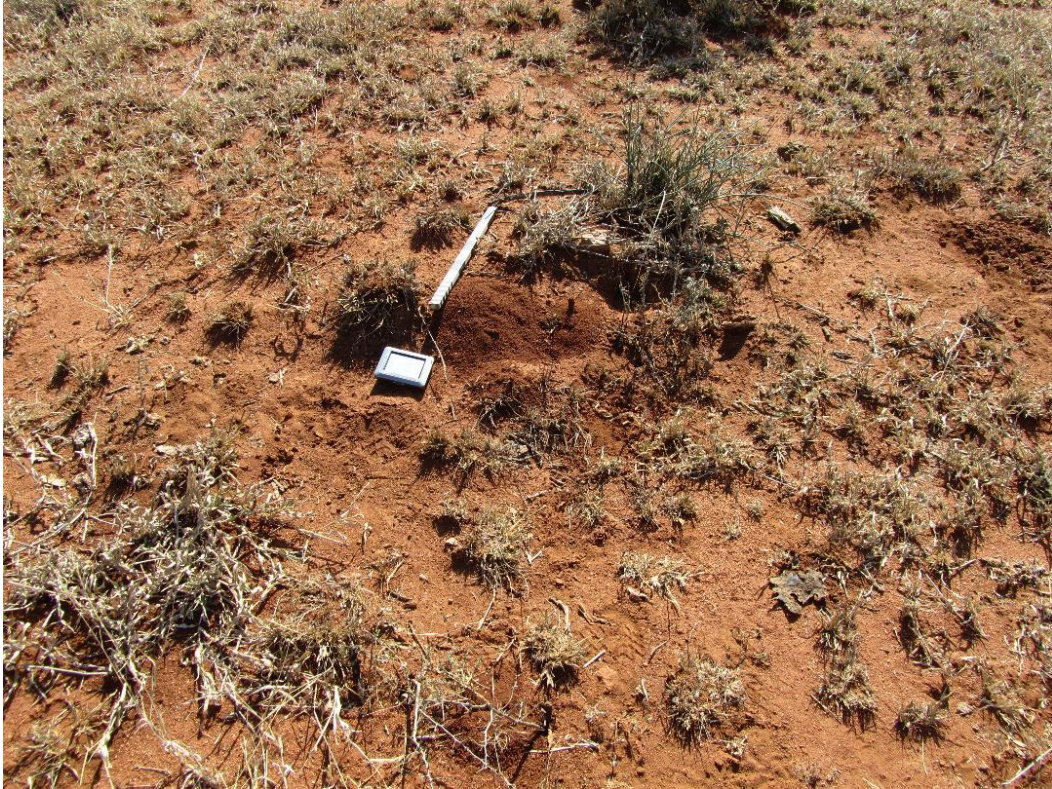
Figure 5. Another ant heap. This was apparently abandoned for a long period but shows signs of recent activity.

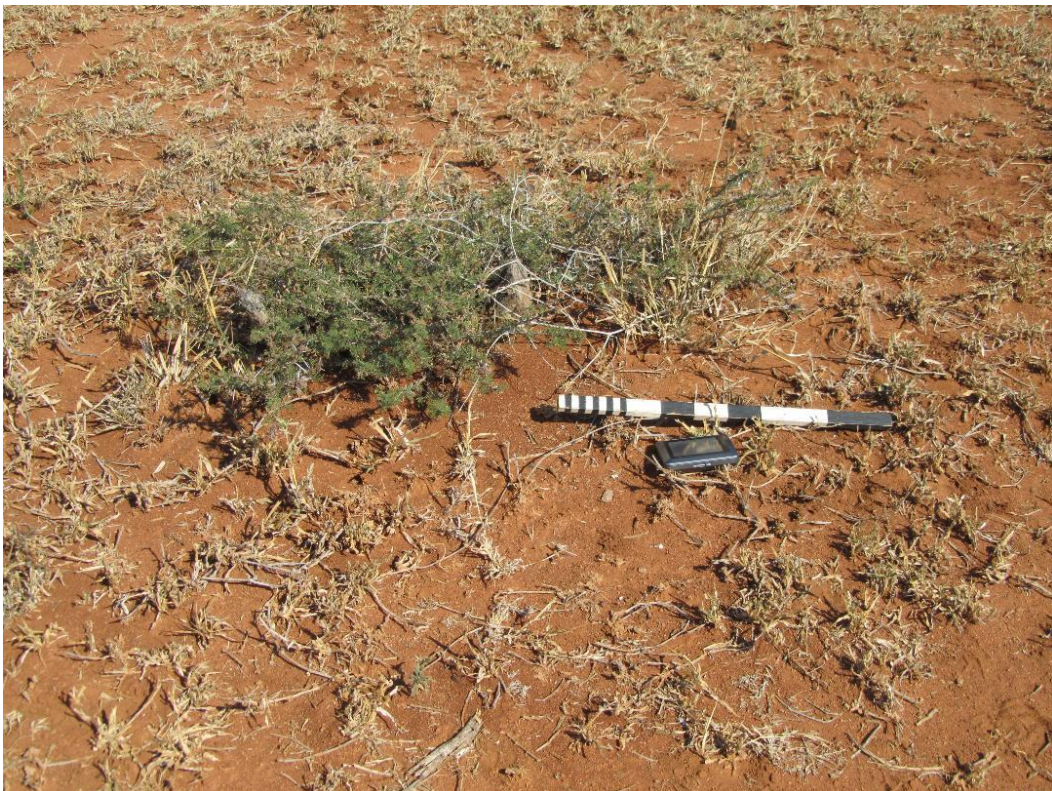
Figure 6. Many of the trees have been cut several times in the past, probably to be used for fire wood by the community nearby, and have now been reduced to shrubs. Their large root systems have caused these raises in the soil.

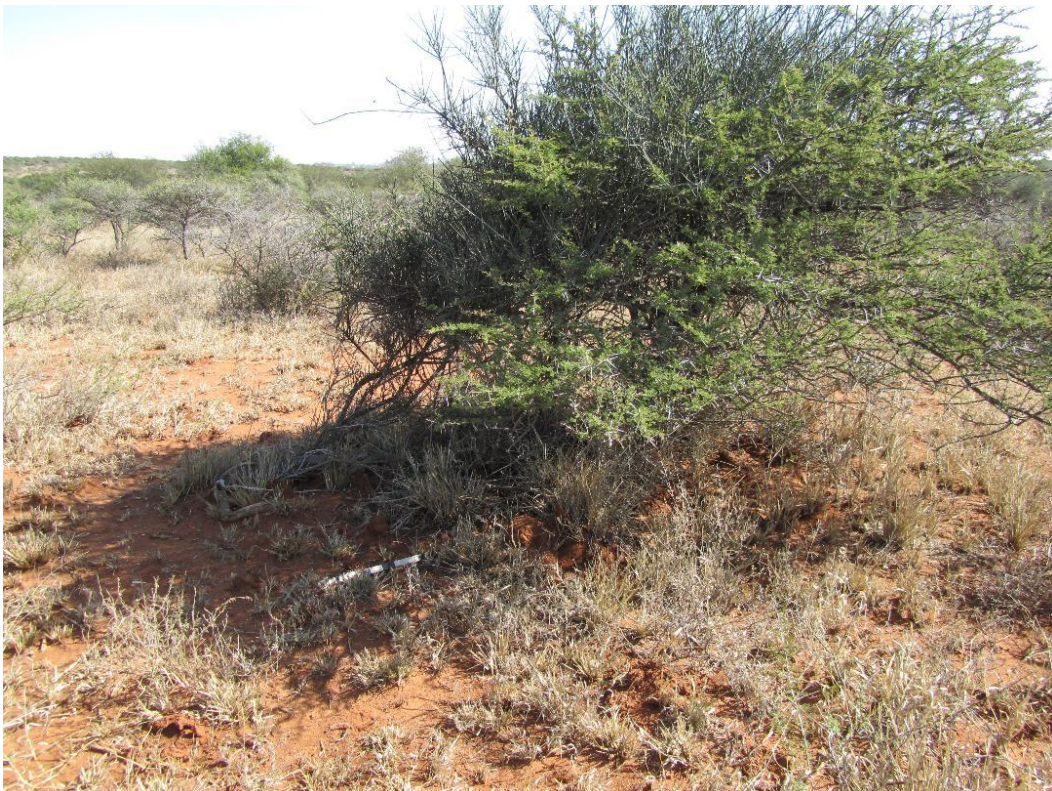
Figures 7 and 8. More examples where the level of the soil had been raised by the underlying root system, forming an “island” in comparison to the rest of the terrain.

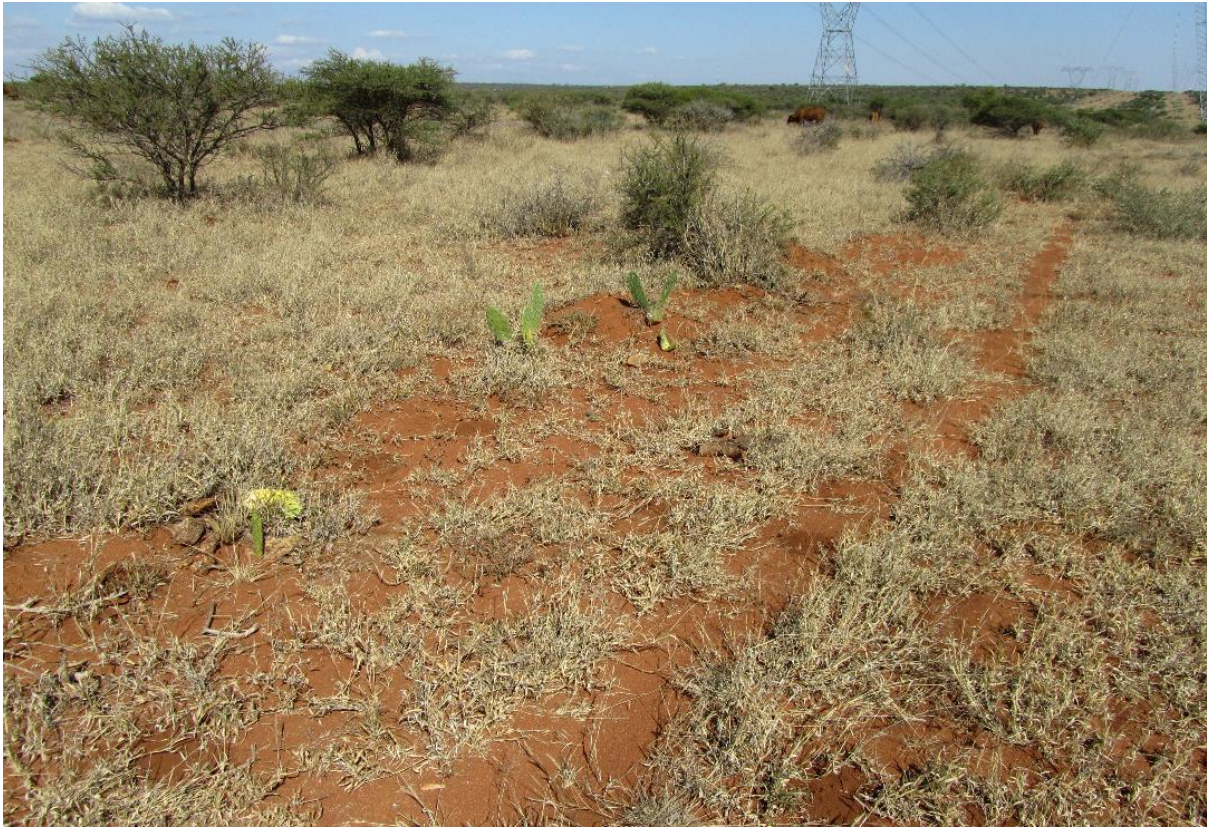
Figure 9. An example of the soil heaps along the previously cleared road. It is also possible that the abandoned ant heaps caused the germination of seeds, thus accounting for the many “islands” containing vegetation.
