PROGRESS REPORT 08: May 28, 2012

Towers 146-147 & Line from Tower 205 - Witkop PROPOSED 400KV TABOR-WITKOP TRANSMISSION LINE, LIMPOPO PROVINCE

For: Stefanutti Stocks Power

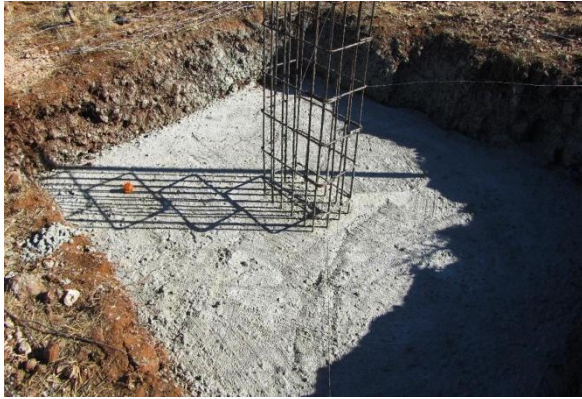
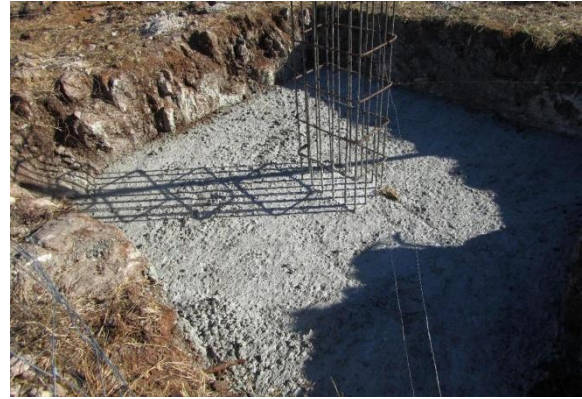
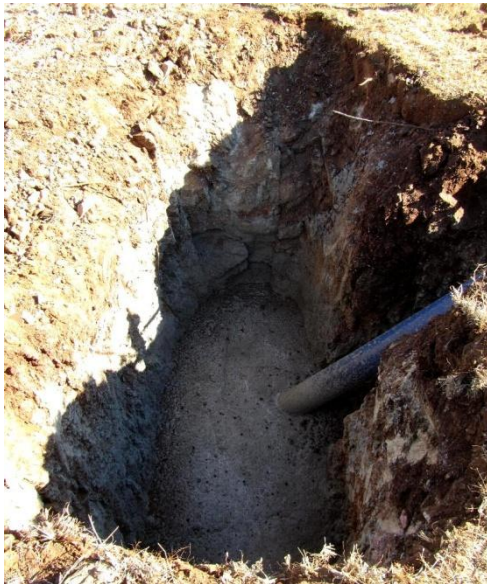
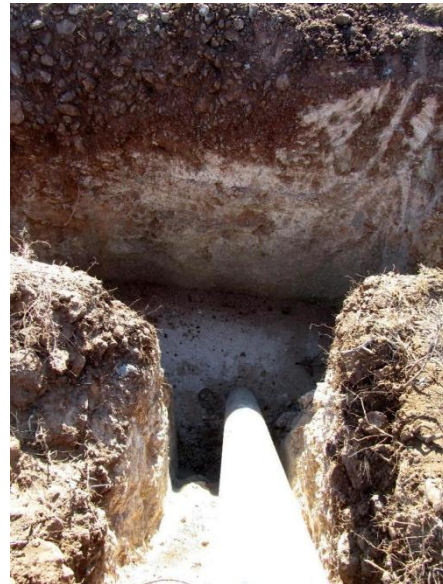
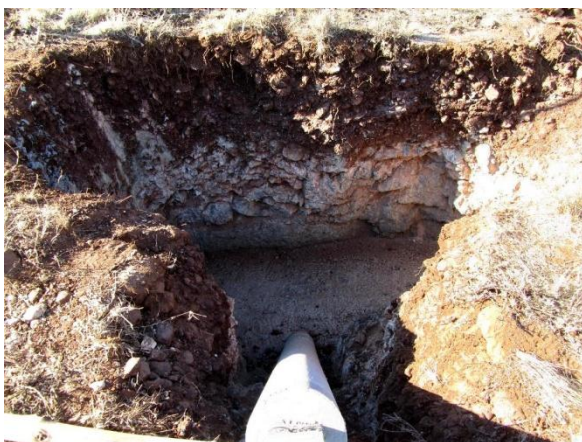
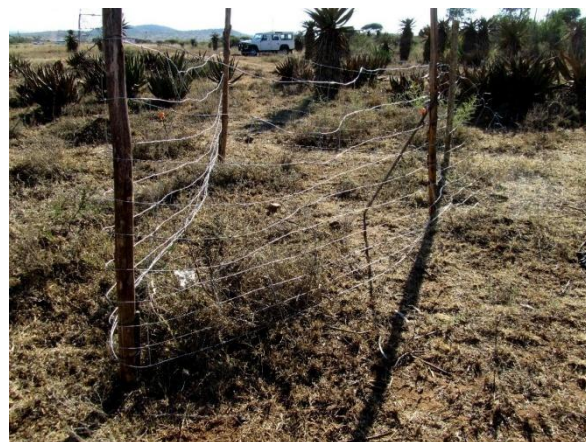
TOWER 146

Figures 1-6. The foundations of Tower 146. No archaeological stratification is visible in the walls of the excavation.

Tower 146 was moved from its initially planned location which was inside a sensitive archaeological site. The new location does not intrude on any archaeological remains. It was however recommended that an archaeologist should be present during the excavation phase of this tower, since it is still in close proximity to the site. This recommendation was, however, not heeded. The importance of an archaeologist being in attendance at sensitive sites, particularly during excavation, such as these cannot be stressed enough. It would be a total contravention of the National Heritage Resources Act (No 25 of 1999) should any destruction of such a site happen without having taken the necessary precautions.

Recommendations

- Since the stringing of the line necessitates heavy vehicle traffic on site, it is recommended that the archaeologist should be present when the stringing of the line between Towers 146 and 147 takes place since the line crosses a large part of the archaeological site.
- Another access route should be mitigated. Although the present access route has been in use for a prolonged period, the recent intensified construction activities are daily causing more damage to the archaeological site. This situation should receive immediate attention.
- The route and access points should be clearly demarcated prior to further construction activities.

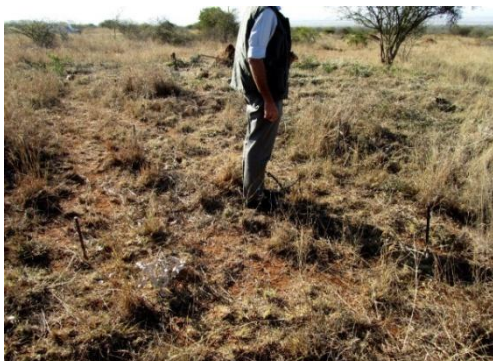
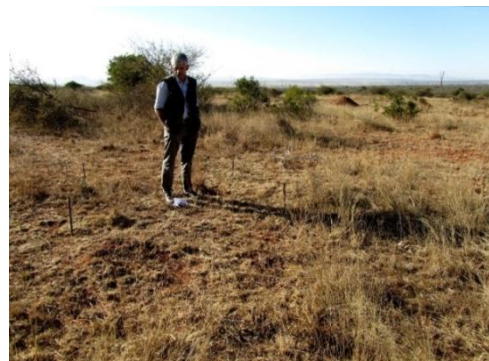
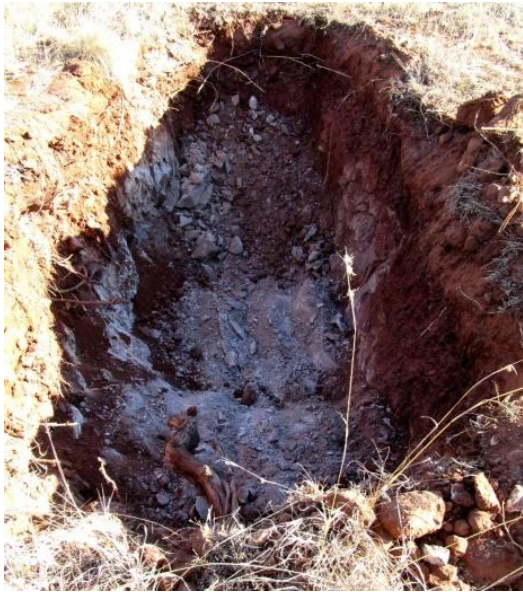
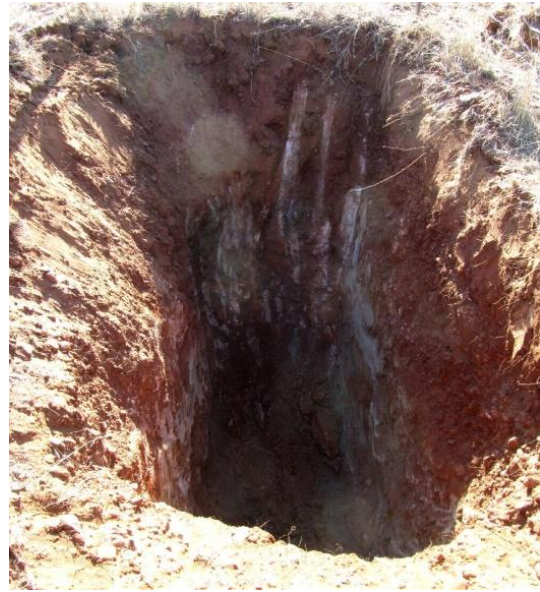
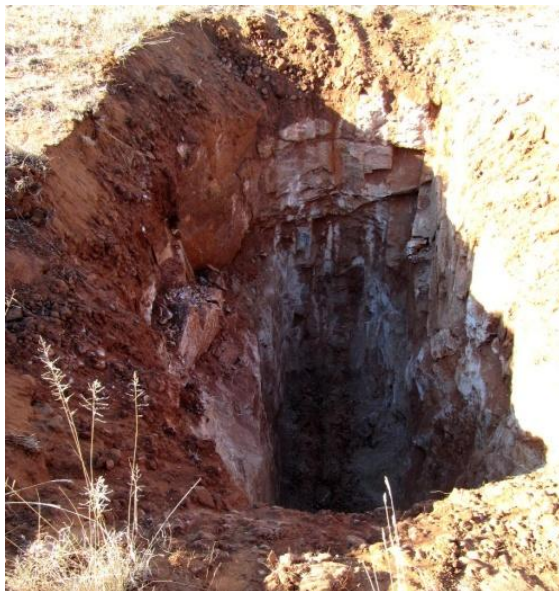
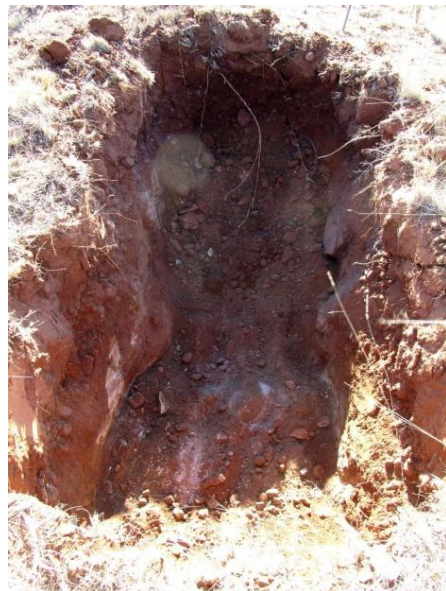
TOWER 147

The relocation of Tower 147 is also well and safely removed from the archaeological site.

Figures 7-12. The foundations of Tower 147. No archaeological stratification is visible in the walls of the excavation. In Figs 7 & 8 Mr Roodt is standing among the delineated areas for the tower legs.

Recommendations

- Since another access road, which doesn't disturb the archaeological site, is recommended, it remains important that the archaeologist be consulted in this regard to insure that the new road does not impair the archaeological site.
- The archaeologist should be in attendance during the stringing of the line, since it will cross the archaeological site with particular sensitive areas. It is understood that heavy vehicles will be used in the process, which could cause further damage.

- The access route and entrance to Tower 147 still need to be decided. In this regard the archaeologist should also be contacted.

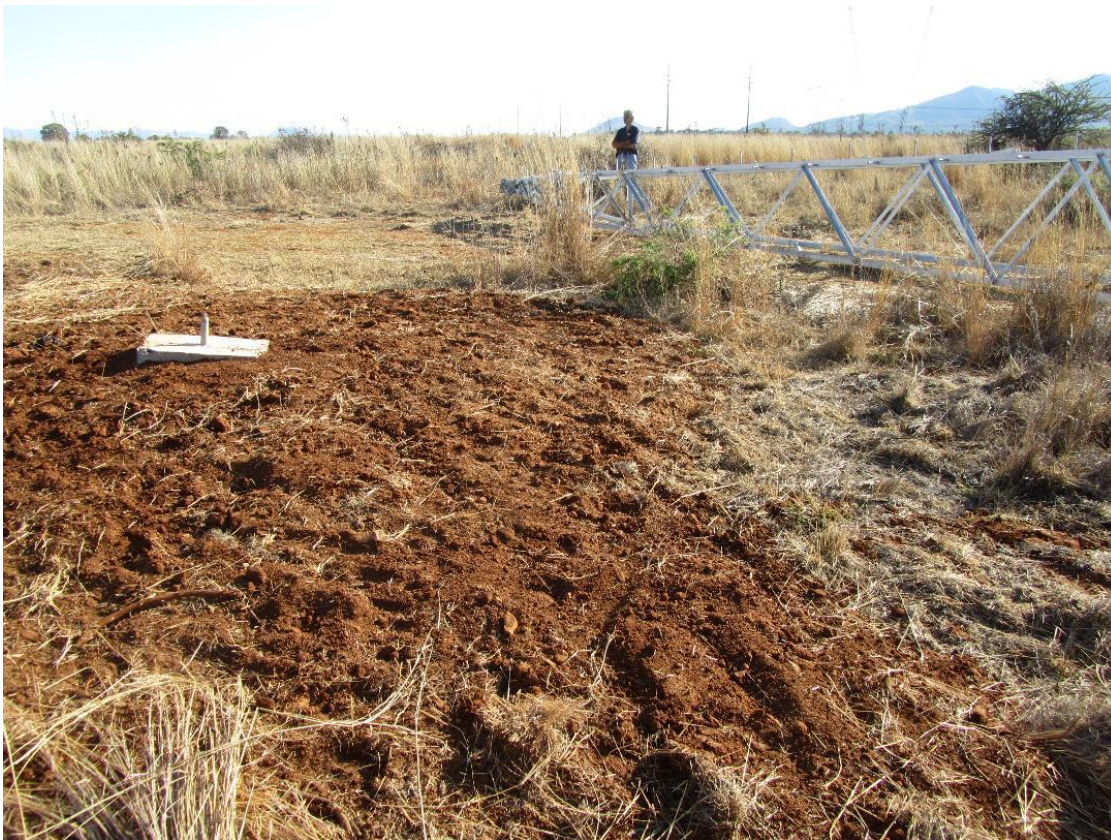
Most of the towers had already been excavated, and some foundations had been cast. Excavations for foundations were inspected for signs of possible archaeological stratigraphy, but none were observed.

Figure 13. Tower 215. Already cast and closed up. The open area around the tower was particularly well searched for possible archaeological remains. None were present.

Recommendations: Should any archaeological material be encountered on any of the sites during construction, the archaeologist should be notified immediately.

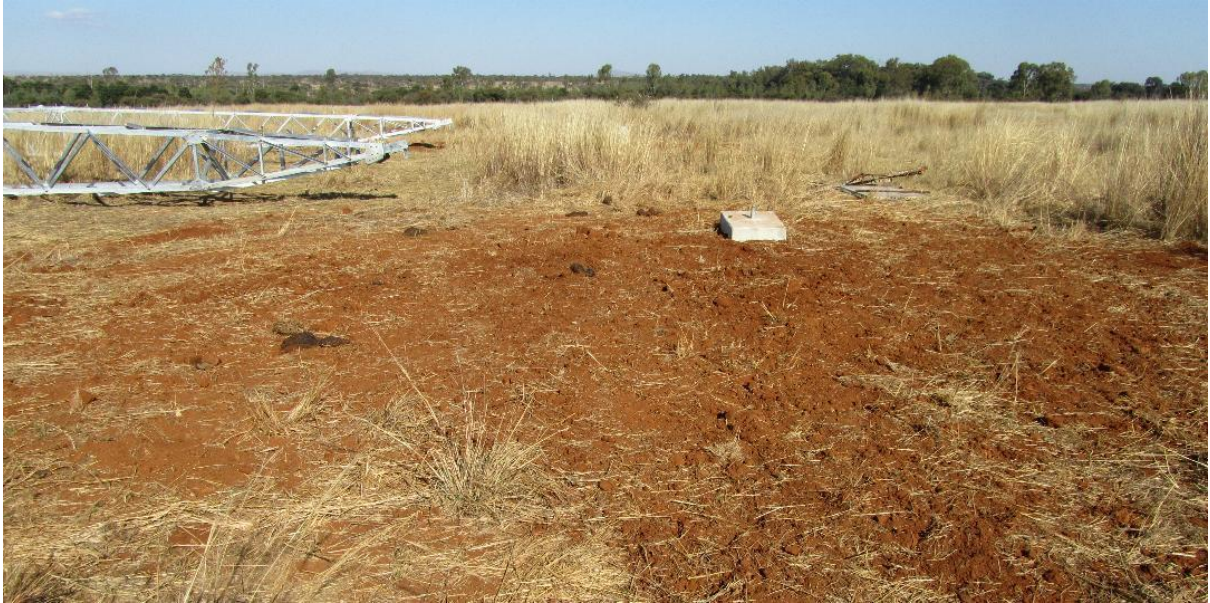
Figure 14. *The area around Tower 216 was also sterile.*

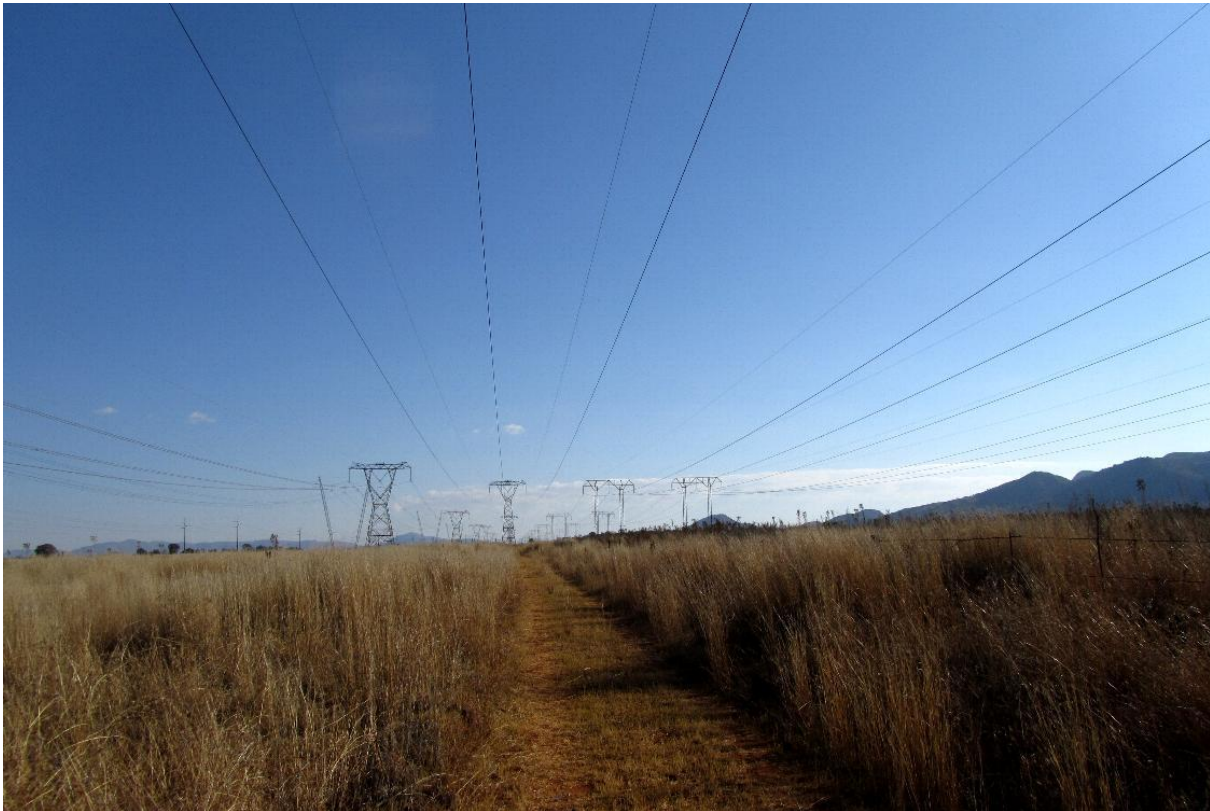
Figure 15. *The relatively wide area covered by several power lines. It is clear that these lines impact upon large areas of the landscape, whether it is natural or human-made. It is thus obvious that laws pertaining to the protection and preservation of archaeological sites are not excessive or unnecessary.*
