## **PROGRESS REPORT 11: June 18, 2012**

### **A REASSESSMENT OF Towers 99, 65, and 56-55 400KV TABOR-WITKOP TRANSMISSION LINE, LIMPOPO PROVINCE**

**For:** Stefanutti Stocks Power

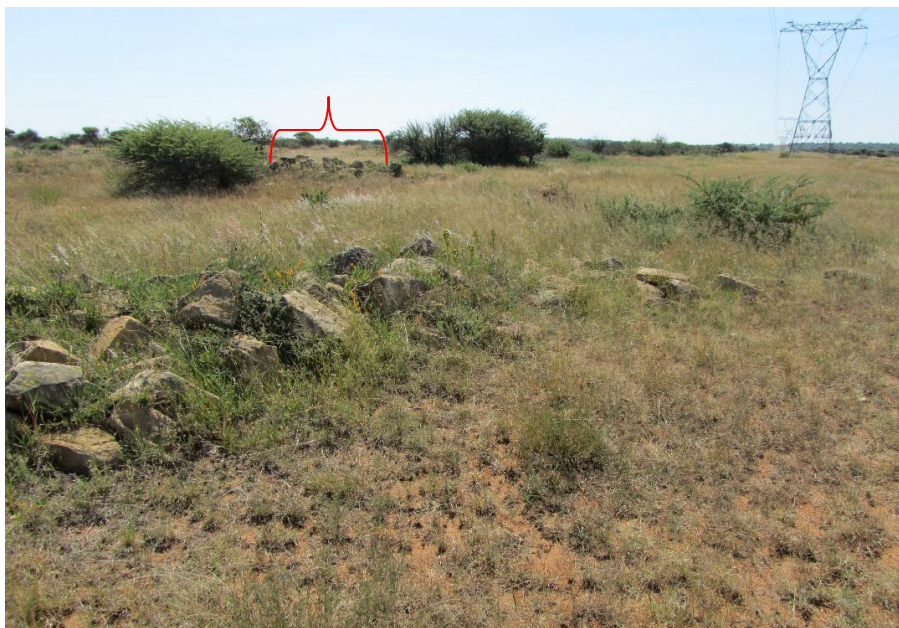
**Figure 1.** The stone-walled farm dam. The retaining wall consisted of roughly stacked rock. Only a small area (indicated by the brace) was moved to make place for the foundation of the tower's one leg.

**Recommendations:** Since this is not considered to be an architectural feature of archaeological importance, it was advised that as little damage as possible should be incurred. The recommendation was regarded, and no further recommendations are needed, however care should be taken not to disturb the feature any further during stringing of the conductor while the access route should circumvent it.

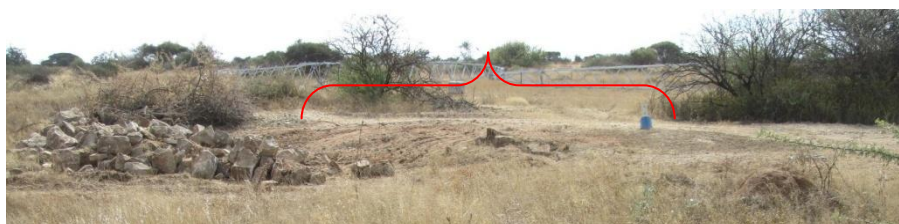
**Figure 2.** Only a small part of the dam was compromised when the stacked rocks were moved a few metres. The original position is indicated with the brace.

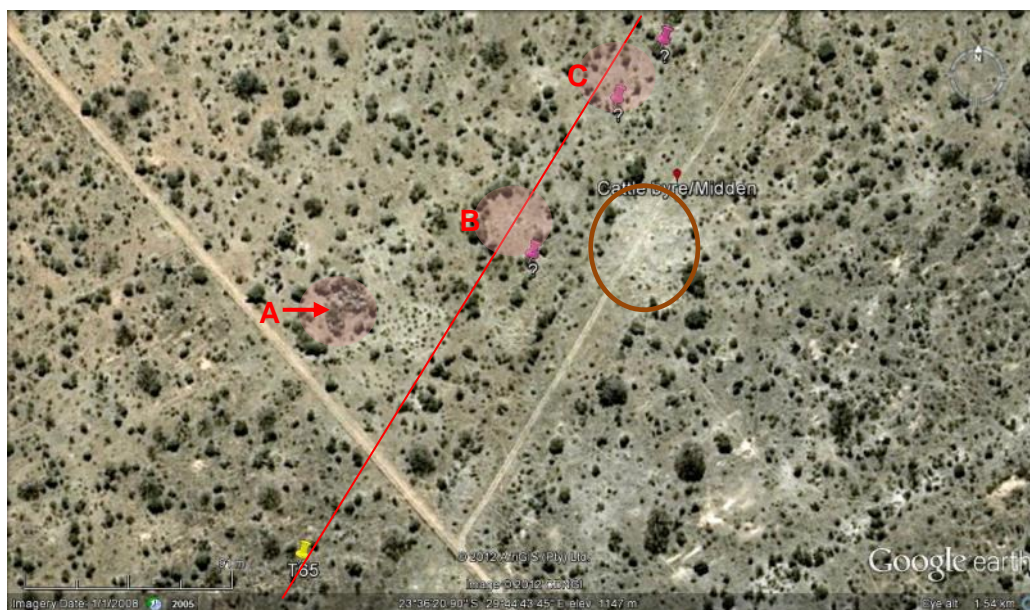
**Figure 3.** S23°36'19.0" E29°44'45.7". A historic multi-component site. Indicative of human habitation and activity is the distinctive light grey colour of the soil, suggesting a cattle byre or midden. Its location is delineated with a brown circle to show the extent of it. The arrow points to Site A, a clump of sisal (see figure below). While on site, the archaeologist could find no signs of habitation, but an aerial view clearly shows distinctive circular structures at the points marked "B" and "C" (the pink tinted areas). Point "A" is rectangular in shape.

**Recommendations:** The tower is not located on these sites, however, the transmission line will cross it and the access road will pass through it. Care should be taken not to damage the structures when the line is being spanned. Access routes should preferably avoid these areas and its location should be mitigated with the archaeologist.

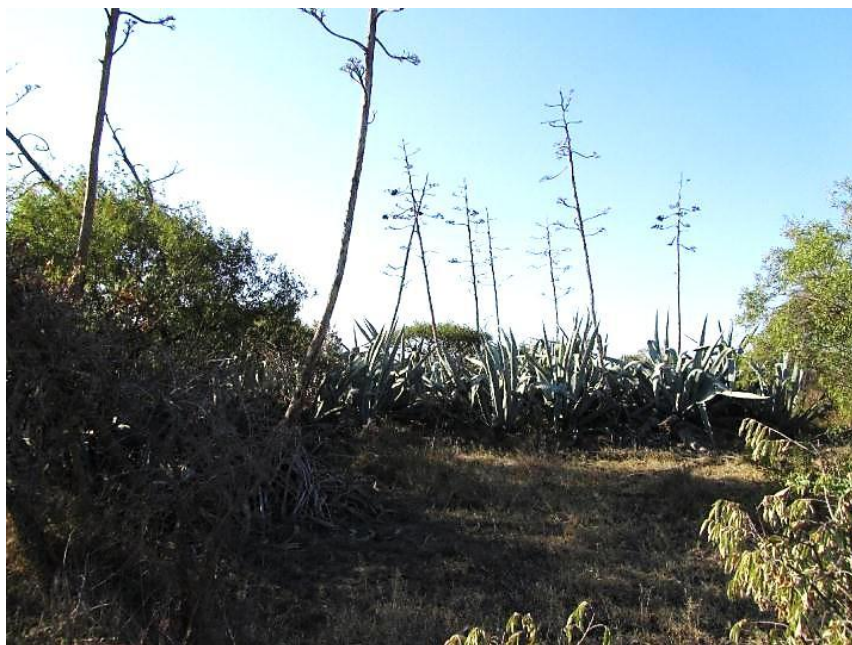
**Figure 4.** A clump of *Agave sisalana* (American agave or sisal). These plants have become naturalised in South Africa. It forms an impenetrable barrier and is still used for that purpose around cattle byres.

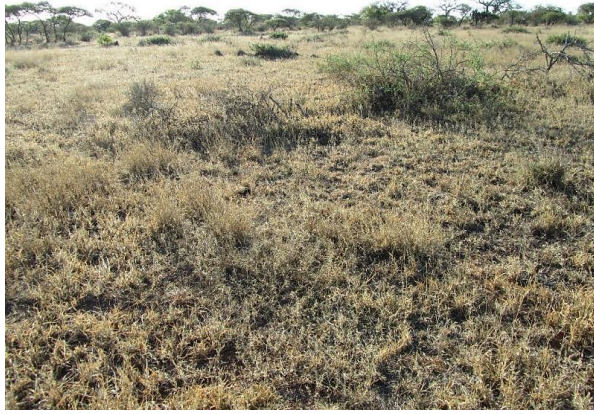
**Figure 5.** The area indicated with a “B” on the map. It is covered in grass and surrounded by trees in a circular shape. The slight rise in the foreground could be due to dung or midden accumulation.

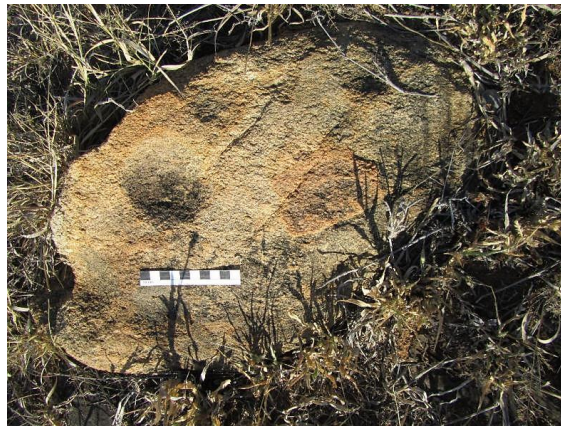
**Figure 6.** A flat stone with several indentations on its upper surface. Its function is unknown, but it shows human skill and activity.

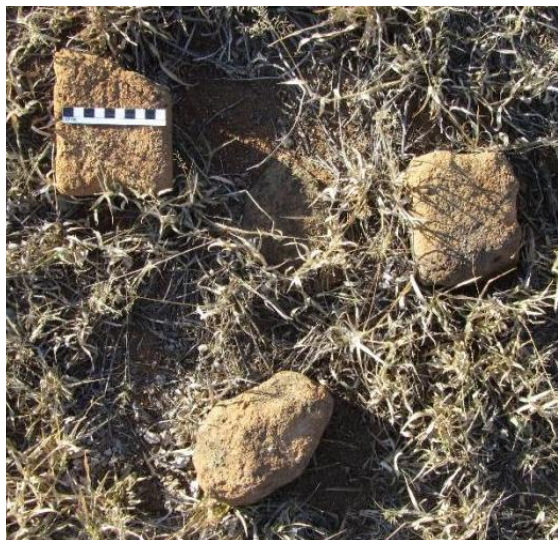
**Figure 7.** Some fragments of rectangular bricks were also recovered not far from the indented stone (Fig 55) which indicates recent historical presence.

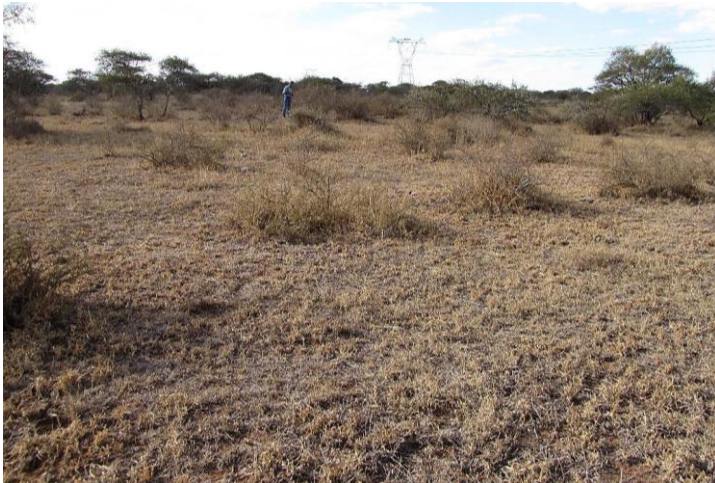
Tower 65 doesn't affect any of these sites, but irreparable damage will occur to the site during stringing operations and by the inspection/access route. The historical remains are sensitive for unmarked burials.

**Figure 9.** *This photograph was taken while standing approximately in the centre of one of the cattle byres. As previously stated, cattle byres usually contain burials and are therefore sensitive to any development.*

- Although the tower is not located on these sites, the transmission line will cross it and the access road will pass through it. Care should be taken not to damage the structures and/or other features (e.g possible burials) during stringing of the conductor.
- Access routes should preferably avoid these areas and its location should be mitigated with the archaeologist. This should be clearly marked and indicated.
- During **all construction related activities** on site an archaeologist should be in attendance to monitor it.

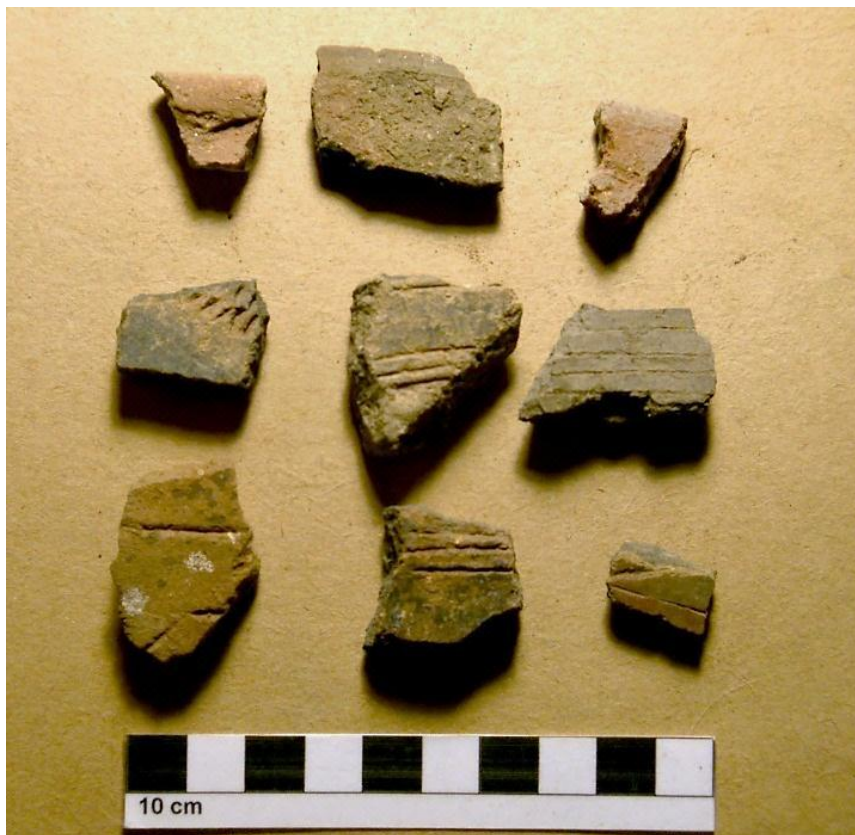
**Figure 10.** *Little cultural material is visible on the surface due to the grass cover, but recent animal activity has brought these pottery sherds to the surface. These sherds do not resemble Venda pottery (Letaba facies), but rather Sotho-Tswana pottery.*

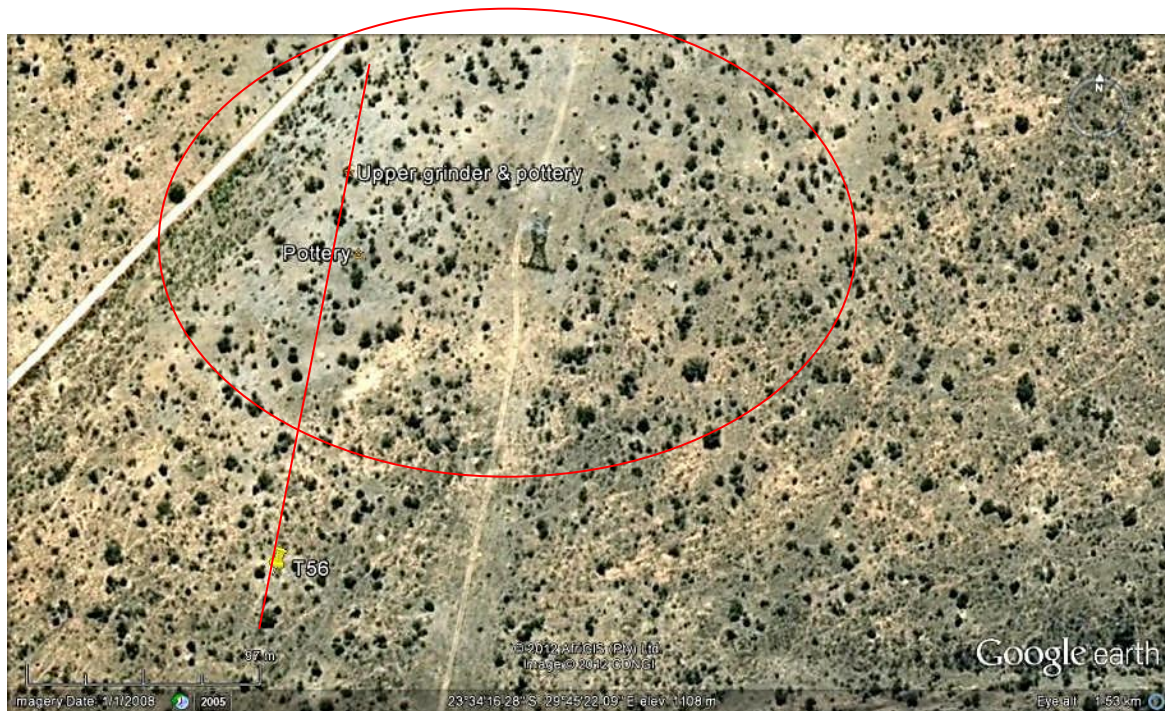
**Figure 11.** A large midden or cattle byre is roughly delineated here. The site extends beyond the dirt road at left as well as the access route of the previous Eskom line.

**Recommendations:** The same as for Tower 58: The archaeologist should be present when the foundations for Tower 56 are excavated, since human skeletal material could be retrieved. Great care should also be taken not to damage cultural remains when the transmission line is spanned. Since the previous access route has already damaged the site, it is advised that this route should also be utilised for the Tabor-Witkop transmission line and that the shortest possible access route or a route which will cause the least disturbance should be demarcated from the original access to the tower.

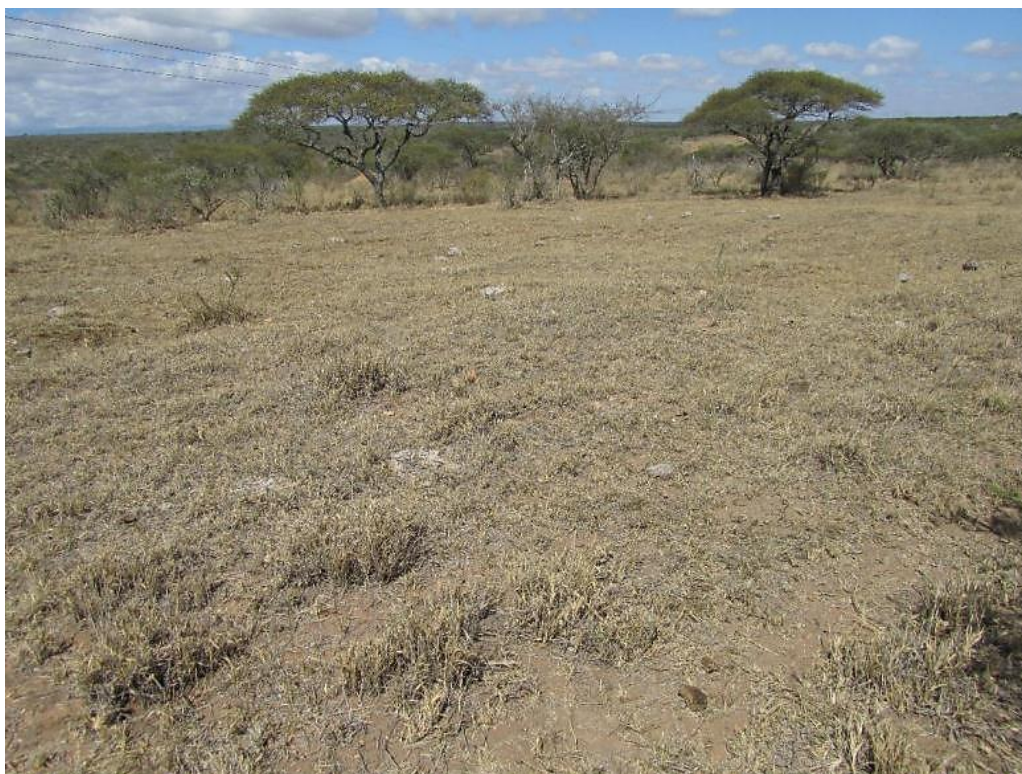
**Figure 12.** The grey ashy composition and colouring of the soil, characteristic of cattle byres, is clear in the image.

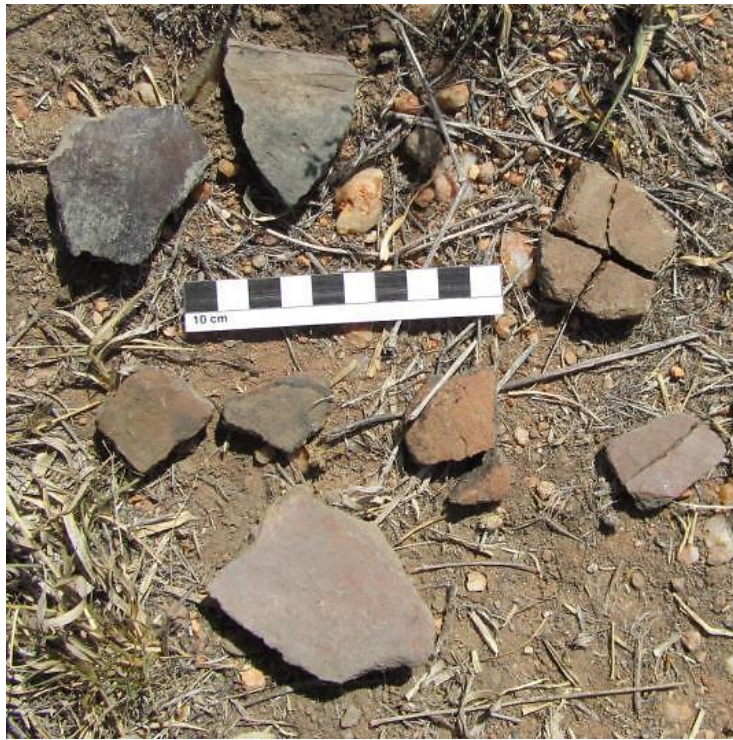
**Figure 13.** A cluster of pottery sherds were located on the surface at co-ordinates S23°34'14.8" E29°45'18.6". The rest of the site would undoubtedly relinquish more and similar samples.

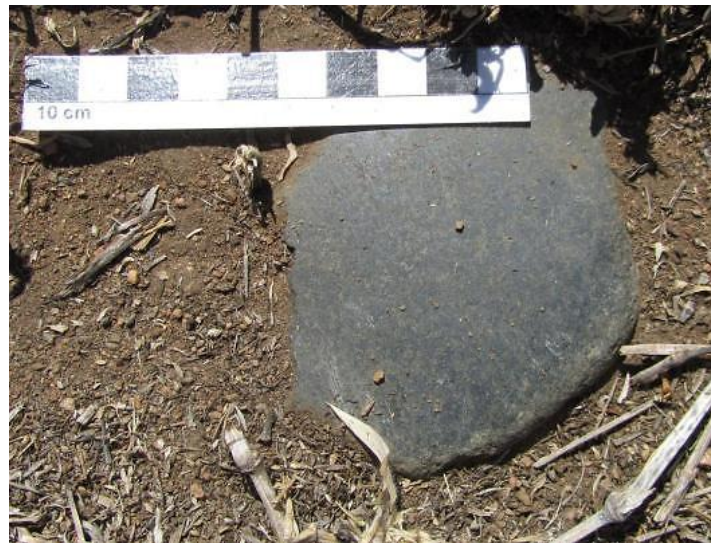
**Figure 14.** A grinder or polishing stone was recovered from co-ordinates S23°34'13.7" E29°45'18.4" together with more pottery sherds.

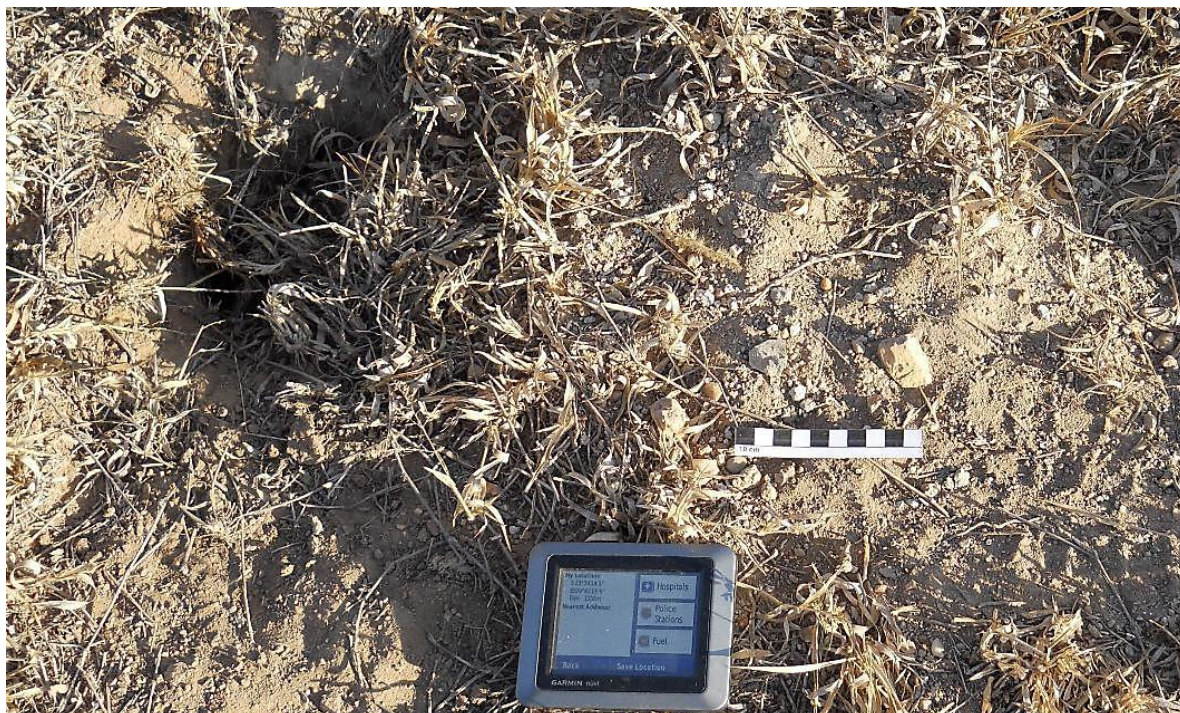
**Figure 15.** The light grey colouring and grainy texture of the soil is characteristic of a cattle byre. Cattle byres are particularly sensitive to the development of a site, since these were traditionally the preferred sites for the interment of the male members of the community. Vehicular traffic will damage the underlying skeletal material.

This site is now identified as a Tavhatshena period site and is regarded as significant from a scientific perspective (see page 6 for a description of the *Tavhatshena facies*). The site is large with a span of approximately 180 meters and contains middens, cattle byres and stone features. It will undoubtedly contain unmarked burials that could be disturbed and damaged by construction activities.

- A phase 2 assessment should be mitigated in the areas that are to be affected by the development.
- All activities on site must be monitored by an archaeologist.
- A site management plan must be developed for the future protection of the site which should bind both ESKOM and the landowner.

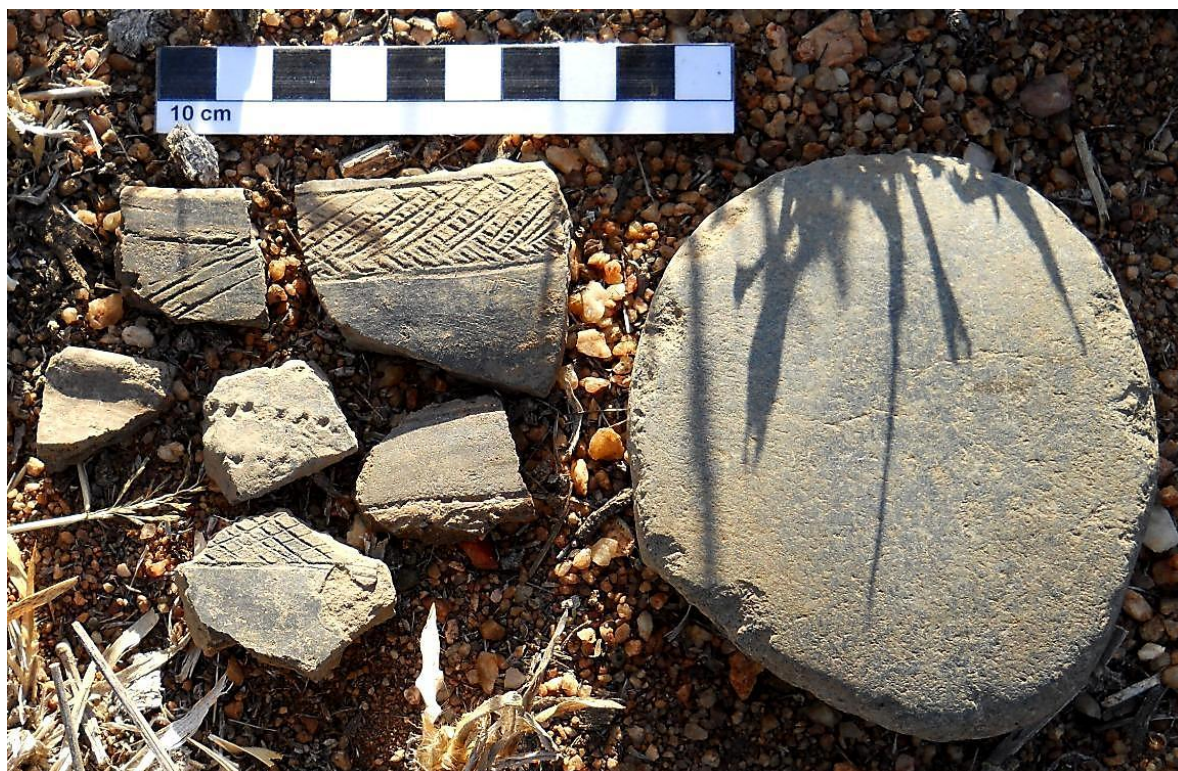
**Figure 16.** Some of the diagnostic pottery found on the site from various locations as well as one of several upper grinders/polishing stones.

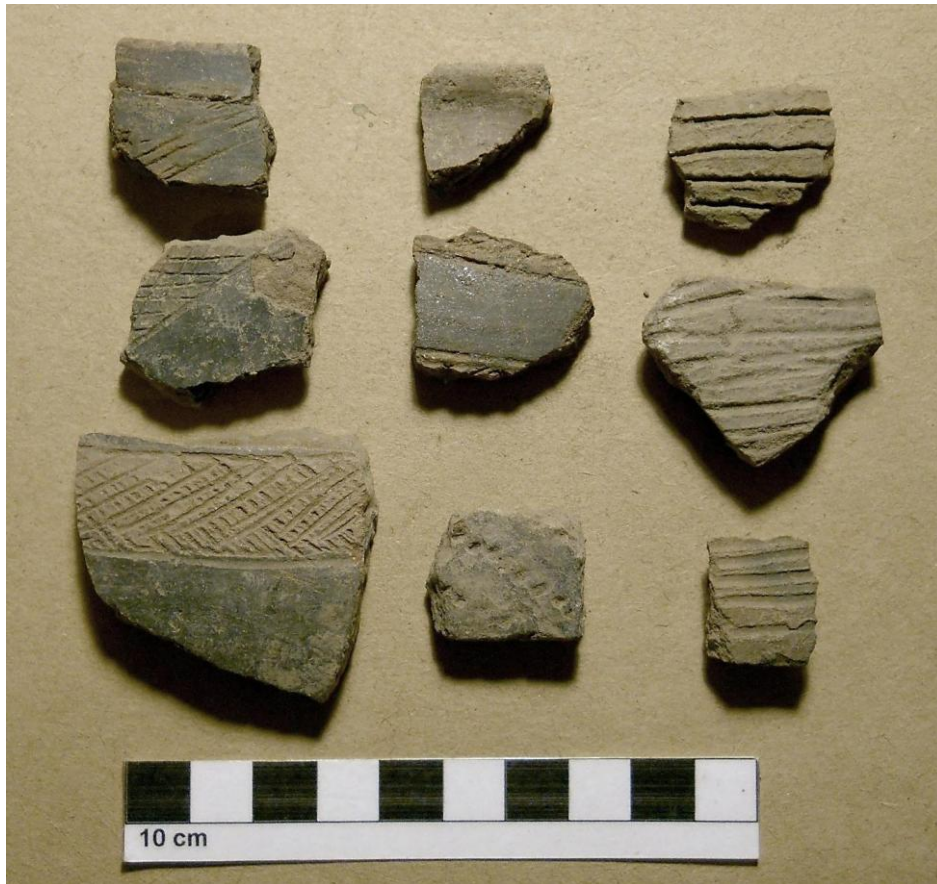
**Figure 17.** Diagnostic pottery found on the site. After analysis of the pottery sherds, it was identified as Tavhatshena facies.

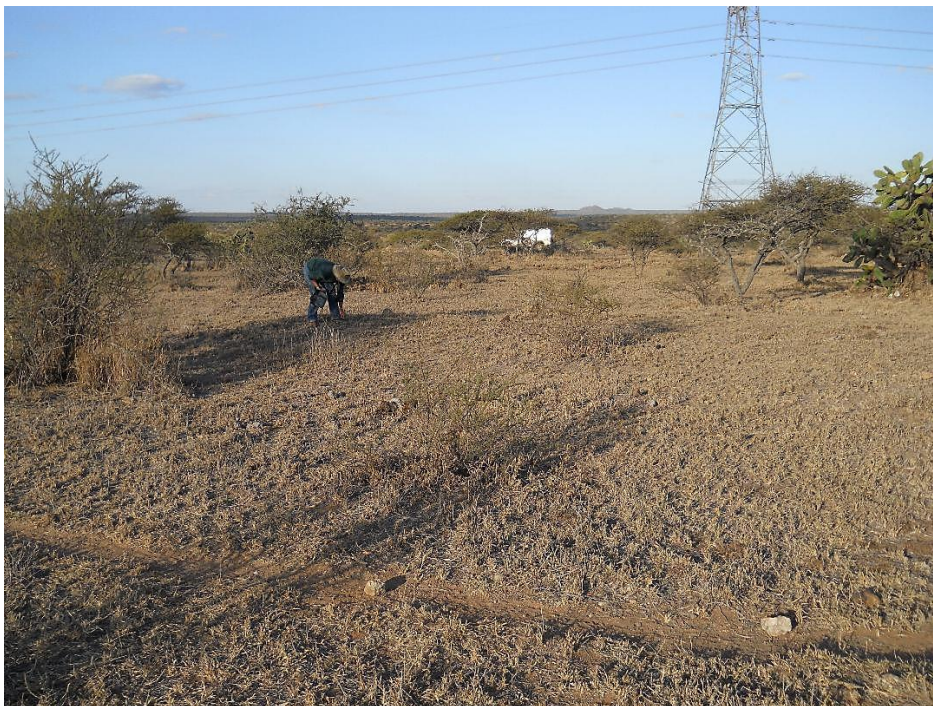
**Figure 18.** Another part of the site which comprises a midden. Middens are usually a rich source for cultural materials and therefore important for the reconstruction of a way of life of a specific group: much information relating to social, political, religious, etc systems can be acquired from features such as this.
