# **GEOTECHNIAL INVESTIGATION REPORT FOR SEWER PIPE BRIDGE IN PAUL ROUX, FREE STATE**

**MAY 2019**

## **GEOTECHNICAL INVESTIGATION REPORT OF SEWER PIPE BRIDGE IN PAUL ROUX, FREE STATE**

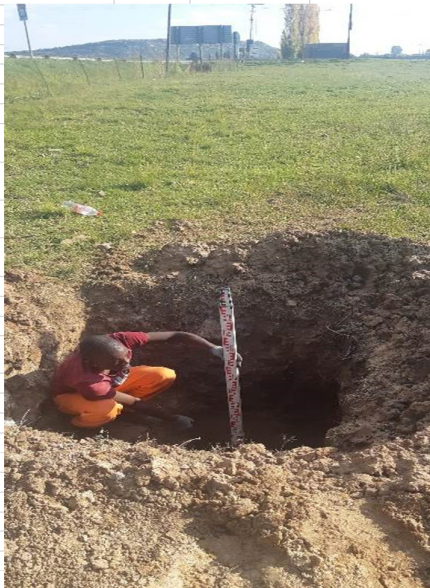
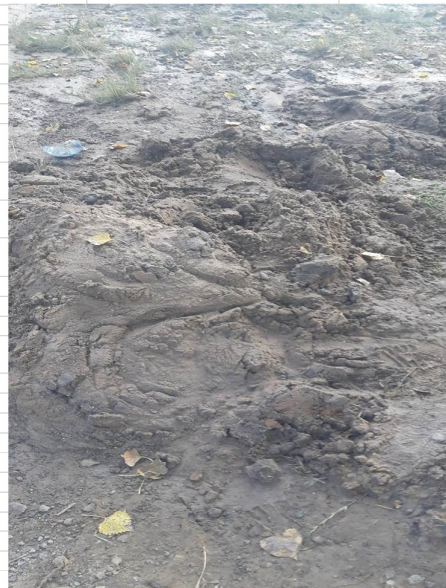
Test Pit : 1

Starting Depth: 0mm  
 End Depth: 1760mm

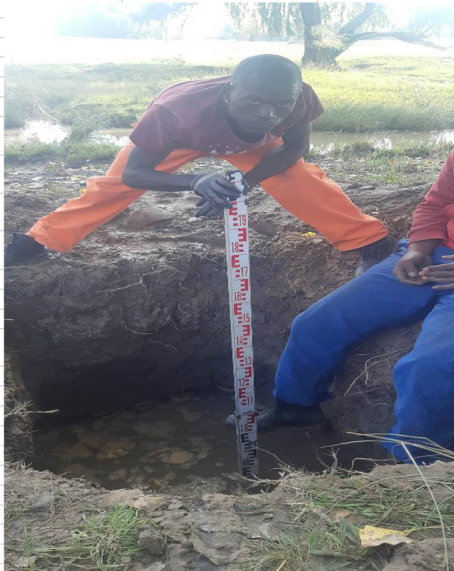
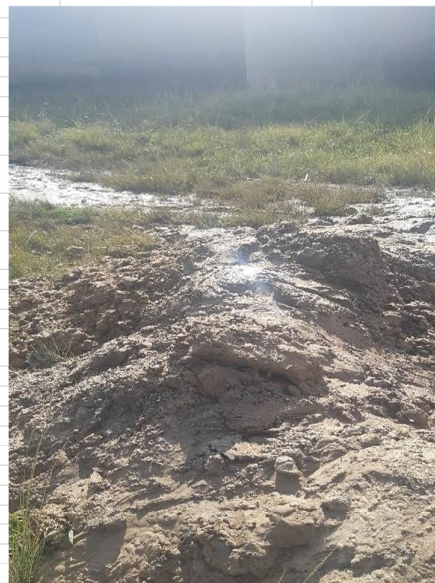
Test Pit : 2

Starting Depth: 0mm  
 End Depth: 1820mm

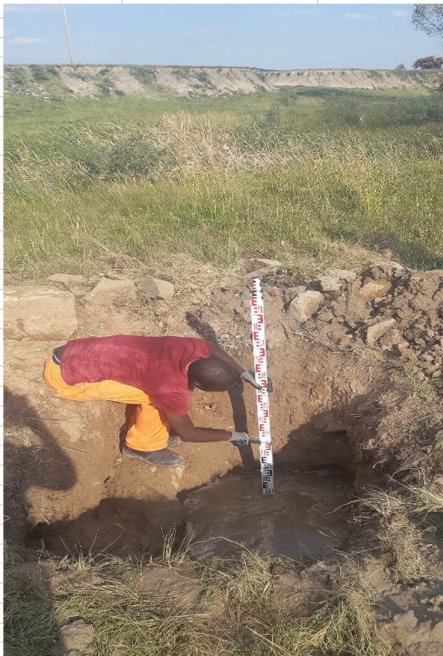
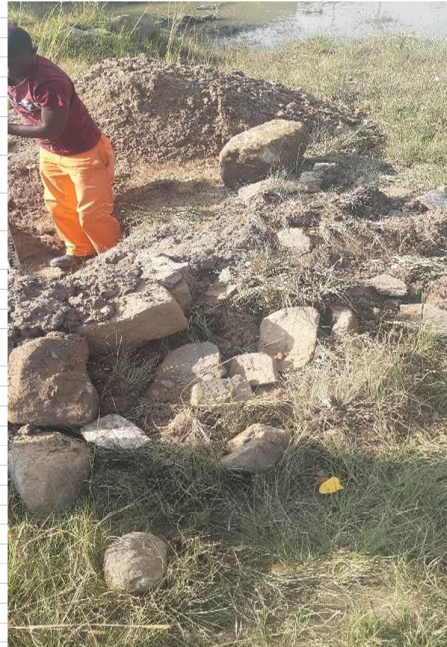
Test Pit : 3

The erosion of soils is a function of the resistance of slope materials to entrainment and transport, and the potential of slope processes that promotes erosion. The resistance of soil to erosion is also related to the mechanical strength, cohesion and particle size of the material self. There were signs of piping (erosion) on Test Pit 3.

Starting Depth: 0mm  
 End Depth: 1838mm

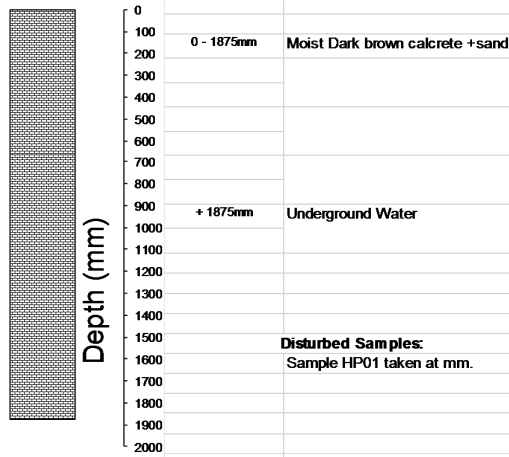
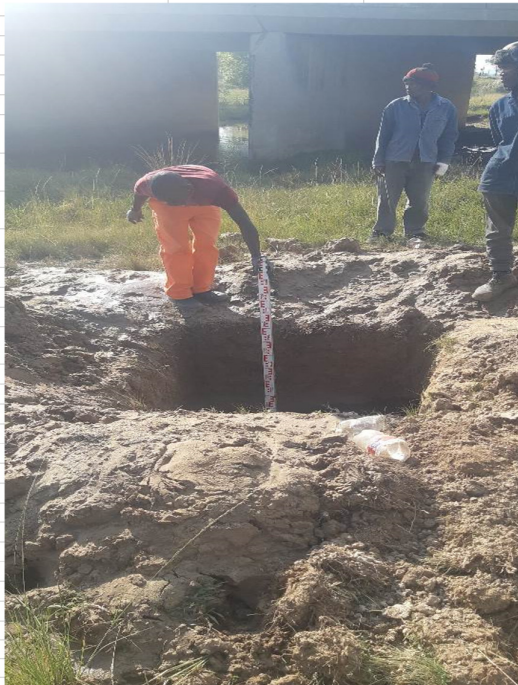
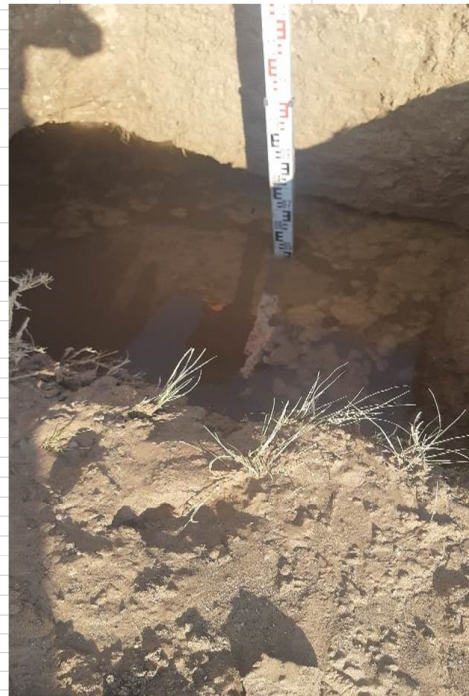
Test Pit : 4

Starting Depth: 0mm  
 End Depth: 1875mm

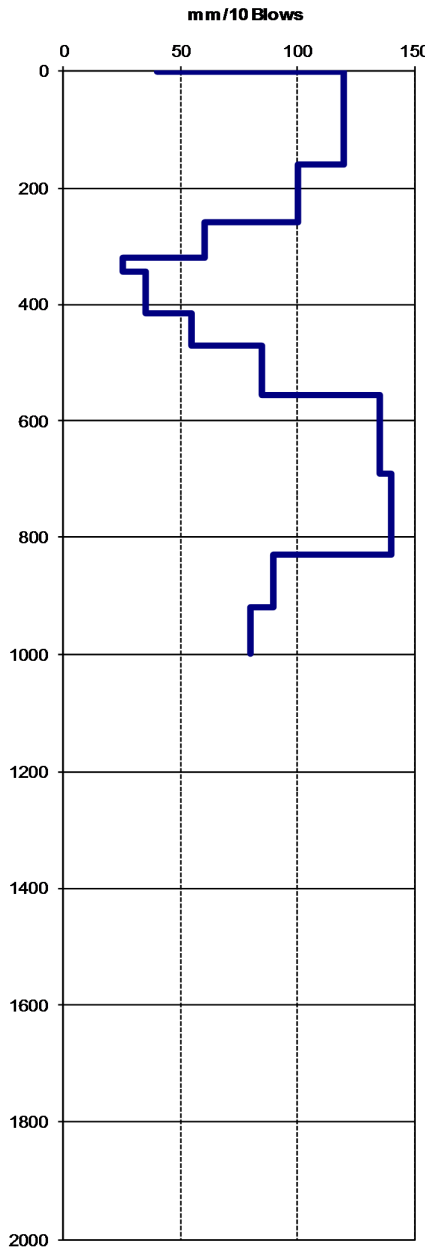
Project :		PAUL ROUX GEO		Lab No:	
		Rd name / No :				Client No :	
		Section from :				Date :	
						MCL006	
						5/A/2019	
<b>DYNAMIC CONE PENETROMETER (DCP)</b>							
TMH 6 Method ST6							
<b>DCP No.</b>		1		<b>Site</b>			
<b>Chainage:</b>				<b>Layer type</b>			
<b>Offset:</b>				<b>Carriageway</b>			
<b>Field Data</b>		<b>Resolved Parameters</b>			<b>Layer Summary</b>		
Depth Gnd Level (mm)	Interval (mm)	Blows	DPI (mm/Blow)	CBR (%)

40	0						
160	120	10	12.0	17			
260	100	10	10.0	22			
320	60	10	6.0	42			
345	25	10	2.5	>110			
380	35	10	3.5	84			
415	35	10	3.5	84			
470	55	10	5.5	47			
555	85	10	8.5	27			
690	135	10	13.5	15			
830	140	10	14.0	14			
920	90	10	9.0	25			
1000	80	10	8.0	29			
<b>REMARKS</b>					Tech :		
					Date :

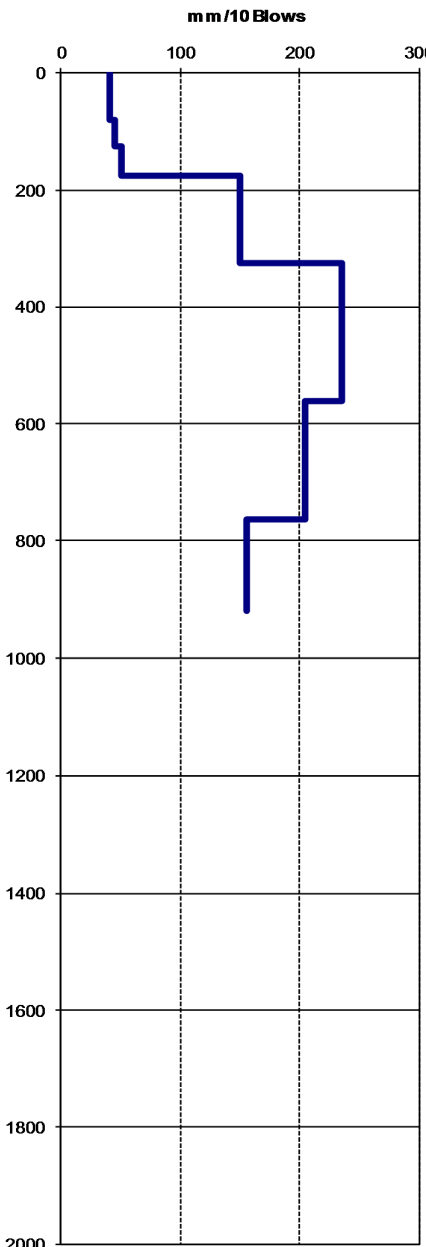
Project :		PAUL ROUX GEO		Lab No :		
		Rd name / No :				Client No : MCL006		
		Section from :				Date : 30-Apr-19		
<b>DYNAMIC CONE PENETROMETER (DCP)</b>								
TMH 6 Method ST6								
<b>DCP No.</b>		<b>2</b>			<b>Site</b>			
<b>Chainage:</b>					<b>Layer type</b>			
<b>Offset:</b>					<b>Carriageway</b>			
<b>Field Data</b>				<b>Resolved Parameters</b>		<b>Layer Summary</b>		
Depth Gnd Level (mm)	Interval (mm)	Blow s	DP1 (mm/Blow)	CBR (%)

40	0							
80	40	10	4.0	70				
125	45	10	4.5	61				
175	50	10	5.0	53				
325	150	10	15.0	13				
560	235	10	23.5	7				
765	205	10	20.5	9				
920	155	10	15.5	13				
<b>REMARKS</b>					Tech :			
					Date :

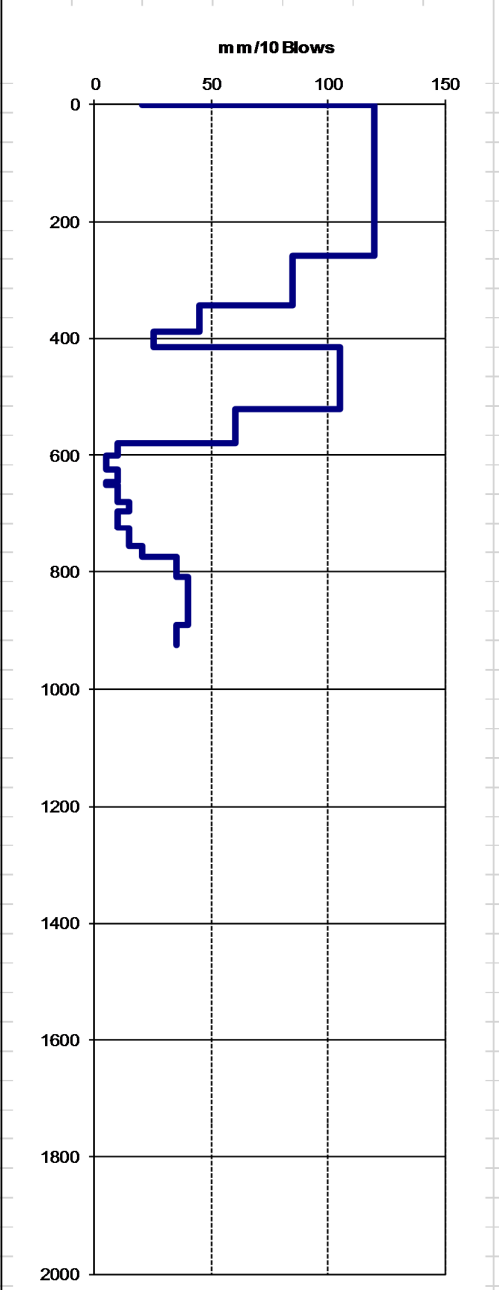
Project :		PAUL ROUX GEO		Lab No:		
		Rd name / No :				Client No : <b>MCL006</b>		
		Section from :				Date : <b>30-Apr-19</b>		
<b>DYNAMIC CONE PENETROMETER (DCP)</b>								
TMH 6 Method ST6								
<b>DCP No.</b>		<b>3</b>			<b>Site</b>			
<b>Chainage:</b>					<b>Layer type</b>			
<b>Offset:</b>					<b>Carriageway</b>			
<b>Field Data</b>				<b>Resolved Parameters</b>		<b>Layer Summary</b>		
Depth Gnd Level (mm)	Interval (mm)	Blows	DPI (mm/Blow)	CBR (%)

20	0							
140	120	10	12.0	17				
260	120	10	12.0	17				
345	85	10	8.5	27				
390	45	10	4.5	61				
415	25	10	2.5	>110				
520	105	10	10.5	21				
580	60	10	6.0	42				
590	10	10	1.0	>110				
600	10	10	1.0	>110				
605	5	10	0.5	>110				
610	5	10	0.5	>110				
615	5	10	0.5	>110				
620	5	10	0.5	>110				
625	5	10	0.5	>110				
635	10	10	1.0	>110				
645	10	10	1.0	>110				
650	5	10	0.5	>110				
660	10	10	1.0	>110				
670	10	10	1.0	>110				
680	10	10	1.0	>110

695	15	10	1.5	>110				
705	10	10	1.0	>110				
715	10	10	1.0	>110				
725	10	10	1.0	>110				
740	15	10	1.5	>110				
755	15	10	1.5	>110				
775	20	10	2.0	>110				
810	35	10	3.5	84				
850	40	10	4.0	70				
890	40	10	4.0	70				
925	35	10	3.5	84				
<b>REMARKS</b>					Tech :			
					Date :
