### PARLIAMENT PRECINCT: AFRICA HOUSE

### PERMIT REQUIREMENTS: APPROVAL FOR DISABILITY COMPLIANCE PROPOSALS

### BUILT ENVIRONMENT UNIT

**DATE: 17 – 10 – 2022**

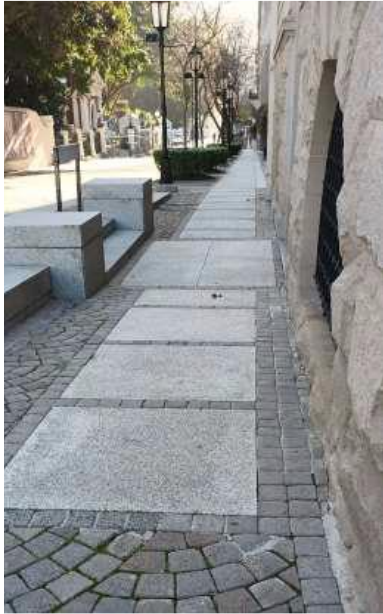
Figure 6 Ramp to Entrance

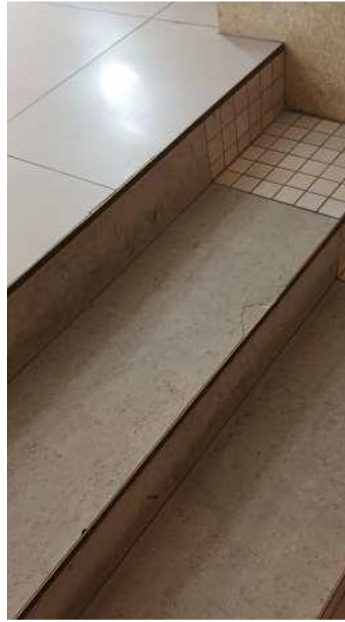
Figure 7 Broken Floor Tiles

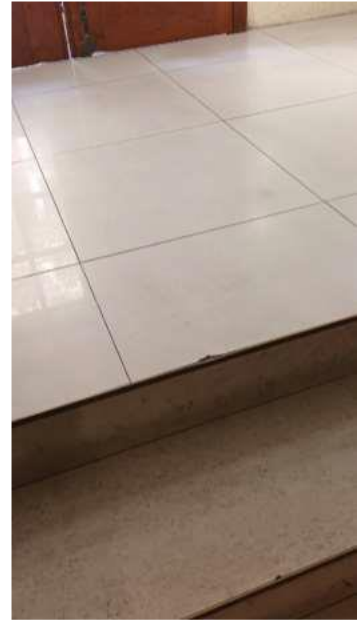
Figure 8 Broken Tiles

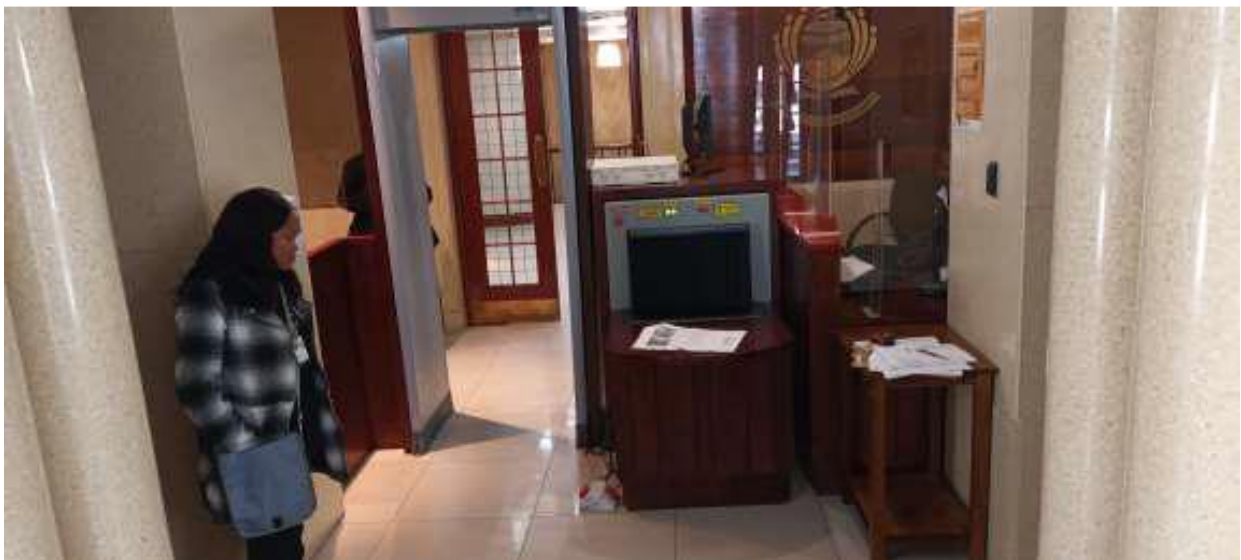
- No provision was made for access for persons with disabilities in this area.
- The Lobbies within the Main Entrance are very small and restricted, making it difficult to implement disabled facilities of any kind. Placing a temporary metal ramp over part of the steps will not work – the gradient will be too steep to navigate.
- As indicated earlier, the Ground floor Foyer is a prominent part of the circulation space in the interior and cannot be adjusted.

Figure 9. Main Entrance Lobby and security access control

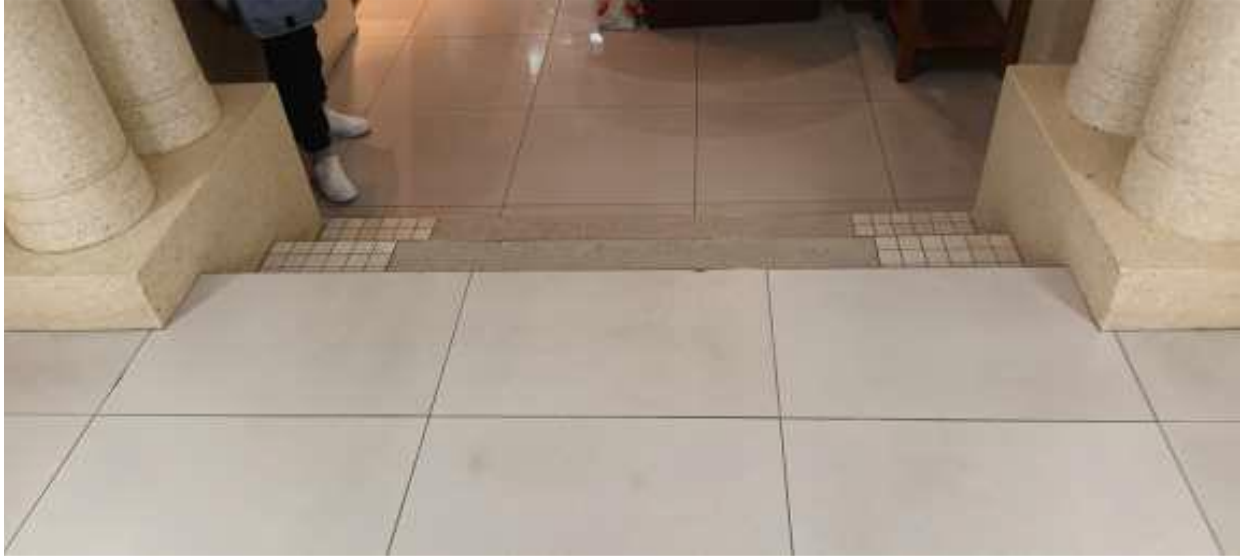
The only provision made for persons with disabilities is the existing external ramp in front of the building. The main entrance is through a system of double doors and a sequence of lobbies. In between these lobby spaces is a change in levels (2 steps leading downwards) which approximates 450mm in height. There are both physical and electronic security controlled access in the Entrance Foyer.

*Figure 10. Main Entrance: Distance between steps and security desk*

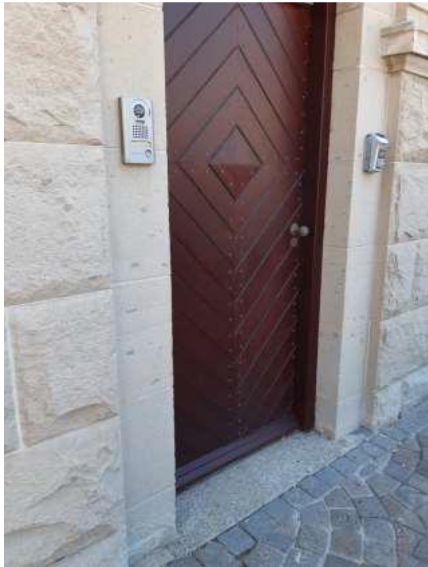
*Figure 11. Secondary Entrance*

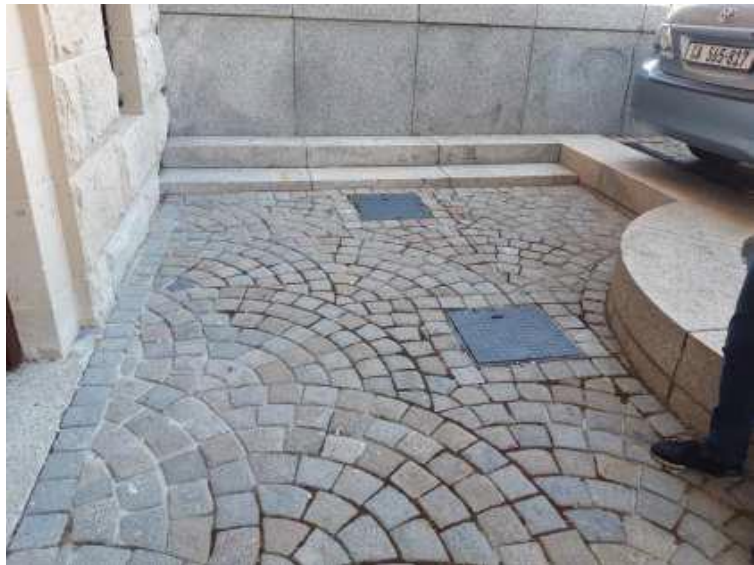
*Figure 12. Location of Proposed Ramp*

5.3.1.1 A new ramp was proposed to reduce the distance wheelchair-bound persons have to travel to gain access to the secondary entrance at Africa House. As mentioned above under items 4.1 and 4.2.2.5, the existing ramp in front of Africa House is. +- 24 meters away from the secondary entrance.

5.3.1.2 To benefit persons with disabilities, it was proposed to convert a small unutilized area just outside the secondary entrance into a short ramp.

c) The following method of construction is proposed for the construction of the ramp:

- Remove the existing cobblestone pavers in the corner, to the right of the entrance door (when facing the door).

- Construct a reinforced concrete ramp with up-stand, and new Mentis type or equally approved GMS hollow core tube handrails and stanchions fitted securely to the up-stands.

- Surface finish on the ramp to be either granite slabs or re-using the existing cobblestone pavers.

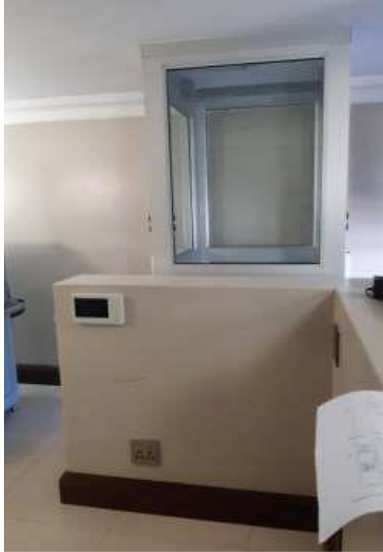
Figure 13 Security Equipment

4.3.1.3 The Existing 'Mantrap' and scanner to remain. The scanner can be positioned next to the 'Mantrap' to utilize the space more efficiently.

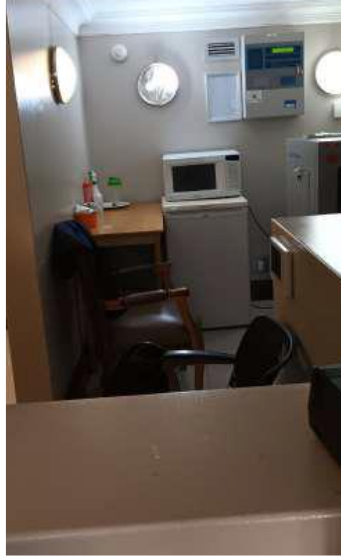
Figure 14. Security Entrance Low wall

4.3.1.2 Remove the bulk of the low L-shape wall, but allow for +- 450mm length of wall to remain and made good.

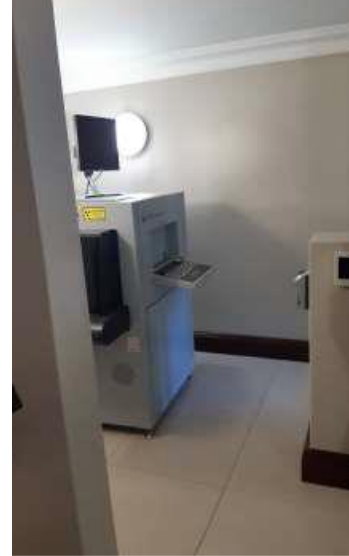
Figure 15. Security work Space
