PESTANA

Wetland and Riparian Zone Identification and Assessment

AUGUST 2019

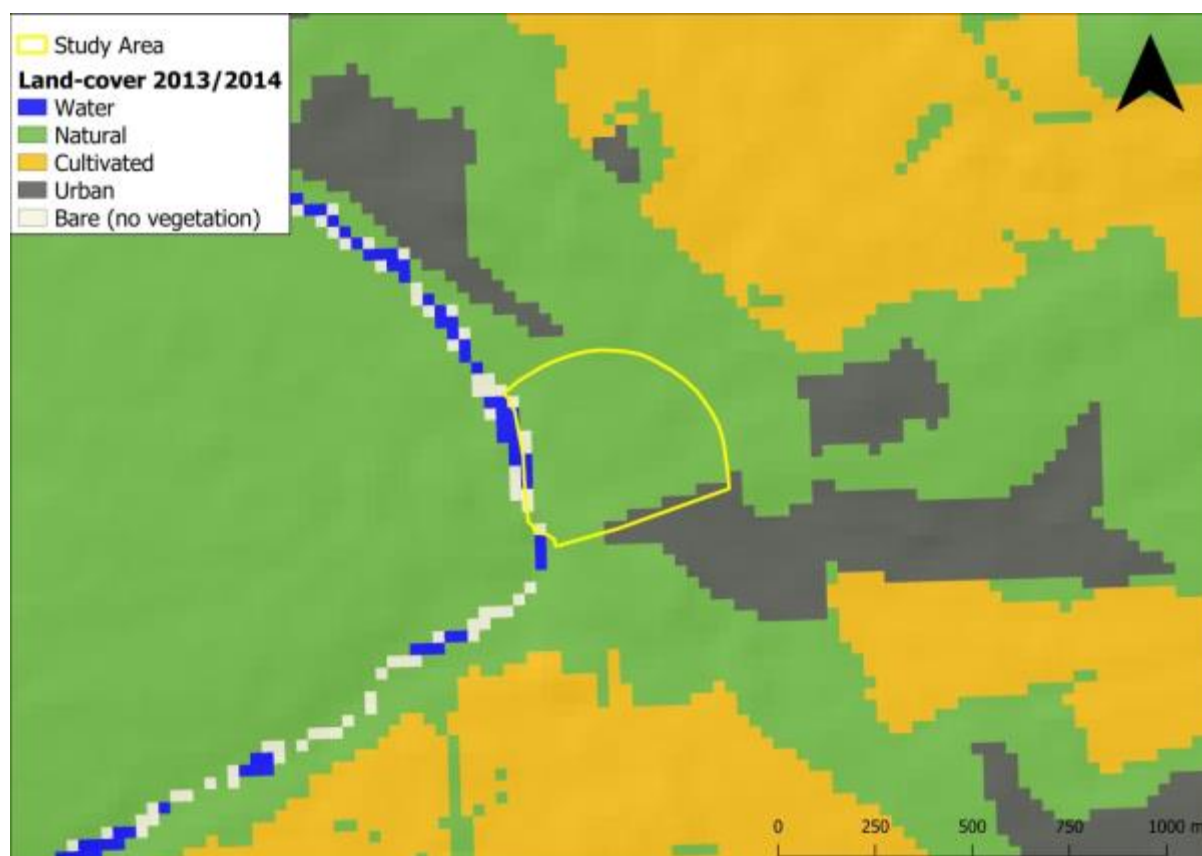
Figure 5-2: 2013/2014 Land-cover data showing the different land-uses within and surrounding the study area

According to the 2013/2014 land-cover data, the study area is almost all-natural, with some water and bare patches, as well as some urban development (Figure 5-2). Urban development and cultivation make up the predominant land-use in the surrounding area (Figure 5-2).

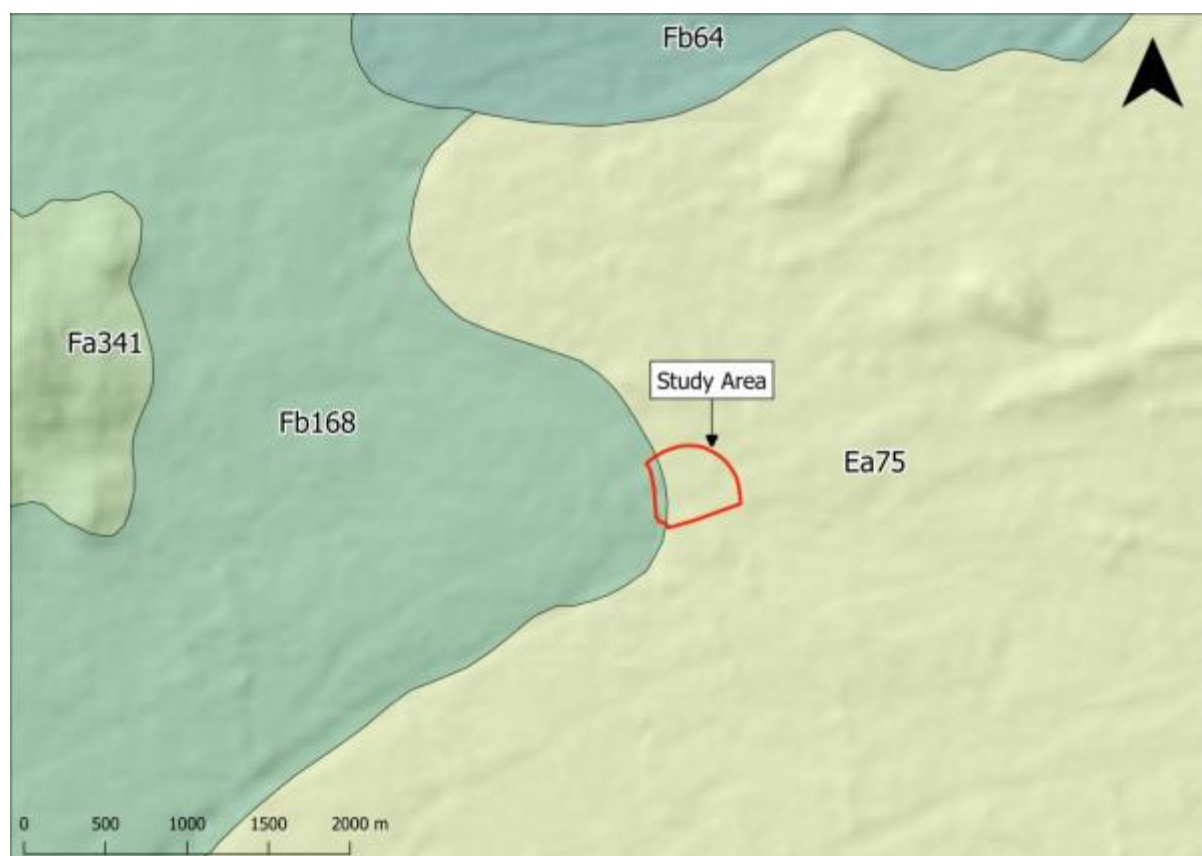
Figure 5-4: Study area in relation to the land types in the vicinity

The study area covers two land types, as per Table 5-1 (Figure 5-4).

Table 5-1: A description of the soils and geology of the two land types associated with the study area (Land Type Survey Staff, 1972–2006)

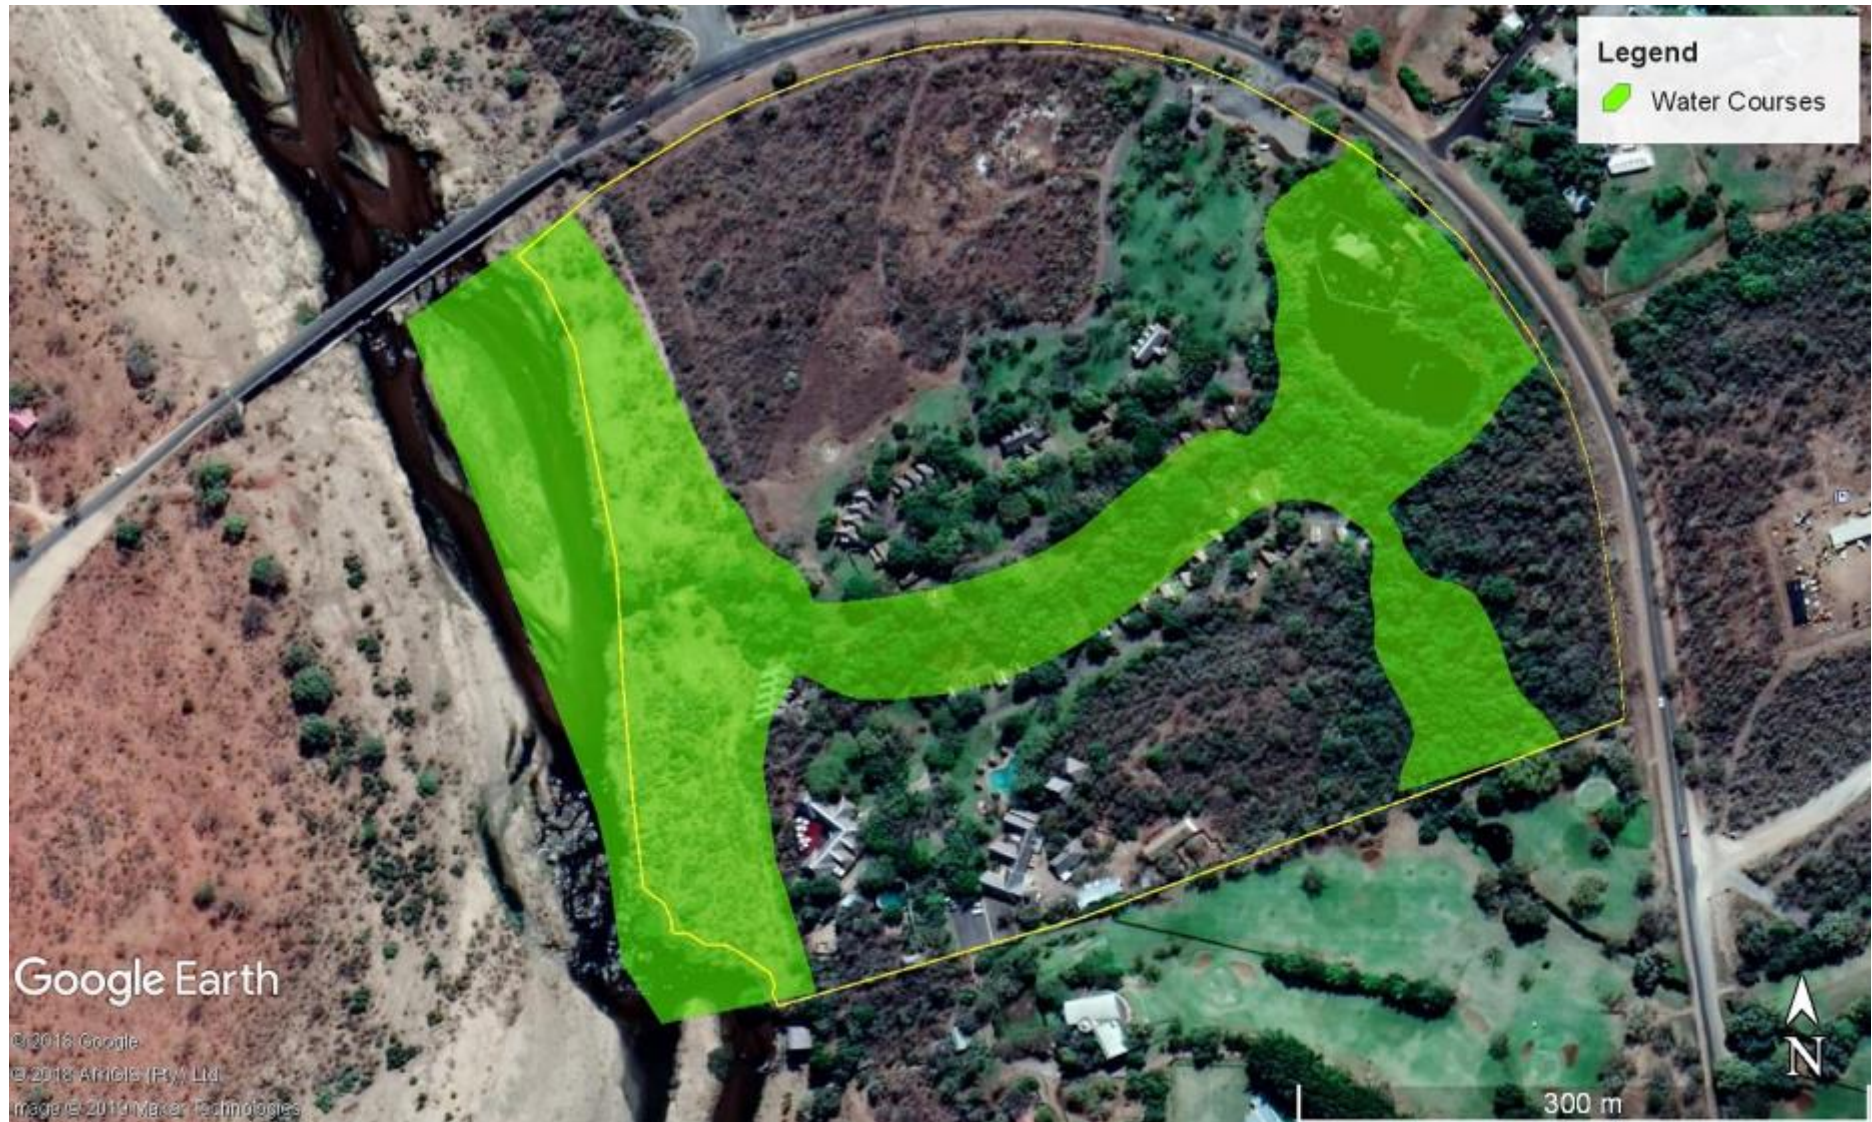
Figure 5-8: Delineated watercourses within the Pestana Study Area

The riparian areas identified were delineated following the guidelines for delineating the boundaries of a wetland, set out by the Department of Water Affairs and Forestry (DWAFF) (DWAFF, 2005). These delineated riparian areas are demarcated and indicated as per the map is shown in Figure 5-8 **Error! Reference source not found.**

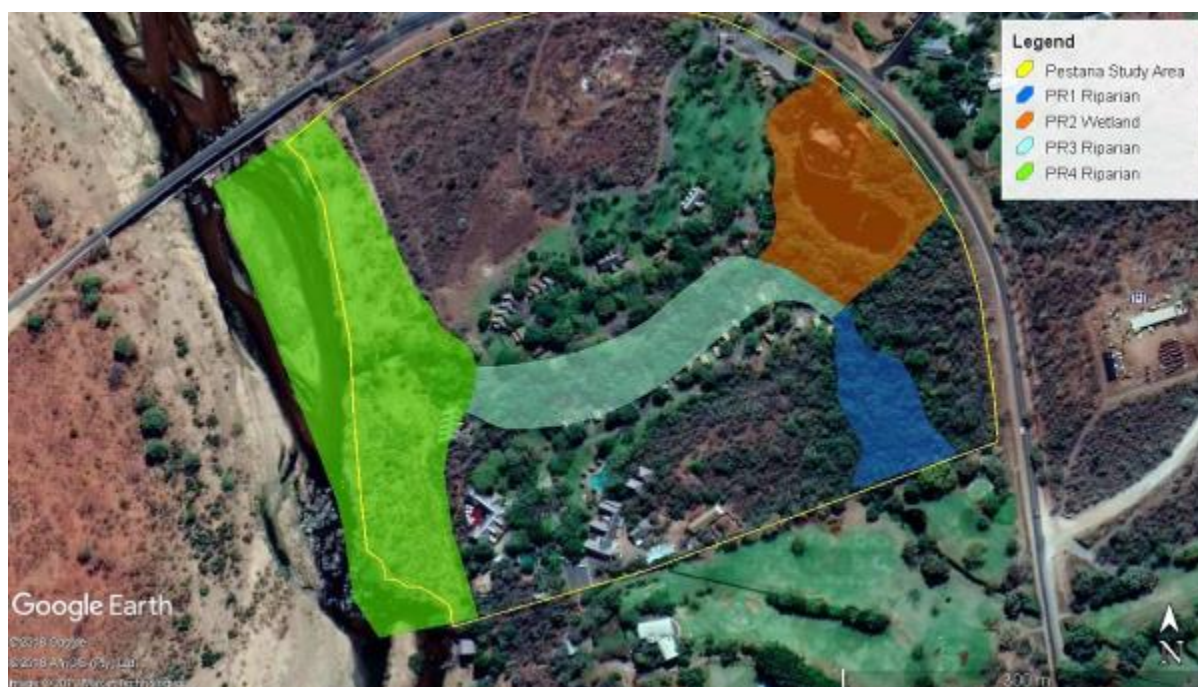
Figure 5-9: Identified Riparian areas for the purpose of this study

Four watercourses were identified and can be described as riverine and a wetland. The wetland area is mostly covered by a dam and leakage taking place that resulted in inundated wetland area downstream thereof. Wetland areas occur around the dam and upstream of the road crossing. The delineated wetland and riparian areas are demarcated and indicated as per the map in Figure 5-9.

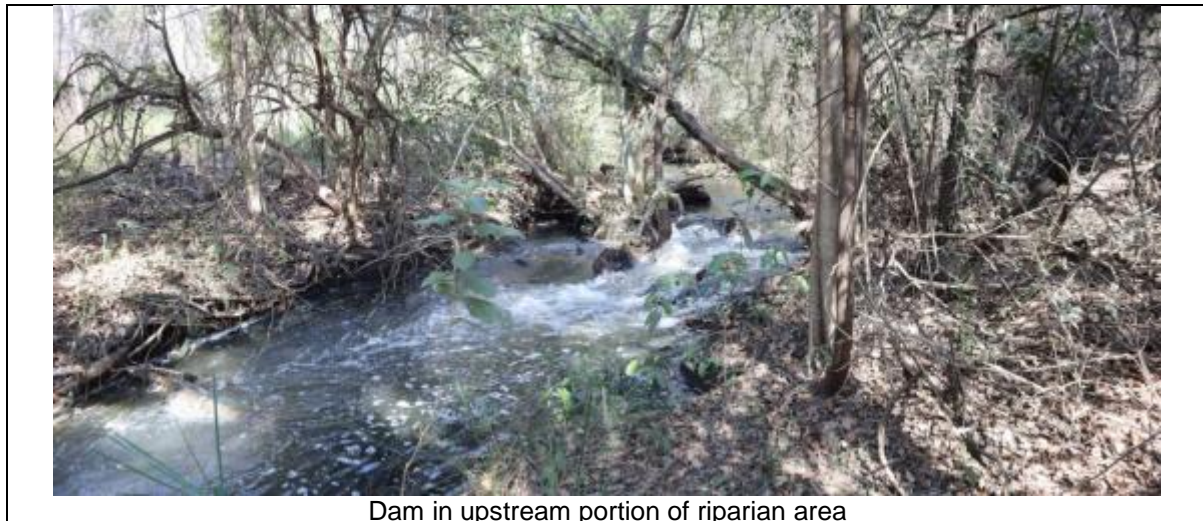
Figure 5-10: Visuals of Site PR1 Riparian

This site is located at 25°27'43.77" S, 31°52'25.21" E. The riparian zone extends upstream from the edge of the property and downstream where it reaches the guesthouses (Figure 5-10 and Figure 5-11).

Dam in upstream portion of riparian area

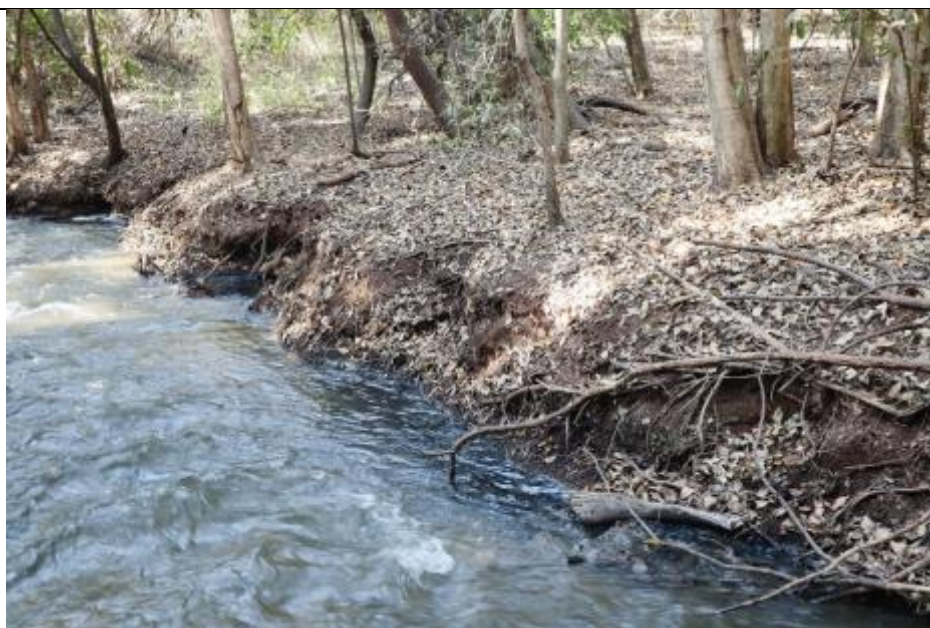
Figure 5-12: Photos of selected VEGRAI site

View of the marginal zone

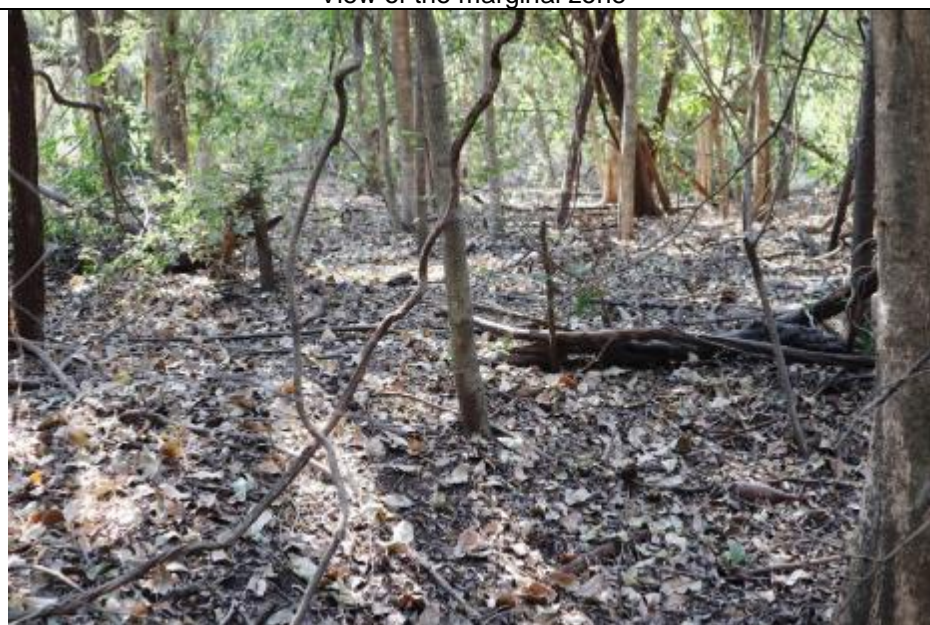
This zone is reasonably wide and is mostly covered by shrubs and trees. The substrate consists mainly of soil material and rocky habitat in places. The ground cover consists mainly of leaf litter and other moribund material. The following woody species occur: *Bridelia micrantha*, *Acacia xanthophloea*, *Philenoptera violacea*, *Phyllanthus reticulatus*, *Ficus sycomorus*, *Syzygium cordatum*, *Celtis africana*, *Sclerocarya birrea* subsp. *caffra*, *Grewia flavescens*, *Bridelia cathartica*, *Phyllanthus reticulatus*, *Gymnosporia senegalensis* and *Gymnanthemum coloratum*, etc. Understory plants such as *Setaria megaphylla*, *Hypoestes forskoolii*, and *Panicum maximum* occur. The exotics, *Melia azedarach* and *Chromolaena odorata* are dominant in places within this zone. Other exotics found include: *Solanum mauritianum*, *Lantana camara*, *Ageratum conyzoides*, etc.

View of the non-marginal zone

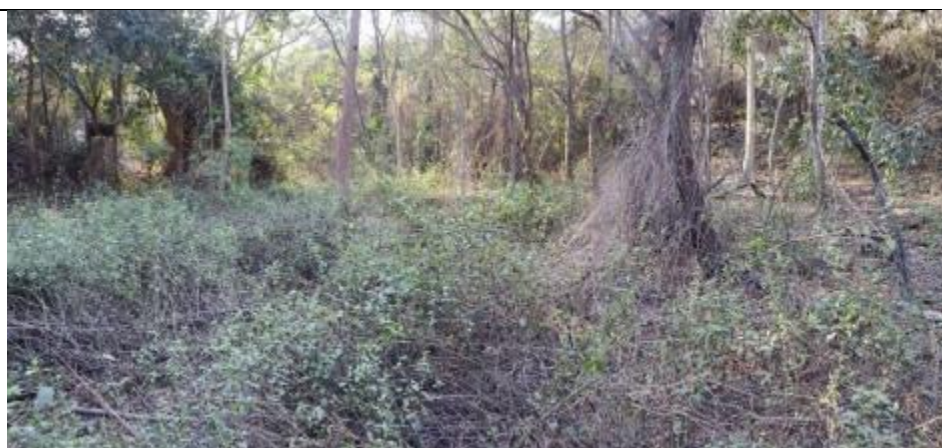
Figure 5-13: Activities that contribute towards the degradation of the PR1 riparian zone's integrity

The Riparian Index of Habitat Integrity (RIHI) for PR1 is a C (62.1%). The main impacts include the upstream road crossing, golf course (impacted corridor upstream of the study area), sugarcane factory upstream, and the presence of exotic vegetation (**Error! Reference source not found.**). The water quality is further degraded by the sugarcane factory and the golf course adjacent to the riparian area. The sugarcane factory can pollute the water in the increase in sucrose and fructose that further benefit the microbe organisms which forms the basis of the food chain, thus the reason for an increase in diversity within this system. Due to the influence of the factory site, a continuous high-flow pattern is experienced through the riparian area, less alluvial material is thus available to the riparian zone, which has resulted in the degradation of the riverbank, referred to as bed-armouring. The result of this can be seen in bank collapse and under-cutting of the bank, which is taking place (Figure 5-13).

The exotic, *Chromolaena odorata*, is smothering potential riparian vegetation habitat

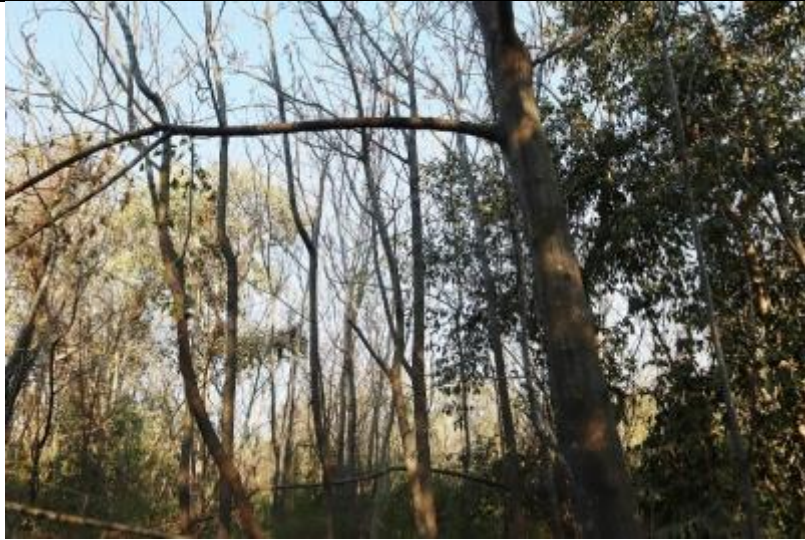
The exotic tree, *Melia azedarach*, growing in abundance within the non-marginal zone of the riparian macro channel

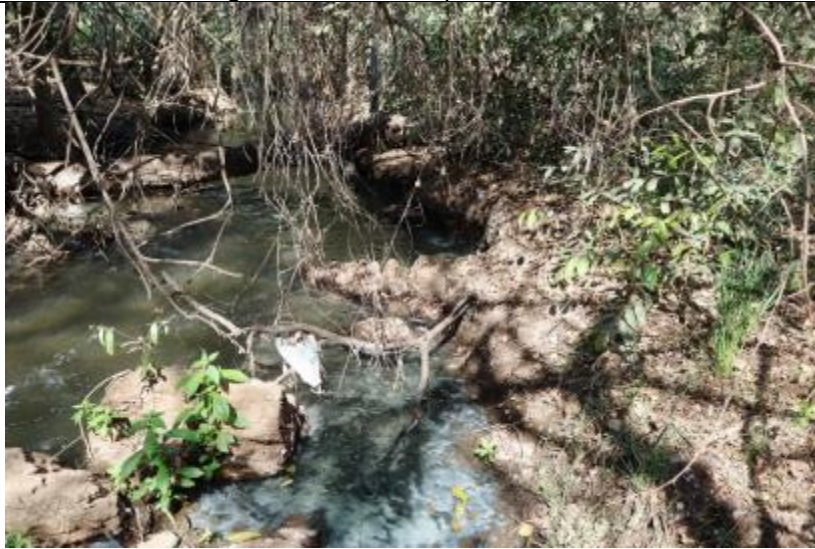
Bank collapse and under-cutting

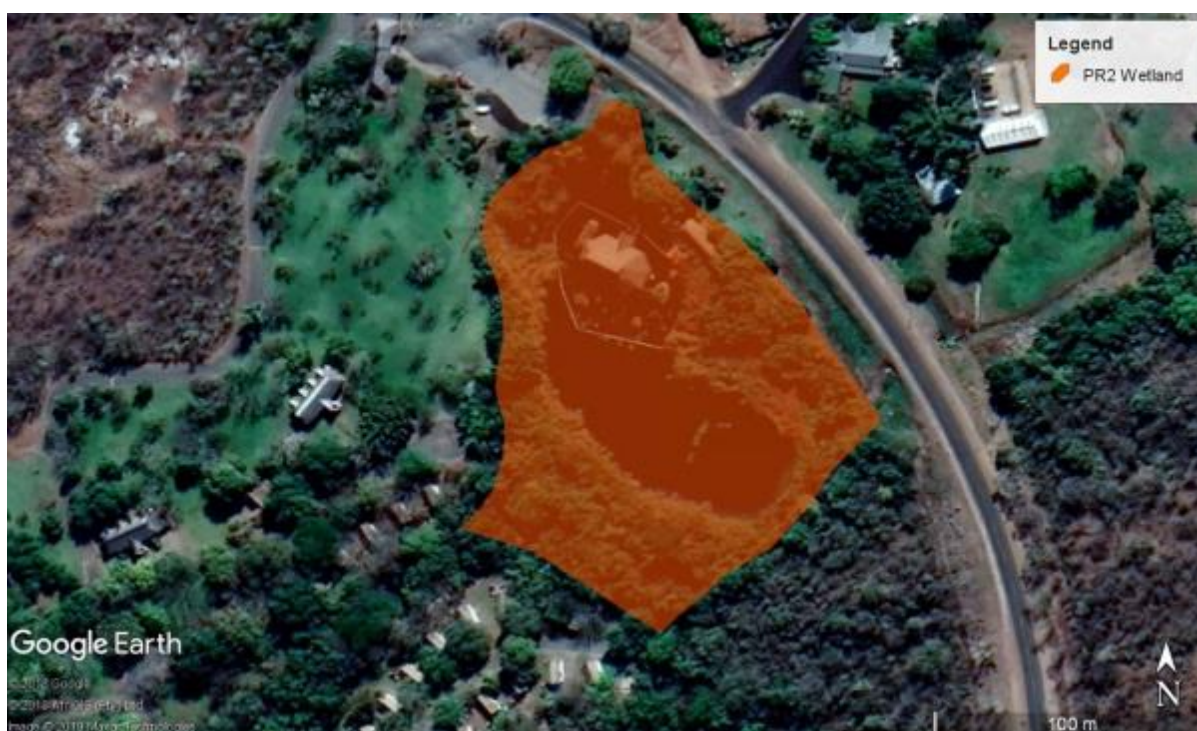
Figure 5-14: Google Earth image of wetland PR2

This site is located at 25°23'09.51 S, 31°53'31.57 E. The wetland extends upstream from the edge of the R570 road and downstream where it joins riparian PR3 (Figure 5-14).

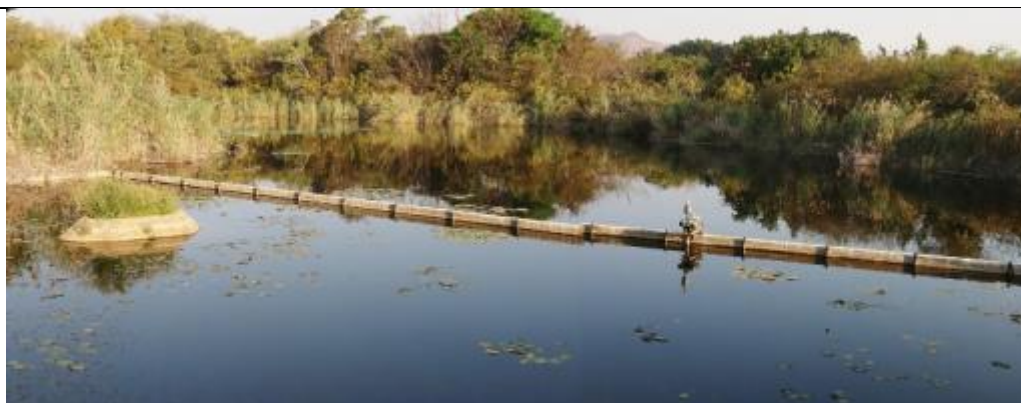
Figure 5-15: Activities in wetland areas that can be detrimental to wetland integrity

To determine the integrity of the wetland, and the condition of the site, the direct and indirect disturbances, etc. were taken into account. The following disturbances in the catchment of the wetland were observed: sugarcane crops, management roads, the R570 road crossing with culverts, fences, pipelines, earthworks (embankment from cultivation activities), alien and terrestrial invasive vegetation species, etc. (Figure 5-15). 74.4% of the wetland has been altered.

Panoramic view of the dam constructed in the wetland

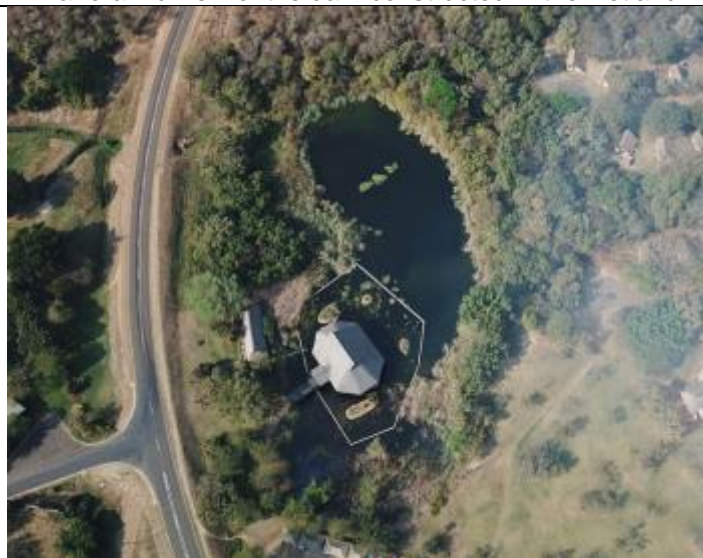
Aerial photo indicating the extent of the dam

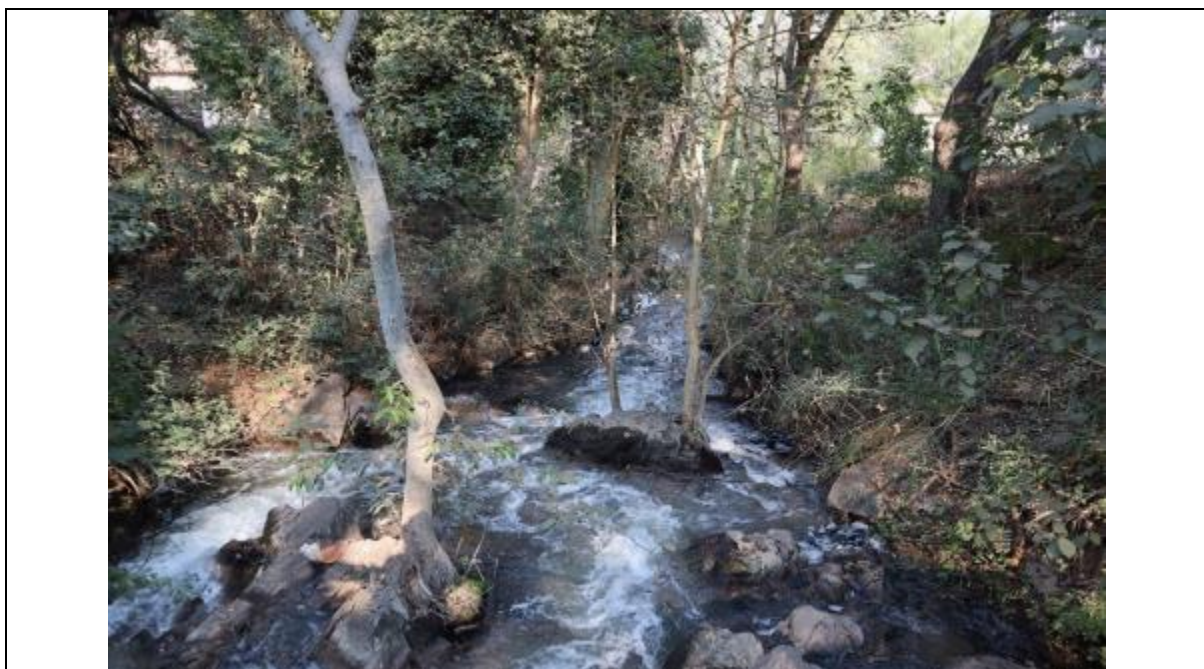
Figure 5-17: Visuals of Site PR3 Riparian

Dam in upstream portion of riparian area

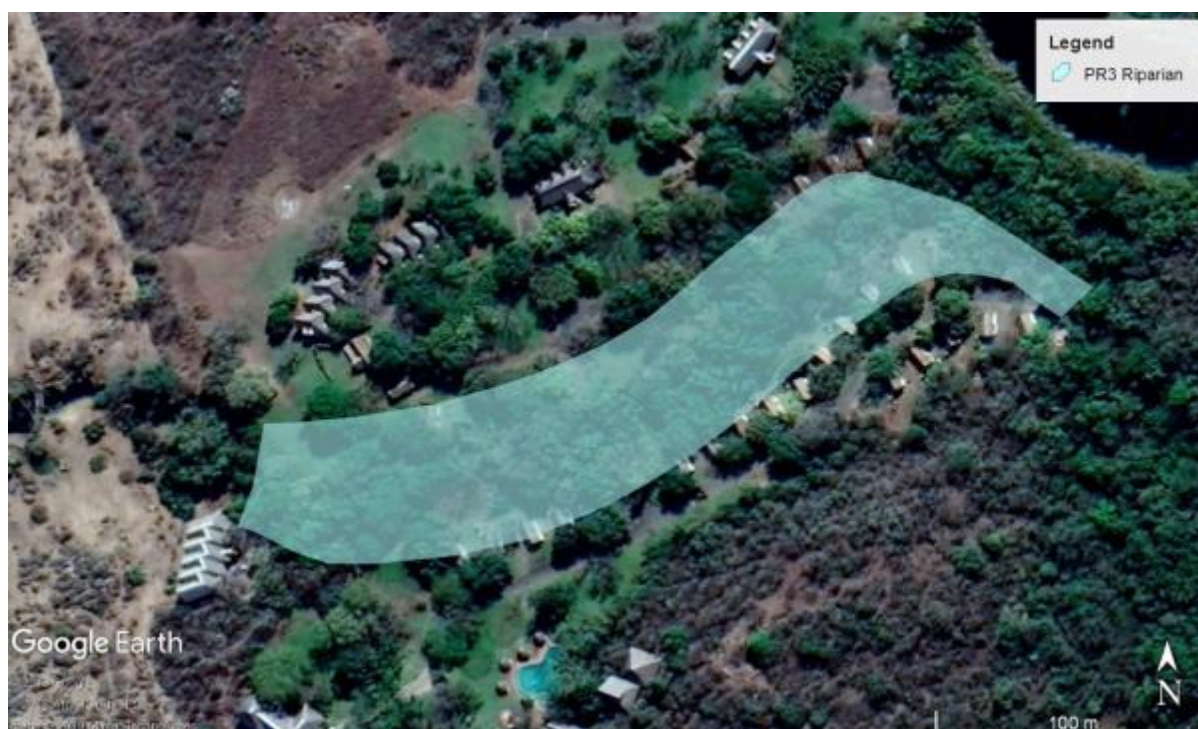
Figure 5-18: Google image of the delineated PR3 Riparian within the study area

This site is located at 25°27'42.91" S, 31°32'18.31" E. The riparian zone extends upstream from the edge of the guesthouses and downstream to where it joins the Crocodile River (Figure 5-10 and Error! Reference source not found.).

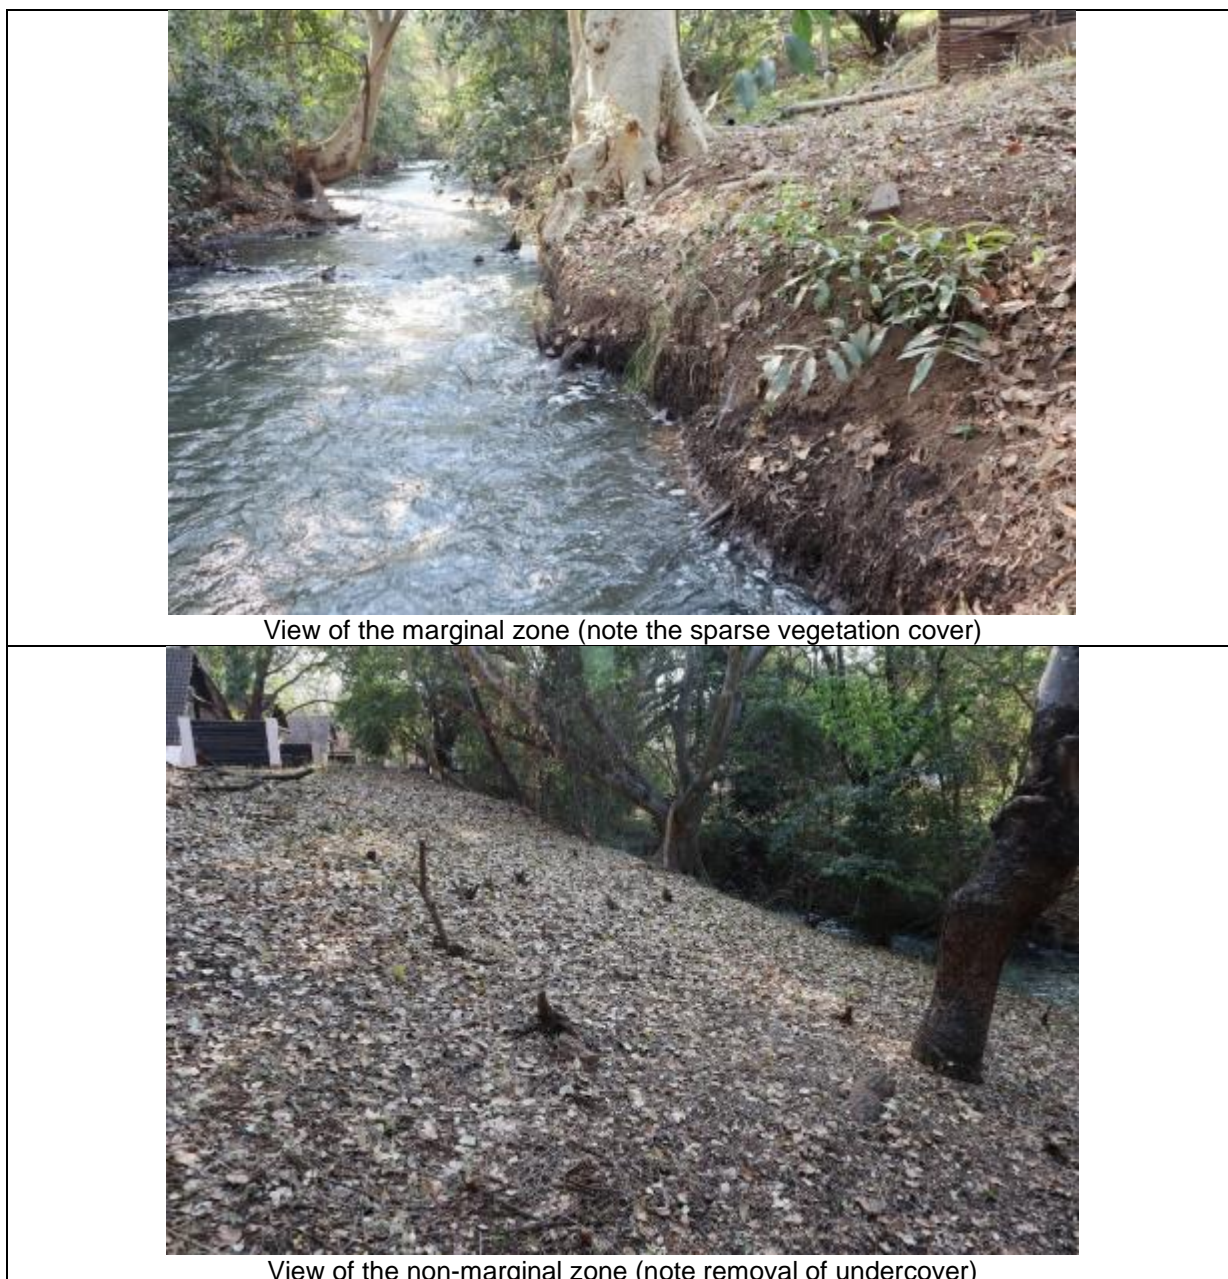
Figure 5-19: Photos of selected VEGRAI site

The presence of a dam upstream, a golf course and industrial site within its catchment and the guesthouse development footprint within the non-marginal zone has resulted in the degradation of the marginal zone's integrity. The dominant tree species are *Ficus sycomorus*, *F. sur*, *Diospyros mespiliformis*, *Combretum microphyllum*, *Syzygium cordatum*, and *Trichilia emetica*. The following grass and sedge species occur, although in low numbers in this zone: *Cyperus sexangularis*, *Pteris vittata*, etc. Exotic vegetation, such as: *Caryota urens*, *Melia azedarach*, *Tecoma stans*, *Tagetes minuta*, *Ricinus communis*, *Lantana camara*, etc. occur.

This zone is dominated by trees, with a few shrubs. The undergrowth has been reduced to garden-like features: mowed grass cover and large areas with no cover, for the purpose of the premises. The substrate consists mainly of soil material and rocky habitat in places. The banks are reasonably steep in places. The following woody species occur: *Philenoptera violacea*, *Ficus sycomorus*, *Syzygium cordatum*, *Celtis africana*, *Sclerocarya birrea* subsp. *caffra*, *Bridelia cathartica*, *Grewia flavescens*, *Bridelia cathartica*, *Combretum erythrophyllum*, *Diospyros mespiliformis*, *Gymnosporia senegalensis*, and *Gymnanthemum coloratum*, etc. Understory plants such as: *Setaria megaphylla*, *Hypoestes forskolii*, *Cucumis zeyheri*, *Cynodon dactylon*, and *Panicum maximum* occur. Some exotic vegetation such as *Melia azedarach*, *Bougainvillea spectabilis*, *Solanum mauritianum*, *Bidens pilosa*, *Lantana camara*, *Ageratum conyzoides*, etc. were also found.

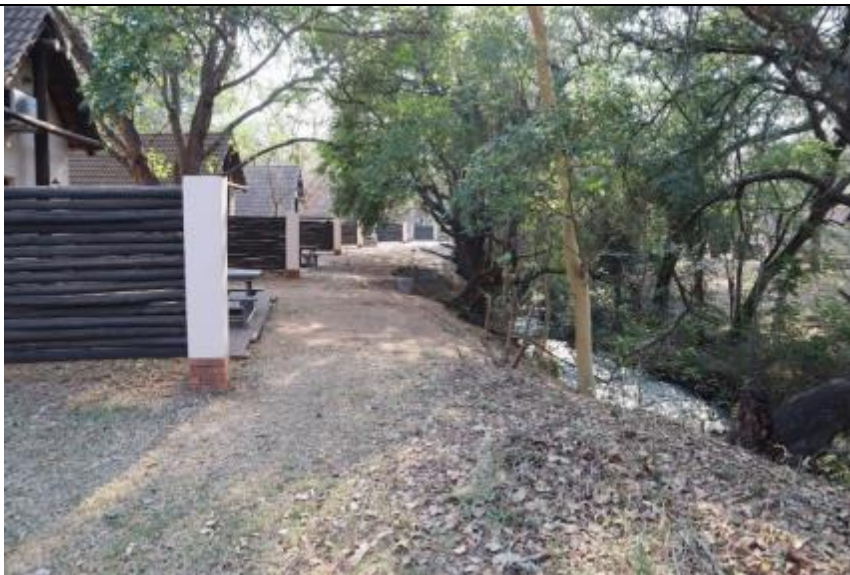
Figure 5-20: Activities that contribute towards the degradation of the PR3 riparian zone's integrity

The Riparian Index of Habitat Integrity (RIHI) is a D (55.9%). The main impacts are the road crossings, lodge footprint (extending into riparian areas, cover an area of 65% of the non-marginal zone), felling of riparian vegetation, and the presence of exotic vegetation (Figure 5-13). Water quality is further degraded as a result of upstream activities such as a dam, industrial site (sugarcane factory) and a golf course. Due to the influence of the dam and other mentioned activities, less alluvial material is released to the downstream areas, which have resulted in the degradation of the riverbank, referred to as bed-armouring. The constant high flows increased the size of the active channel and have had a bearing on the integrity of the non-marginal zone as well. The result of this can be seen in bank collapse and under-cutting of the bank which is taking place. There is also vegetation clearing in the riparian areas' which reduces the vegetation roughness coefficient (Figure 5-13).

Footprint of the lodge extend into the non-marginal zone

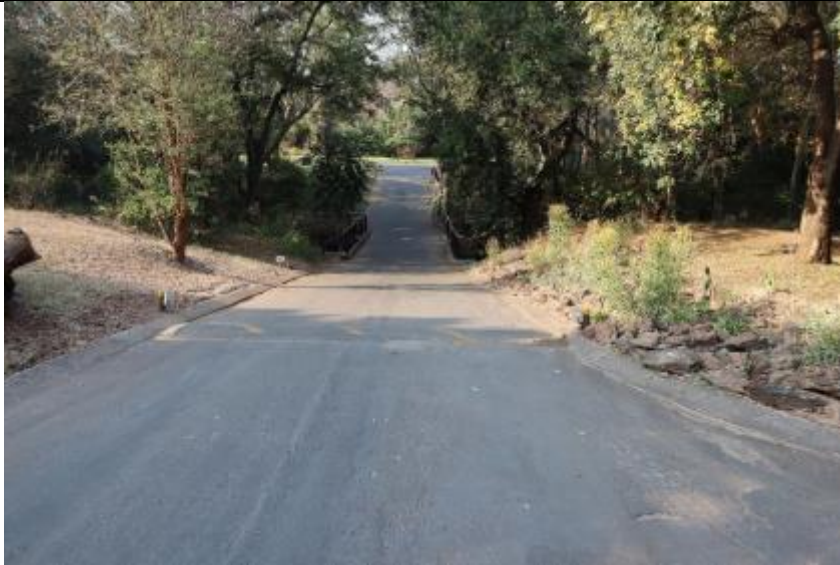
Road crossing bisects riparian area

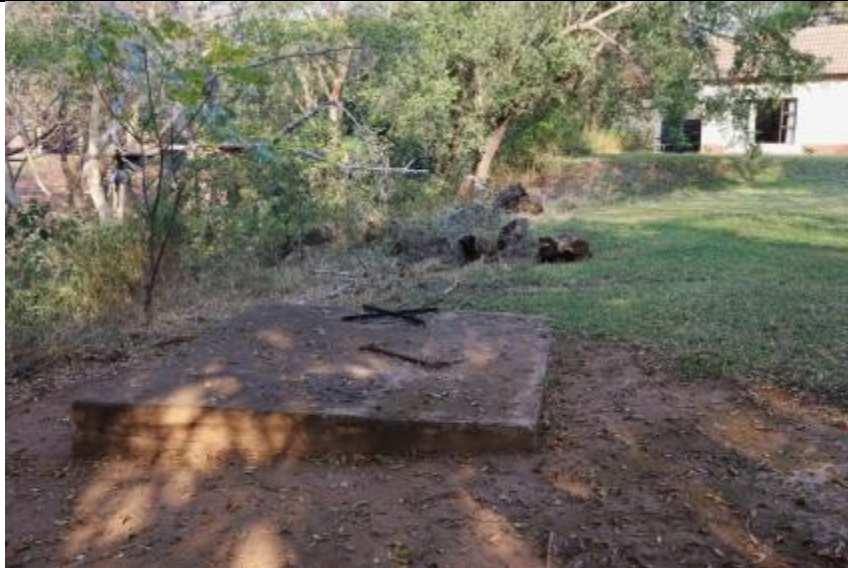
Remnant infrastructure and the felling of riparian trees

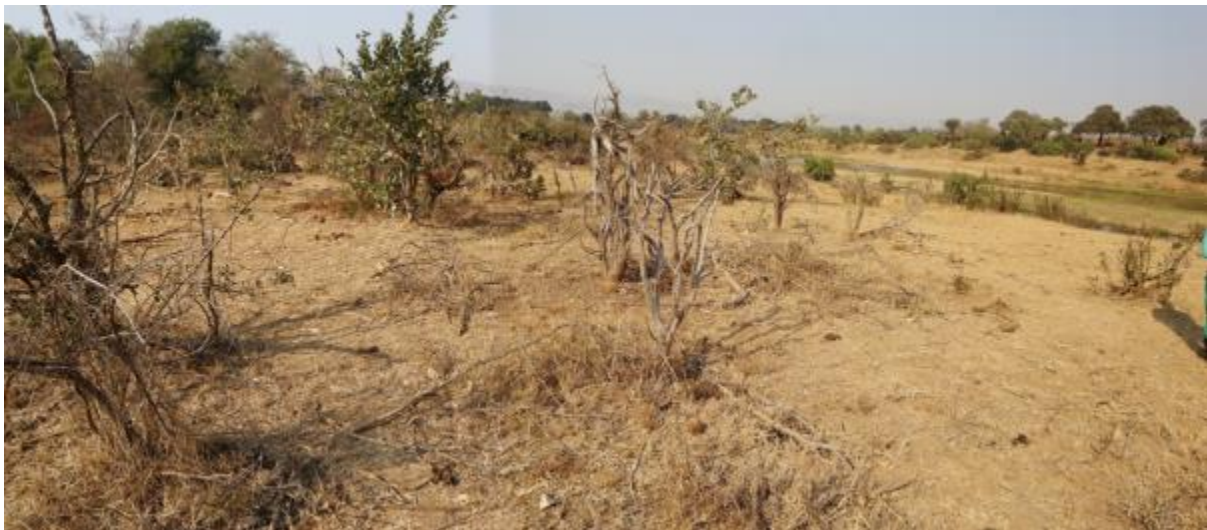
Figure 5-21: Panoramic view of the riparian area PR4

The Crocodile River site is located at 25°27'43.05" S, 31°32'11.06" E. A panoramic view of the study area can be seen in Figure 5-21. Figure 5-22 is a Google aerial photo indicating the extent of this riparian zone.

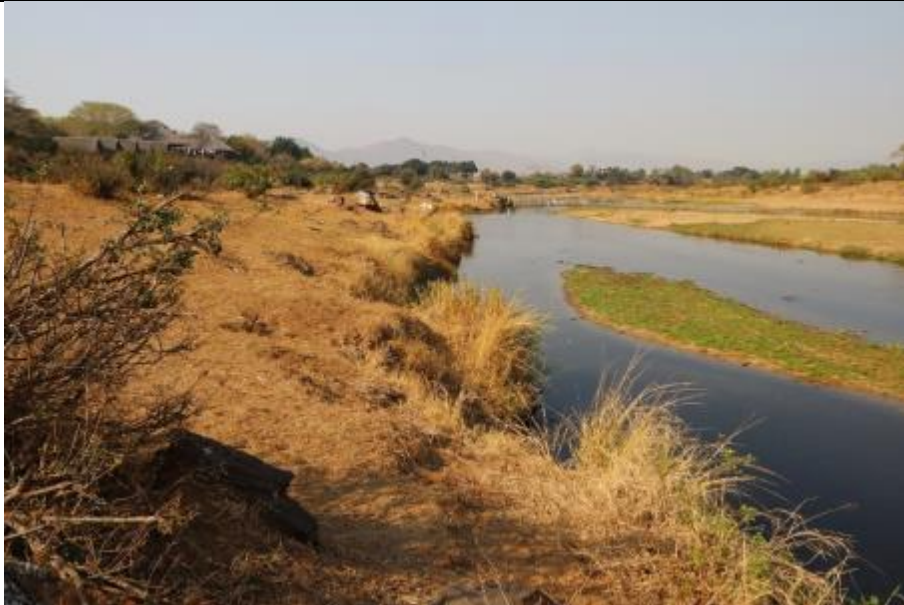
Figure 5-23: Photos of selected VEGRAI site

View of the marginal zone

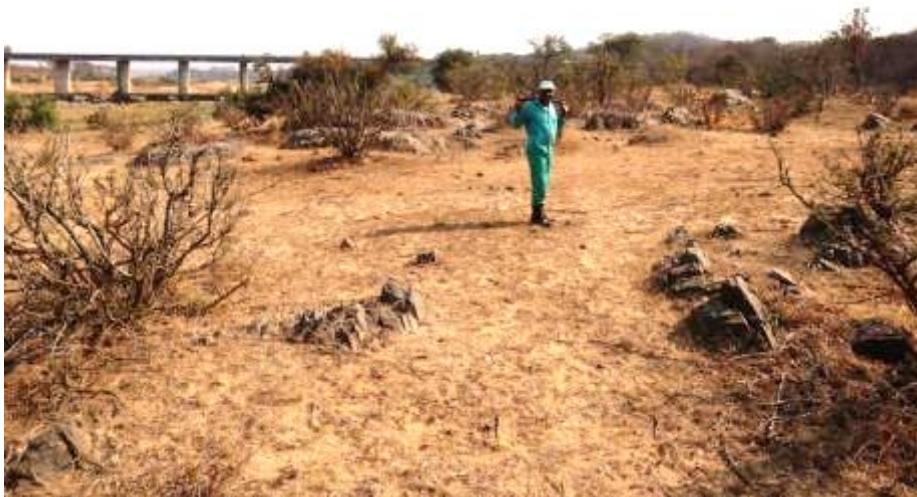
This riparian area is situated at the outflow point of a small tributary (as mentioned above) consisting of water from a sugarcane factory and a golf course upstream. As previously mentioned, it is expected that the water will be high in nutrients and a higher temperature than the norm. This has resulted in a higher occurrence and diversity of animals (crocodiles, hippopotamus, elephant, etc.) at its confluence with the Crocodile River resulting in trampling and overgrazing of this zone.

View of the non-marginal zone

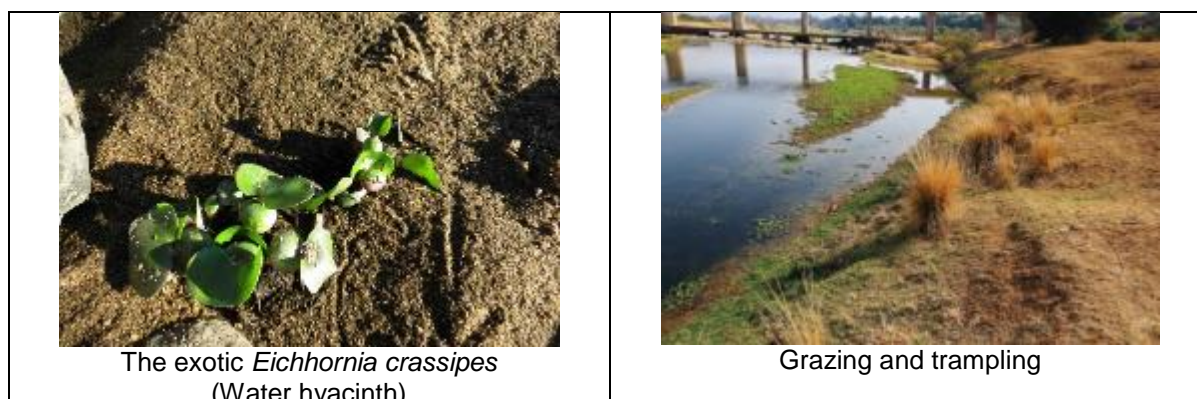
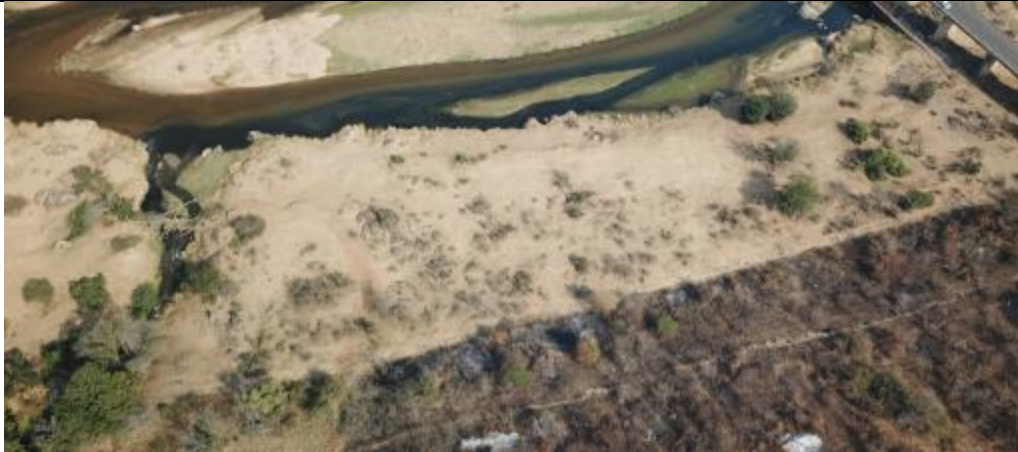
Figure 5-24: Impacts identified in the Crocodile River Riparian zone

The Riparian Index of Habitat Integrity (RIHI) is a C/D (59%), with the main impacts flooding events, extensive grazing and trampling (stunted trees and shrubs), a tributary consisting of polluted water from industrial sugarcane factory and the presence of exotic species (Figure 5-24). The influx of enriched waters attracts higher animal numbers than would have been the case in similar natural conditions.

From this photo the overgrazed area of the riparian zone is obvious

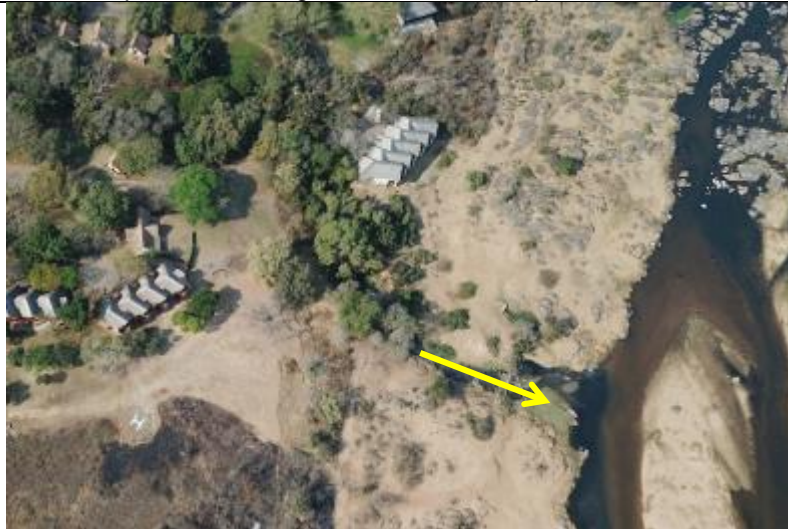
Tributary releasing enriched water from the sugarcane factory into the Crocodile river

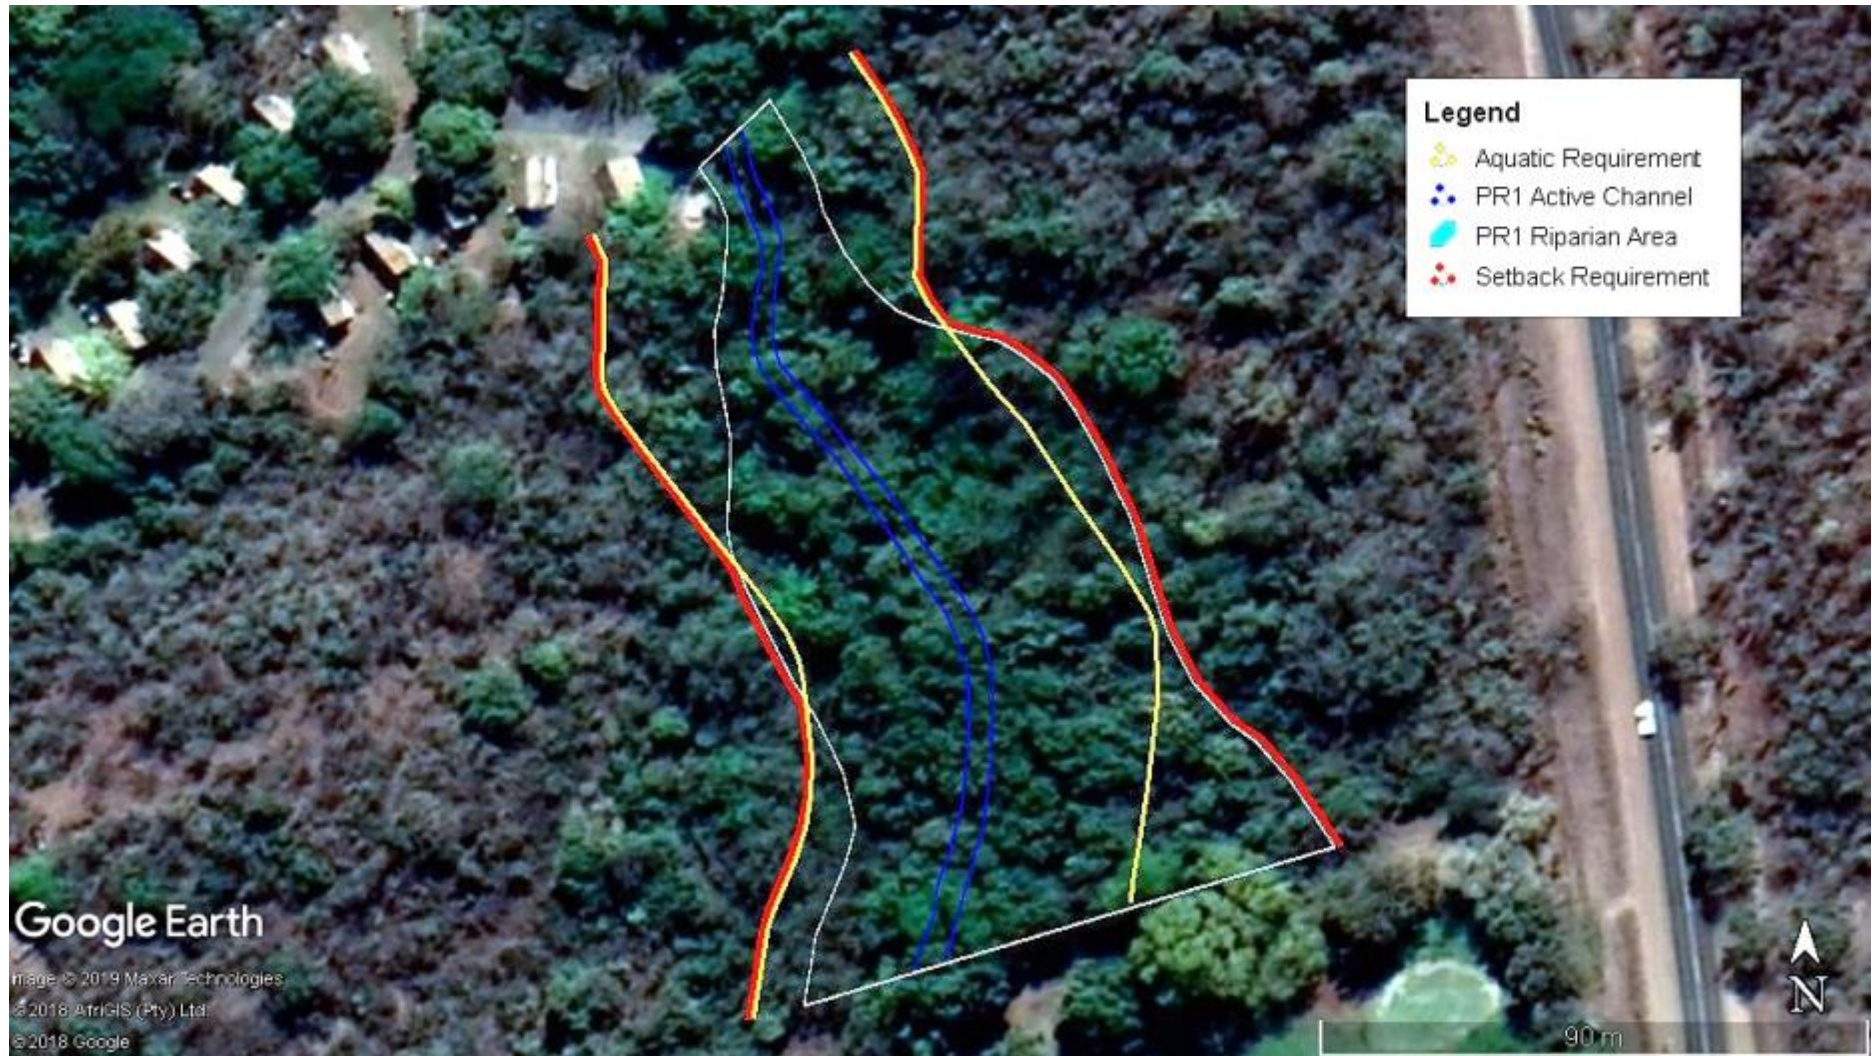
- PR1 : 25 m
- PR2 : 25 m
- PR3 : 25 m
- PR4 : 70 m

Figure 5-26: Delineation of the PR1-Riparian site's active channel edge, aquatic requirement, riparian edge and then the final setback requirement
