PESTANA

Wetland and Riparian Zone Identification and Assessment

AUGUST 2019

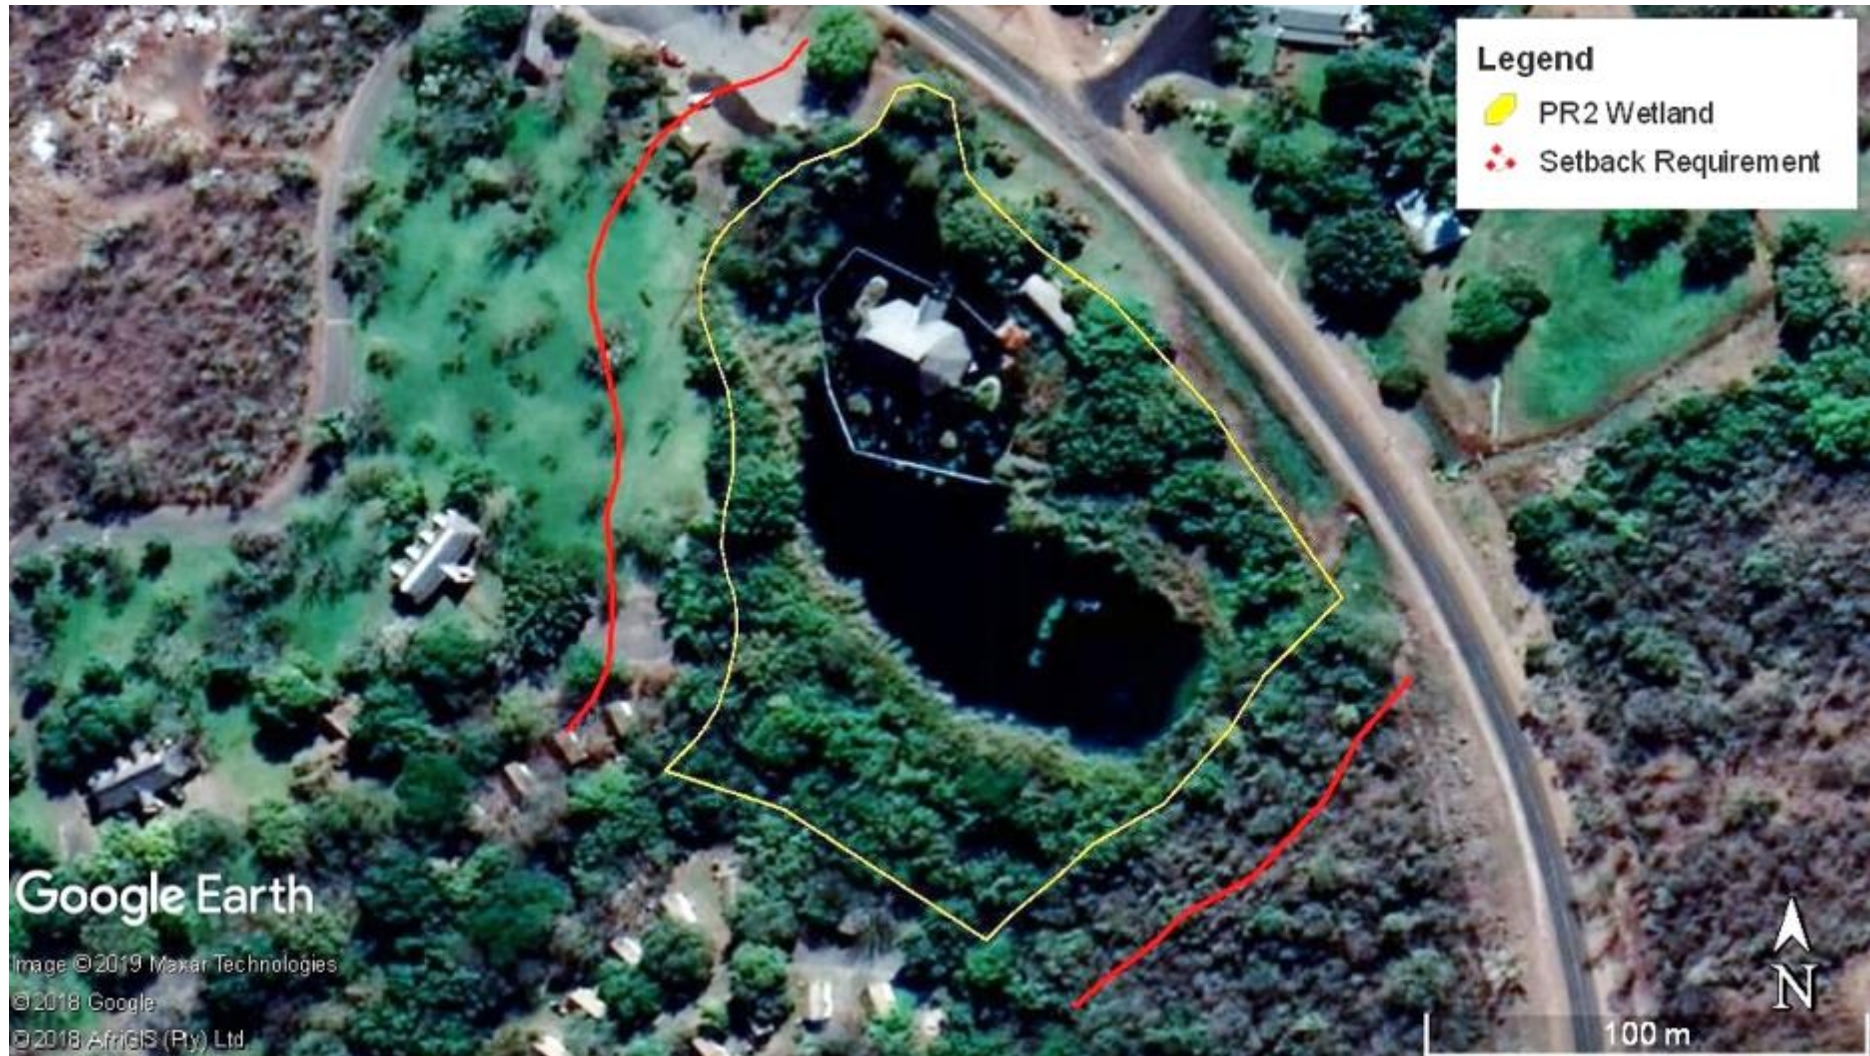
- PR1 : 25 m
- PR2 : 25 m
- PR3 : 25 m
- PR4 : 70 m

Figure 5-27: Delineation of the PR2-Wetland site's with setback requirement

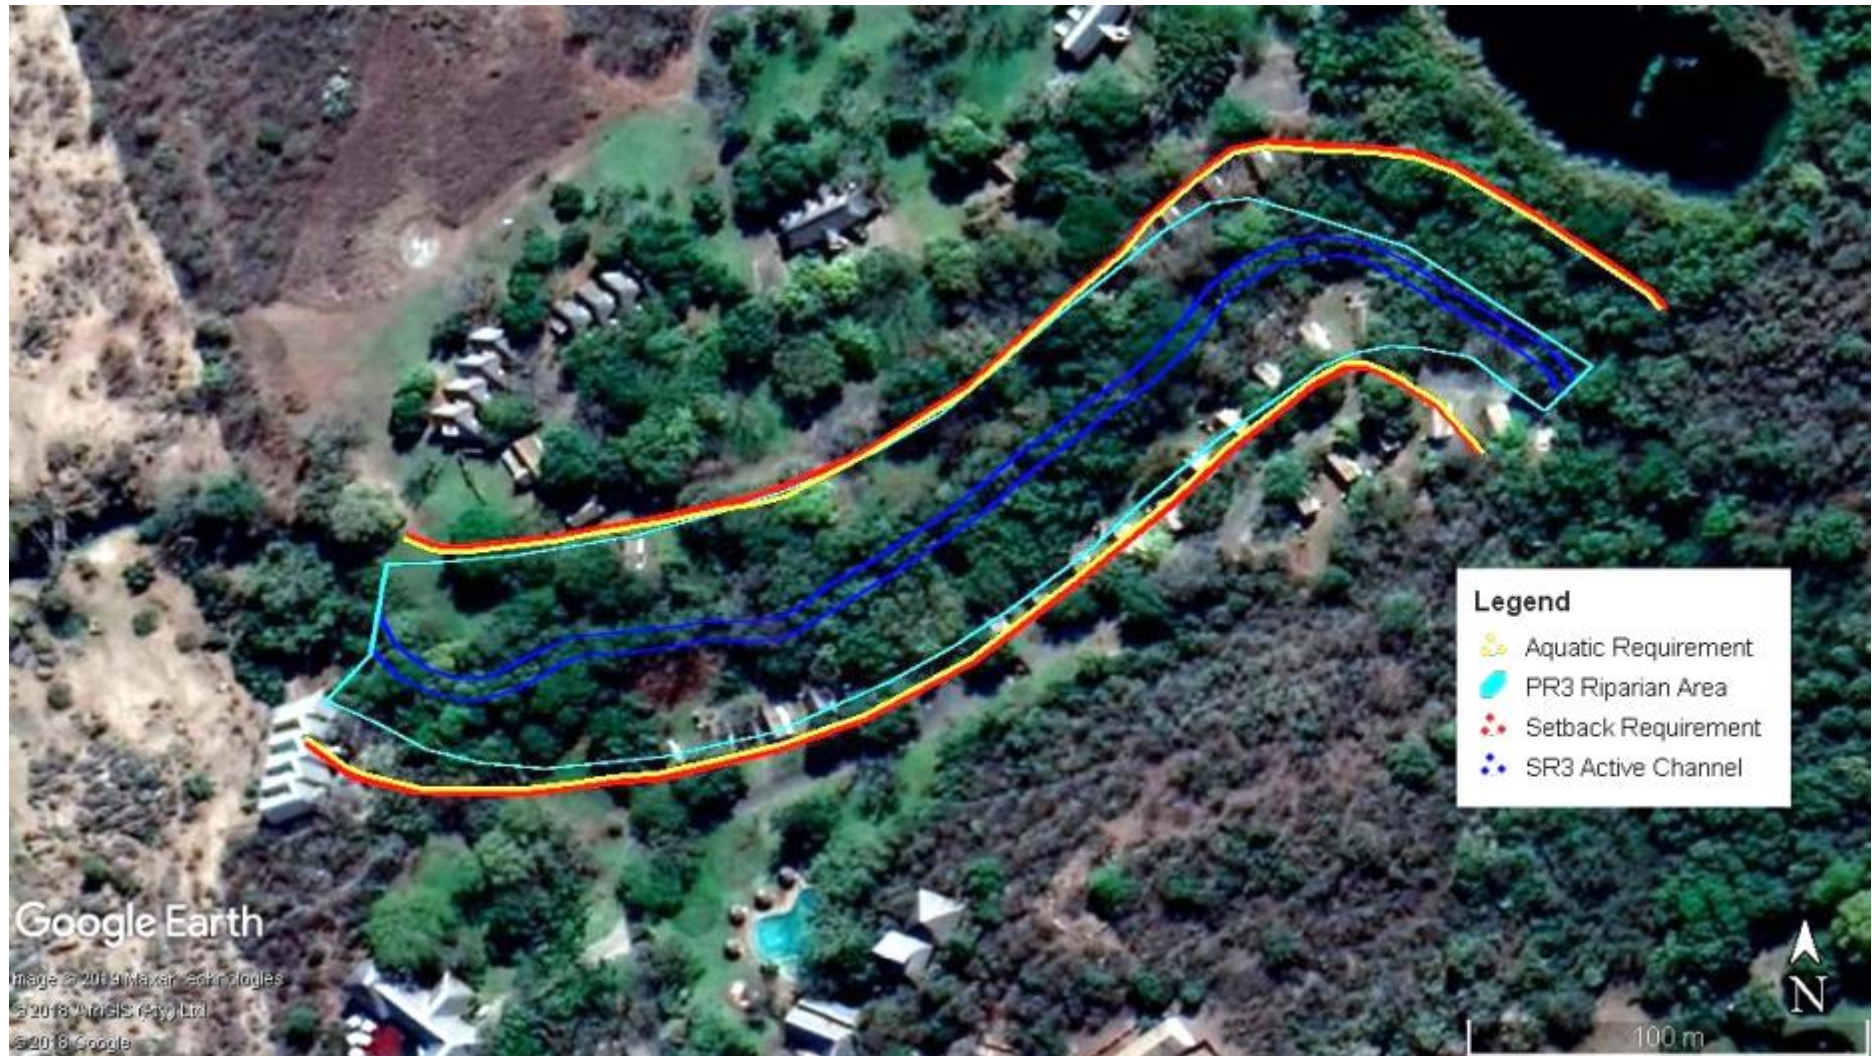
Figure 5-28: Delineation of the T03-Riparian site's active channel edge, aquatic requirement, riparian edge and then the final setback requirement
