**Scoping Archaeological Impact Assessment  
With ADDENDUM for Amendment Application, 2018 (see from  
pg 23)**

**Proposed development of the Plan 8 Grahamstown Wind Energy  
Project: including Farms Gilead 361, Peynes Kraal 362 and Tower Hill  
363, Grahamstown, Makana Municipality, Eastern Cape Province**

15 December 2011

**With ADDENDUM for Amendment Application, 2018  
(see from pg 23)**

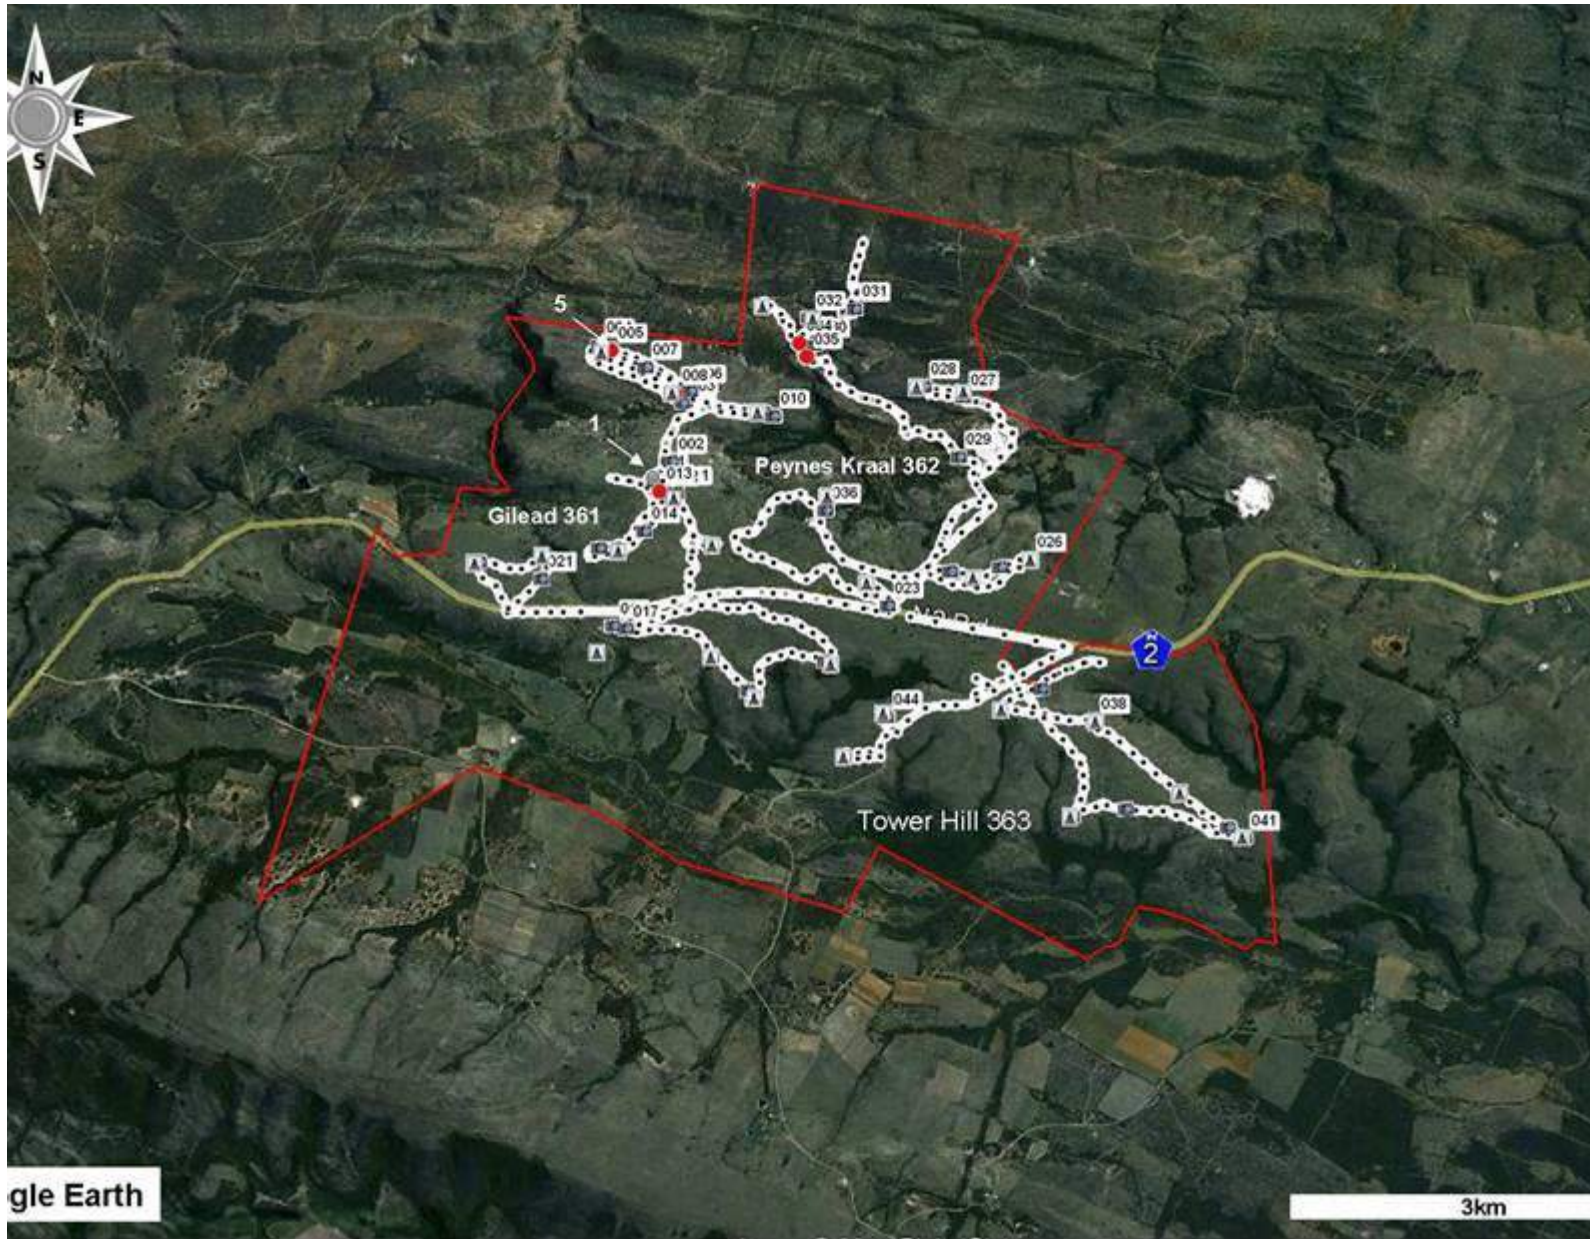
Figure 3. Enlarged area indicated in Figure 1 with walk tracks (white), waypoints (red dots) and photo localities (camera icons).

Survey tracks were fixed with a hand held Garmin Camo GPS to record the search area (Figure 3, gpx tracking file is available from the author). The position of identified archaeological occurrences and photo localities were fixed by GPS (Figure 3, Plates 1 through 8 and Table 2). Digital audio notes and a comprehensive, high quality digital photographic record were also made (full data set available from author). In this report, localities of archaeological occurrences and photograph localities are established by matching the numbers on photographs with those of waypoints in Figure 3 (also see Table 2). Directions of photographic views are indicated with compass bearing names like E is east; WSW is west south west, and so on. Bearing names on panoramic views indicate the bearing at the position of the label on the photograph.

On 29 and 30 November 2011- in 2 days of survey - a distance of 38km was walked and 6km traversed by vehicle, covering an area of about 250ha of which an average of some 30% provided good archaeological visibility (Figure 3 and Plates 1 through 8).

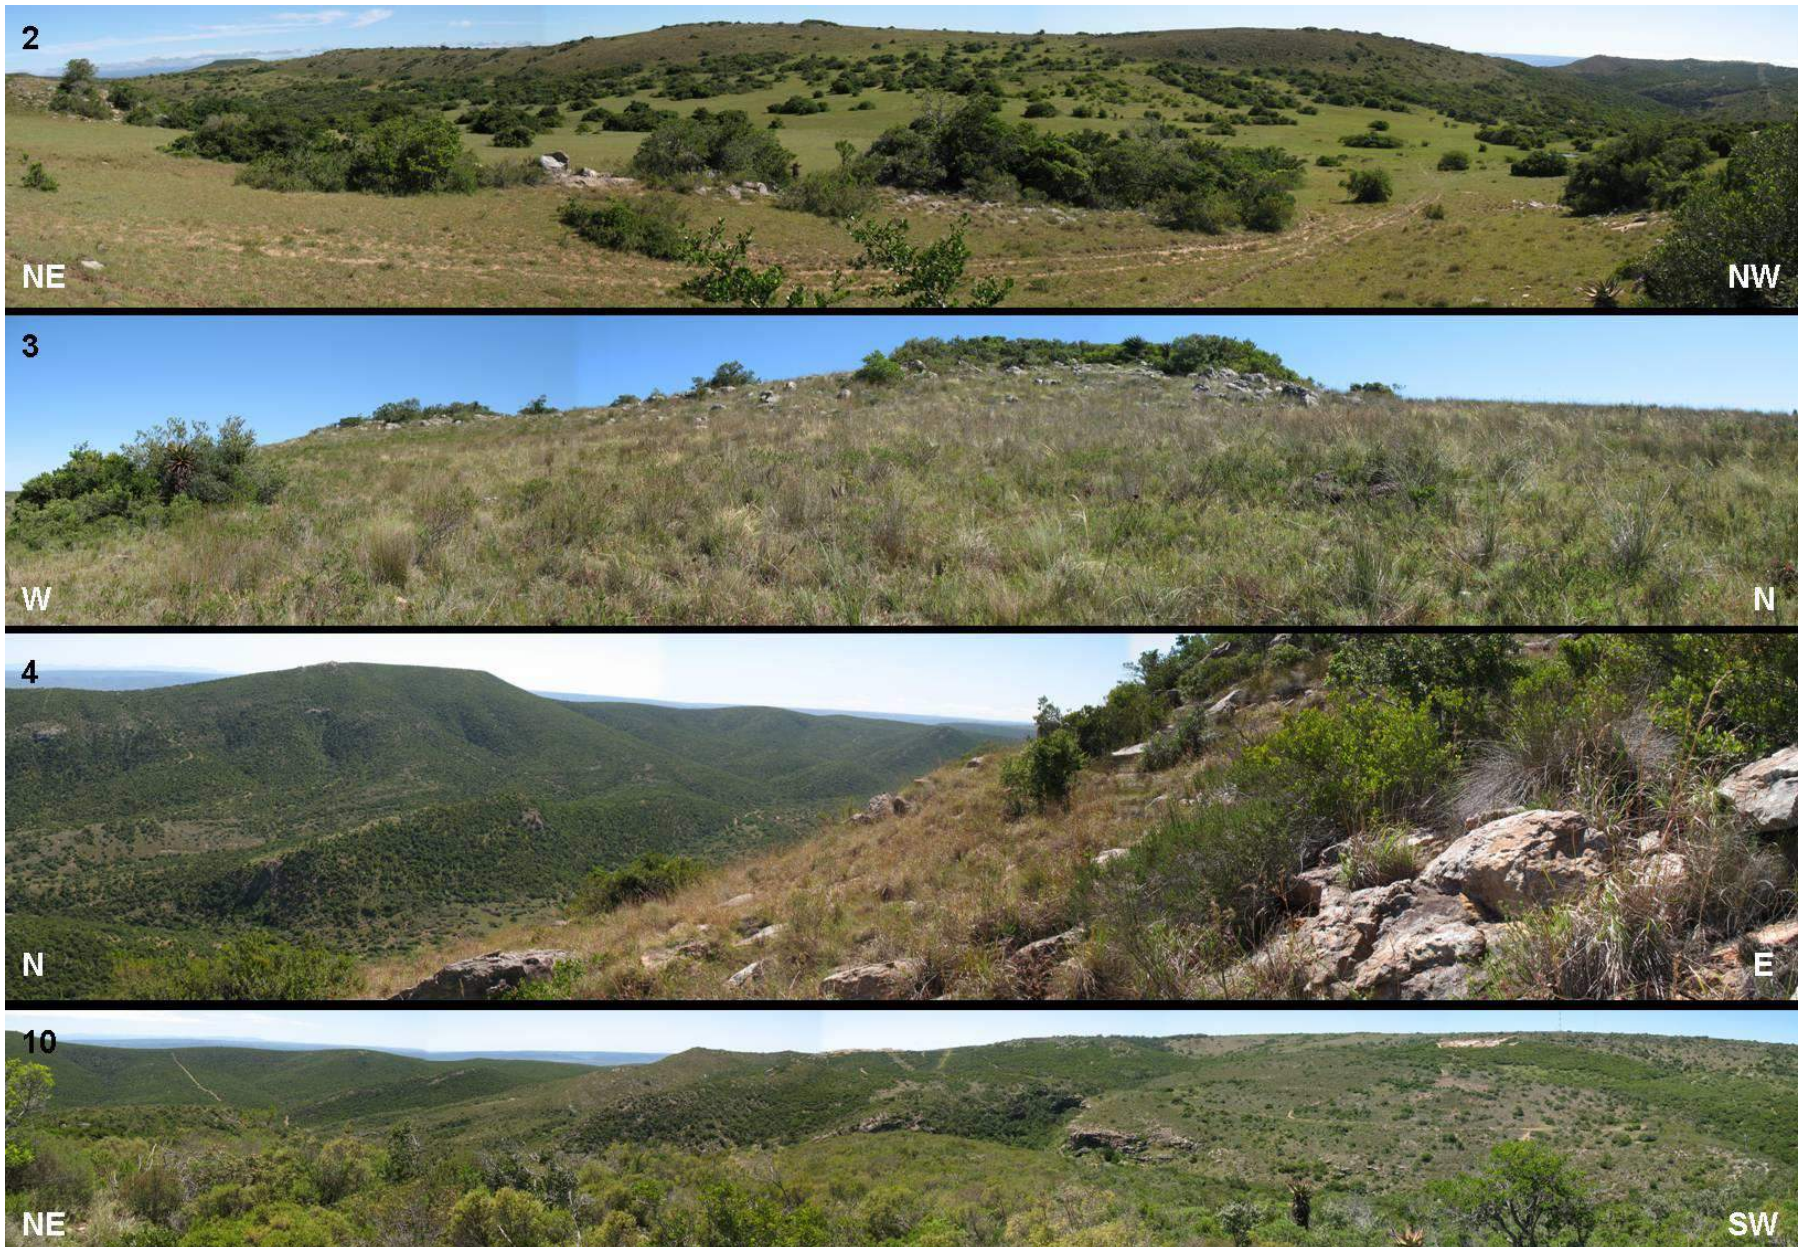
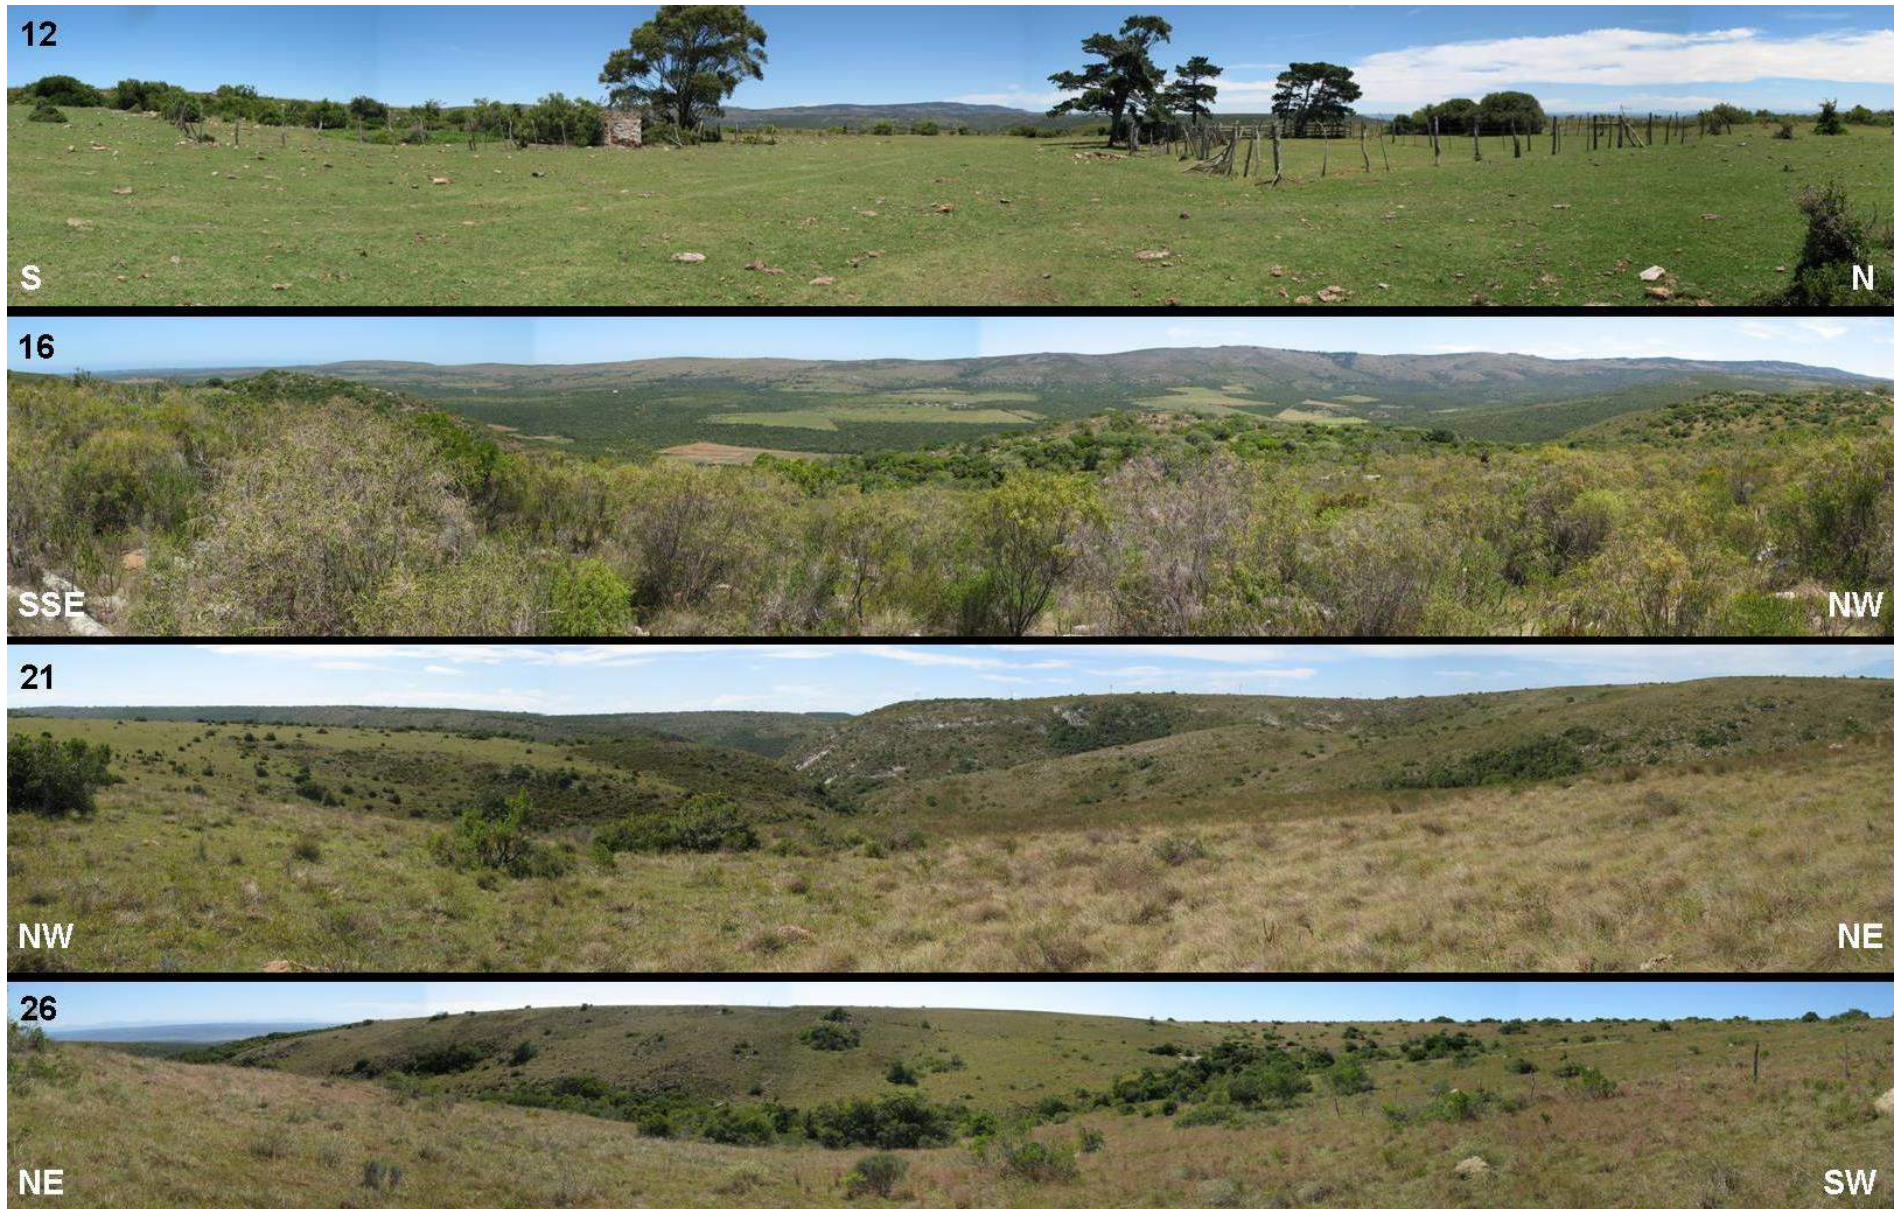
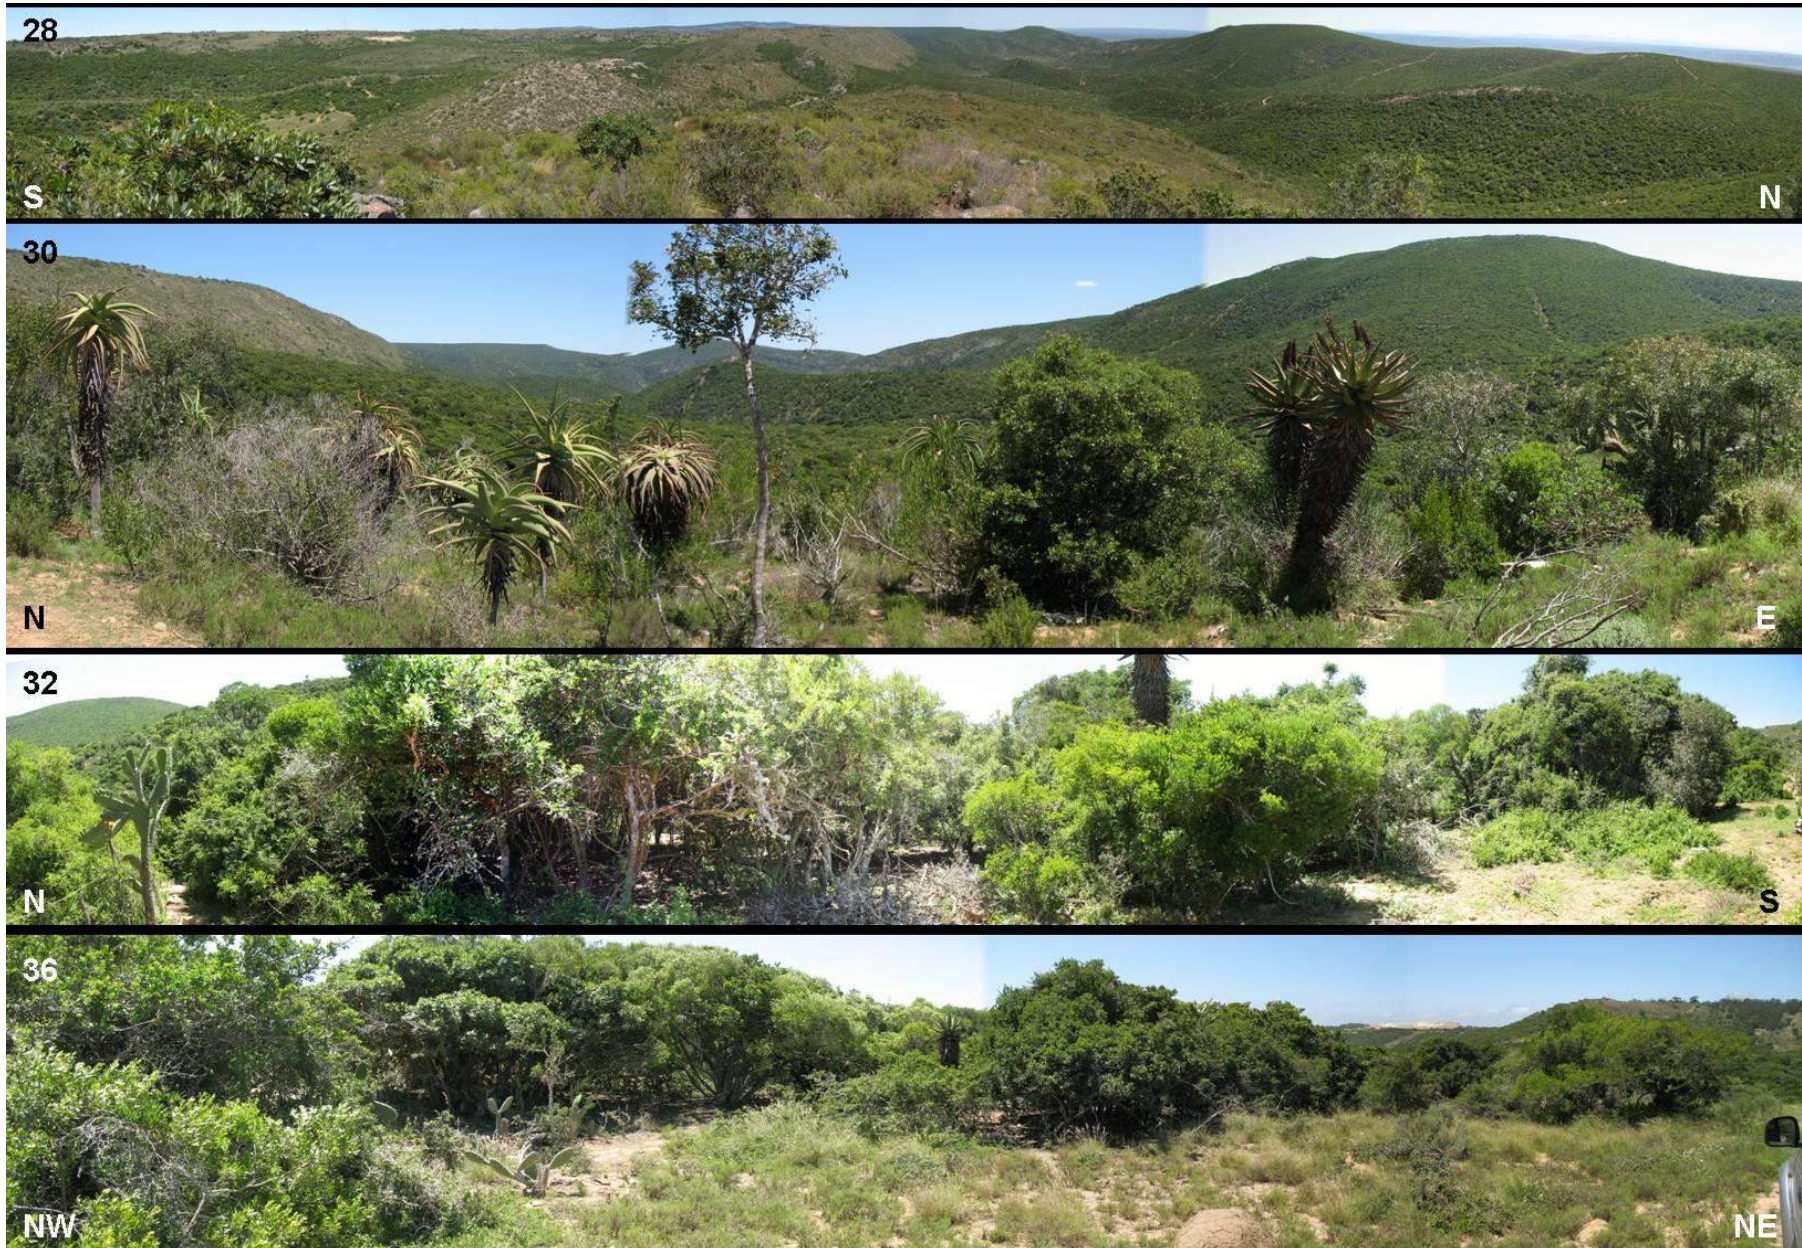
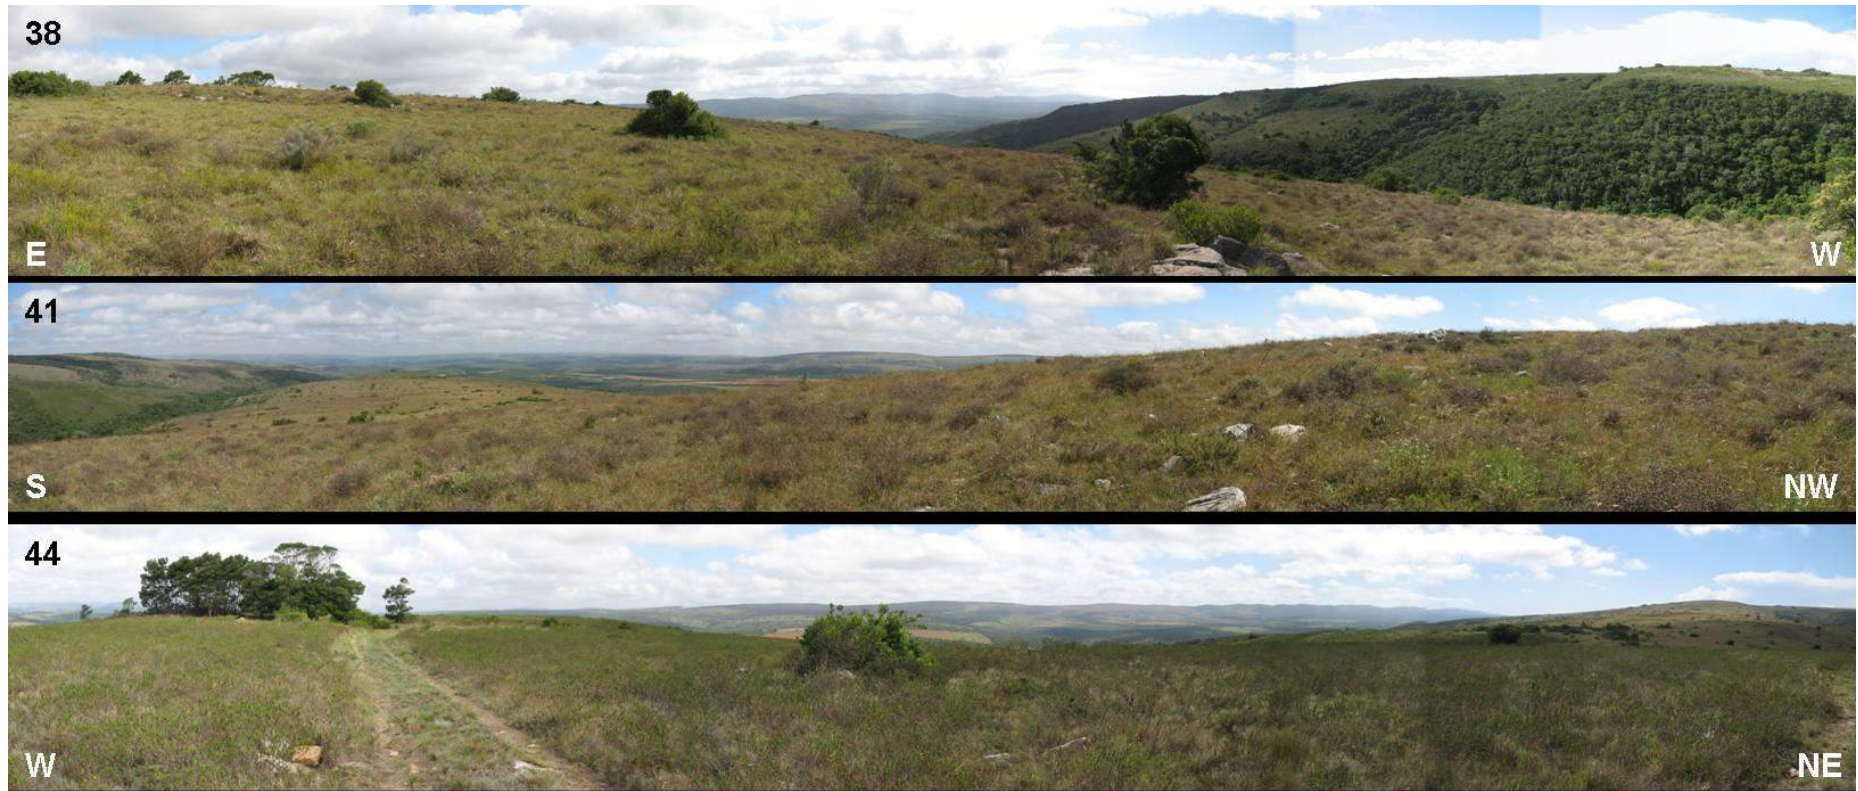
The high lying areas are relatively flat and consist of gently undulating hills that slope steeply toward small ravines and gorges. Overall, the area is very rocky and not suitable for cultivation. The higher lying areas are vegetated with grasses, bushes and shrubs while ravines and gorges include trees and thicket. Due to dense vegetation cover, archaeological visibility is generally poor. Nevertheless, sufficient ground surfaces were inspected to determine the overall archaeological sensitivity of the affected properties. Modern human activities in the studied area consist mostly of vehicle tracks, and two large clay quarries were noted. Evidence for burrowing by large and smaller mammals was also seen. Examples of the affected environment – vegetation, topography, exposed surfaces and so on - are shown in Plates 1 through 5.

Plate 1. Examples of the surrounding environment, exposures, topography and vegetation cover (see Figure 3 and Table 2).

Plate 2. Examples of the surrounding environment, exposures, topography and vegetation cover (see Figure 3 and Table 2).

Plate 3. Examples of the surrounding environment, exposures, topography and vegetation cover (see Figure 3 and Table 2).

Plate 4 Examples of the surrounding environment, exposures, topography and vegetation cover (see Figure 3 and Table 2).

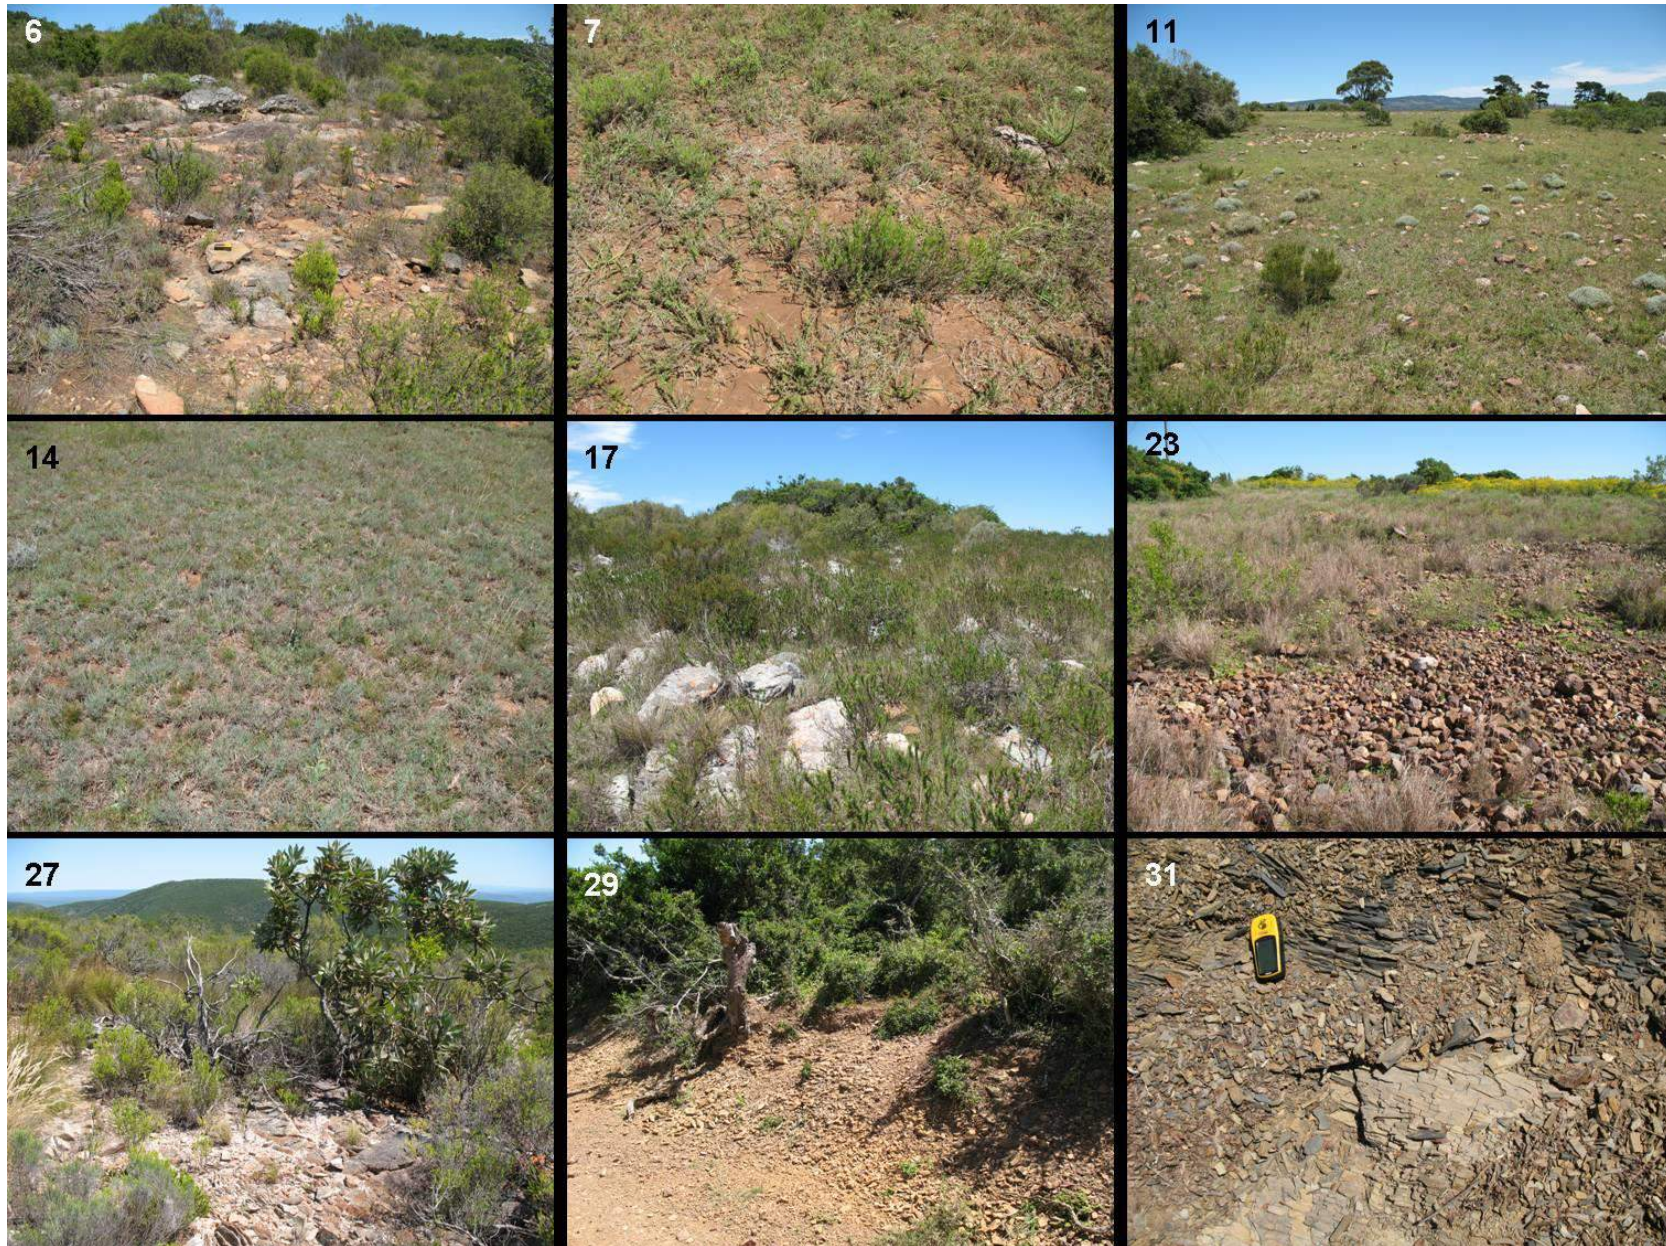
Shales were seen in several locations including **Waypoints 29 and 31** (Plate 5[29&31], Figure 3 and Table 2). The presence of sedimentary geological deposits suggests that fossiliferous sediments may occur in the study area.

Plate 5 Examples of exposed surfaces and shale outcrops at waypoints 29 & 31 (see Figure 3 and Table 2).

**Significance and Recommendation:** If the shales proved to be fossil bearing, then these occurrences will be of high significance. It is recommended that a Palaeontological Impact Assessment (Desktop Study) be conducted to establish whether or not the shales in the study area are potentially fossil bearing.

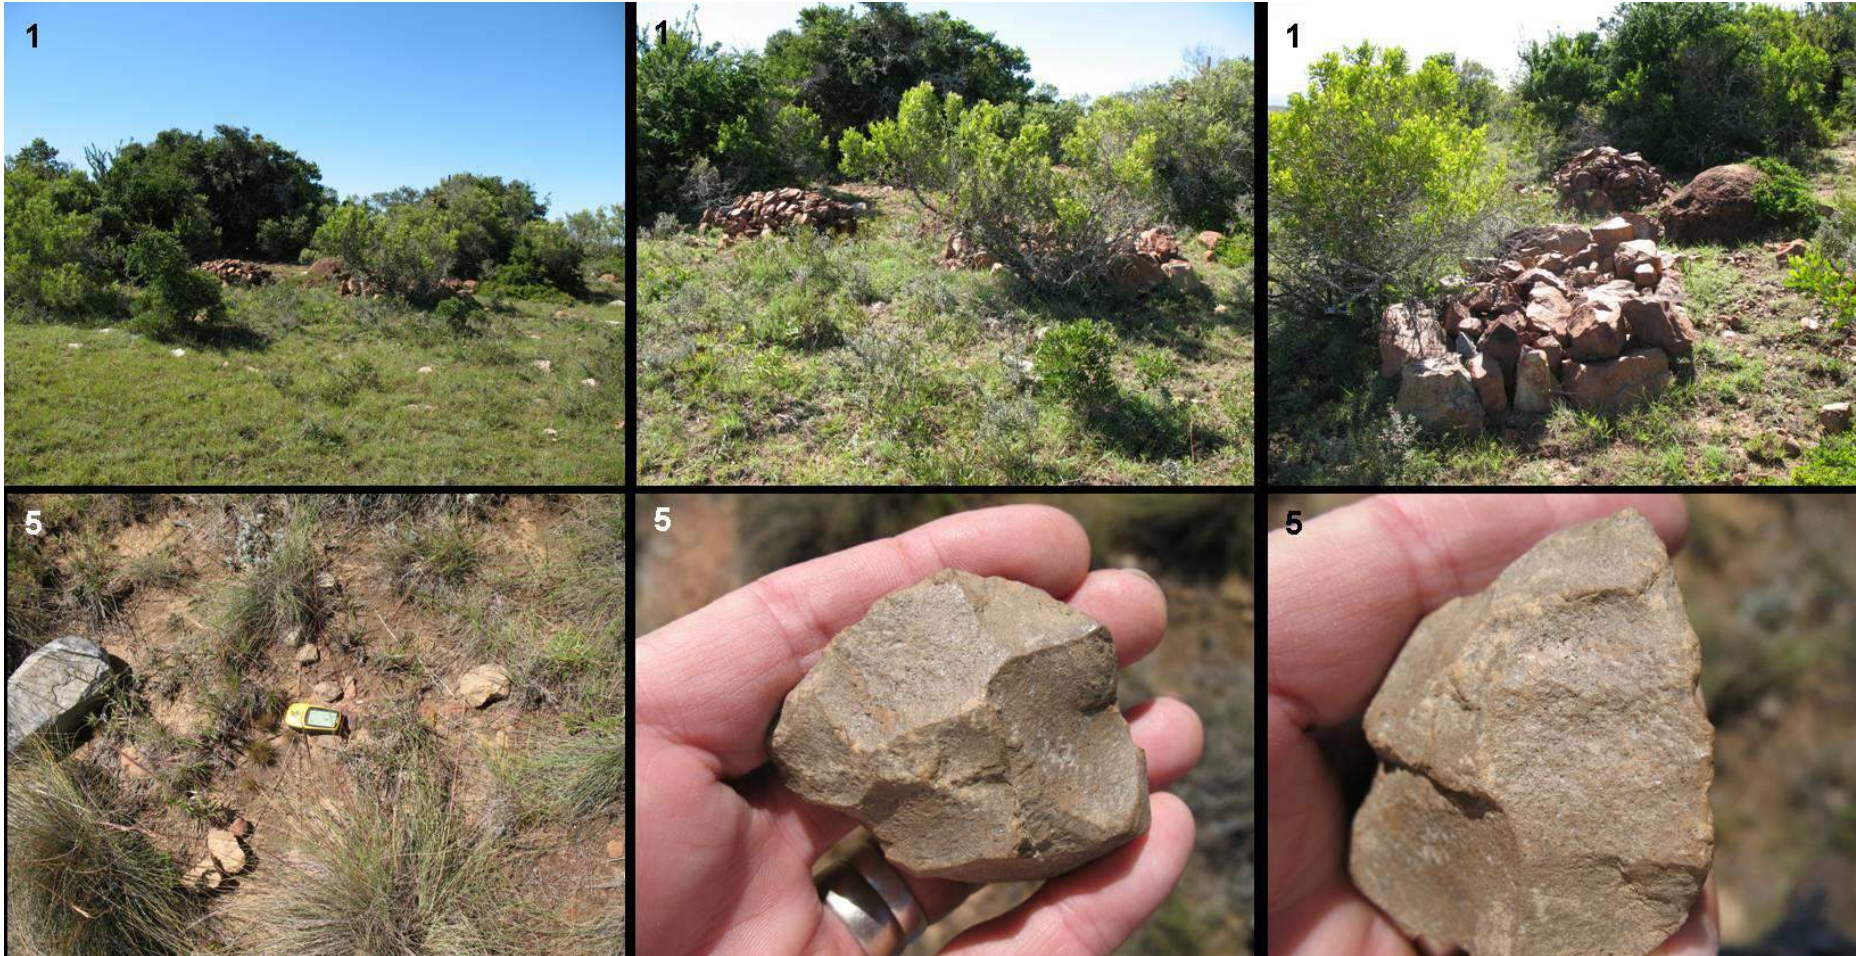
Two unmarked graves are situated at **Waypoint 1** (Plate 6 [1], Figure 3 and Table 2). Because the substrate is very rocky, the graves are likely to be very shallow and this would also explain why the burials are covered with substantial stone piles. Both burials are west-east aligned and the ovals measure some 2m in length and about 80cm in width. According to Mr Dixon, they are the graves of two farm workers who lived nearby in wattle and daub structures which have since disintegrated. The burials are thought to be at least 80 years old.

An isolated Later Stone Age core/scrapper was identified at **Waypoint 5** (Plate 6[5], Figure 3 and Table 2). The stone artefact is in quartzite and one surface is retouched to produce a scrapper edge.

Plate 6 Examples of contexts and archaeological finds. Top images are of two unmarked graves and bottom images are of a Later Stone Age core/scrapper (see Figure 3 and Table 2).

Human burials are protected by law, are normally considered to be of significance and are archaeologically sensitive. As such, it is recommended that the burials not be disturbed and that a buffer zone of at least 15m in radius should be put in place in the form of a balustrade or suitable wooden palisade fencing.

**Significance and Recommendation:** Because this specimen occurs in isolation and is in secondary context, it is of no scientific value and is considered to be of no archaeological significance. No further mitigation measures are necessary.

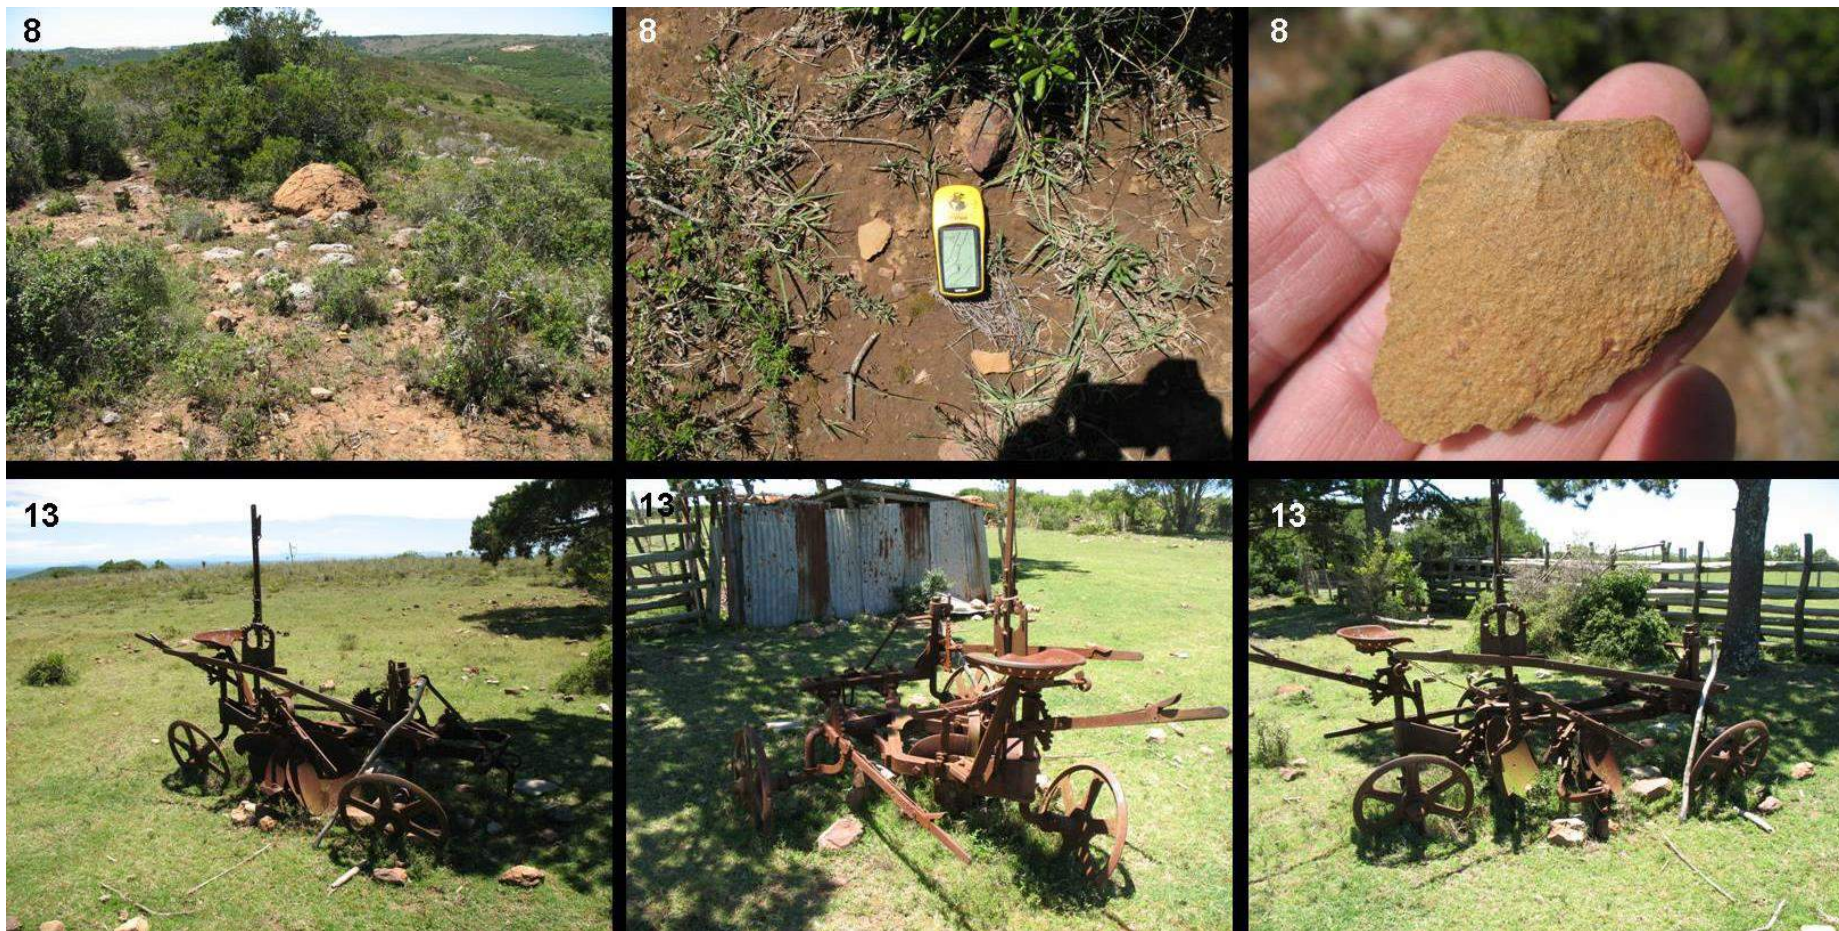
An isolated Stone Age flake of indeterminate age was recorded at **Waypoint 8** (Plate 7[8], Figure 3 and Table 2). The specimen is in quartzite and is not retouched.

An old and rusted horse/oxen drawn plough is located at **Waypoint 13** (Plate 7[13], Figure 3 and Table 2).

Plate 7 Examples of contexts and archaeological finds. Top images are of an unretouched flake of indeterminate age (see Figure 3 and Table 2).

**Significance and Recommendation:** Because this specimen occurs in isolation and is in secondary context, it is of no scientific value and is considered to be of no archaeological significance. No further mitigation measures are necessary.

**Significance and Recommendation:** Examples of this type of plough are relatively common on South African farms and the implement is of no particular historic value. Nevertheless,

it forms part of the history of agricultural implements and machinery used in South Africa. Since the implement is in close proximity to the unmarked graves at waypoint 1, it is suggested that it be included in the buffer zone that will protect the graves.

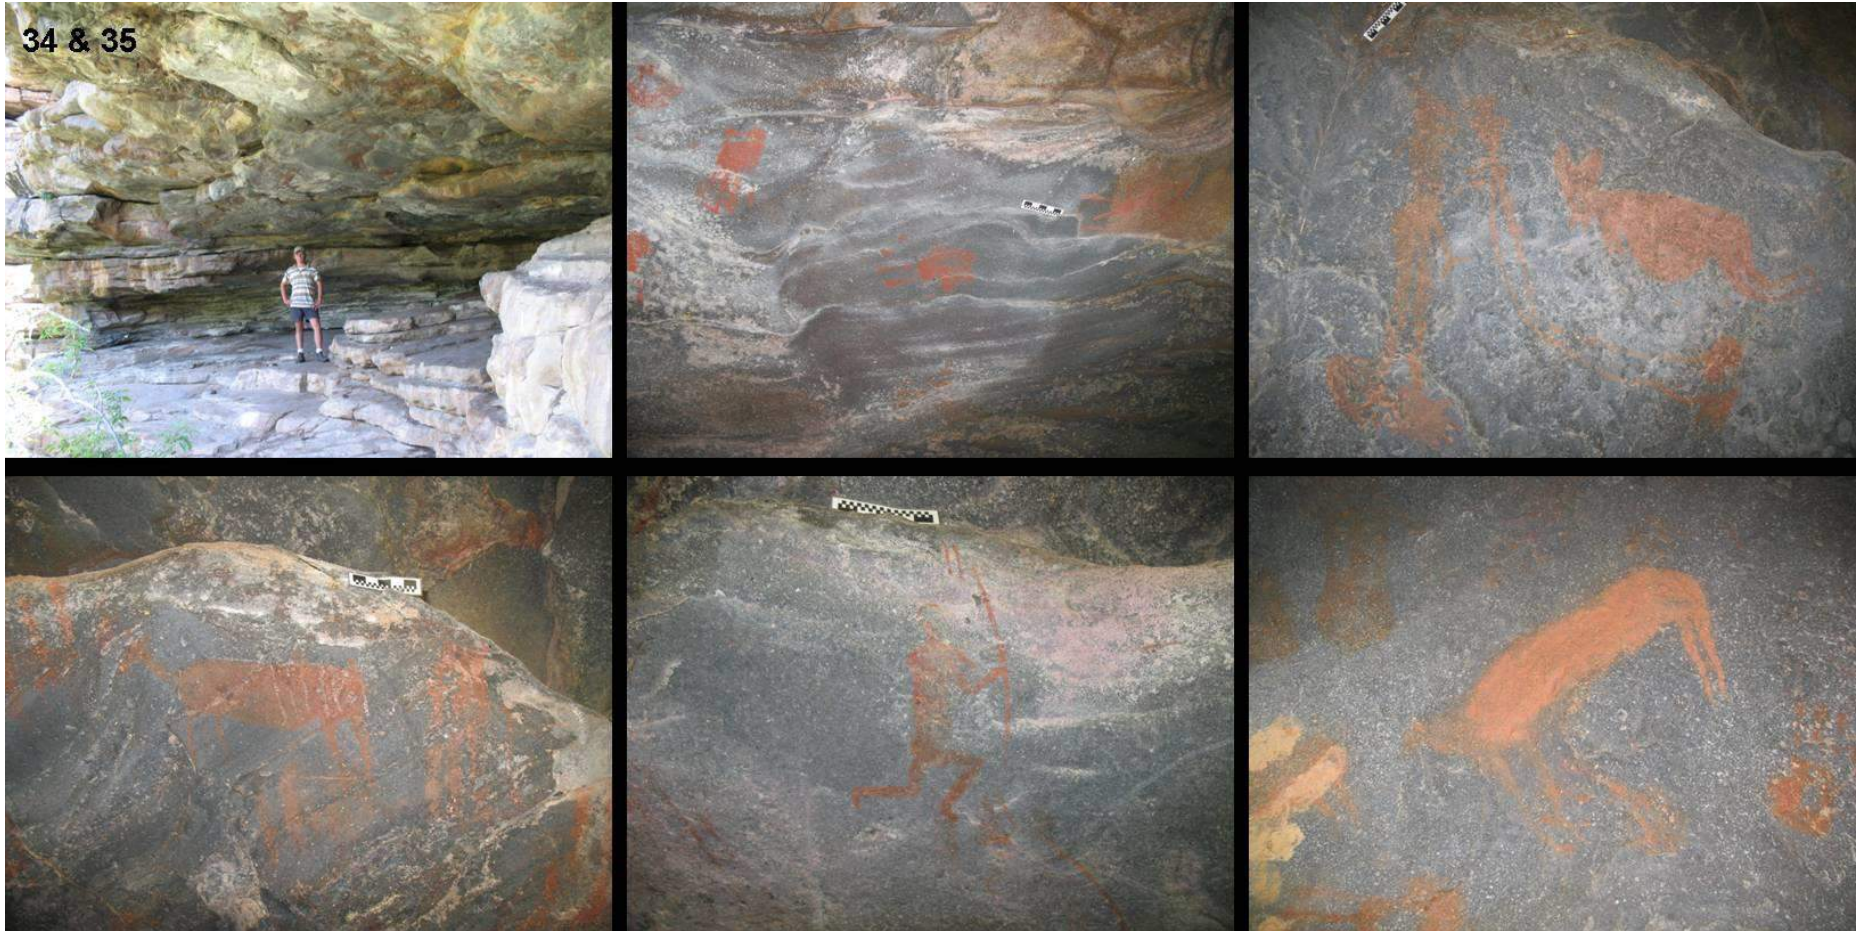
**Waypoints 34 and 35** represent the location of a cave with rock paintings (Plate 8, Figure 3 and Table 2). The site is situated in a gorge and is not readily visible until one is relatively close to it. Without the guidance of Michael Nortier, the site would not have been found since the focus of the study was on the higher lying ground. Within the drip-line the cave is approximately 8 meters in length and about a maximum of 5 meters deep. The most common paintings are hand prints in red ochre. Most paintings are in red or orange ochre and no polychromes were identified. However, the presence of “hook heads” suggests that human faces were probably painted in lighter colours which have since faded. A few depictions of antelope and thereanthropes were also seen.

Plate 8 Rock shelter with paintings including hand prints, hunter with “hook head”, antelope and thereanthropic depictions (see Figure 3 and Table 2).

**Significance and Recommendation:** The rock art site is considered to be of high significance, but it will not be directly impacted by the proposed activity because it is situated in a gorge and because wind turbine sites occur on high lying areas. It may be best not to draw any attention to the site because it is not readily visible and therefore it is not easily stumbled upon. No mitigation measures are necessary.

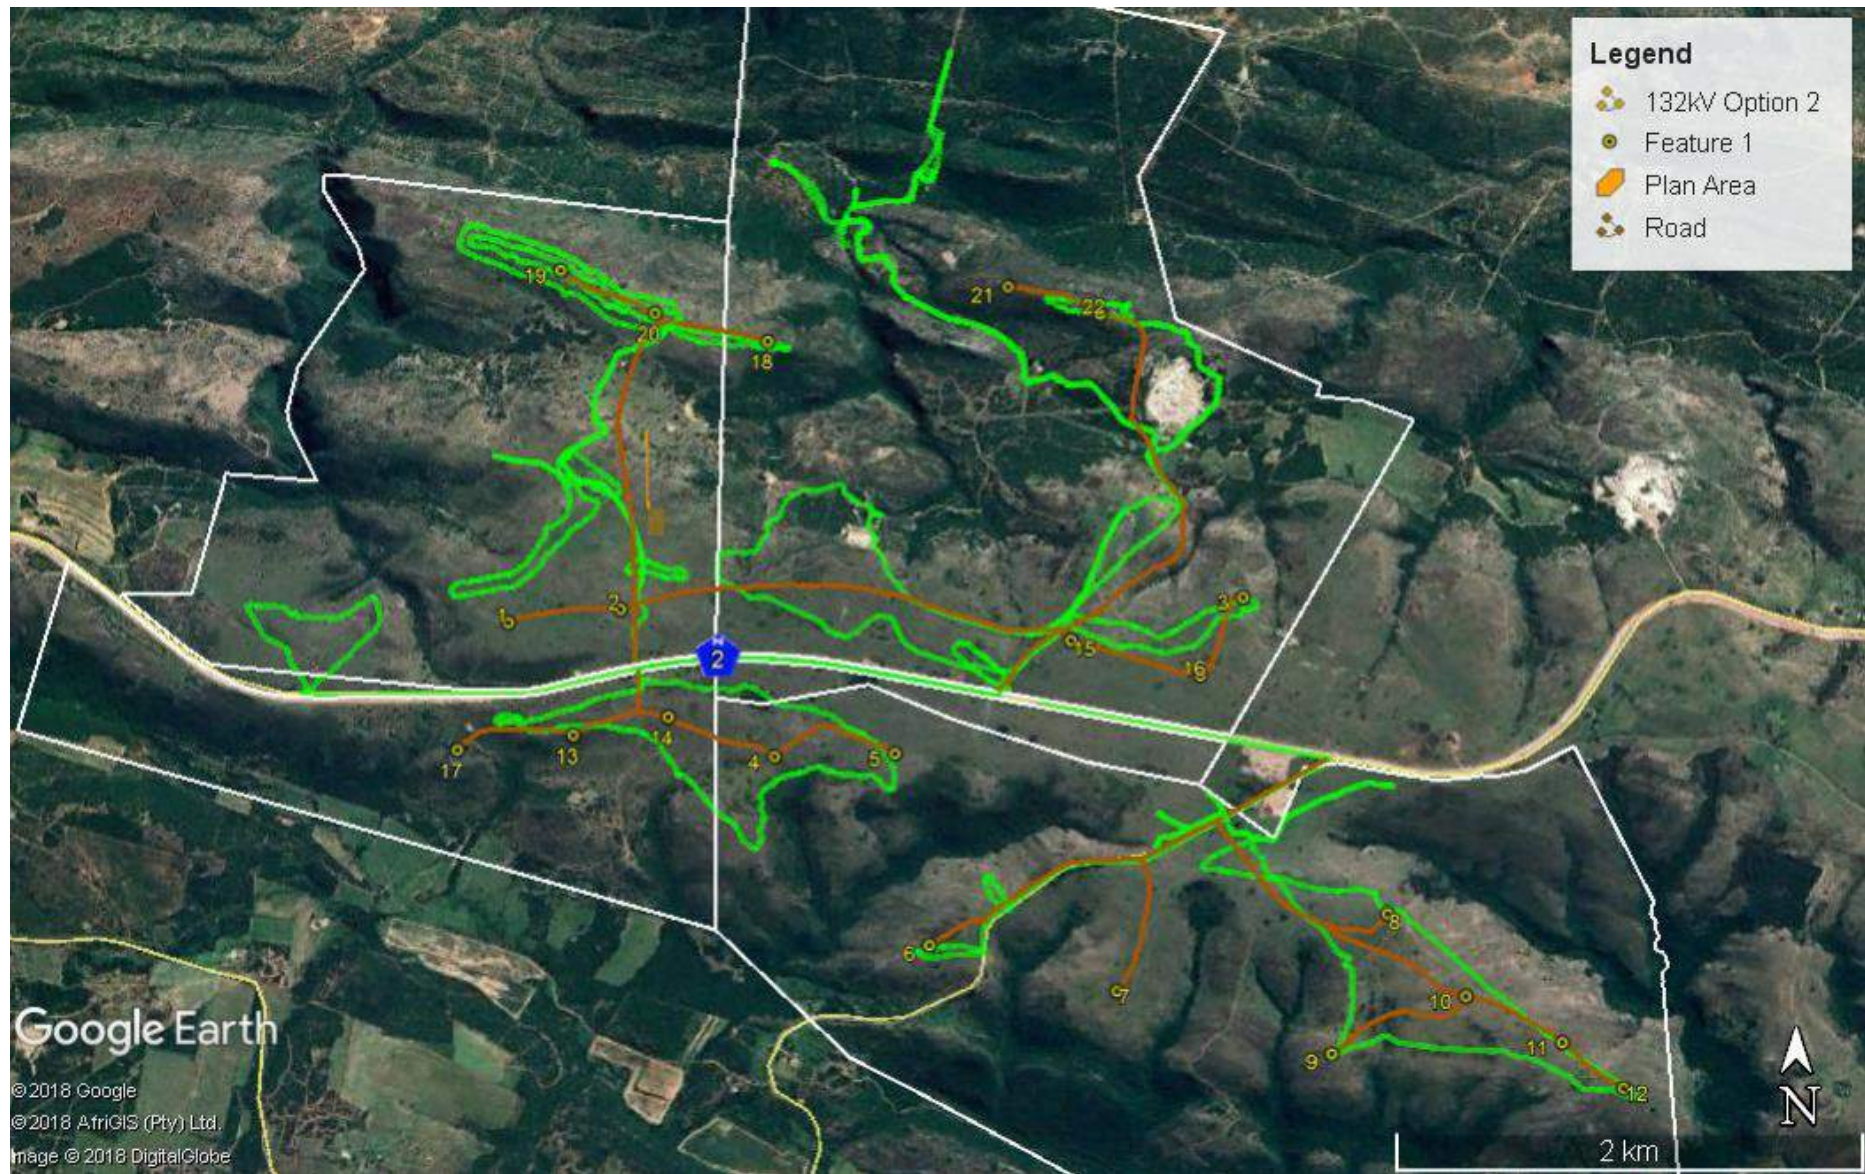
The above make it clear that the main concern is not with the proposed amendments to the approved development layout and turbine specifications, but rather with the fact that considerable areas within the development footprint have not been assessed from an archaeological standpoint. Note that the input and recommendations given here are for archaeological resources only and do not cover any other heritage-related resources.

Figure 4. Latest development layout for Plan8 Grahamstown WEF with overlay of archaeological survey tracks (green) from the 2011 scoping study. Note turbine localities, substation site, grid connection and road sections not covered during the 2011 study.

- It is recommended that SAHRA's recommendations of 2012 be incorporated in the Environmental Management Program for the development.
- That an archaeological walk-down study of areas not covered during the original assessment should be undertaken prior to the construction phase of development and that this study need not be a full Phase 1a Archaeological Impact Assessment.
- That this addendum be submitted to EC PHRA for comment prior to submission of the Amendment Application to the DEA.
