CHAPTER THREE: DESCRIPTION OF THE AFFECTED ENVIRONMENT

The provisional development proposal entails the subdivision of a portion of the site (62/10 Little Chelsea) for the establishment of a rural-residential estate with 10 peri-urban erven; as well as the provision of associated services infrastructure (access, water, electricity, and sanitation). The portion of the site proposed for subdivision and development will cover an estimated 20.2 ha of the farm (total extent of approximately 42.8ha). The development will include the clearing of vegetation, landscaping and levelling the portion of the site which is to be developed, the provision of bulk services to the individual erven and the establishment of an access road (Detail in Chapter 2).

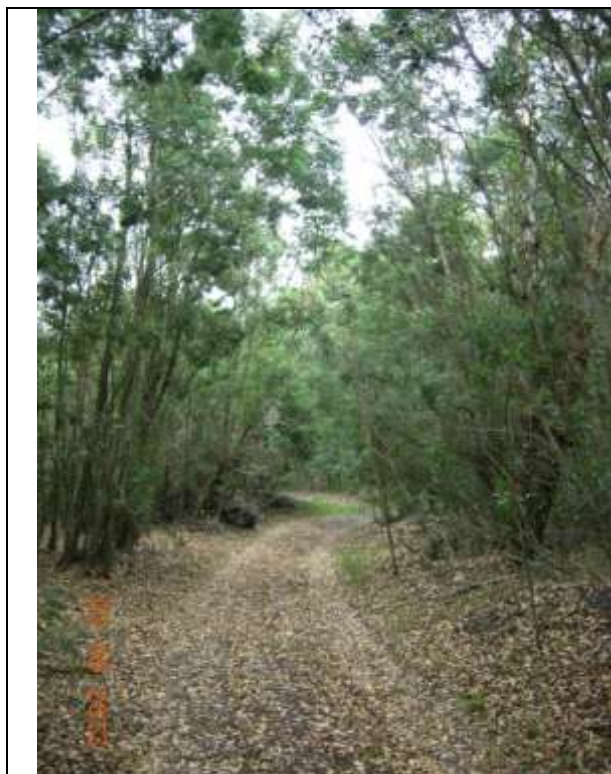
Photo 3.1 Most of the southern half of the site is heavily overgrown by exotic and weedy vegetation.

It would seem that historically the southern portion of the site was used as an informal horse race training track. However, it has become heavily overgrown by exotics and weedy vegetation, thus there are only remnants of the track and footpaths over this portion of the site.

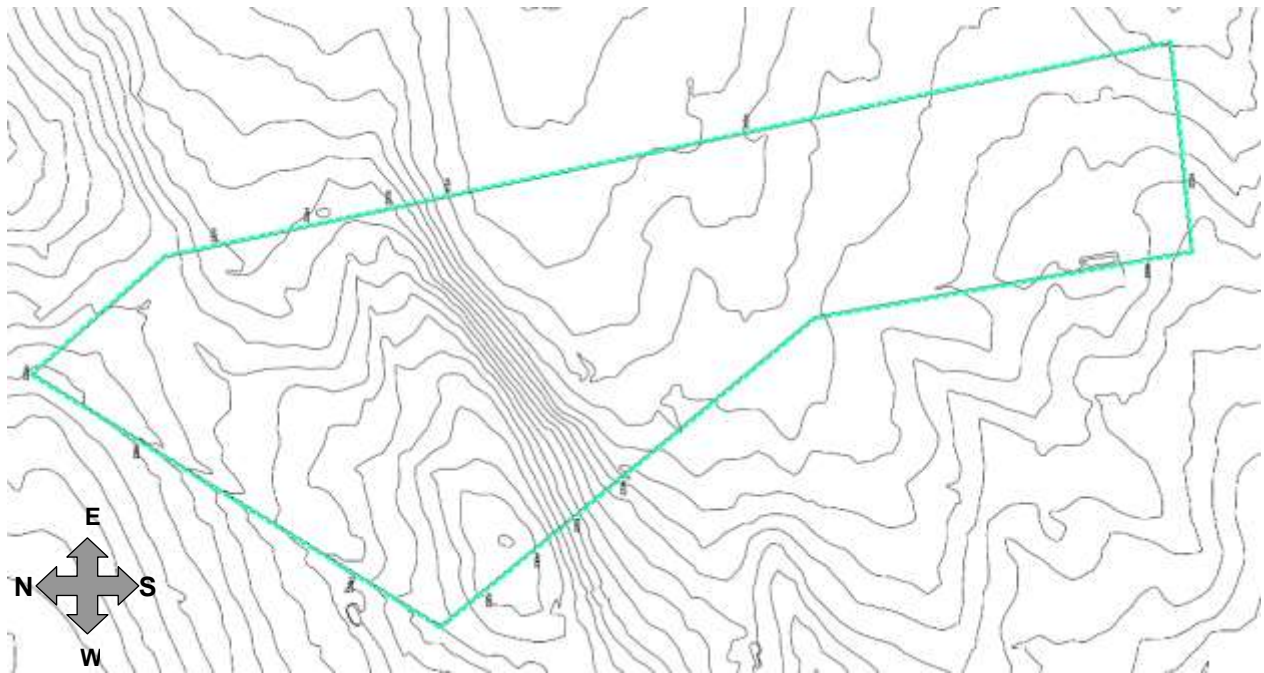
Map 3.3 Contour map showing topography of Portion 62 of Farm 10.

The topography of the landscape is generally gently sloping towards the centre of the site from the northern and southern boundary. Elevation is highest in the western corner at 230masl and lowest on the eastern boundary towards the centre of the site at 214masl.

A small ridge extends the width of the site, the southern slope of which roughly marks the edge of the portion of the site proposed for development. The ridge is steeper on the south facing slope and may be prone to erosion, as is evident at some locations, particularly previously disturbed portions of the ridge.

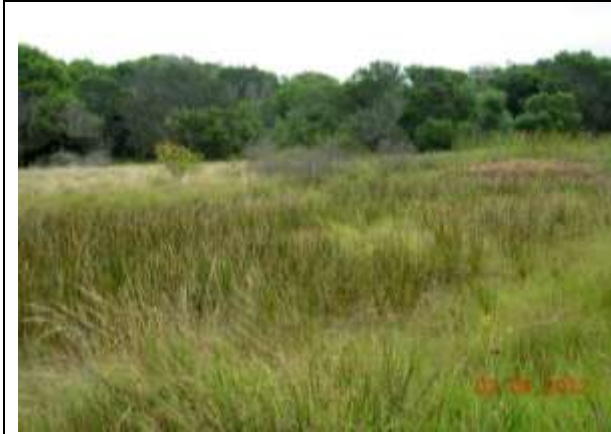
Photo 3.3. Dam containing standing water and hydrophytic vegetation in the south western corner of the property.

During the site visit two man-made dams were noted on the site. These surface water bodies may represent wetland areas as defined in terms of the National Water Act, 1998 (Act 39 of 1998). One straddles the boundary of the property with Portion 80 of Farm 10 in the south western corner, and consists of an excavation with a large earthen embankment along its eastern edge. This dam contained standing water and associated hydrophytic vegetation, for example sedges / rushes and reeds. The other dam represents a roughly round excavated area at the base of the southern slope of the ridge that runs the width of the property. A disused vehicle track passes along its edge. At the time of the site visit it did not contain standing water; however hydrophytic vegetation was present in the excavation.

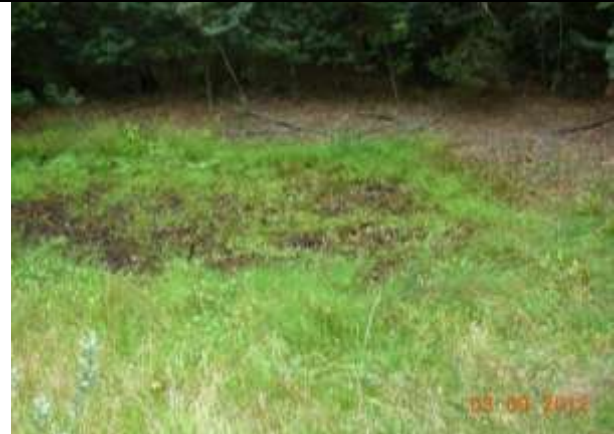
Photo 3.4. Dam in the northern portion of the site which at present does not contain standing water, although hydrophytic vegetation is present.

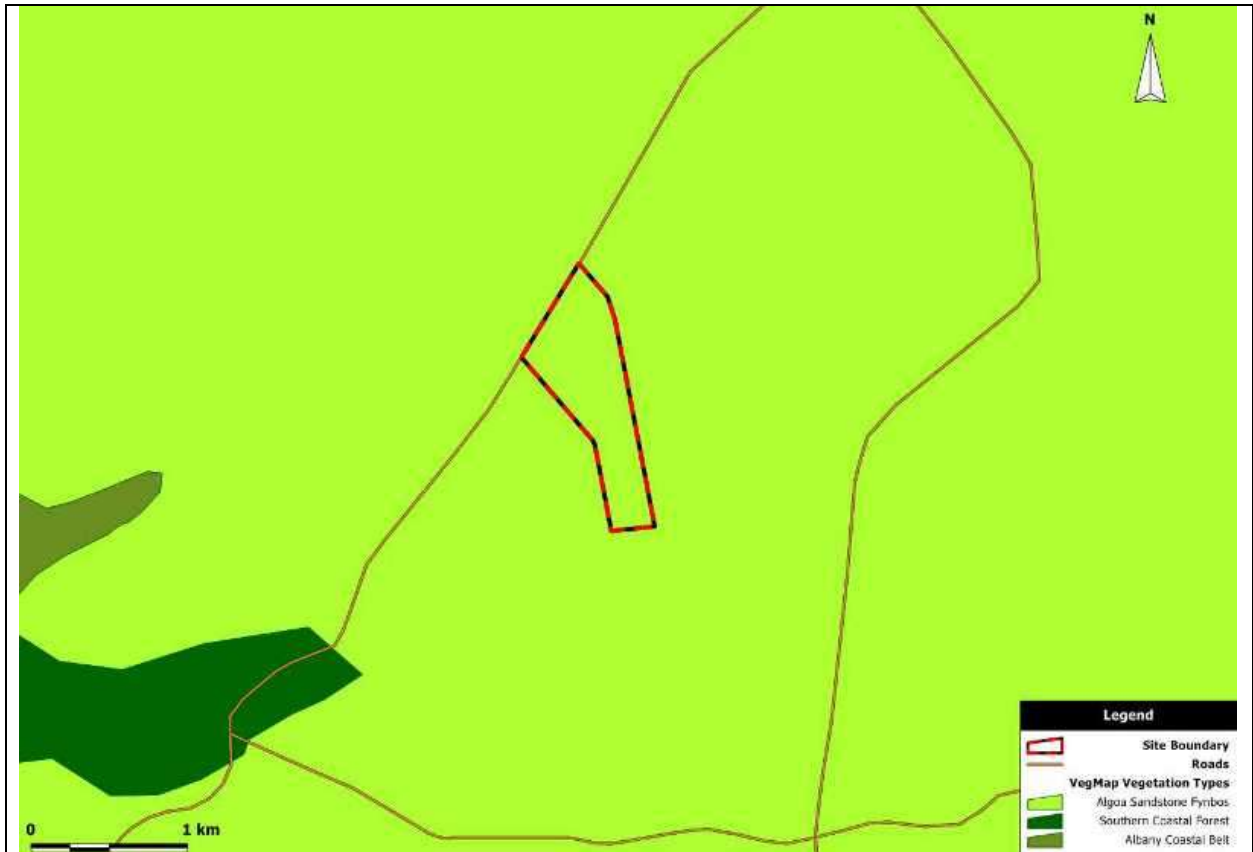
Map 3.4. Vegetation on the proposed site as mapped in VegMap showing Algoa Sandstone Fynbos present on site.

The **NSBA** (National Spatial Biodiversity Assessment) and the Vegetation Map of South Africa, Lesotho and Swaziland (VEGMAP, Mucina and Rutherford, 2006) maps show the vegetation on the subject sites as Algoa Sandstone Fynbos. The vegetation usually includes as endemic taxa *Agathosma gonaquensis*, *Cyclopia pubescence*, *Erica etheliae* and *Holothrix longicornu*. This vegetation type is considered Endangered and poorly protected, as its conservation target is set at 23%, while only 2% is formally conserved. Approximately 50% of Algoa Sandstone Fynbos has been transformed due to cultivation and urban sprawl, while invasion by alien species is considered a further threat.

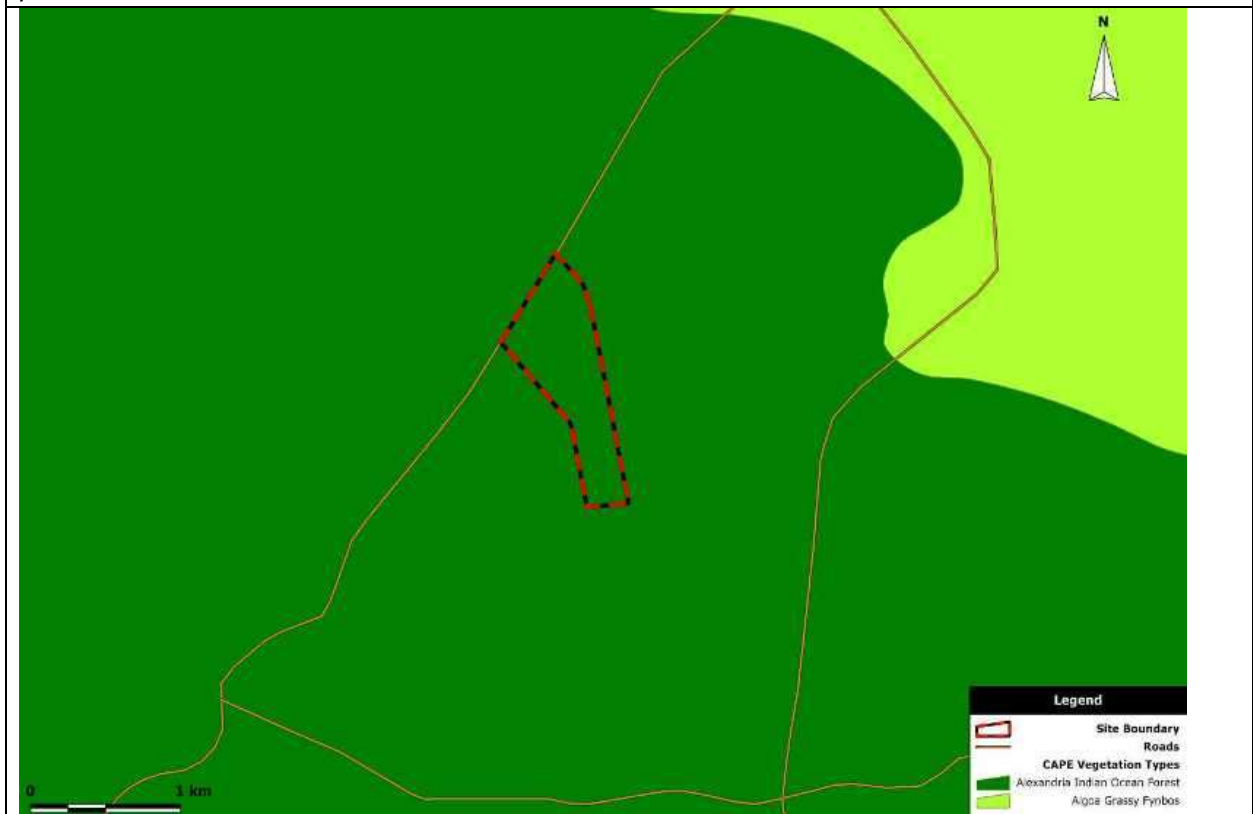
Map 3.5. Vegetation on the proposed site as mapped in CAPE showing Alexandria Indian Ocean Forest present on site.

The **CAPE** (Cape Action for People and the Environment) maps indicate the vegetation expected to occur on site is Alexandria Indian Ocean Forest, but does not assign a conservation status to the vegetation.

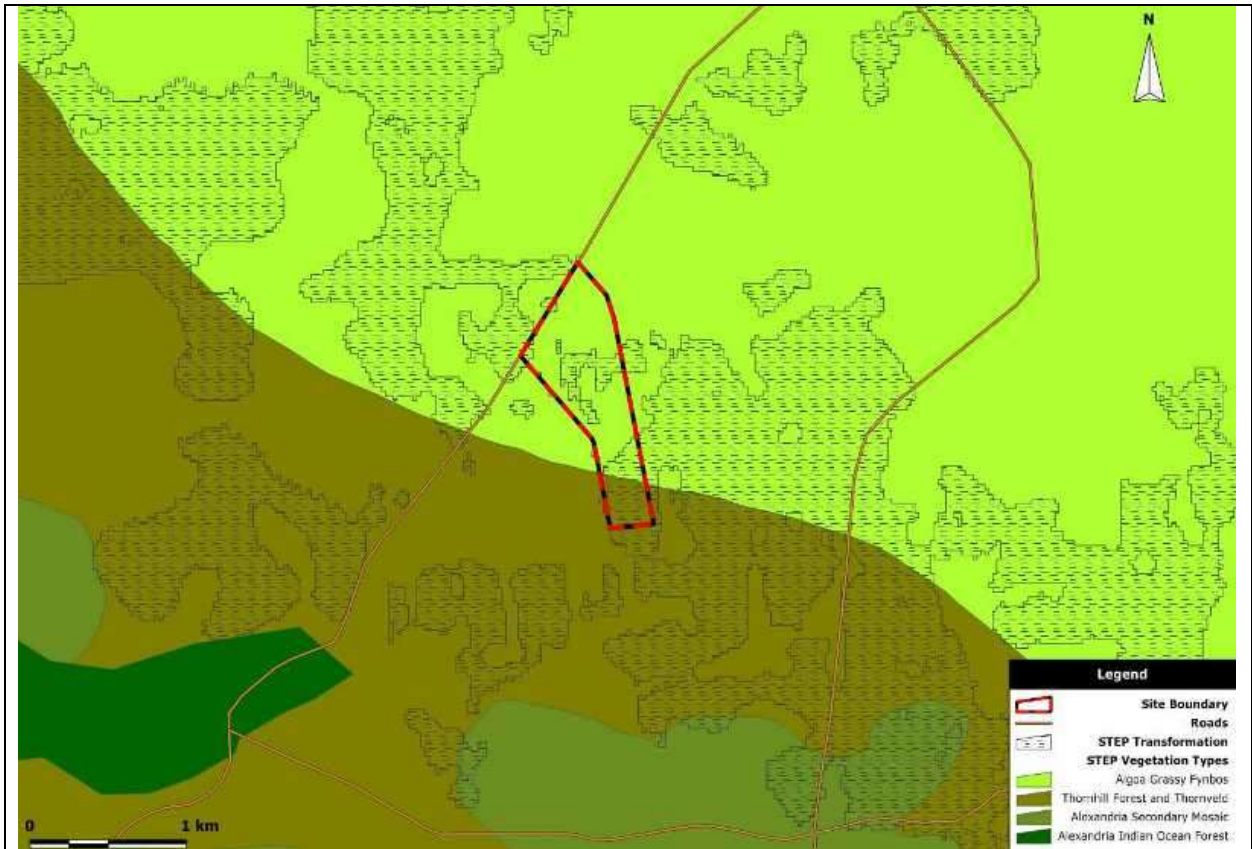
Map 3.6. Vegetation on the proposed site as mapped in STEP showing Algoa Grassy Fynbos as well as the level of transformation of the site

STEP (Subtropical Thicket Ecosystem Programme) (Pierce & Mader 2006.) - According to the STEP mapping resources the majority of the site is covered by Algoa Grassy Fynbos, which is considered *Vulnerable*. A small portion of the site, in the south western corner is mapped as Thornhill Forest and Thornveld. This vegetation type is considered *Currently Not Vulnerable*. The STEP Transformation maps further show that a large portion of the site is currently transformed.

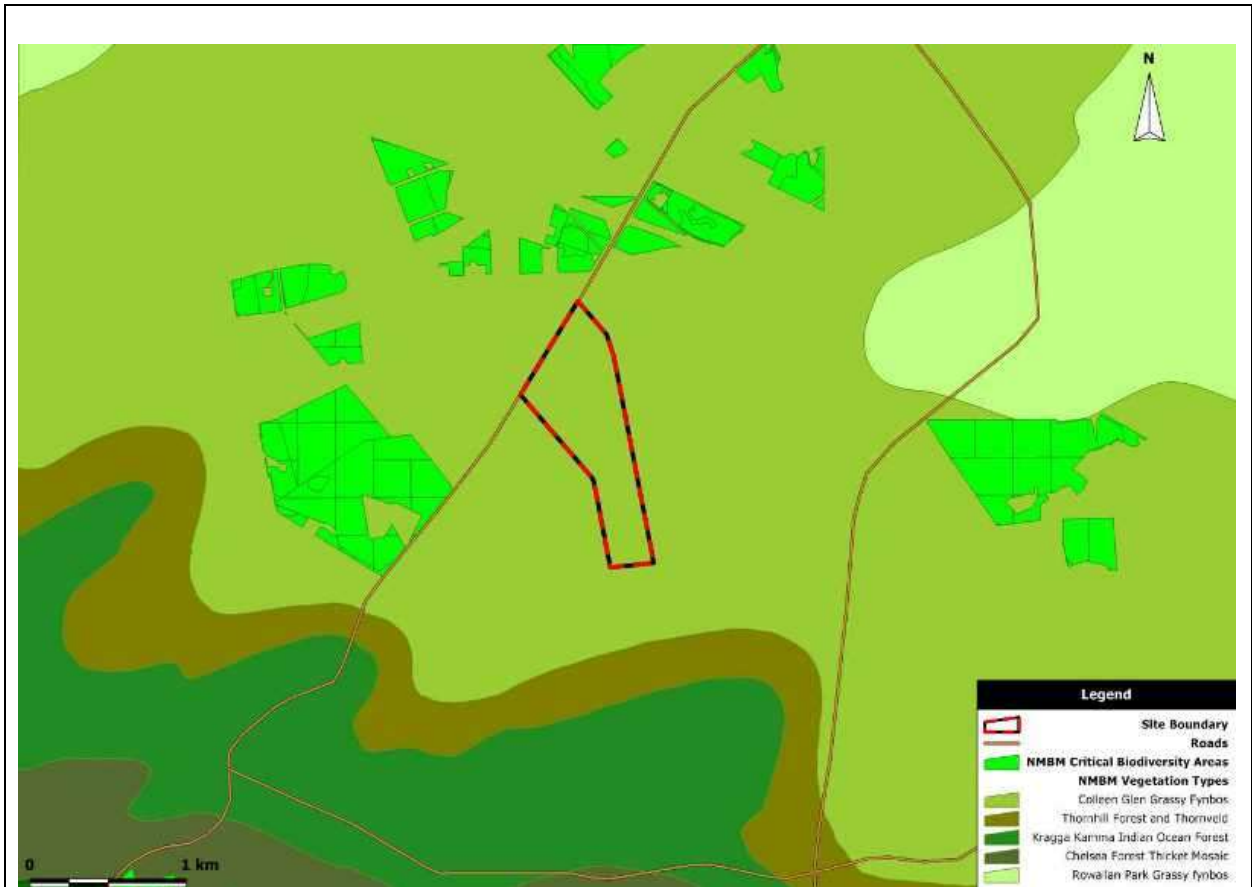
Map 3.8. Vegetation on the proposed site as mapped in the NMBM Conservation Assessment and Plan (NMBM CAP) showing Colleen Glen Grassy Fynbos present on site and CBAs in the vicinity

NMBM CAP (Nelson Mandela Bay Municipality Conservation Assessment & Plan) - The NMBM CAP indicates the site is expected to have *Colleen Glen Grassy Fynbos*, a Critically Endangered vegetation type, as its natural vegetation cover. However the NMBM CAP Land-cover map further indicates the vegetation on the entire site has been transformed by agriculture.

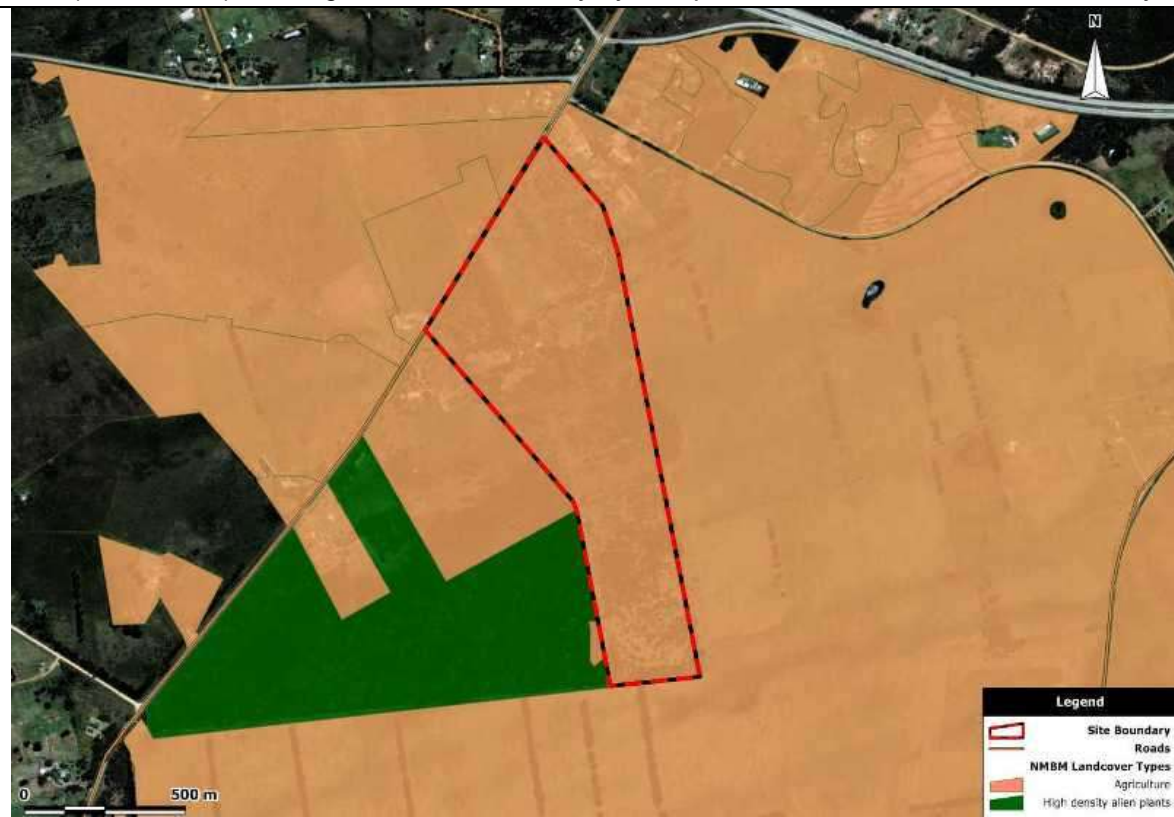
Map 3.9. Landcover Map from the NMBM CAP showing the whole site has been transformed for agriculture.

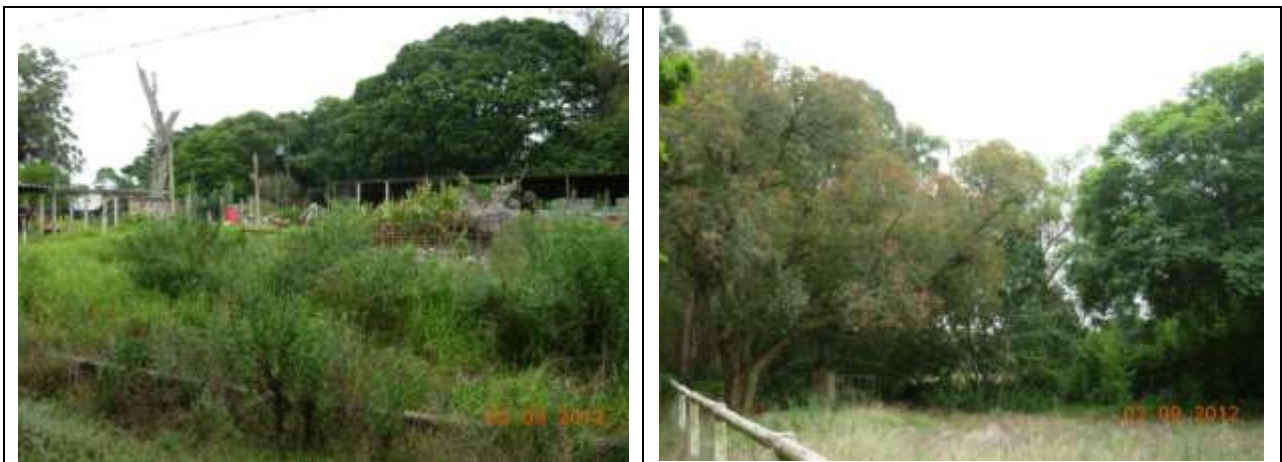
Photo 3.5. Transformed nature of the vegetation in the northern portion of the site

The initial site visit and overview of the vegetation at the site seemed to confirm the transformed nature of the site that has been described in the STEP and NMBM CAP mapping. The northern portion of the site is largely transformed into dwellings, ornamental gardens and outbuildings associated with the small scale agricultural activities on site which include equestrian activities as well as a small citrus orchard and planted crops.

Most of the site has been overgrown by weedy and exotic vegetation. In particular, species of the Genus *Pinus* as well as *Eucalyptus* dominate the tree canopy. The groundcover for the most part consists of grasses, with a few herbaceous shrubs - remnants of the original fynbos vegetation. These include *Metalasia muricata*, *Helichrysum aureum* and *Aspalathus chortophila*.

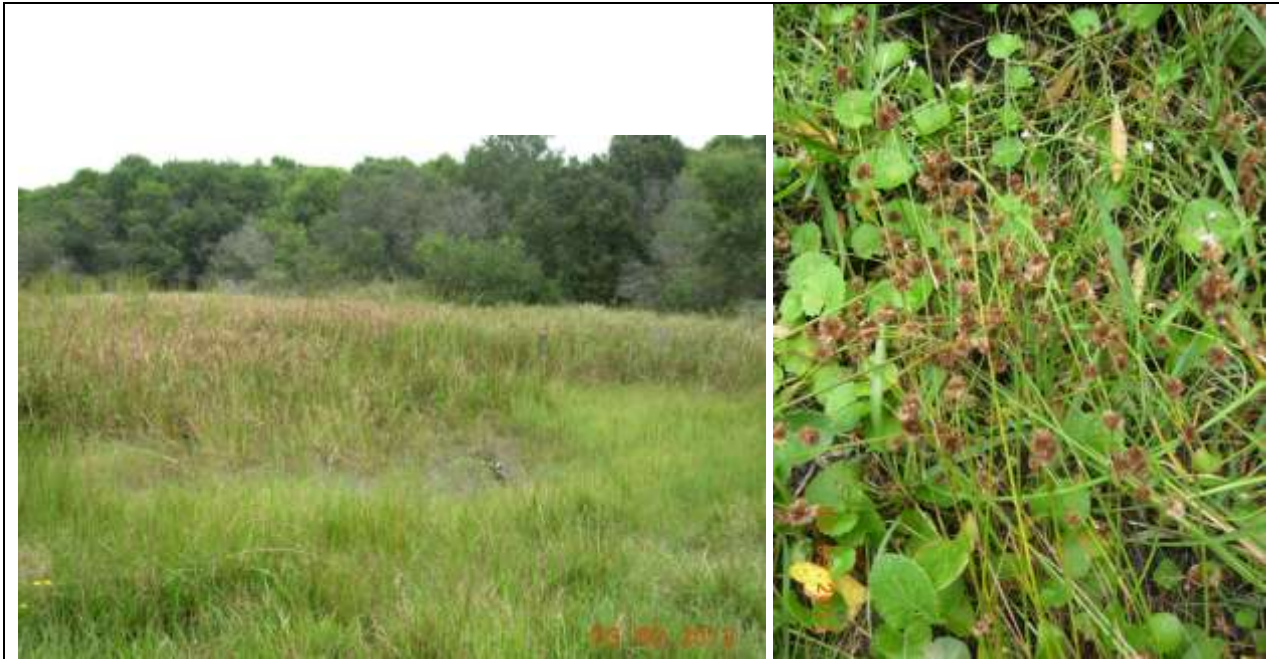
Photo 3.6 Typical wetland vegetation associated with the wetlands on the site.

The vegetation associated with the two dams on the site is characteristic of wetland habitat including a number of sedge species, water lilies (*Nymphaoides indica*) and other hydrophytic species.
