2.15 WETLANDS BASELINE

Scientific Aquatic Services (SAS) was appointed to conduct a wetland assessment as part of the EIA and EMPR Addendum process for the Glencore Merafe Boshhoek Mine and Plant (GMBS). A concise summary of the general findings of this assessment is discussed in this section. Additionally, the complete Wetlands Specialist Report is attached as **APPENDIX 2.15 (A)**.

2.16 AQUATIC ECOSYSTEMS BASELINE

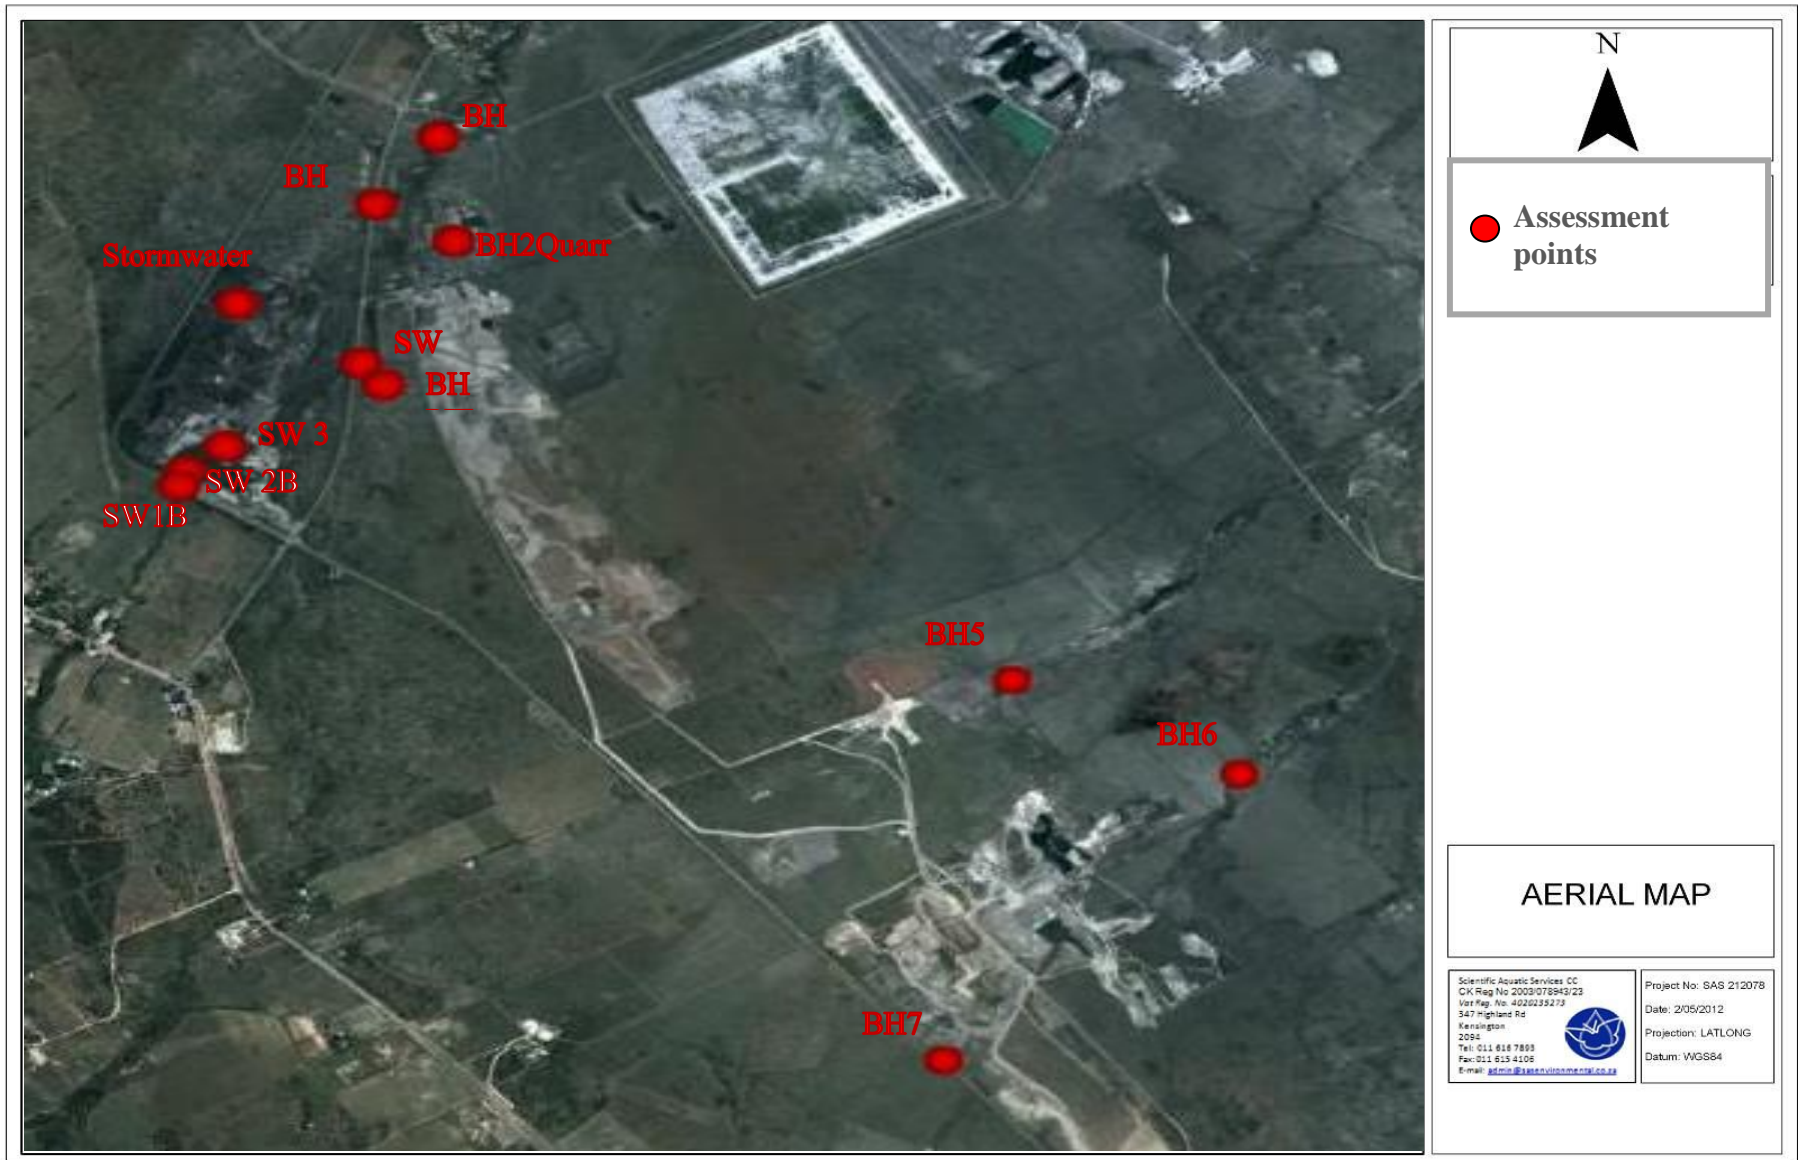
Figure 2.16.1 (a): Assessment Points indicated on an Aerial Photograph

Refer to Figure 2.16.1 (a) for the assessment sites located in the study area.

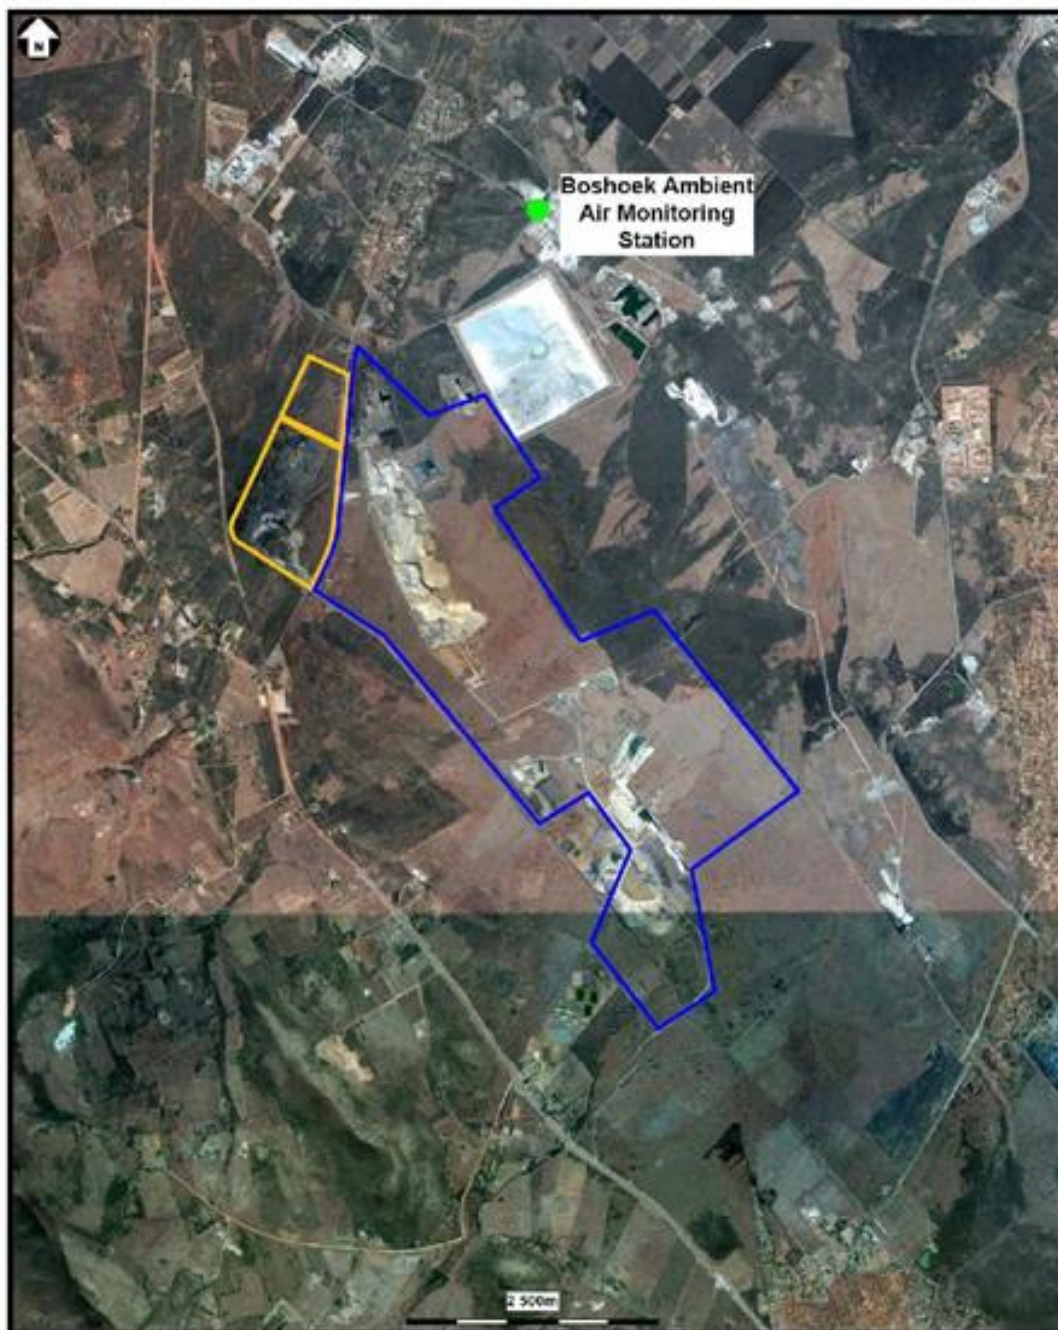
Figure 2.17.2 (a): Location of the Boshhoek Monitoring Station relative to the Site of Works

Ambient air Sulphur dioxide (SO₂) and Particulate matter (PM₁₀) measurements were obtained from the Boshhoek ambient air monitoring station located approximately 4 km northeast of the smelter complex (refer Figure 2.17.2 (a)).

It should be noted that the location of the station is directly north of a large tailings storage facility, located between the monitoring station and the Site of Works. The monitoring station is also neighbouring other heavy mining activities to the north and east of the station.

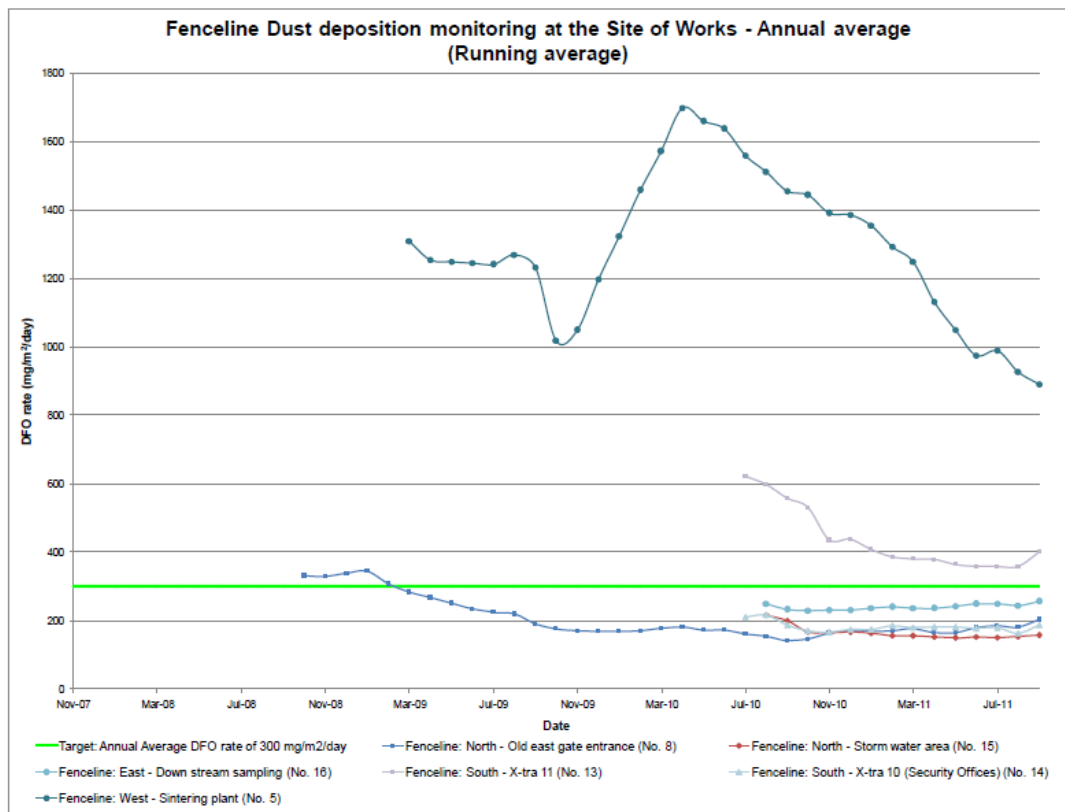
Figure 2.17.2.3 (b): Fence-line Dust Deposition Monitoring at the Site of Works - Annual Average (running average)

- With regards to the annual average DFO rate (refer Figure 2.17.2.3 (b)):
 - Only one of the three locations, “Sintering plant” (No. 5), had more than 12 reported DFO rates which could be included in the graph;
 - Historical DFO rates at this location shows a downward trend in DFO rates, but excessively high DFO rates reported for November 2009 to May 2010 negatively impacted on this trend;
 - From June 2010 to September 2011 the annual average DFO rate again showed a downward trend;
 - The annual average DFO rate at this location never reached the Target DFO rate of 300 mg/m²/day;
 - Overall, apart from the November 2009 to May 2010 sampling periods, the DFO rates reported have shown a decrease in DFO rates from November 2007 to September 2011;

Figure 2.17.2.3 (b) will show the annual average DFO rate, as a running average, for the Fence-line monitoring locations.

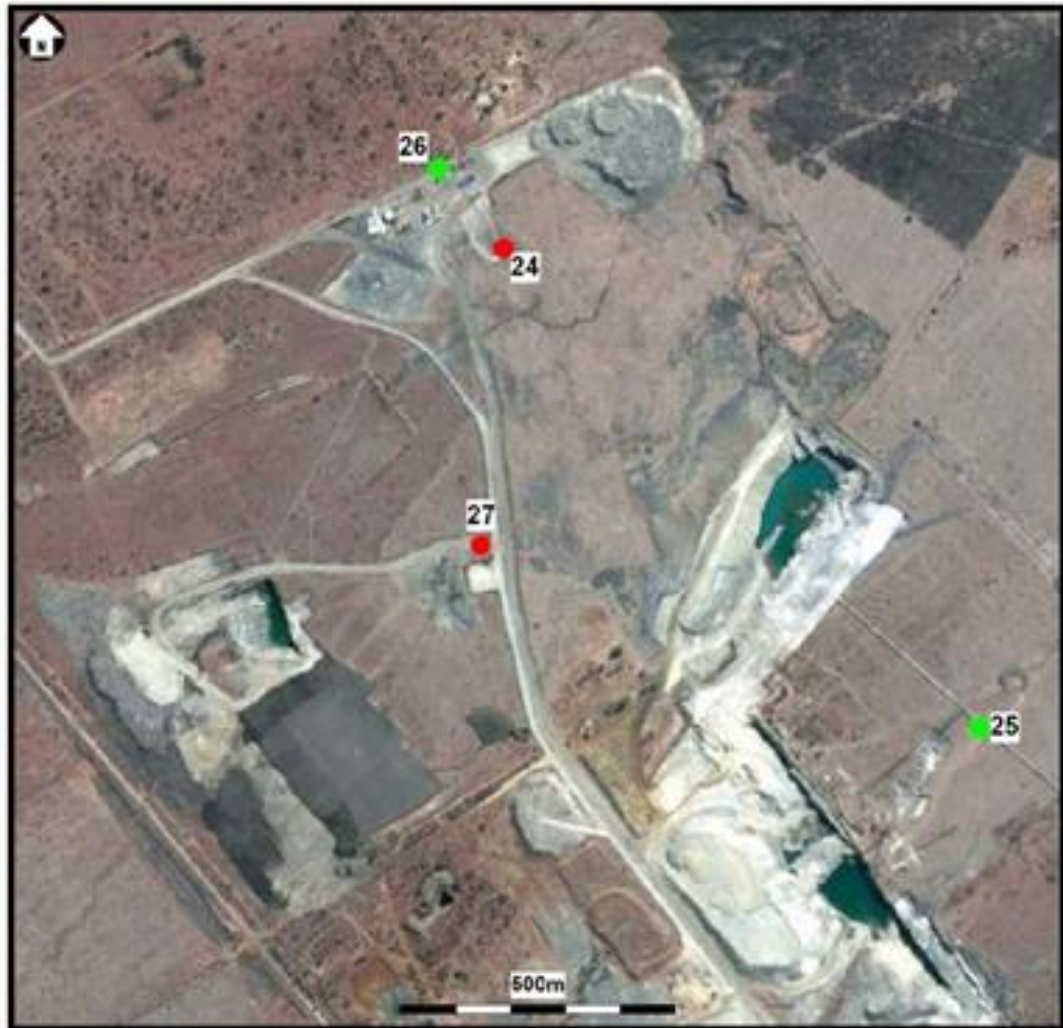
Figure 2.17.2.3 (c): Andru Mining Area Dust Deposition Monitoring Locations

Two DFO locations are located close the boundary to the Andru mining area, while two DFO locations at the mining operations are considered “onsite” locations, and the results thereof were not evaluated.

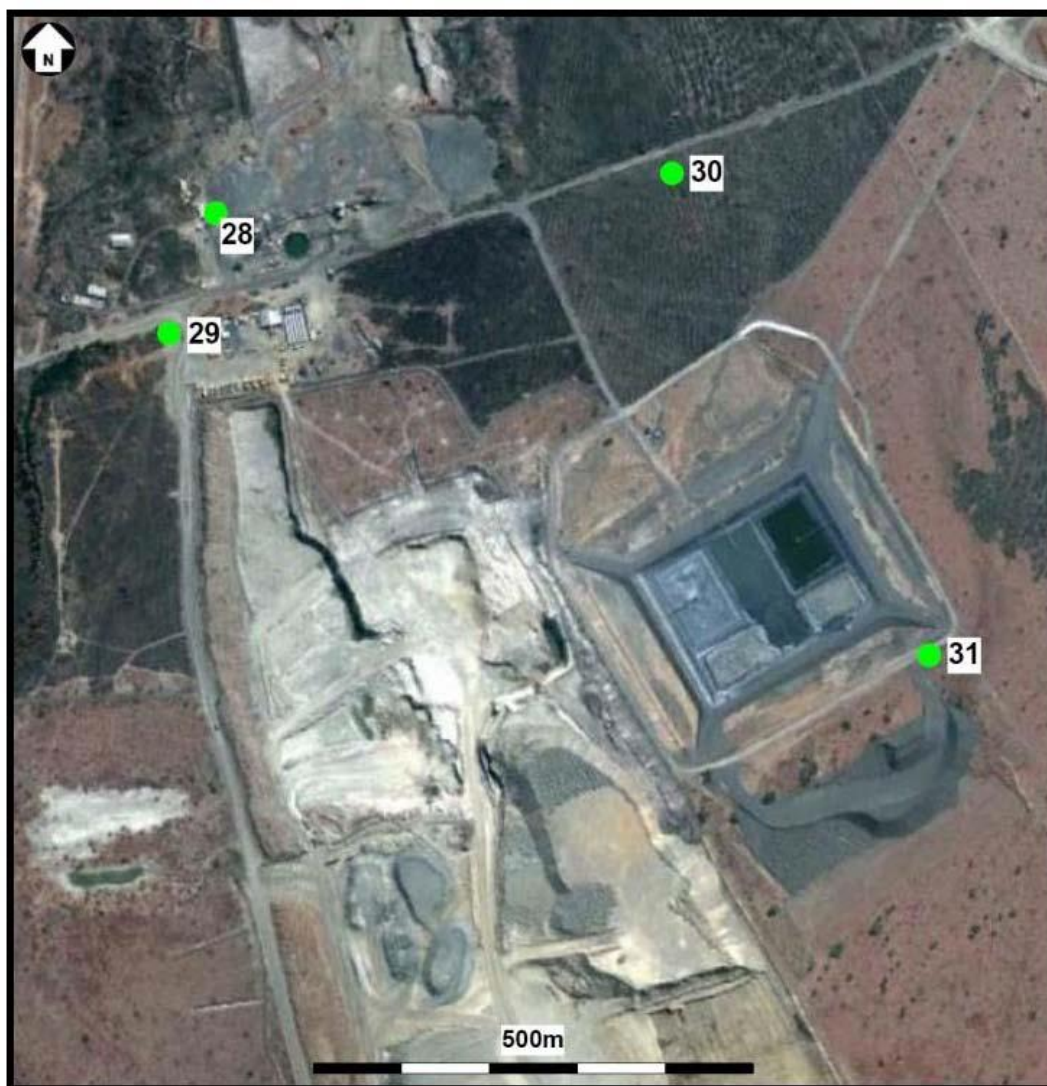
Figure 2.17.2.3 (d): Benhaus Mining Area Dust Deposition Monitoring Locations

All four DFO locations in the Benhaus mining area are considered as located close to the boundary;

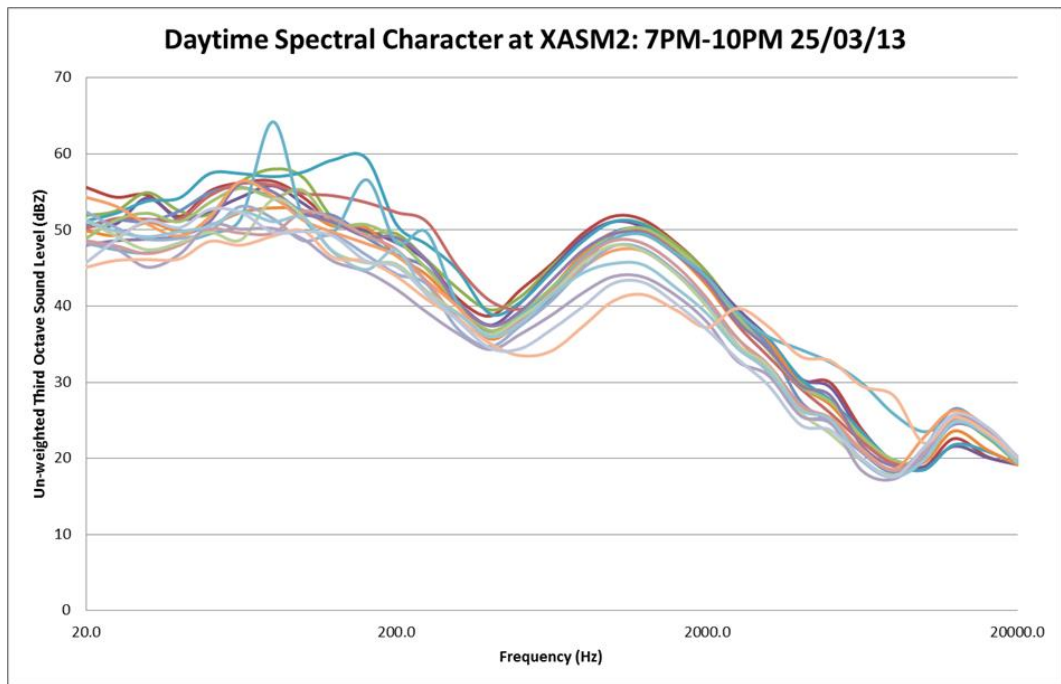
Third octaves were measured and are displayed in Figure 2.18.3.2 (b), Figure 2.18.3.2 (c), Figure 2.18.3.2 (d) and Figure 2.18.3.2 (e),

Figure 2.18.3.2 (b): Spectral Character during rainfall event: XASM02 (25th – 26th March)

Figure 2.18.3.2 (c): Spectral Frequency Distribution as measured on-site at XASM02 - evening

Figure 2.18.3.2 (d): Spectral Frequency Distribution as measured on-site at XASM02 – night-time

Figure 2.18.3.2 (e): Spectral Frequency Distribution as measured on-site at XASM02 – morning and day

Lower frequency (20 – 250 Hz) – Noise sources of significance in this frequency band would include nature (wind especially) and sounds of anthropogenic origin, especially vehicles. Lower frequencies can travel further through the atmosphere than higher frequencies. Most of the measurements reflect significant acoustic energy in these frequency bands, likely relating to traffic on the R565.

Higher frequency (2,000 Hz upwards) – Smaller faunal species such as birds, crickets and cicada use this range to communicate and hunt etc. Some peaks were observed in this frequency range that could be contributed to faunal species such as bird song or cicada communications (possibly even bats at frequencies higher than 16,000 Hz).

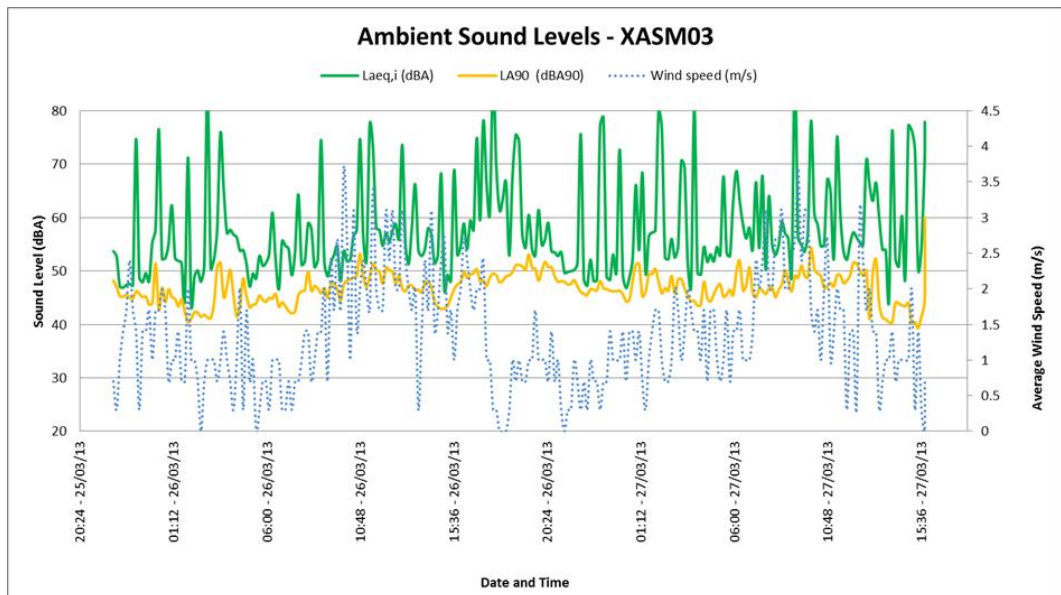
Figure 2.18.3.3 (a): Ambient Sound Levels measured at XASM03: 25 – 27 March 2013

LA_{Ieq} - LA₉₀ average difference, day/night-time: The average daytime difference between the LA_{Ieq} and LA₉₀ variables was 11.3 dBA while the night-time was 10.0 dBA. This large difference is typical of an area where impulsive sounds dominate. This likely relates to noise from the railway as well as the activities at the railway siding. While sounds were audible from the smelter buildings ambient sound levels was dominated by sounds closer to the microphone location.

L_{Amax} night-time occurrences: Many instantaneous noise events occurred during the night-time measurement hours likely from the industrial activities in the area (188 events where sound levels exceeded 65 dBA out of 275 measurements). Maximum noise events may affect sleeping patterns in humans.
