CONSULTATION IN TERMS OF SECTION 40 OF THE MPRDA OF 2002: ENVIRONMENTAL MANAGEMENT PLAN: PROPOSED BORROW PIT OF THE R61 SECTION 4 BETWEEN TARKASTAD AND QUEENSTOWN, EASTERN CAPE

**Basic Assessment Application
for the Rehabilitation of the
R61 from Tarkastad
to Queenstown
Eastern Cape**

Report No 326/03/11

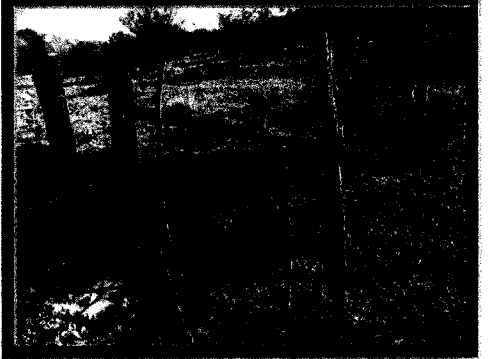
<p data-bbox="895 1402 1381 1442">Photo 8 Sneezewood fence poles</p>

12.0	Another culvert running on both sides of the road. Side drain now running on both sides of the road and on the western side there are two drains. There are some Sneezewood poles which need to be salvaged if they are going to clear up the area.

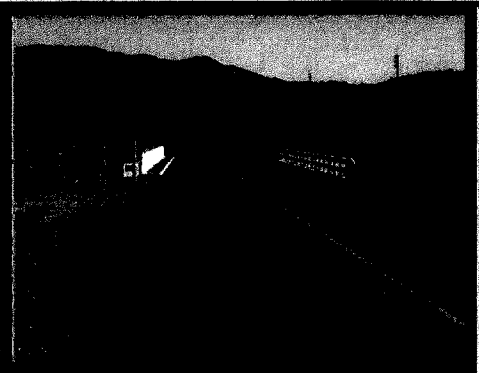
Km	Profile	Comment
54.8	The river is called du Plessis with a bridge which was built in 1959 with a weir on the western side. There is also a gate on the western side just beyond the river and now the Telkom line has come in from the east and is running parallel to the road and there is also a big quarry on the eastern side

<p data-bbox="890 622 1365 663">Photo 26 du Plessis Bridge</p>

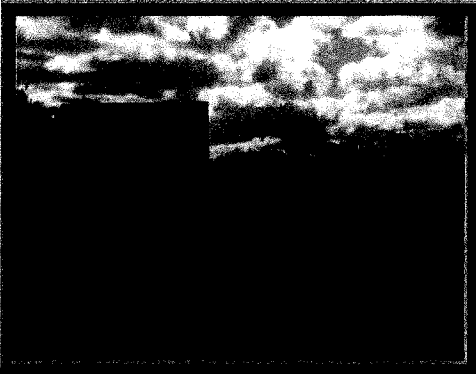
<p data-bbox="931 712 1370 741">Photo 27 Signage to Queenstown</p>
60.2-61.0	Approaching a stop sign at a fork in the road. There is a row of Pines on the eastern side. The above sign indicates the directions to Whittlesea and Fort Beaufort. On the west is the R67. A warning sign indicates this is a dangerous intersection and the speed limit is 80 km.
