Rehabilitation of the Port Nolloth Infrastructure Project

Port Nolloth, Northern Cape

Archaeological Impact Assessment Report

February 2017

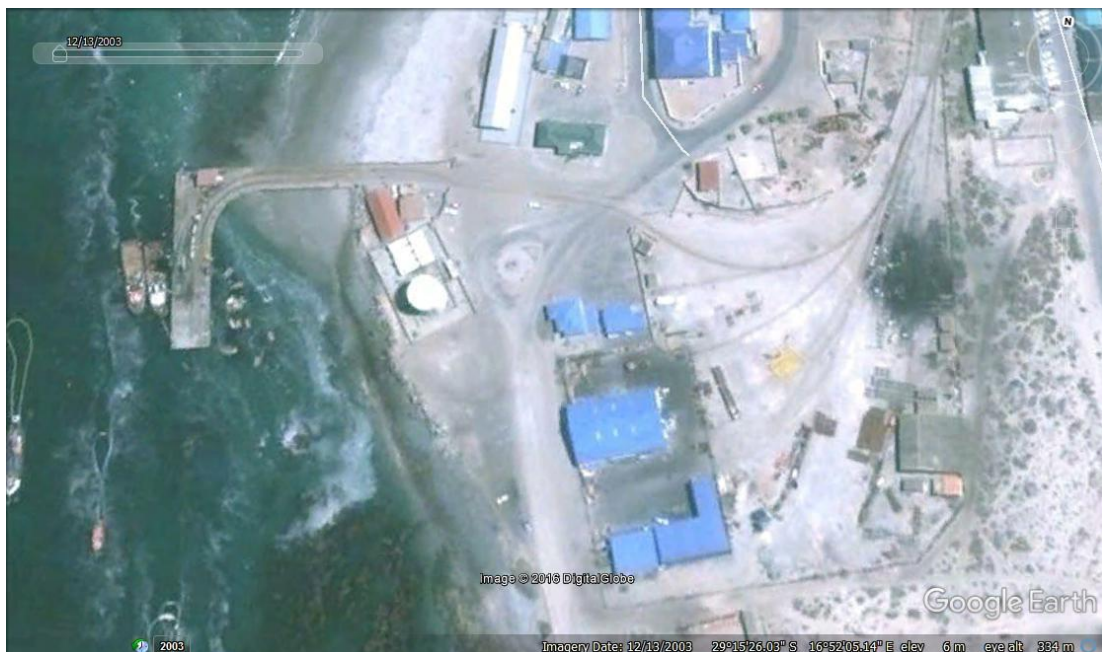
Figure 4: Railway tracks still visible in 2003, layout similar to the 1988 sketch above. (Source: Google Earth Imagery 13/12/2003).

The area surveyed for the purpose of this assessment, covered the entire shoreline south from the concrete jetty up to the old 19th century slipway which included the proposed revetment area. The area contained remnants of activities taking place over the past 160 years including a pair of wooden piles remaining of the old wooden jetty. The area also contains rails remnant of the old railway, metal debris, concrete blocks and the old slipway built in 1889 for ship repairs (Harbour master report, 1889). The recovered object lies outside the area ~2 metres adjacent to the excavation area (see image 3 and 4, figure 5). Similar to the beach north and area further south of the slipway, this area would have originally been rock overlaid with sand and has been dramatically shaped by the activities and developments that took place in this area. Due to the shifting nature of the sand caused by tide, strong southerly winds and human activity, the shoreline has changed and over the years seems to have been stabilised using rock, concrete walling and fill containing all sorts of debris including the remains of the old railway and concrete used in the infrastructure of the Caltex fuel tanks (fuel tanks visible in figure 4) (pers. comm. Visser, February 2017).

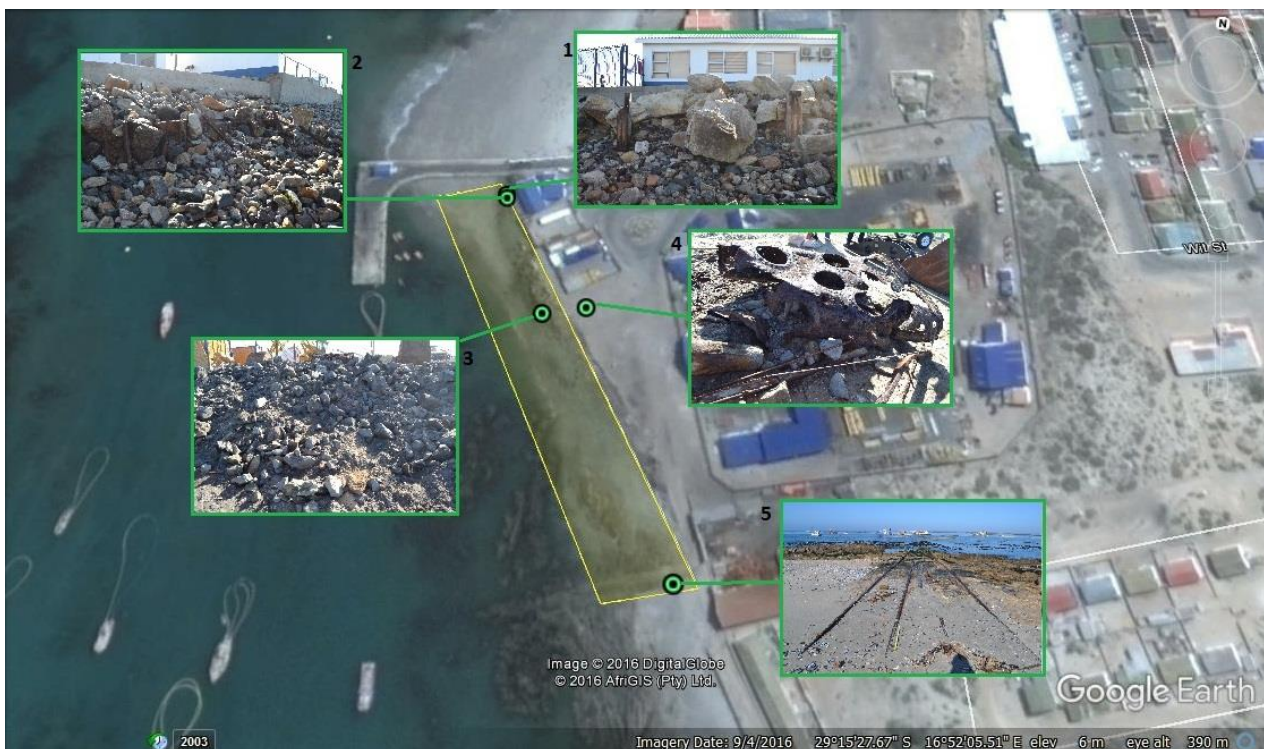
Figure 5: Polygon showing the area surveyed during the site assessment on the 14th February 2017. Image 1: Remains of wooden jetty; Image 2: Old railway rails used to stabilise rock; Image 3: Rock covering area where the boiler was excavated; Image 4: Boiler and metal stockpile & Image 5: 19th century slipway. (Source: Google Earth Imagery 9/04/2016).

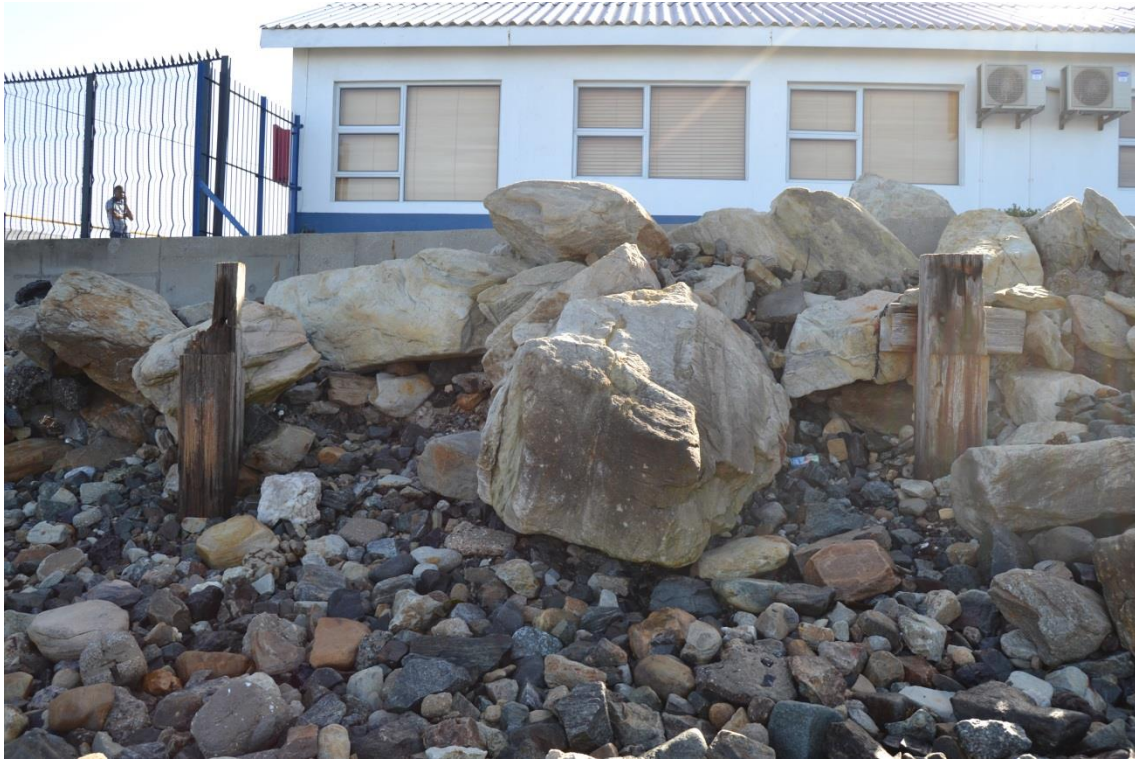
No visible shipwreck debris was seen during the survey of the area between the concrete jetty and the old slipway. From the records, it seems unlikely that there were any ships that ran ashore immediately south of the jetty. The shoreline was mostly scattered with rock and construction debris possibly from the Caltex fuel tank infrastructure, piled up for the most part against the current concrete foundation wall. Objects of cultural significance include the wooden piles remnant of the old wooden jetty, and the rails remnant of the old railway found next to the wooden piles and further south protruding only slightly from the embankment. The rails seem to have been used to stabilise the rock next to the wooden piles; it is uncertain at which date these rails would have been placed here and any significant context seems to have been lost.

Figure 6: Remnants of the old wooden jetty

- The remains of the 19th century wooden jetty seem to be the only structure of heritage significance still in its original context. Mitigation measures should be undertaken to ensure that these piles continue to be conserved in situ.

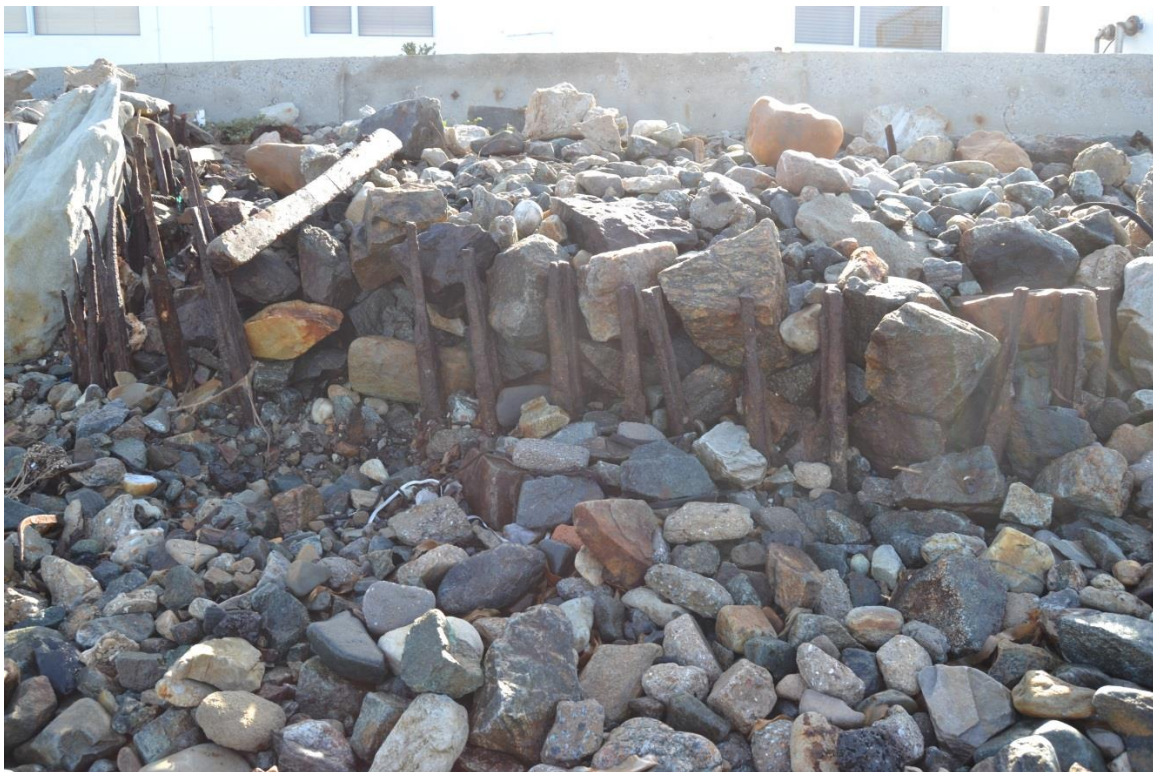
Figure 7: Old railway rails reused to support and stabilise rock.

- Consideration should also be given to the old railway rails used to stabilise the current revetment. It is recommended that these be left in situ and efforts be taken to minimise the impact during the placement of the new rock revetment.

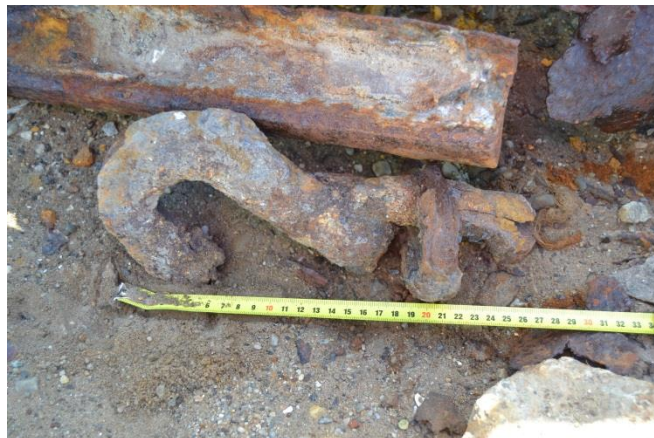
The object removed from the excavation in December 2016 currently lies in a metal stockpile approximately two metres from the area that it was said to be originally located. The stockpile consisted of construction debris alongside remains of old railway rails, an iron cargo hook and what are possibly the remains of an old boiler. These were all said to be removed from the same excavation pit with the exception of the construction debris that was later added to the pile. The boiler is mostly broken up and the remains consist of the outer shell largely in one piece, parts of the shell and parts of the flue tubes. Basic measurements of the shell were taken during the assessment of the boiler; the length of the shell measured 204cm and the width 153cm. The diameter of the man-holes measured to 31cm. The metal is in a bad state of corrosion and thickness varies from ~1mm along the edges to 2.4cm around the man-holes.

Figure 8: Iron cargo hook

- Since the boiler and rail remains in the stockpile have already been removed, it is recommended that these be removed to a facility that is able to take it in and further conserve it. A permit from the responsible heritage authority in the Northern Cape will be required to remove the material. After speaking with the Port Nolloth Museum curator, George Moyses, it appears that the local museum cannot take the items due to lack of storage and an alternative solution needs to be found.

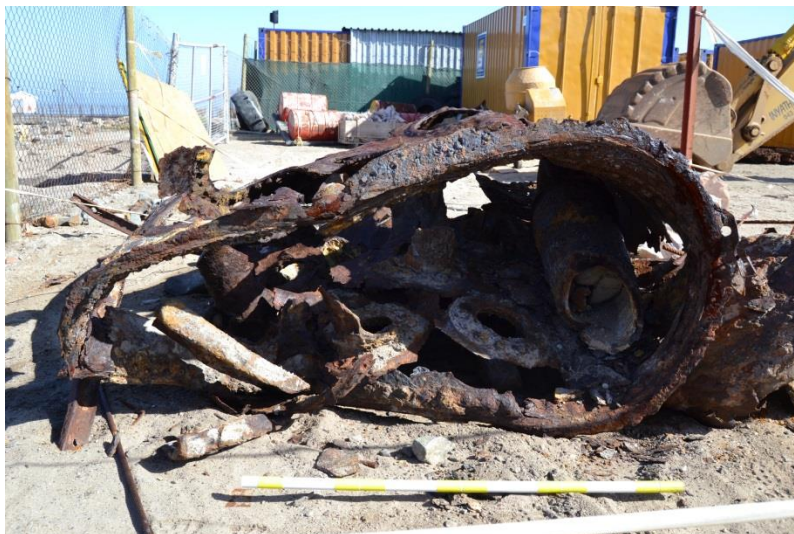
Figure 9: Remains of the outer shell of the boiler.

The object removed from the excavation in December 2016 is likely the remains of a boiler used during late 19th to 20th century circa in Port Nolloth. Removed from its original context and in a bad state of preservation, the remains are of low archaeological significance. Nevertheless, it is still of some heritage value and is a remnant of the early railway industry taking place at Port Nolloth.

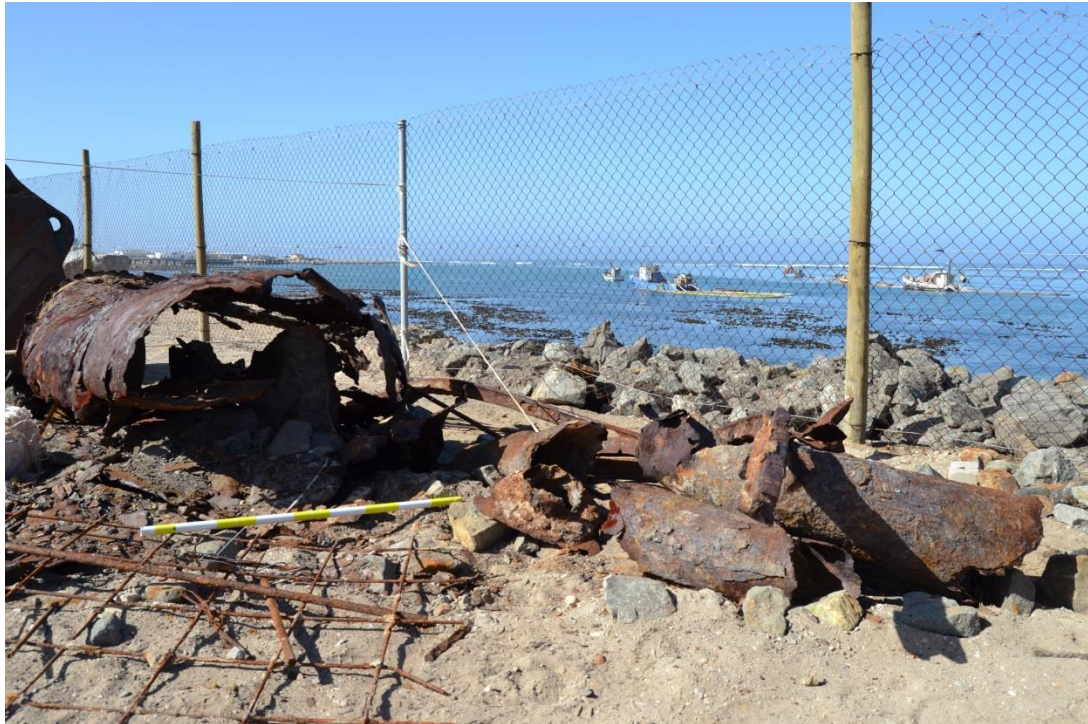
Figure 10: Remains of the outer shell, man-hole frames and flue tubes of the boiler and old railway rails.

Upon further assessment of the remains and research into the history of the port, evidence suggests that the boiler was possibly a cylindrical vertical type boiler used for powering steam-powered winches or rail cranes used at the port in the late 19th to early 20th century, see example in figure 11.

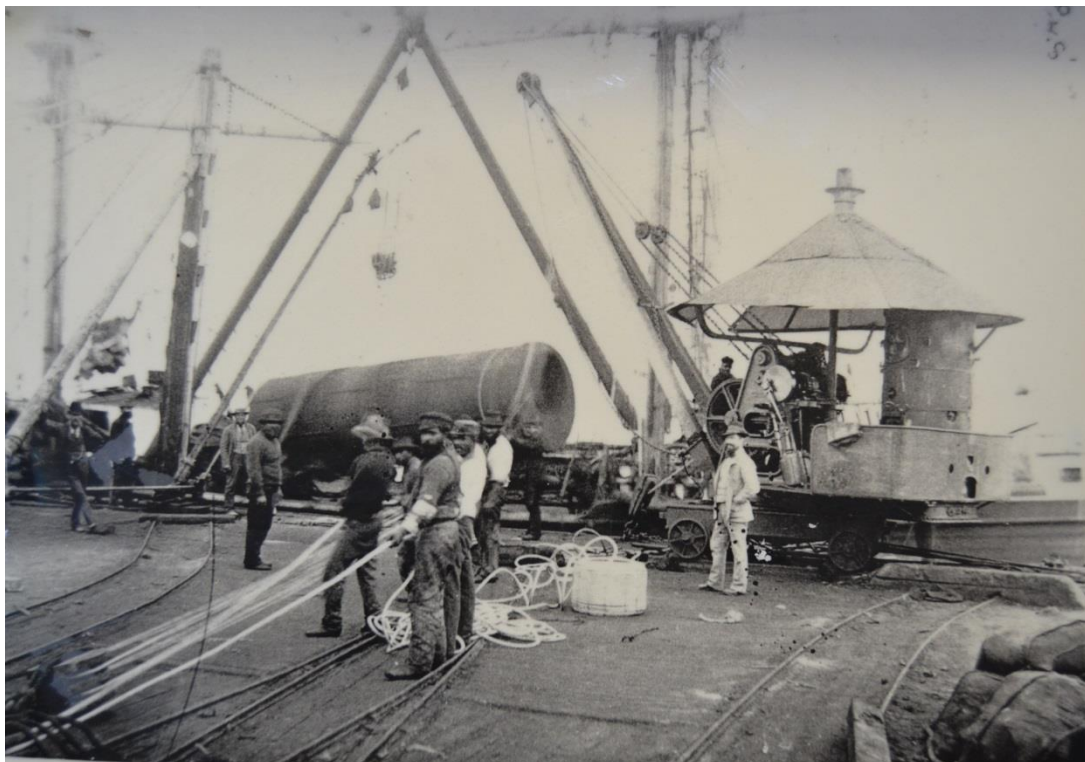
Figure 11: Picture of a mobile steam crane and vertical boiler, taken by H.R Moffatt circa 1880. Courtesy of the Port Nolloth Museum.

These were generally low pressure boilers (often not more than 100lb per square inch) used for hoisting and lowering cargo, which only required small quantities of steam (Molloy, 1941). A Bishop visiting the port on *SS Namaqua* in the 1880s describes the use of a basket to lower passengers on to the jetty. He also describes the use of a donkey boiler alongside a pulley and chain system, a picture of the basket can be seen in figure 12 (Carstens, 2011)
