**A REPORT ON A CULTURAL HERITAGE IMPACT ASSESSMENT FOR THE
PROPOSED DEVELOPMENT OF UPMARKET TOURISM ACCOMMODATION ON
THE SELATI RAILWAY BRIDGE, SKUKUZA, KRUGER NATIONAL PARK,
MPUMALANGA PROVINCE**

REPORT NO.: AE01810V

8 March 2018

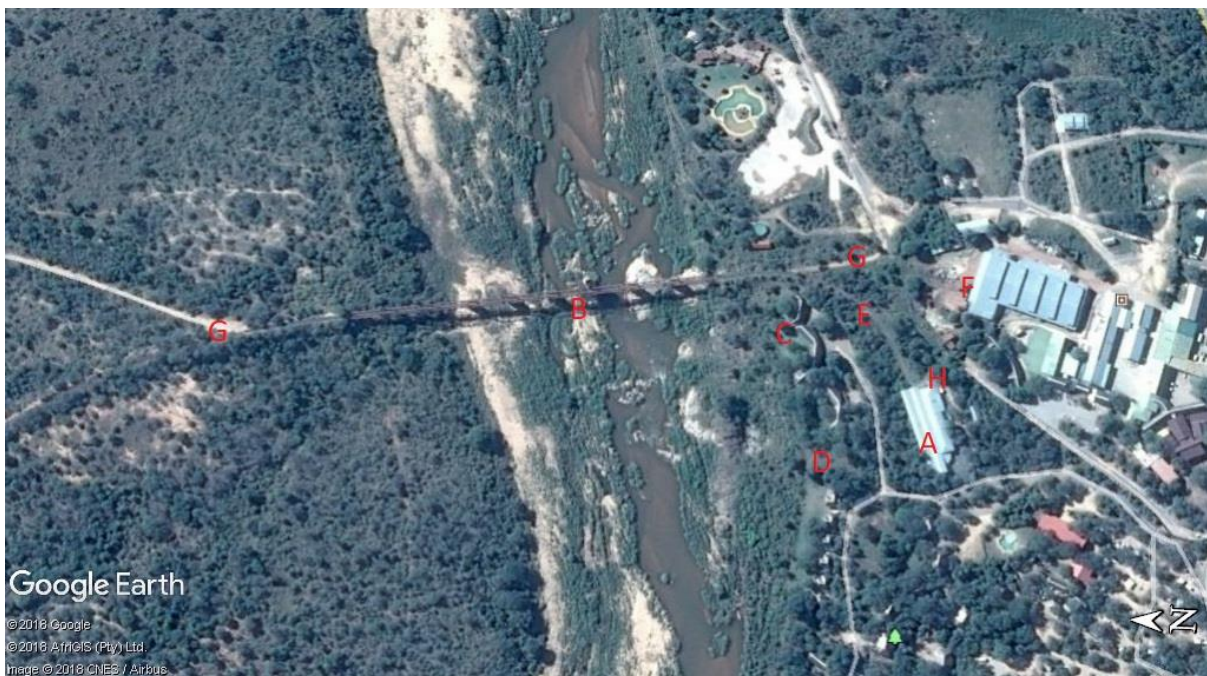
FIGURE 3A: LOCATION OF PROJECT COMPONENTS.

The proposed development includes a number of interrelated components (Figure 3A-B – Also see Appendix F with indications of conceptual layout) described as follows:

- The existing Selati Restaurant footprint will be refurbished and fitted to provide the following facilities (see A in Figure 3):
 - Parking for both guests and the general public;

- Departure/arrival point for guests to be transported to the bridge via the existing pump trolley to a point just south of the sleeper carriages.
- A stationary box carriage positioned on the existing railway tracks just to the north of the sleeper carriages to serve as storage and backdrop for bush diner functions and the departure/return of game drives (see G in Figure 3).

- The existing Waterkant and Nyati guesthouses to be included into the concession and refurbished as upmarket 16 bed guest accommodation in line with the style of the sleeper carriages and the facility as a whole, also to include a lounge and fine dining restaurant for guests, and a spa (see C in Figure 3).

- Replacement accommodation units to be constructed for and at a locality to be identified by SANParks (see D in Figure 3)

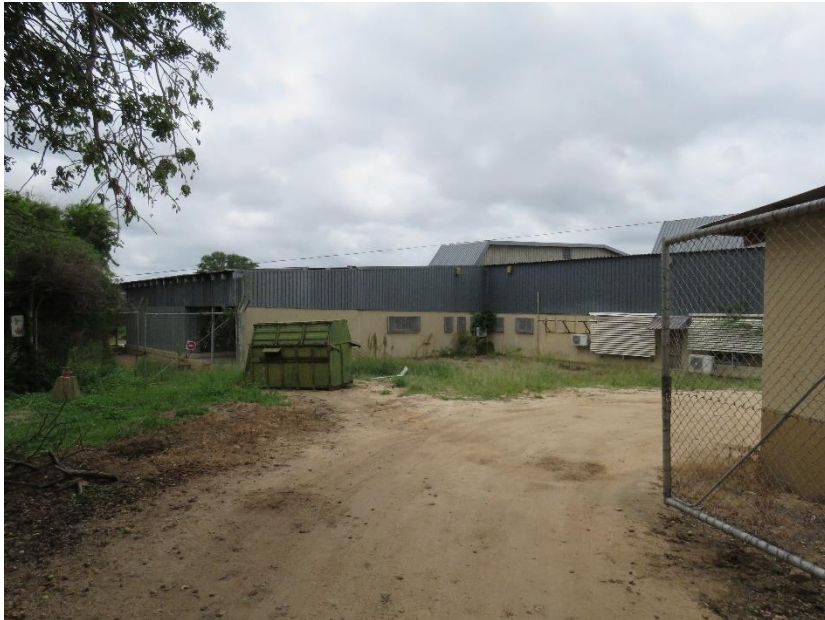
- F. Existing yard and portion of the existing Distribution Centre is to be leased from SANP to provide storage and laydown, work areas during construction and as a service area and theatre / media centre for guests in operational phase (Figure 9). Access of staff and deliveries etc. (construction and operations) is via the existing service routes and eliminates all disruptive non-visitor traffic through the Skukuza camp.

FIGURE 9: DISTRIBUTION CENTRE.

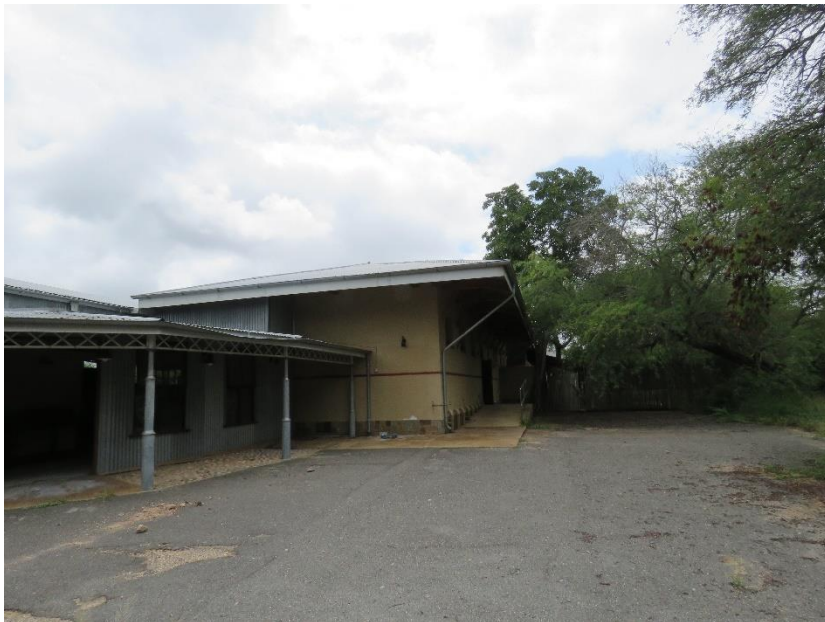
FIGURE 10: ENTRANCE TO THE SELATI RESTAURANT, BUILT DURING THE 1980'S.

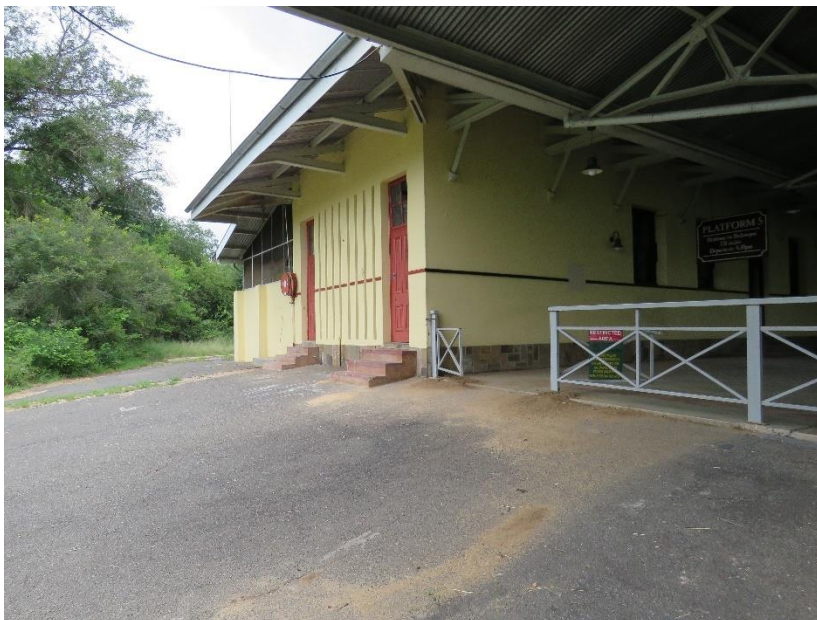
- H. Existing position of transformer for connection to existing Skukuza electrical supply with warranted capacity as well as approximate connection to existing sewer reticulation for centralized treatment at existing facility (Figure 14).

FIGURE 14: EASTERN ENTRANCE TO SELATI RESTAURANT. THE ELECTRICITY TRANSFORMER IS JUST TO THE EAST THEREOF.

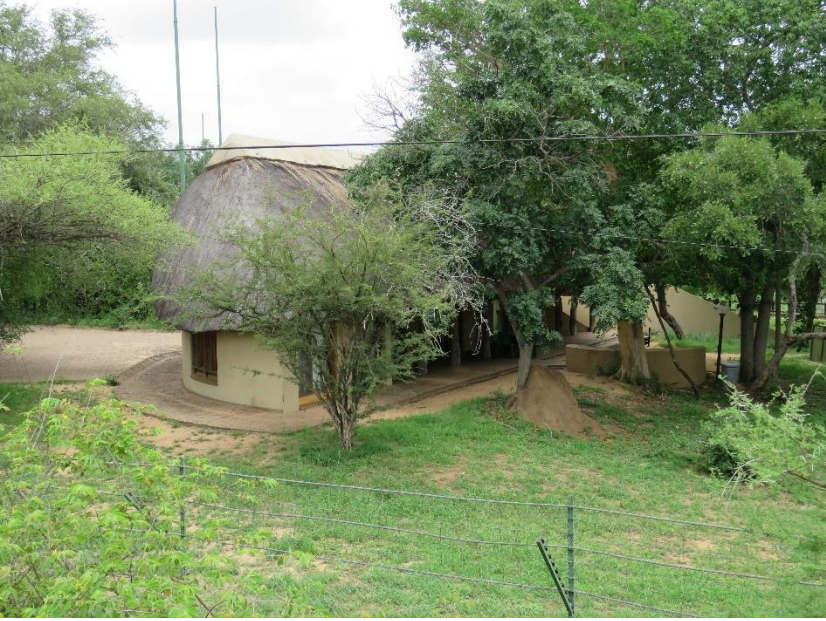
- B. The bridge, discussed below.
- C. The existing Waterkant guest houses to be included in the accommodation offering by the concessionaire and the existing buildings refurbished appropriately (Figure 17). This building is younger than 60 years of age.

FIGURE 17: WATERKANT GUEST HOUSE.

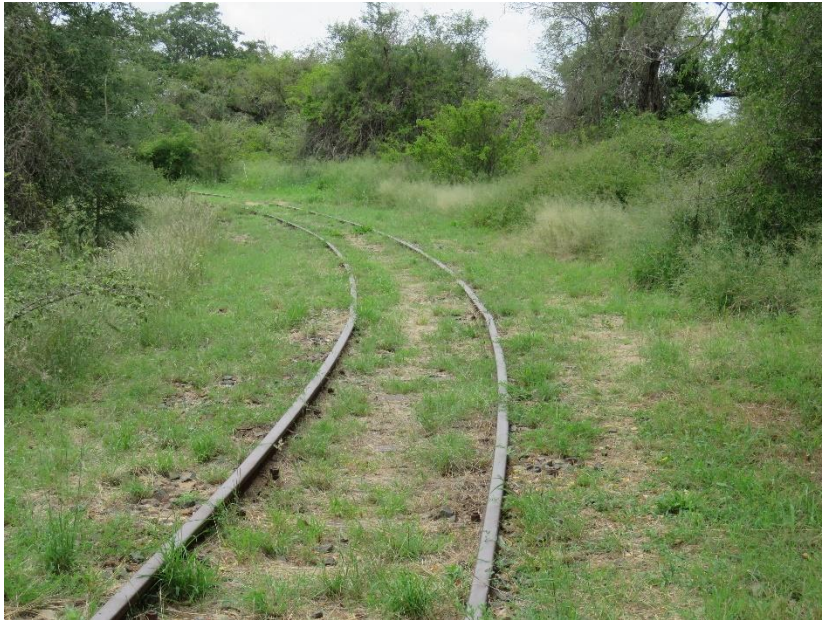
- D. Replacement accommodation. The concessionaire is required to construct replacement accommodation on this site (Figure 18).
- E. Access from the restaurant, lounge, boma facilities for concession guests, to and from accommodation on the bridge, is via the existing rail track (Figure 19) and an adjacent paved pedestrian / golf cart path and using the existing "pomp trolley", a hand powered cart on rails (Figure 20) which will be electrified (solar).

FIGURE 19: EXISTING RAILWAY TRACK BETWEEN THE RESTAURANT AND THE BRIDGE.

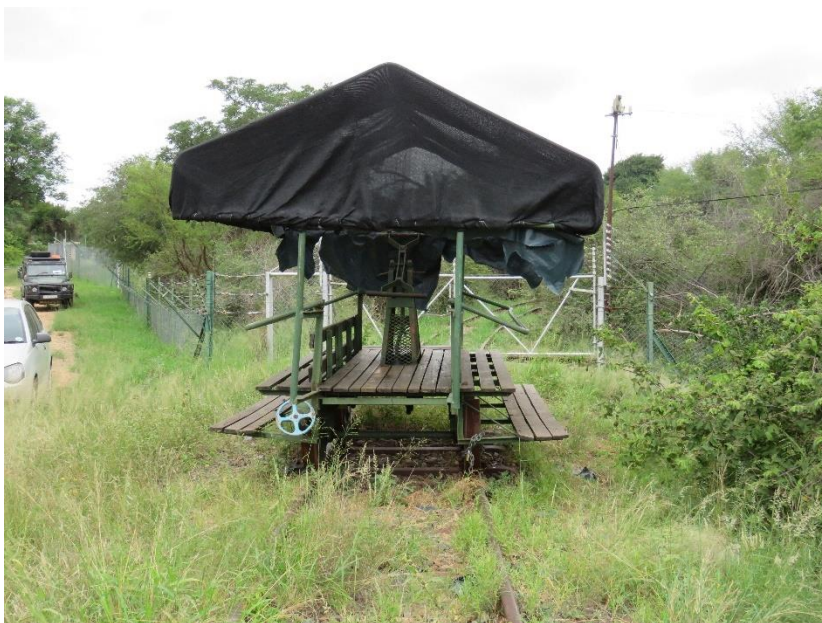
FIGURE 20: TROLLEY TO BE UTILISED WITH NEW DEVELOPMENT.

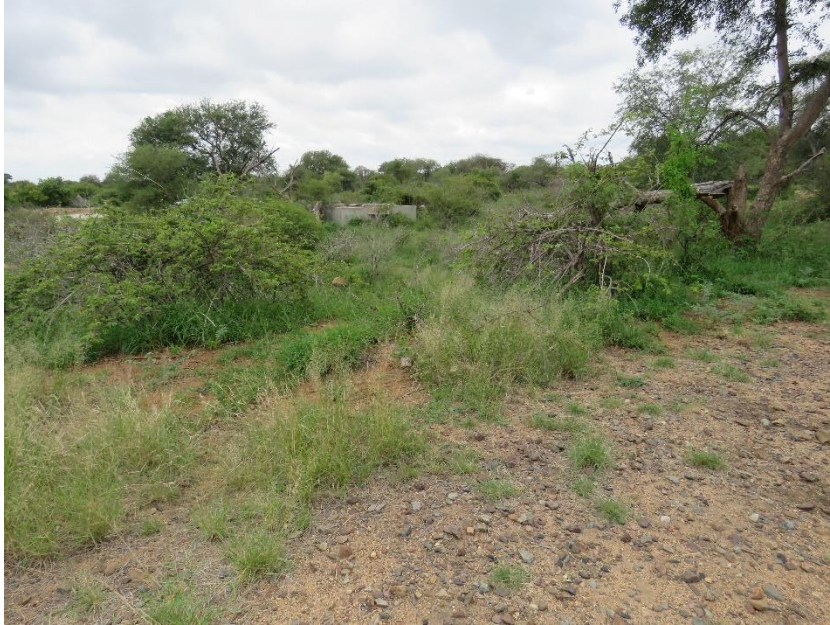
FIGURE 21: ACCESS TO THE BRIDGE ON THE SOUTHERN SIDE OF THE RIVER. NOTE THE CONCRETE STRUCTURE WHICH FORMS PART OF THE WATER PUMPING SYSTEM.

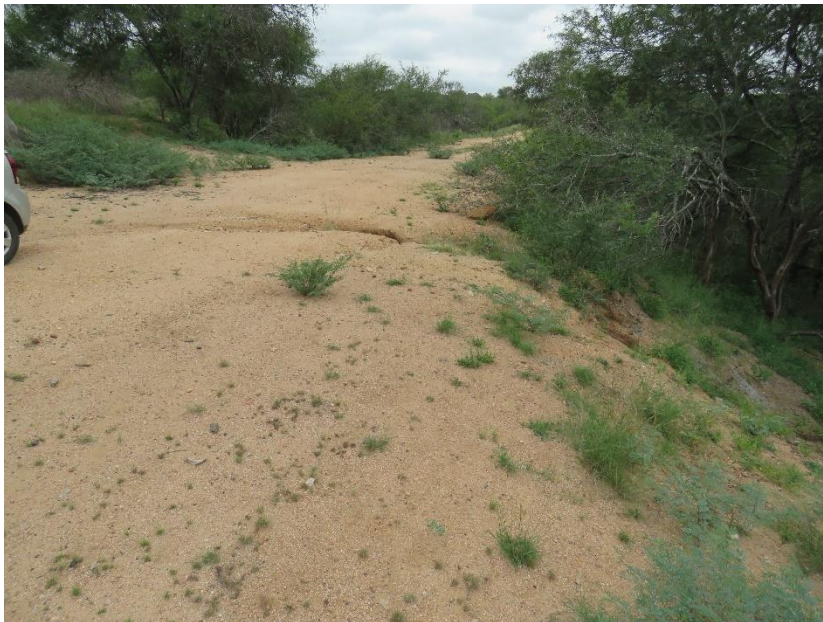
- G. South: Offloading and final fitment area for rail carriages delivered by road. Temporary tracks to be laid on the existing foundation / ballast of the original rail line (Figure 21). All major refurbishment of carriages will be done off site in JHB prior to delivery and setting on tracks, shunting into position.
North: Position proposed for a stationary box carriage as storage and backdrop for bush diner functions and departure return of game drives (subject to agreement with neighbouring concessionaire). Rail tracks existing as a continuation of those over the bridge (Figure 22).

FIGURE 22: ACCESS TO THE BRIDGE ON THE NORTHERN SIDE OF THE RIVER.

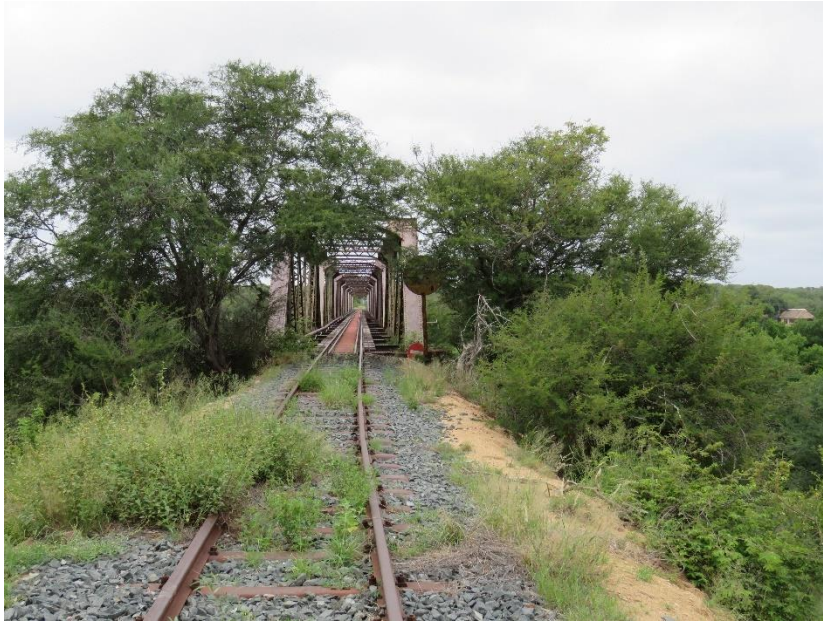
FIGURE 24: NORTHERN VIEW OF THE RAILWAY BRIDGE.

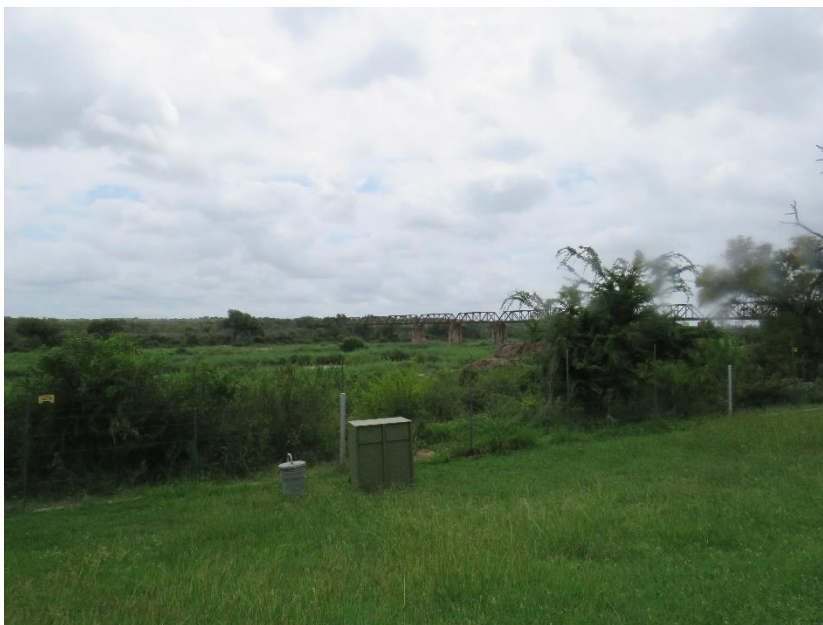
FIGURE 25: VIEW OF THE RAILWAY BRIDGE TAKEN FROM SKUKUZA (SOUTH-WEST).

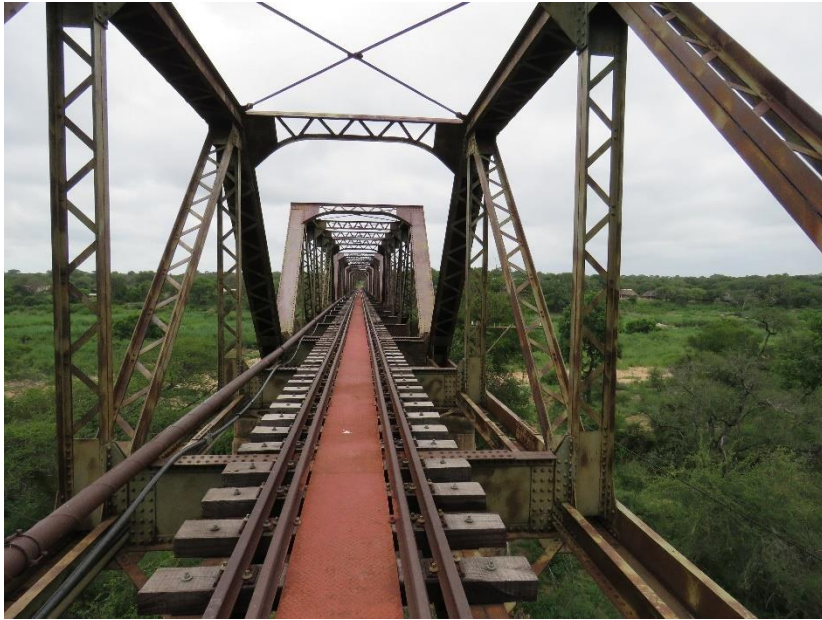
The bridge is in a reasonably good condition. Although somewhat rusted, the steel construction (Figure 26) and sandstone pillars (Figure 27-28) are still sturdy and likely will still be able to hold its weight as well as that of the proposed railway carriages.

FIGURE 26: DETAILED VIEW OF THE BRIDGE.

In principle nothing that would be a permanent intervention to the bridge structure should be allowed. Later additions to the bridge, such as cables and pipes, which have lost its functionality, should be removed. The pump house may be reused and changed since it does not form part of the original construction. The plan indeed is to remove redundant services, e.g. the old telephone line, rusted water pipes etc., but the water supply to the airport from Skukuza must obviously remain.

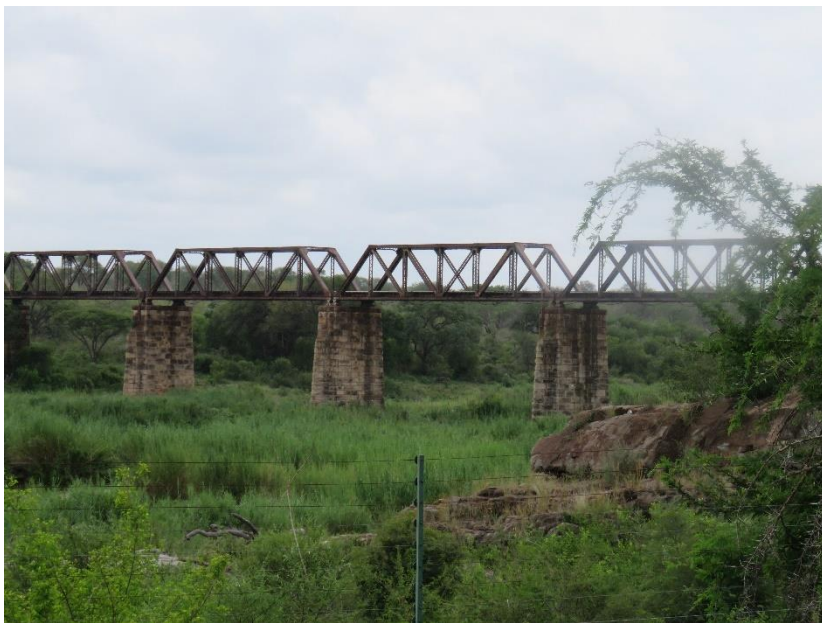
FIGURE 27: NOTE THE SANDSTONE PILLARS OF THE BRIDGE.

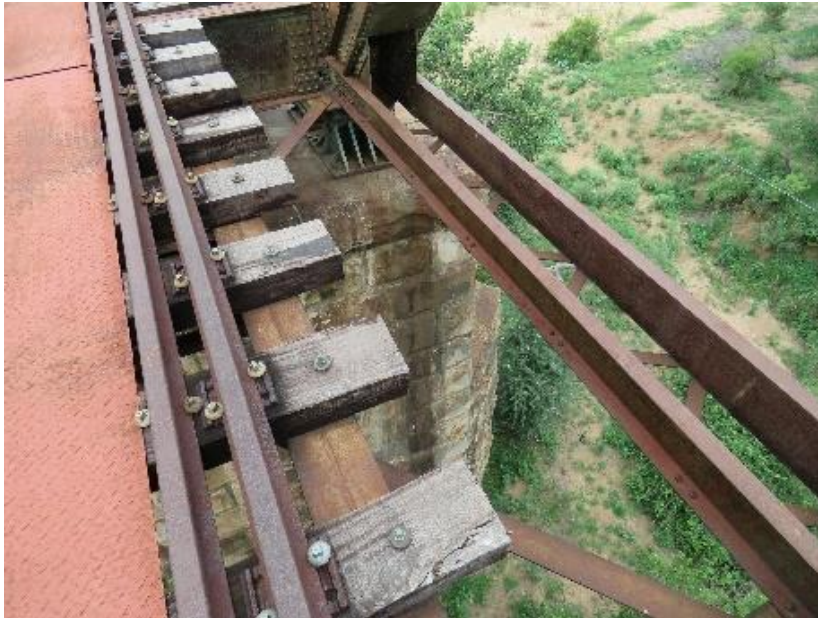
FIGURE 28: DETAILED VIEW OF ONE OF THE PILLARS OF THE BRIDGE.

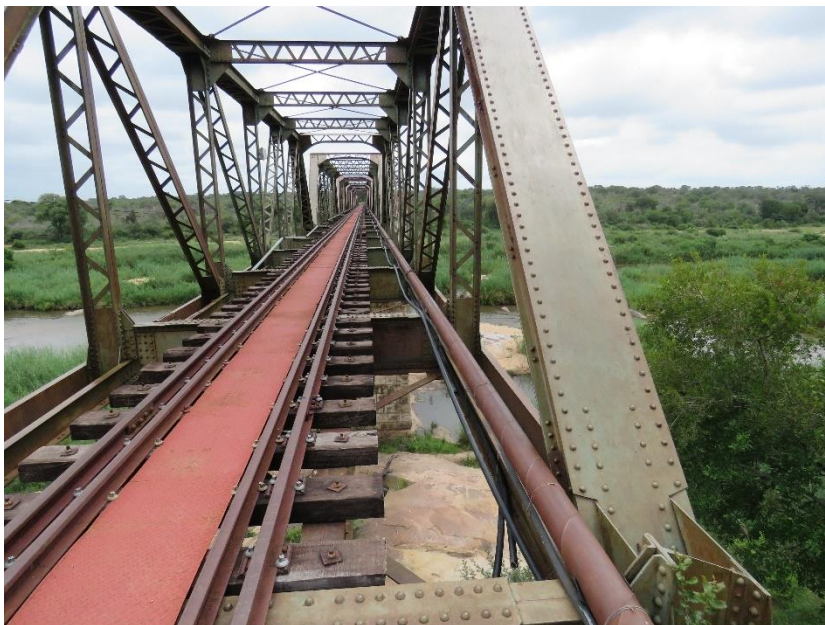
A few changes were made to the bridge over the years (Figure 29). These mainly include services, which are mostly reversible. One exception is a pump house on the

FIGURE 29: NOTE THE PIPE ON THE RIGHT-HAND SIDE AS WELL AS CABLES, AN INDICATION OF LATER, BUT REVERSIBLE ADDITIONS TO THE BRIDGE.

6. Later additions to the bridge, such as cables and pipes, which have lost its functionality, should be removed. The pump house may be reused and changed since it does not form part of the original construction. The plan indeed is to remove redundant services, e.g. the old telephone line, rusted water pipes etc., but the water supply to the airport from Skukuza must obviously remain.

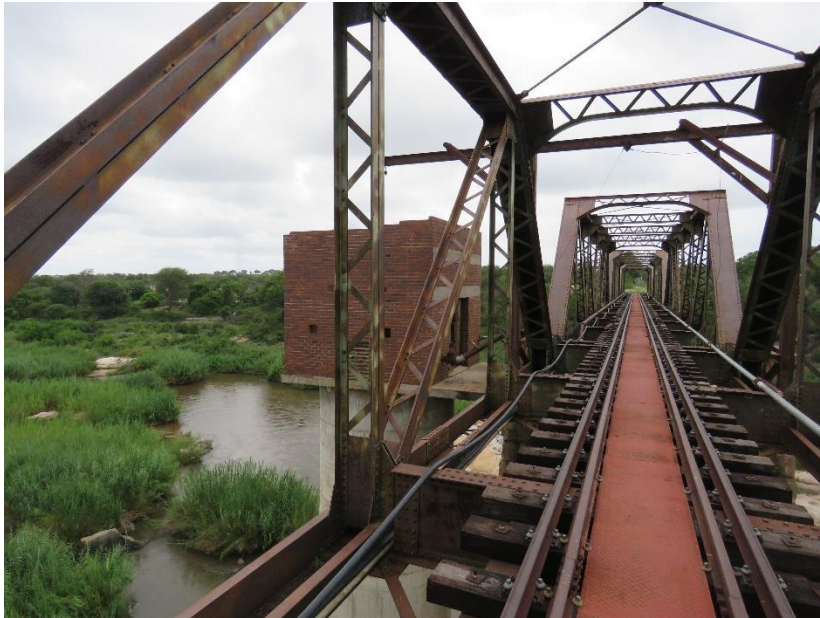
bridge (Figure 30). The pump house dates to the late 1950's/ early 1960's and therefore is younger than 60 years of age. However, it does not have any heritage significance.

FIGURE 30: THE PUMP HOUSE ON THE BRIDGE. THE PUMP HOUSE DATES TO THE LATE 1950'S/ EARLY 1960'S AND THEREFORE IS YOUNGER THAN 60 YEARS OF AGE. HOWEVER, IT DOES NOT HAVE ANY HERITAGE SIGNIFICANCE.

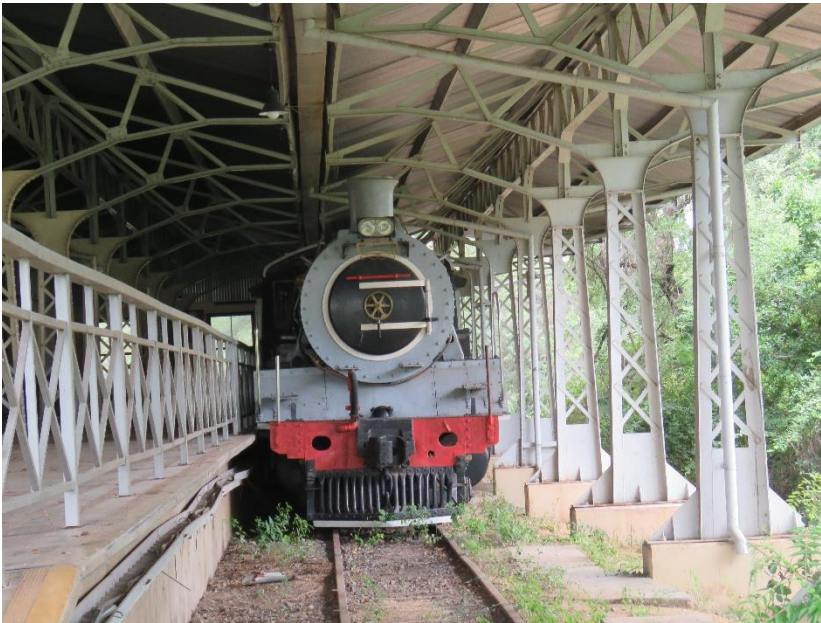
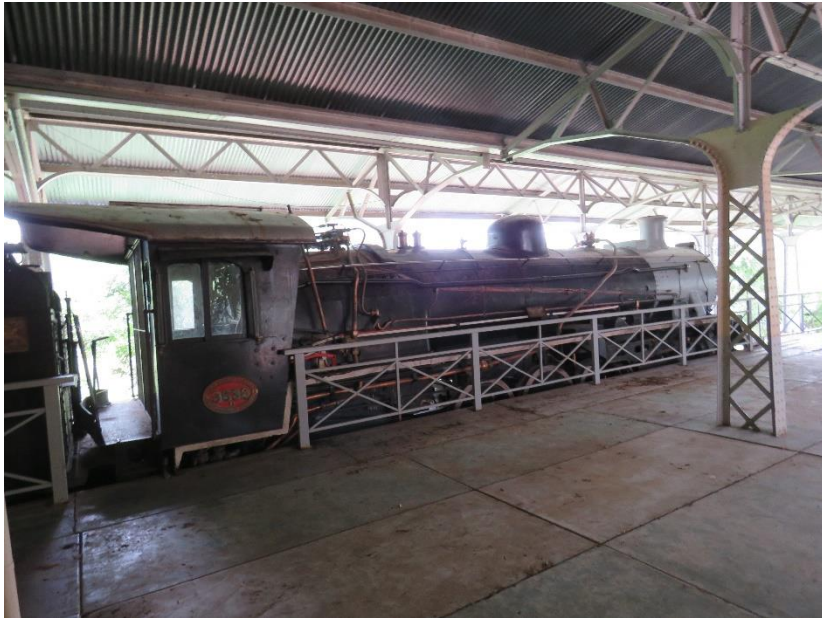
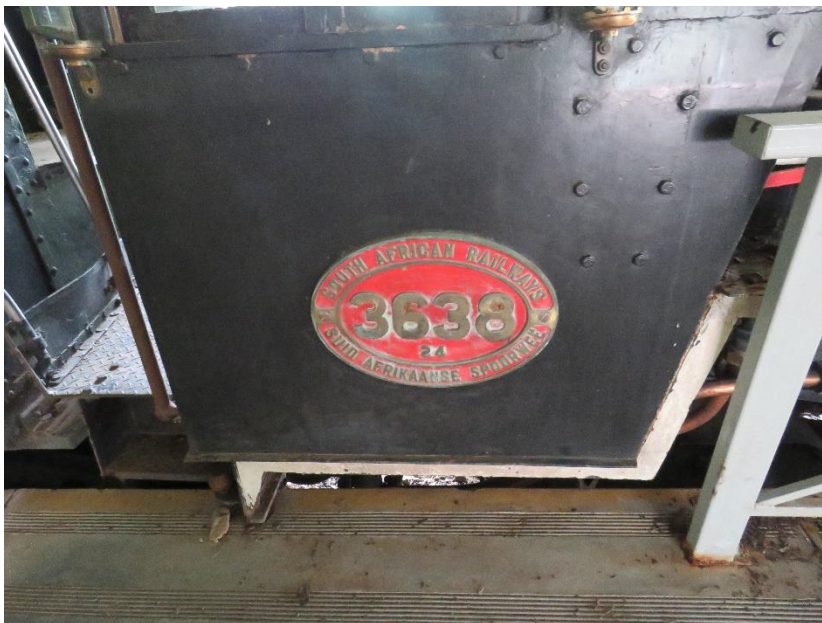
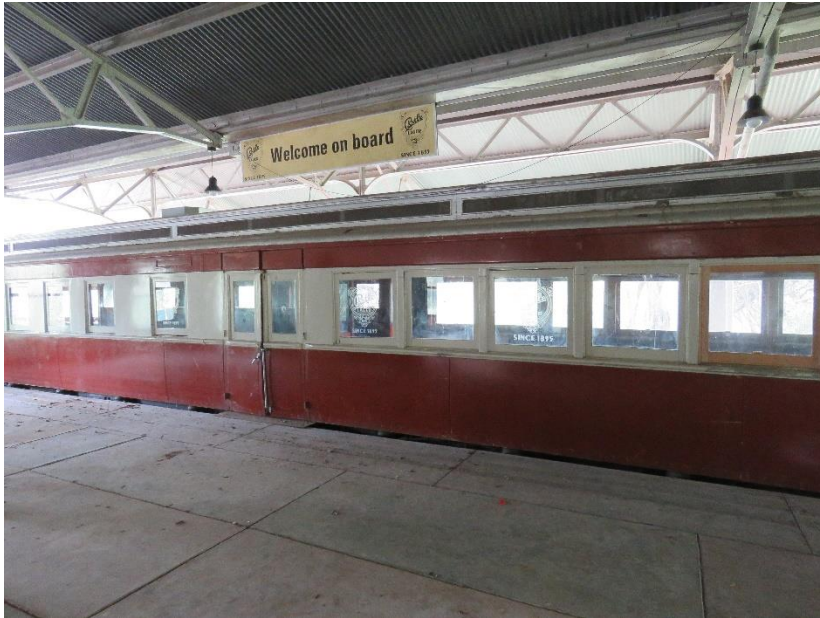
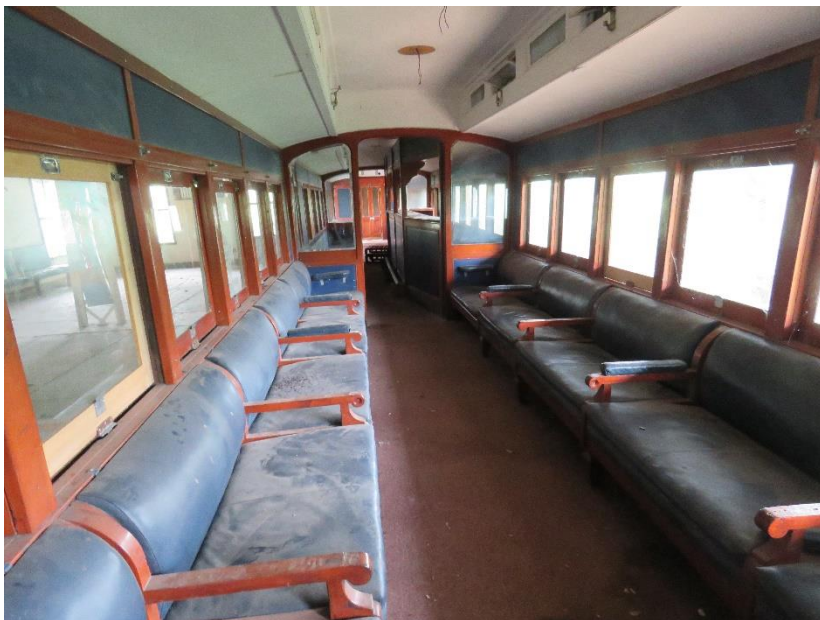
The locomotive is in a reasonable condition but needs some restoration work. This goes for both the interior as the exterior (Figure 31-35). It is a pity for instance that SANParks left it open for animals to enter and mess inside.

FIGURE 31: FRONT OF THE LOCOMOTIVE.

FIGURE 32: SIDE VIEW.

FIGURE 33: THE NUMBER OF THE LOCOMOTIVE – 3638.

FIGURE 34: RAILWAY CARRIAGE AT THE SELATI RESTAURANT.

FIGURE 35: INTERIOR OF THE CARRIAGE.

7. In principle nothing that would be a permanent intervention to both the interior and exterior of the locomotive and carriage currently at the station should be allowed. However, some changes have been made in the past and these needs to be taken into consideration. This means that historical features should be kept as far as possible. Changes should only be allowed when it is entirely unavoidable or when it impacts on features which had already been changed in the past and therefore had already been compromised to some extent.

In this particular case, it should be regarded as an integrated component of the history and heritage of the railway bridge and may therefore be utilized for the proposed development. However, strict controls need to be implemented to ensure that it is not damaged in the process. Detailed plans indicating the interventions should be approved by SAHRA and included in the CMP as discussed above.

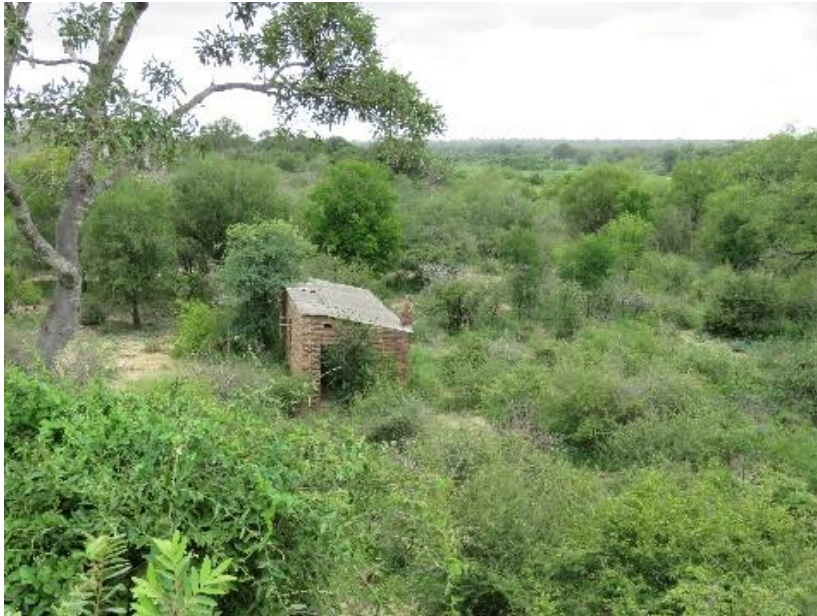
FIGURE 36: STORAGE LITY USED BY THE FOREMER SA DEFENCE FORCE. THIS LIES BETWEEN THE RAILWAY TRACK AND THE STEINAECKER'S HORSE SITE.

The site was also later used by the former SA Defence Force. A small storage room linked to this period is found here. It has no heritage significance but can perhaps be reused.

12. A final report of interventions, including a CMP, should be delivered to SAHRA on completion of the project.
13. The former SANDF building on the northern side of the bridge is less than 60 years and may therefore be demolished without any further heritage approval. Of course, it may also be utilised as part of the mentioned media facility.
14. It should be noted that the subterranean presence of archaeological and/or historical sites, features or artifacts is always a distinct possibility. Due to the density of vegetation it also is possible that some sites may only become known later on. Operating controls and monitoring should therefore be aimed at the possible unearthing of such features. Care should therefore be taken when development commences that if any of these are discovered, a qualified archaeologist be called in to investigate the occurrence.

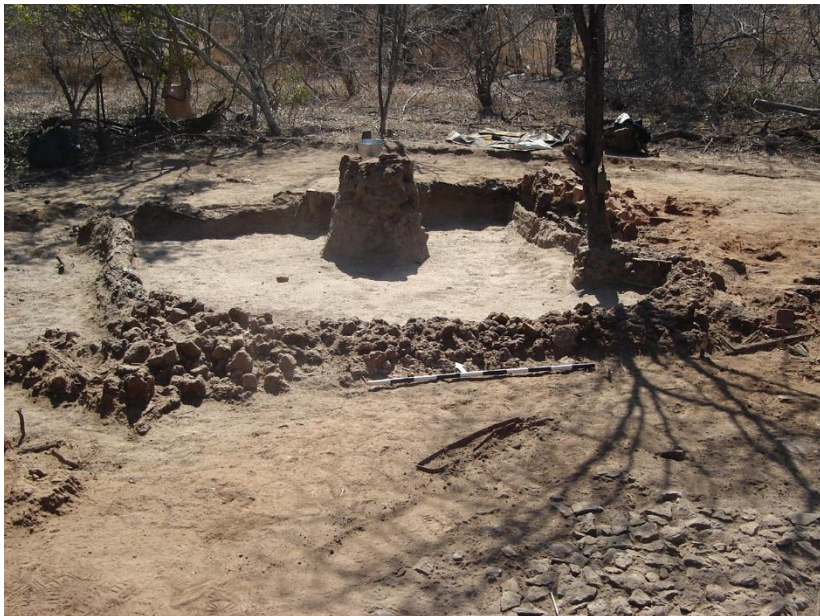
FIGURE 39: ONE OF THE EXCAVATED FEATURES AT THE SABI BRIDGE SITE OF STEINAECKER'S HORSE. THIS ONE PROBABLY HAVE LINKS TO BOTH THE WAR AND THE BUILDING OF THE RAILWAY.

8. Since the Sabi Bridge site of Steinaecker's Horse has unexcavated sections and is very close to the development, the developer needs to ensure that it is

not impacted. Currently it seems it will not be impacted directly, but negotiations with the concessionaire is still in process. Bearing this in mind, a buffer zone of at least 20 m should be implemented. In order to do this the exact perimeters of the site should be determined.

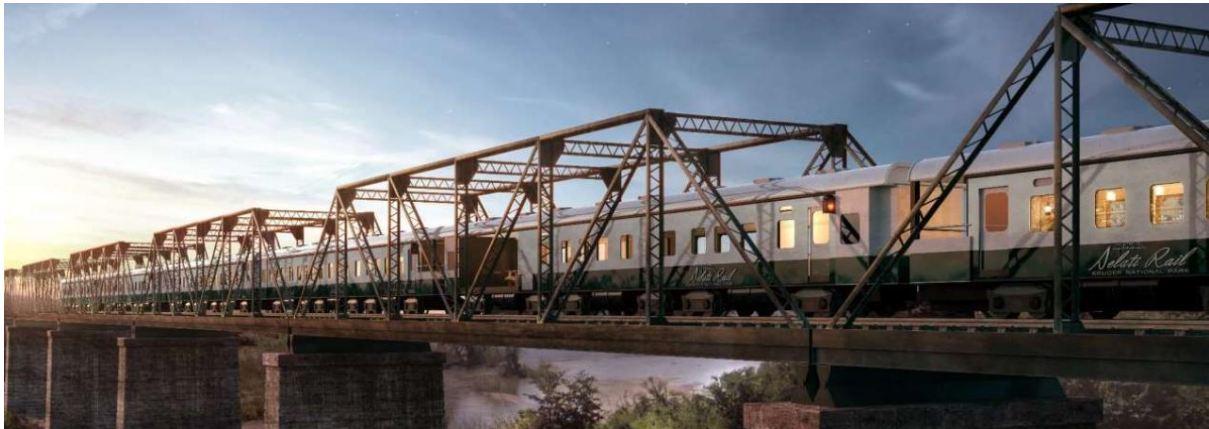
RAILWAY CARRIAGES ON BRIDGE

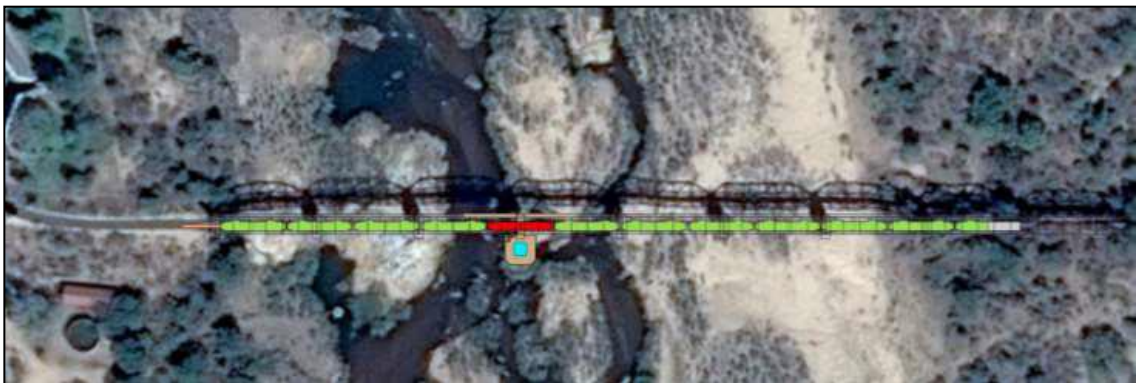
THE OPTIMAL MODEL AND CONFIGURATION PROPOSED BY KRUGER SELATI (PTY) LTD.

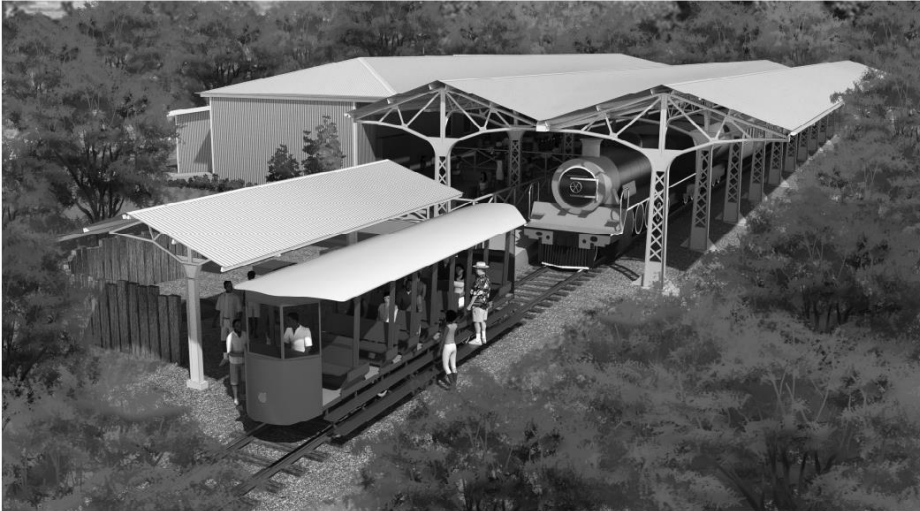
HISTORICAL TRAIN AT STATION WITH TRAM LOADING DOCK. NOTE HOWEVER, THAT A TRAM WILL NOT BE UTILISED (THIS WAS PART OF AN EARLIER DESIGN). THE PUMP TROLLEY CURRENTLY AT THE STATION (FIGURE 20) WILL BE USED.

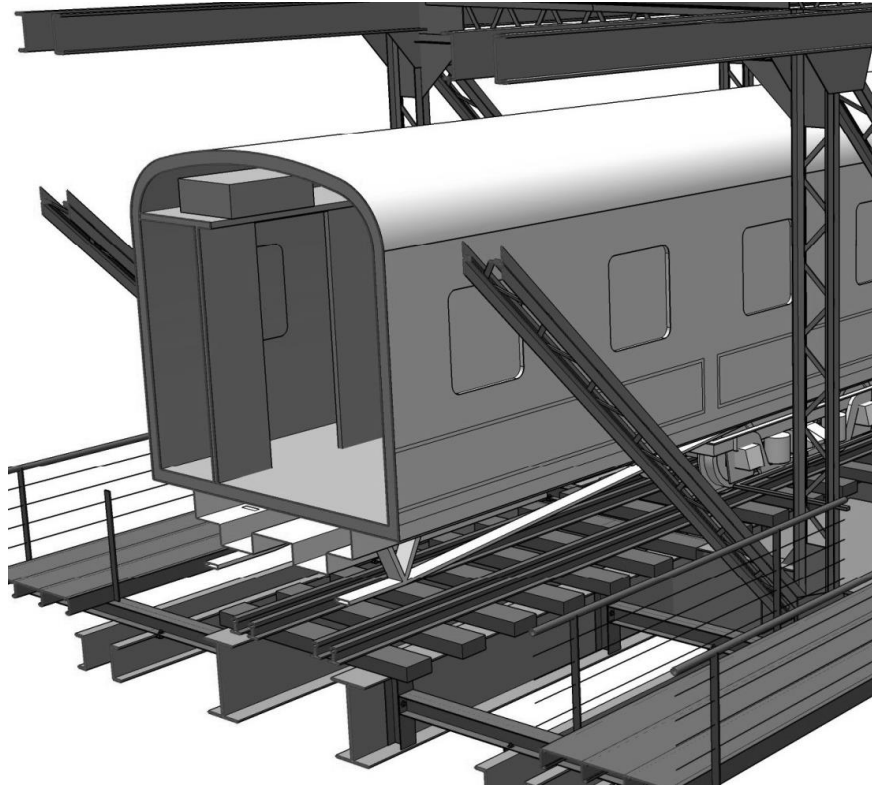
WALKWAY ALONG BRIDGE. THIS IS A 'CLIP-ON' AND FULLY REVERSABLE.

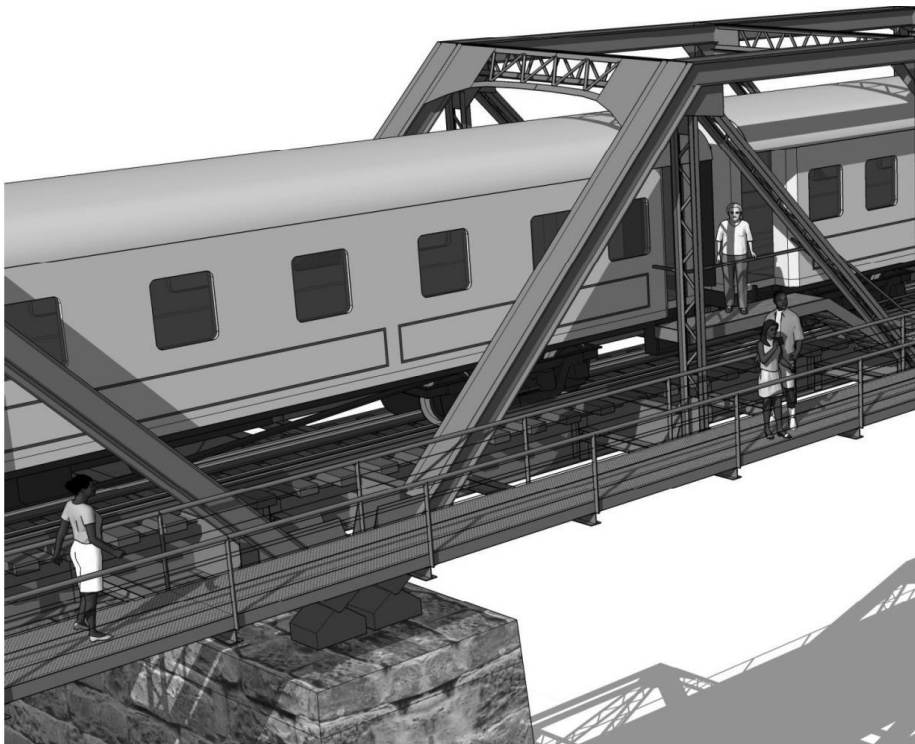
WALKWAY AND RAILWAY CARRIAGES ON THE BRIDGE
