**A REPORT ON A CULTURAL HERITAGE IMPACT ASSESSMENT FOR THE  
PROPOSED MINING OF THE GLOSAM MINE CLOSE TO POSTMASBURG,  
NORTHERN CAPE PROVINCE**

**REPORT NO.: AE02138V**

***5 October 2021***

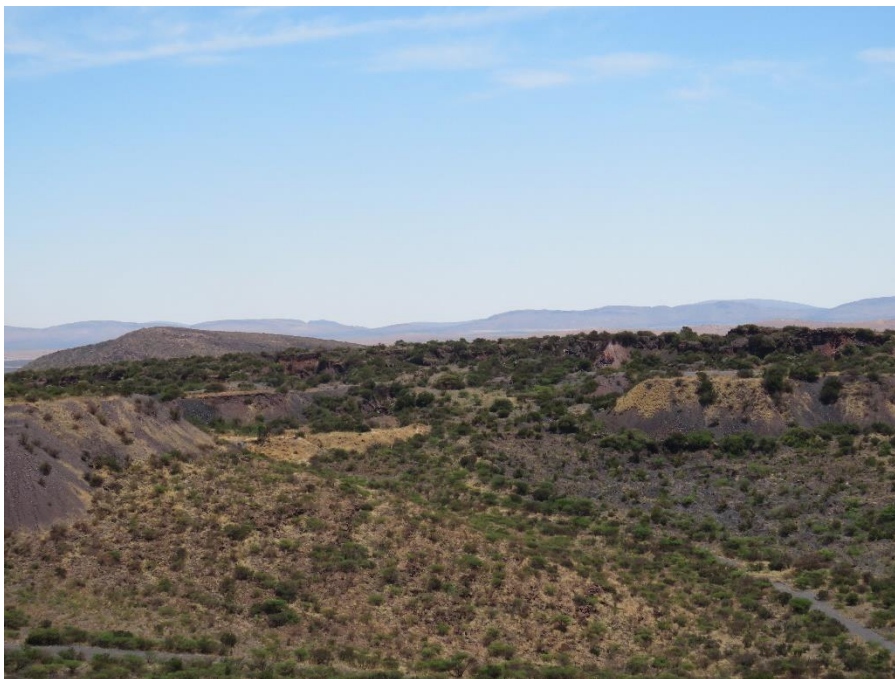
**FIGURE 15: GENERAL VIEW OF THE SURVEYED AREA SHOWING OLD MINING.**

The topography of the surveyed area shows a hill in the north and west, which have mostly been mined for manganese in recent historical times. Accordingly, it is a very disturbed area. The southern and eastern portions of the farm are flatter (Figure 14).

Apart from the mentioned mining activities (Figure 15-17), other infrastructure is also found on site. This includes residential and official building which will be discussed below. Many dirt roads are found on the property and a railway track cuts through it, running from the north to the south-west.

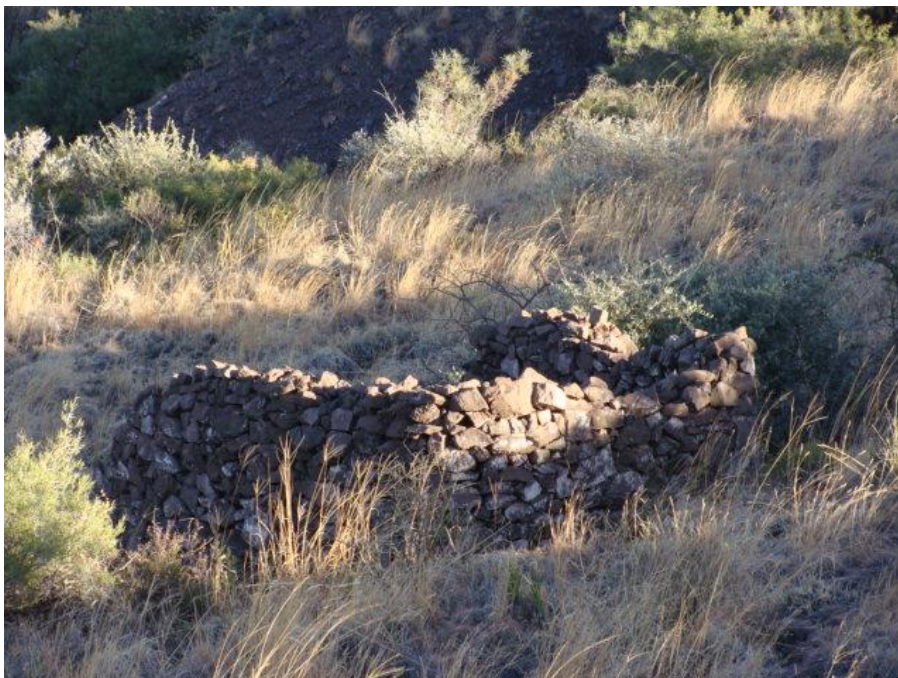
Site 1 - GPS: 28°03'54.2"S; 23°02'43.7"E (Figure 24-25)

Here are two such Miners boxes, a few meters from each other. The first is approximately 3 x 3 m in size with stone walling of 1,5 m high. The second is larger, having measurements of 7 x 4 m and also is approximately 1,5 m high. This one may even have more than one room, but the fallen stones make it difficult to determine this precisely.

**FIGURE 24: REMAINS OF A MINERS BOX AT SITE NO. 1.**

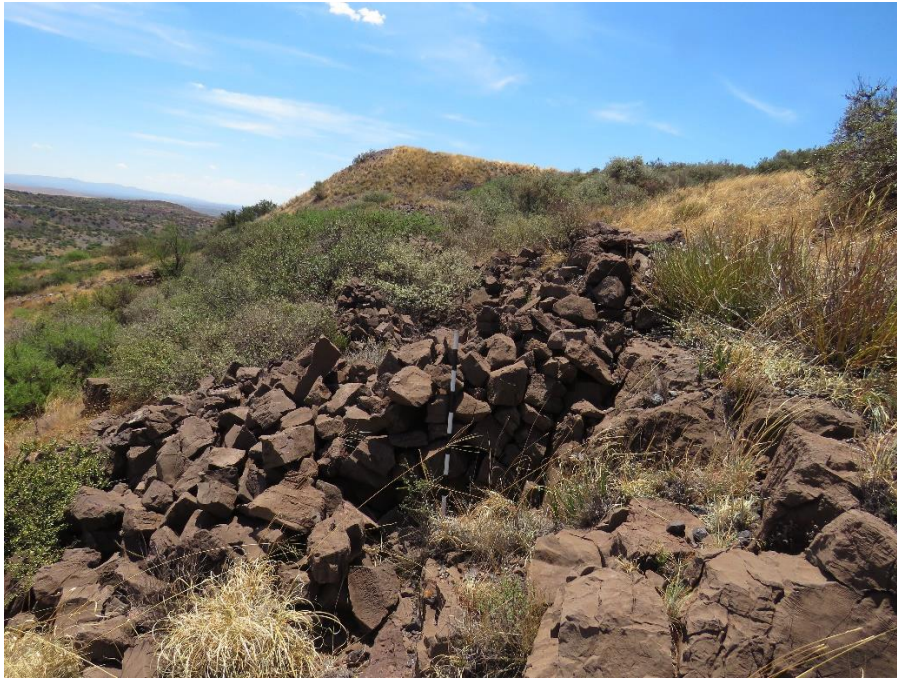
**FIGURE 25: REMAINS OF THE SECOND MINERS BOX AT SITE NO. 1.**

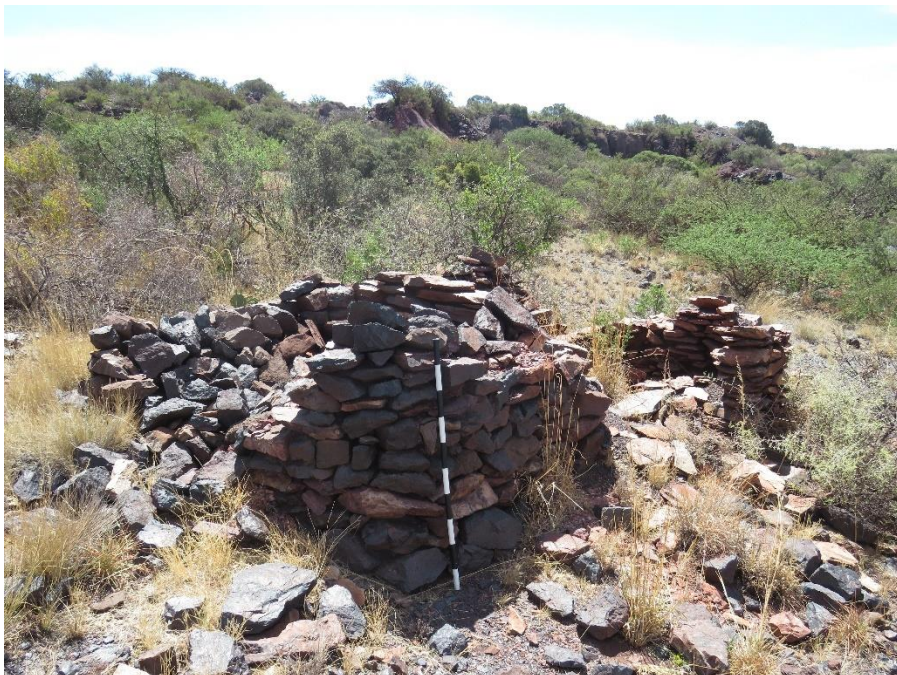
Site 13 - GPS: 28°04'02.6"S; 23°02'17.1"E (Figure 26)

This one has measurements of 4 x 3 m and the stone walls are approximately 1 m high. It also has at least two rooms, indicated by a dividing wall.

The site lies 130 m from the area to be mined.

**FIGURE 26: REMAINS OF THE MINERS BOX AT SITE NO. 13.**

- Sites number 13, 17, 25 and 26 **should be documented** so that the information remains available should it be damaged. This documentation includes doing test excavations and drawing a site map of each.

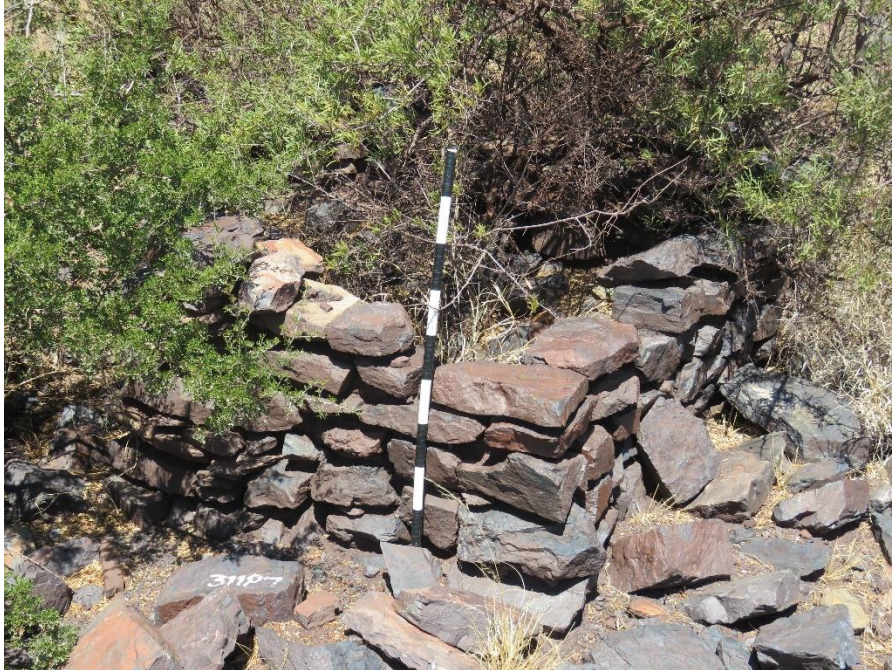
Site 17 - GPS: 28°04'03.8"S; 23°01'51.4"E (Figure 27)

This one has measurements of 3 x 2 m and the stone walls are approximately 3 m high. In front (at the entrance?) it has a stone with a number (311P7) painted thereon.

**FIGURE 27: REMAINS OF THE MINERS BOX AT SITE NO. 17.**

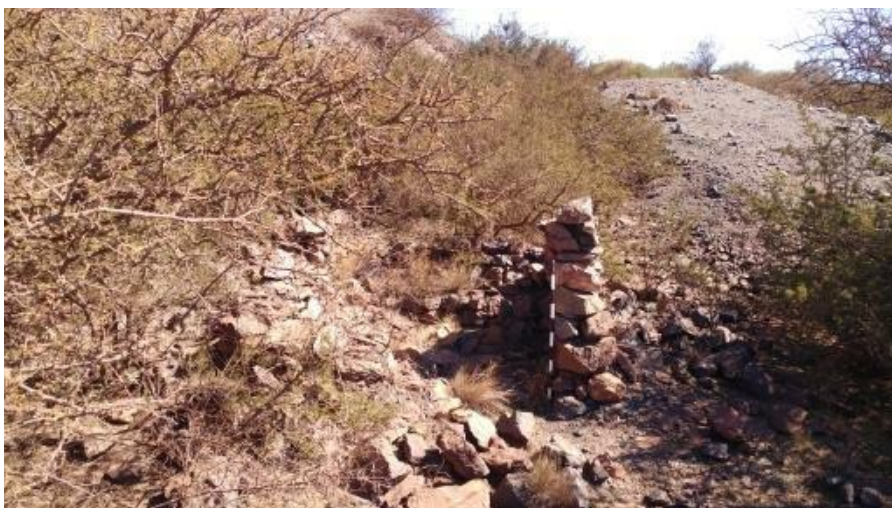
**FIGURE 28: REMAINS OF THE MINERS BOX AT SITE NO. 25.**

Site 25 - GPS: 28°03'32.09"S; 23°02'17.38"E (Figure 28)

This one has measurements of about 3 m x 2 m and is about 1,4 m high. Again it is built from stone. No entrance could be detected.

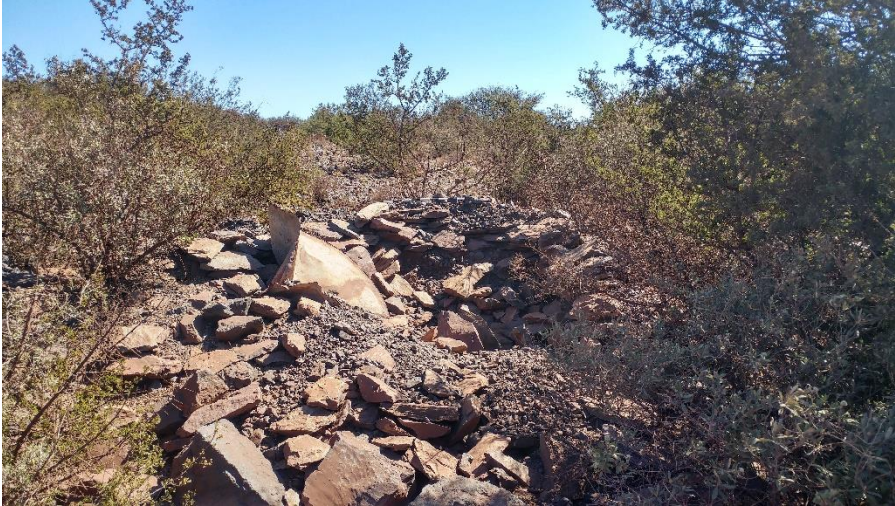
**FIGURE 29: REMAINS OF THE MINERS BOX AT SITE NO. 17.**

Site 26 - GPS: 28°04'03.8"S; 23°01'51.4"E (Figure 29-30)

This one has measurements of 3 x 2 m and is about 25 m from site number 25. It is about 1,4 m high and built from stone. It has a round metallic sheet that could have been part of the structure in the past. There also is a painted number on one of the stones (A575).

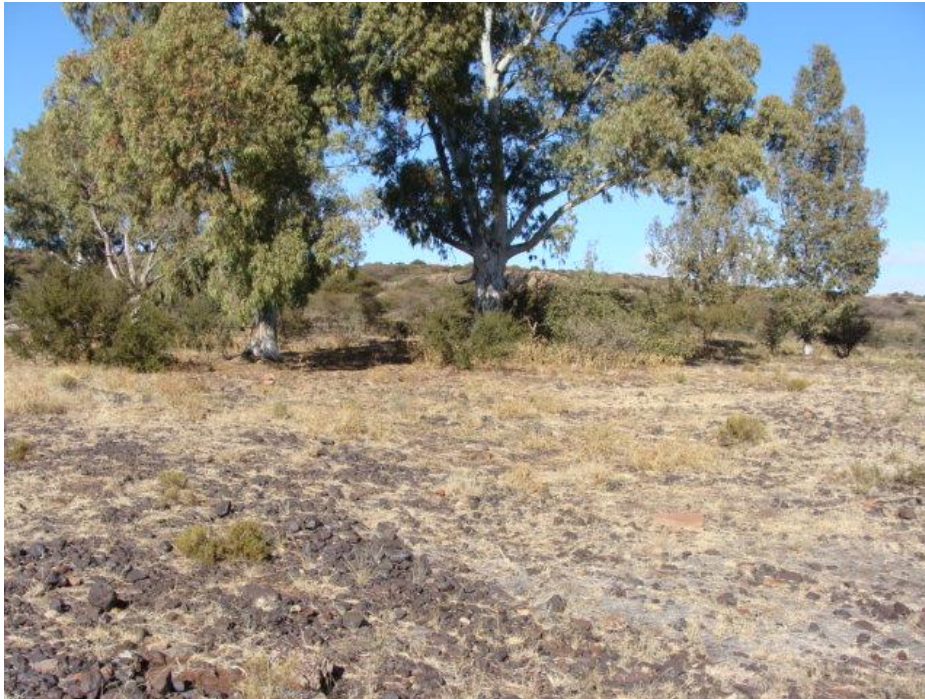
**FIGURE 31: AREA WHERE MINE HOSTELS USED TO STAND. IT ALSO SEEMS AS IF IT WAS USED AS A STOCK PILE AREA.**

This is the remains of the old hostel area on the mine (Figure 31). It dates to between the 1950's and 1960's and therefore is likely older than 60 years. It has been demolished and only a few bricks and other rubble remain as indication of its existence. Next to this the old recreation hall which currently is used as a store room (Figure 32). It also is not older than 60 years.

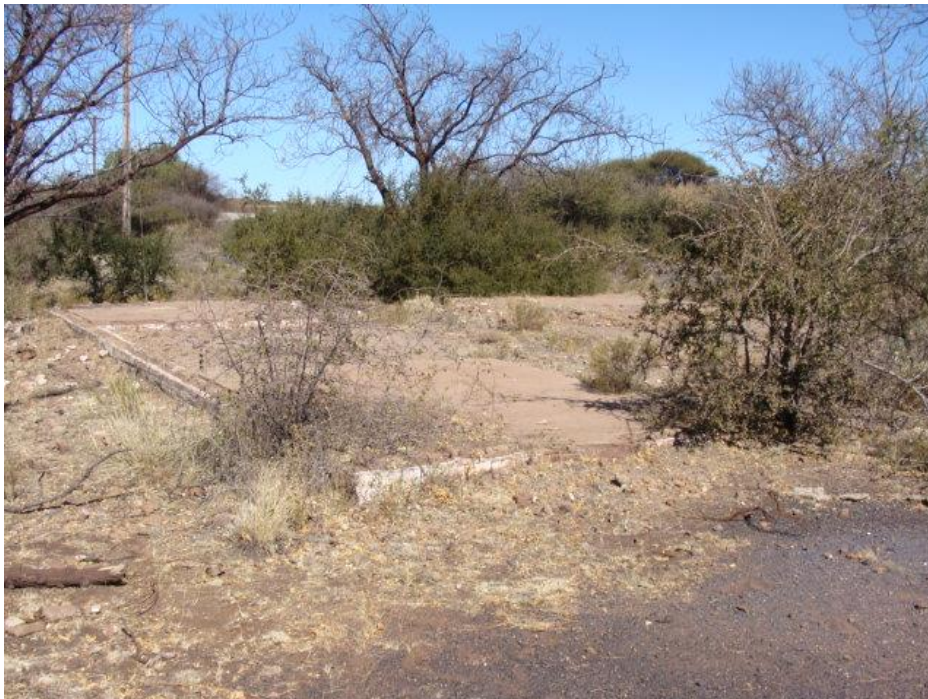
This is the foundation of a house or office building (Figure 43). Nothing of the walls or roof remained, but it probably is older than 60 years. The site lies outside of the proposed mining impact area.

**Figure 43: Foundation of a building more than 60 years old.**

- The foundation (site 5) and metal framework of an industrial building (site 21) has no cultural heritage value and may therefore be demolished. It does however lie outside of the area of impact. Since it is older than 60 years, a permit would be required from the SAHRA. The mine however indicated that it will be left as it is.

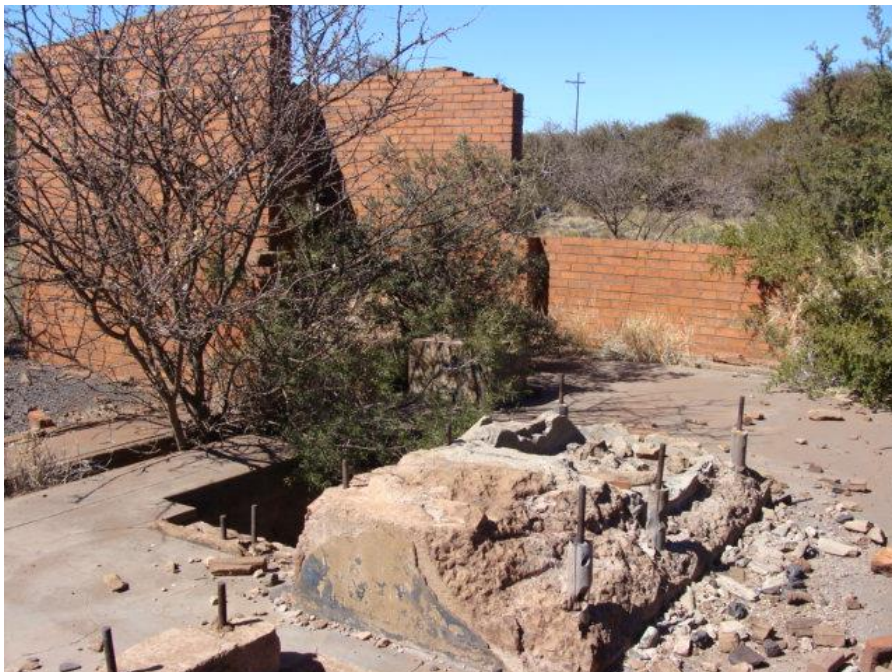
This is the remains of two associated industrial buildings within the mining area. The first has dimensions of 6 x 4 m and have concrete 9 pillars, approximately 2 m high. The second is a small brick building with walls of about 3 x 3 m and 2 m high. It was built in 1964, as indicated in an inscription in the cement (Figure 44-46). The site lies only 40 m from the proposed mining impact area.

**FIGURE 44: REMAINS OF AN INDUSTRIAL BUILDING IN THE MINING AREA.**

- The remains of industrial building (site 6) and the base of a water reservoir (site 9) is reasonably close to the mining development. However both have no cultural heritage value. This report is seen as ample mitigation. The structures are younger than 60 years and in a very poor condition. It may be demolished without a permit from SAHRA. The mine however indicated that it will be left as it is.

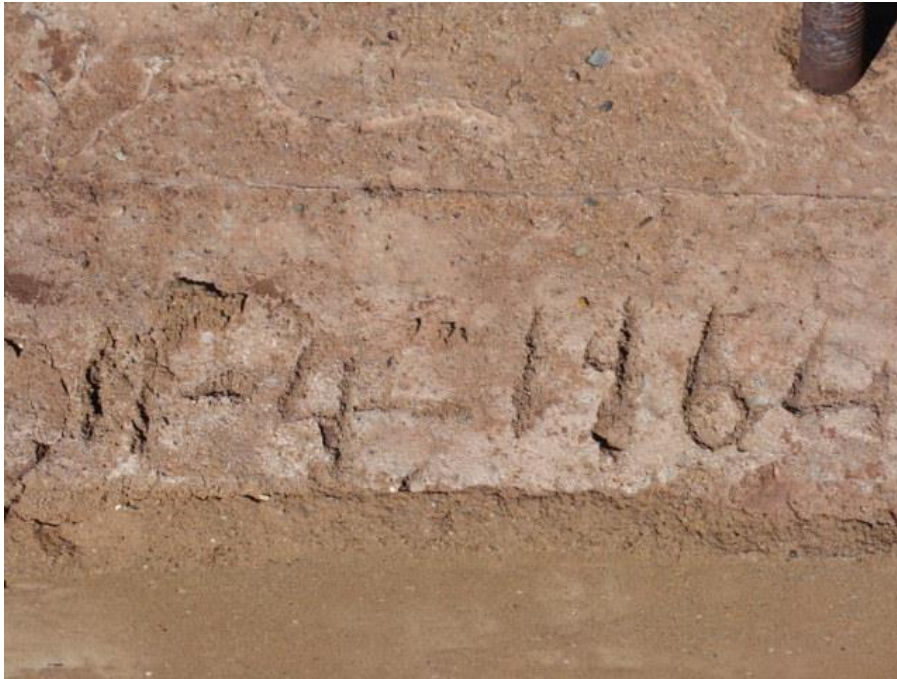
**FIGURE 45: (11-4-1964) INDICATED ON THE BUILDING.**

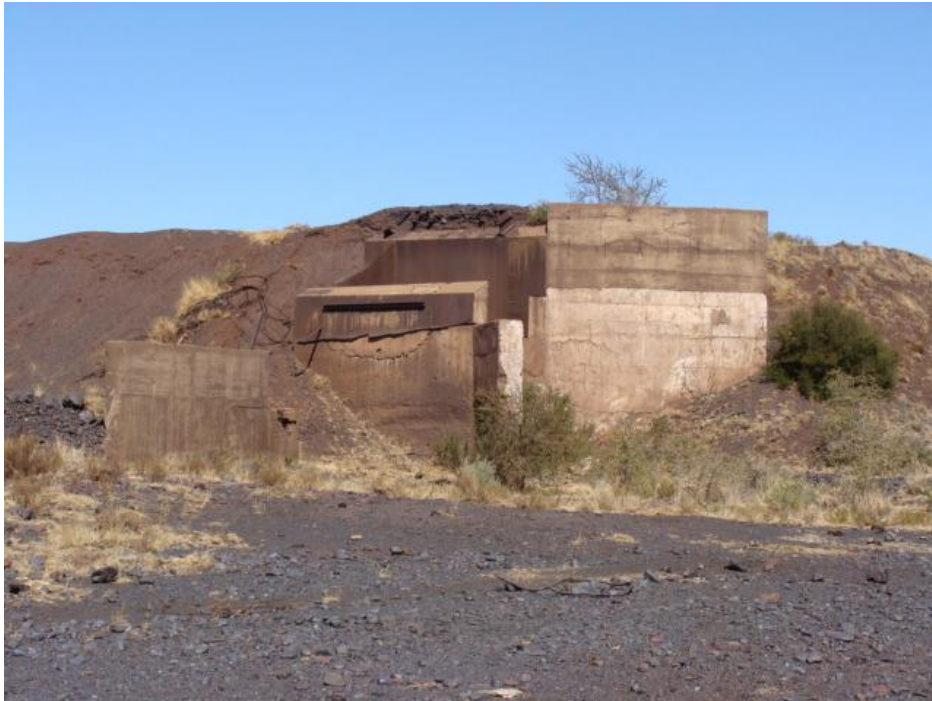
**FIGURE 47: REMAINS OF AN ORE LOADING BAY, SITE NO. 7.**

The field rating for these sites are Local Grade IIIC. The description in the phase 1 heritage report is seen as sufficient recording (low significance) and it may be granted destruction. Since these sites are all younger than 60 years and in a very poor condition, it may be demolished without a permit from SAHRA.

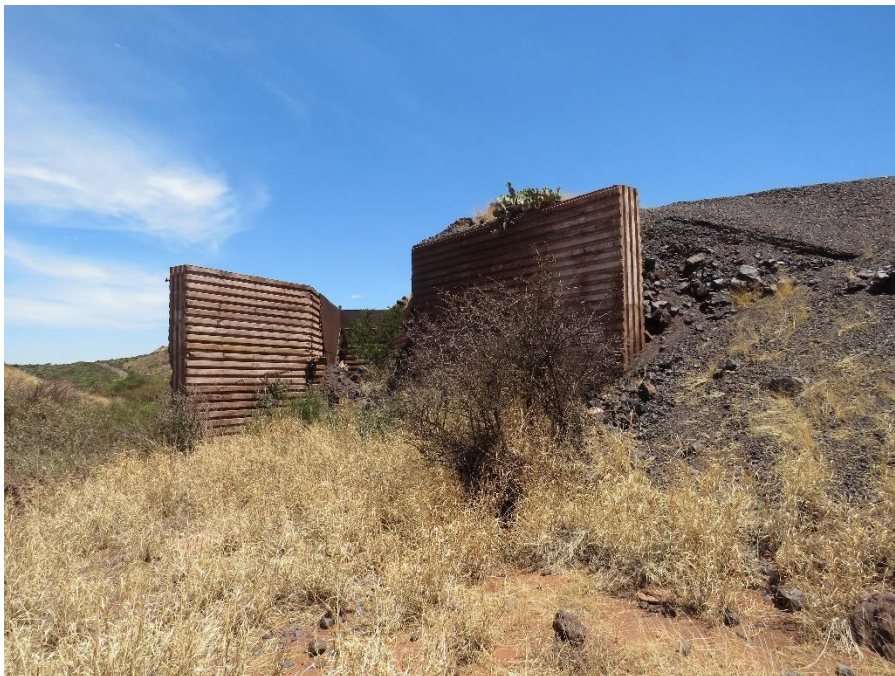
**FIGURE 48: REMAINS OF AN ORE LOADING BAY, SITE NO. 14.**

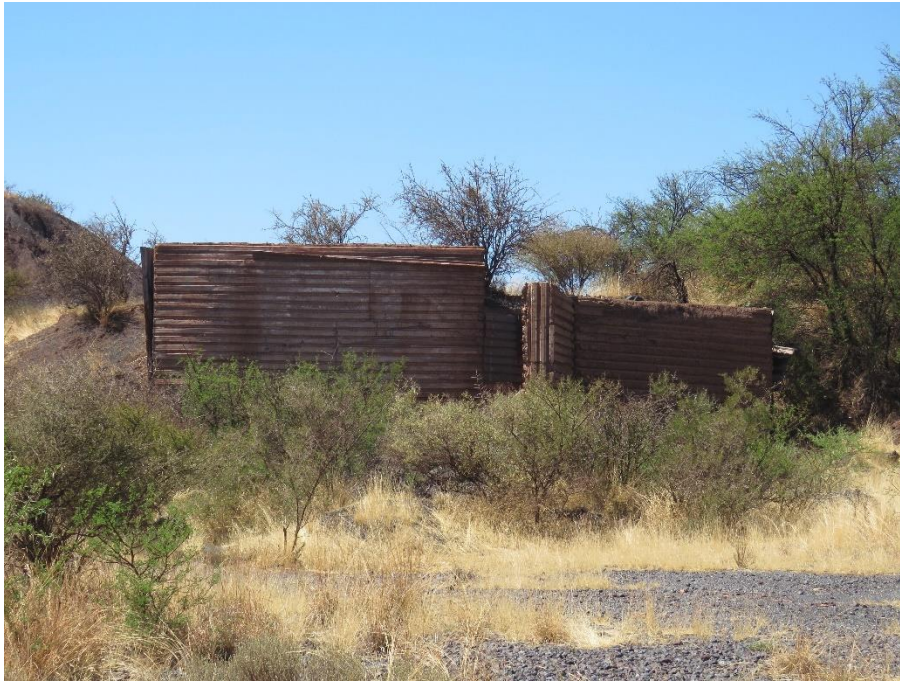
**FIGURE 49: REMAINS OF AN ORE LOADING BAY, SITE NO. 19.**

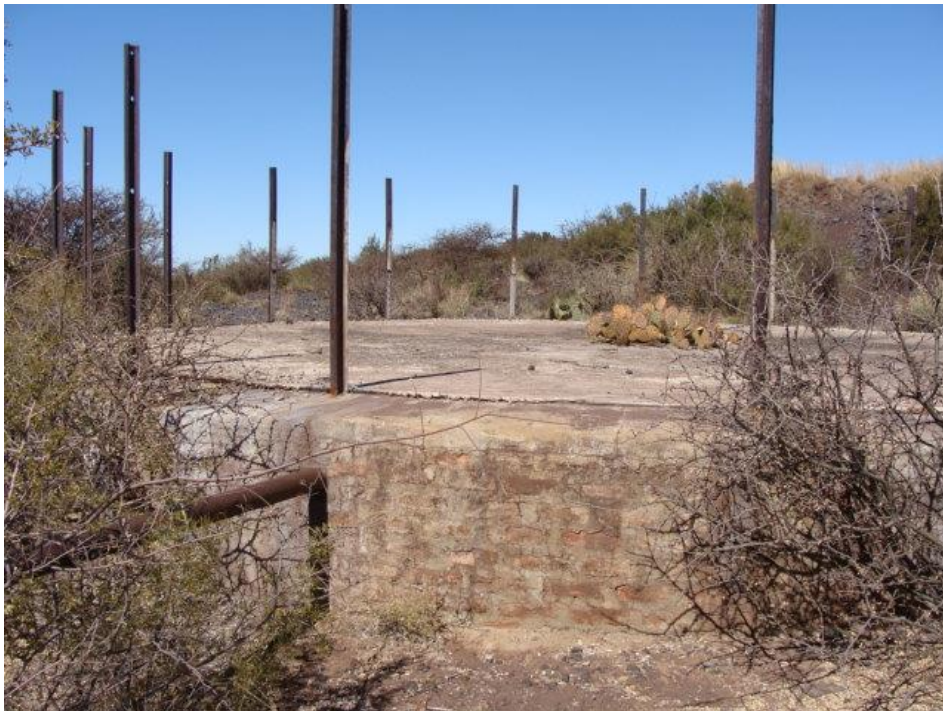
This is the base for a water reservoir which is younger than 60 years as the date 1981 is inscribed in the concrete (Figure 52-53). It has a diameter of 10 m. A second, complete reservoir (Figure 54) was identified closer to the village. The site lies 70 m from the proposed mining impact area.

**FIGURE 52: REMAINS OF A WATER RESERVOIR.**

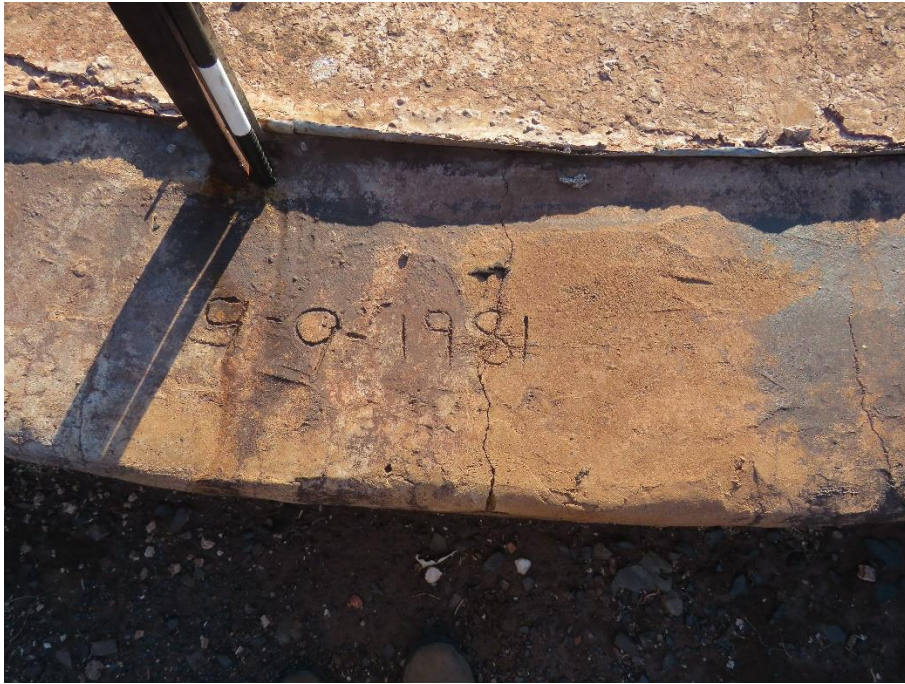
**FIGURE 53: DATE INSCRIBED IN THE CONCRETE.**

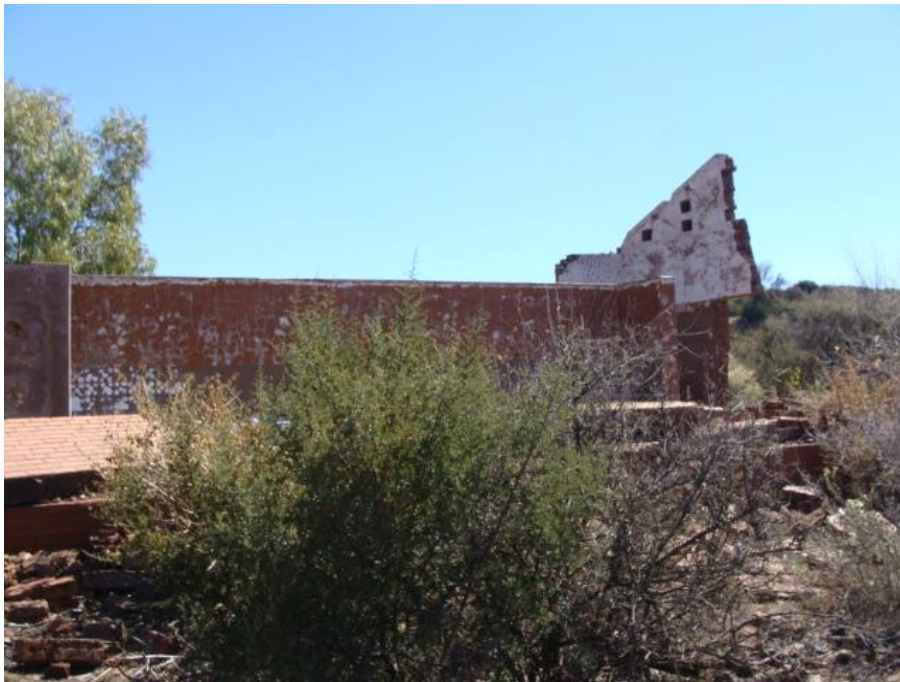
This is the remains of different buildings (at least 5) made from bricks and concrete. These probably had the function of offices or an industrial use. One could be identified as a set of toilets which was probably used by workers (Figure 55-56). One of the porcelain toilets has the manufacturing date 16/1/1968 with a maker's mark on it. The function of other structures (Figure 57-60) could not be identified. From the bad state of the site it seems it was deliberately demolished. The site lies 140 m from the proposed mining impact area.

**FIGURE 55: REMAINS OF THE TOILET BUILDING.**

- The office complex remains (site 10), various remains of brick buildings (site 11) and the farm yard (site 18) has no cultural heritage value and lies outside of the area of impact. This report is seen as ample mitigation. The structures are younger than 60 years and in a very poor condition. It may be demolished without a permit from SAHRA. The mine however indicated that it will be left as it is.

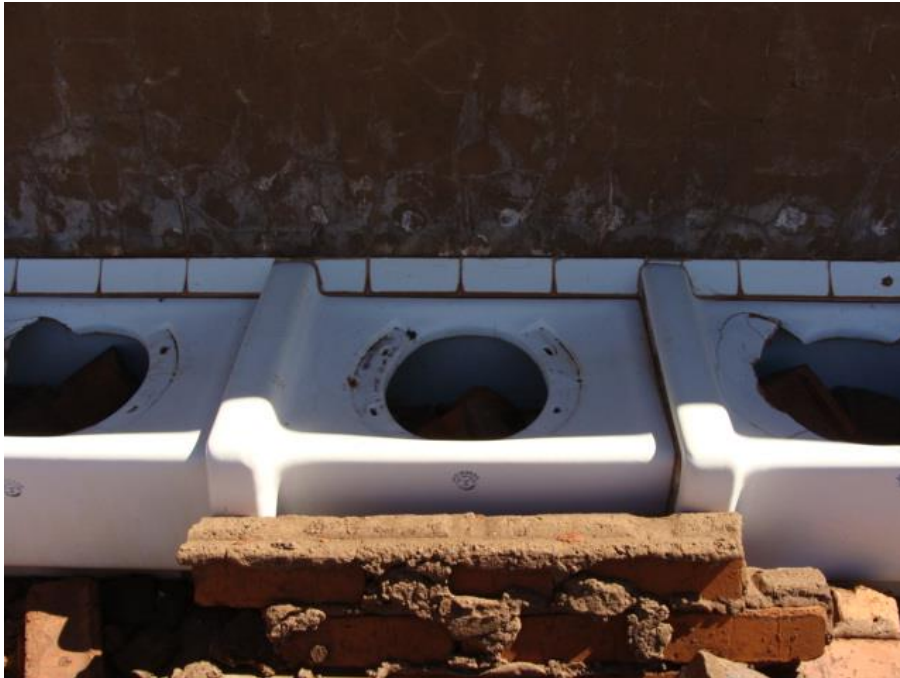
**FIGURE 56: PART OF THE ROW OF TOILETS INSIDE OF THE BUILDING.**

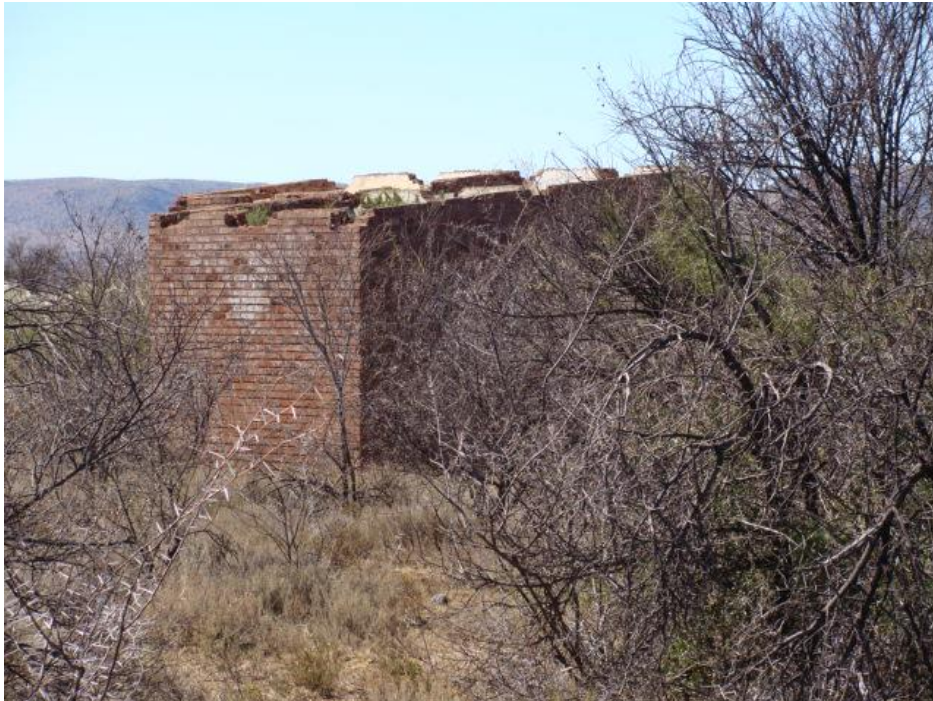
**FIGURE 61: REMAINS OF ONE OF THE BUILDINGS AT SITE NUMBER 11.**

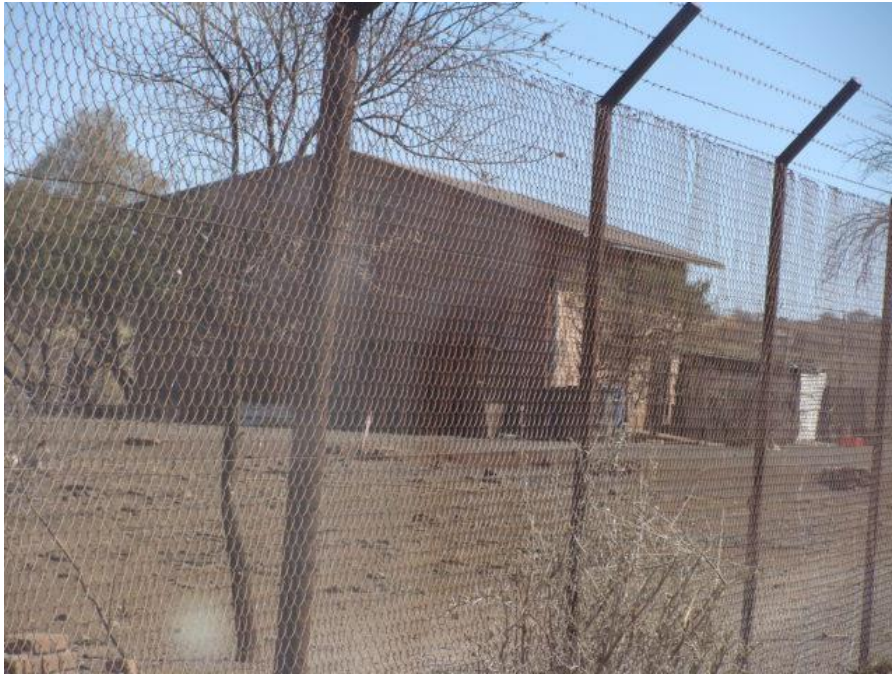
**FIGURE 63: ONE OF THE BUILDINGS INSIDE OF A FENCED IN CATTLE CAMP.**

It is a camp, probably for cattle, with a few old and one new building inside (Figure 63). It seems to be used as stores or livestock enclosures. Some small dams are also found in the vicinity as well as a cattle dip and feeding area somewhat to the east.

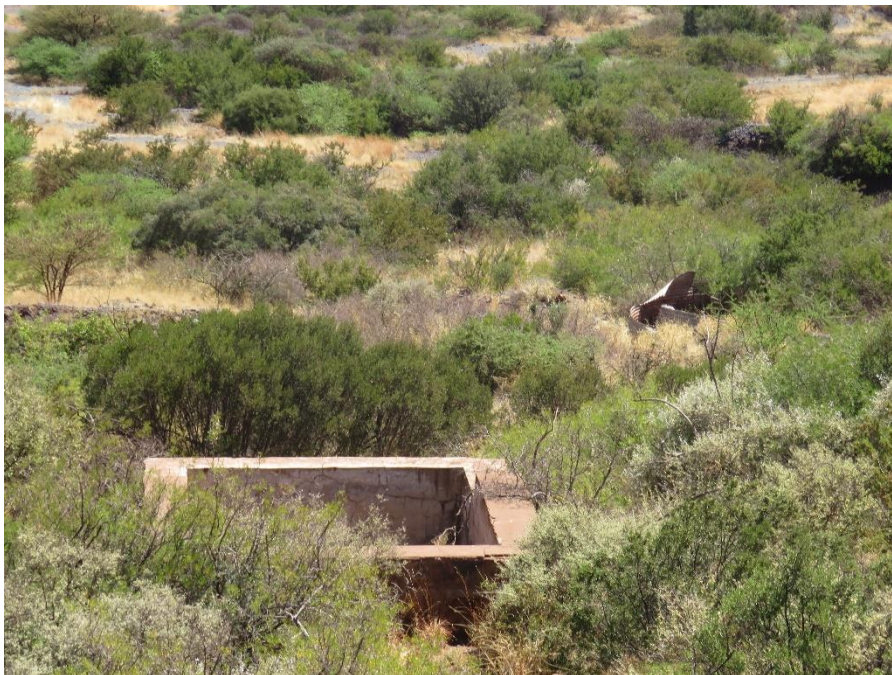
**FIGURE 66: BUILDING ASSOCIATED WITH LOADING PLATFORM.**

This is a building, likely associated to the loading platform (site 8). It is built with stone and concrete, with sizes of approximately 3 x 4 m as well as some loosely packed stone walling (Figure 66).

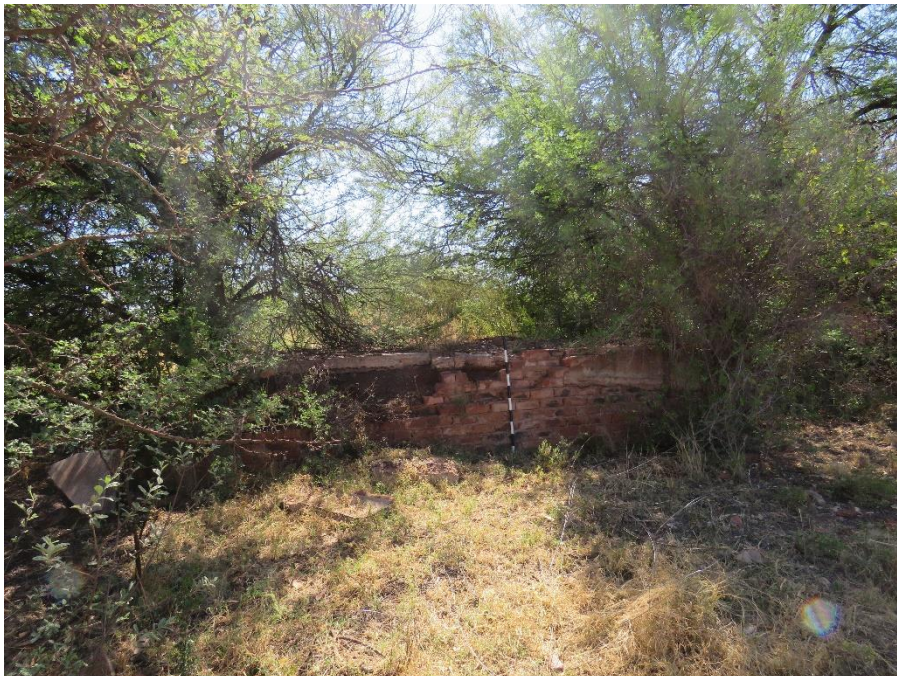
**FIGURE 67: HOUSE REMAINS AT FARM YARD.**

This is an abandoned farm yard consisting of the remains of a house (without walling), other concrete floors, a dam, fences etc. The house floor has a size of 18 x 11 m (Figure 67). It likely dates to the 1960's.

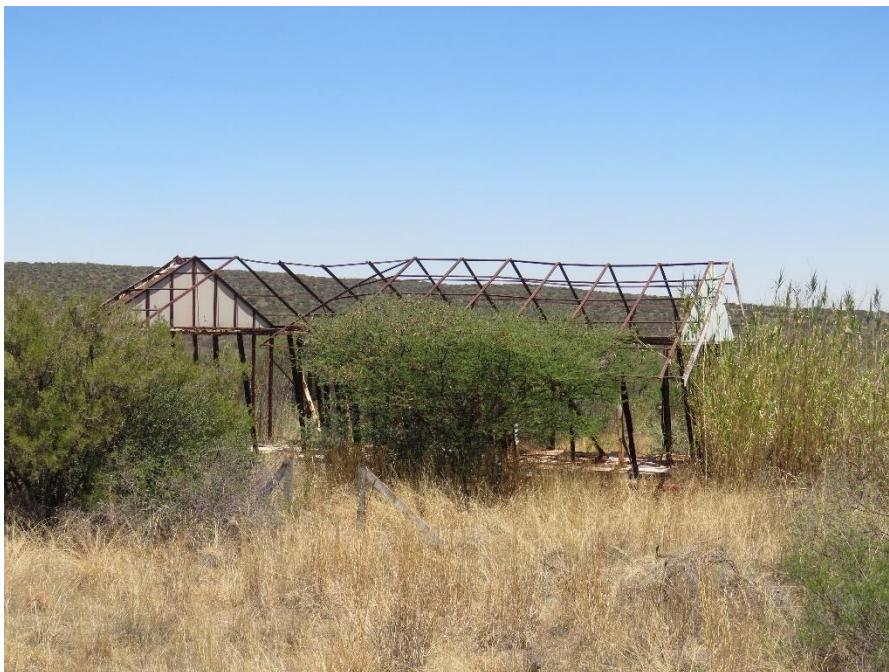
**FIGURE 68: STEEL FRAME OF A RAILWAY BUILDING.**

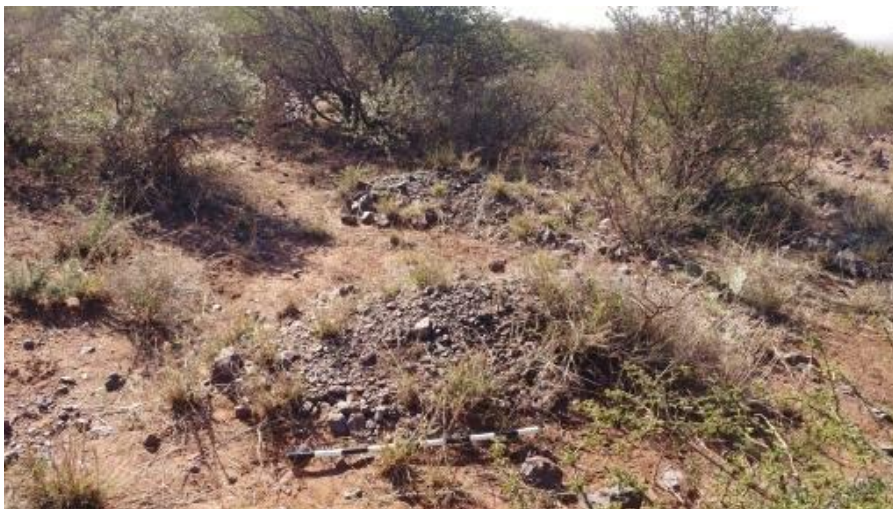
**FIGURE 69: SOME OF THE GRAVES AT SITE NO. 22.**

This is a large grave yard consisting of at least 304 graves. All of these are unmarked and packed with stones (Figure 69). Two headstones were mentioned by a mine employee, but only one of these could be located (Figure 70). It however is not possible to determine from which grave it comes. It has no dates indicated and the surname is Zakapea.

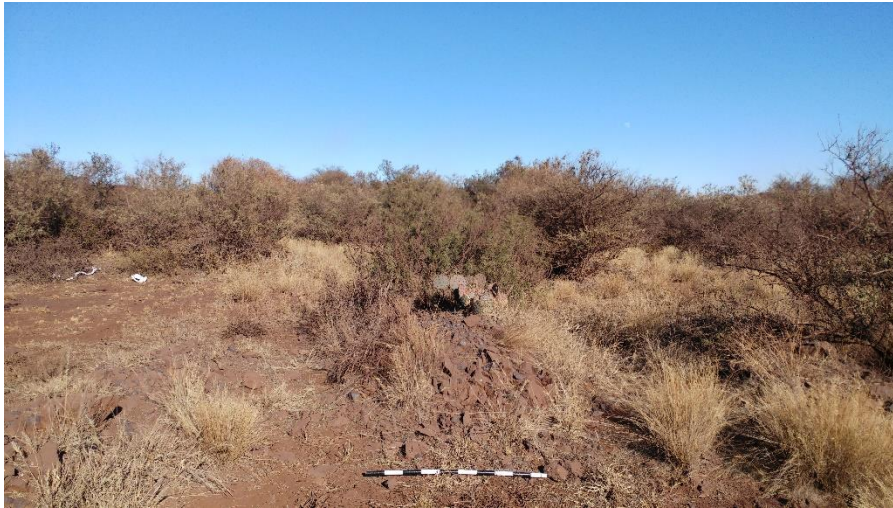
**FIGURE 71: ONE OF THE GRAVES AT SITE NO. 23.**

The graves are unmarked with stone dressing, and one had a cactus growing out on top (Figure 71). All the graves are thus unknown and needs to be handled similar to heritage graves.

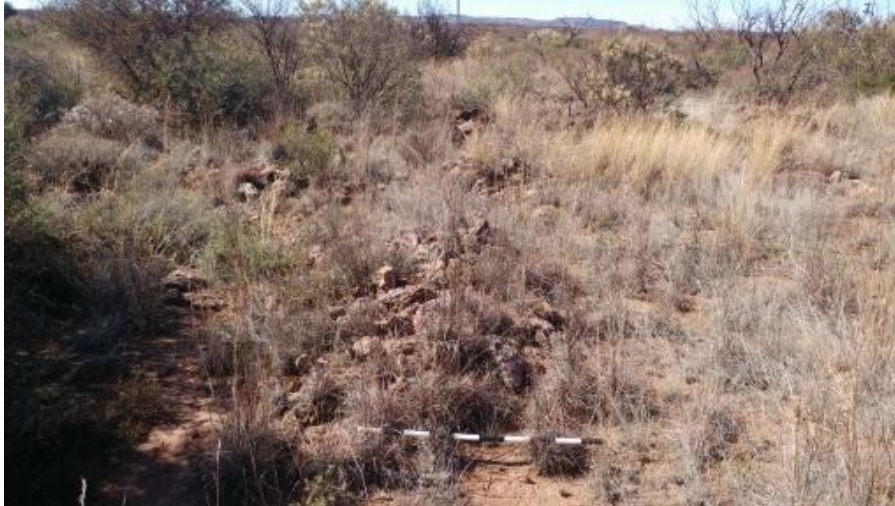
**FIGURE 72: SOME OF THE GRAVES AT SITE NO. 24.**

The site lies 450 m from the proposed mining impact area.

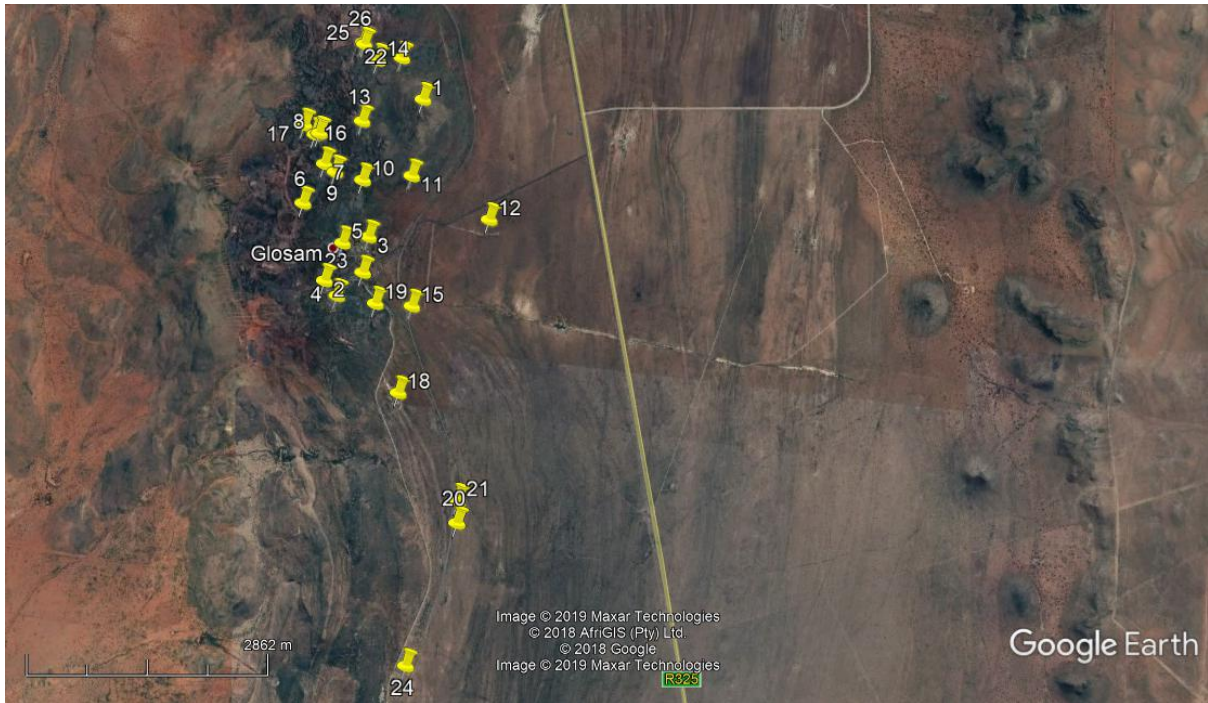
**FIGURE 74: GOOGLE EARTH IMAGE INDICATING THE SITES IDENTIFIED.**

The HIA of the indicated areas was completed successfully. As indicated twenty-six sites of cultural heritage significance were identified (Figure 74-78).

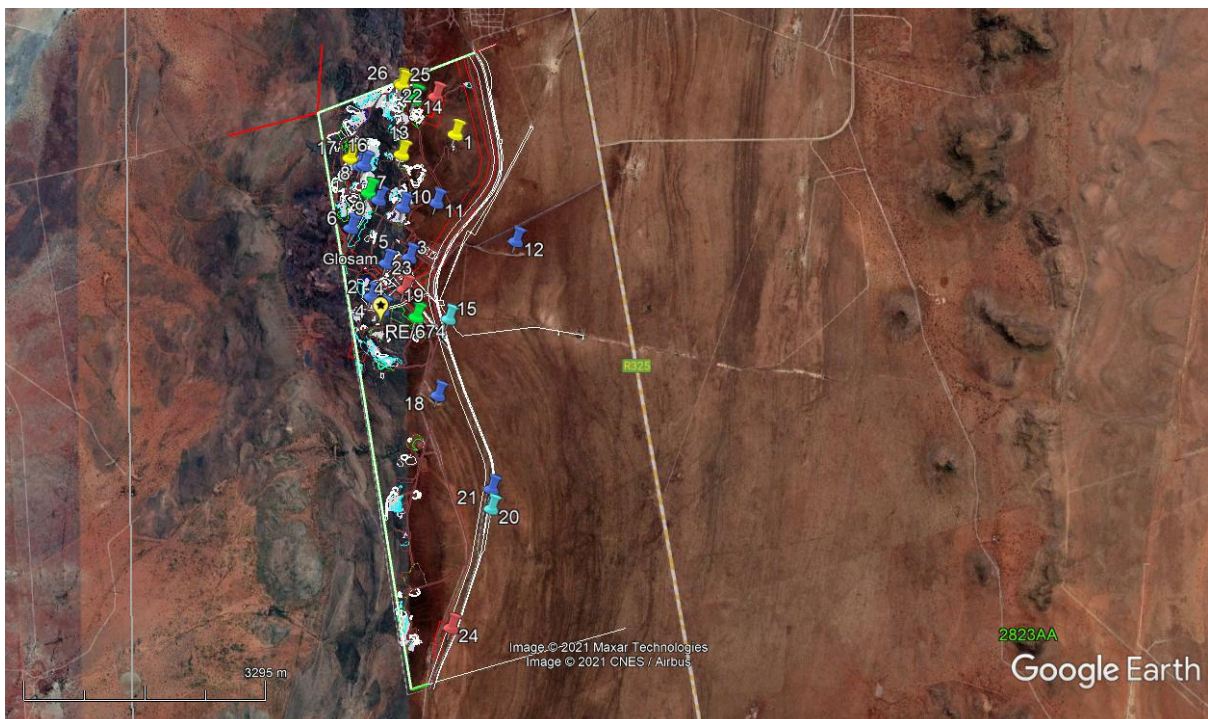
**FIGURE 75: IDENTIFIED SITES IN CONTEXT WITH PROPOSED MINING ACTIVITIES (TURQUISE).**

- YELLOW – MINERS BOXES**
- RED – GRAVES**
- GREEN – ORE LOADING BAYS**
- LIGHT BLUE – RAILWAY SIDINGS**
- DARK BLUE – OTHER (BUILDINGS, INFRASTRUCTURE ETC.)**
