ARCHAEOLOGICAL IMPACT ASSESSMENT

PROPOSED UPGRADE OF THE KOMMAGAS WATER SUPPLY SYSTEM ON PORTION 5 AND REM. OF FARM KOMMAGAS 200 NORTHERN CAPE

SAHRA Case ID: 14268

**MARCH
2020**

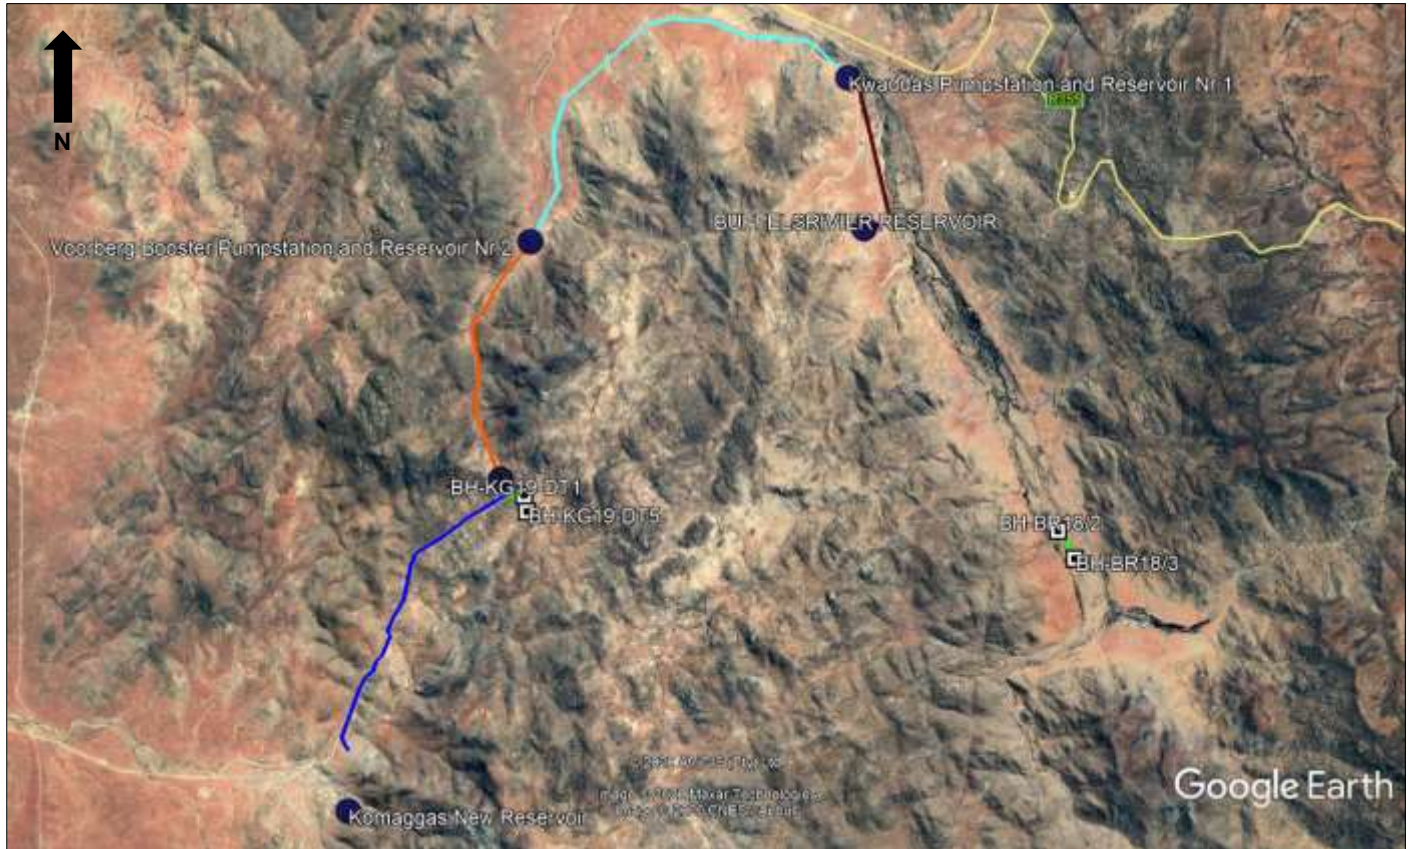
Figure 3. Kommagas Water Supply Project: Proposed infrastructure

The proposed project comprises the following components (Figures 3-6):

- Refurbishment of existing boreholes
- Construction of a 1.5 Ml concrete water reservoir adjacent the existing reservoir in Komaggas (Figure 4)
- Refurbishment of existing water main from Buffelsrivier to Kommagas (brown, magenta, orange & blue lines)
- Construction of new water pipelines between boreholes (green lines in Figures 5 & 6).
- Construction of electricity supply lines to the new boreholes
- Refurbishment of existing pump stations

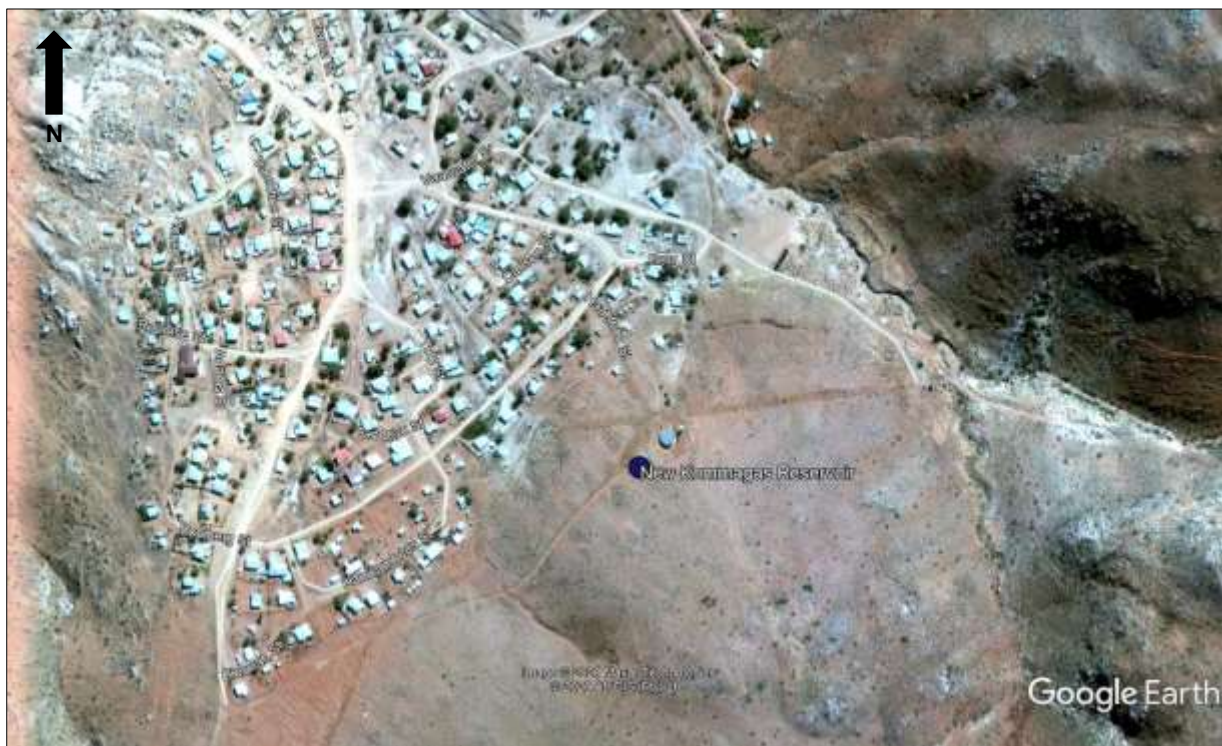
Figure 4. Kommagas Water Supply Project: Proposed new infrastructure

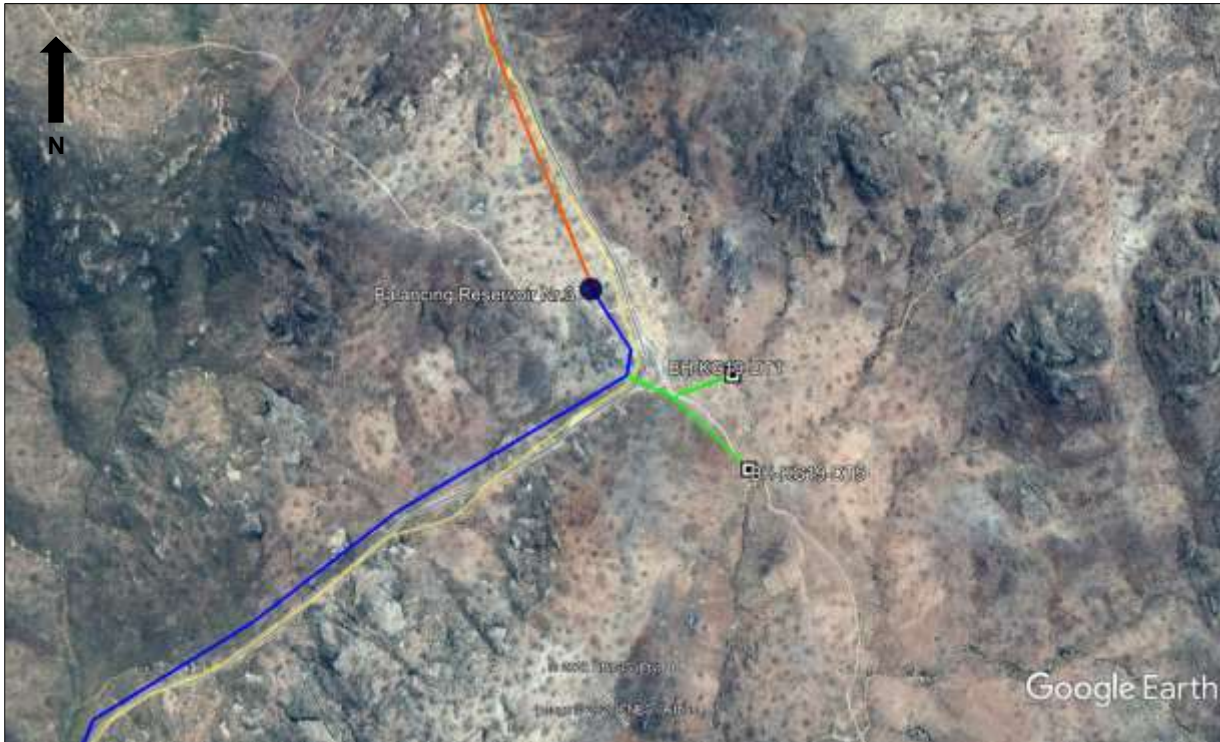
Figure 5. Kommagas Water Supply Project: Proposed new infrastructure

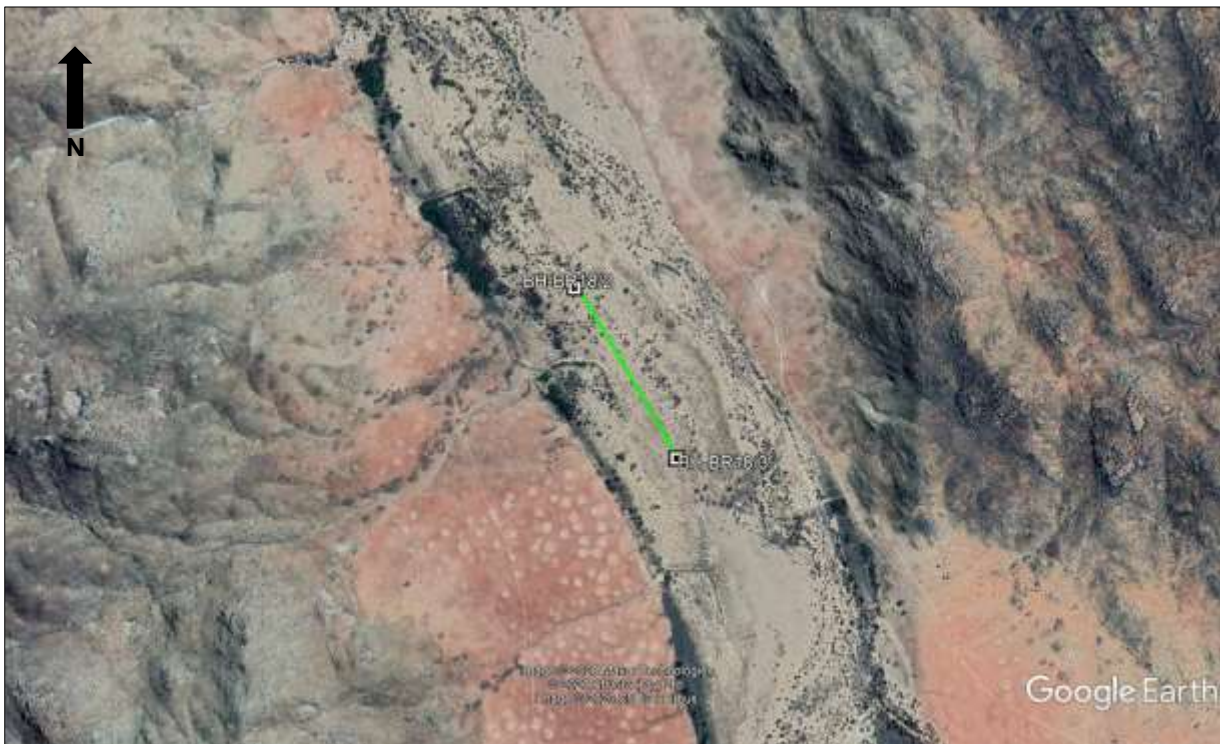
Figure 6. Kommagas Water Supply Project: Proposed new infrastructure

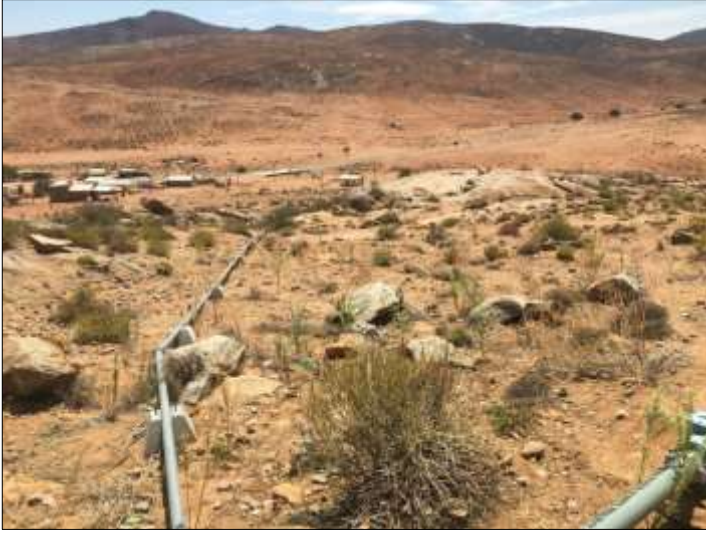
Figure 7. Pipeline in Kommagas

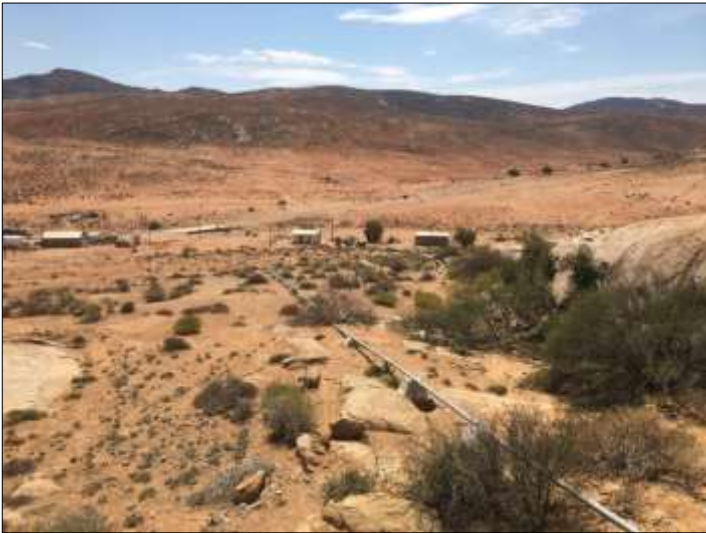
Figure 8. Pipeline in Kommagas

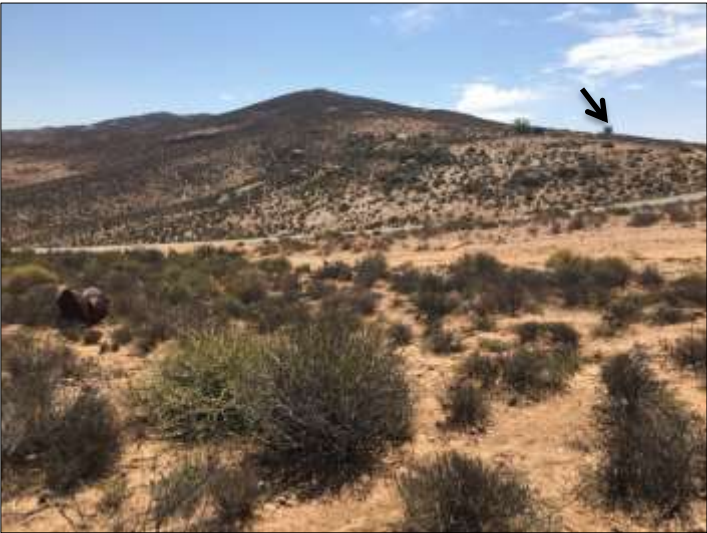
Figure 22. Arrow indicates Balancing Reservoir No. 3

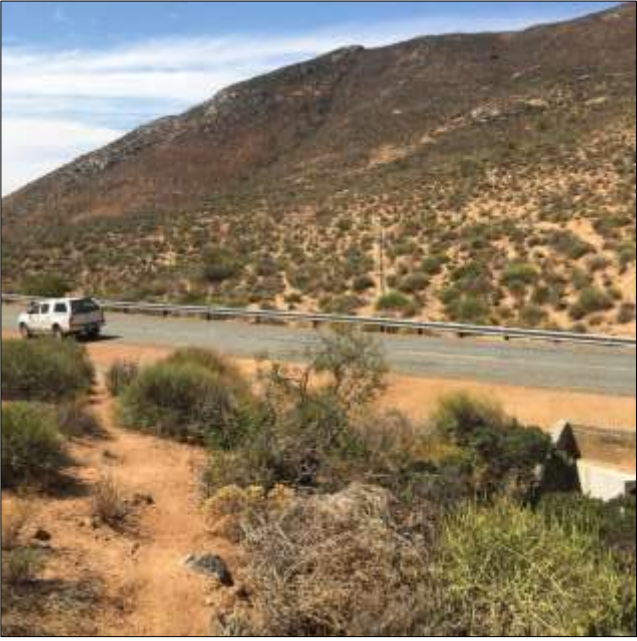
Figure 26. Pipeline from Kommagas cross the road (under the culvert) to Buffelsrivier

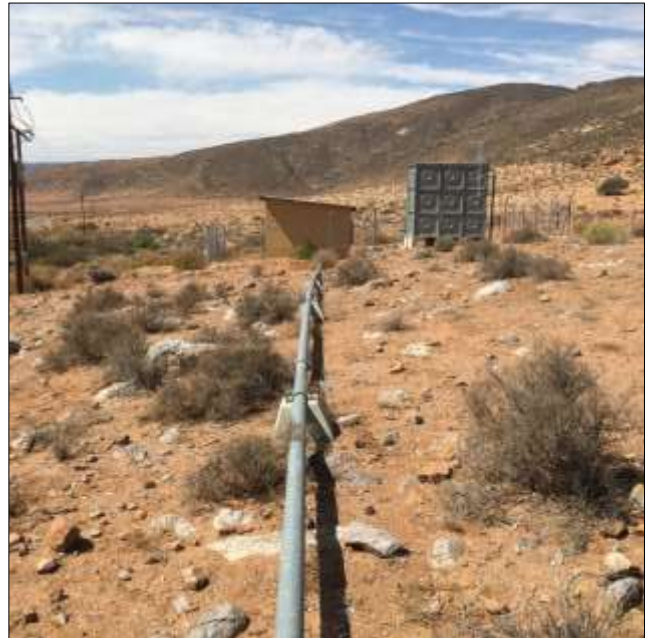
Figure 30. Voorberg Pump Station & Reservoir No. 2

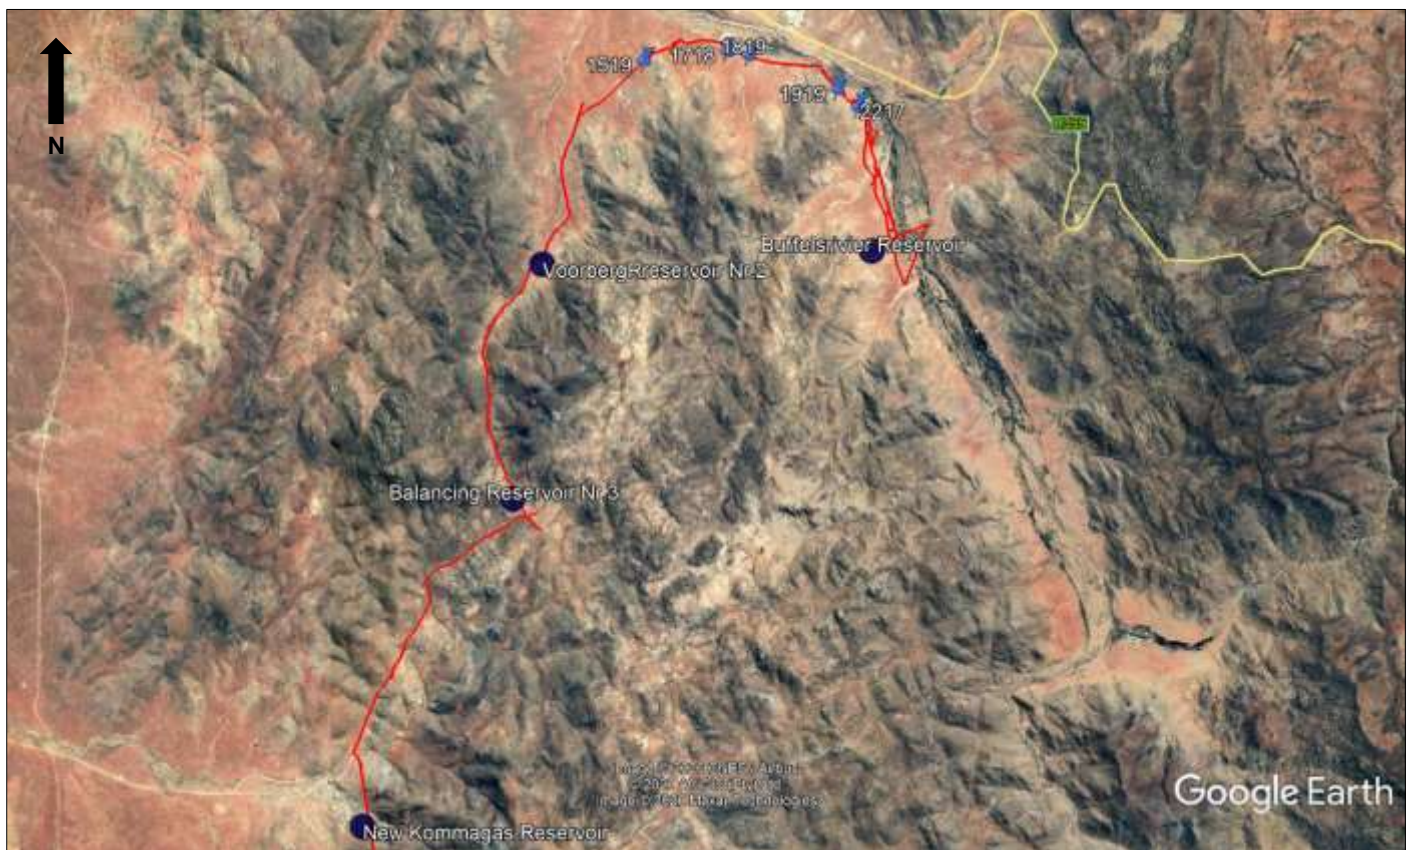
Figure 50. Track paths (in red) and waypoints of archaeological finds

Trackpaths and waypoints of archaeological resources recorded during the study are illustrated in Figures 50 & 51).

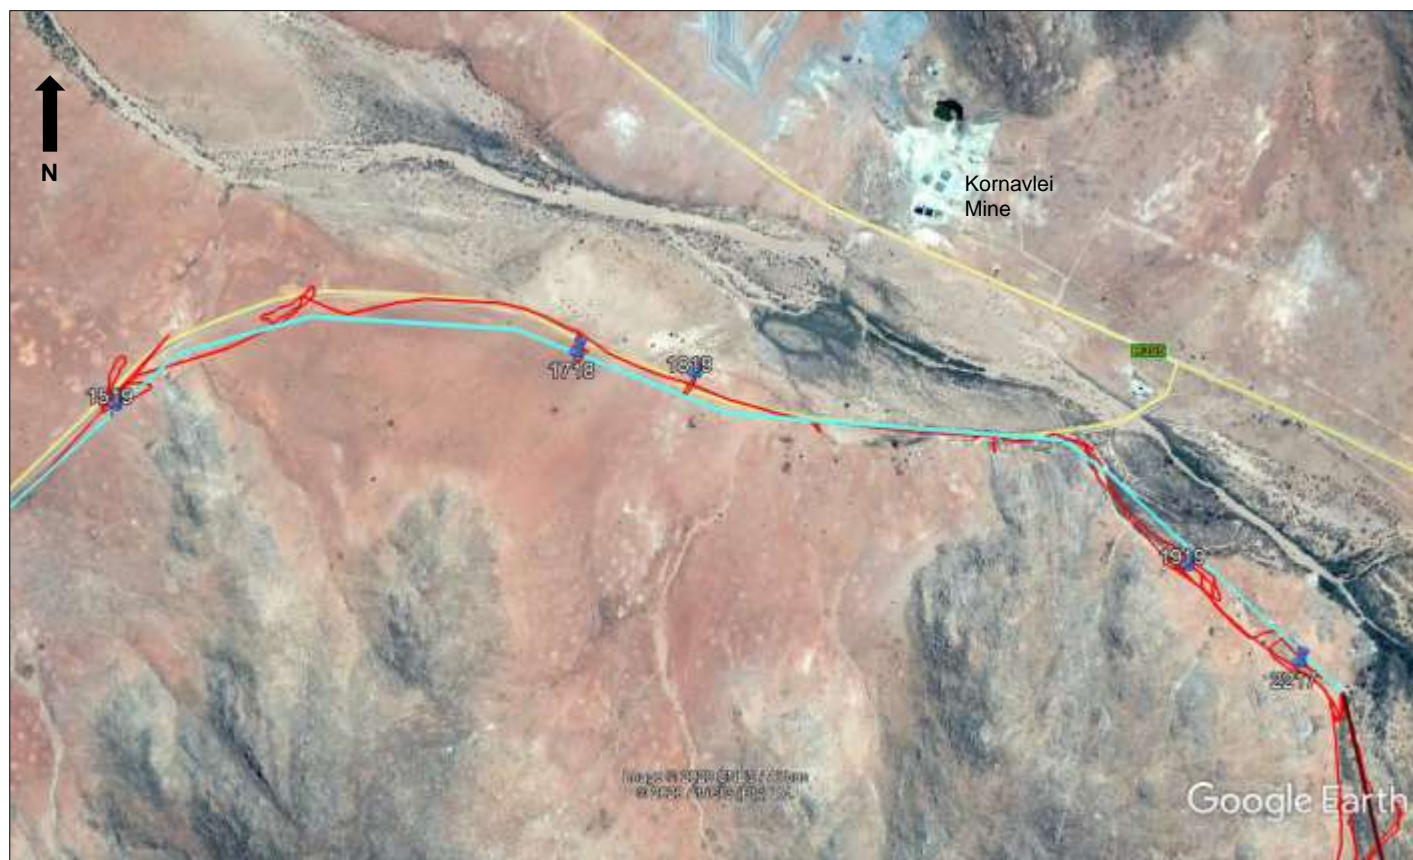
Figure 51. Track paths (in red) and waypoints of archaeological finds

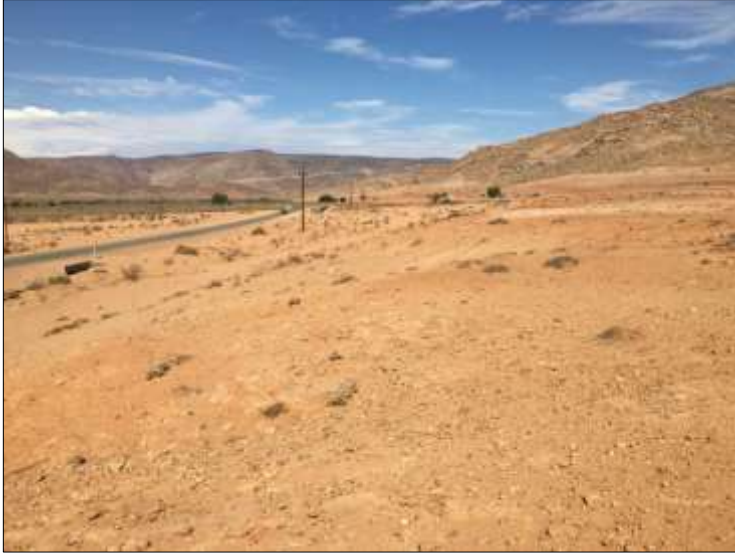
Figure 52. Waypoint 1519. Context in which the remains were found.

A small number of Middle Stone Age (MSA) tools were recorded during the field assessment. These include a MSA quartzite blade and flake (Waypoint 1519) in a highly degraded context, alongside the DR2955 between Kommagas and Buffelsrivier (Figures 52 & 53). A quartzite chunk/core, a possible hammerstone, and several MSA quartzite flakes and blade (Waypoint 1718) were found in a heavily transformed context in a, Eskom servitude, on the outskirts of Buffelsrivier (Figures 54 & 55). A MSA quartzite flake (Waypoint 2217) was found on a degraded slope close to the Kwaddas Reservoir, and a broken LSA silcrete flake (Waypoint 1919) was found on a sheet washed patch of ground alongside the gravel road just before on enters the village in Buffelsrivier (Figure 56).

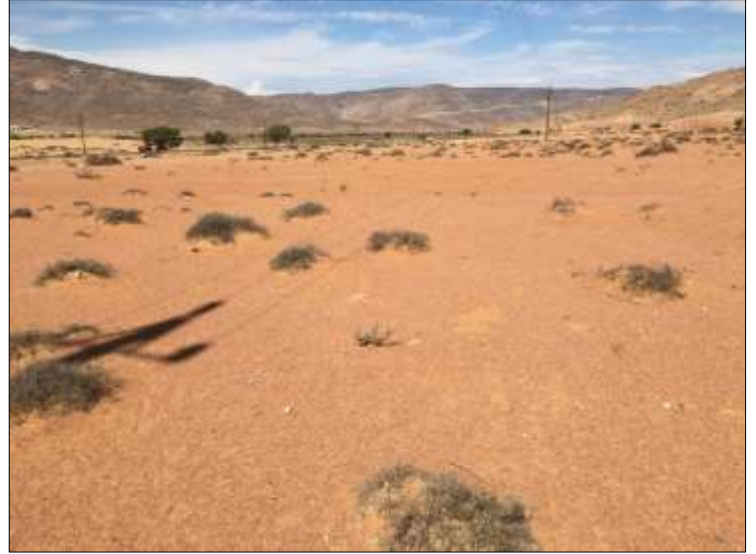
Figure 54. Waypoint 1718. Context in which the remains were found

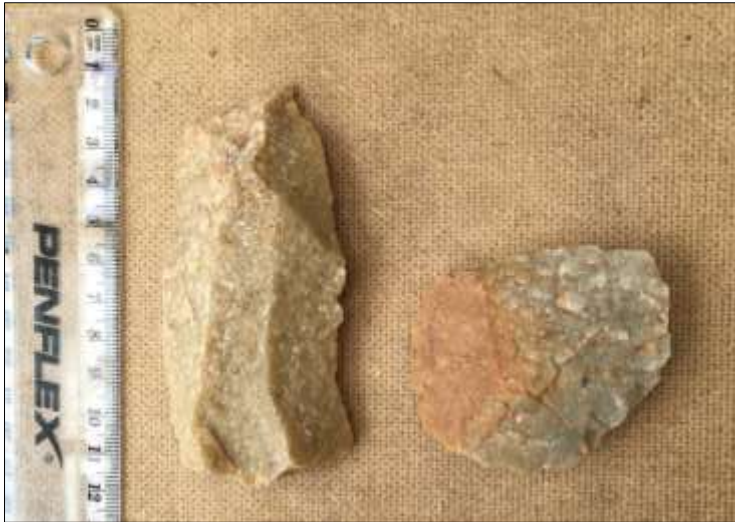
Figure 53. Tools from waypoint 1519. Ruler scale is in cm

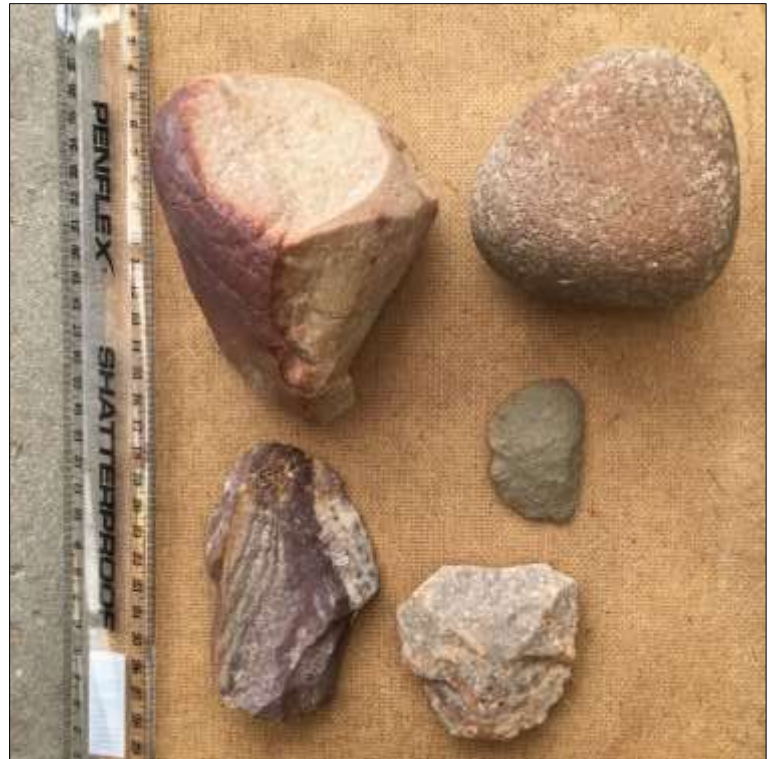
Figure 55. Waypoint 1718. Scale is in cm

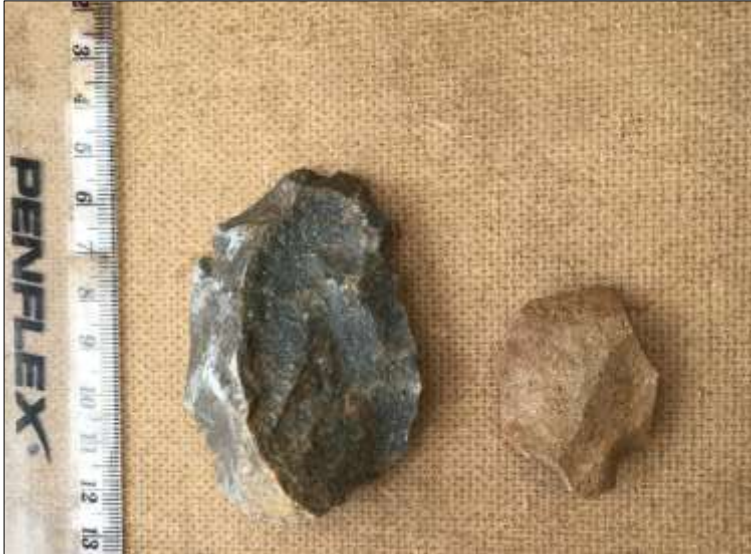
Figure 56. Waypoints 2217 & 1919. Ruler scale is in cm
