### DRAFT BASIC ASSESSMENT REPORT AND ENVIRONMENTAL MANAGEMENT PROGRAMME

Farm Name: Dorp Gronden Ladybrand 451/RE

# BASIC ASSESSMENT REPORT And ENVIRONMENTAL MANAGEMENT PROGRAMME REPORT

# Phase 1 Heritage Impact Assessment of a proposed new borrow pit near Ladybrand, FS Province.

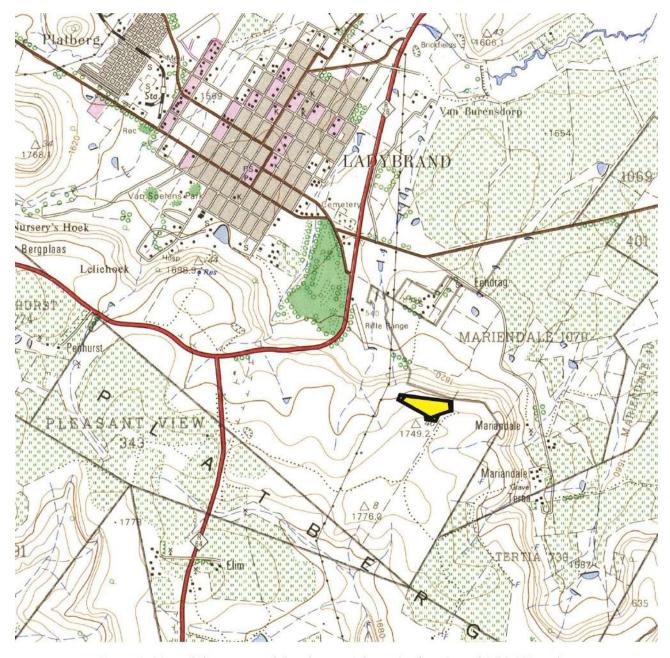
Figure 1. Map of the proposed development footprint (portion of 1:50 000 scale topographic map 2927AB Ladybrand).

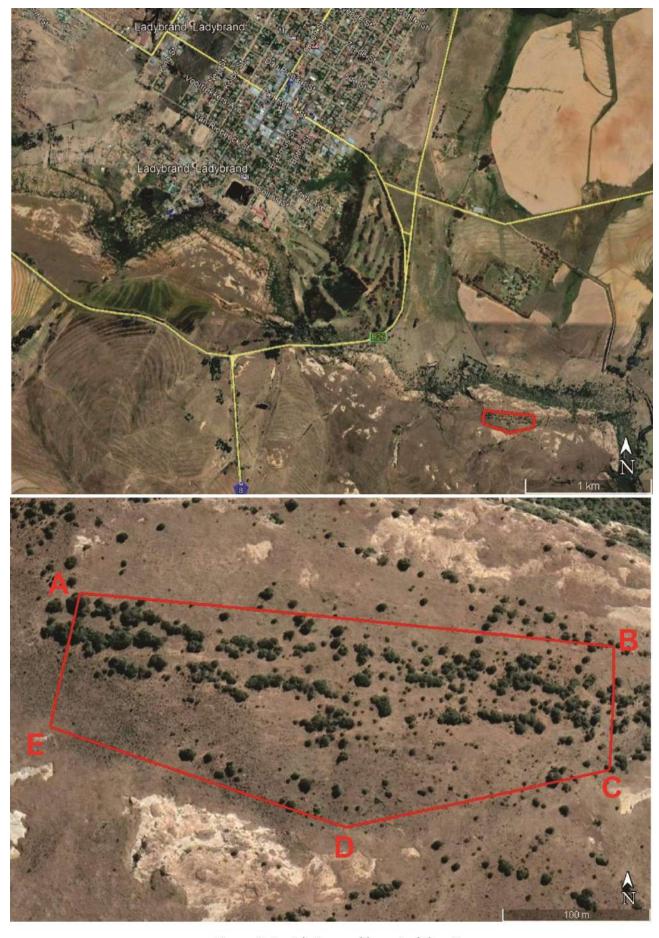
Figure 2. Aerial view and layout of the site.

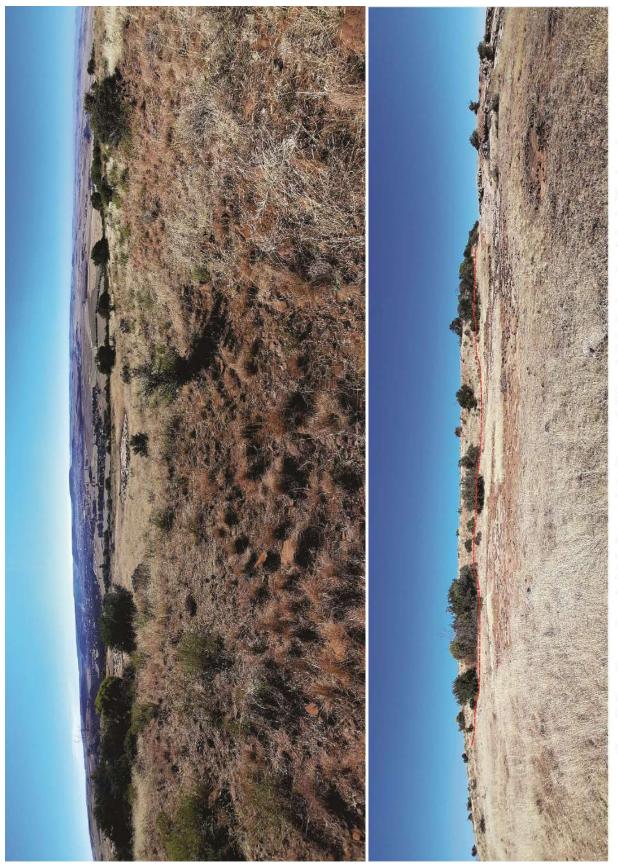
Figure 3. Standing on degraded dolerite matrix looking north (above). Dolerite intrusion (stippled line) resting on top of Elliot Frm sandstone, looking south (below).

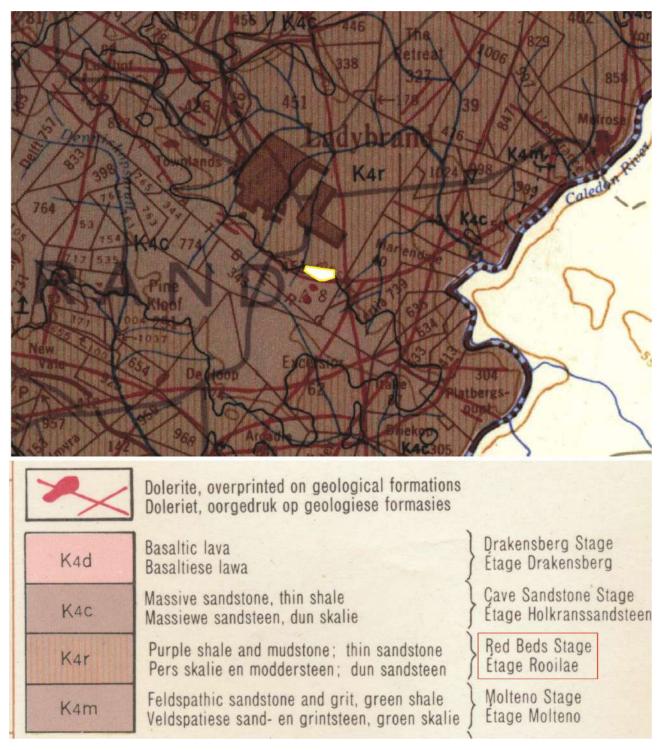
Figure 4. Study area (white polygon) marked on portion of 1:250 000 scale 2926 Bloemfontein. The footprint is located within the outcrop area of the Late Triassic – Early Jurassic Elliot Formation of the Stormberg Group (upper Karoo Supergroup).

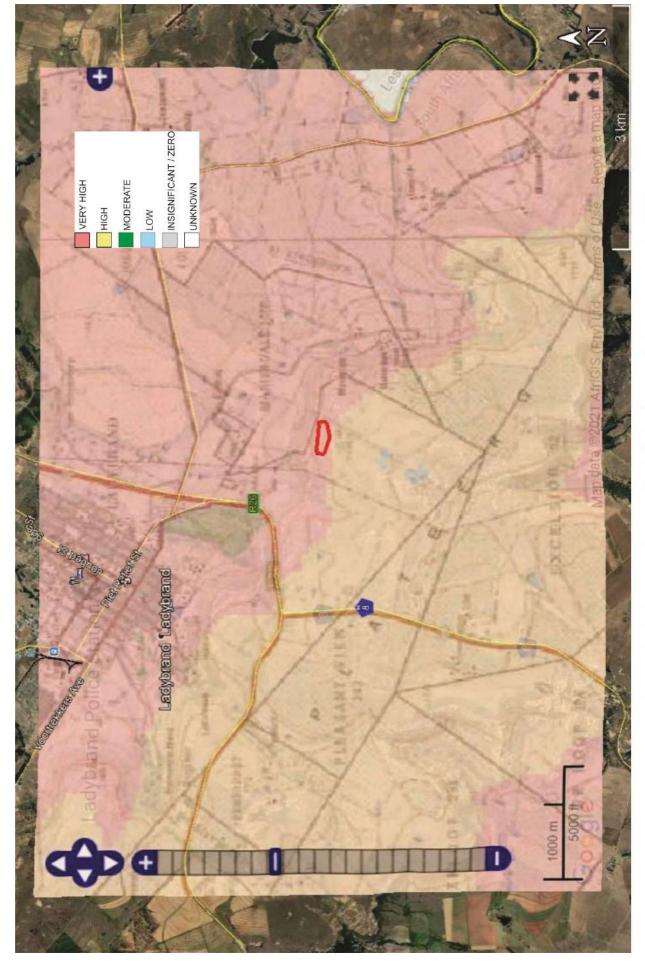
Figure 5. Aerial view of study area with SAHRIS palaeosensitivity map overlay (c. 2021)

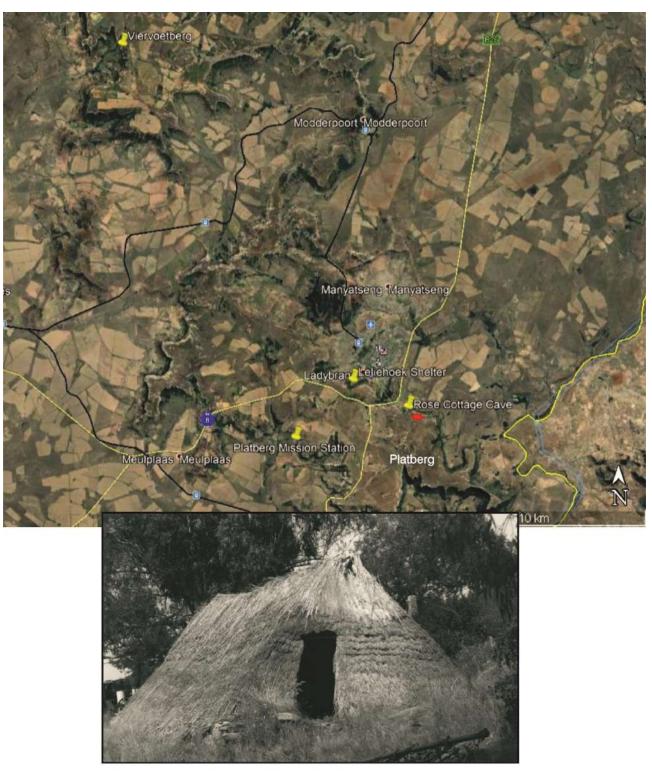
Figure . Archaeological and historical sites mentioned in text, including the site of a 19th century Wesleyan Missionary Society station. The photograph below depicts of one of the last recorded South African kapstylhuise found at Platberg (after Walton 1981).

The archaeological footprint in the area are primarily represented by Stone Age archaeological localities open and cave sites including rock art) and an extensive footprint related to the distribution of Iron Age settlements and early history of Sothospeaking communities along the Caledon River Valley. Previously recorded Stone Age sites in the region are found at Bokpoort, Orange Springs, Leliehoek and Rose Cottage Cave (Thorp and De Ruiter 1997 (Fig. 7). In addition to Later Stone Age levels with European and Iron Age artifacts and rock art, Rose Cottage Cave also has a long cultural sequence incorporating several MSA and LSA industries ranging from ca. 70 ka to around 10 ka ago (Wadley 1992). Rock shelters associated with more recent hunter – gatherer activities are found at Rooikrans, Mauermanshoek, Westbury and Tienfontein. Numerous rock art sites have been recorded in the region, with over 30 farms listed in the Ladybrand district including the famous Tandjiesberg site near Modderpoort (Van Riet Low 1941) (Fig. 8).

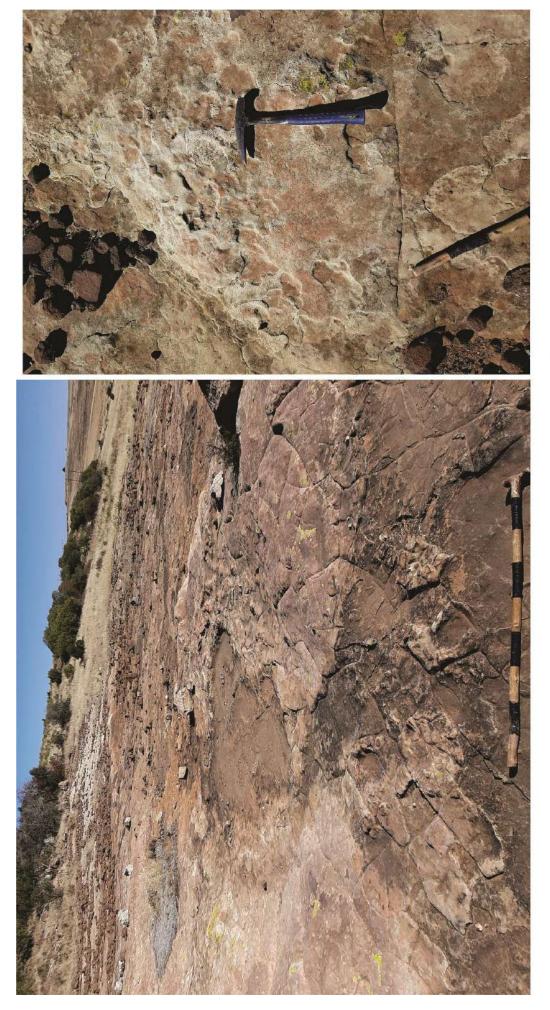
Figure 10. Fractured sandstone surface with flat-floored depressions (left) and smaller micro-weathering features with evidence of flaking along bedding planes (right).

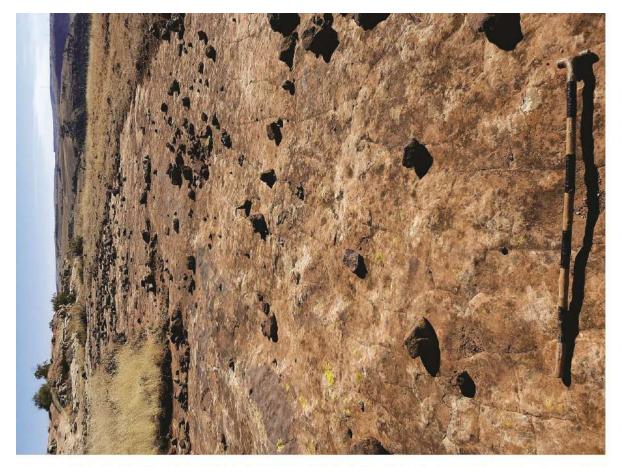
Figure 11. Fine- to medium-grained, sandstone: tabular (left) and horizontally laminated with dessication cracks (right).

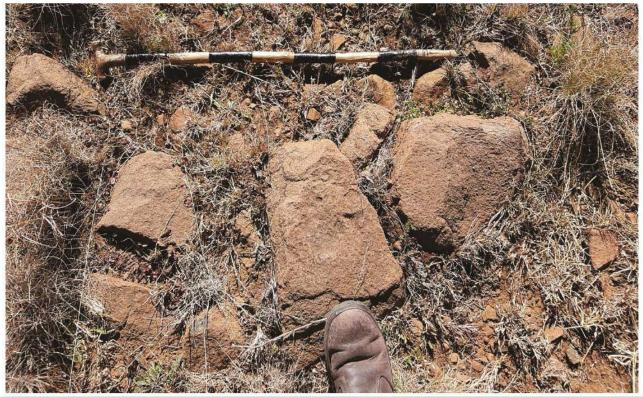
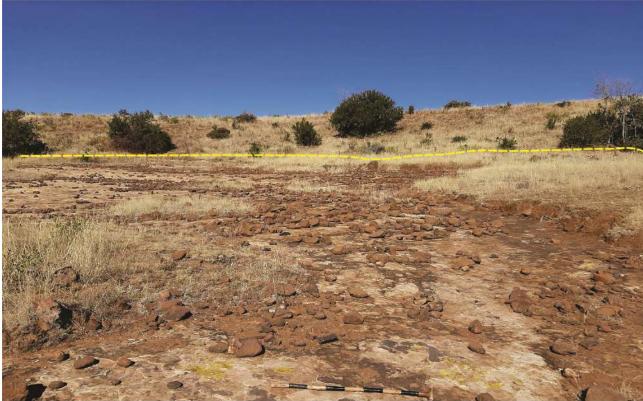
Figure 12. Degraded dolerite rubble capping (above and stippled line below) with down-weathered remnants on Elliot Formation sandstone (below). Scale 1 = 10 cm.

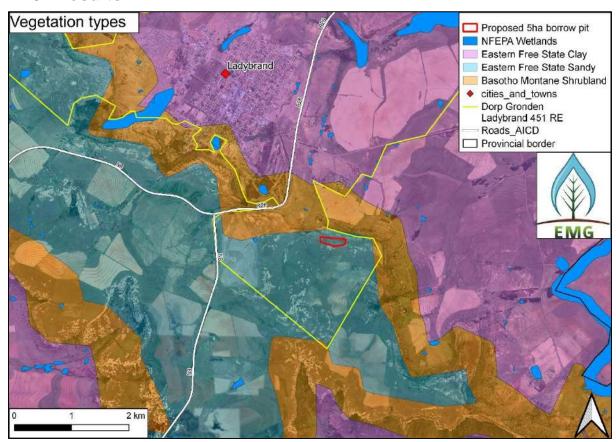
Figure 2 vegetation type map indicating the site's locality within the Eastern Free State Sandy type (Gm4). The Mohokare River is depicted as an NFEPA wetland (Right side of map) bordering Lesotho to its East.

The site is situated in the Eastern Free State Sandy Grassland type (Gm4) (SANBI, 2018) (Figure 2). The Sandy Grassland is an endangered vegetation type that is very poorly conserved. Only 2% of the targeted 24% is formally conserved (Mucina and Rutherford, 2006). The Free State Biodiversity Map indicated that the site and its surroundings are degraded (Collins, 2015) (Figure 8). This statement was opposed because the area presented various habitats (outcrop plant communities, mountain catchment drains, grassland, and tall shrublands associated with Gm5), relatively low levels of anthropogenic disturbance, numerous protected floras, and is placed within an endangered vegetation type. It was concluded that the site deserves a higher conservation consideration. Therefore, the report regards the area as having a moderate conservation priority.

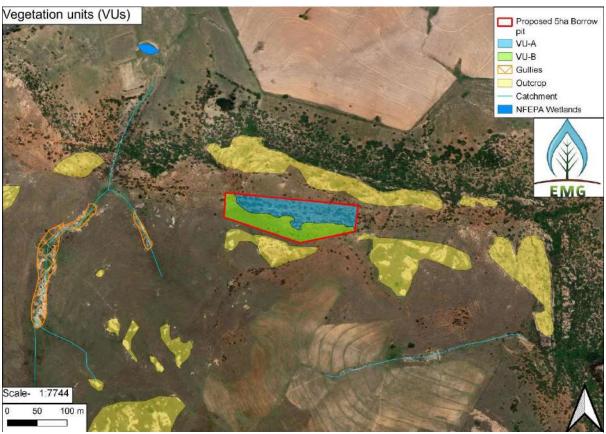
Figure 3 map indicating the two homogenous vegetation units. The numerous Sandstone outcrops are depicted on this map and should be regarded as sensitive habitats (Yellow). Mountain catchment drain lines are depicted in blue along with the NFEPA wetlands

The floral survey resulted in the delineation of two major homogeneous vegetation units (VUs) (Figure 3). These units will be described in the following heading. The underlying geology has affinities to the Eliot and Clarens formation from the Karoo Supergroup. The surrounding soils may be characterised as fine-grained sandstone and siltstone associated with the Clarens formation and red, green, grey mudstone and subordinate sandstone associated with the Elliot formation. Numerous sandstone and dolerite outcrops extrude through the surrounding topography, creating a sensitive habitat occupied by a diverse assemblage of xeric flora. These outcrops become more prominent closer to the mountain edge.

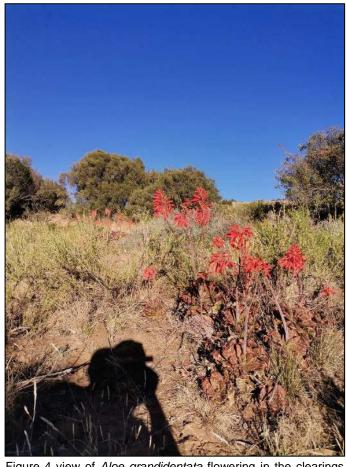
Figure 4 view of *Aloe grandidentata* flowering in the clearings between tall shrubs. The scattered distribution of *F. filifolia* can also be seen. Tall *S. lancea, and S. erosa* are growing in the background.

This unit is physiognomically described as a dense, medium to tall shrub stand growing closest to the mountain edge. VU-A's dense shrublike community consists of the following dominant species: Diospyros lycoides, D. whyteana, Euclea crispa, Searsia erosa, S. lancea, and Olea europaea subsp. africana. Other shrubs frequently recorded were Searsia Heteromorpha burchellii, arborescens Rhamnus prinoides and Osyris lanceolata. The herbaceous layer is not well developed due to the closed canopy created by a dense stand of shrubs. The herbaceous layer prominent becomes more clearings where more sunlight penetrates the lower strata. In these clearings and around the periphery of VU-B, the grass layer is represented by a few pioneering to sub-climax grasses such as Aristida congesta, Melinis repens,

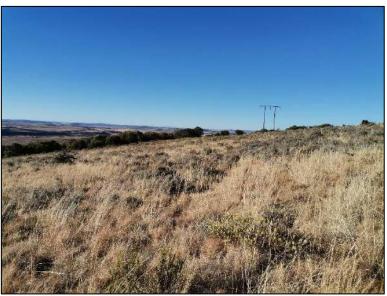
Figure 5 view of VU-B. Notable bush encroachment by *S. plumosum* Dense tall shrubs of VU-A depicted in the background.

VU-B primarily is represented by a broken grassland intercepted small sandstone intrusions. A wide array of sub-climax to climax grasses dominate the layer. herbaceous These include Themeda triandra, Sporobolus fimbriatus, Cymbopogon pospischilii, Hyparrhenia hirta, Eragrostis chloromelas and Eragrostis lehmanniana. Sheet erosion becomes more prominent closer to sandstone outcrops. Aristida congesta

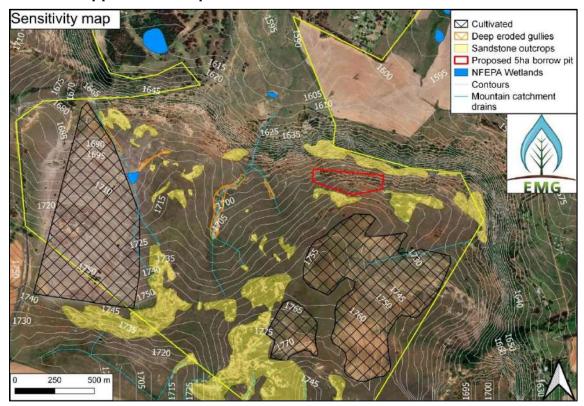
Figure 6 Sensitivity map indicating the vast majority of intact habitat which is intercepted by the scattered sandstone outcrops (Yellow). Fast flowing water down the catchment drains (blue) have caused deep eroded gullies (slanted orange).

The presence of deep, extensively long gullies indicates that the site and its immediate surroundings are erosion-prone (Figure 6, 8). The numerous outcrops present a hardened surface which impedes the absorption of water. Thus causing increased water runoff which is accelerated by steep slopes. Over time the fast-flowing has eroded much of the topsoil, forming these extensively long gullies.

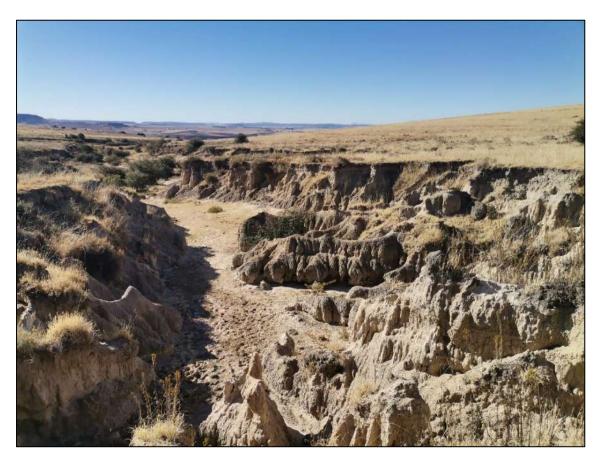
Figure 8 View of the deep donga approximately 500m from the proposed borrow pit.

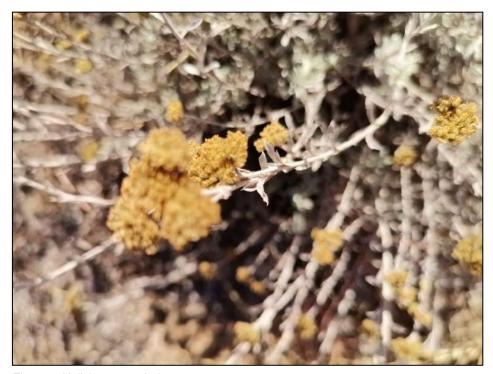
Figure 9 Helichrysum subglomeratum

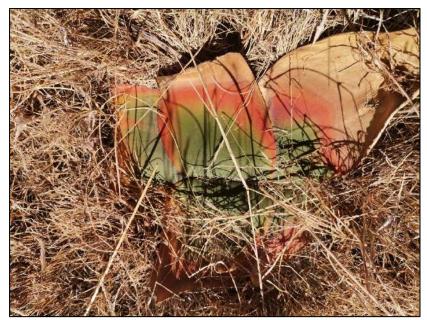
Figure 10 *Brunsvigia cf. radulosa* growing between grasses. This species is difficult to spot as it grows amongst tall grasses.

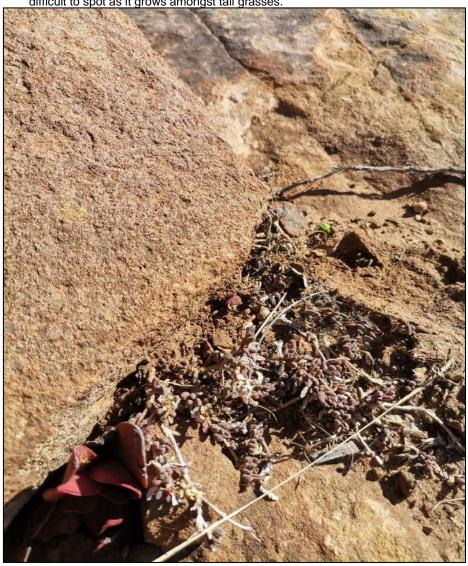
Figure 11 *Crassula nudicaulis* and *Delosperma lavisiae* growing in very shallow soils. These species can easily be overlooked.

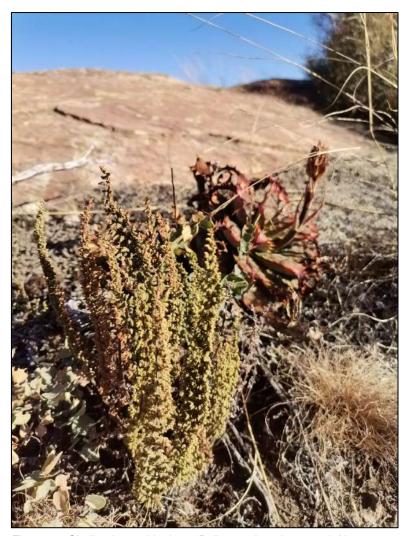
Figure 12 *Cheilanthes eckloniana*, *Pellaea calomelanos* and *Aloe grandidentata* growing in the shallow soils derived from weathered sandstone.

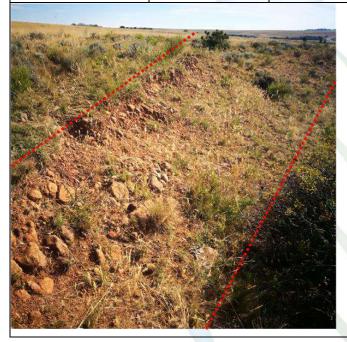
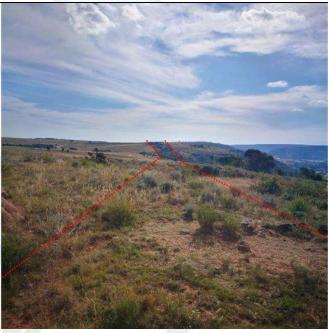
Name	Coordinates	Farm Name	Municipal Land (Y/N)				
AREA 1	-29.217332°S	Dorp Gronden Ladybrand	Yes				
AREAT	27.473351°E	451/RE	res				
Expected Material	Distance from	Comments					
Quality	Town	Comments					
Dolerite G5 – G6	11 km	Could be accessed from t	the R26 but a new access road needs to				
Dolente G5 – G6	TTKIII	be constructed.

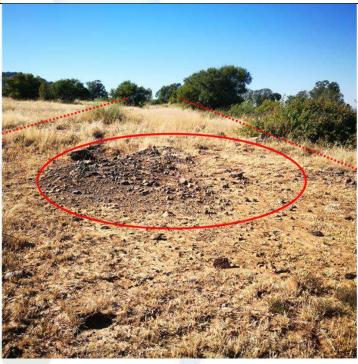
Name	Coordinates	Farm Name	Municipal Land (Y/N)			
AREA 2	-28.930791°S	Excelsior 358/RE	Yes			
AILAZ	27.086397°E	EXCOSION 550/TC	res			
Expected Material	Distance from	Comments				
Quality	Town	Comments				
Dolerite G5 – G6	6.5 km	Resource is of limited extent
