# **DRAFT BASIC ASSESSMENT REPORT AND ENVIRONMENTAL MANAGEMENT PROGRAMME**

**Farm Name: Mamma Hoek 802  
Magisterial District: Thaba Nchu**

**BASIC ASSESSMENT REPORT**  
**And**  
**ENVIRONMENTAL MANAGEMENT PROGRAMME REPORT**

**NAME OF APPLICANT: Mantsopa Local Municipality**

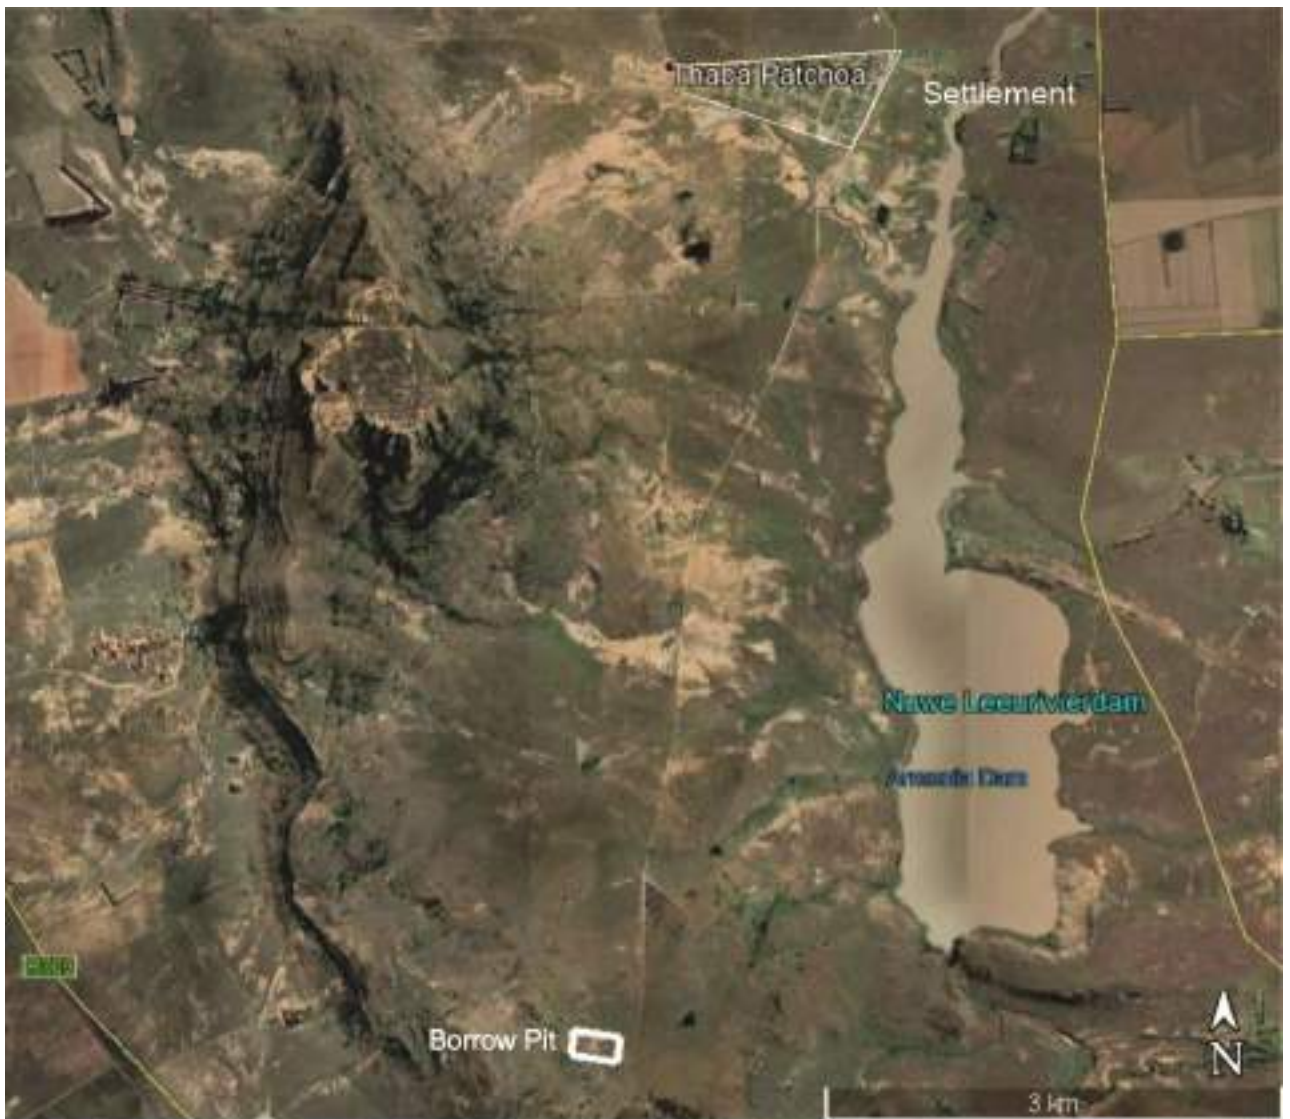
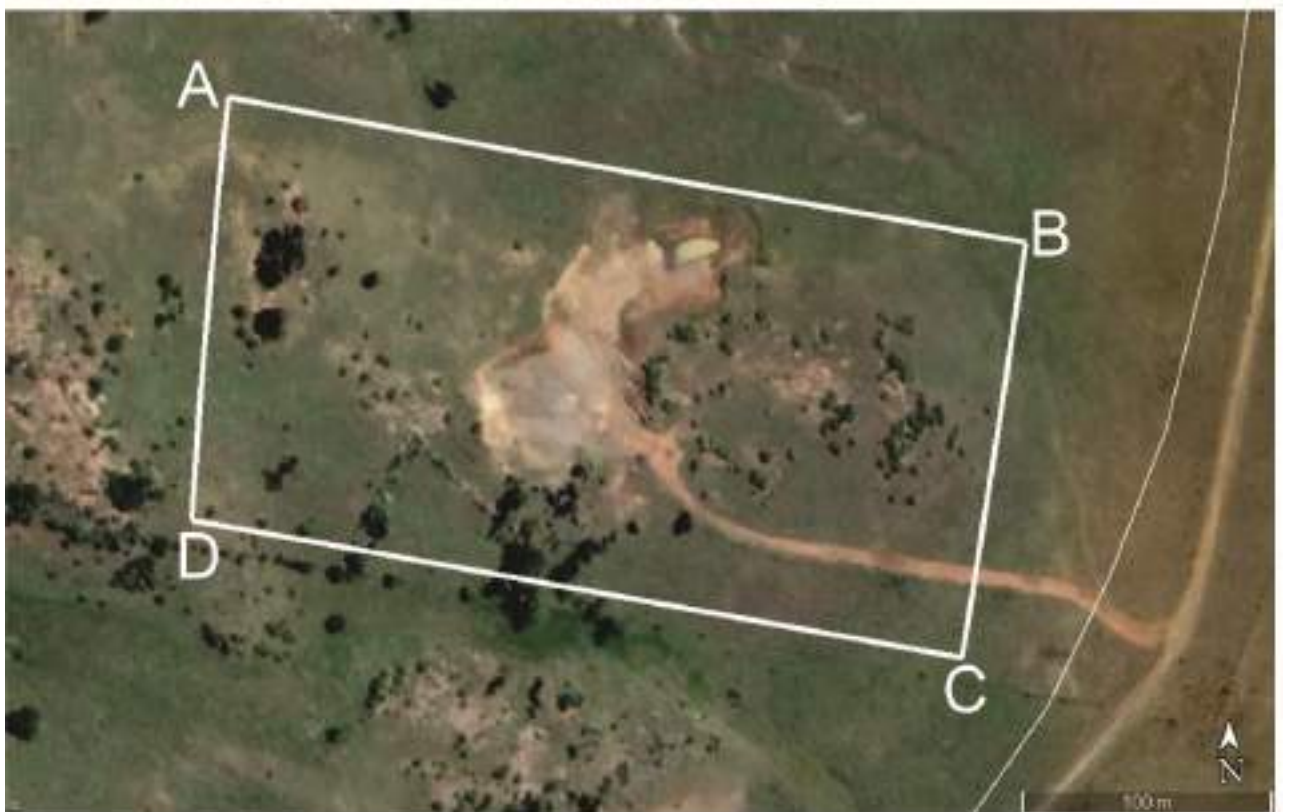
Figure 2. Aerial view and layout of the site.

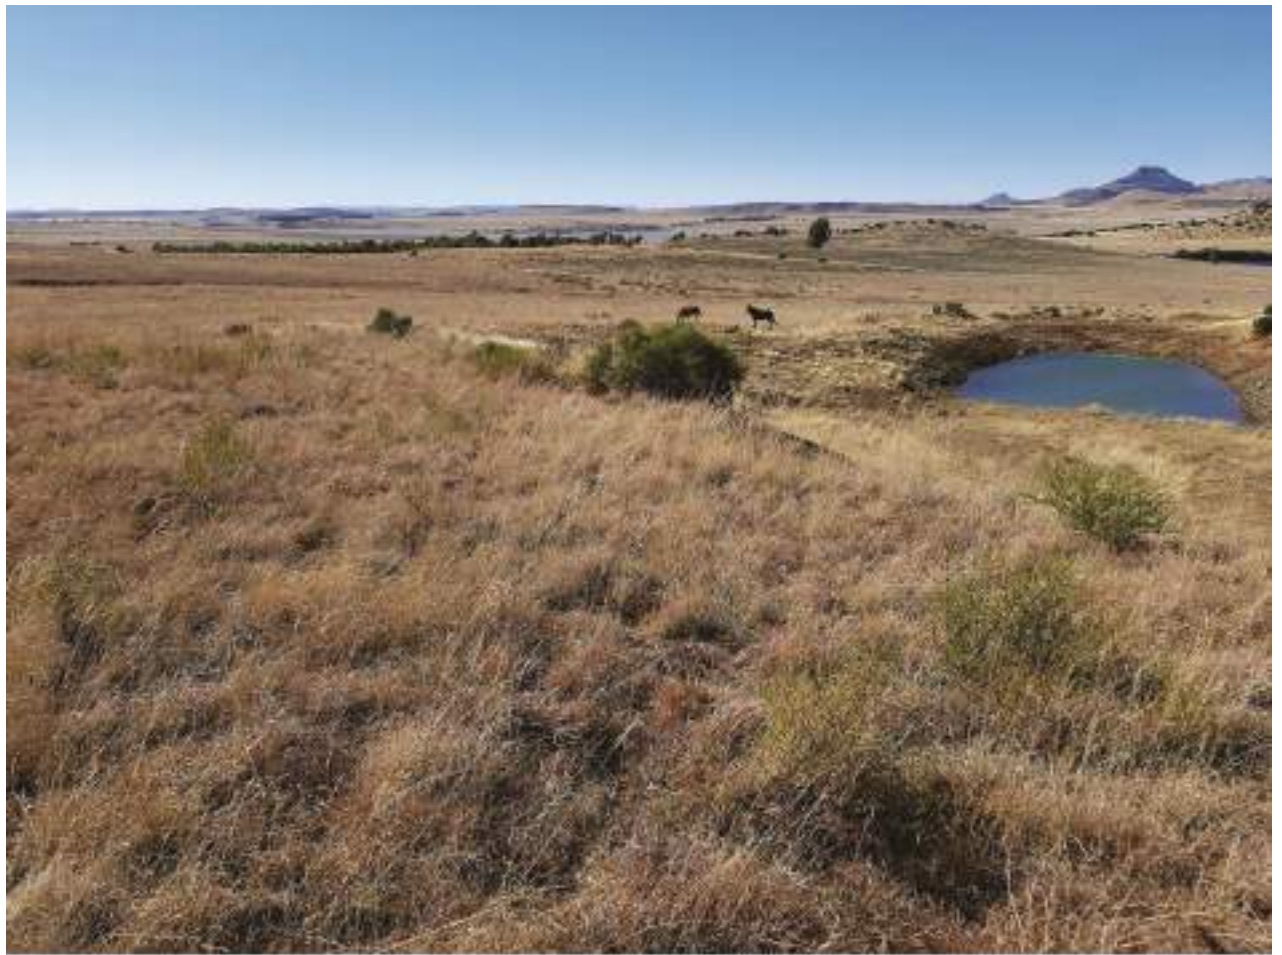
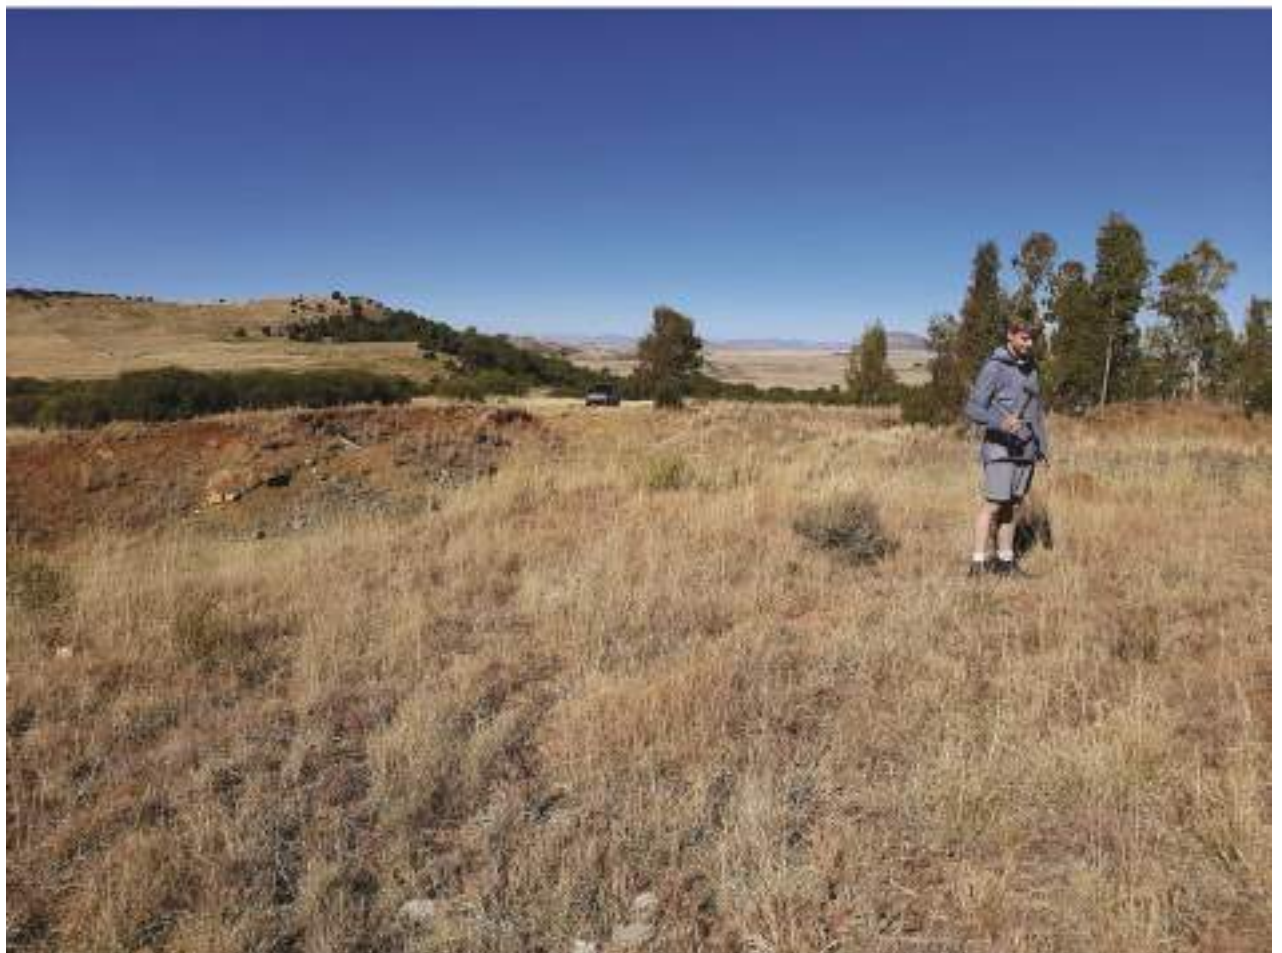
Figure 3 General view of the site, looking northeast (above) and southeast (below).

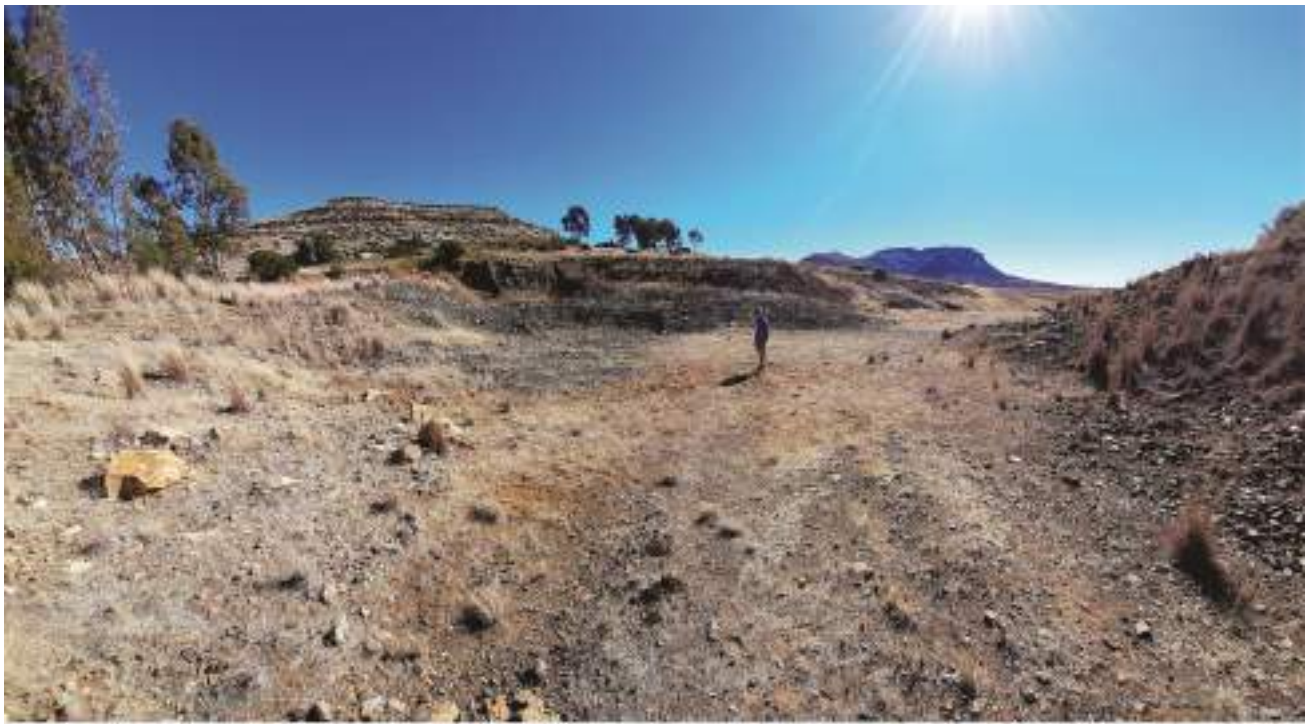
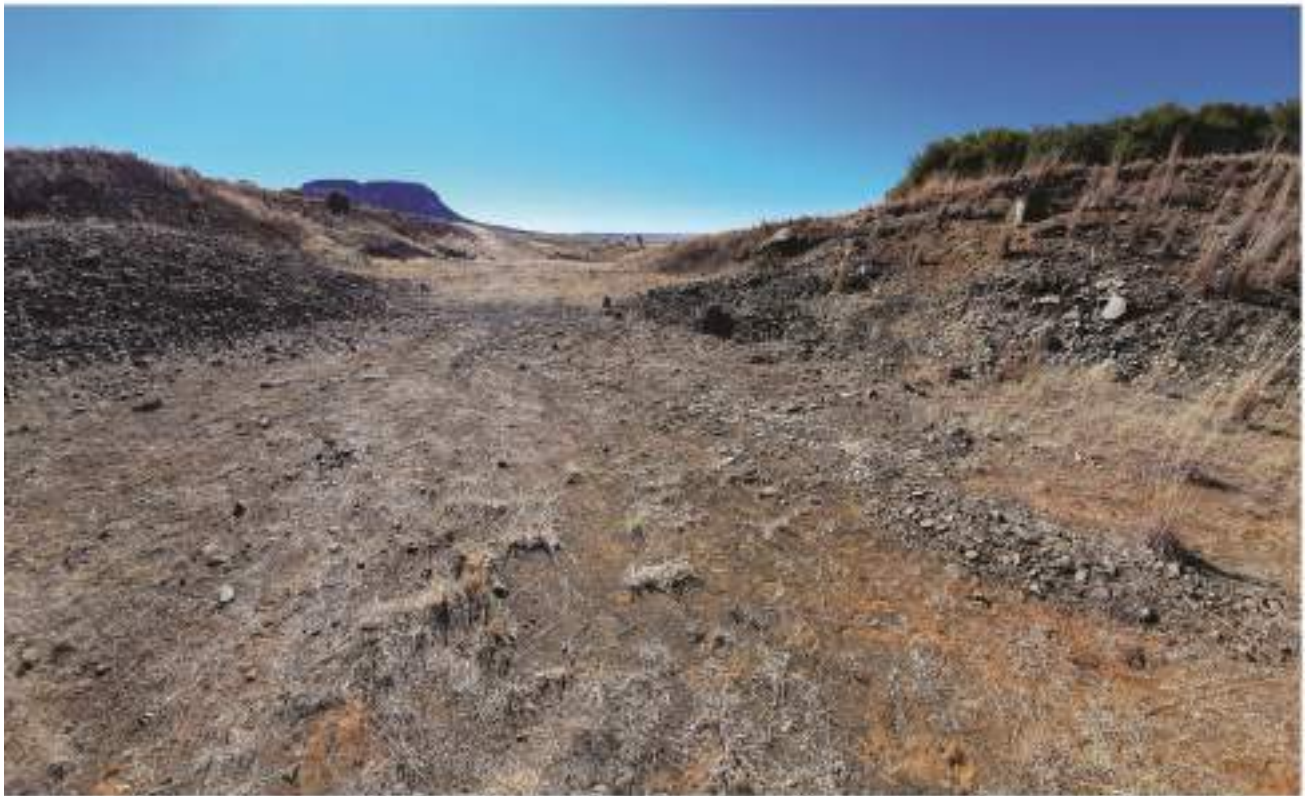
Figure 6. Dolerite exposures within existing borrow pit area, looking west (above) and north (below).

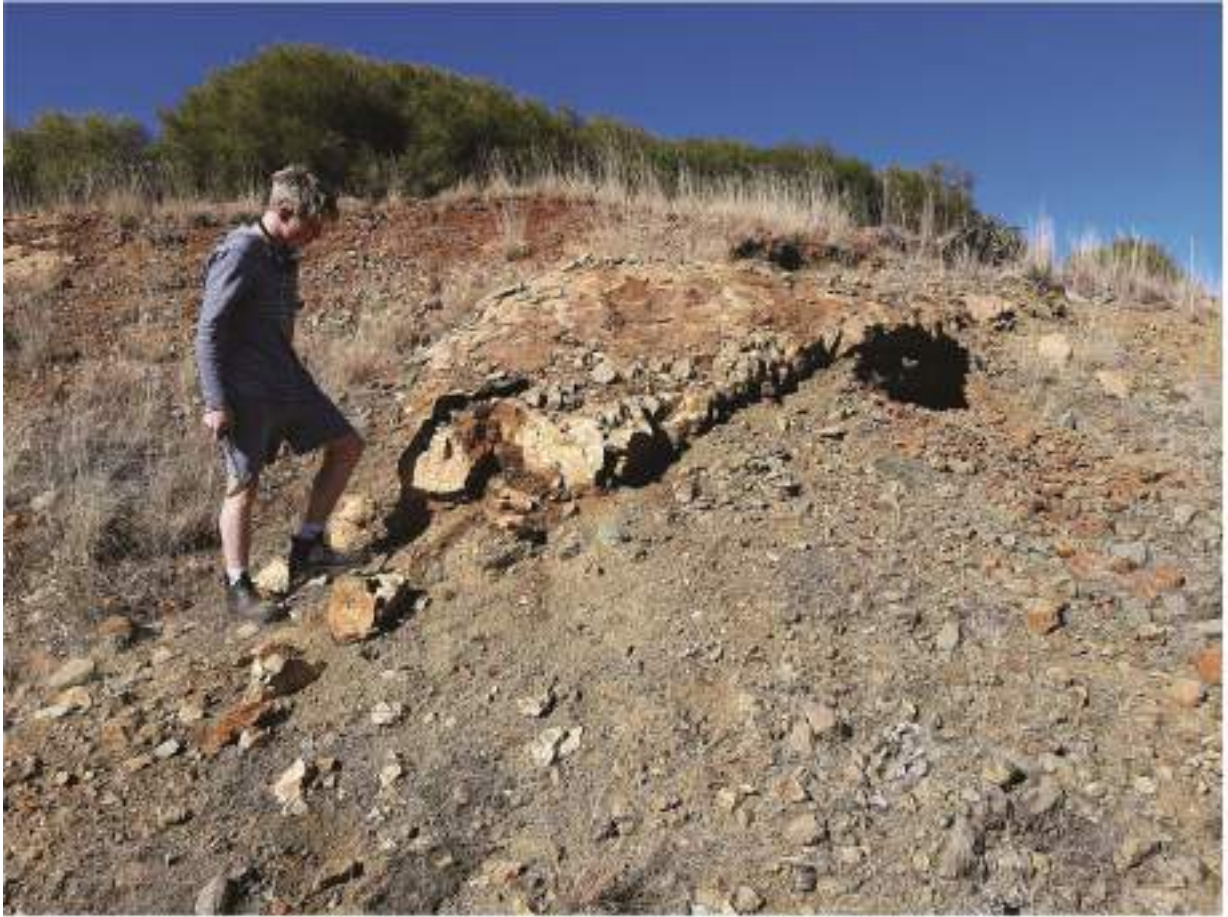
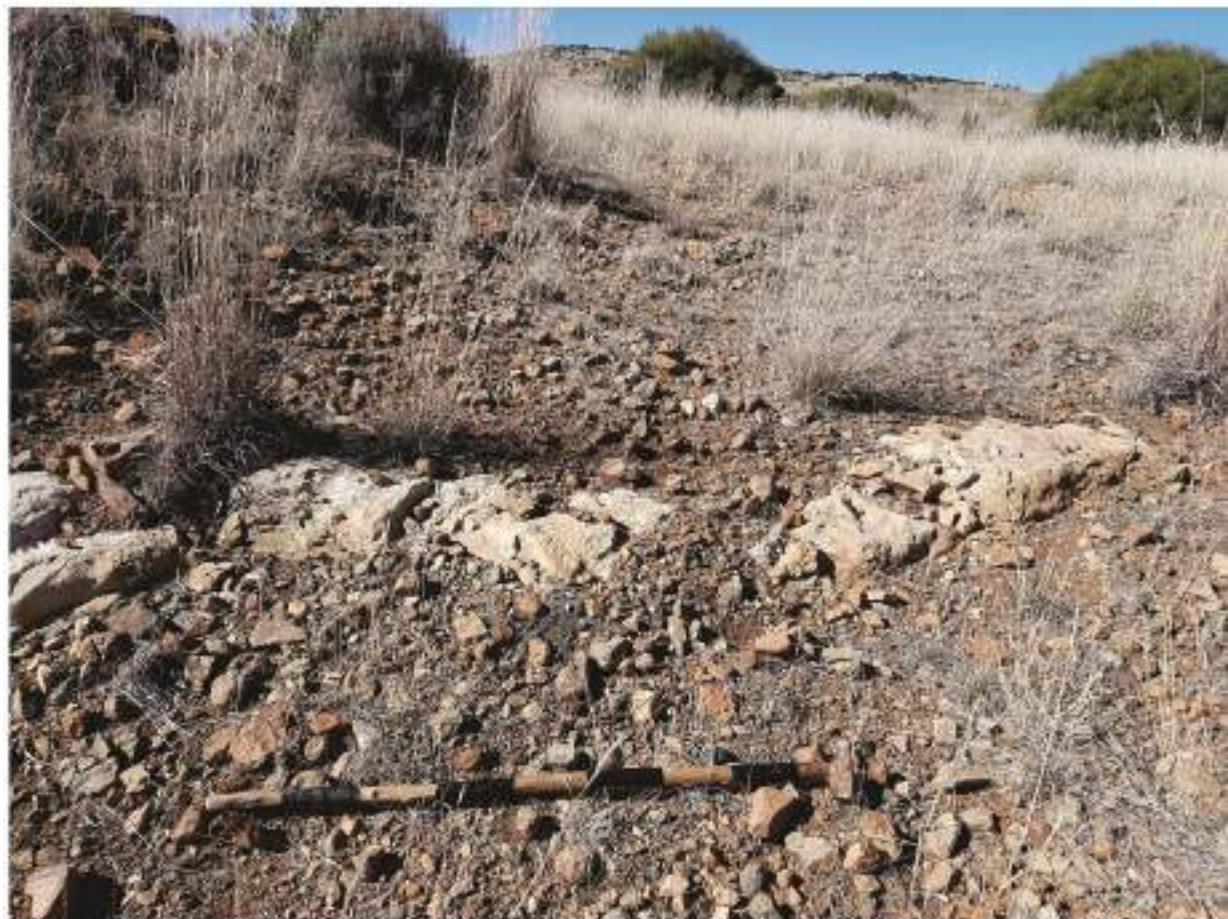
Figure 7. Partially incorporated Molteno Formation metasediments.  
Scale 1 = 10 cm.

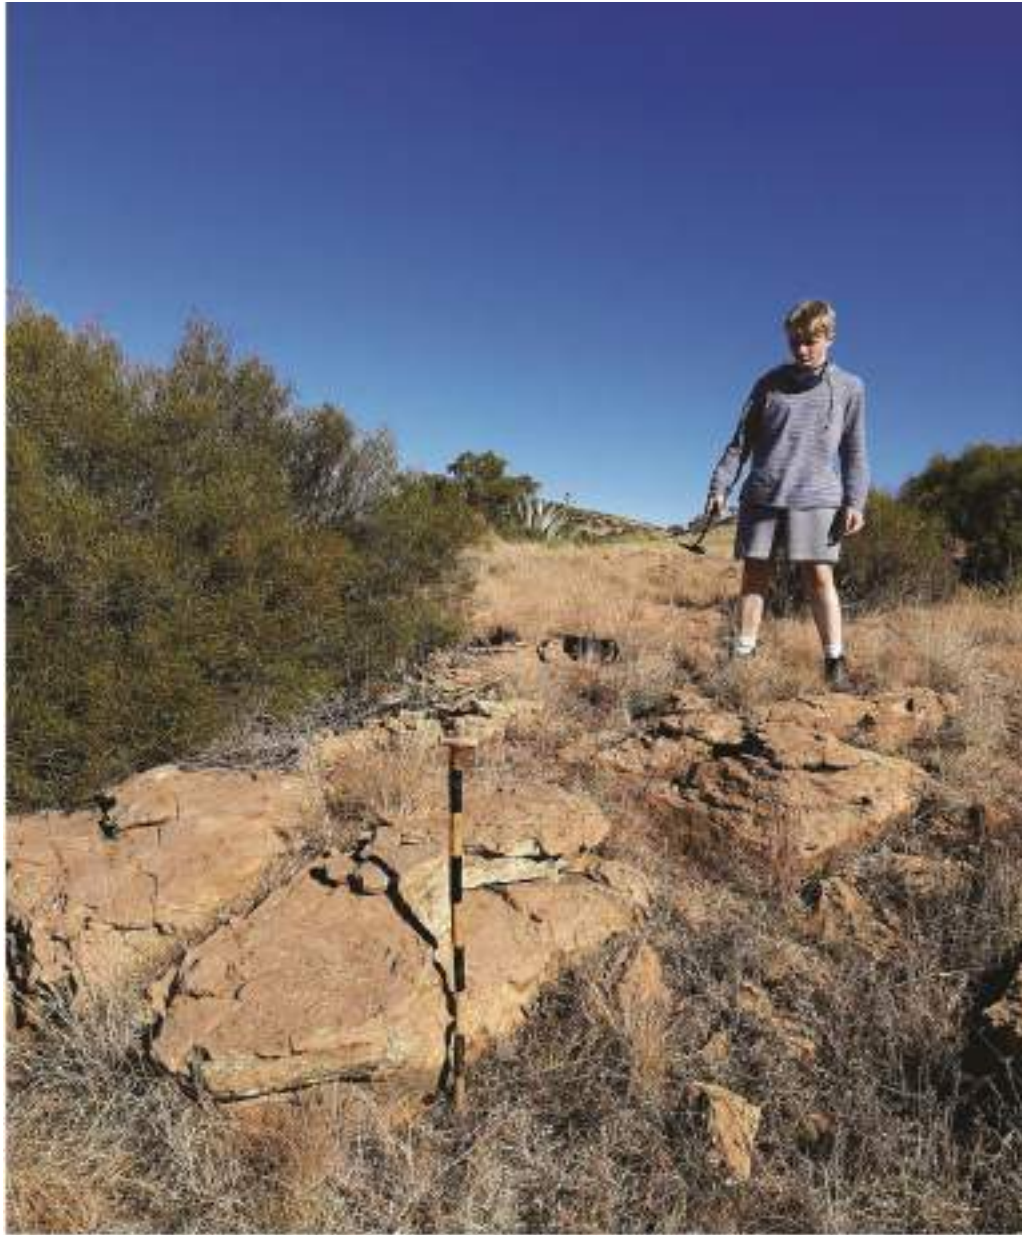
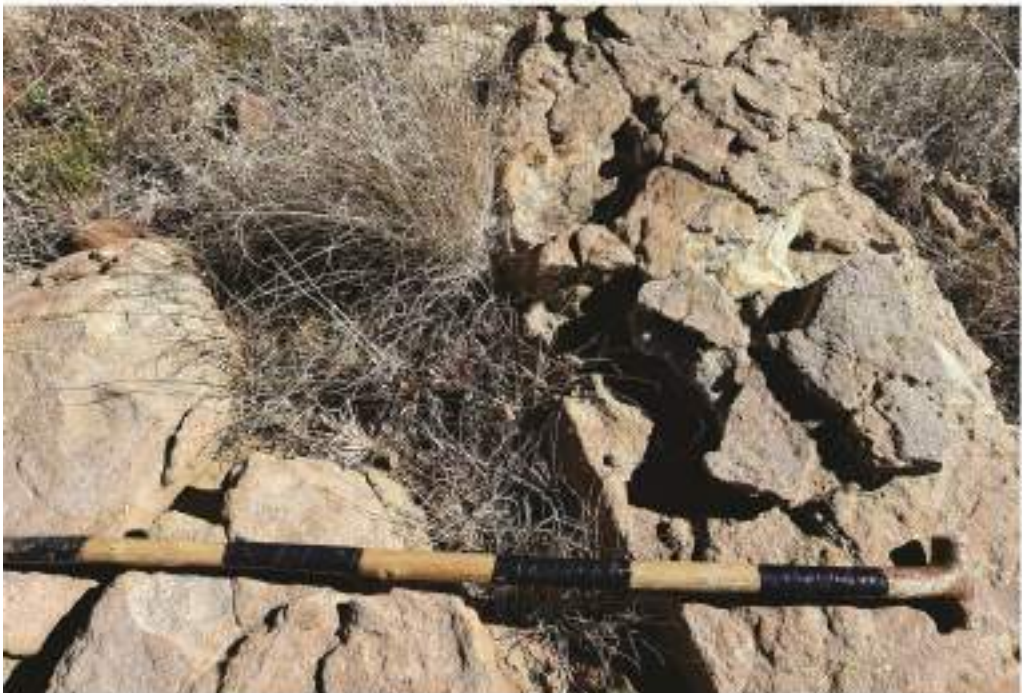
Figure 8. Intact, coarse-grained Molteno Formation sandstone outcropping to the west, south and east of the existing borrow pit.  
Scale 1 = 10 cm.

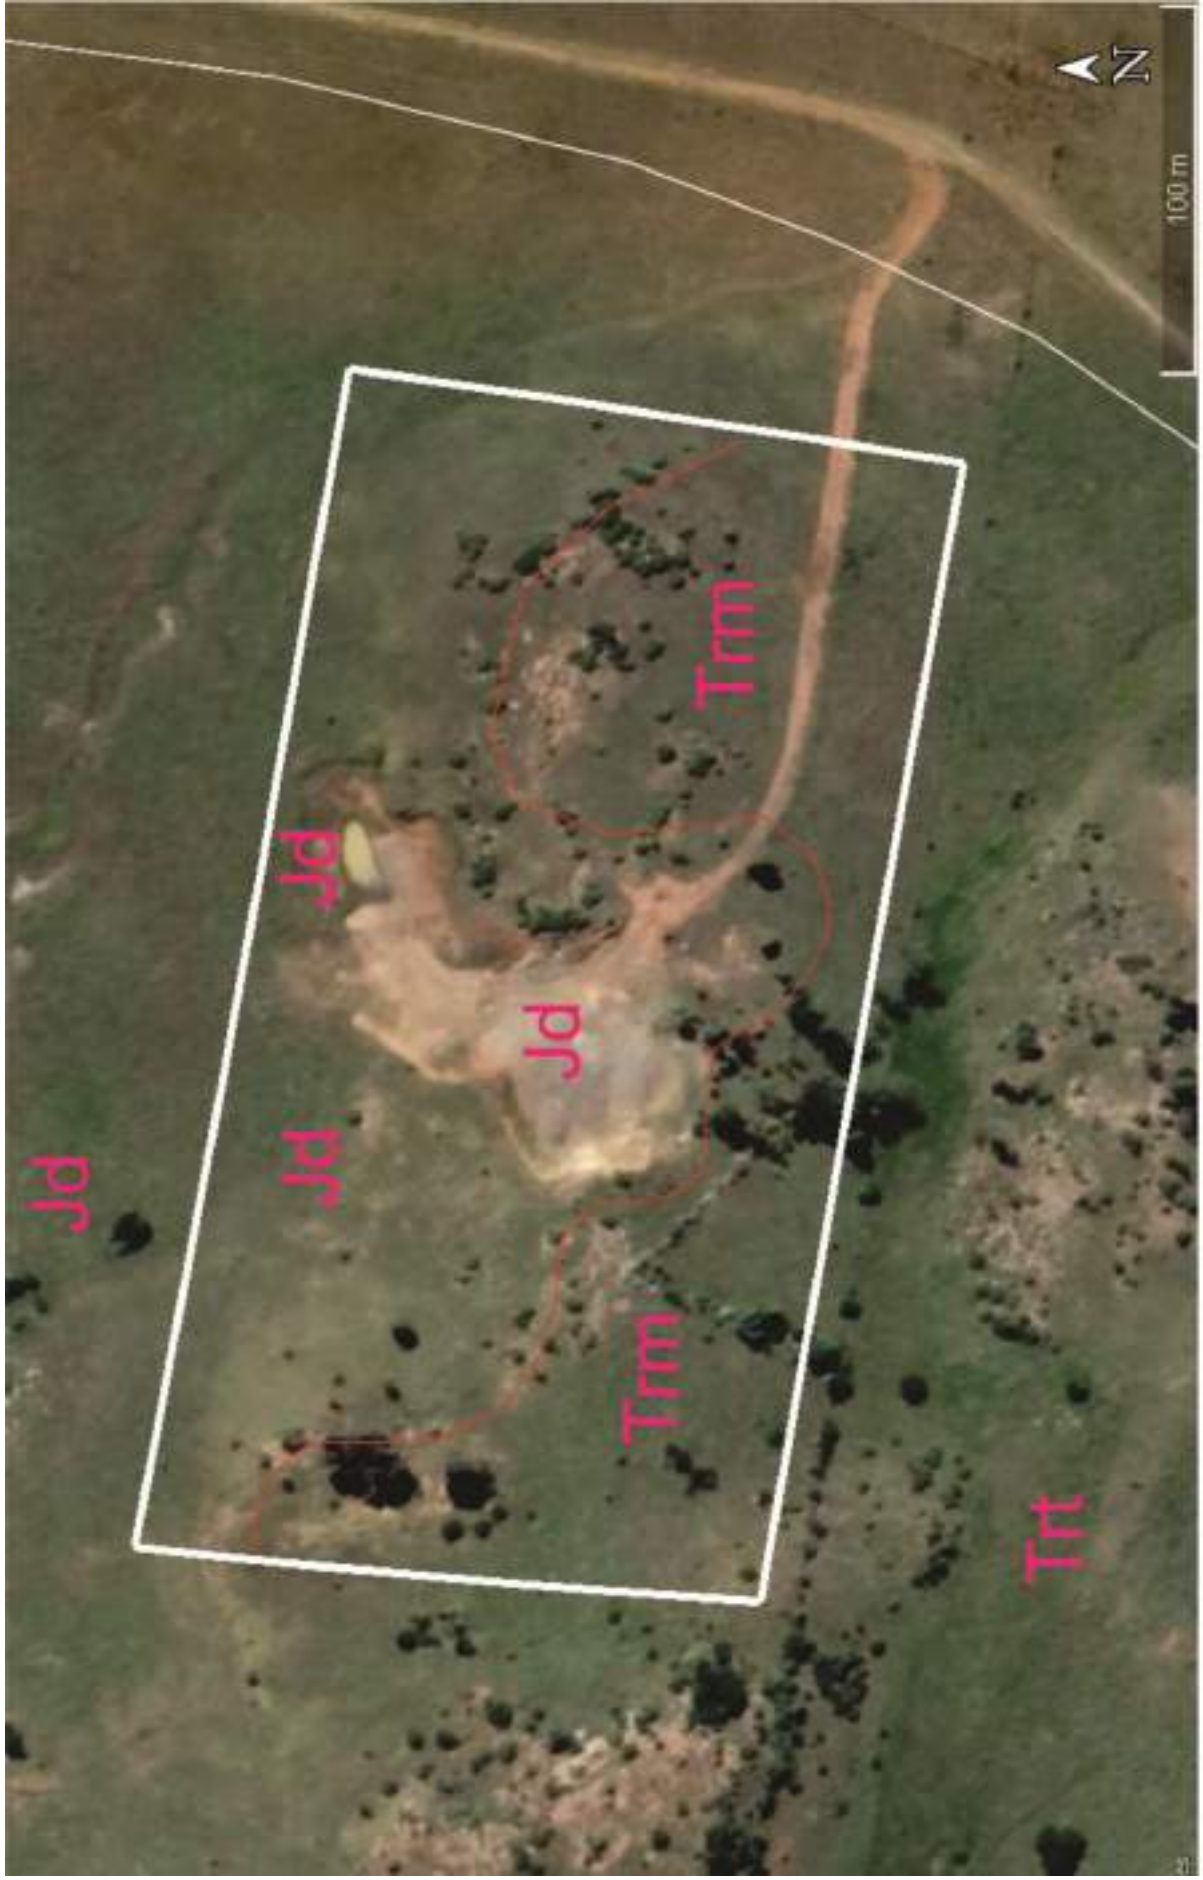
Figure 9. Distribution of potentially fossil-bearing sedimentary rock (*Trt*, *Trm*) and volcanic rock (dolerite, *Jd*) based on field assessment.

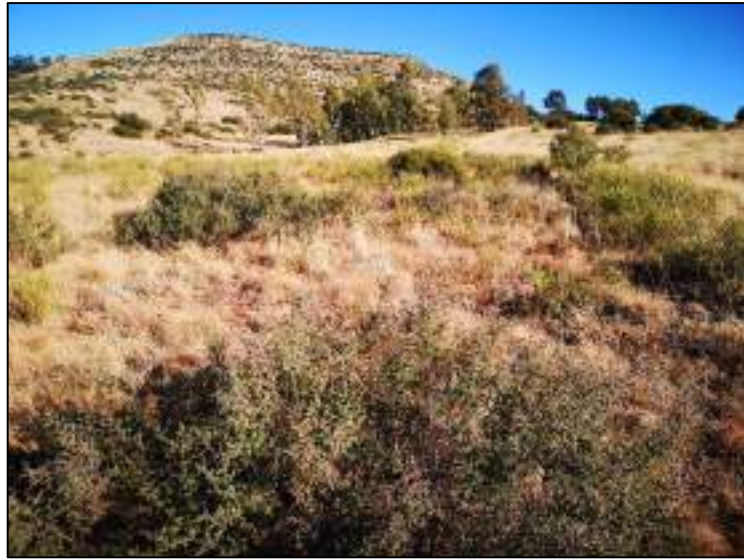
Figure 4 view of VU-A taken from the access road. The proliferation of woody and spinescent shrubs depicted by *Indigofera nigromontana*, *Seriphium plumosum*, *Chrysocoma ciliata* and *Felicia filifolia* indicate early stages of bush encroachment.

VU-A is described with a moderately well-developed grass layer consisting of pioneering to sub-climax grass species. These include *Aristida congesta*, *Chloris virgata* and *Eragrostis obtusa* widely distributed across the site but increasing in density closer to the access road and again nearing the borrow pit (Figure 4). Further up the foot of the mountain (West), the density of sub-climax to pioneering grass species increases. These include *Themeda triandra*, *Cymbopogon pospischilii*, *Eragrostis lehmanniana*, *E. chloromelas* and *Digitaria eriantha*. These species are not widespread and mainly occur in relatively dense clumps intertwined with pioneering grasses. The herbaceous layer closer to the access road is more broken, with numerous open ground patches visible that are sparsely occupied by pioneering grasses. The area closer to the access road has a greater density of woody and spinescent elements indicative of early bush encroachment (Figure 4). Numerous cattle dung heaps suggest that the site is used as a communal grazing area that experiences moderate to high grazing.

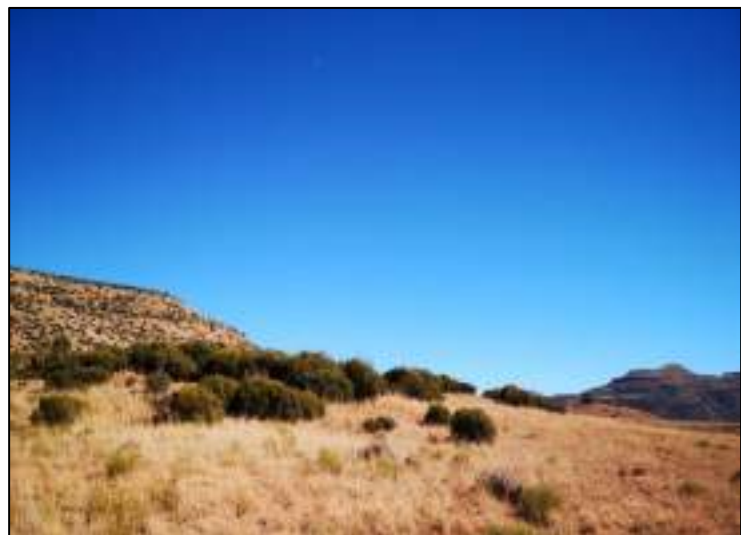
Figure 5 dense stand of medium to tall shrubs. *Searsia erosa*, and *Searsia lancea* are the most abundant shrubs in this unit.

VU-B is described as having a much greater density of medium to tall shrubs consisting of *Searsia erosa*, *S. lancea*, *S. burchellii* and *Cussonia paniculate* (Figure 5). VU-B presents shallow dolerite extrusions, which is sparsely occupied by pioneering grass species, concentrated in depressions where alluvial deposits and weathered dolerite congregate. These species are *Aristida congesta*, *Urochloa cf. panicoides* and *Chloris virgata*. The shallow weathered dolerite soils do not have much water retention potential, and thus the species occurring in this area are primarily distributed in depressions where deeper soils are deposited. A few

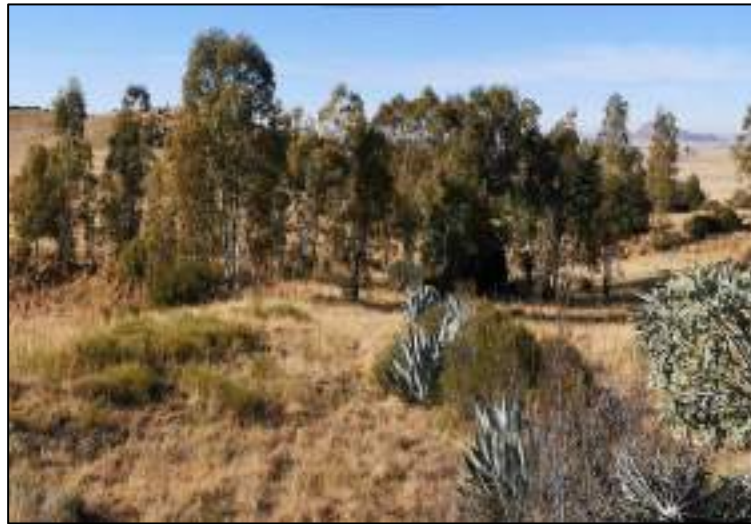
Figure 6 view of the dense stand of *E. camaldulensis* and *E. sideroxylon*. A straight line of *Agave americana* can be seen growing along a small stone wall. *C. paniculata* viewed in the right side of the photograph.

Many *Eucalyptus camaldulensis* and *E. sideroxylon* dominate this unit (Figure 6). These tall exotic trees are known to cause habitat loss, especially in mesic habitats. These trees produce allelopathic compounds, limiting the establishment of native species (Hirsch et al., 2019; CABI, 2021). The herbaceous layer is poorly developed, only represented by a few sparsely distributed pioneering species. *Aristida congesta* and *Eragrostis obtusa* represents

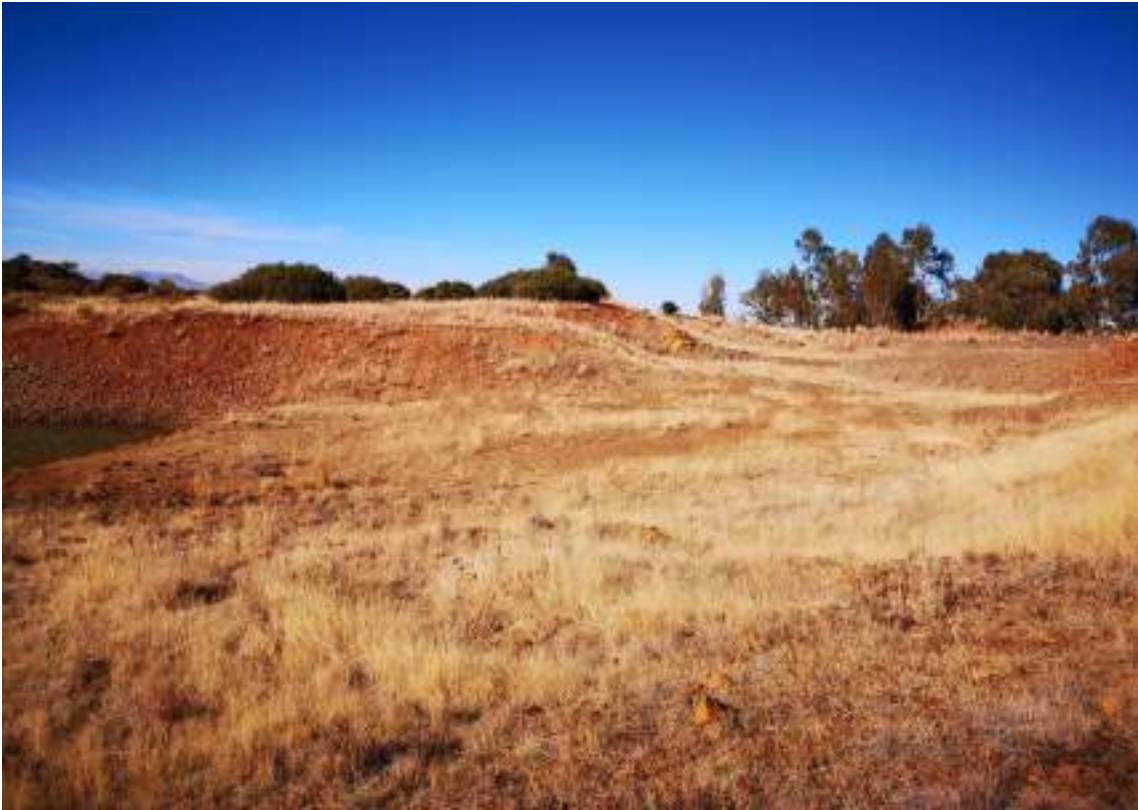
Figure 7 ground level view of the mined area. The disturbed soil has only partially been covered by pioneering grasses. Much of the mined area is left barren.

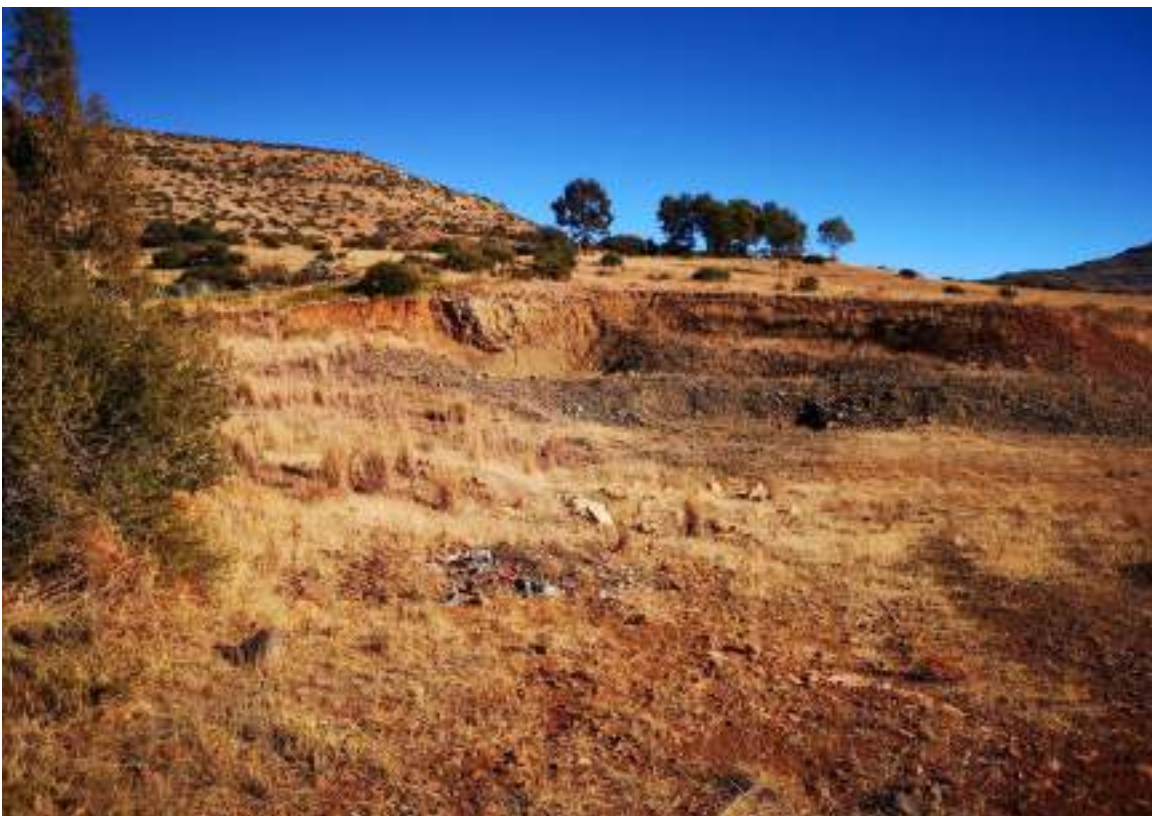
Figure 8 ground view of the mined area depicting much uncovered soil and littering.

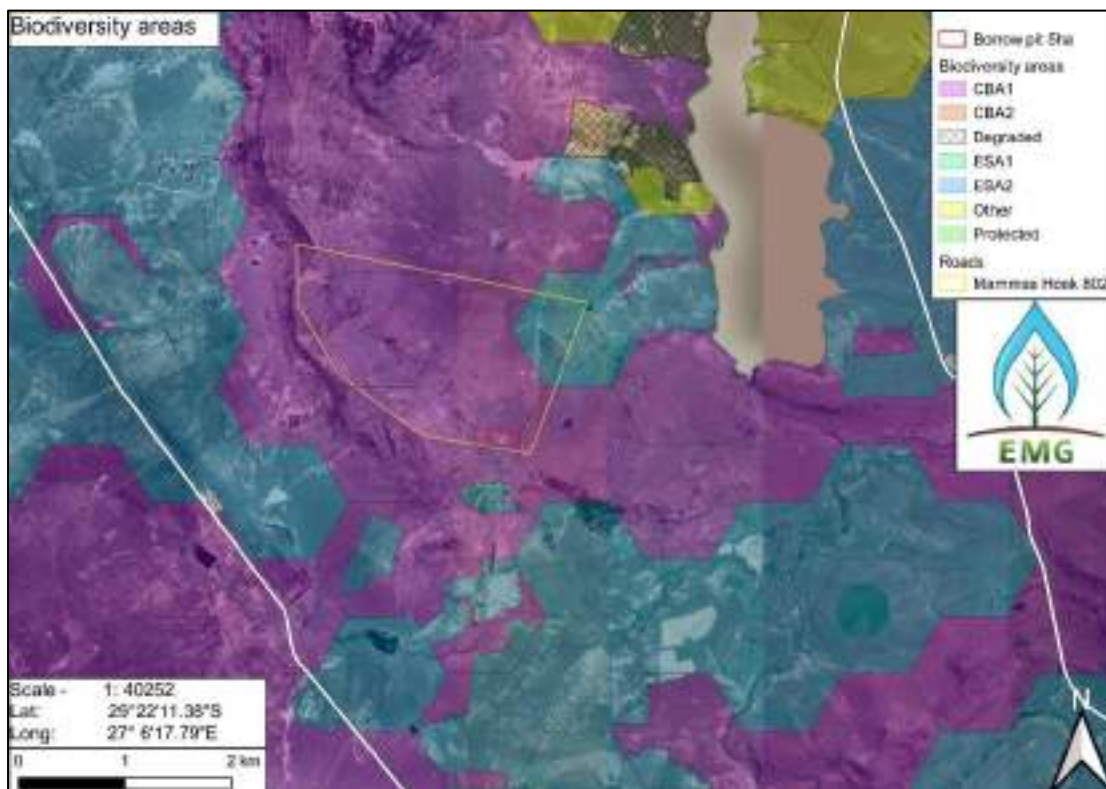
Figure 11 CBA and ESA map indicating the site's locality within a CBA1 zone.

The site is mapped within Gm5, a vulnerable vegetation type. However, it is also near Gm3, an endangered vegetation type (Mucina and Rutherford, 2006; DEA, 2016). The site is also listed in a CBA1 zone and connected to other CBA and ESA areas (Figure 11). The site's formal conservation evaluation, location within and connectivity to other CBA and ESA areas considerably raises its conservation value. At face value, it would have a high conservation priority; however, due to the transformed state of the vegetation, it cannot be associated with such a high conservation priority. Therefore, the site is considered to have a moderate conservation priority.
