Aquatic Biodiversity Impact Assessment – Riet Fountain Solar Photo-Voltaic (PV) Solar Energy Facility and associated Grid Connection Infrastructure

**Pixley ka Seme District Municipality,
Northern Cape Province**

Report Date: September 2022

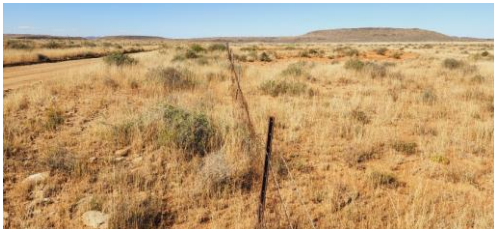
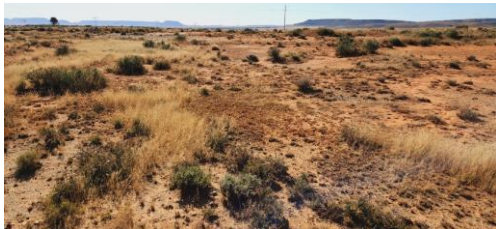
Comments	Located on the Western Tributary in the lower portion of this tributary that will be traversed by the proposed linear infrastructure (powerlines and roads). This site was presented by a wide drainage area (alluvial floodplain) with an inconspicuous channel, which was dry at the time of the survey.	
GPS-coordinates	30°38'50.53"S 24° 6'0.03"E	
Artificial Dam

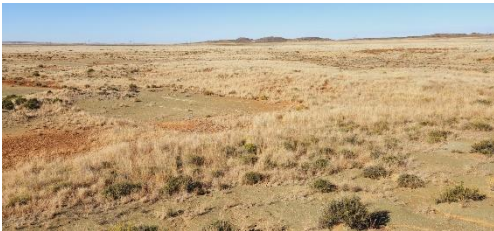
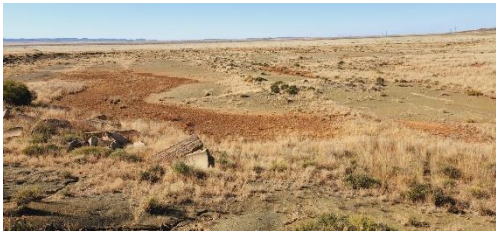
Comments	A dam located along a public road with no clear drainage lines. The dam is located adjacent to the BESS area of the PV area. The dam is considered artificial and a result of the presence of the road. The site was dry and considered to have low aquatic ecology importance or sensitivity due to its artificial nature.	
GPS-coordinates	30°41'20.69"S 24° 8'52.01"E

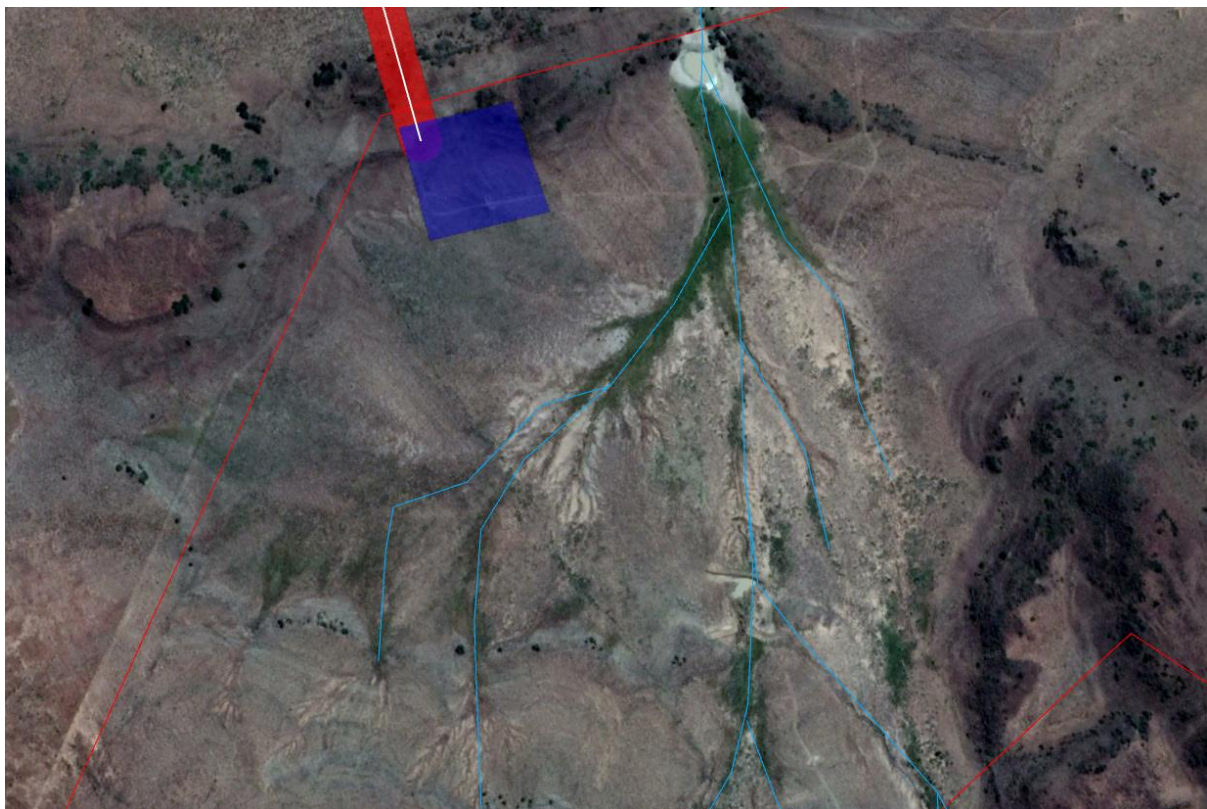
Figure 5-2 Illustration of the alluvial fans (green areas) in wet periods (Google Earth 3/2017)

The on-site assessment of the watercourses presented largely dry conditions, with the numerous ephemeral systems presenting no clear banks or riparian features which is typical for watercourses in an arid region (Figure 5-5 and Figure 5-4). Many of the drainage features presented as alluvial fans that have formed in the low laying areas below mountain slopes or gorges due to the flat topography and low water energy that has resulted in the accumulation of alluvial sediment. These areas are broad presenting as wide floodplain-like features which are difficult to observe in-field and are best seen from satellite imagery (Figure 5-3, Figure 5-5 and Figure 5-4). These drainage areas are highlighted in times of good rainfall when the vegetation cover is greatest from inundated soils, with an example from March 2017 imagery highlighting the extent of these areas (Figure 5-2). The areas are prone to flooding during large storm events and may remain saturated for several days to weeks, depending on the permeability of the soils and climate conditions. These areas are important for groundwater recharge.

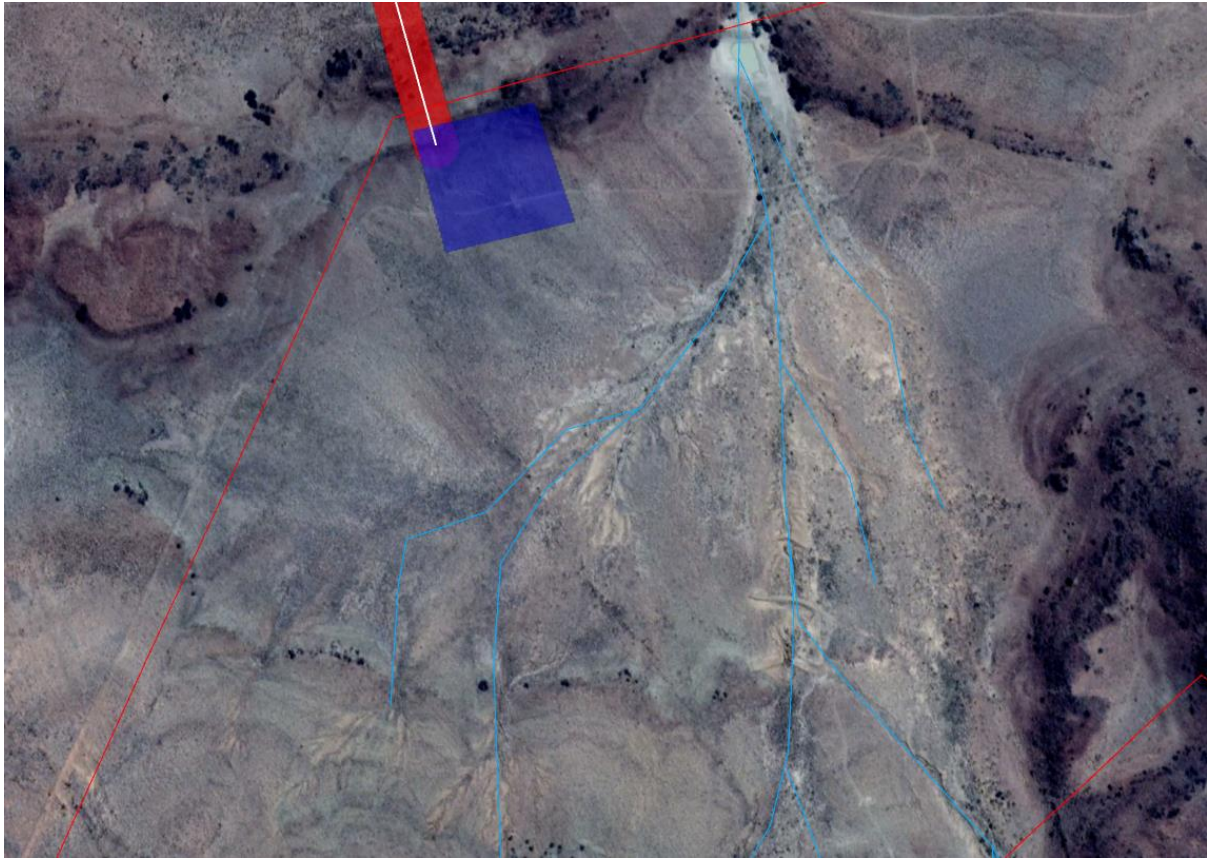
Figure 5-3 Illustration of the alluvial fans in dry periods (Google Earth 4/2020)

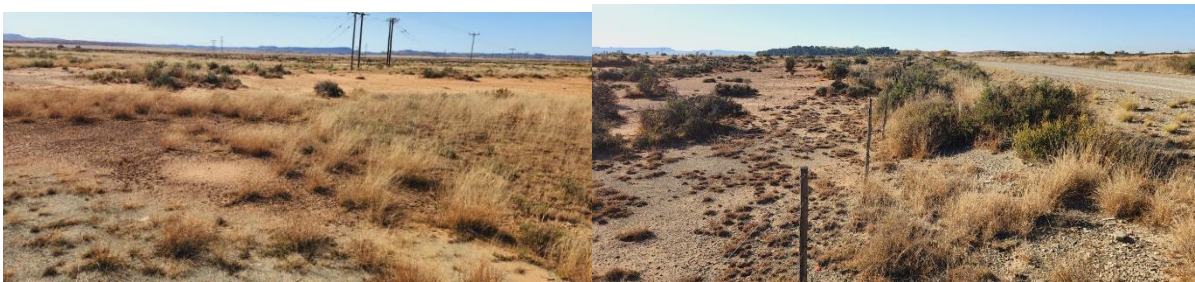
Figure 5-4 Illustration of the ephemeral habitat features of the Western tributary (June 2022)

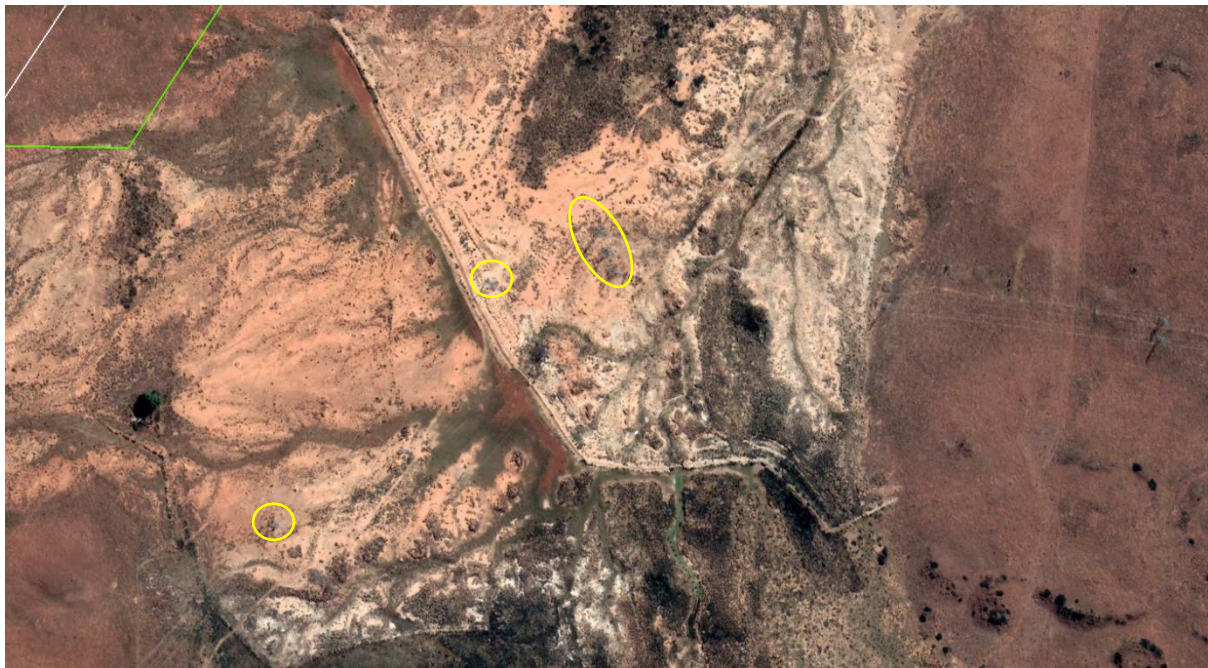
Figure 5-6 Illustration of existing instream weirs structures and powerline pylons (yellow circles) within the drainage features (Google Earth)

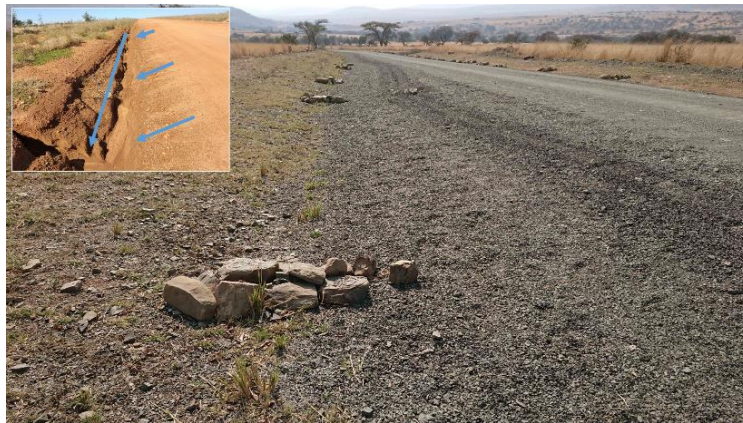
- Energy dissipation, such as stone berms or blocks must be strategically placed along the road margins for the entire road network as surface runoff leaves the roads and enters the surrounding environment with the potential for severe erosion. The steeper the slope of the road, the more regular the berms should be spaced and can be as close as one meter apart where necessary;

Figure 6-3 Example of road margin erosion prevention
