Riparian Delineation

*PROPOSED AGGREGATE QUARRY OPERATION
LOCATED ON PORTION 16 OF THE FARM HERMANUS KRAAL
EZAKHENI DISTRICT OF LADYSMITH, KWAZULU- NATAL*

January 2012

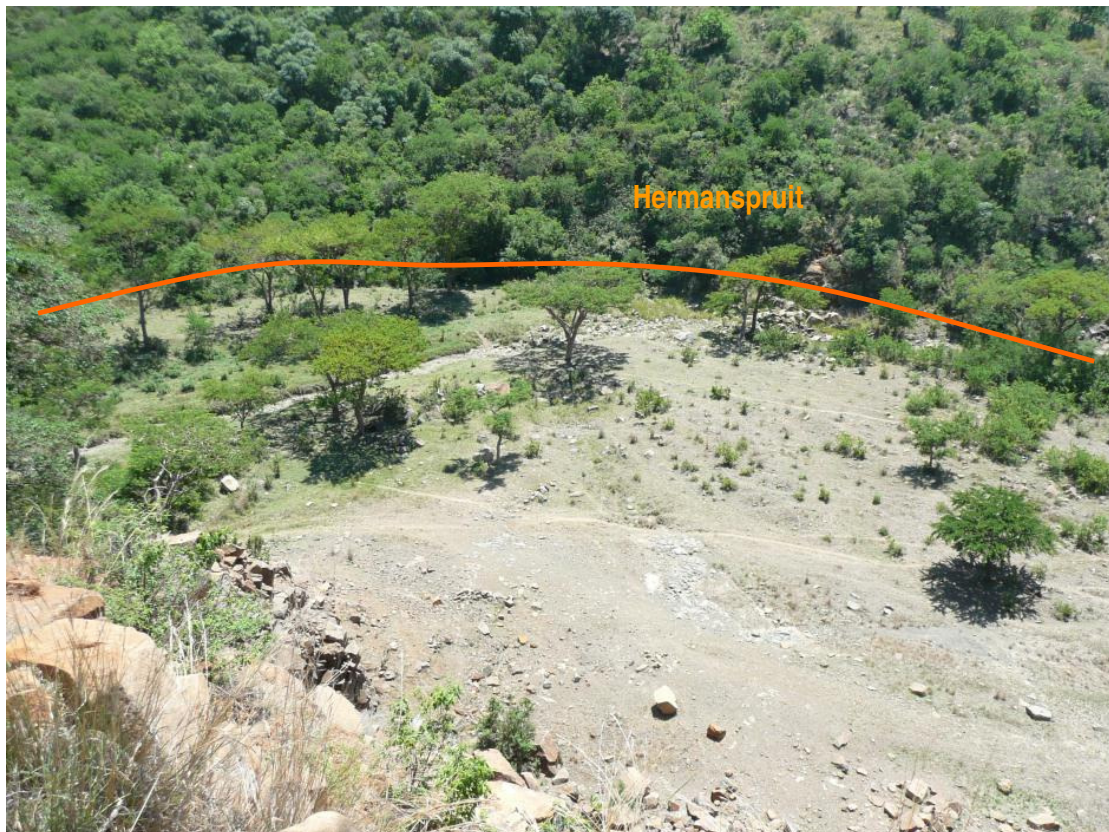
The Hermanspruit stream is located to the north of the proposed aggregate quarry site. This watercourse runs down the Hermanspruit Valley in the west, and into the Klip River to the east. The Hermanspruit is outside the boundary of the proposed mining site, however it is in close proximity to the site and therefore has the potential to be impacted upon during mining activities.

Photograph 1. Note the Hermanspruit stream flowing near the northern boundary of the mining site.

The Hermanspruit is currently in a stable condition, and no wetland areas occur within the mining area. In order to safeguard the riparian habitat, it is recommended that the Hermanspruit be afforded a 30m buffer from the edge of the macro-channel embankment. See the map of the buffered stream in Appendix A.

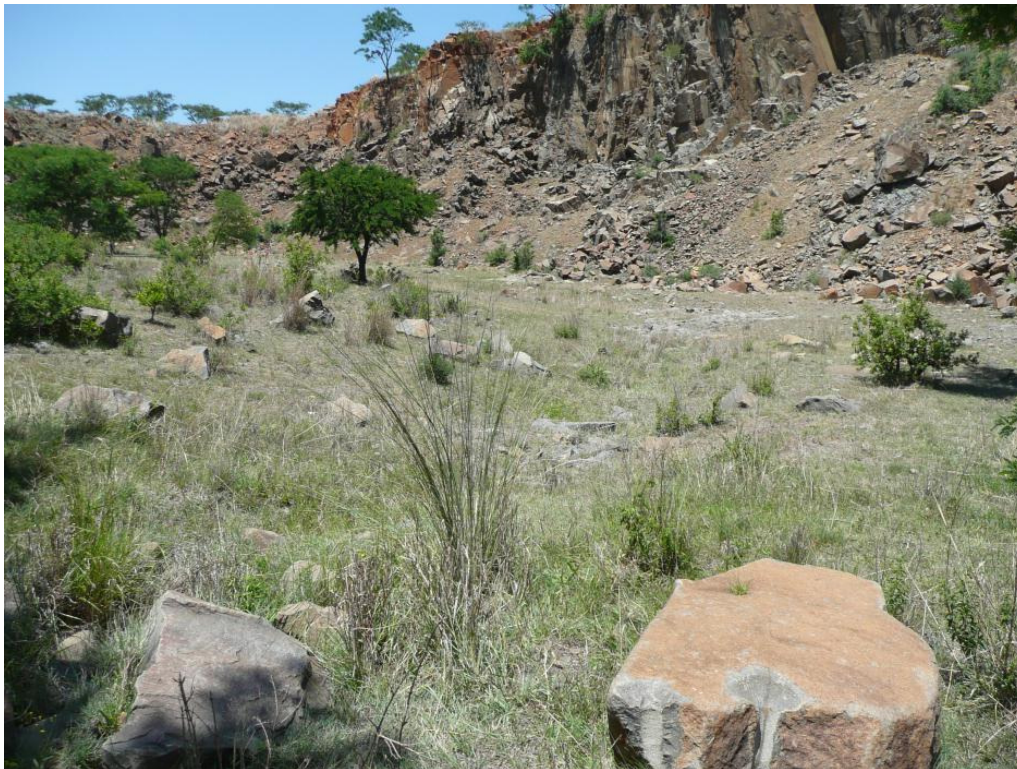
Photograph 2. From the Hermanspruit, looking back towards the mining site.

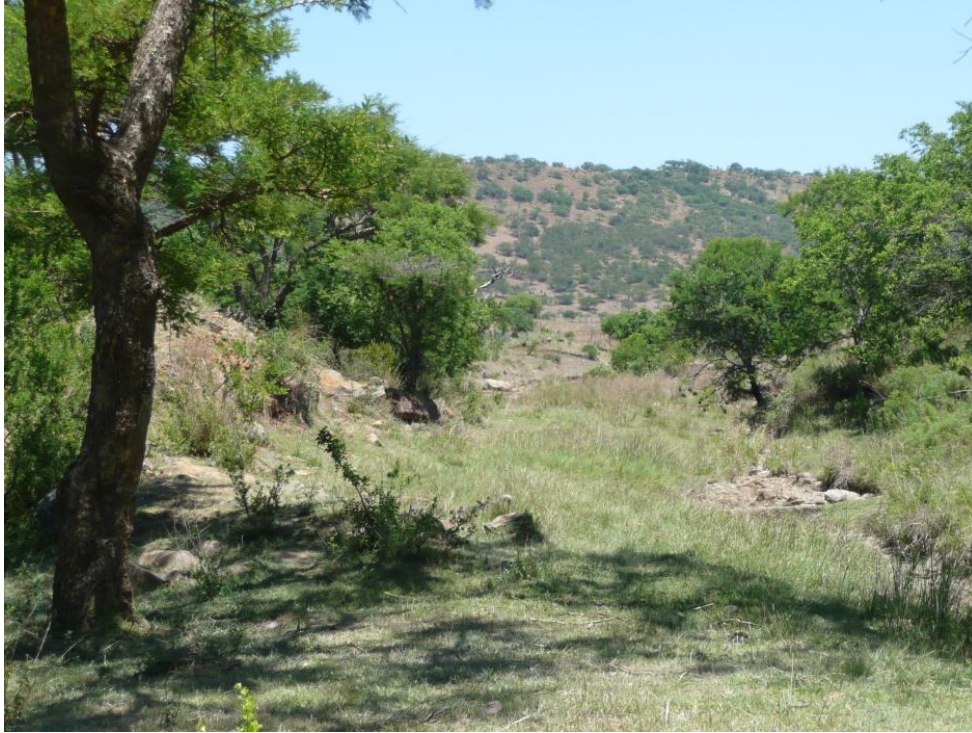
Photograph 3. Looking west, upstream.

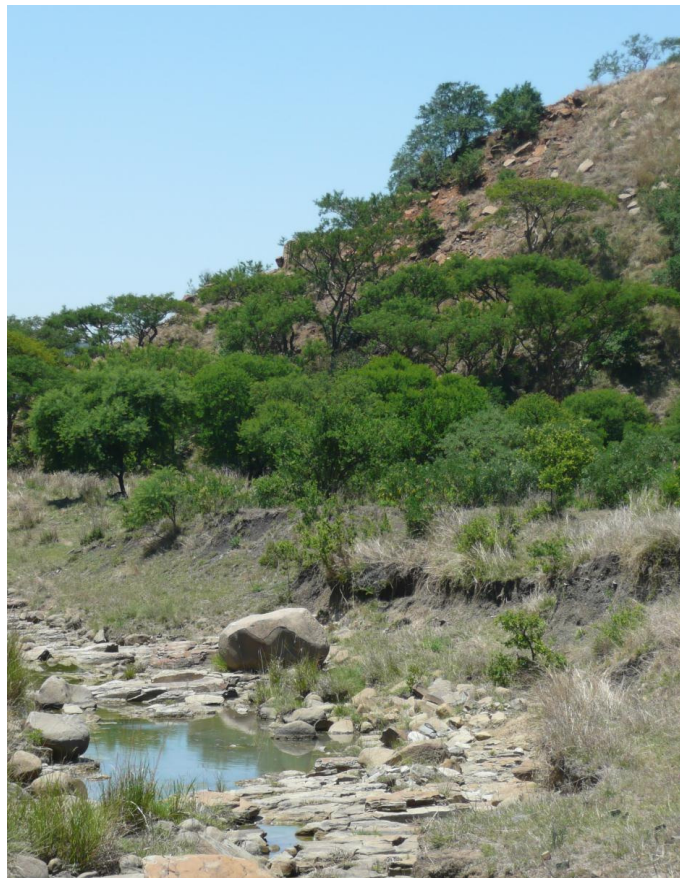
Photograph 4. Looking east, downstream.
Note the clearly evident macro-channel embankment.

The mining site was operational in the 1950's, at which time the stream bank was subjected to minor earthworks. During the 50-odd years the mine was abandoned, riparian vegetation recovered well and the Hermanspruit appears to be in a stable, natural state. However, the past earthworks have formed a defined macro-channel embankment, which clearly delineates the boundary of the stream (see photograph 3 above).

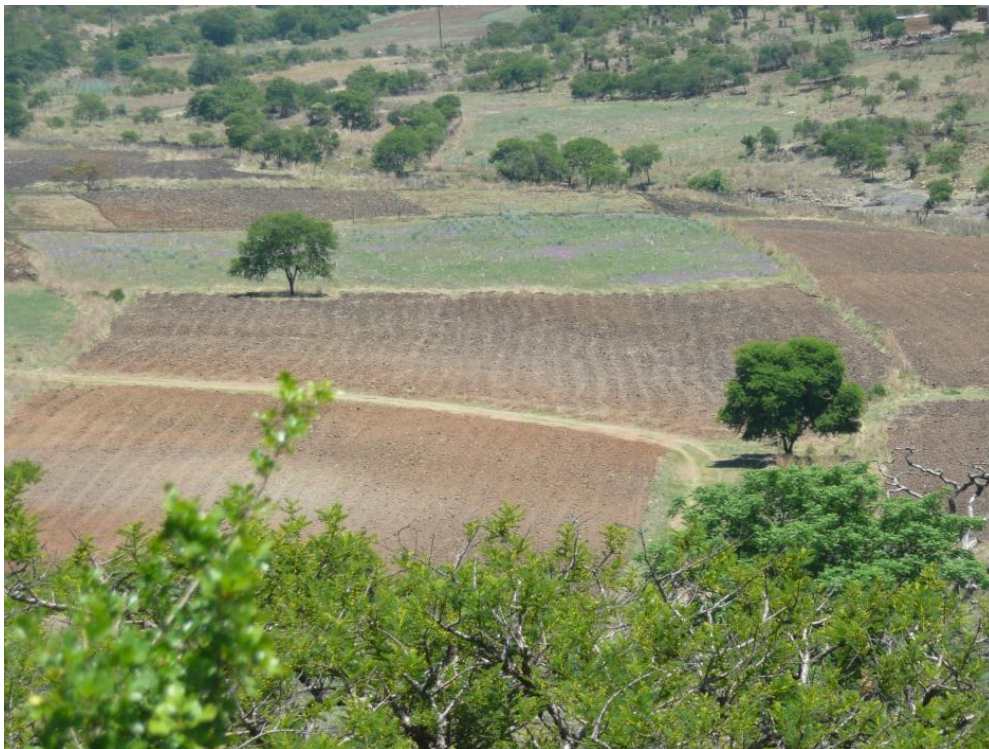
No wetlands exist within the immediate mining site, however the access road traverses a wetland relic area. This wetland area is deemed to be a 'relic' as the system has been highly modified by cultivation and the functional health compromised. See the photographs below.

Photograph 5. Wetland totally transformed by cultivation.

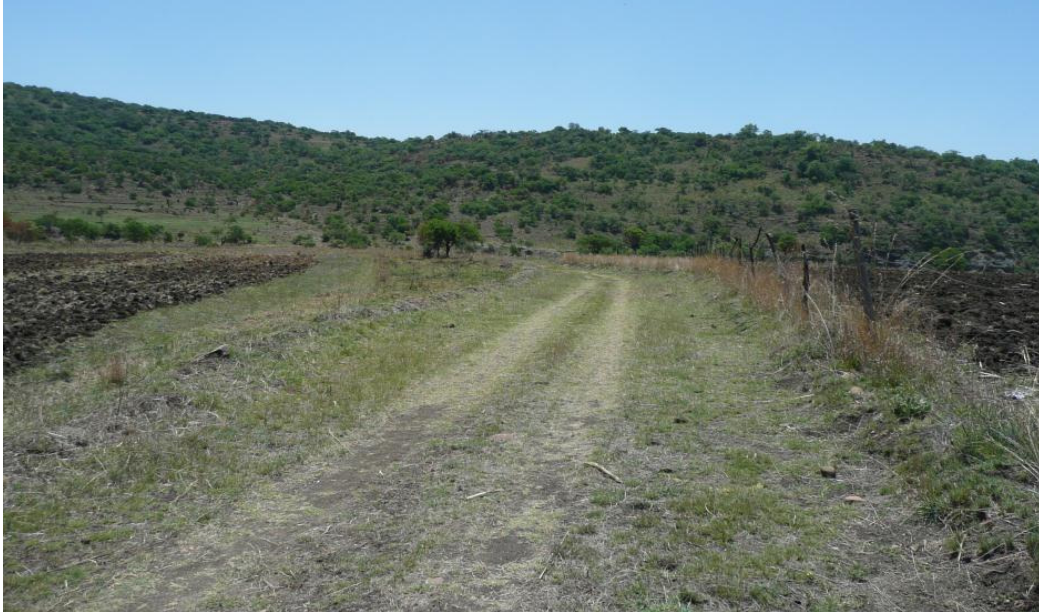
Photograph 6. Access road through wetland area.

Upon decommissioning of the mining site, if the access road no longer serves a purpose, it should be ripped and hydro-seeded with appropriate, robust wetland species.

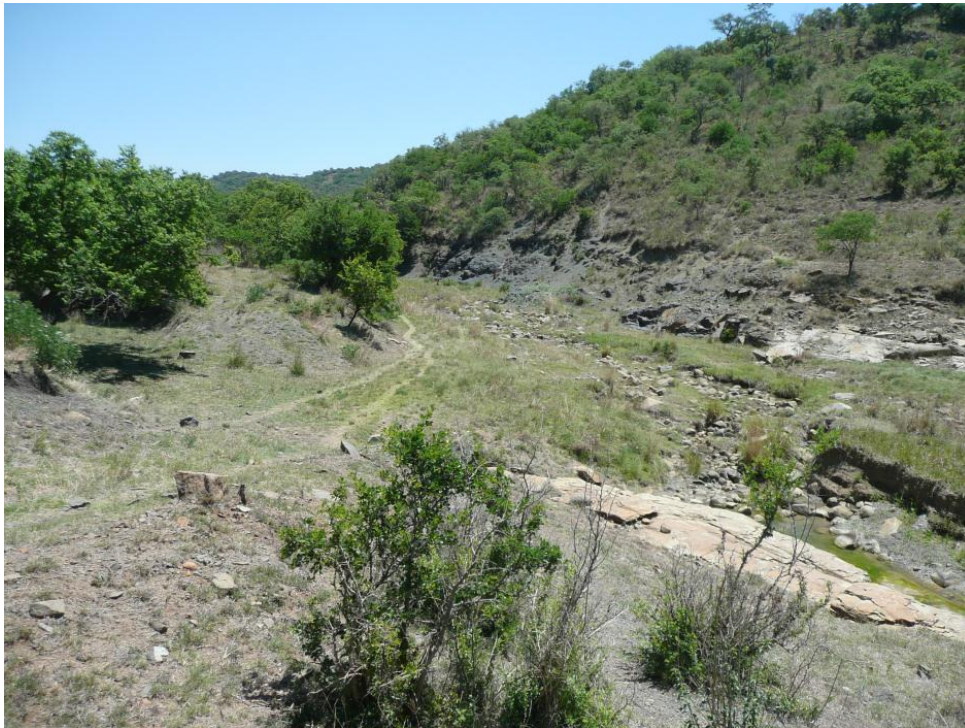
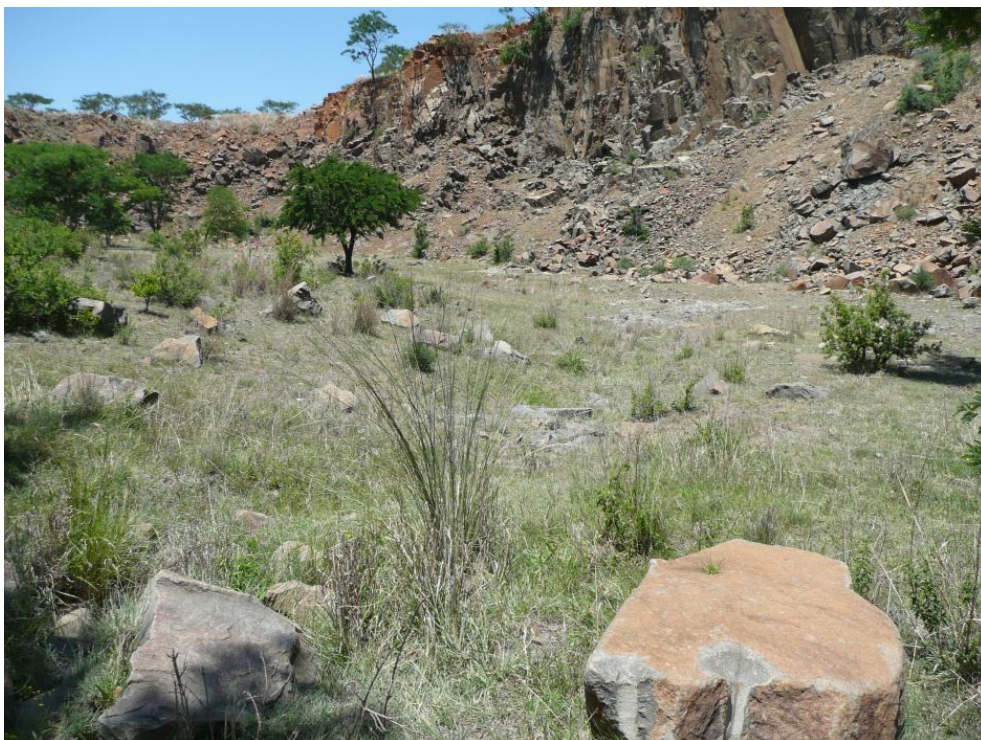
Photograph 6 and 7. Areas where sandbags and diversion berms are to be located.

In order to avoid siltation of the Hermanspruit with stormwater runoff from the mining site, sandbags should be placed at two locations within the riparian buffer zone, as indicated on the map in Appendix B and photographs below. The sandbags should be positioned along the contour such that they filter stormwater runoff before it enters the stream.
