CHAPTER THREE: DESCRIPTION OF THE AFFECTED ENVIRONMENT

The provisional development proposal entails the development of an additional approximately 300 hectares on the Remainder of Farm 82 Wolve Kop (~908 ha), Portion 1 of Farm 77 Wellshaven (~22ha) and Portion 3 of Farm 77 Honeyvale (~128ha) for agricultural purposes. The expansion of the agricultural infrastructure of the farm will include the clearing of indigenous vegetation, landscaping and levelling the site for citrus orchards, installation of water reticulation and irrigation infrastructure, construction of a balancing dam, the establishment of unpaved access roads and the establishment of windbreaks (Detail in Chapter 2).

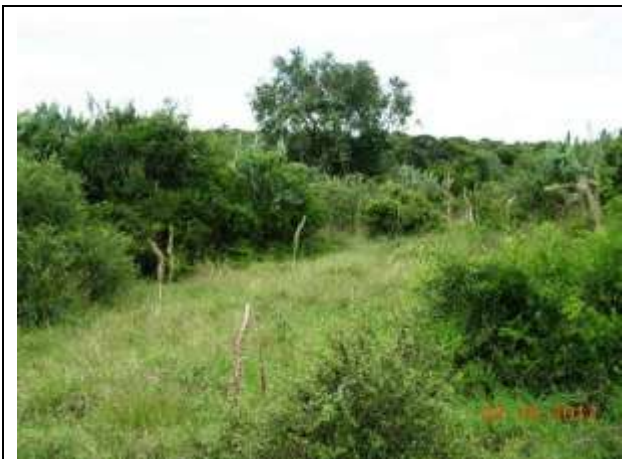
Photo 3.3. Broad grassed swale, which represents the drainage line in the eastern valley in the study area.

The main drainage features on the site are two broad valleys that run the length of the site, and drain the northern portion of the study area. These are broad low lying grassed swales, rather than typical watercourses with well-defined channel and riparian areas. While these drainage features are not characterised by a continuum of hydrophytic vegetation; accumulations of surface water at certain points within these remain for long enough for wetland conditions to establish. In view of the above; these valleys may represent watercourses as defined in terms of the National Water Act, 1998 (Act 39 of 1998). As indicated above, these eventuate into the Coerney River in the southern portion of the site. The Coerney River flows in an East-West direction, and traverses the entire River Bend Citrus farming operation.

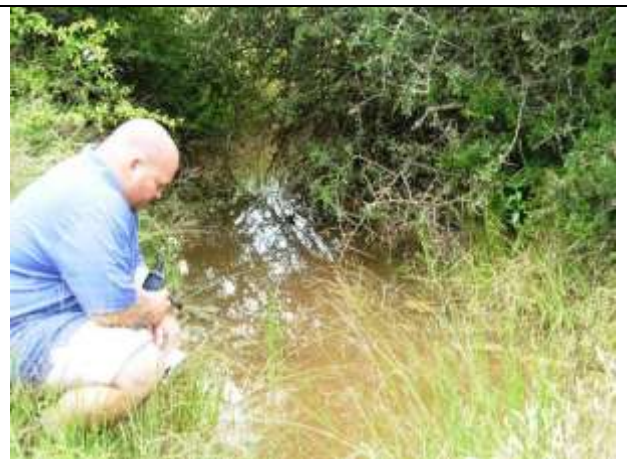
Photo 3.4. Ponding of runoff in a depression along the eastern drainage line leads to the establishment of hydrophytic vegetation.

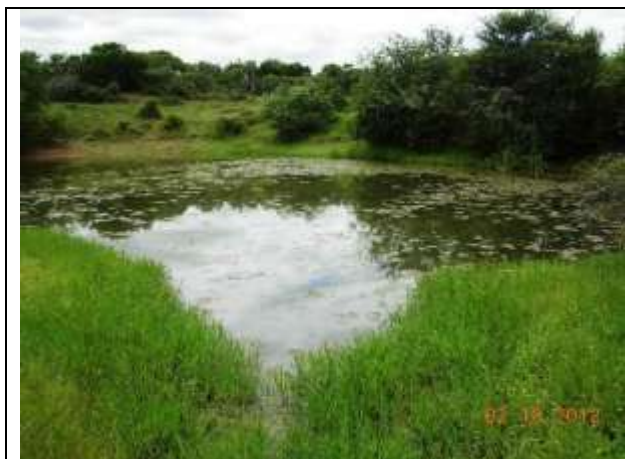
Photo 3.5. Dam / pan associated with the western drainage line.

The site visit revealed that there are a number of dams and potential wetland areas, particularly in the northern portion of the site. These are predominantly areas where runoff has been artificially impeded by the creation of man-made berms or dam walls. It is not known whether these dammed features were originally natural ephemeral pans prior to human intervention. At least 5 such dams / pans were noted at the site. Notwithstanding their origins, these features contain standing water, and associated hydrophytic vegetation, e.g. sedges / rushes, as well as aquatic fauna such as frogs and terrapins. The conservation value, as well as the requirements of the National Water Act as it pertains to activities near such features will need to be considered by the wetland specialist in the EIA phase of the assessment.

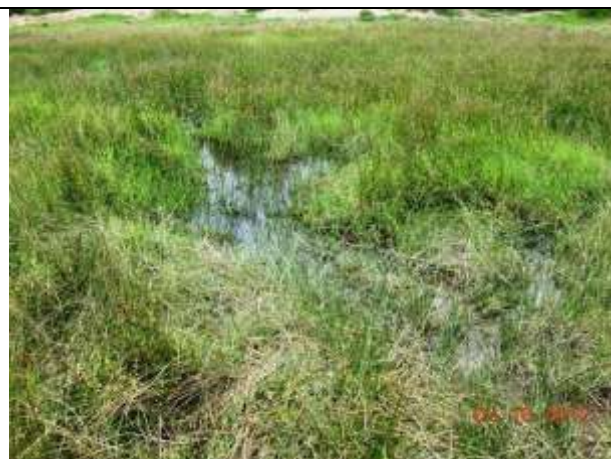
Photo 3.6. Sedges and hydrophytic grasses in a pan in the central portion of the site.
