Wetland Assessment for alluvial diamond mining operations on Portion 1 and the Remaining Extent of the Farm Rooidam 101 near the town of Windsorton, Northern Cape Province.

February 2016

Executive Summary

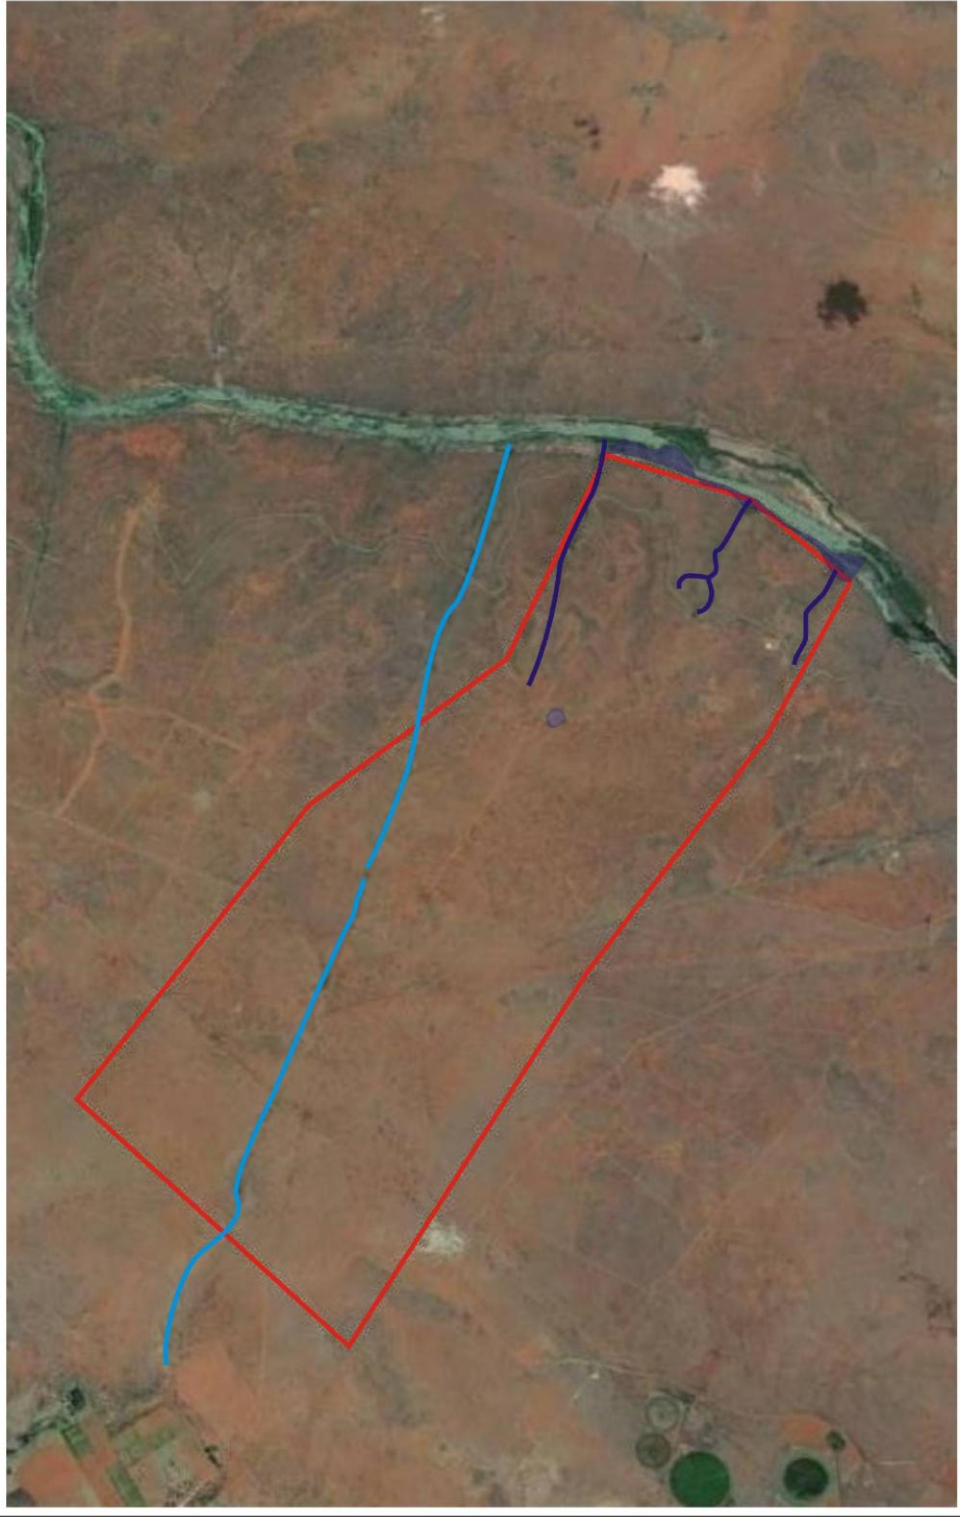
Surface water of the proposed alluvial diamond mining operations on Portion 1 and the Remaining Extent of the Farm Rooidam 101 near Windsorton, Northern Cape Province.

Map 2: Surface water features of the proposed alluvial diamond mining operations on Portion 1 and the Remaining Extent of the Farm Rooidam 101 near the town of Windsorton, Wetland areas are associated with the floodplain of the Vaal River, Seasonal streams and ephemeral pan. The seasonal streams within the interior of the study area is also indicated.

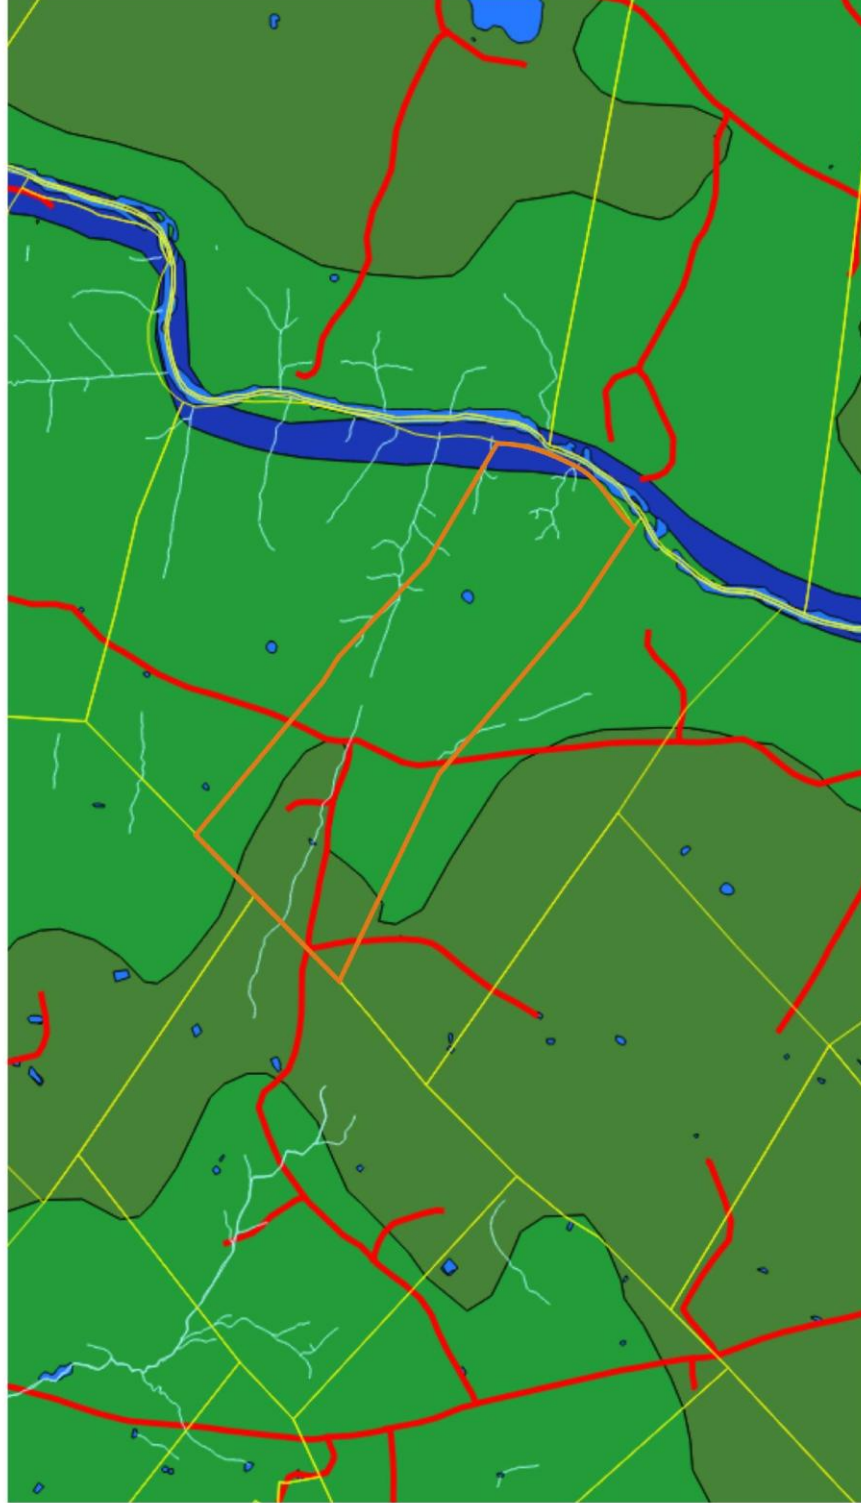
Broad ecology of the proposed alluvial diamond mining operations on Portion 1 and the Remaining Extent of the Farm Rooidam 101 near Windsorton, Northern Cape Province.

Map 3: Broad ecology of the proposed alluvial diamond mining operations on Portion 1 and the Remaining Extent of the Farm Rooidam 101 near the town of Windsorton, Northern Cape Province. No Threatened Ecosystems, Important Bird Areas or other significant areas occur in the study area.

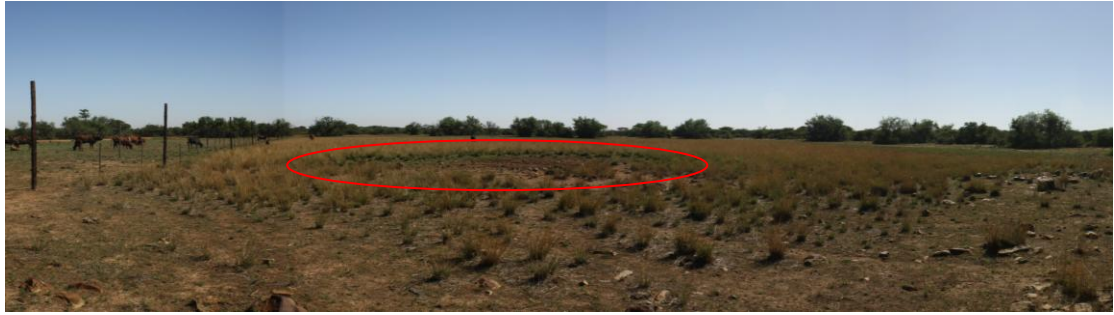
Figure 1: Panorama of the ephemeral pan within the study area. Note dominance of wetland grass, *Diplachne fusca*. The centre (red circle) contains an area of higher moisture regime.

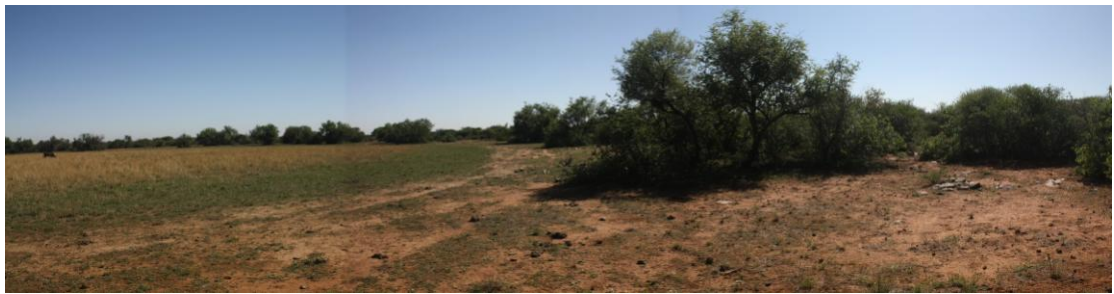
The ephemeral pan within the interior of the site is largely intact although trampling by domestic stocks is high and has lead to degradation of the pan to some extent. As this is a grassy pan and collects water it is favoured by stock which then cause high levels of trampling. Natural fauna such as game do not cause this level of trampling as they are not as dependant on water as livestock. Despite the high level of trampling the pan is still considered relatively intact and natural.

Figure 2: Panorama of the ephemeral pan. Note the fringe of riparian trees around the pan.

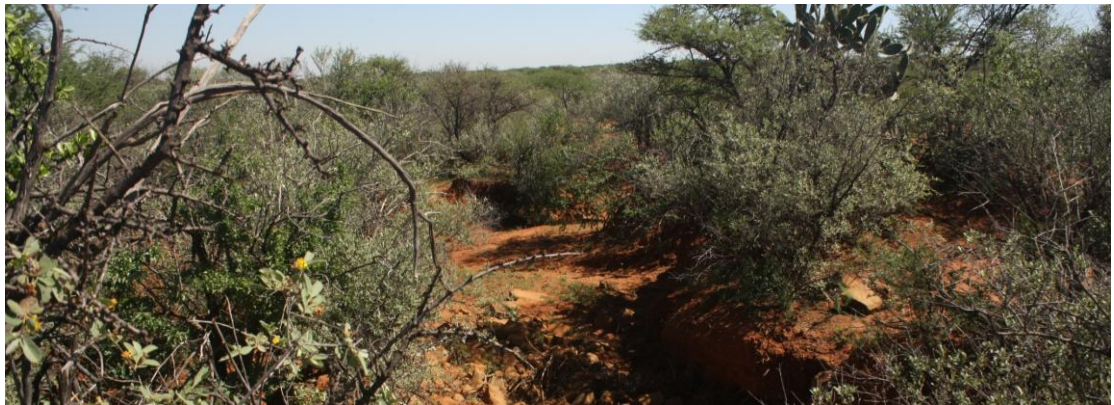
Figure 3: View of the seasonal stream within the interior of the study area.

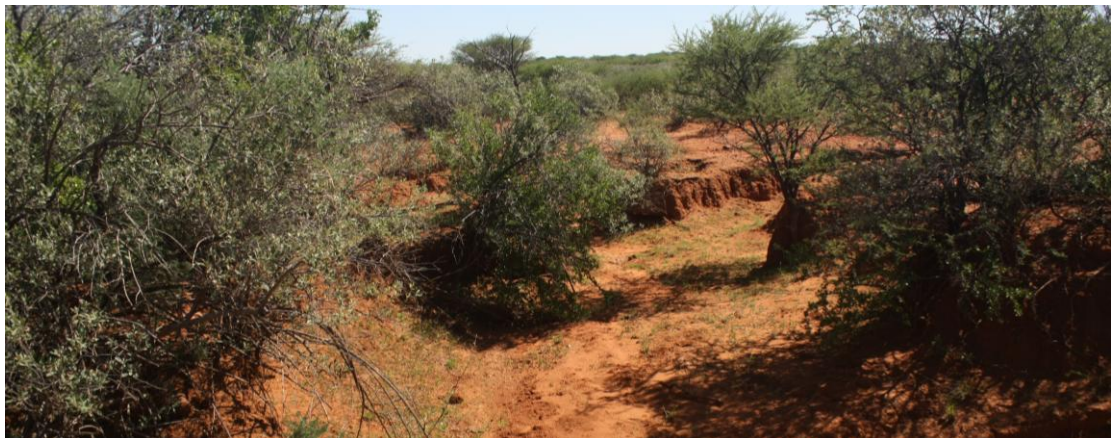
Figure 4: View of the seasonal stream within the interior of the study area.

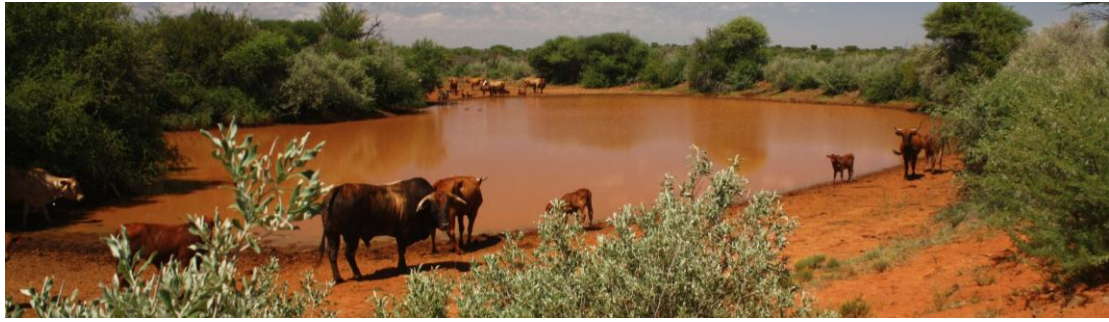
The two interior seasonal streams are largely intact with few impacts. Several artificial dams have been constructed in the main channel of the streams. This has caused alteration in the flow characteristics and flooding of the streams. These are considered the most relevant impacts on the streams.

Figure 5: Artificial dam constructed in the seasonal stream.

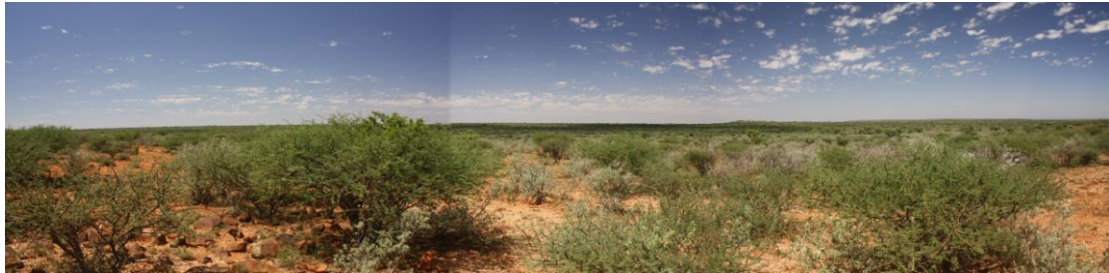
Figure 6: Panorama of the region within the interior of the study area. Note the relatively flat topography.

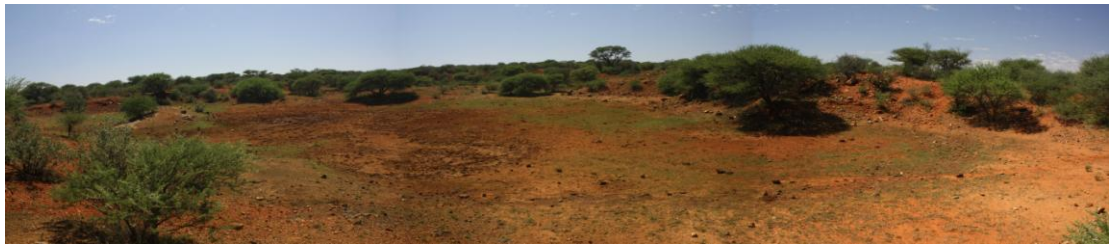
Figure 7: Historical excavation within the interior of the study area which does not represent a waterbody.

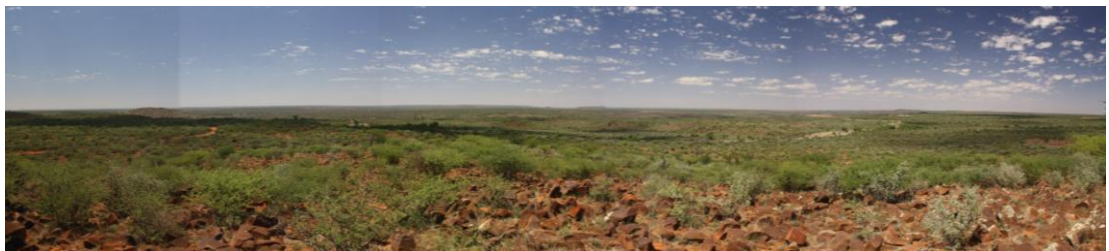
Figure 8: Panorama of the eastern portion of the study area where the terrain is uneven with low hills and ridges and promotes the formation of ravines and streams.

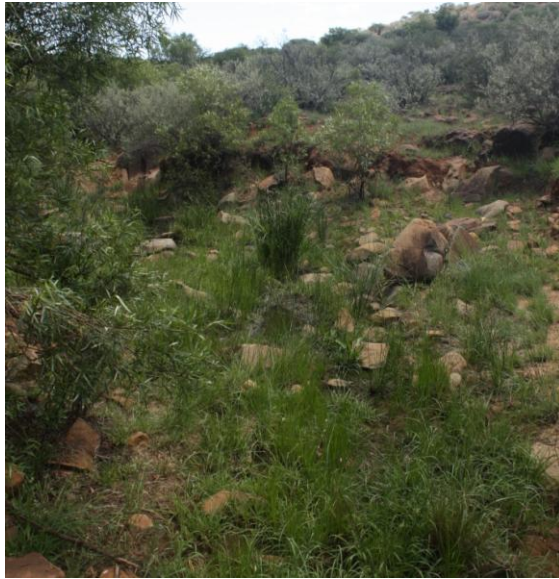
Figure 9: View of the seasonal stream within the northern portion of the study area supporting a diversity of wetland vegetation species.

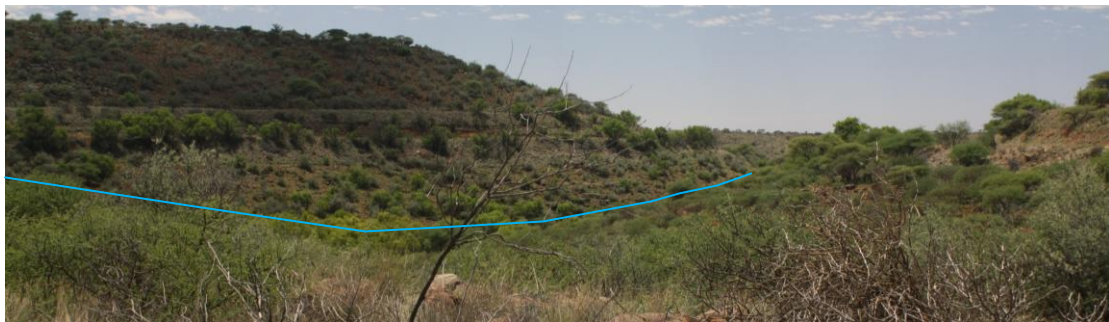
Figure 10: View of the seasonal stream within the northern portion of the study area (indicated in blue).

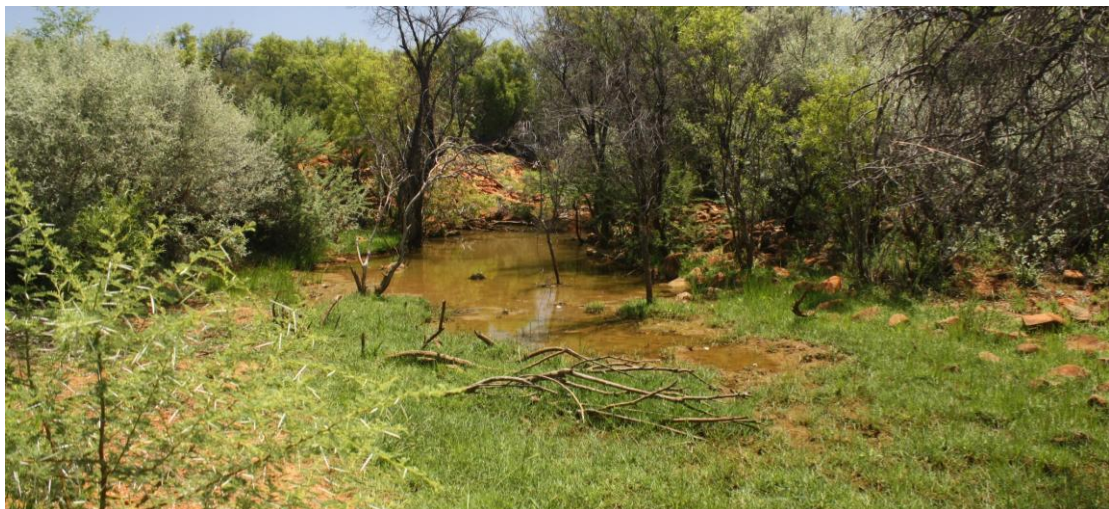
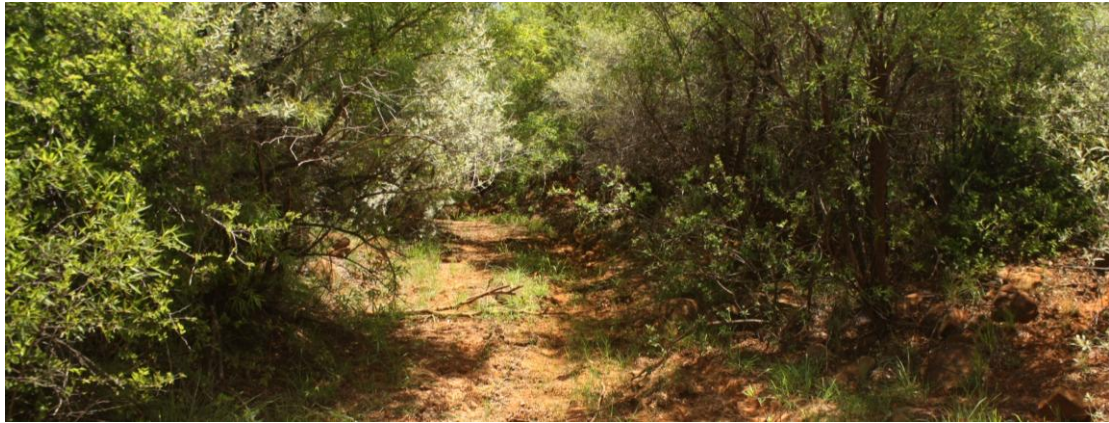
Figure 11: View of one of the seasonal streams in the southern portion of the study previously affected by historical mining.

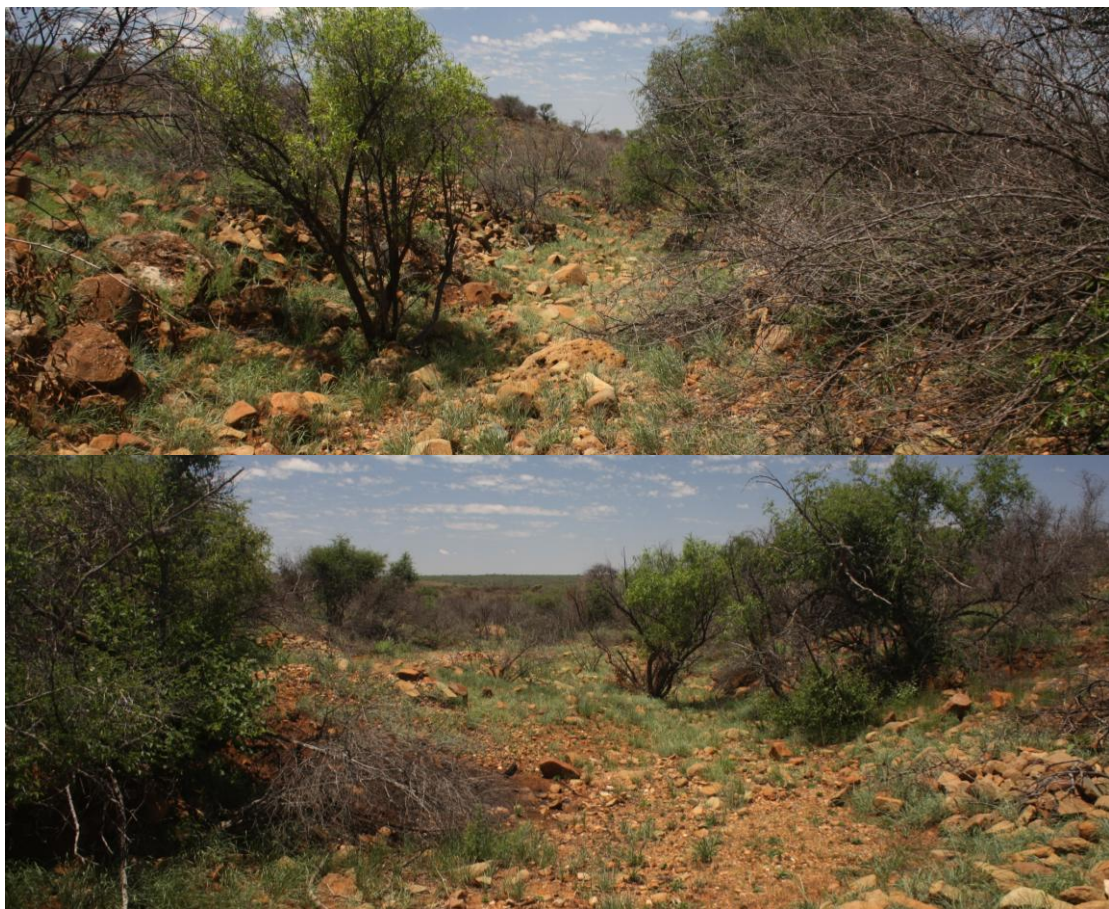
Figure 12: View of the other seasonal stream within the southern portion of the study area. This stream has been heavily affected by previous historical mining.

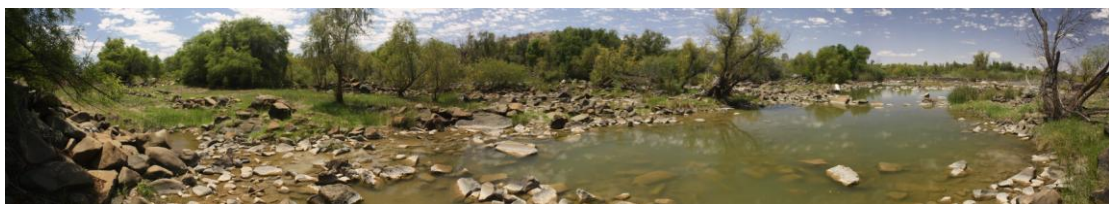
Figure 13: Panorama of the Vaal River in the study area. This area contains extensive floodplain also considered wetland areas. Historical mining has however affected a large portion of this area.

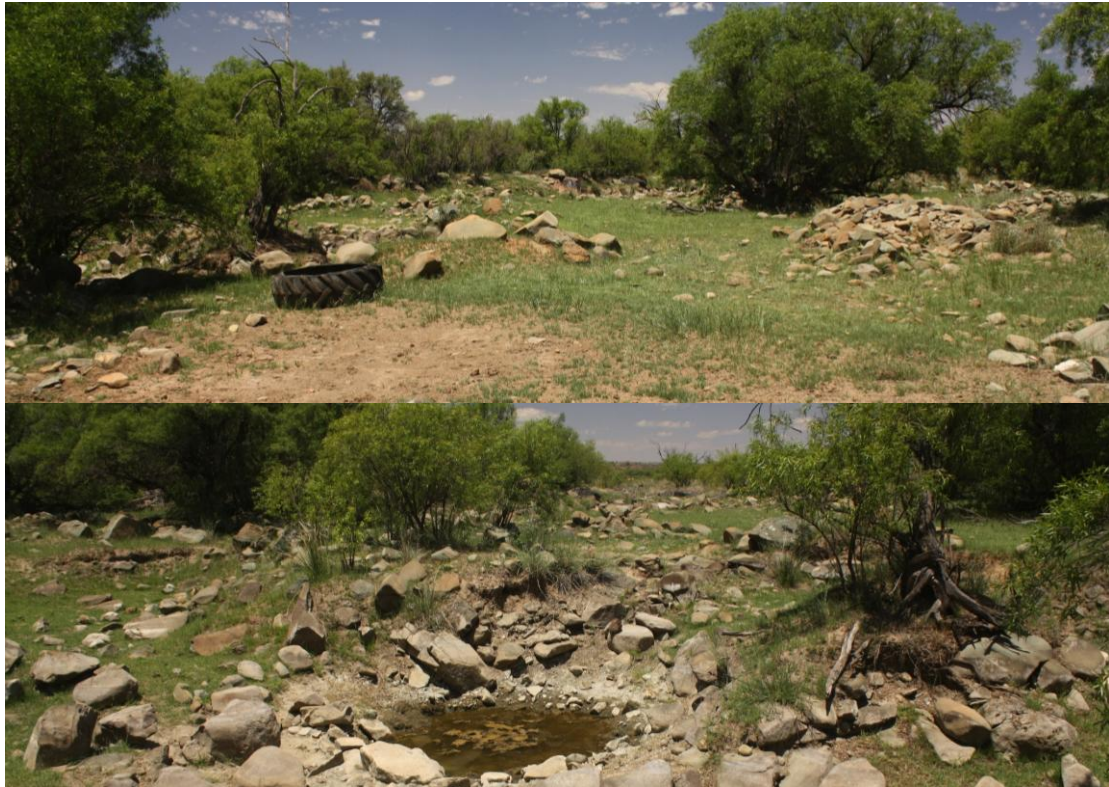
Figure 14: The lower zone of the Vaal River. Note the disturbance caused by historical mining operations.

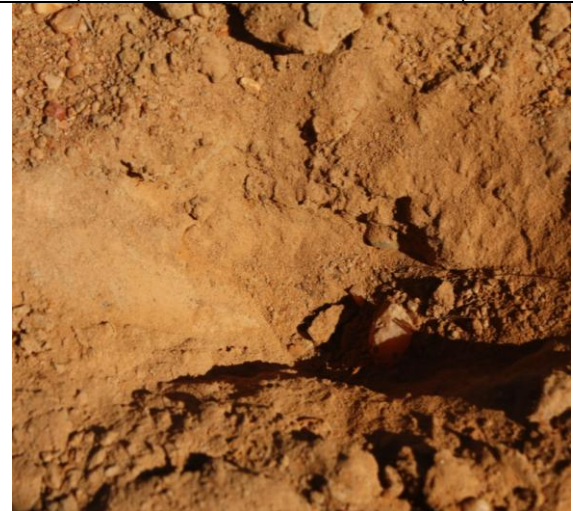
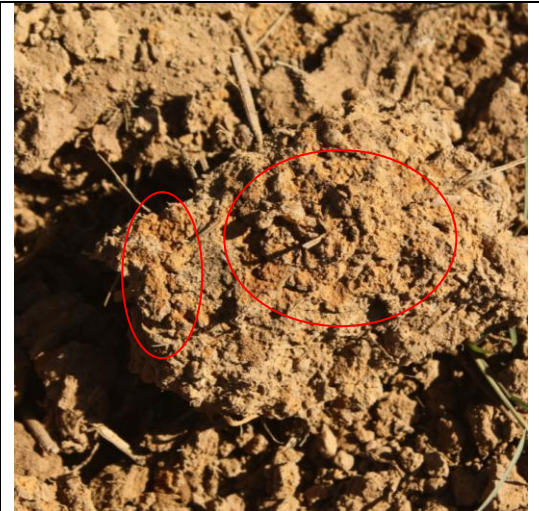
Table 2: Soil samples taken within the ephemeral pan within the interior of the Rooddam study area (S 28° 13' 57.38" E 24° 41' 58.66").

<p>Soil sample taken outside the pan but within the riparian periphery of the pan. The soil does not contain a prominent grey matrix or any mottles and is not considered as a wetland area.</p>	<p>Soil sample taken within the pan. The soil contains a somewhat grey matrix with numerous mottles. It may be considered as part of the seasonal zone of wetness. The riparian grasses within the pan confirms this.</p>

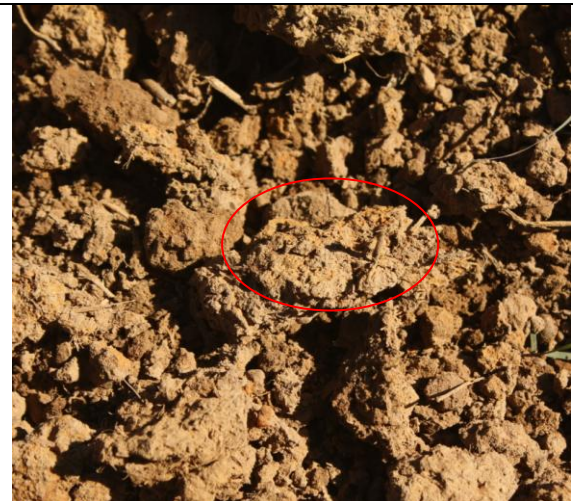
<p>Soil sample taken within the centre of the pan. A grey matrix (>10%) is present and numerous mottles are evident. This also indicates a seasonal zone of wetness. The presence of aquatic ferns confirm the presence of this wetland area.</p>

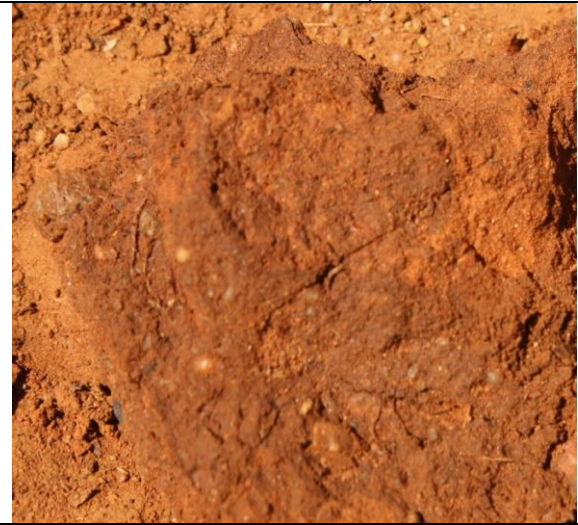
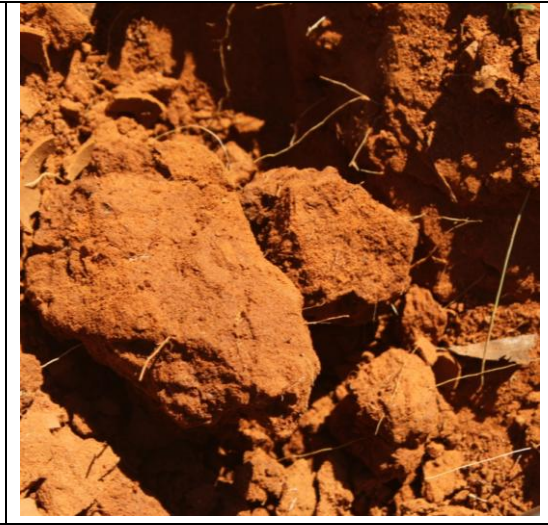
Table 3: Soil samples taken within the interior seasonal streams of the Rooddam study area (S 28° 12' 33.62" E 24° 39' 51.34").

<p>Soil sample taken within the main channel of the seasonal stream. The soil does not contain a visible grey matrix although a low degree of mottles is present indicating a temporary zone of wetness.</p>	<p>Soil sample taken within the main channel of the seasonal stream. The soil does not contain a grey matrix or mottles and is not considered as having wetland condition. This is also confirm by the vegetation which does not contain wetland species although riparian trees are present.</p>

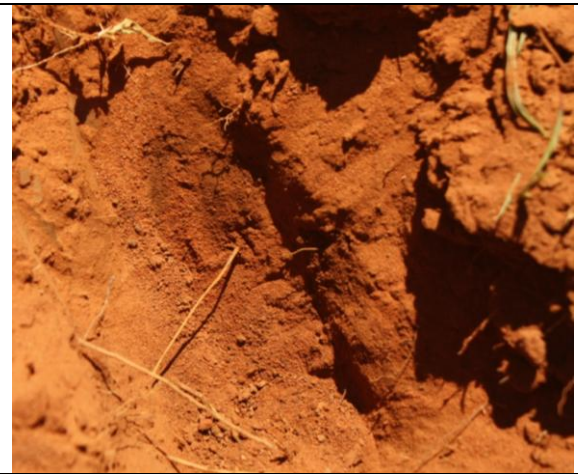
<p>Soil sample taken within the main channel of the seasonal stream. The soil does not contain a grey matrix or mottles and is not considered as having wetland condition. This is also confirm by the vegetation which does not contain wetland species although riparian trees are present.</p>
