Ecological and Wetland Assessment for alluvial diamond mining operations at Rooipoort on the farms Zandplaats 102/5, Vogelstruis Pan 101/0, Vogelstruis Pan 98/0, Bergplaats 100/0 and Klipfontein 99/0 near Schmidtsdrif, Northern Cape Province.

August 2018

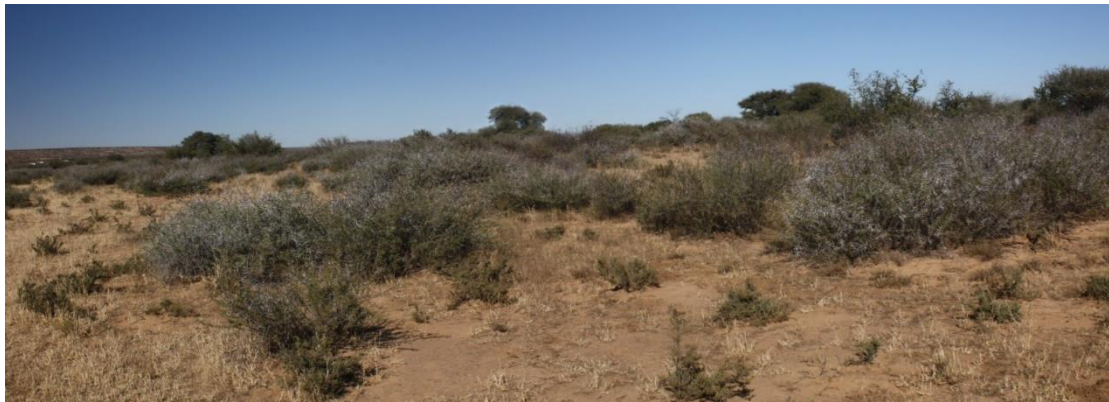
Figure 1: Panorama of the remaining natural vegetation within the floodplain. Vegetation structural elements are clearly visible, sparse grass layer, dense shrub layer and scattered trees.

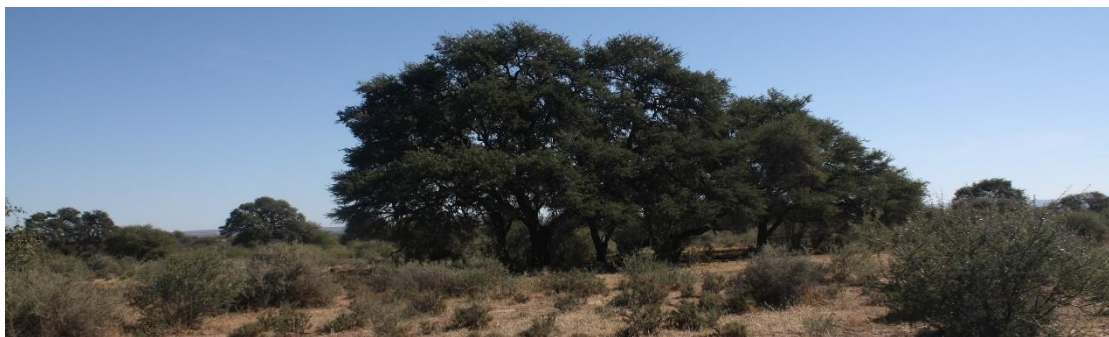
Figure 2: Scattered specimens of the protected Camel Thorn (*Vachellia erioloba*) was observed in the floodplain community.

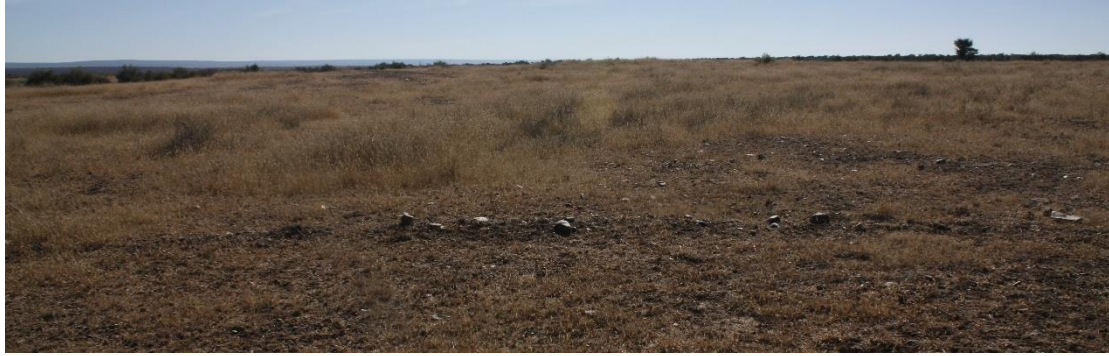
Figure 3: View of a portion of the floodplain community which was subjected to recent mining. An indigenous grass layer has established although a tree layer is still absent.

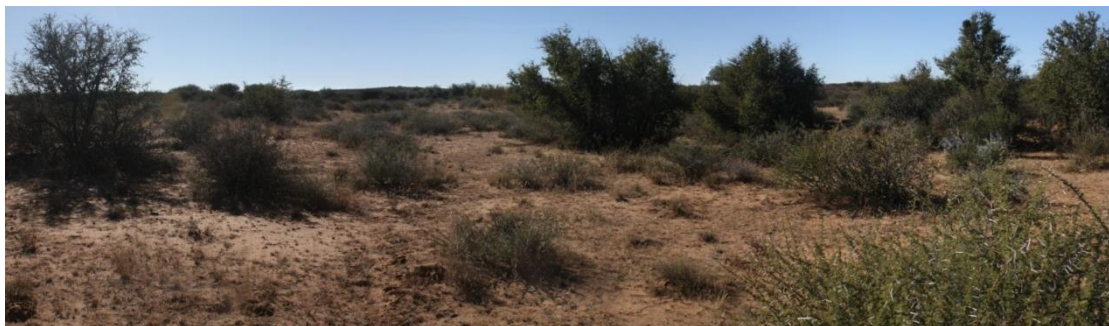
Figure 4: Areas with deeper sandy soils are clearly devoid of surface rock, a sparse grass layer, well-developed shrub layer, with scattered trees are clearly visible.

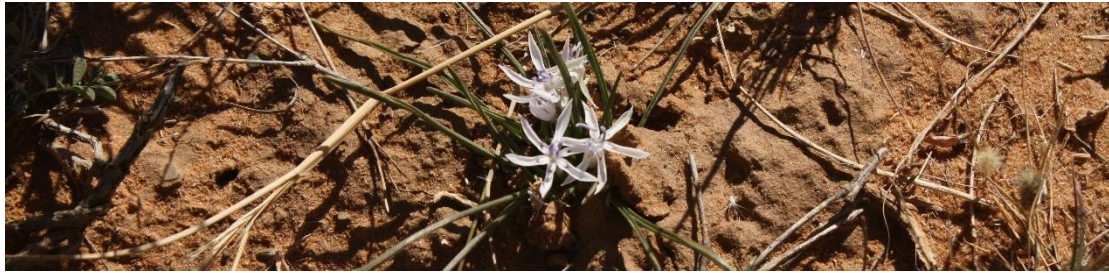
Figure 5: *Lapeirousia plicata*, occurs in the sandy soils of this community (S 28.672785°, E 24.082828°). It is an uncommon and protected species.

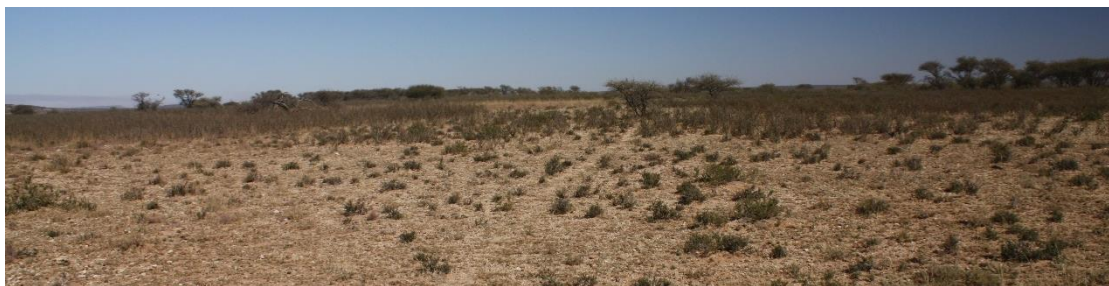
Figure 6: View of a portion of the area where superficial calcrete is abundant, here dwarf karroid shrub coverage is high, grass coverage low with scattered trees.

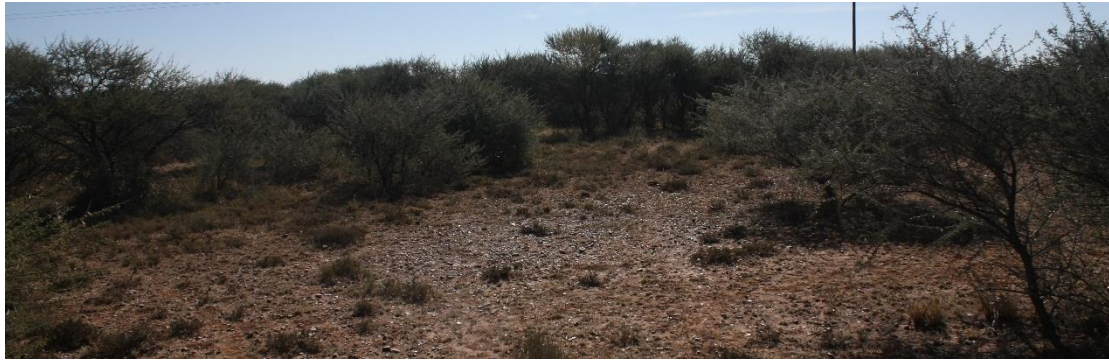
Figure 7: View of another portion of this area where the tree/shrub canopy cover is much higher. Note again an increase in superficial calcrete.

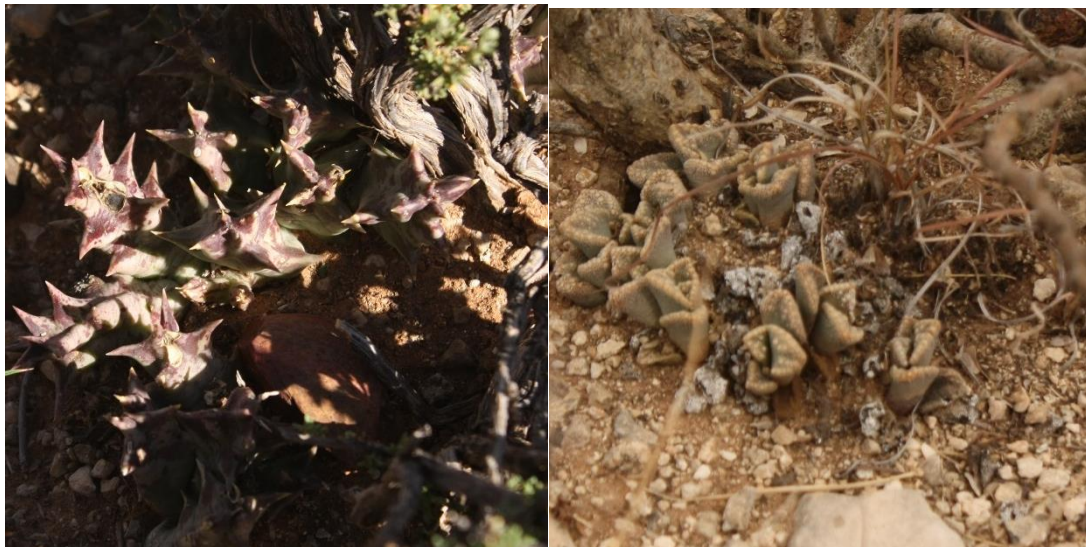
Figure 8: Two protected species encountered in this area are *Orbea* sp. (left) and *Titanopsis calcarea* (right) (S 28.672785°, E 24.079374°).

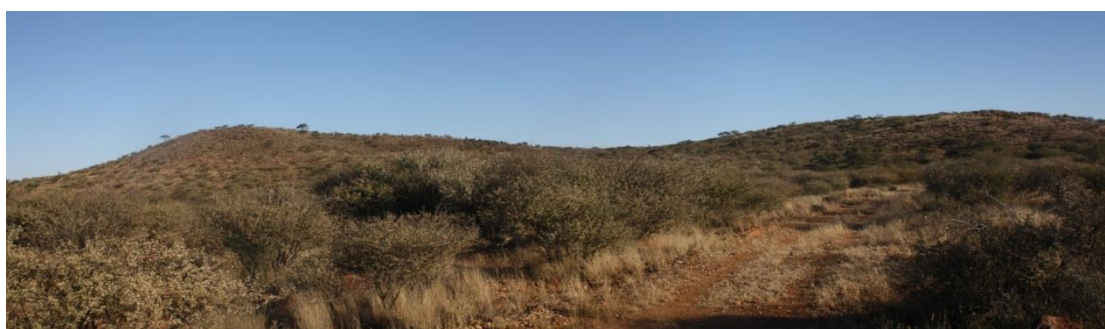
Figure 9: Panorama of the hills in the eastern portion of the area. Note the relatively dense canopy cover dominated by *Senegalia melifera*.

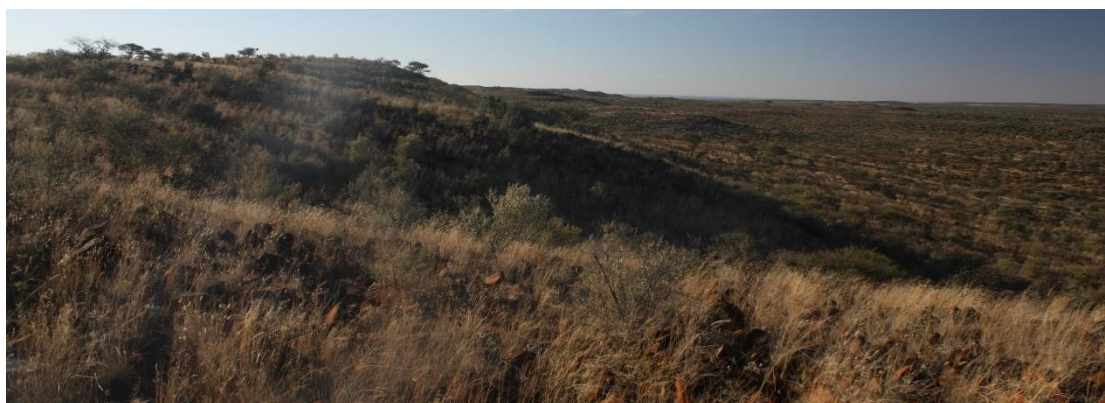
Figure 10: Another view of these hills also illustrating the well-developed grass layer.

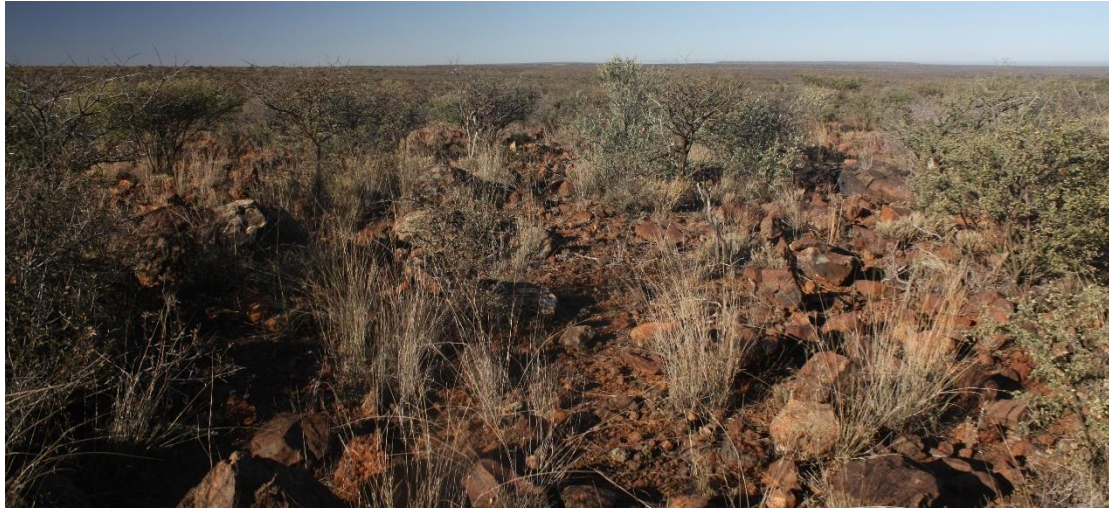
Figure 11: View of a plateau within the mountainous portion. Note a high percentage rock coverage and sparse grass layer in this area.

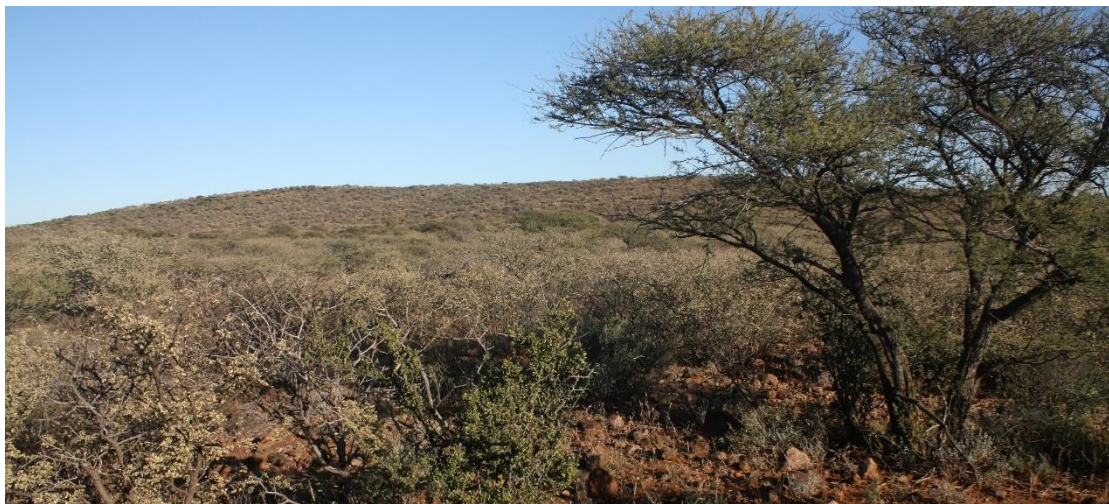
Figure 12: View of a footslope/midslope area of the mountainous portion. Here the tree/shrub layer is exceedingly dense.

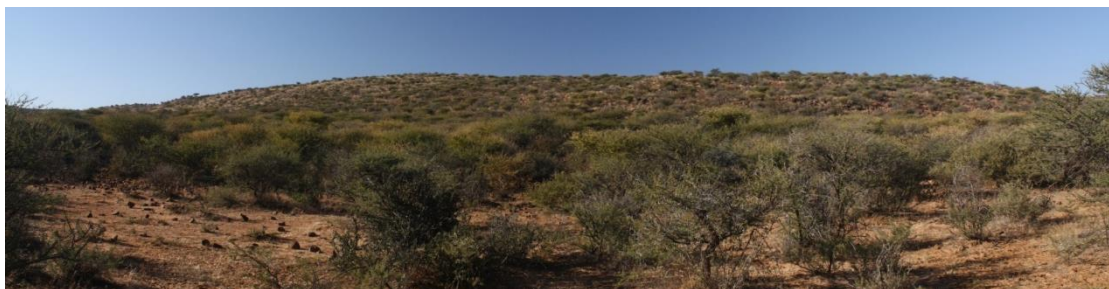
Figure 13: Panorama of one of the hills near the Vaal River. Note again a relatively closed, but low canopy cover, dominated by *Senegalia melifera*.

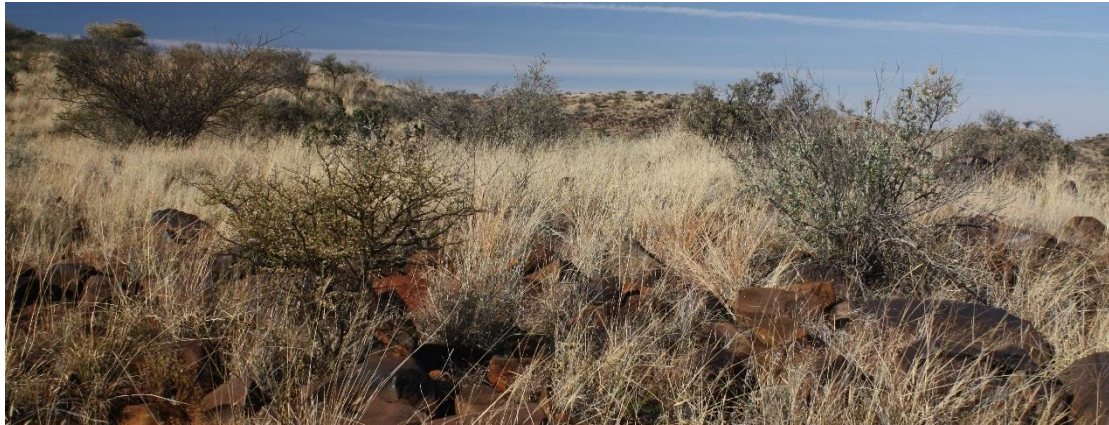
Figure 14: Close-up view of one of the hills near the river. Note here a much denser grass layer, dominated by *Cenchrus ciliaris*.

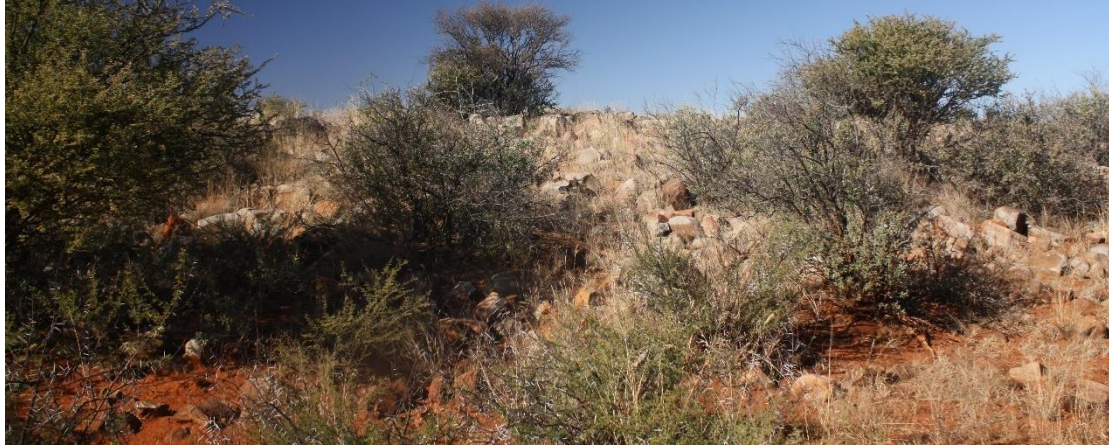
Figure 15: View of the slope of the quartzite ridge. Note an open tree/shrub layer and well-developed grass layer.

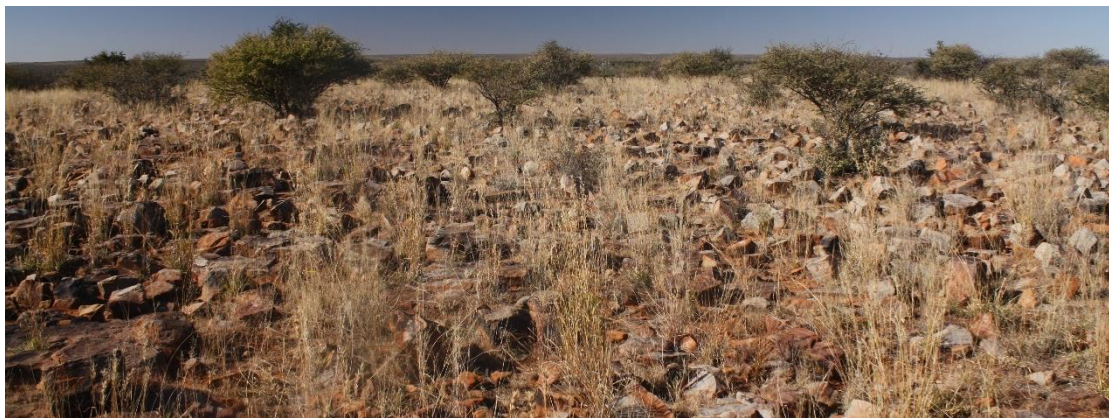
Figure 16: View of the plateau of the ridge, note relatively flat gradient.

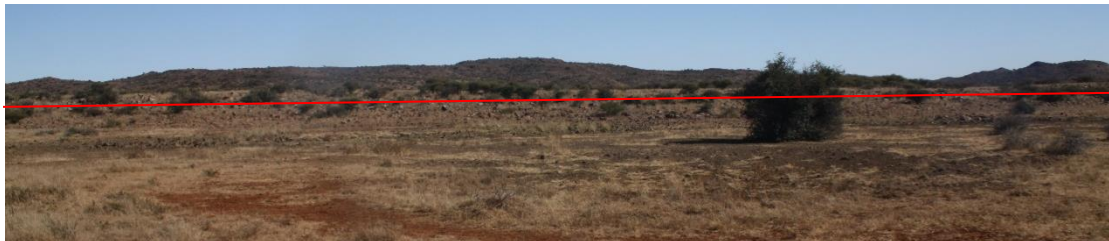
Figure 17: Another view of the ridge (red). Note the elongated shape and relatively low elevation.

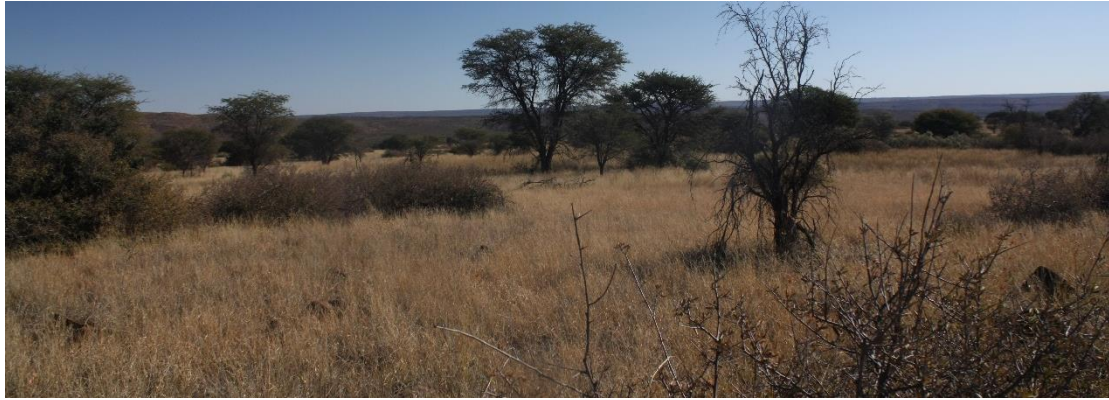
Figure 18: View of the northern area within this portion. Note an open tree layer with large specimens of *V. erioloba*, a dense, well-developed grass layer and scattered shrubs.

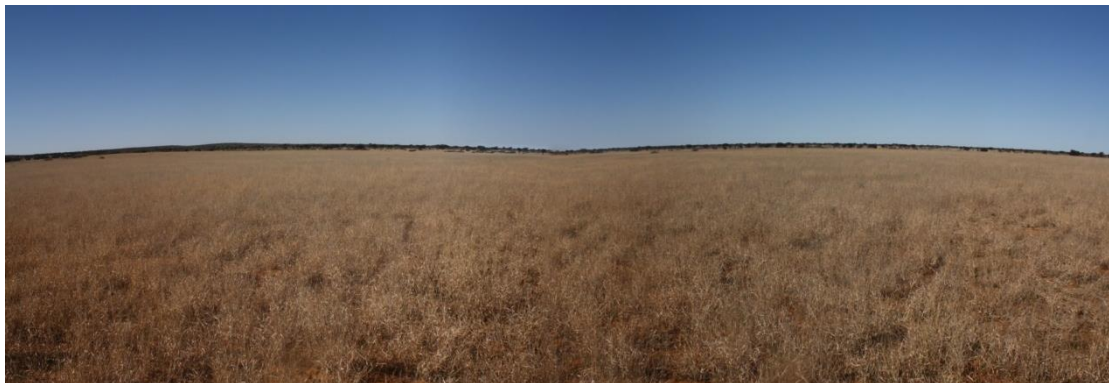
Figure 19: View of the central area within the portion. The absence of trees/shrubs and dense grass layer is prominent.

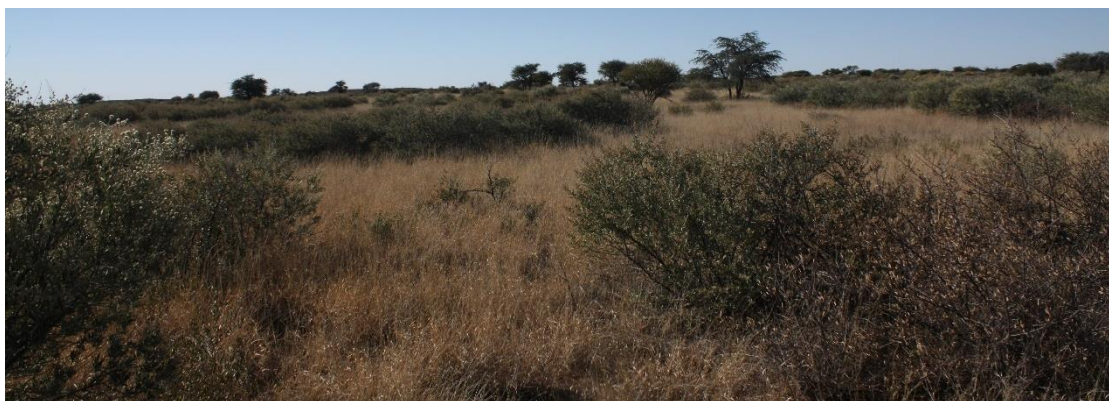
Figure 20: View of the southern area in this portion where the shrub component becomes more prominent.

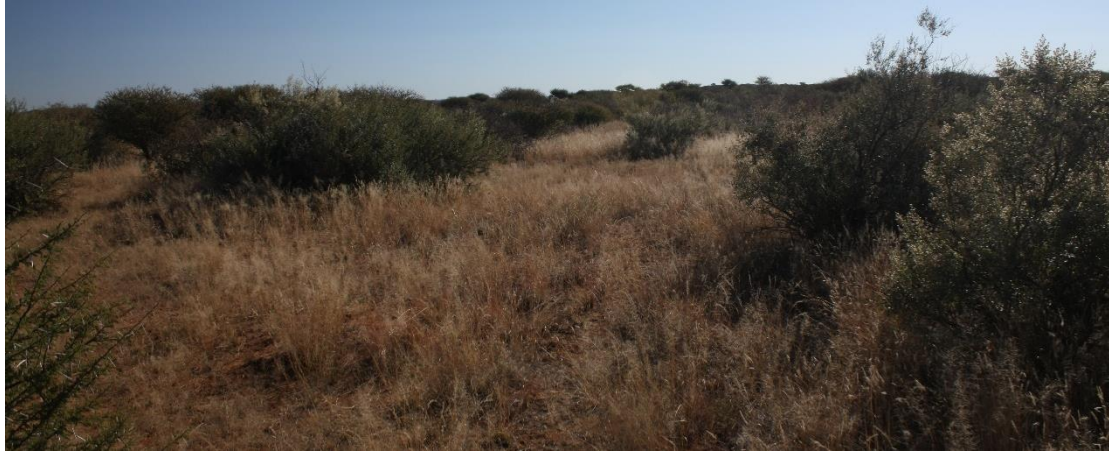
Figure 21: Another view of the southern area where the shrub component becomes dominant and the tree layer is largely absent.

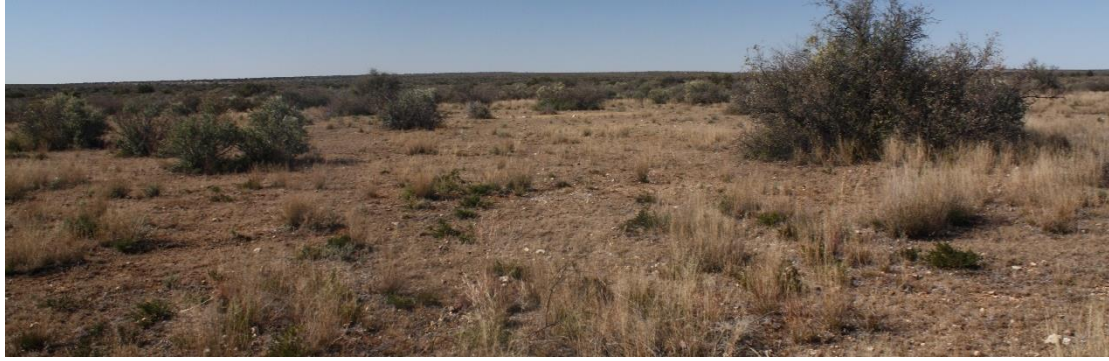
Figure 23: Another view of the south western portion. Again, note the sparse grass layer.

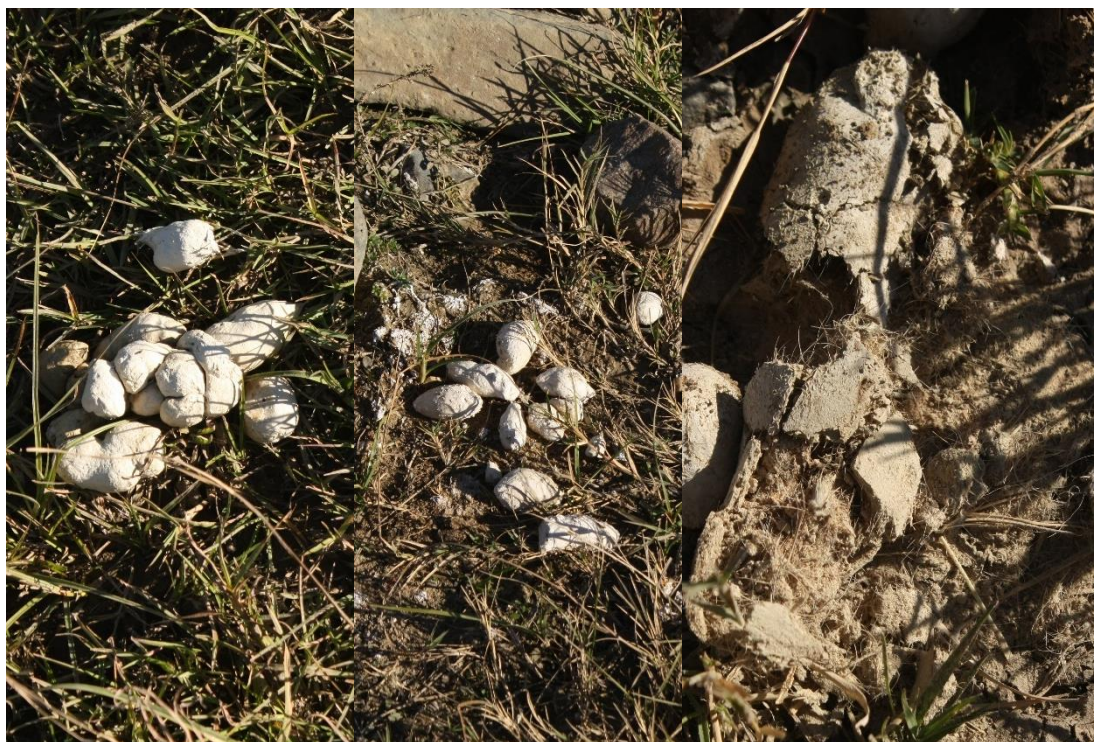
Figure 24: Dung which can be positively identified as that of the Brown Hyena (*H. brunnea*) occurring near the remains of a Giraffe adjacent to the Vaal River in the study area.

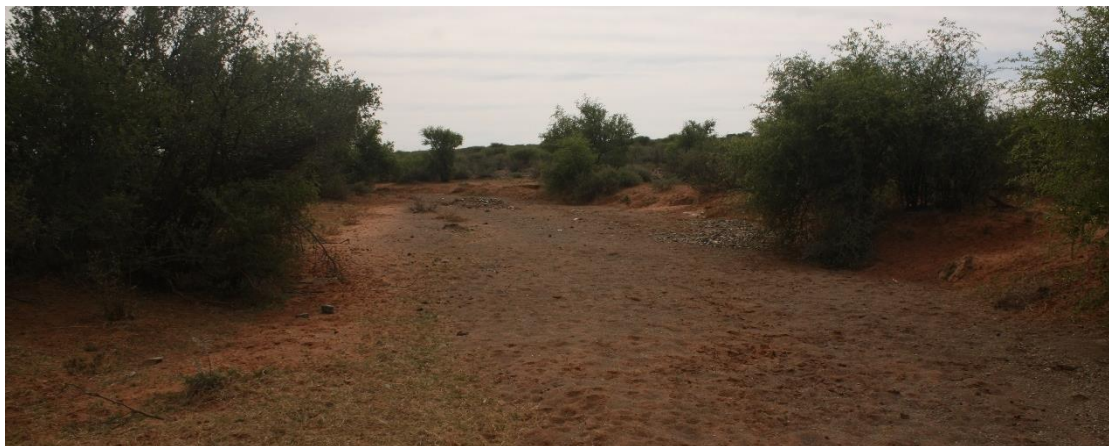
Figure 26: View of one of the larger streams in the southern portion of the study area. Note a clearly defined main channel is present, wetland vegetation is absent although the banks contain riparian tree species.

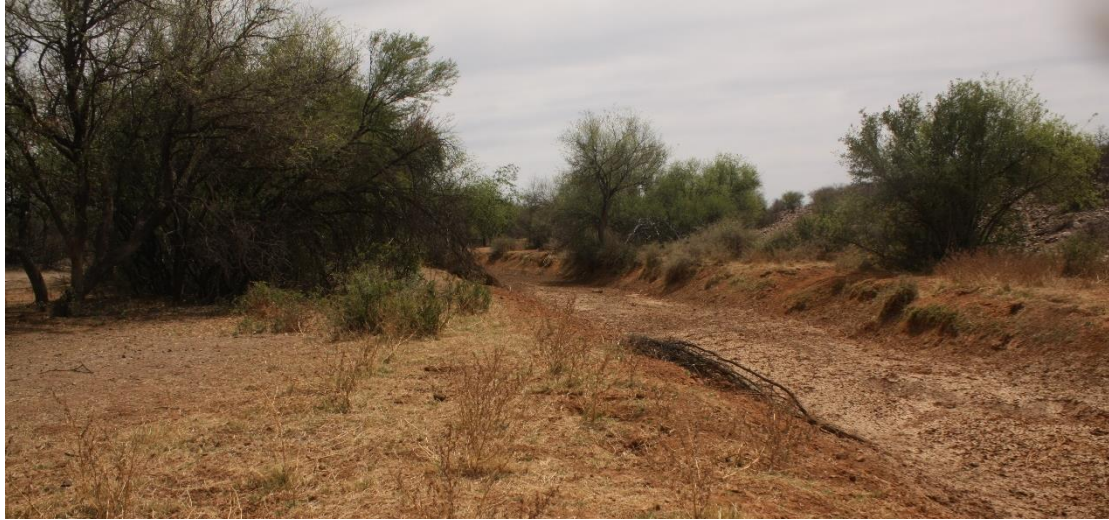
Figure 27: View of another large stream in the southern portion of the study area. This portion closer to the Vaal River contains wetland condition albeit on a seasonal basis.

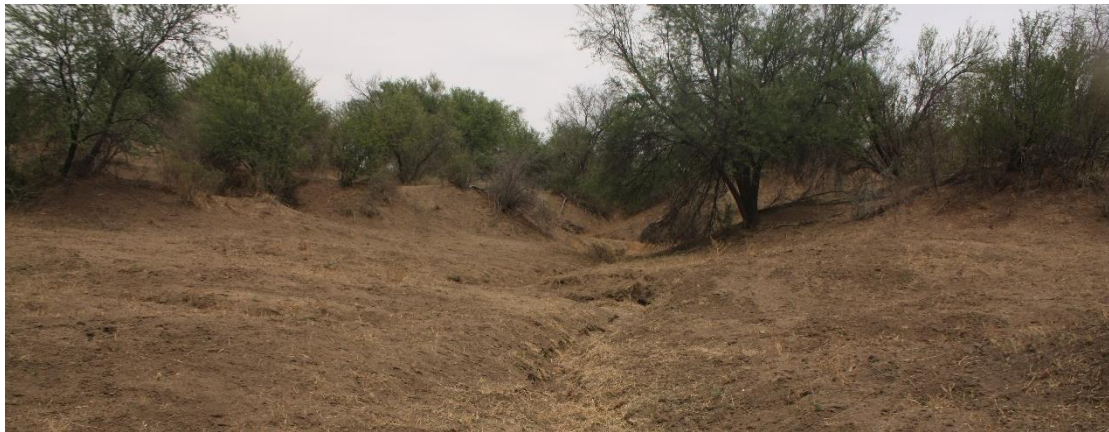
Figure 28: One of the smaller drainage lines in close proximity to the Vaal River. Note a main channel is still clearly visible although the drainage line is small. Erosion is also much more prominent in the silty soils of the floodplain.

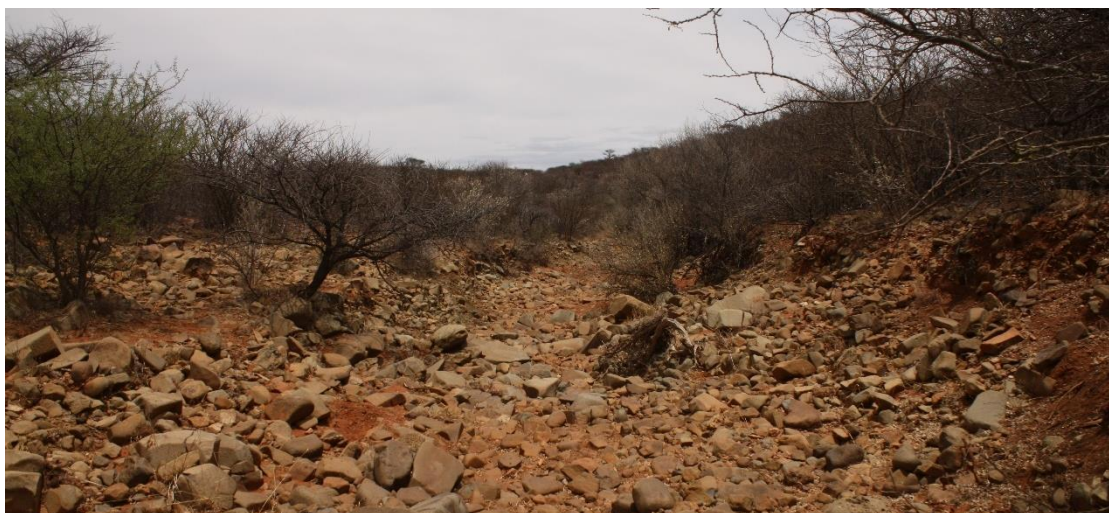
Figure 29: View of one of the drainage lines within the interior of the rocky, uneven central portion. A main channel is still prominent although riparian vegetation is largely absent.

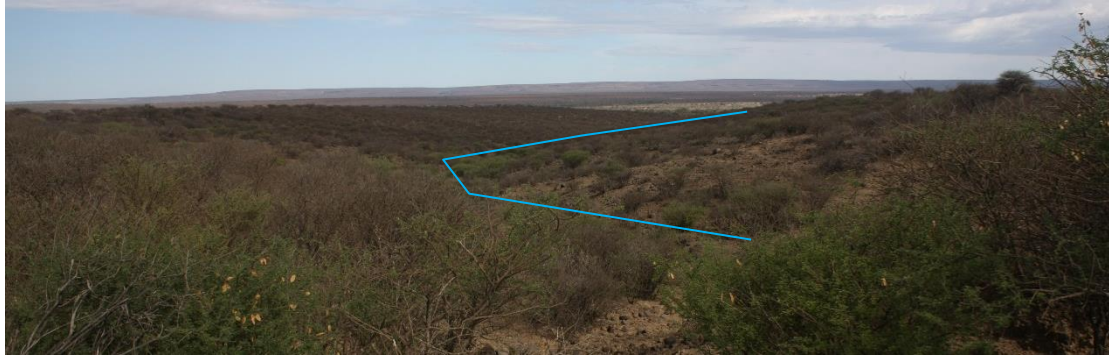
Figure 30: View of one of the drainage lines within the rocky, uneven central portion as it flows toward the Vaal River.

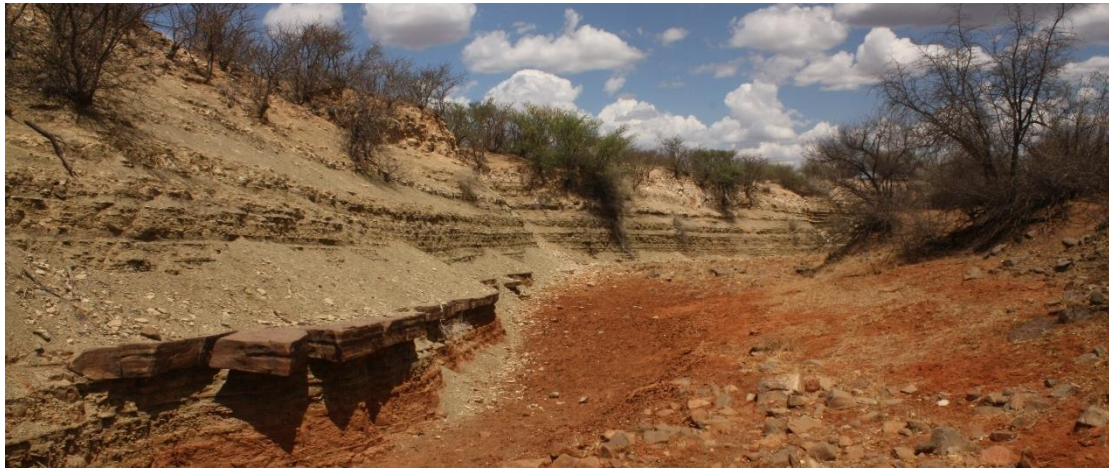
Figure 31: View of one of the larger streams closer to the Vaal River. The stream increases in magnitude in proximity to the river and riparian trees are prominent along the banks.

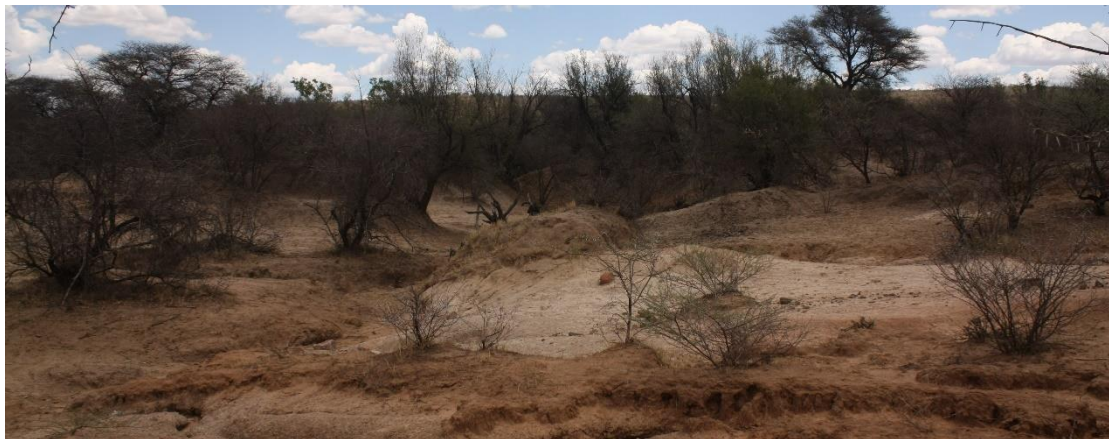
Figure 32: View of an alluvial fan caused by a significant stream flowing into the Vaal River. Note extensive erosion caused by silty soils and diffuse surface flow from the stream.

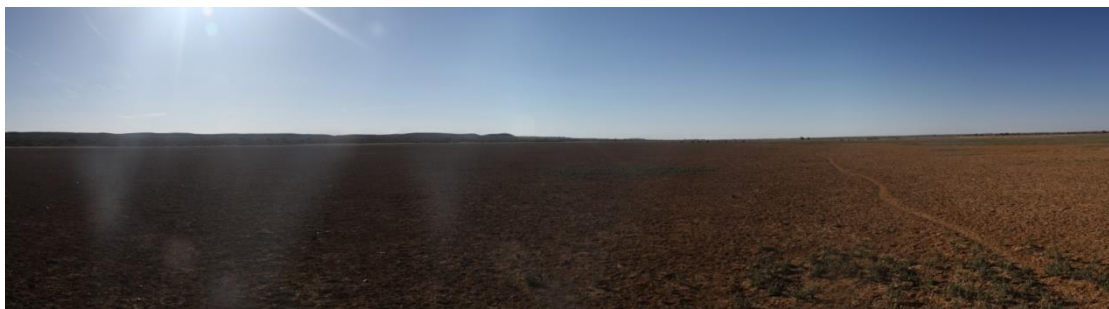
Figure 35: View of the central portion of the Hoffman's Pan. Due to the vast extent of the pan the shape and characteristics of the pan is not easily visible.

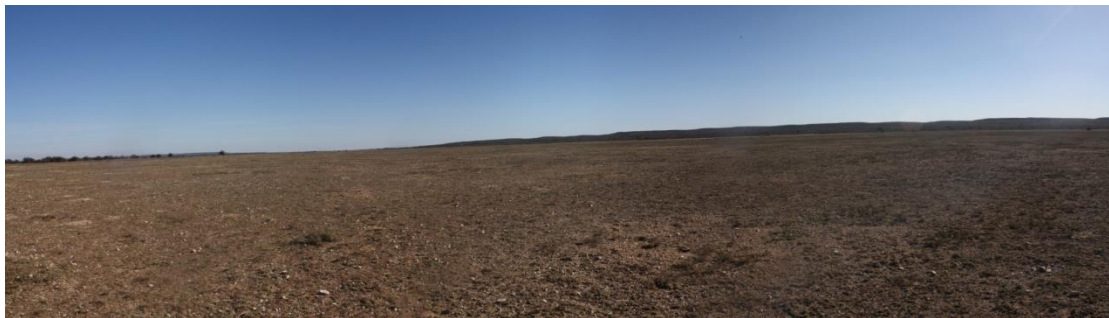
Figure 36: View of the shore/floodplain of the pan to the eastern border. Again, the vast size does not easily illustrate the characteristics of this area.

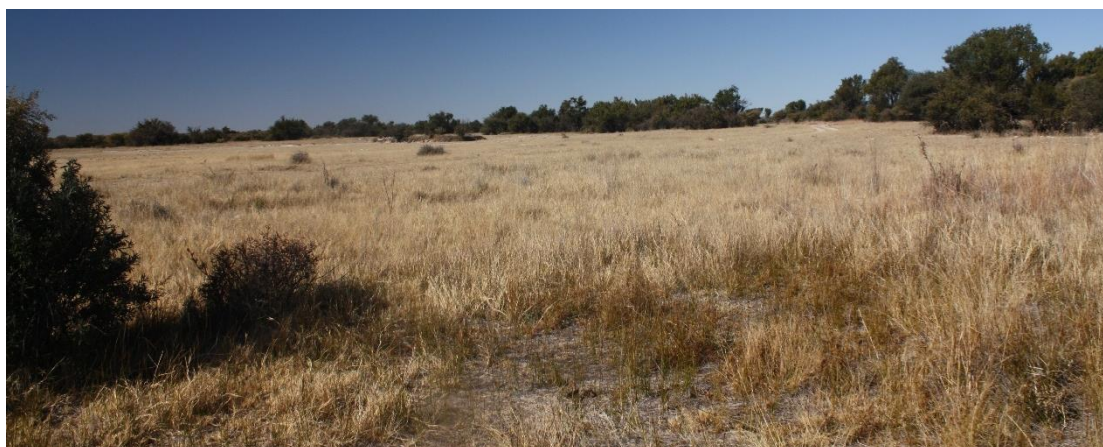
Figure 37: View of one of the flat wetland areas situated within the large seasonal stream.

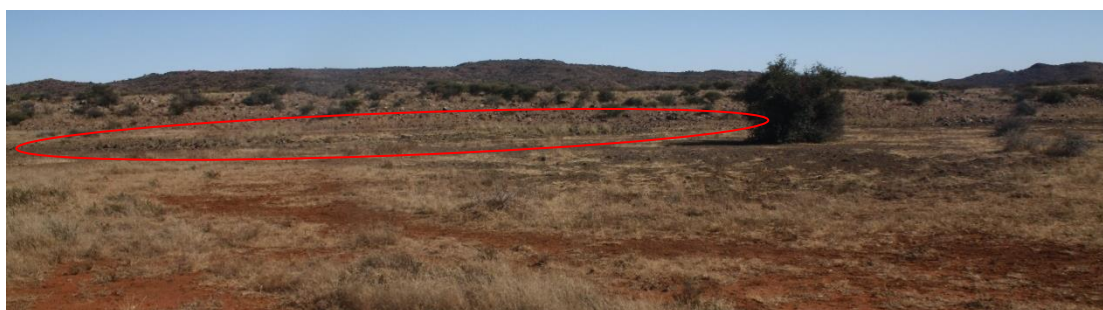
Figure 38: View of one of the other wetland areas (red) adjacent to the quartzite outcrop.

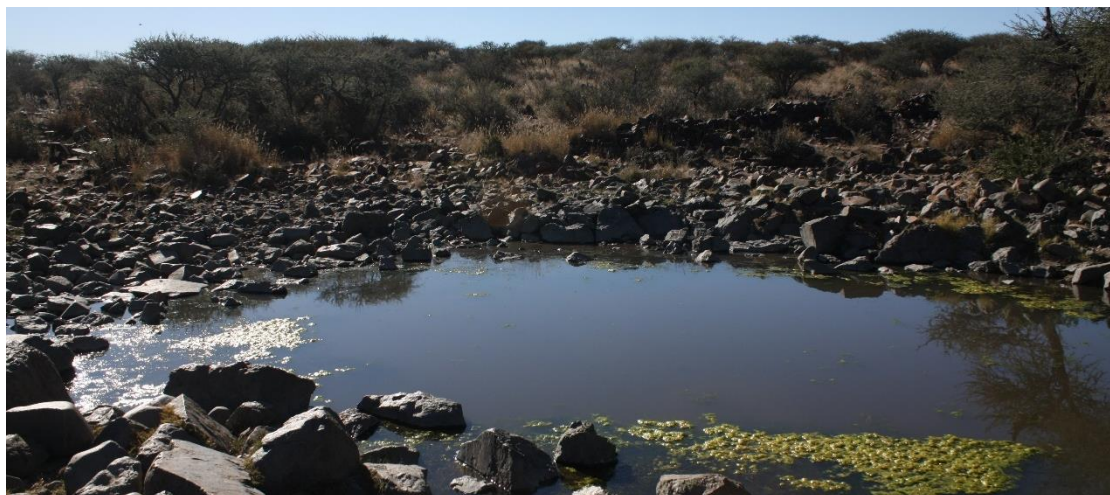
Figure 39: View of the rock pool formed by the fountain.

This is a relatively accurate description of the fountain. The fountain is situated on the gentle slope of a quartzite outcrop and flows from cracks in the exposed rock. Outflow at the time of the site visit was present and the surrounding area indicates that the fountain may increase significantly in outflow during the rainy season. This is also confirmed by aerial images. The fountain does not form a distinct channel and does not give rise to a watercourse. Outflow is likely to infiltrate and recharge groundwater. The fountain is situated within the quartzite formation with no soils present and therefore wetland soils are absent. However, the sedge, *Schoenoplectus decipiens*, occurs in the fountain and indicates wetland conditions. The fountain is considered perennial in nature as a pool occurred during the site visit indicating that it functions throughout the year. It is considered a very unique system that consequently has a high conservation value.

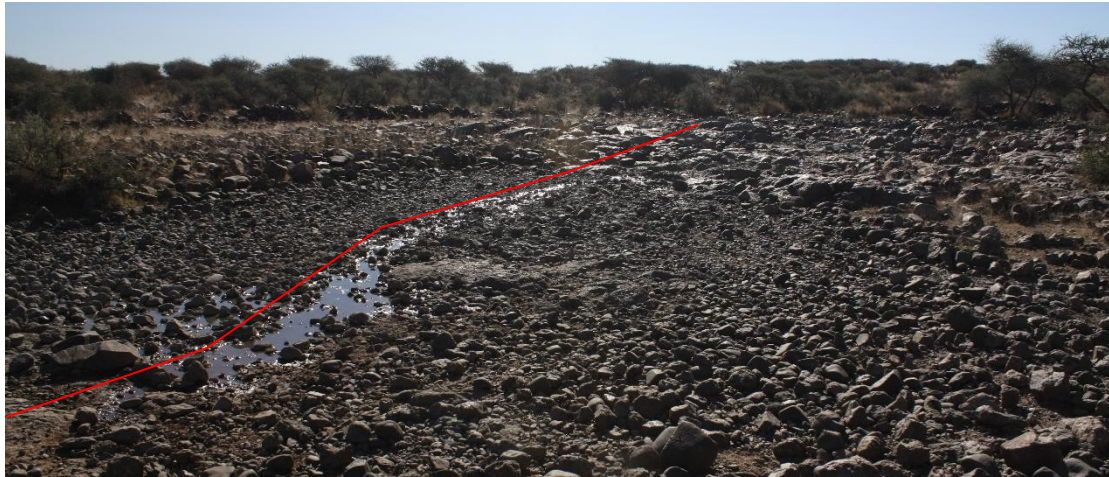
Figure 40: From the rock pool water overflows downslope (red).

In close proximity to the above described wetland areas but considered a separate system is a very unique artesian fountain which seems to be entirely of natural origin (Table 6, Map 4). Systems such as this is exceptionally rare and considered highly unique. The fountain originates within a quartzite outcrop and flows down a gentle slope into a small natural rocky depression from where it overflows to the south into a sandy area. Here a low berm is present and considered

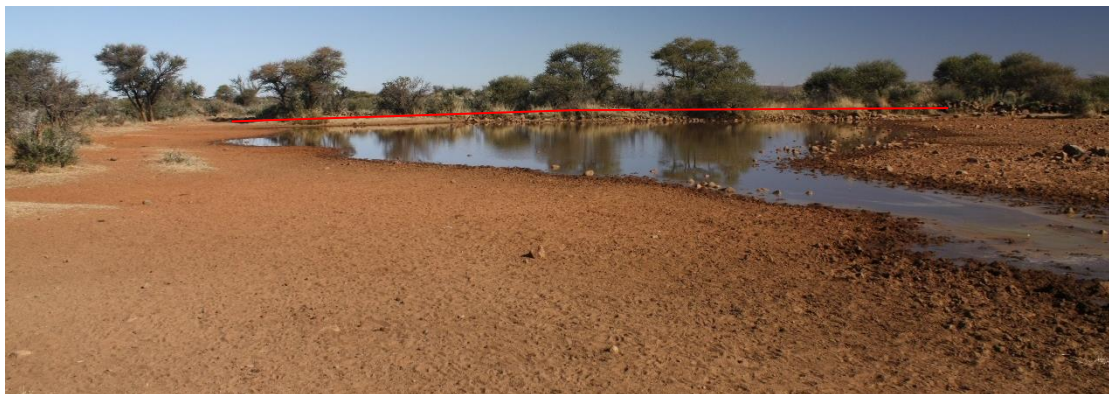
Figure 41: Water from the fountain accumulates in a shallow depression adjacent to an artificial berm (red).

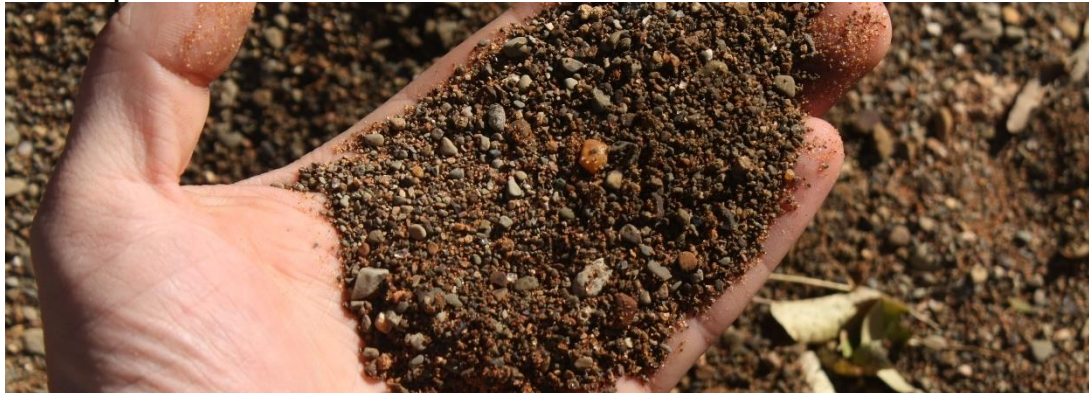
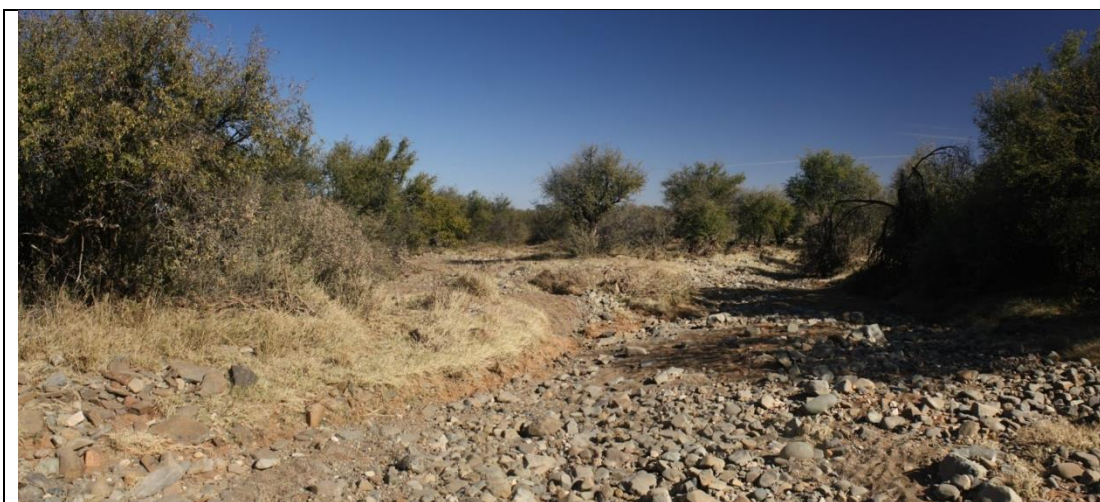
Watercourse name: #1 Unnamed	Coordinates of crossing: S 28.696636°, E 24.082677°	Flow regime: Seasonal stream
Description of watercourse: A large and significant stream in the southern portion of the study area. The flow regime of the stream is not clear though it is of significant size and is considered borderline seasonal to ephemeral. It flows from east to west and into the Vaal River and consists of several smaller tributaries which confluence with this significant stream. The catchment is undulating to flat. It contains a clearly defined main channel with gravel/sandy bed and round stream rocks. Vegetation along the stream is clearly of riparian composition though obligate wetland vegetation is absent. The riparian grass, <i>Cynodon dactylon</i> , does indicate elevated moisture levels. Soils consist of gravel/sand without any wetland moisture indicators. Wetland conditions are therefore absent at the point of sampling though it is likely that wetland conditions will occur in the section near the confluence with the Vaal River. The stream is natural without any significant impacts although crossing by two haul roads will cause some retardation of flow and flooding.

Dominant plant species: <i>Ziziphus mucronata</i> , <i>Grewia flava</i> , <i>Eragrostis superba</i> , <i>Cynodon dactylon</i> (FW), <i>Aristida congesta</i> , <i>Cenchrus ciliaris</i> , <i>Sporobolus fimbriatus</i> , <i>Schmidtia pappophoroides</i> , <i>Eragrostis lehmanniana</i> , <i>Themeda triandra</i> , <i>Vachellia tortilis</i>		
Soil sample:

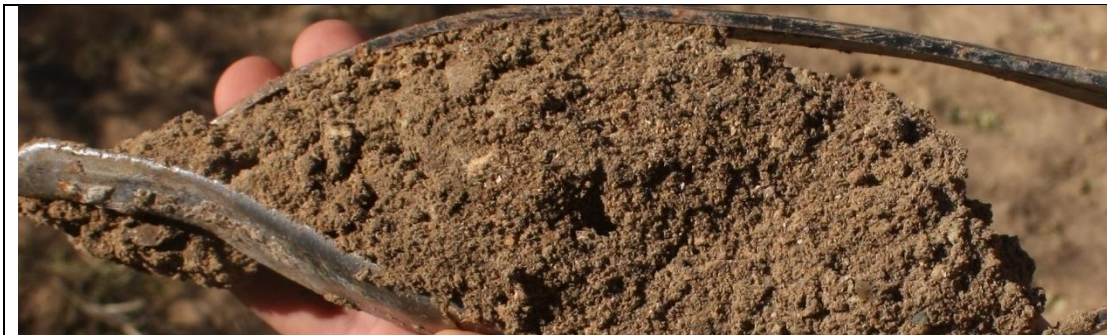
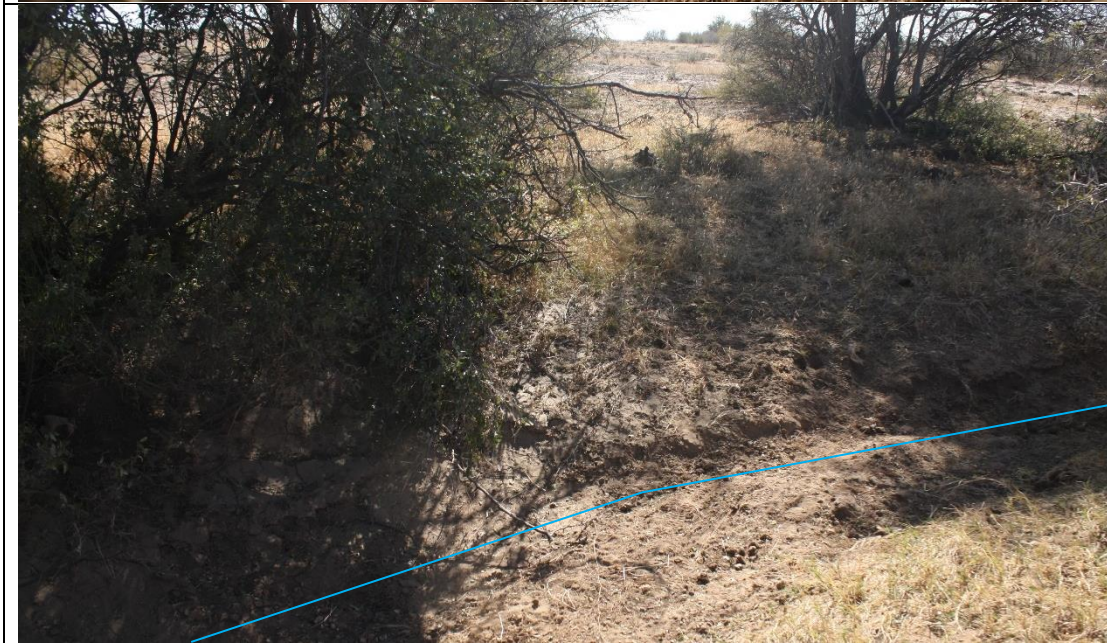
Watercourse name: #2 Unnamed	Coordinates of crossing: S 28.685581°, E 24.066288°	Flow regime: Ephemeral drainage line
--	---	--

Description of watercourse:
 A relatively small drainage line in the south western portion of the study area flowing into the Vaal River. The drainage line is representative of approximately five other smaller drainage lines adjacent to it. The flow regime will most likely be ephemeral in nature and although it is likely to flow for very short periods on an annual basis it cannot be considered to be of a seasonal nature. These drainage lines are short in length and form in the floodplain of the Vaal River where an increase in slope cause an increase in runoff and therefore a concentration within channels, thereby forming drainage lines. All these drainage lines flow from east to west and into the Vaal River and is relatively short in length. The catchment is small with a gentle slope toward the river and confined to the floodplain of the Vaal River. They contain clear main channels with a silt/clayey bed without any prominent rocks/pebbles. Vegetation along the drainage line is clearly of riparian composition and the occurrence of grass species considered Facultative Wetland grasses does indicate that some wetland conditions may be present. Soil samplings also exhibit a low degree of grey matrix and is also considered to indicate a temporary zone of wetness. The presence of wetland conditions are therefore considered borderline present but will increase closer to the river where it should be represented much clearer. All of these drainage lines are situated within the floodplain which was previously subjected to mining operations. This has had a significant impact on them and also indicated by the presence of a few exotic weeds, absent from other natural watercourses. Impacts include a decrease in vegetation cover and an increase in erosion and sediment load.

Soil sample:
