Ecological and Wetland Assessment for alluvial diamond mining operations at Rooipoort on the farms Zandplaats 102/5, Vogelstruis Pan 101/0, Vogelstruis Pan 98/0, Bergplaats 100/0 and Klipfontein 99/0 near Schmidtsdrif, Northern Cape Province.

August 2018

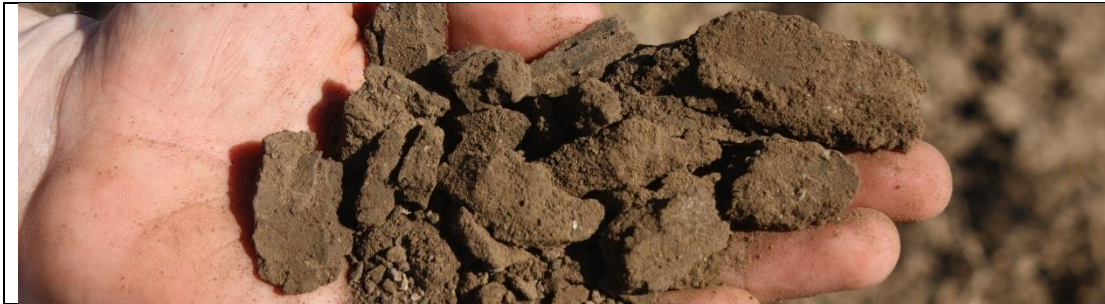
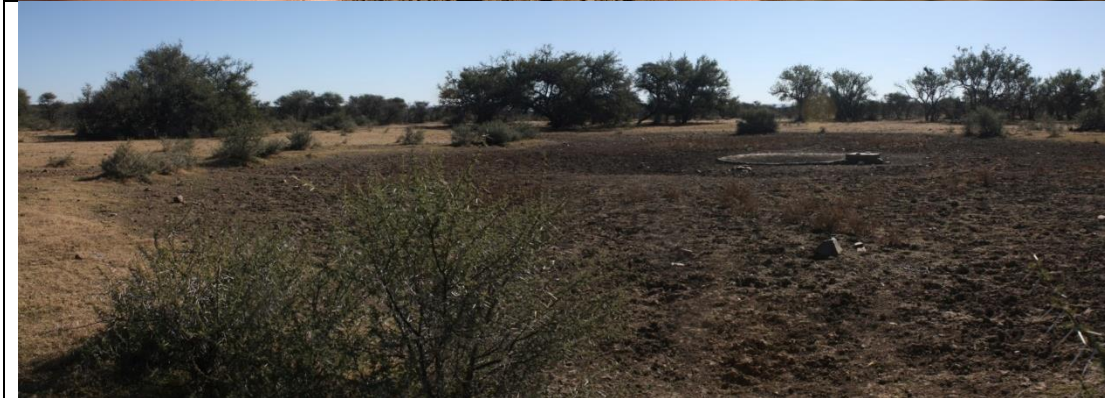
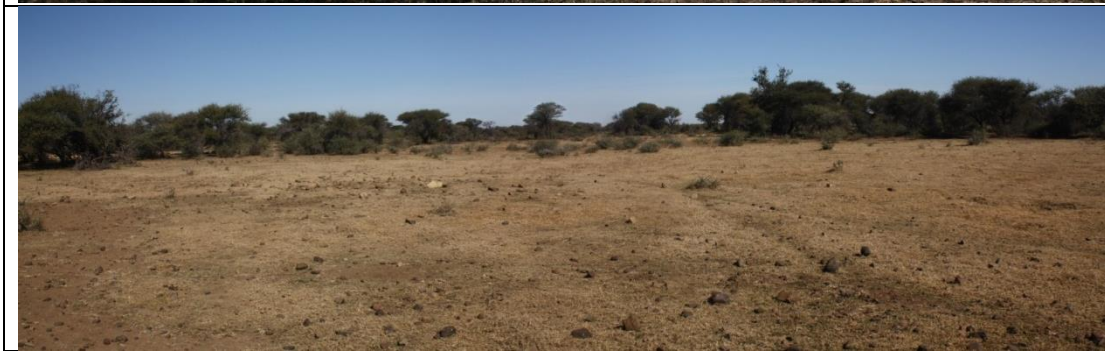
Watercourse name: #3 Unnamed	Coordinates of crossing: S 28.675168°, E 24.127259°	Flow regime: Small ephemeral pan
Description of watercourse: A small ephemeral pan is situated to the east of “Diamantkoppie” and at the origin of #4 Drainage Line. The pan is considered to have an ephemeral hydrological regime and will only contain surface water after exceptional rainfall events. The pan is one of the smaller systems in the study area and has a diameter of approximately 170 m. Although existing maps indicates it having an outflow, the on-site survey did not illustrate an in- or outflow. The pan is flat bottomed, situated in a plain and vegetation is dominated by a fringe of riparian trees and a short grass layer in the interior of the pan. The vegetation in the pan contain Obligate Wetland species and indicate definite wetland conditions even though only of temporary wetness. Soil samples contain a high clay content though a grey matrix or mottling was not evident at the time of sampling. Wetland conditions are considered present though of a temporary zone of wetness. An artificial watering point has been constructed in the pan and consequently trampling by game has become prominent. This has led to some degradation of the vegetation layer and will influence the hydrological regime of the pan to some extent, i.e. increased infiltration rates, etc. The presence of exotic weeds also confirm the disturbance of the vegetation layer.

Dominant plant species: <i>Ziziphus mucronata</i> , <i>Cynodon dactylon</i> (FW), * <i>Xanthium spinosum</i> , <i>Alternanthera sessilis</i> (OW), <i>Chloris virgata</i> , * <i>Alternanthera pungens</i>		
Soil sample:

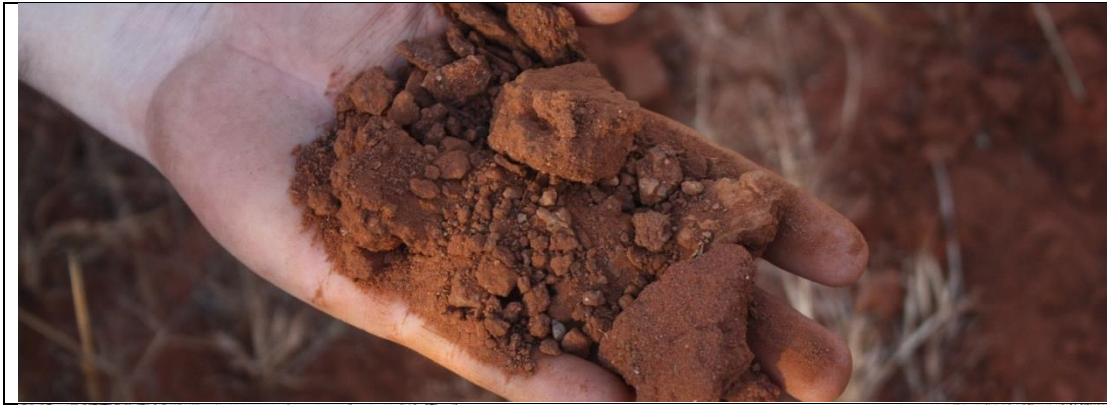
Watercourse name: #6 Unnamed	Coordinates of crossing: S 28.663771°, E 24.165048°	Flow regime: Ephemeral drainage line
<p>Description of watercourse: A relatively small drainage line in the south eastern portion of the study area flowing into the Hoffman's Pan. The drainage line is representative of a series of drainage lines which drain from the rocky ridge to the west of the pan and feeds into this pan. The flow regime will undoubtedly be ephemeral though draining the rocky ridge it is likely to flow for very short periods (hours) after heavy rainfall. These drainage lines are all of short length and drain from the crest of the ridge toward the east and into the pan. They have a distinct main channel with a significant slope. The bed and banks of these drainage lines are dominated by red, sandy soils but with a matrix of large rocks. A high percentage surface rock is also present. Vegetation along the drainage line is of terrestrial composition without any riparian species. This is most likely due to high velocity discharge, small size and therefore limited moisture retention. Despite this the clear main channel confirm the presence of a watercourse. Soil samples also confirm the absence of any wetland conditions. None of these drainage lines are affected by any significant impacts. Some crossings by dirt tracks do cause erosion of the watercourses but not to a high degree.</p>

<p>Dominant plant species: <i>Eragrostis lehmanniana</i>, <i>Eragrostis obtusa</i>, <i>Chloris virgata</i>, <i>Aristida congesta</i>, <i>Enneapogon cenchroides</i>, <i>Tarchonanthus camphoratus</i>, <i>Lantana rugosa</i>, <i>Cenchrus ciliaris</i></p>		
<p>Soil sample:</p>

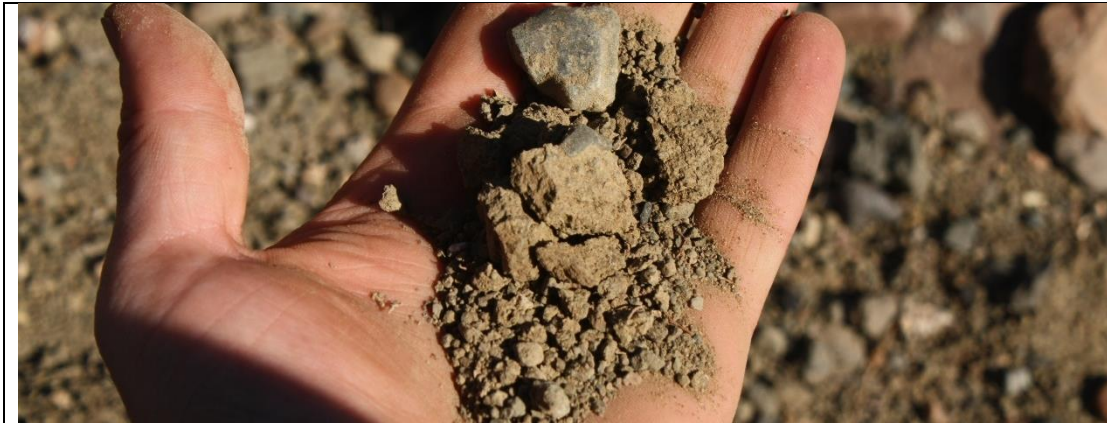
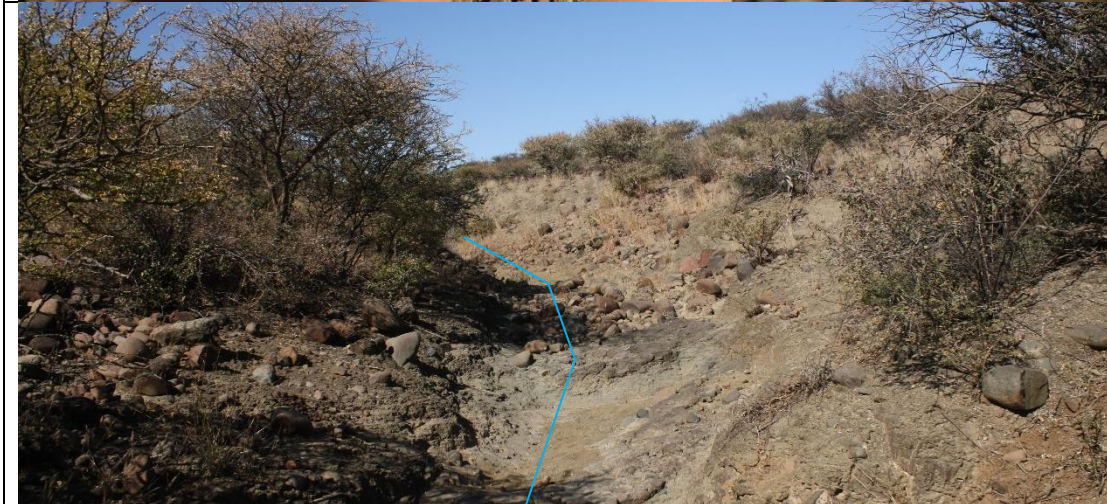
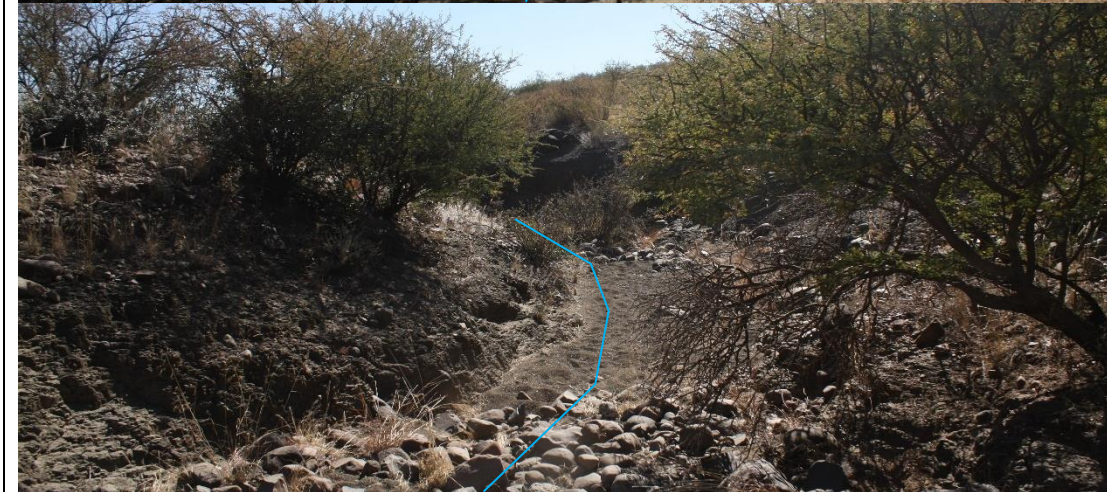
Watercourse name: #8 Unnamed	Coordinates of crossing: S 28.665490°, E 24.082655°	Flow regime: Ephemeral Drainage Line
Description of watercourse: A relatively small drainage line along the western border of the study area which flows into the Vaal River. It drains from an exceedingly rocky ridge into a shallow valley and into the river. It is of relatively short length and drains from south to north and into the river. The flow regime will undoubtedly be ephemeral though draining the rocky ridge it is likely to flow for very short periods (hours) after heavy rainfall. A distinct main channel is present with a significant slope. The bed is dominated by gravel with a high percentage surface rock and bedrock also outcropping in areas. Vegetation along the drainage line is of terrestrial composition without any riparian species. This is most likely due to high velocity discharge, small size and therefore limited moisture retention. Despite this the clear main channel confirm the presence of a watercourse. Soil samples also confirm the absence of any wetland conditions. It is not currently affected by any significant impact.

Dominant plant species: <i>Senegalia mellifera, Eragrostis lehmanniana, Heteropogon contortus, Ehretia rigida, Aristida diffusa, Ennepogon cenchroides, Asparagus larcinus, Olea europaea subsp. africana, Grewia flava</i>		
Soil sample:

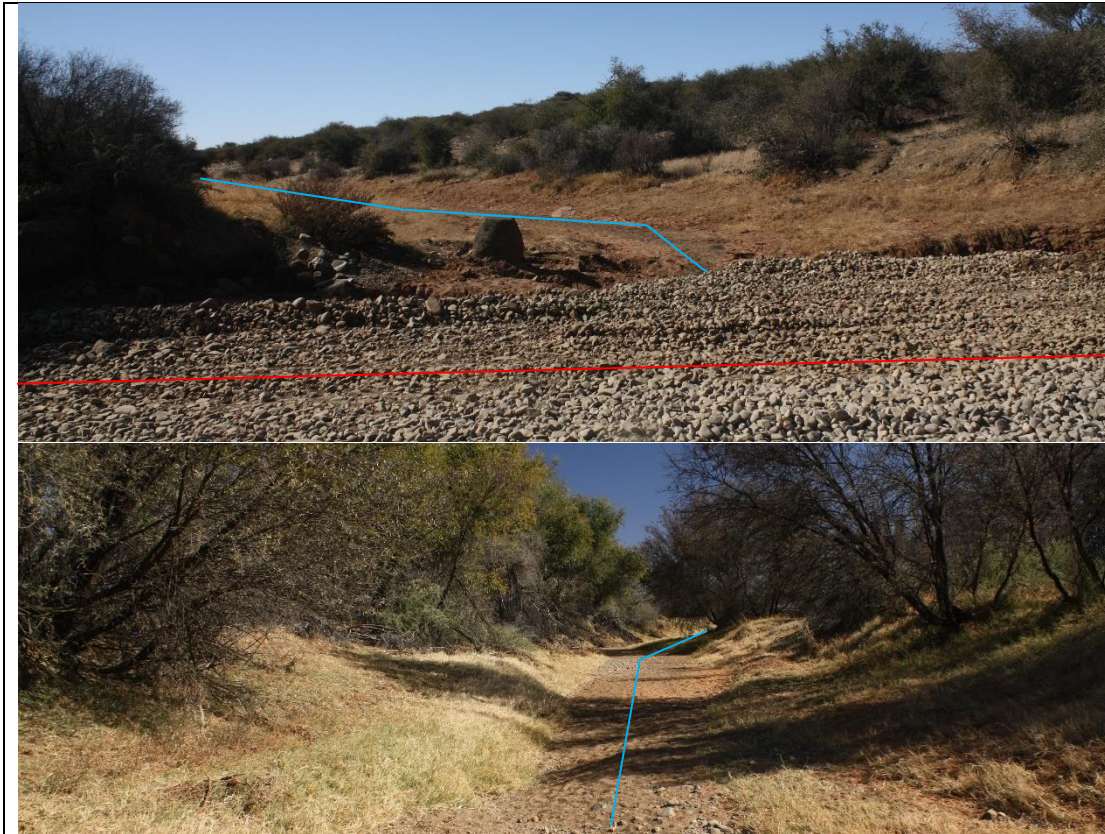
Watercourse name: #11 Unnamed	Coordinates of crossing: S 28.663899°, E 24.134726°	Flow regime: Seasonal Stream
Description of watercourse: An upstream section of #10 Seasonal Stream to the east of #10 in the foothills of the stream and within a rockier area. The flow regime is considered close to seasonal and will flow for short periods in the rainy season and on an annual basis. The flow volumes will however be much lower as compared to #10 and moisture content lower. The section also flows from east to west. A large and clearly defined main channel is also present with gravel/sandy bed and round stream rocks. Vegetation along the stream is mostly of terrestrial species composition though abundant riparian species are also present. Obligate wetland vegetation is absent. Soils consist of gravel/sand without any indicators of wetland conditions. The stream is natural without any significant impacts though crossing by a small dirt track will act as flow barrier and contribute to erosion within the stream.

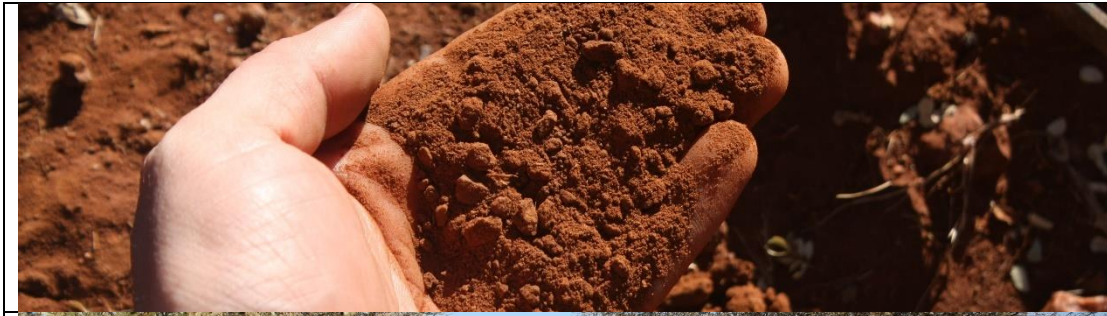
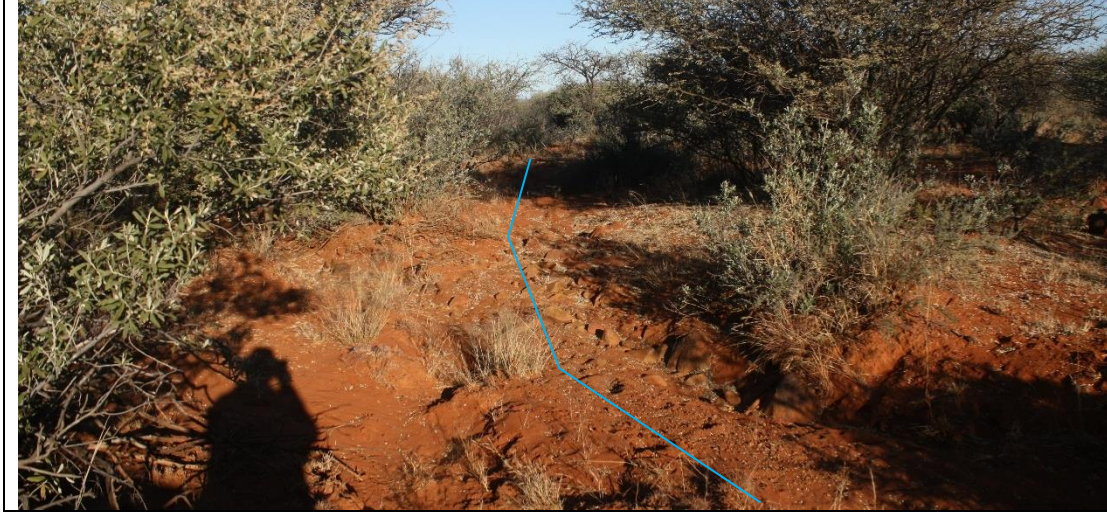
Watercourse name: #12 Unnamed	Coordinates of crossing: S 28.641931°, E 24.137384°	Flow regime: Seasonal Stream
Description of watercourse: A section within the upper reach of #10 Seasonal Stream to the east of #11 near the origin of the stream and situated in the rocky, uneven, mountainous terrain in the study area. The flow regime here will be ephemeral and will flow for very short periods after heavy rainfall events. The flow volume will be low and only as a result of tributaries and accumulated runoff will the downstream section attain a seasonal nature. The section flows from north to south. A small but clearly defined main channel is present with a sandy soil and very high rock content. Vegetation along the watercourse is exclusively of terrestrial composition without any riparian or wetland species. This is also due to high velocity runoff and low volumes which decrease the retention of moisture. Soils consist of red sand without any indicators of wetland conditions. The stream is without any visible impacts.

Dominant plant species: <i>Senegalia mellifera</i> , <i>Tarchonanthus camphoratus</i> , <i>Eragrostis lehmanniana</i> , <i>Aristida congesta</i>		
Soil sample:

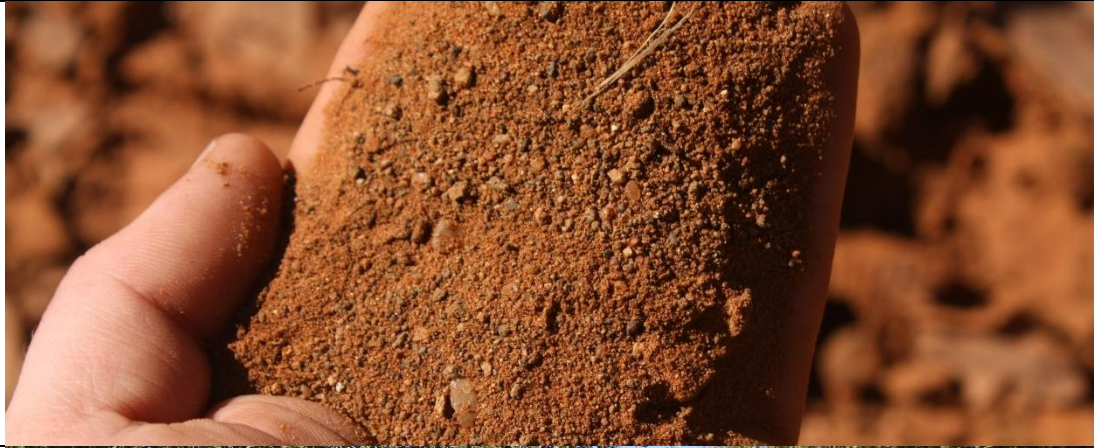
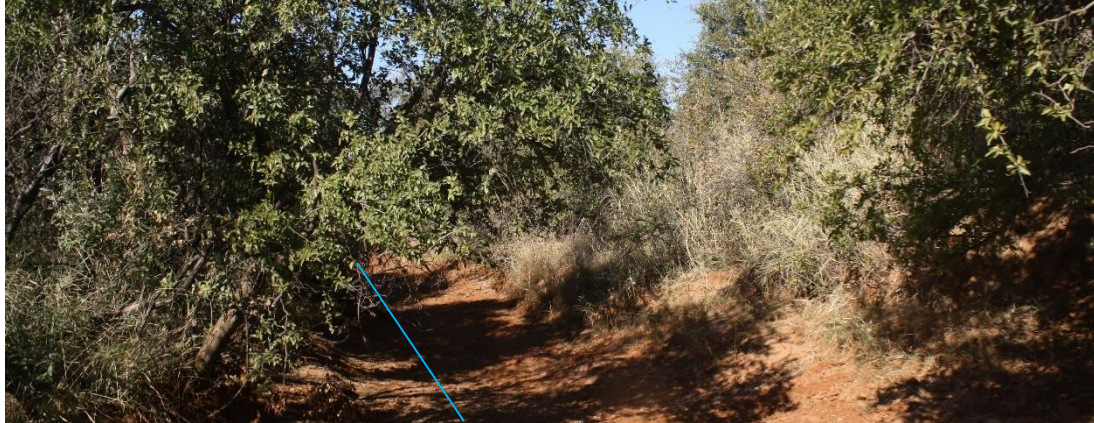
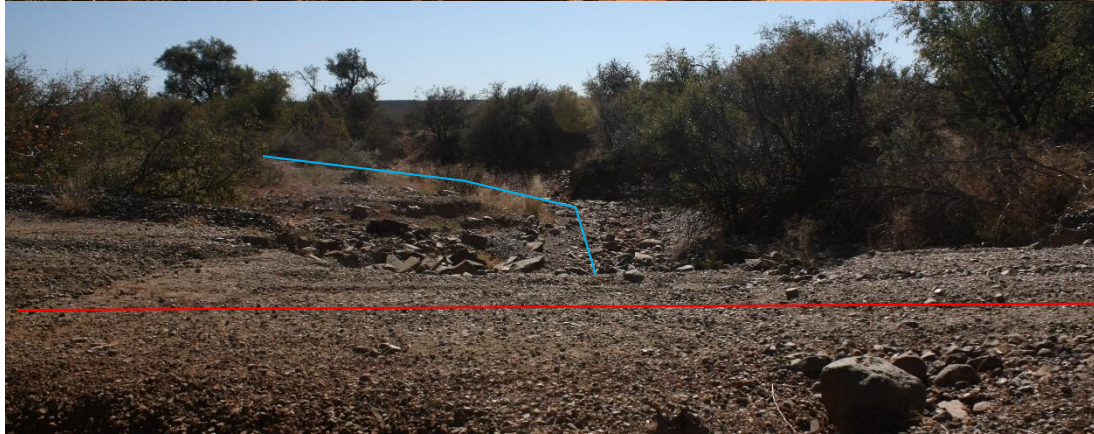
Watercourse name: #13 Unnamed	Coordinates of crossing: S 28.627865°, E 24.101653°	Flow regime: Ephemeral stream
Description of watercourse: A large and significant stream draining part of the rocky, uneven terrain in the central portion of the study area. The point of survey was in the downstream portion of the stream. The flow regime is considered as ephemeral. It is evident that short periods of flow must occur annually during the rainy season though not enough to be considered a seasonal system. The stream flows from east to west and into the Vaal River and consists of several smaller tributaries which confluence with this significant stream. The catchment is largely rocky, uneven terrain. It contains a large and clearly defined main channel with gravel/sandy bed and round stream rocks. Vegetation along the stream is clearly of riparian composition with some Facultative Wetland species present. This indicates that a temporary zone of wetness wetland conditions may be present but is however not confirmed by soil samples. Soil consists of red sand without a grey matrix or mottling. The presence of wetland conditions can therefore not be confirmed although plant species indicate that a temporary zone of wetness may be present. The stream is natural without any significant impacts although crossing by a large gravel road will impact it in terms of flow and flooding retardation and consequent alteration of the flow regime.

Dominant plant species: <i>Ziziphus mucronata</i> , <i>Eragrostis rotifer</i> , <i>Panicum coloratum</i> (FW), <i>Cenchrus ciliaris</i> , <i>Searsia lancea</i>		
Soil sample:

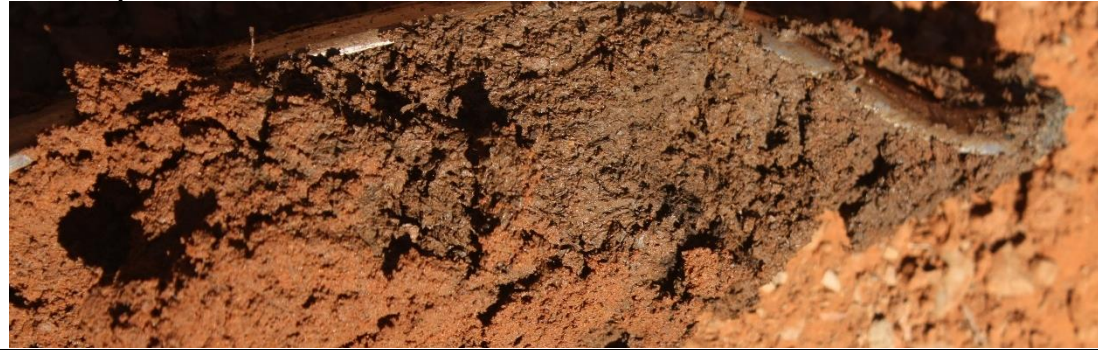
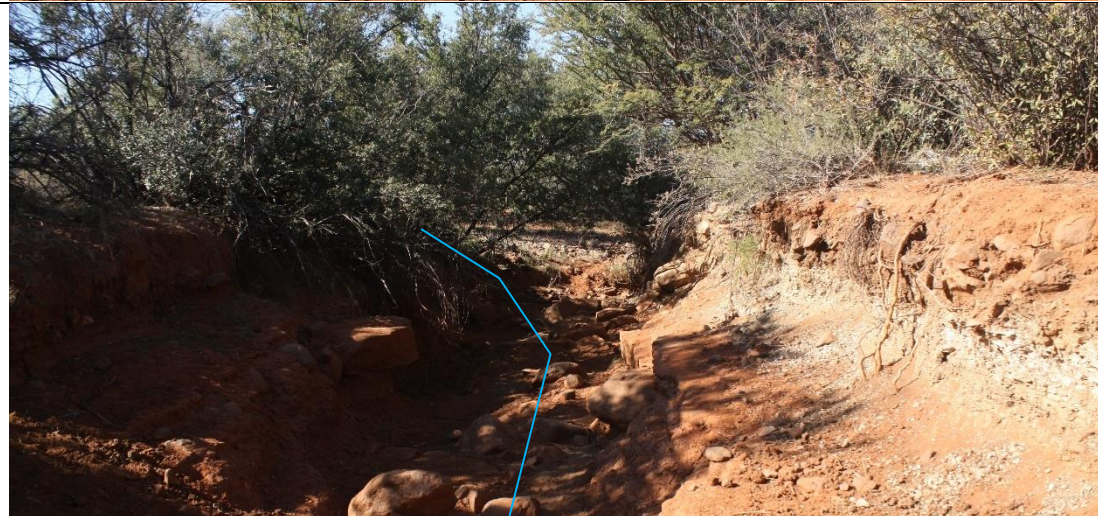
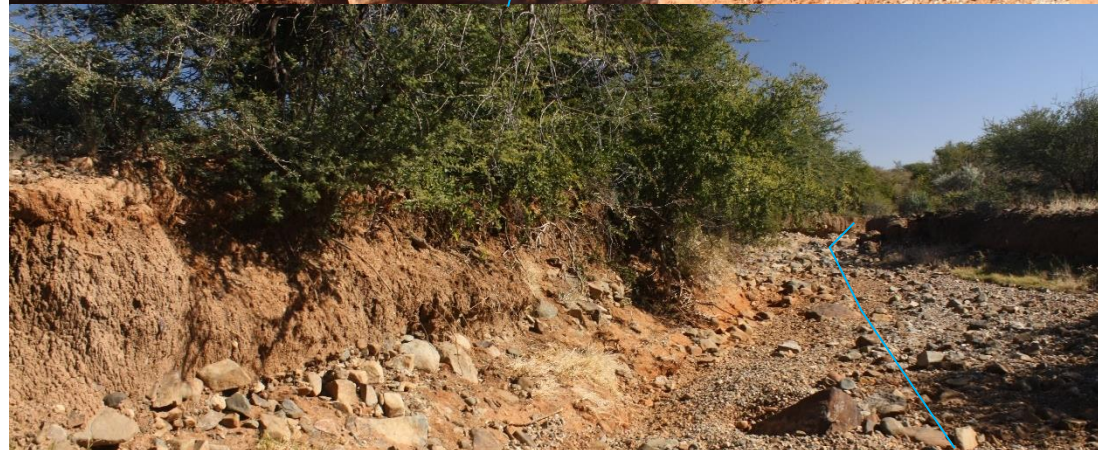
A large stream draining a portion of the central, uneven, rocky terrain. The point of the survey was near its confluence with the Vaal River. One other survey point upstream near the origin of the stream was also surveyed and included in survey point #15. The flow regime is considered close to seasonal and will flow for short periods in the rainy season and on an annual basis. This is confirmed by a high moisture content even during the dry period of the study. The stream generally flows from the north east to the south west and into the Vaal River and consists of several smaller tributaries which confluence with this significant stream. The catchment is largely rocky, uneven terrain. It contains a large and clearly defined main channel with a sandy and very rocky bed. The main channel is subjected to significant levels of scouring by floodwaters and consequently the vegetation layer is absent or sparse. The banks are however lined with a dense riparian tree thicket. Obligate wetland vegetation is absent.

The riparian grass, *Cynodon dactylon*, does indicate elevated moisture levels. Soil samples contained a high moisture level, a grey matrix and some mottling. Consequently wetland conditions are regarded as present. The stream is natural without any significant impacts although crossing by a large gravel road will impact it in terms of flow and flooding retardation and consequent alteration of the flow regime.

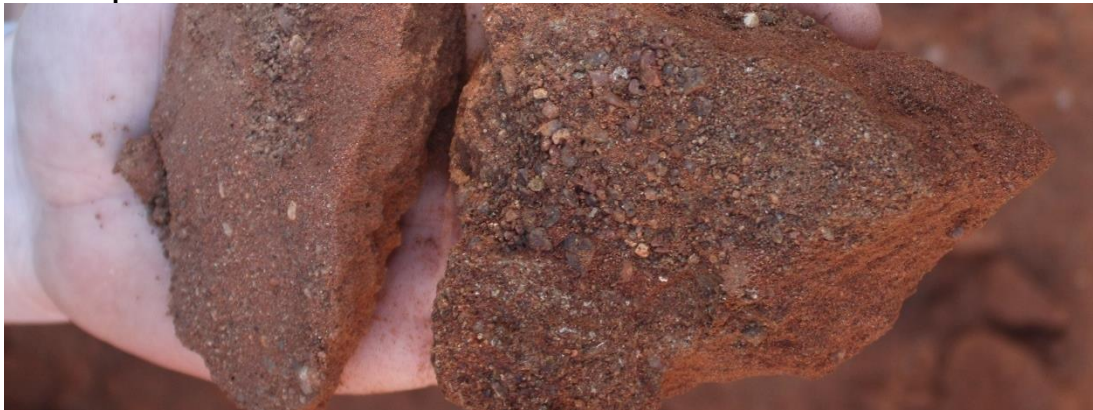
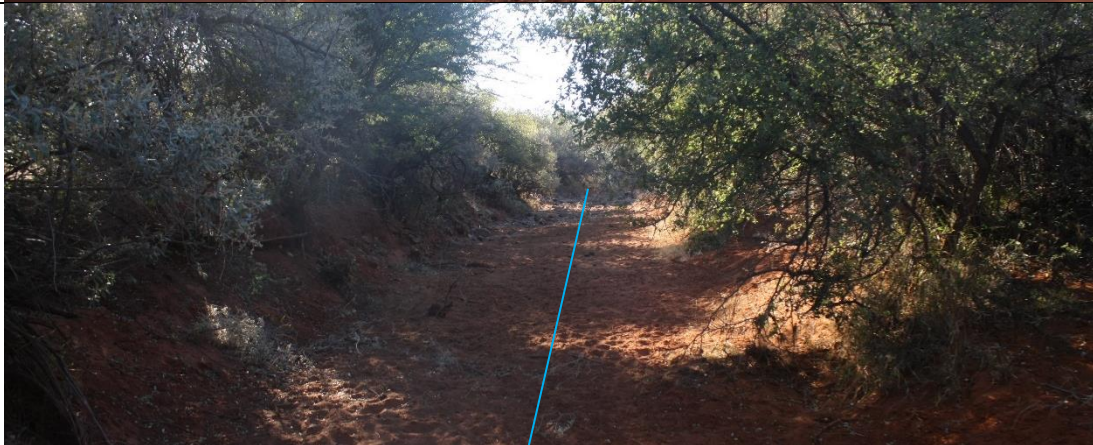
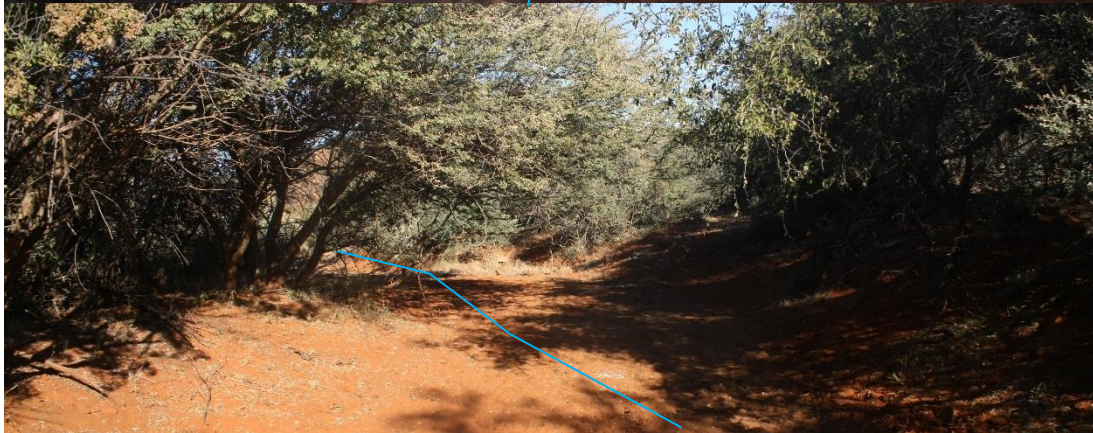
#15 Unnamed

An upstream section of #14 Seasonal Stream to the north east of #14 in the upper reaches within the uneven rocky, mountainous terrain. The flow regime is considered close to seasonal and will flow for short periods in the rainy season and on an annual basis. The flow volumes will however much lower as compared to #14 and moisture content lower. The section also flows from north east to south west. A large and clearly defined main channel is also present with gravel/sandy bed but without significant rocky surface coverage. Vegetation along the stream is mostly of terrestrial species composition though abundant riparian species are also present. Obligate wetland vegetation is absent. Soils consist of gravel/sand without any indicators of wetland conditions. The stream is natural without any significant impacts.

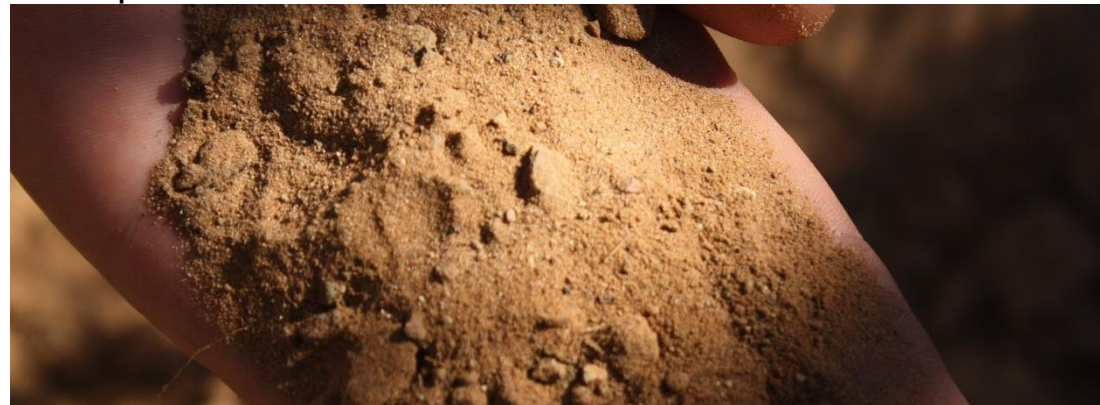
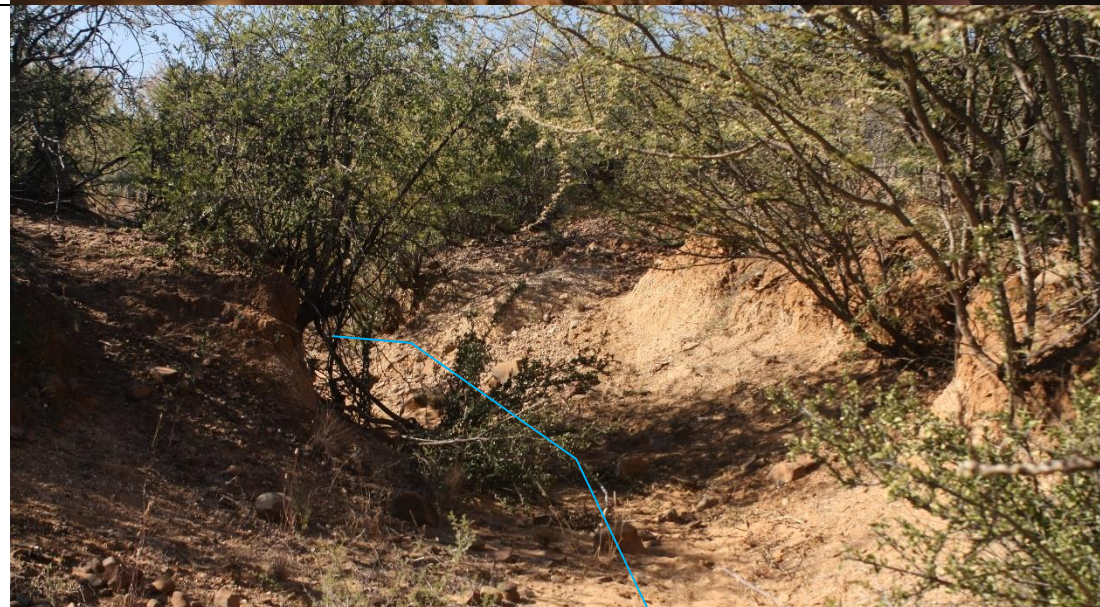
#17 Unnamed

Dominant plant species:
Vachellia tortilis, *Grewia flava*, *Ehretia rigida*, *Fingerhuthia africana*, *Ziziphus mucronata*, *Enneapogon cenchroides*, *Eragrostis lehmanniana*

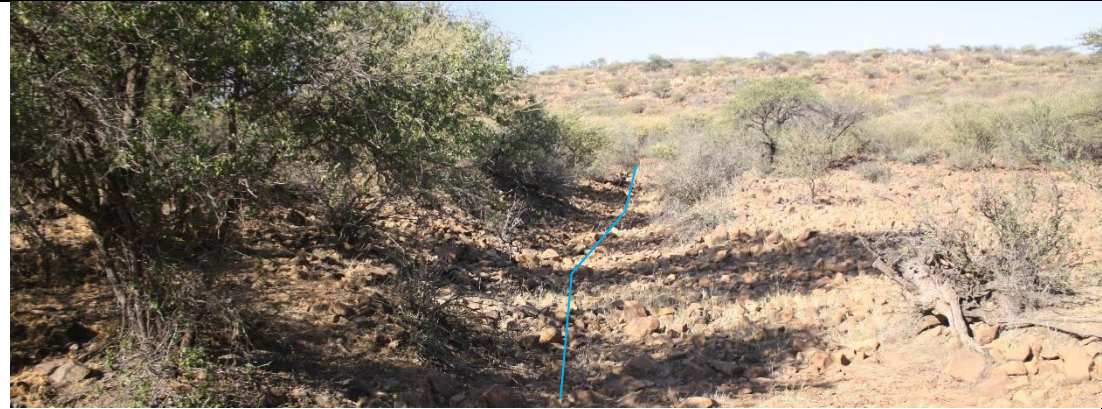
Watercourse name: #18 Unnamed	Coordinates of crossing: S 28.602290°, E 24.120241°	Flow regime: Ephemeral drainage line
---	---	--

Description of watercourse:
A relatively small drainage line along the western border of the study area and to the north and in close proximity to #17 Ephemeral Drainage Line and very similar in all respects. It flows through a shallow valley from east to west and into the Vaal River. It is a relatively short drainage line and taken as representative of adjacent similar drainage lines to the north. The

flow regime will undoubtedly be ephemeral though draining the rocky portion it is likely to flow for very short periods (hours) after heavy rainfall. A distinct main channel is present and the bed is dominated by sand with a very high percentage rock coverage which also prevented soil sampling. Vegetation is dominated by terrestrial species though several riparian species are present indicating a higher moisture regime. Vegetation however indicate the absence of wetland condition though it must clearly be regarded as a watercourse. It is being crossed by a small dirt track which will have a limited impact as a flow barrier.

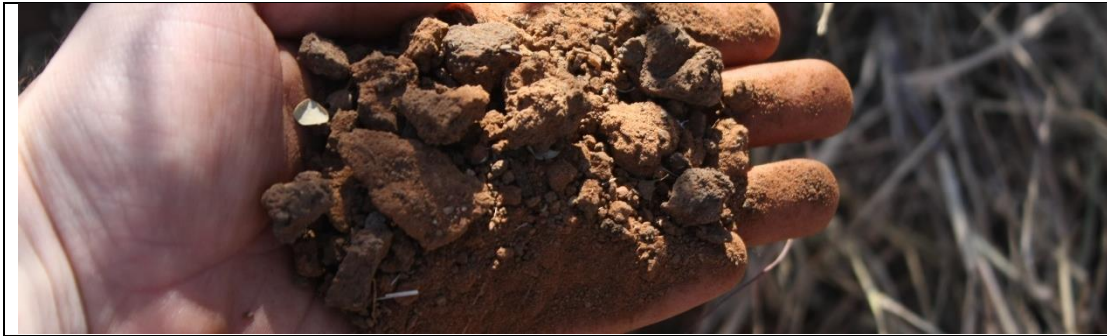
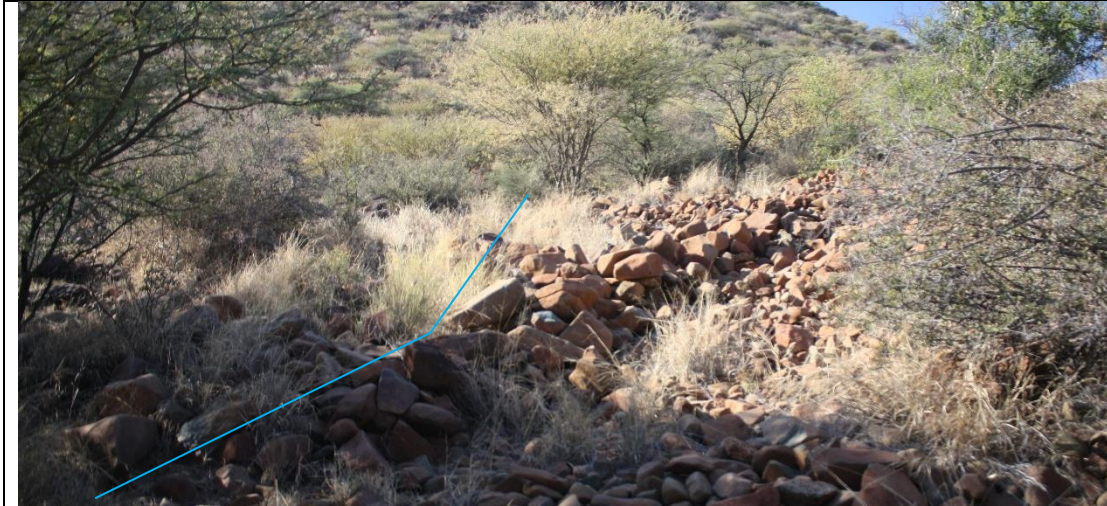
Watercourse name: #19 Unnamed	Coordinates of crossing: S 28.581448°, E 24.141855°	Flow regime: Ephemeral Drainage Line
---	---	--

Description of watercourse:
 A relatively small drainage line along the western border of the study area and to the north of #17 and #18 Ephemeral Drainage Lines and very similar to them in most respects. It flows through a shallow valley from east to west and into the Vaal River. It is a relatively short drainage line and taken as representative of adjacent similar drainage lines adjacent to it. The flow regime will undoubtedly be ephemeral though draining the rocky portion it is likely to flow for very short periods (hours) after heavy rainfall. A distinct main channel is present and the bed is dominated by gravel/sand with a very high percentage rock coverage. Vegetation is dominated by terrestrial species though several riparian species are present indicating a higher moisture regime. Vegetation and soil however indicate the absence of wetland condition though it must clearly be regarded as a watercourse. It is being crossed by a small dirt track which will have a limited impact as a flow barrier.

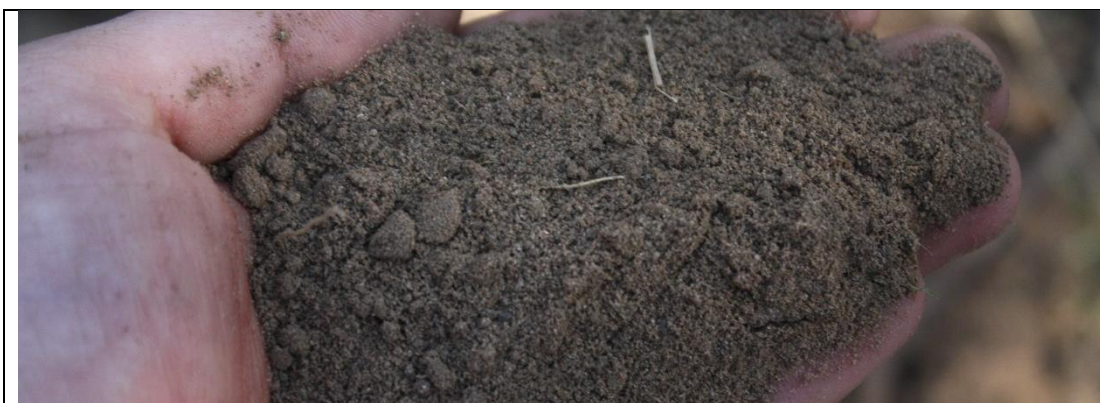
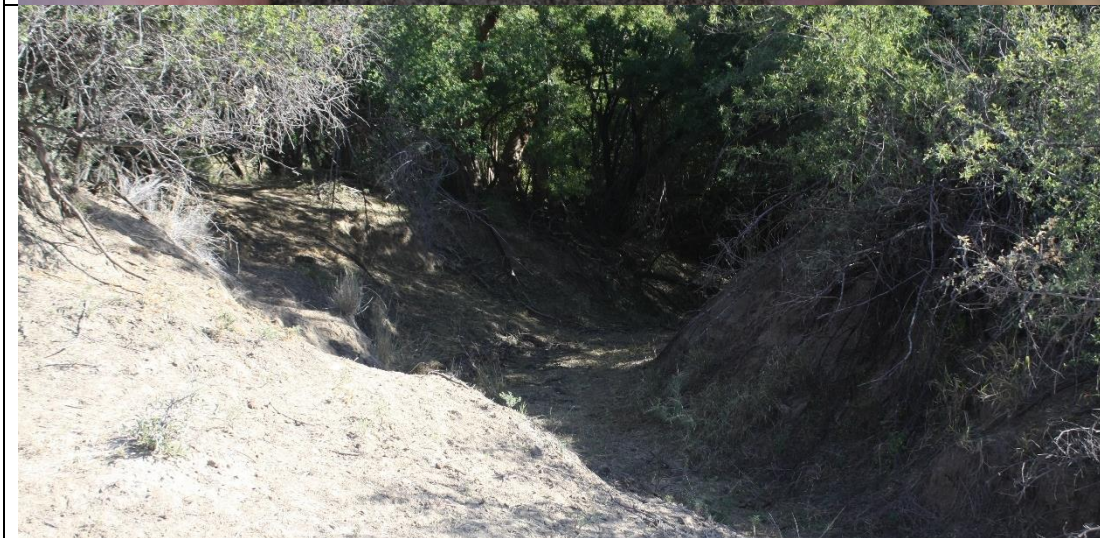
Watercourse name: #20 Unnamed	Coordinates of crossing: S 28.576840°, E 24.147116°	Flow regime: Ephemeral drainage line
Description of watercourse: A relatively small drainage line along the western border of the study area and to the north of #19 Ephemeral Drainage Line and very similar to it in most respects. It flows through a shallow valley from east to west and into the Vaal River. It is a relatively short drainage line and taken as representative of adjacent similar drainage lines adjacent to it. The flow regime will undoubtedly be ephemeral though draining the rocky portion it is likely to flow for very short periods (hours) after heavy rainfall. The point of survey was taken near its confluence with the Vaal River and consequently the main channel is dominated by sand and without any visible surface rock. Vegetation this close to the river is dominated by riparian thicket which indicate a higher moisture regime. Vegetation and soil however indicate the absence of wetland condition though it must clearly be regarded as a watercourse. It is being crossed by a small dirt track which will have a limited impact as a flow barrier.

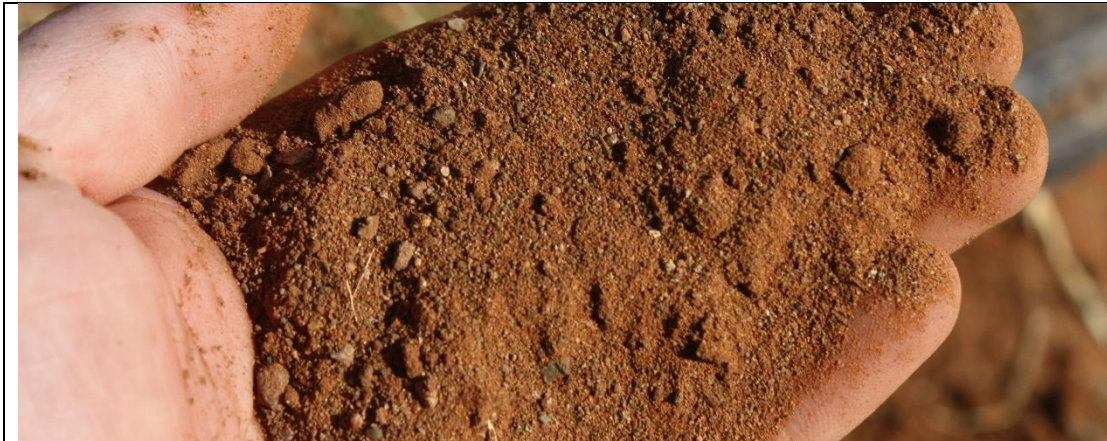
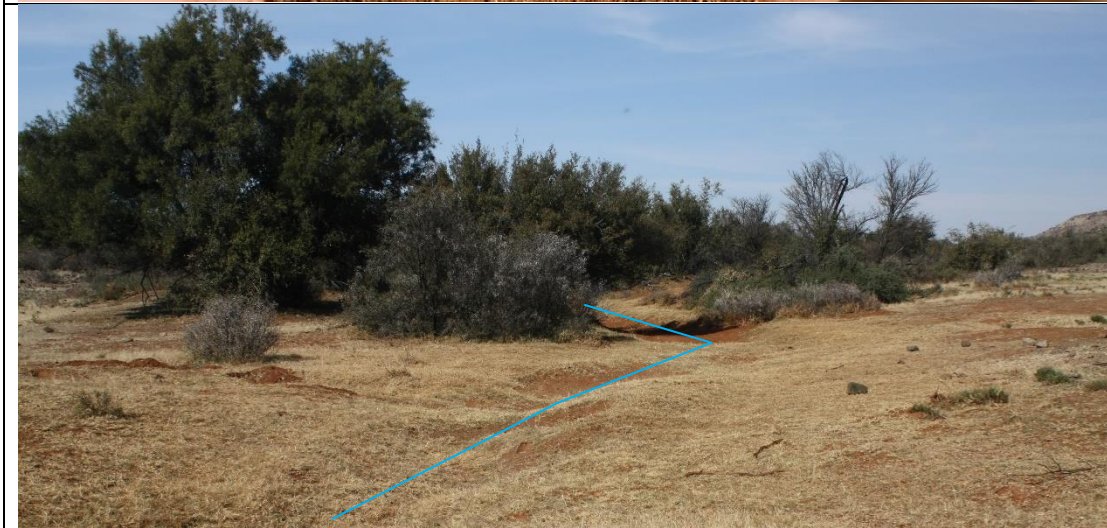
Watercourse name: #21 Unnamed	Coordinates of crossing: S 28.562657°, E 24.164046°	Flow regime: Ephemeral stream
---	---	---

Description of watercourse:
 A large and significant stream draining a portion of the north eastern rocky, uneven terrain in the central portion of the study area. The point of survey was in the downstream portion of the stream near its confluence with the Vaal River. The flow regime is considered as ephemeral. It is evident that short periods of flow must occur annually during the rainy season though not enough to be considered a seasonal system. The stream flows from south to north and into the Vaal River and consists of several smaller tributaries which confluence with this significant stream. The catchment is largely rocky, uneven terrain. It contains a clearly defined main channel with a red sandy bed and without any visible surface rocks. Vegetation along the stream is clearly of riparian composition with some Facultative Wetland species present. This indicates that a temporary zone of wetness wetland conditions may be present but is however not confirmed by soil samples. Soil consists of red sand without a grey matrix or mottling. The presence of wetland conditions can therefore not be confirmed although plant species indicate that a temporary zone of wetness may be present. The stream is natural without any significant impacts although crossing by a dirt road will impact it in terms of flow and flooding retardation and consequent alteration of the flow regime. This is also confirmed by the presence of a few exotic weeds.

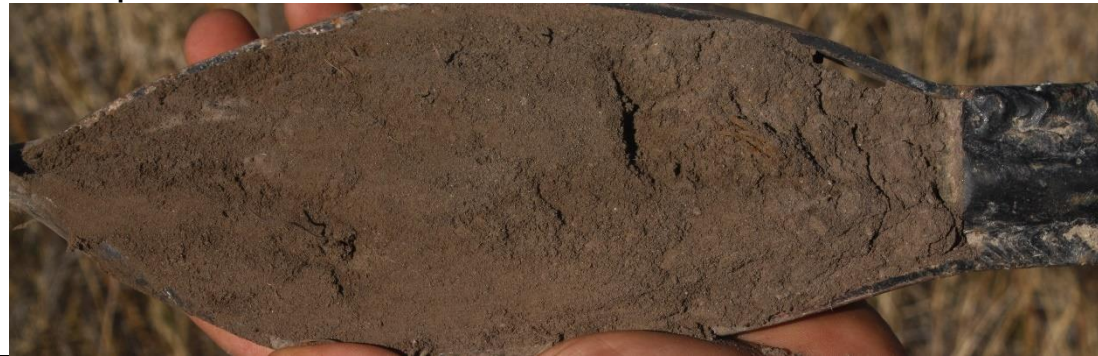
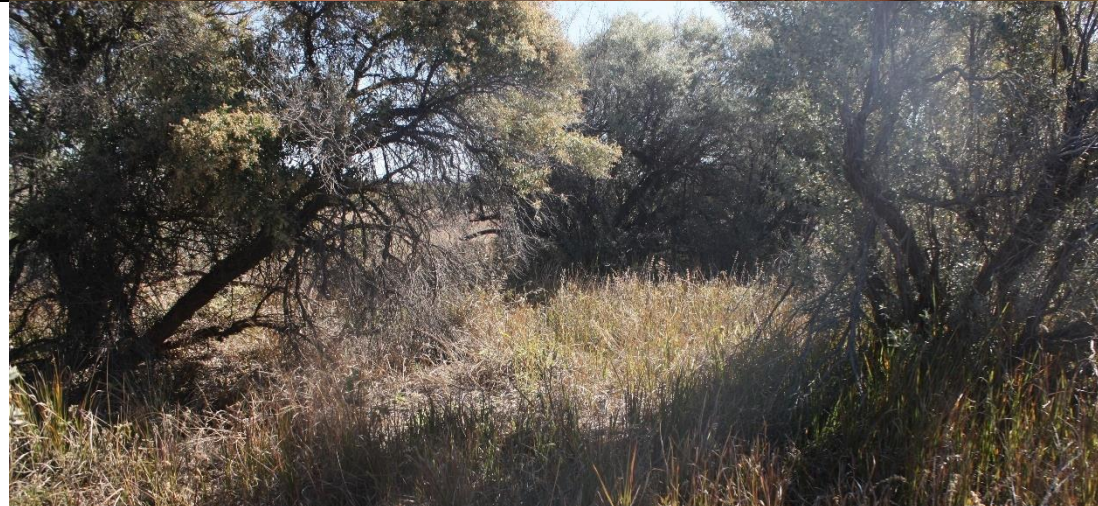
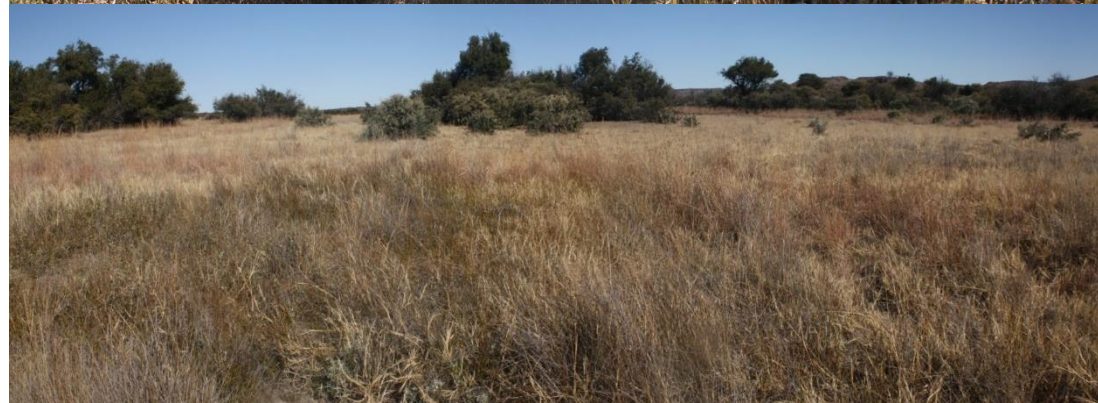
Watercourse name: #22 Unnamed	Coordinates of crossing: S 28.574933°, E 24.185421°	Flow regime: Seasonal stream
Description of watercourse: Probably the largest stream in the study area with the largest catchment area draining a portion of the central rocky terrain but with the majority of the catchment in the plains portion in the north east of the study area. The point of this survey was in the downstream section near its confluence with the Vaal River. Several upstream survey points in this stream was also done and included in subsequent survey point #23 to #28. The flow regime is considered close to seasonal and will flow for short periods in the rainy season and on an annual basis. This is confirmed by a high moisture content even during the dry period of the study. The stream drains a large area but generally flows from south east to north west and into the Vaal River and consists of several smaller tributaries which confluence with this significant stream. At the point of the survey the streams main channel broadens and a main channel is largely absent and consists of a clayey substrate without any visible surface rocks. The vegetation is dominated by hygrophilous grasses and sedges with many being Obligate Wetland species. The fringe of the area also contain riparian tree species. Soils consists of clayey sediment with a visible grey matrix and feint mottling considered indicative of a seasonal zone of wetness. Consequently wetland conditions are regarded as present. The stream is natural without any significant impacts although crossing by a dirt road will impact it in terms of flow and flooding retardation and consequent alteration of the flow regime.

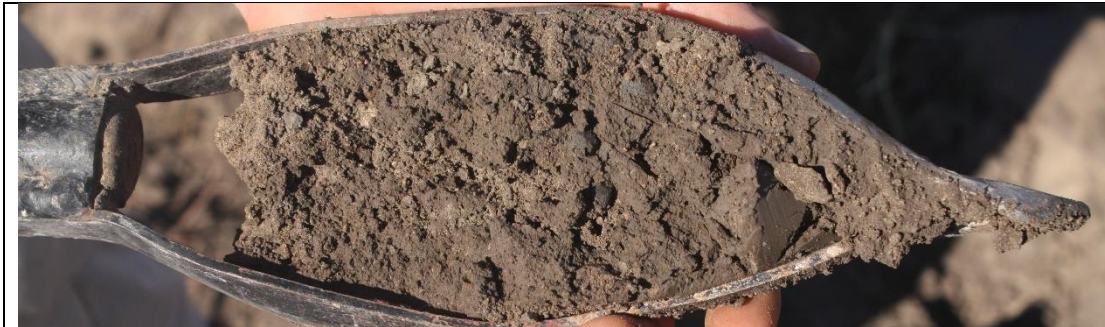
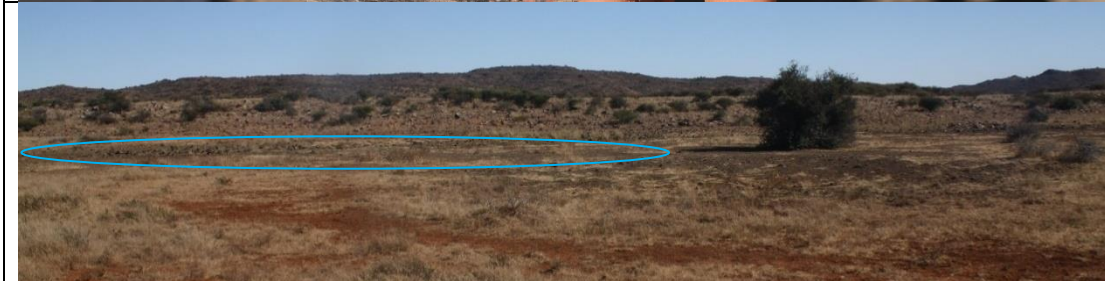
A site taken some distance upstream of #22 Seasonal Stream adjacent to the low quartzite ridge and forming a unique wetland area. It is adjacent to two other similar wetland areas in the stream and also taken as representative of these. The flow regime is considered close to seasonal and will flow for short periods in the rainy season and on an annual basis. This is confirmed by a high moisture content even during the dry period of the study. The portion of the stream at the site is also being fed by runoff and seepage from the quartzite ridge, in addition to the main channel flow. A depression has formed here and a main channel is largely absent and indistinct and consists of a clayey substrate without any visible surface rocks. The vegetation is dominated by hygrophilous grasses and sedges with many being Obligate Wetland species. Soils consists of clayey sediment with a visible grey matrix and feint mottling considered indicative of a seasonal zone of wetness. Consequently wetland conditions are regarded as present. The stream is natural without any significant impacts near this survey point although game utilising this area as water source leads to high levels of trampling.
