Ecological and Wetland Assessment for alluvial diamond mining operations at Rooipoort on the farms Zandplaats 102/5, Vogelstruis Pan 101/0, Vogelstruis Pan 98/0, Bergplaats 100/0 and Klipfontein 99/0 near Schmidtsdrif, Northern Cape Province.

August 2018

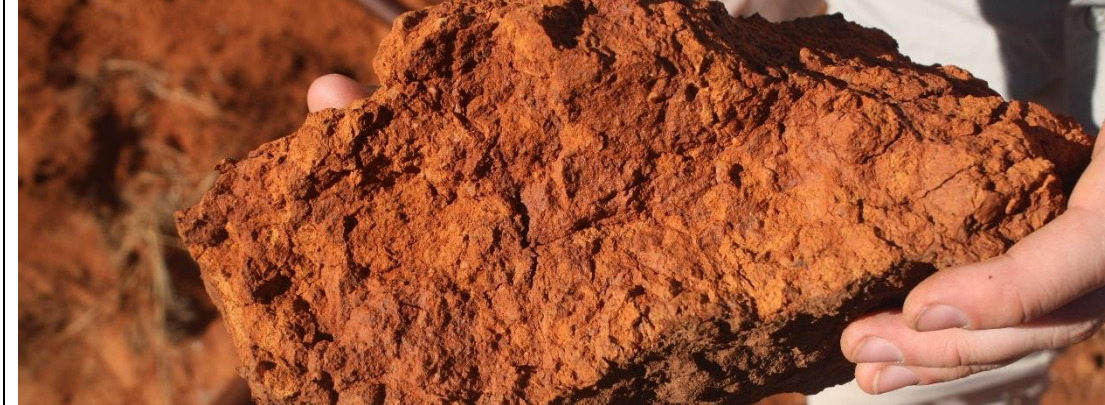
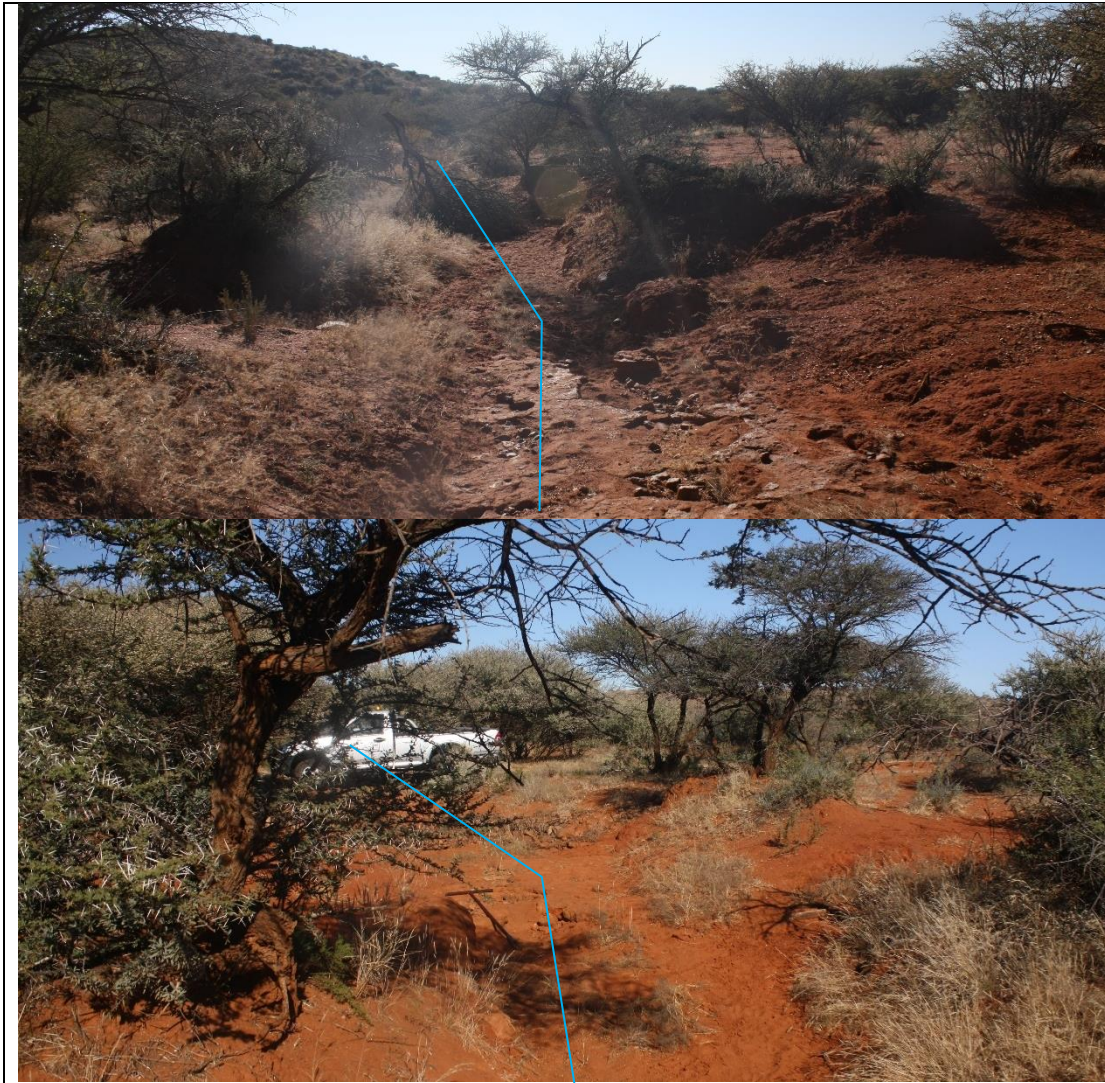
Watercourse name: #25 Unnamed	Coordinates of crossing: S 28.604928°, E 24.181572°	Flow regime: Seasonal stream
---	---	--

Description of watercourse:
 An upstream section of #22 Seasonal Stream in the southern rocky, uneven terrain and draining this portion of the catchment. The flow regime is considered close to seasonal and will flow for short periods in the rainy season and on an annual basis. The flow volumes will however be much lower as compared to #22 and moisture content lower. The section flows from west to east. A large and clearly defined main channel is also present with gravel/sandy bed, without pronounced surface rock but with compacted sandy/clay bed. Vegetation along the stream is mostly of terrestrial species composition though abundant riparian species are also present. Obligate wetland vegetation is absent. Soils consist of gravel/sand without any indicators of wetland conditions. The stream is natural without any significant impacts though crossing by a small dirt track will act as flow barrier and contribute to erosion within the stream.

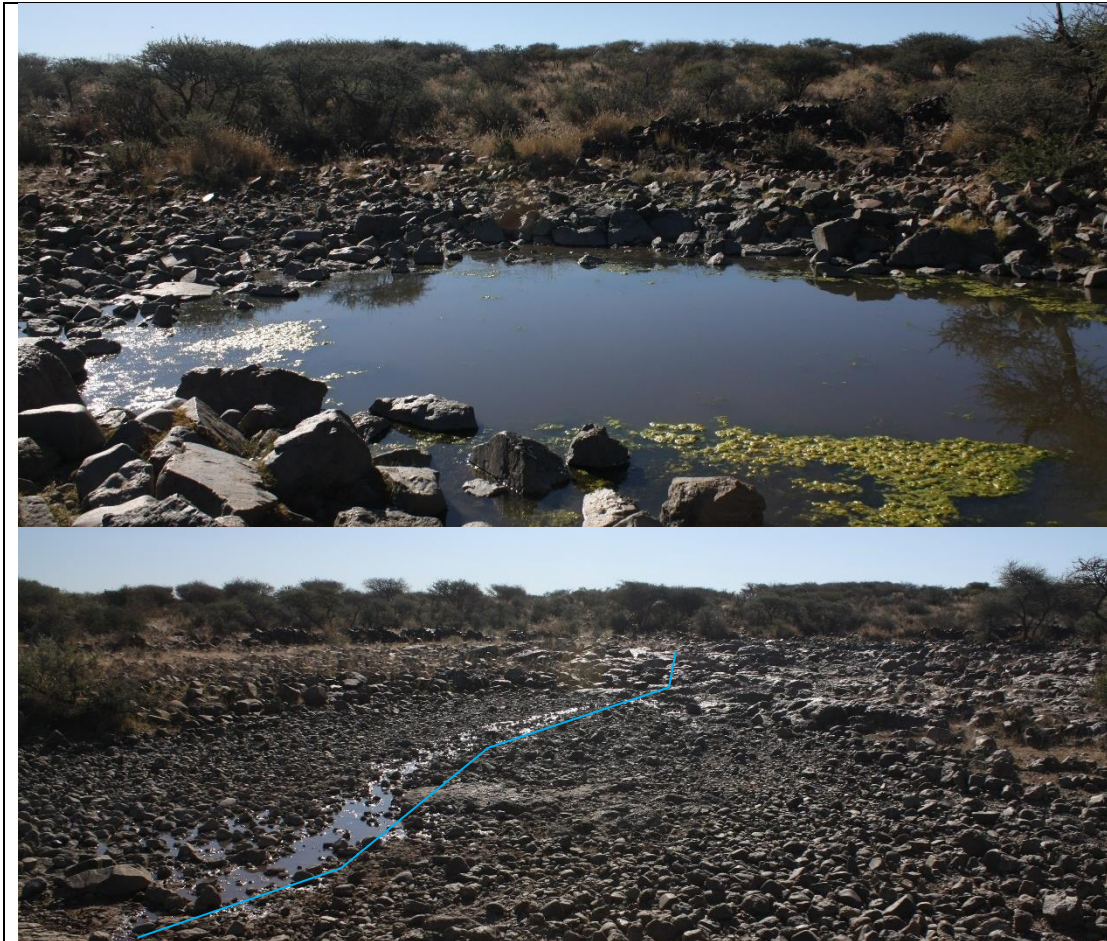
Watercourse name: #26 Boesmanfontein	Coordinates of crossing: S 28.598147°, E 24.215126°	Flow regime: Artesian fountain
Description of watercourse: A very unique natural artesian fountain situated in close proximity and associated with #22 Seasonal Stream. Systems such as this is exceptionally rare and considered highly unique. The fountain originates within a quartzite outcrop and flows down a gentle slope into a small natural rocky depression from where it overflows to the south into a sandy area. A more comprehensive description of this system can be found in section 4.3.4. Soils sampling is not possible due to the bedrock nature of the fountain. However, due to its perennial nature obligate wetland vegetation has become established around the fountain and clearly indicate the presence of wetland conditions. It is not currently subjected to any significant impacts although some trampling by game occurs and would cause some impacts on the fountain.

Dominant plant species: <i>Kalanchoe rotundifolia</i> , <i>Sporobolus ioclados</i> , <i>Gomphrena celosioides</i> , <i>Chloris virgata</i> , <i>Cynodon dactylon</i> (FW), <i>Setaria verticillata</i> , <i>Schoenoplectus muricunix</i> (OW)		
Soil sample: Surface rock coverage prevented soil sampling

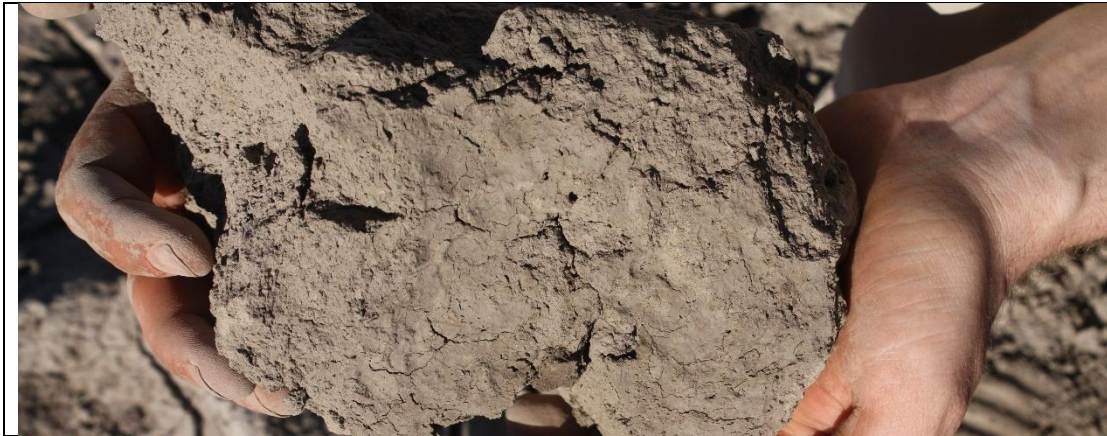
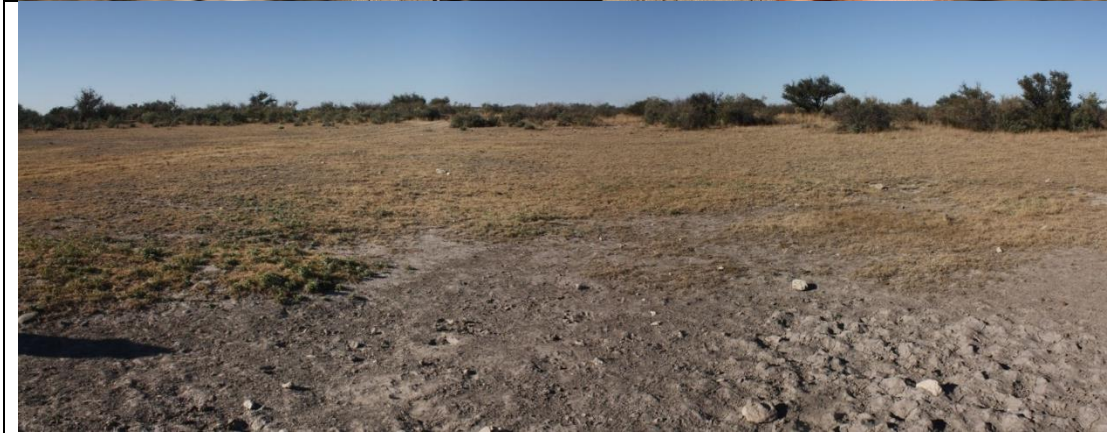
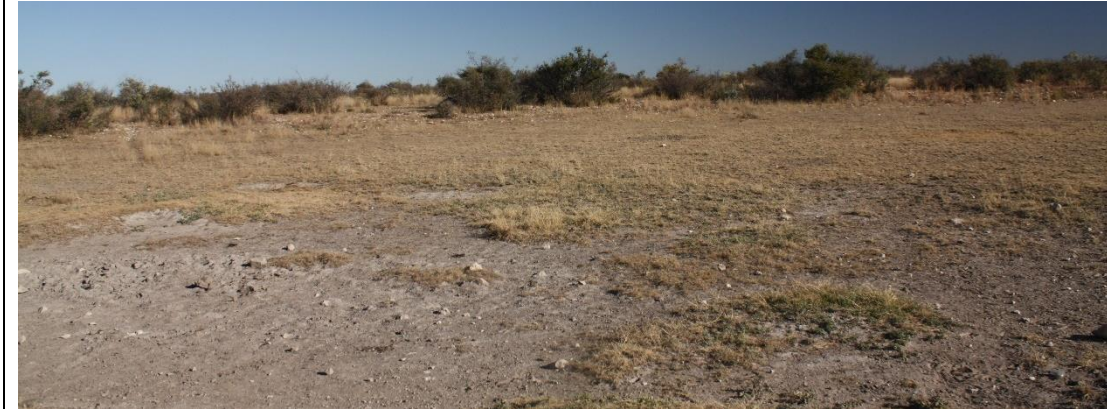
Watercourse name: #27 Unnamed	Coordinates of crossing: S 28.603473°, E 24.196949°	Flow regime: Small ephemeral pan
Description of watercourse: A small ephemeral pan situated adjacent and along the southern reach of #22 Seasonal Stream. The pan is considered to have an ephemeral hydrological regime and will only contain surface water after exceptional rainfall events. The pan is one of the smaller systems in the study area and has a diameter of approximately 120 m. No in- or outflow could be observed. The pan is flat bottomed, situated in a plain and vegetation is dominated by a fringe of riparian trees and a short grass layer in the interior of the pan. The vegetation in the pan contain Obligate Wetland species and indicate definite wetland conditions even though only of temporary wetness. Soil samples contain a high clay content though a grey matrix or mottling was not evident at the time of sampling. The wetland conditions are considered present though of temporary zone of wetness. The small pan is not currently subjected to any significant impacts though a dirt road does cross it but is anticipated to have a limited impact on infiltration and hydrology.

Dominant plant species: <i>Cynodon dactylon</i> (FW), <i>Ziziphus mucronata</i> , <i>Stachys</i> sp., <i>Schoenoplectus muricunix</i> (OW), <i>Eragrostis echinochloidea</i> , <i>Eragrostis lehmanniana</i> , <i>Eragrostis bicolor</i>		
Soil sample:

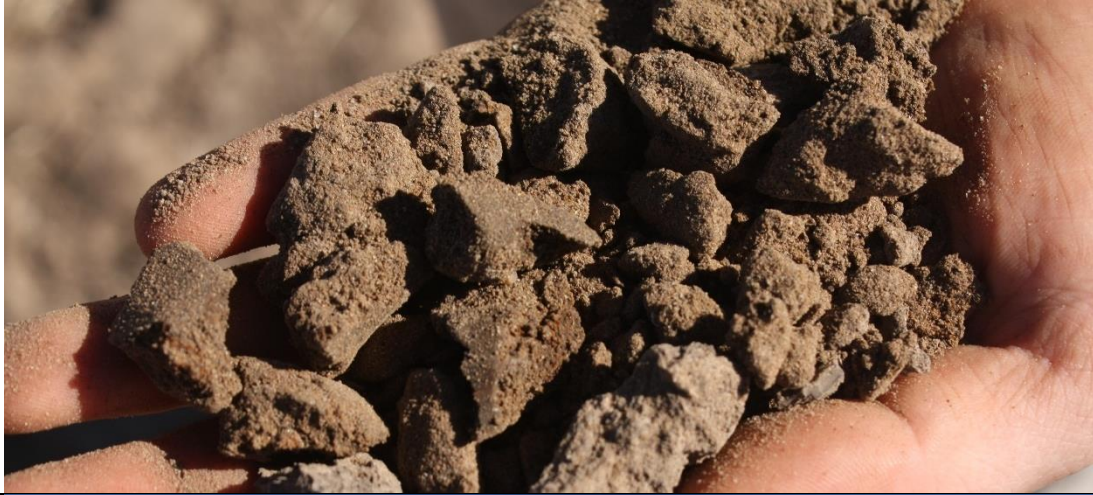
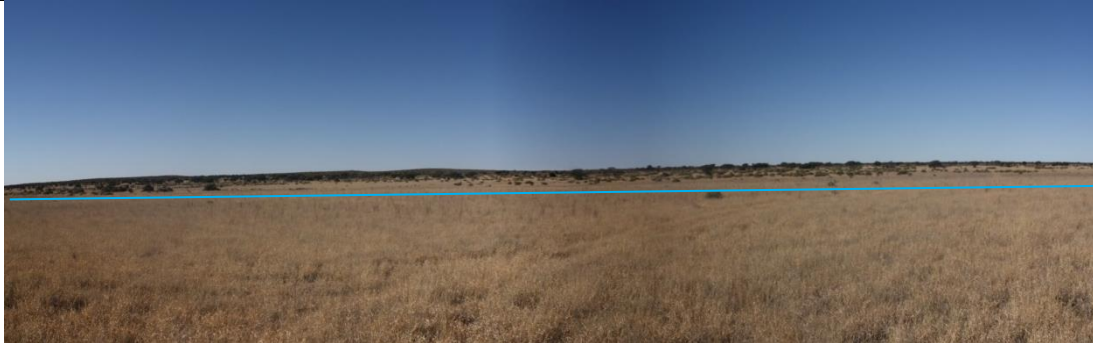
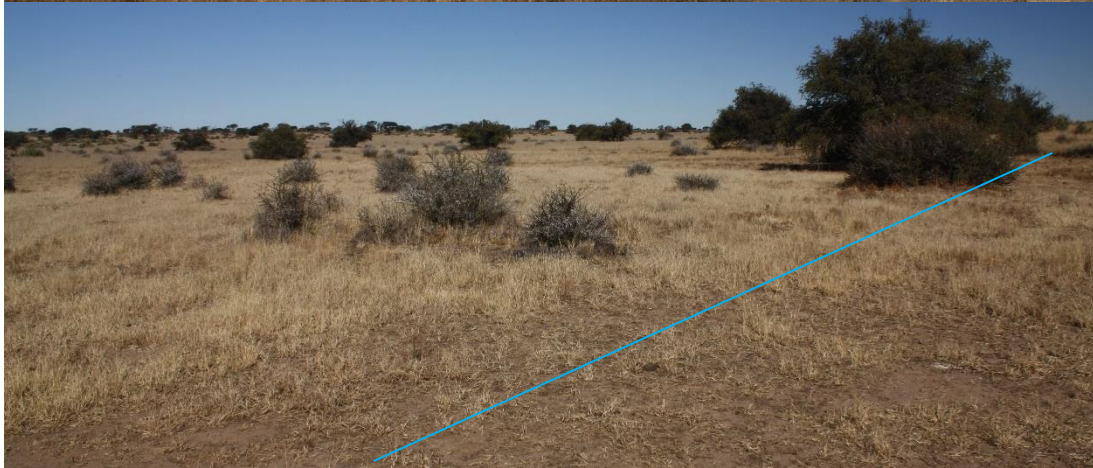
A large and significant stream along the northern border of the study area. The flow regime of the stream will undoubtedly be of ephemeral nature. It is situated in the sandy northern portion of the study area. Due to the sandy soils the stream does not contain a very well defined main channel and surface flow will infiltrate into the soil quickly decreasing the likelihood of surface water. It is highly likely that subterranean flow may occur. The area where the stream was surveyed contains an area where the subsoil is exposed and illustrates the presence of a flow pattern. Therefore, although a distinct main channel is absent and it is not easily distinguished it must still be considered a watercourse. Several other drainage lines in close proximity also functions in this manner and this stream is taken as representative of these. The stream flows from east to west and into the Vaal River. The catchment is dominated by relatively flat, sandy plains without any visible surface rock. Vegetation along the stream is not easily identified as being riparian although the presence of the riparian tree, *Ziziphus mucronata*, and grass, *Cynodon dactylon*, does indicate elevated moisture levels. Soils at the sampling point

consisted of sandy clay though over the majority of the stream this will be exclusively sandy in the upper soil layers. Wetland conditions are therefore absent. The stream is natural without any significant impacts although trampling by game at the sampling site does impact it to some extent.

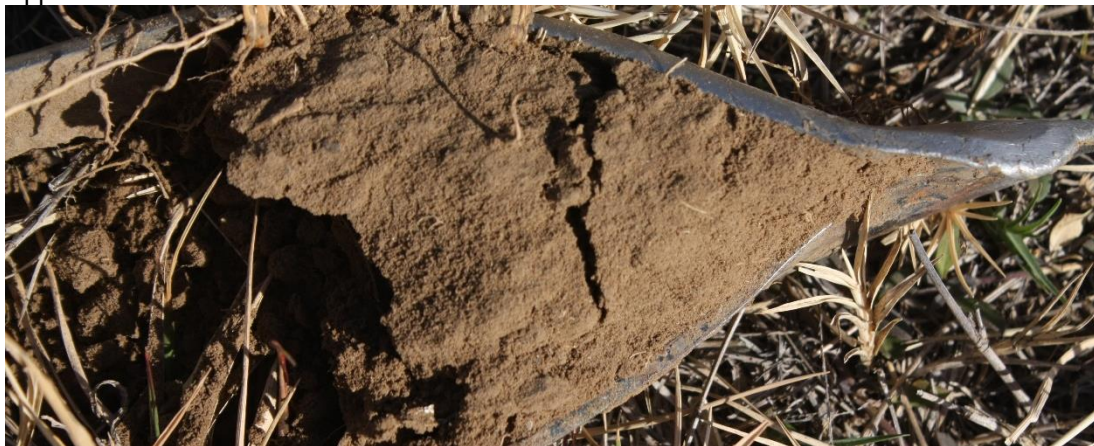
Lower Zone (Upper limit)

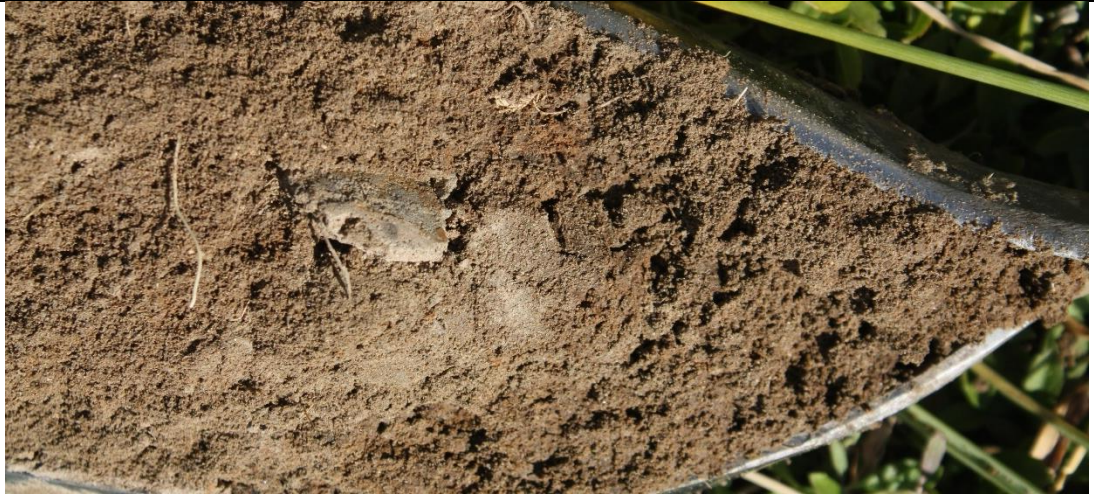
Lower Zone (Lower limit)

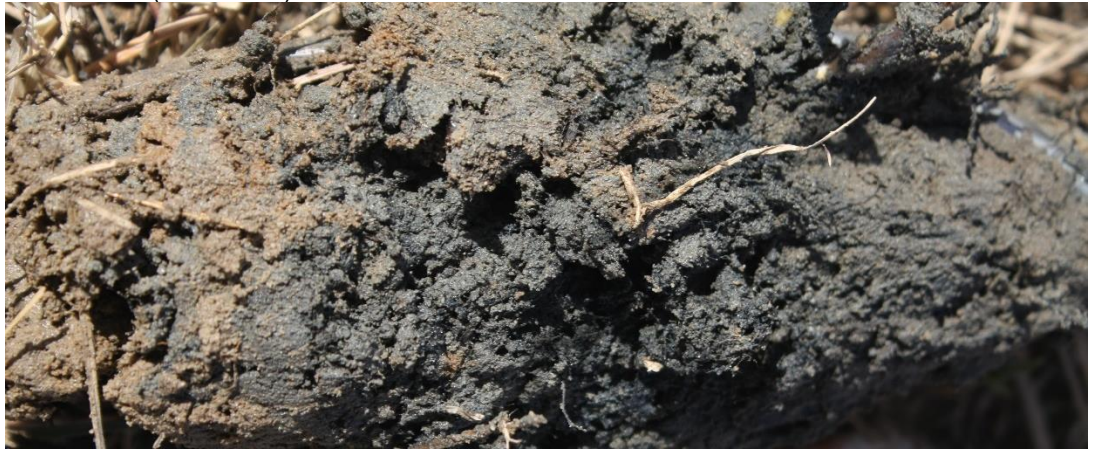
Marginal Zone

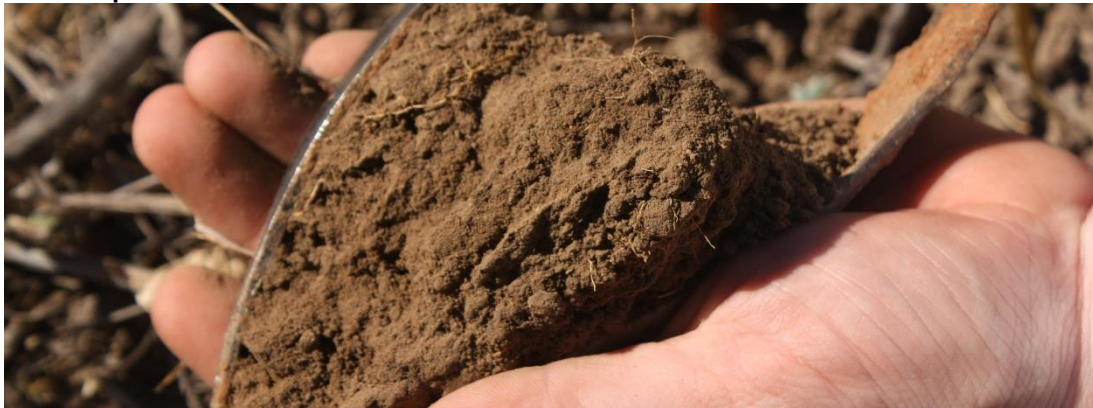
Upper Zone

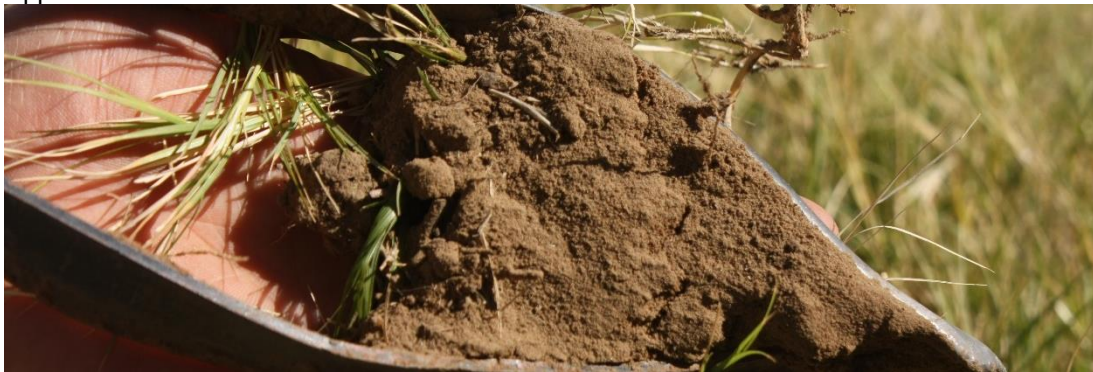
Lower Zone (Upper limit)

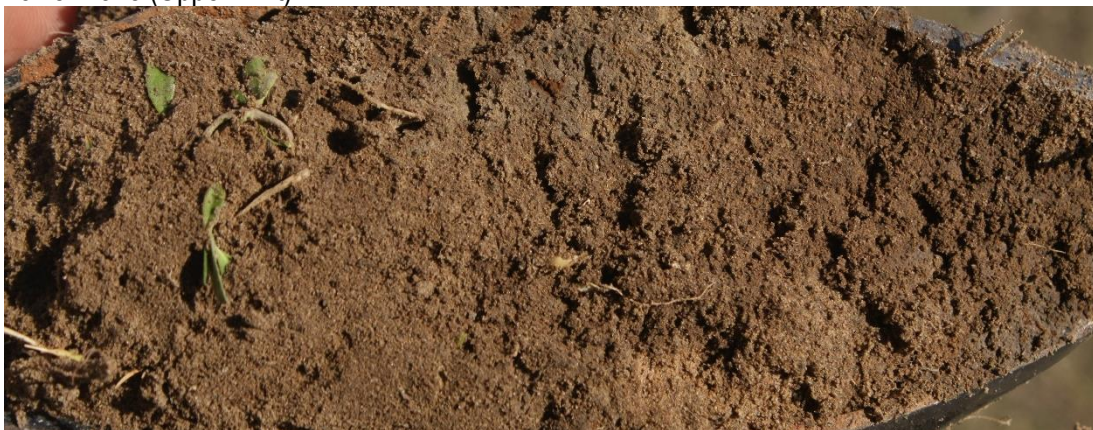
Lower Zone (Lower limit)

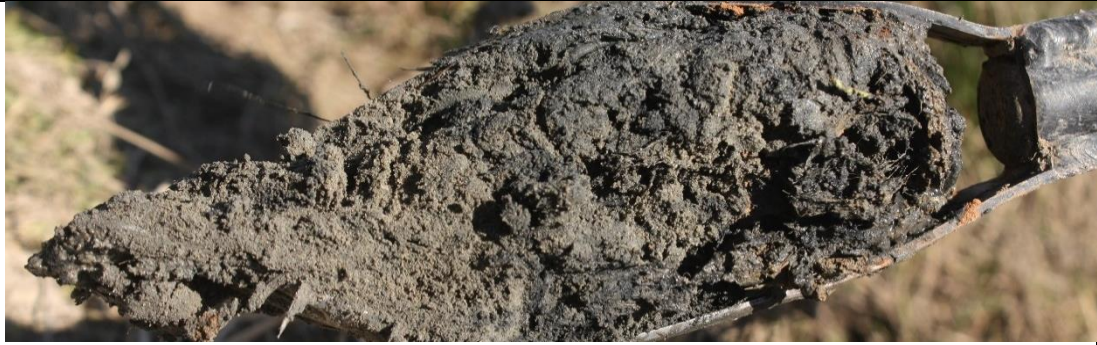
Marginal Zone

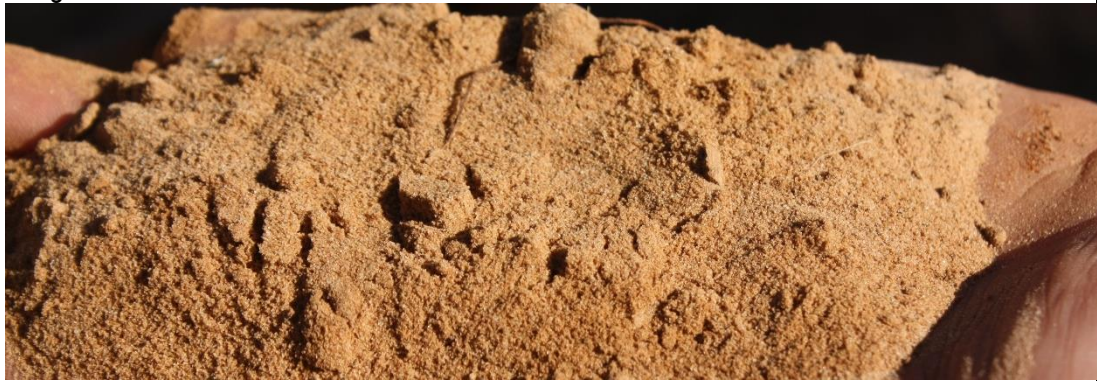
Alluvial floodplain

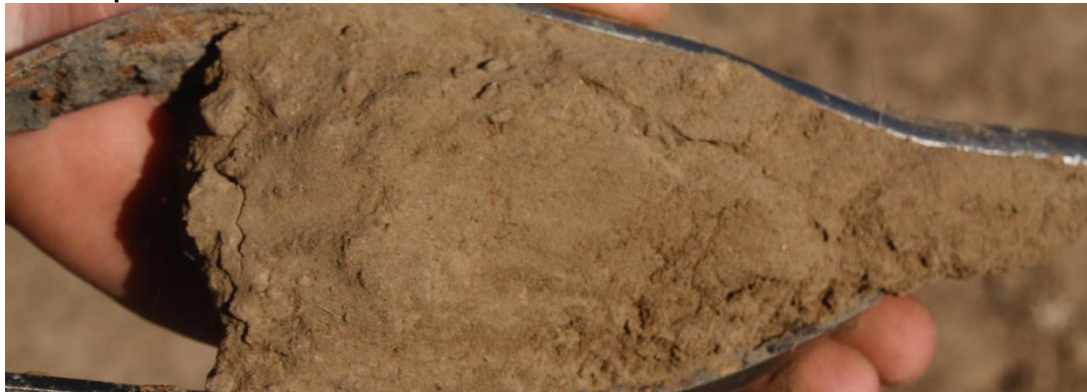
Upper Zone

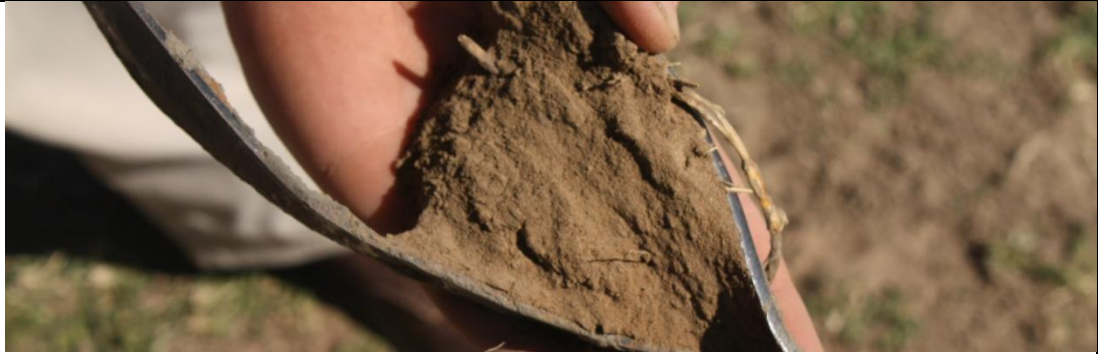
Lower Zone (Upper limit)

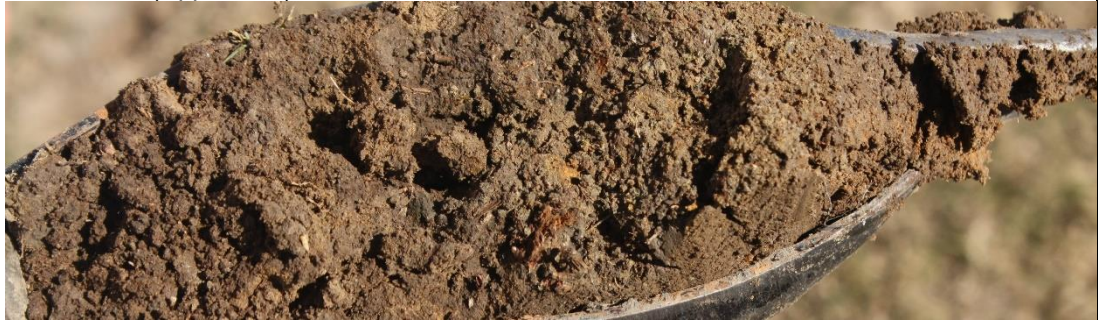
Lower Zone (Lower limit)

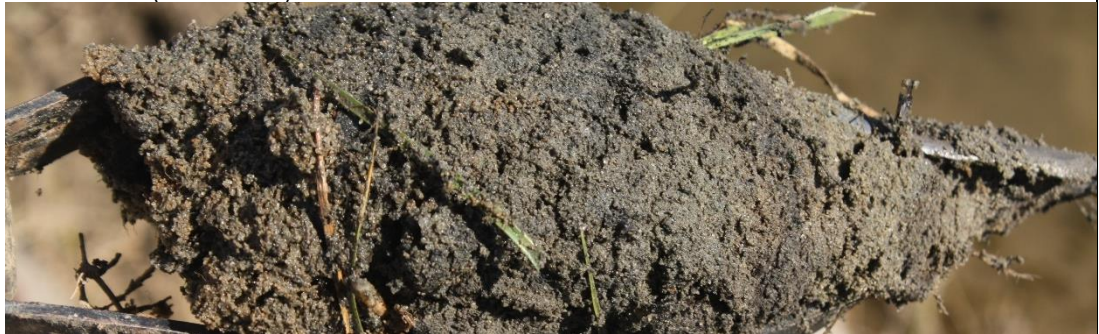
Marginal Zone

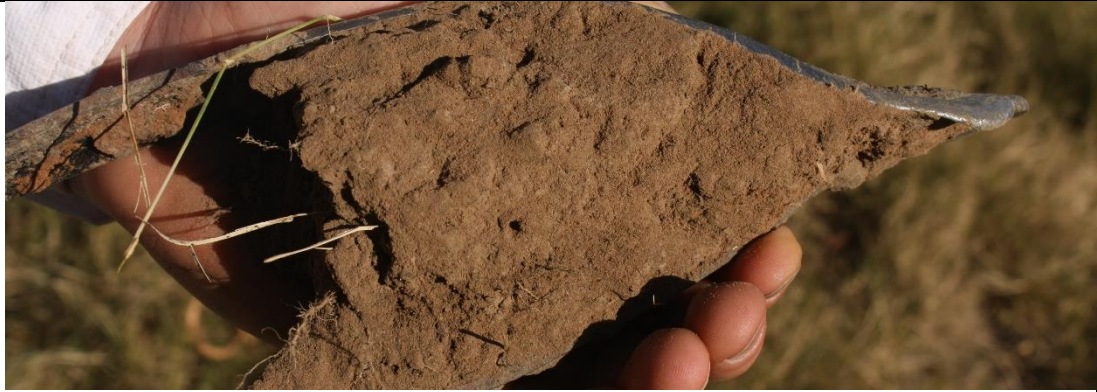
Lower Zone (Upper limit)

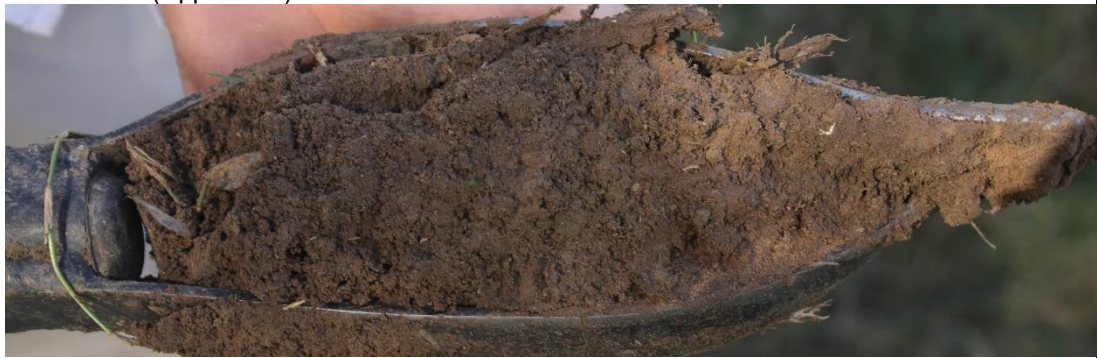
Lower Zone (Lower limit)

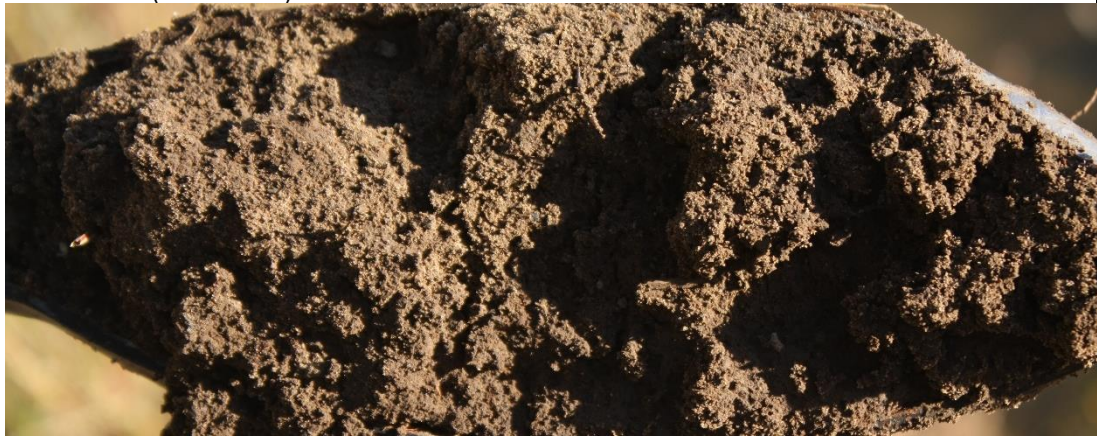
Marginal Zone

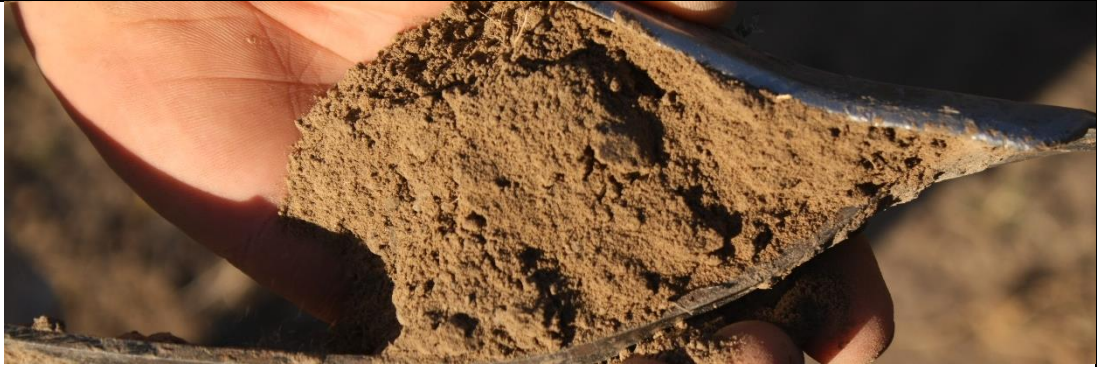
Upper Zone

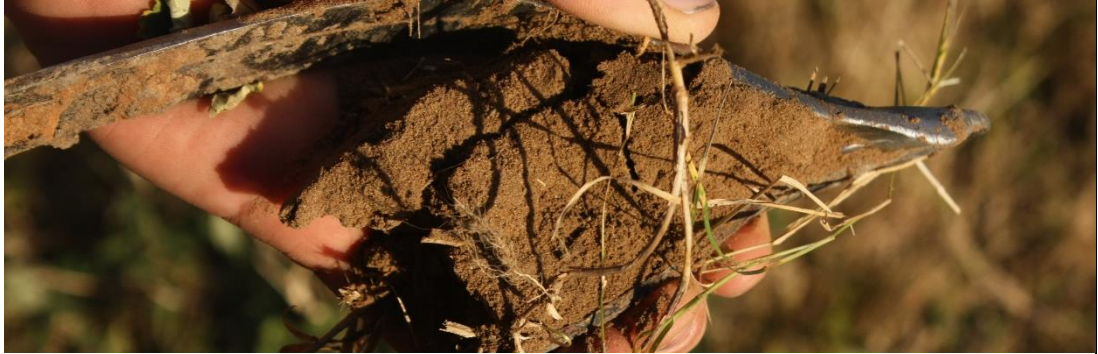
Lower Zone (Upper limit)

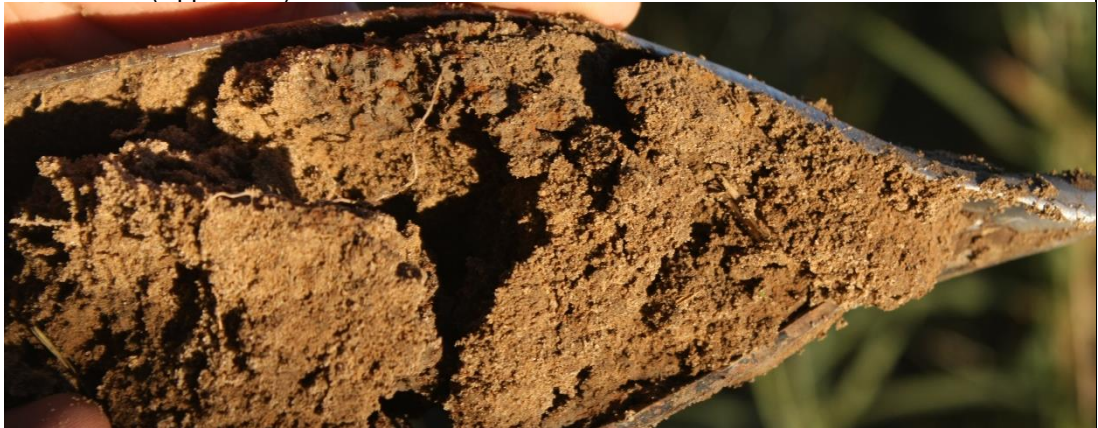
Lower Zone (Lower limit)

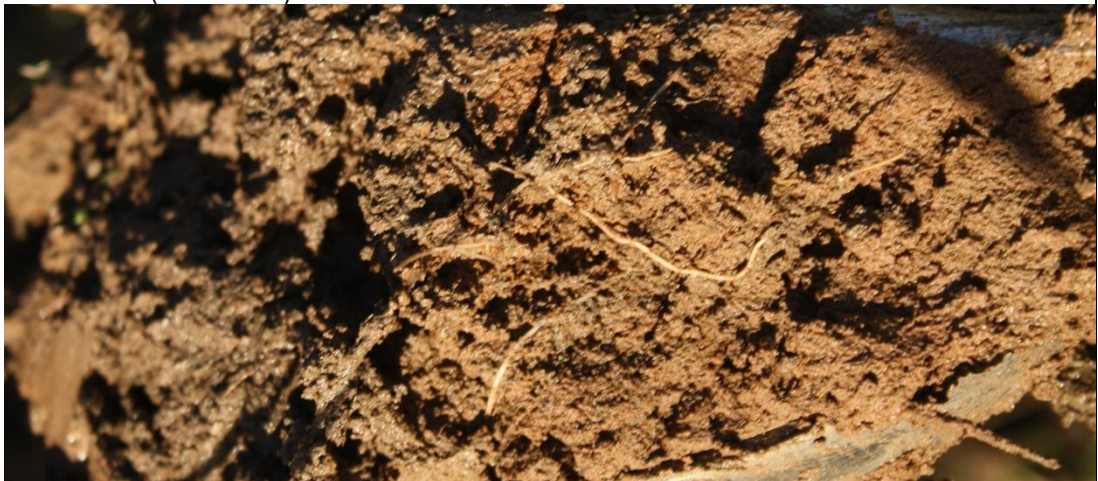
Marginal Zone
