Landscape Maintenance Plan for alluvial diamond mining operations at Rooipoort on the farms Zandplaats 102/5, Vogelstruis Pan 101/0, Vogelstruis Pan 98/0, Bergplaats 100/0 and Klipfontein 99/0 near Schmidtsdrif, Northern Cape Province.

Darius van Rensburg, M. Sc. Pr.Sci.Nat. Ecology

Report Version	Final 1.0		
Title	Landscape Maintenance Plan for alluvial diamond mining operations at Rooipoort on the farms Zandplaats 102/5, Vogelstruis Pan 101/0, Vogelstruis Pan 98/0, Bergplaats 100/0 and Klipfontein 99/0 near Schmidtsdrif, Northern Cape Province.		
Author	DP van Rensburg (Pr.Sci.Nat)	 	Aug'18

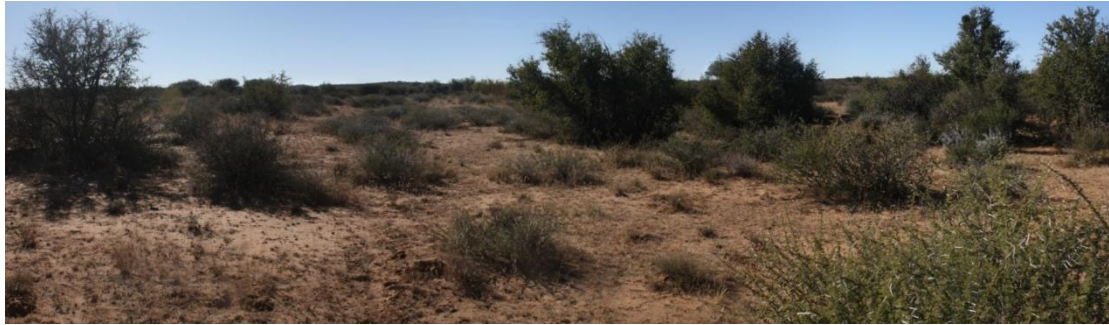
Figure 2: Areas with deeper sandy soils are clearly devoid of surface rock, a sparse grass layer, well-developed shrub layer, with scattered trees are clearly visible.

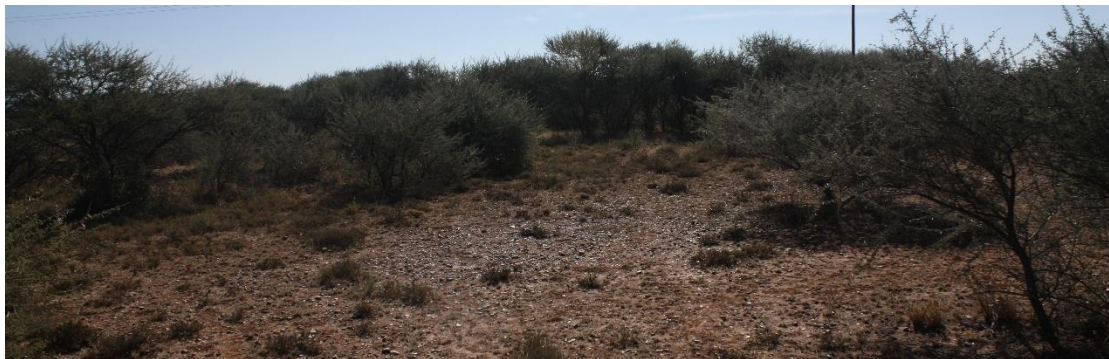
Figure 3: View of another portion of this area where the tree/shrub canopy cover is much higher. Note again an increase in superficial calcrete.

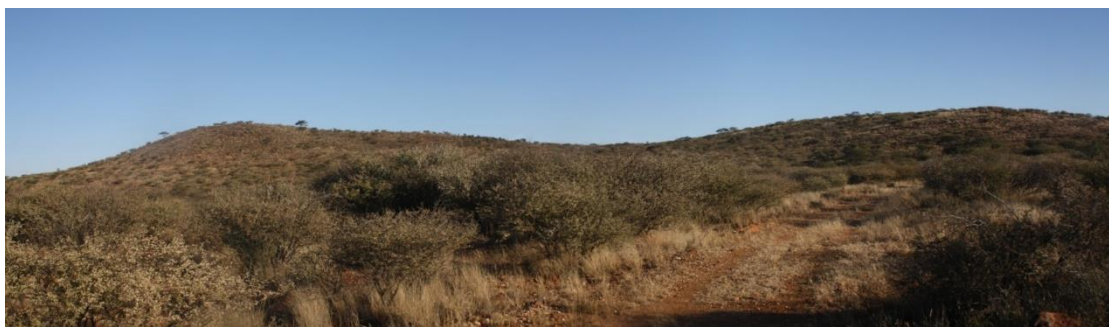
Figure 4: Panorama of the hills in the central portion of the area. Note the relatively dense canopy cover dominated by *Senegalia melifera*.

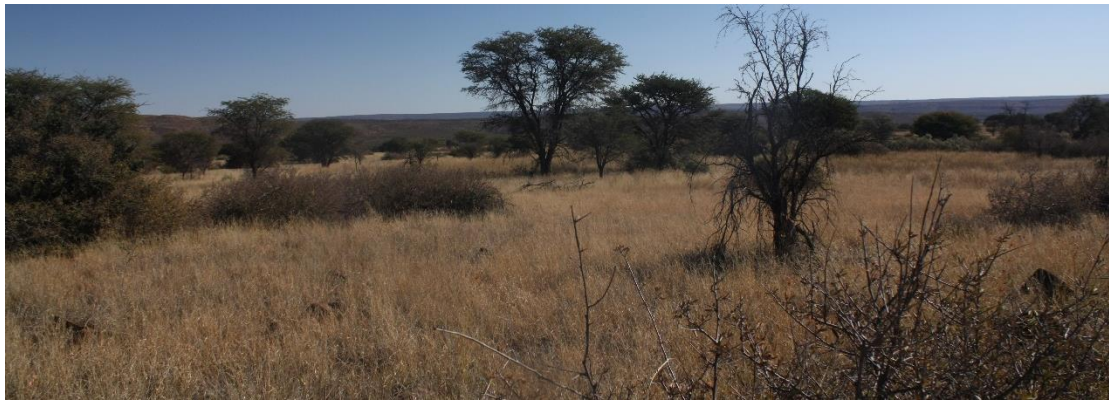
Figure 5: View of the northern portion within the study area. Note an open tree layer with large specimens of *V. erioloba*, a dense, well-developed grass layer and scattered shrubs.

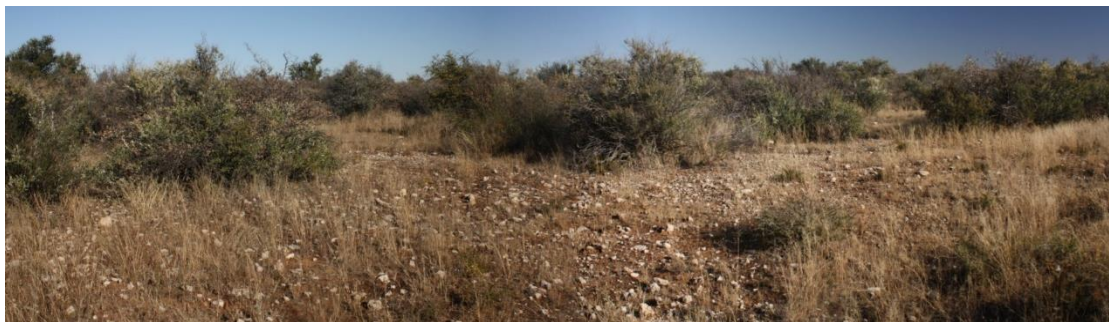
Figure 6: Panorama of the south western area in this portion. Note the high percentage of surface calcrete covering. A sparse grass layer and dense shrub layer is evident.

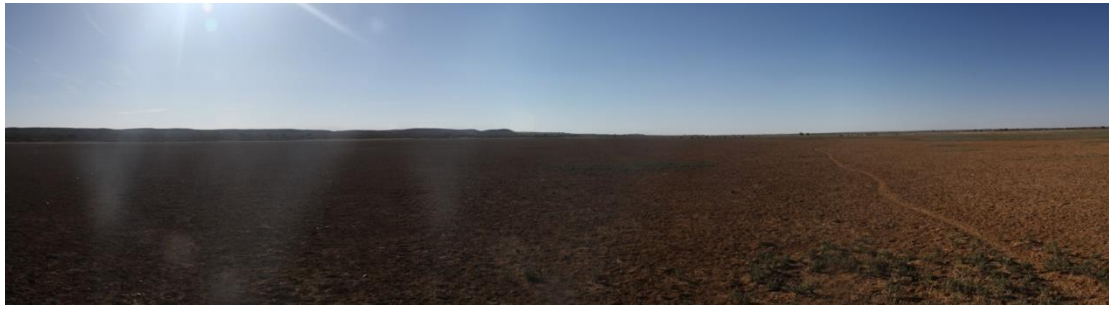
Figure 9: View of the central portion of the Hoffman's Pan. Due to the vast extent of the pan the shape and characteristics of the pan is not easily visible.

Two large pans occur in the south eastern portion of the study area (Map 2 & 3). The larger of the two is named Hoffman's Pan situated along the southern border of the study area. The other, smaller though still large pan is situated to the north of Hoffman's Pan. The pans are situated along the eastern side of a rocky ridge which also drains into these pans by means of numerous small drainage lines. The Hoffman's Pan has a length of approximately 3.5 km with the pan to its north approximately 1 km in length. It should be evident that both are of exceptionally large size. These pans are flat-bottomed with their interiors mostly devoid of vegetation, relatively deep soils and without prominent surface stone. The floodplain or shore of these pans is quite extensive along their eastern borders. Here the vegetation is dominated by a short grass layer and karroid component represented by dwarf karroid shrubs. The hydrological regime of these pans are considered to be ephemeral and will only contain surface water after exceptional rainfall.

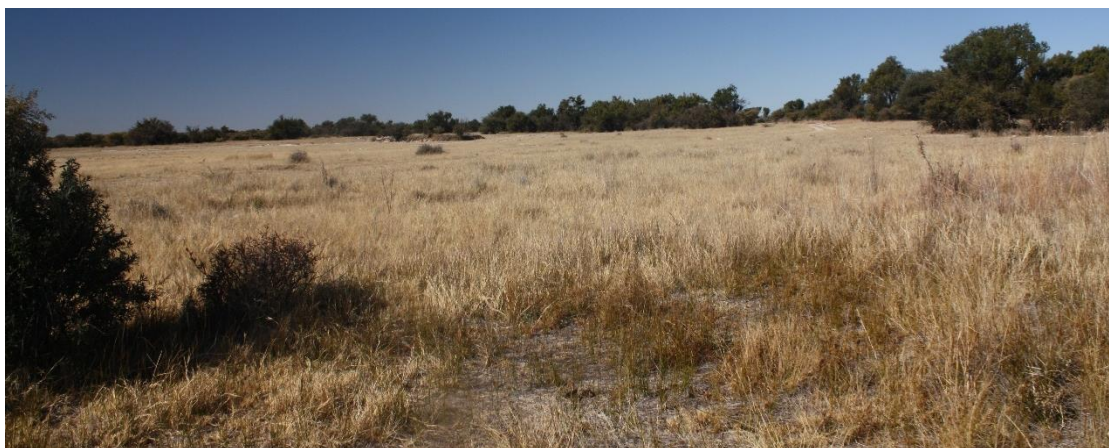
Figure 10: View of one of the flat wetland areas situated within the large seasonal stream.

The northern portion of the study area consists of a relatively flat topography with the result that it contains few watercourses. However, a few are still present, especially one large stream draining the interior of this portion. Due to the flat topography areas of ponding is easily formed. As a result of this, wetland areas have formed in and around the main channel of this stream system (Map 3). These areas are mostly flat, without a channel, and contain a relatively dense vegetation layer dominated by hygrophilous grasses and sedges. The central portions of these wetland areas may also be devoid of vegetation. Obligate wetland vegetation is prominent and soil samples also indicate clear wetland conditions occurring. These wetland areas are considered to have a seasonal regime and will contain surface water on a seasonal basis.

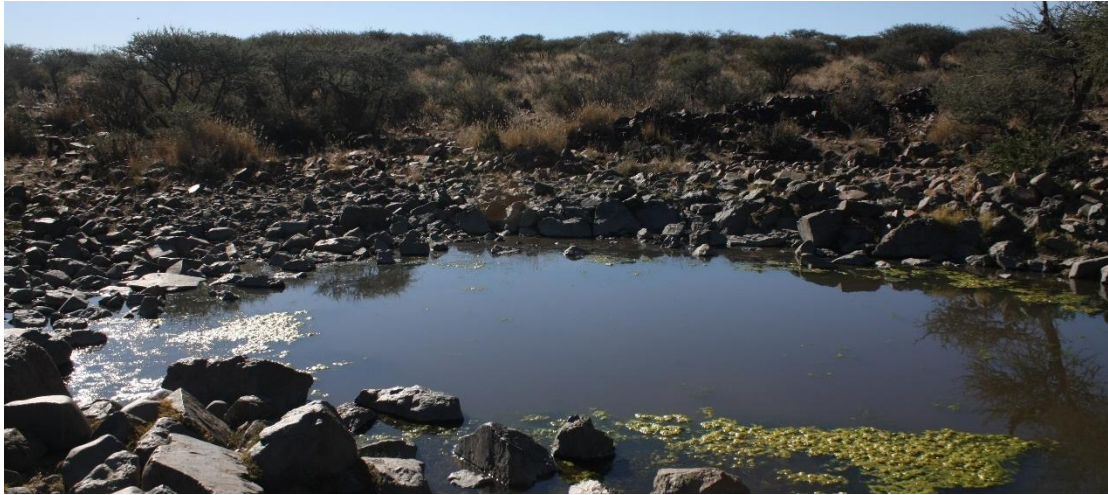
Figure 11: View of the rock pool formed by the fountain.

In close proximity to the above described wetland areas but considered a separate system is a very unique artesian fountain which seems to be entirely of natural origin (Map 3). Systems such as this is exceptionally rare and considered highly unique. The fountain originates within a quartzite outcrop and flows down a gentle slope into a small natural rocky depression from

where it overflows to the south into a sandy area. The extent of this entire fountain is no more than 1 hectare. During the survey surface water was present and a constant flow was also still present indicating that this fountain is a perennial system and provides a water source throughout the year.

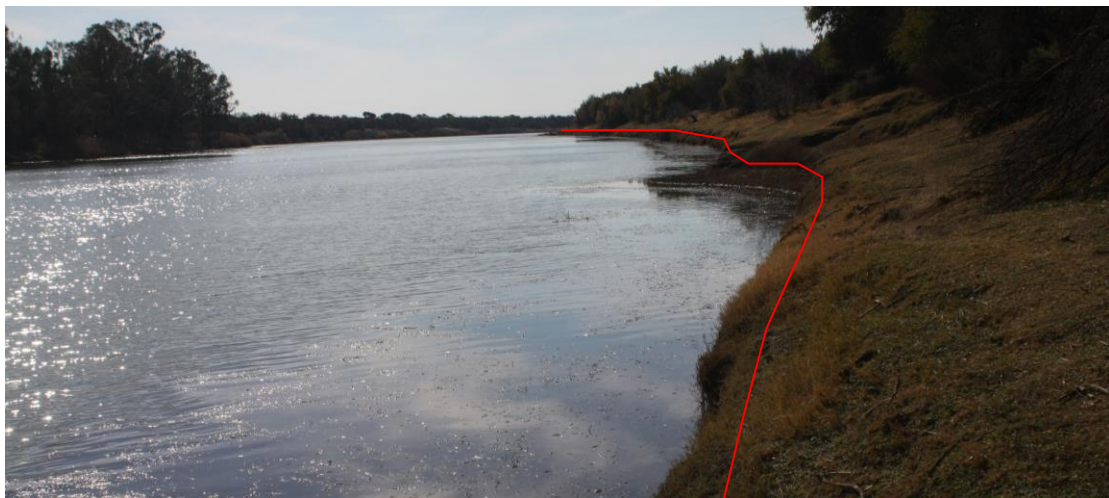
Figure 12: View of the marginal zone (red). Note at this site the zone has a relatively steep slope, narrow width and dominance by sedges and hygrophilous grasses.

The marginal zone is relatively narrow and is situated from the water' edge up to the lower zone (Figure 12 & 13). The zone has a width varying from 1 to 5 meters and the slope gradient is moderate to low. It is permanently saturated and is subjected to environmental conditions which makes this a specialised habitat which can only be colonised by plant species adapted to waterlogged soils and flooding. As a result the zone contains a high amount of sedges,

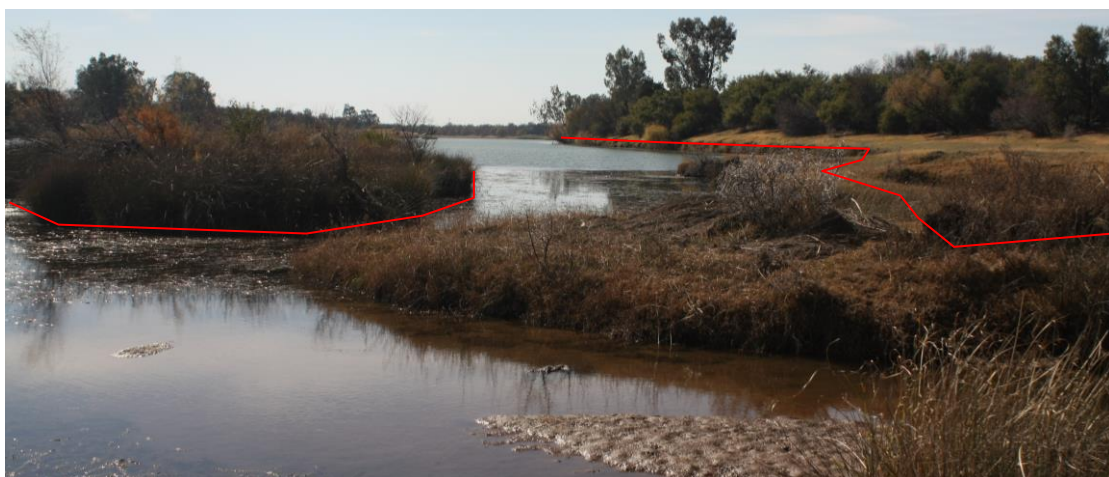
Figure 13: View of the marginal zone (red). Note in this area a much more extensive width, lower slope gradient and higher dominance of sedges and reeds.

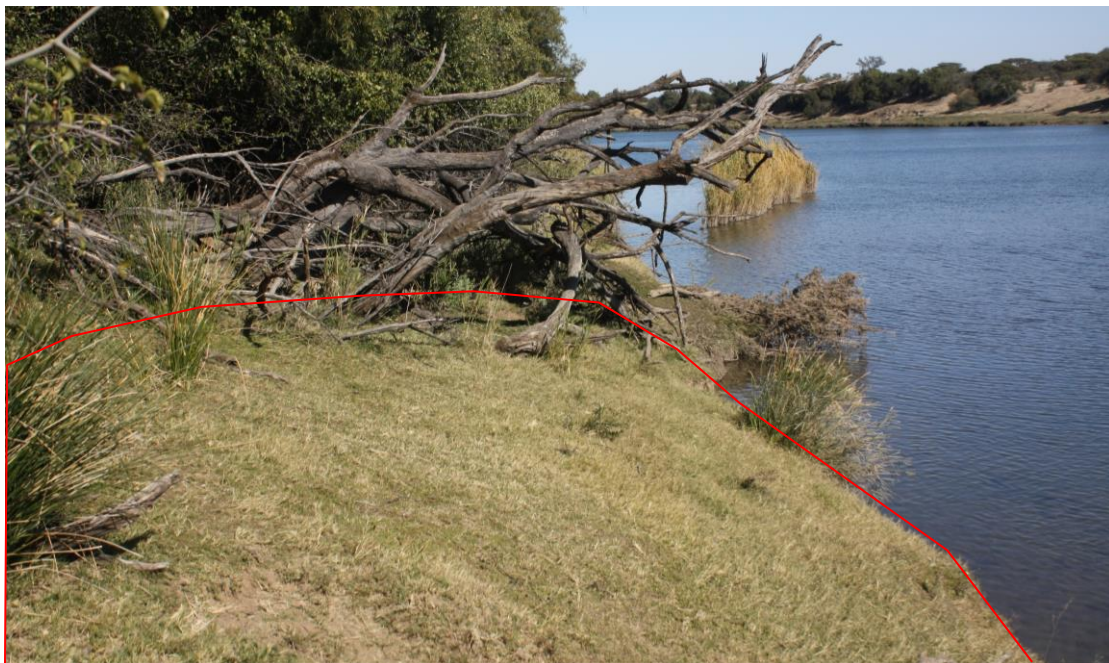
Figure 14: View of the lower zone (red). Note absence of tree, steep slope and dominance by a short grass layer. Trees dominating the upper zone is clearly visible on its border.

The lower zone is also relatively narrow but significantly broader than the marginal zone (Figure 14 & 15). It is situated from the marginal zone up to the upper zone and has a width varying from 10 to 20 meters. A characteristic of this zone is the significant increase in slope of this zone. It is still subjected to annual flooding however soils are not saturated on a permanently waterlogged basis but only for short periods at a time. As a result the zone is able to sustain terrestrial species as well as hygrophilous (water loving) species. The zone is dominated by several grass species and has a relatively low diversity of species. These include *Chloris virgata*, *Cynodon dactylon*, *Cyperus sexangularis*, *Phyla nodiflora* and *Eragrostis lehmanniana*. These are also adapted to the annual flooding. *Chloris virgata* is an annual species and readily establish from seed and in this manner survive flood damage. *Cynodon dactylon* is a perennial grass with underground runners and is therefore able to survive underground if damaged by flooding. The zone also contains a high amount of exotic species which may dominate in certain areas. These species are all recommended for rehabilitation and will be easily propagated by means of seeding which is commercially available. The zone is likely to be affected by the mining activities and the slope of the lower zone should be re-instated as far as possible. Measures to re-instate the slope has been discussed in the rehabilitation plan dated August 2018.

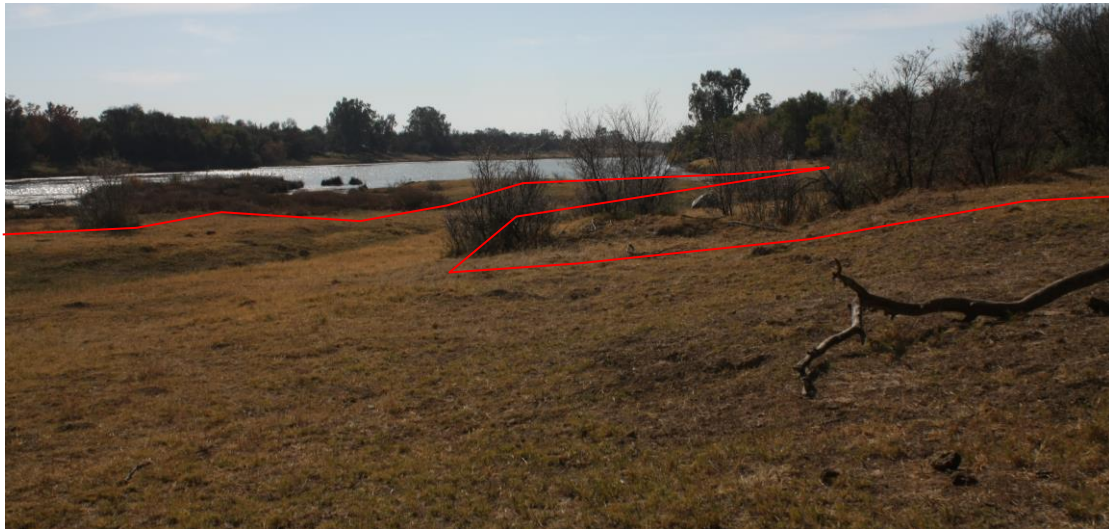
Figure 15: View of the lower zone (red). Note the more extensive width, lower slope gradient but again dominant short grass layer.

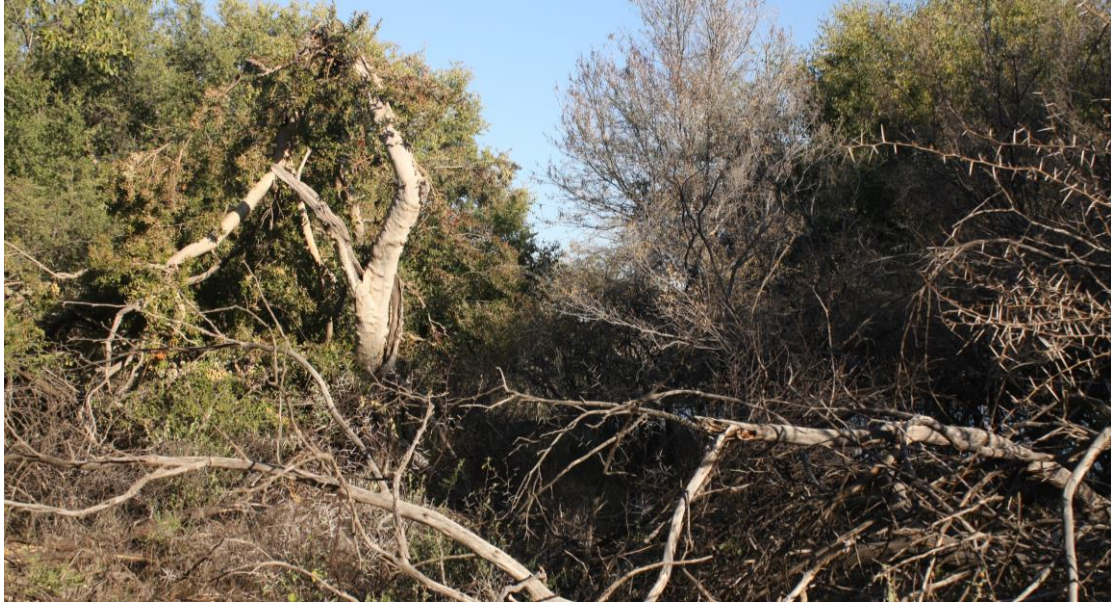
Figure 16: View of the upper zone. Note the tall and dense tree canopy.

The upper zone is relatively narrow and distinguished from the floodplain by a dense riparian thicket characterised by a few riparian trees confined to this zone. It is situated from the lower zone up to the floodplain. It has a width of approximately 40 meters. The zone has distinct levelling off of the slope gradient and contains only a gradual slope, a steep portion may be present at the border with the lower zone. This zone will only be subjected to flooding during exceptionally large floods. The zone contains a lower soil moisture and consequently vegetation consists predominately of terrestrial species with few riparian species present. Vegetation is dominated by riparian trees and shrubs and include *Vachellia karroo*, *Ziziphus mucronata*, *Grewia flava*, *Lycium hirsutum*, *Asparagus larcinus*, *Lycium arenicola*, *Combretum erythrophyllum*, *Searsia lancea* and *Diospyros lycioides*. Of these, *V. karroo*, *C. erythrophyllum* and *S. lancea* are largely absent from the floodplain and confined to the upper zone. They are however also present along some of the large stream systems. The understorey beneath these riparian trees is dominated by a sparse layer of grasses and herbs adapted to a shadier environment. These include *Setaria verticillata*, *Chloris virgata*, *Eragrostis lehmanniana*, *Panicum coloratum*, *Dicliptera leistneri*, *Aristida congesta* and *Tragus berteronianus*. The majority of these are also annual, pioneer species. All of the above species are recommended to be utilised in landscape maintenance as they will be easily propagated. It will be important to re-establish the riparian thicket/tree layer by means of sapling establishment and an understorey can easily be seeded with the shade loving species present. The zone is likely to

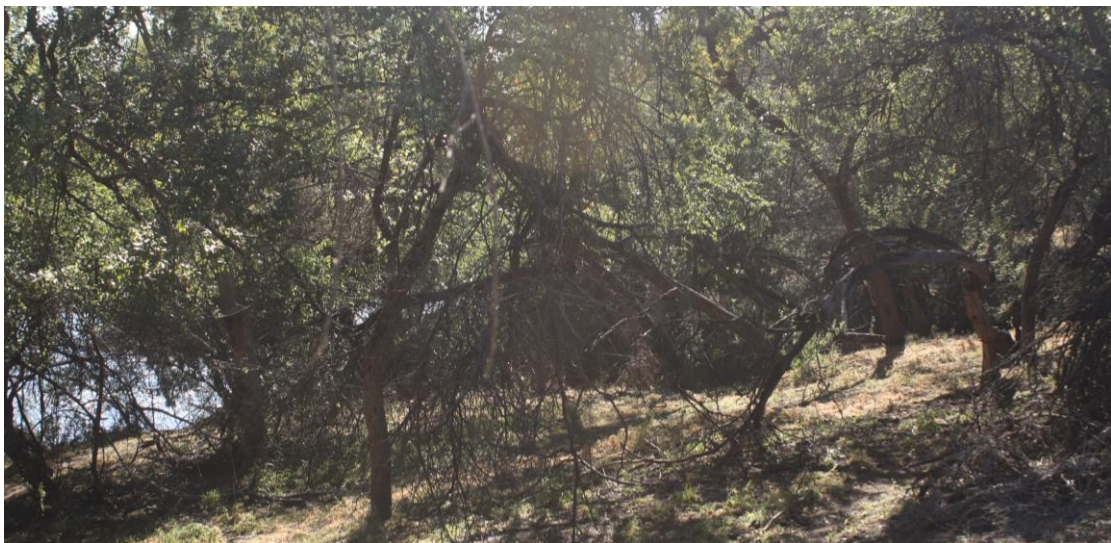
Figure 17: View of the upper zone. Again, note the dense tree canopy and sparse understorey.

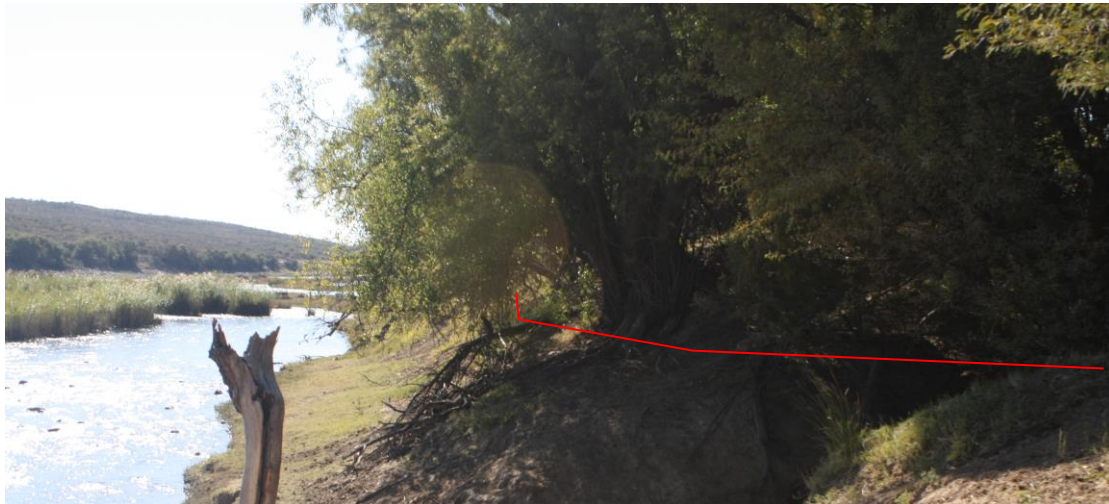
Figure 18: View of the upper zone (red). The border between lower and upper zones are clearly visible.

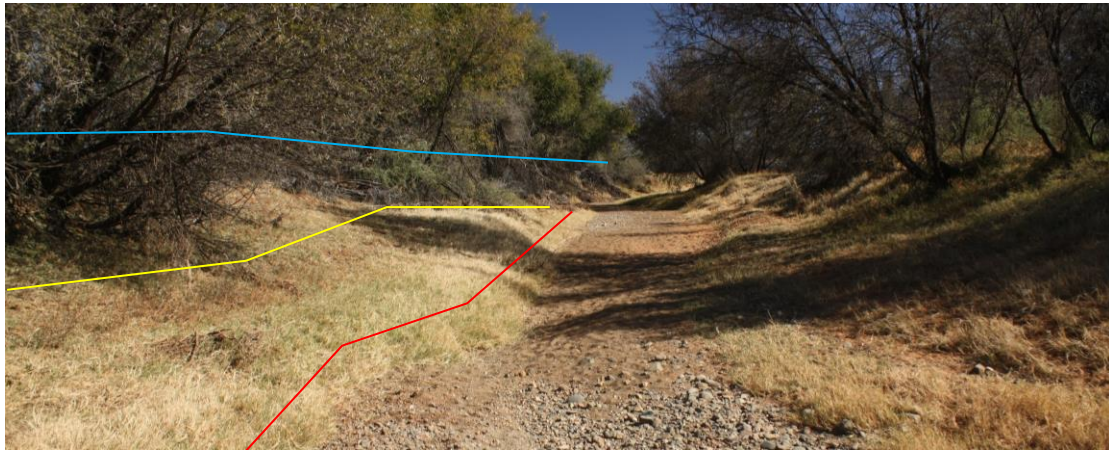
Figure 21: View of another stream in the study area. The zonation is again present and much similar as Figure 20.

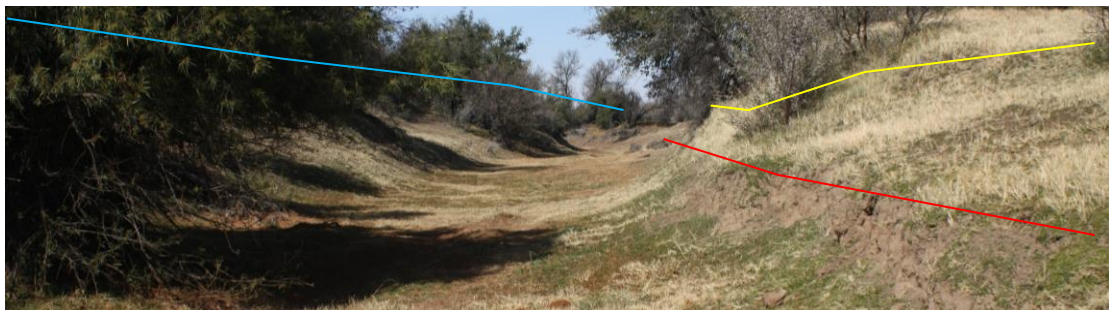
Figure 23: Although the majority of watercourses contain a main channel without vegetation, a few do contain a grassy main channel. However, zonation remains the same.

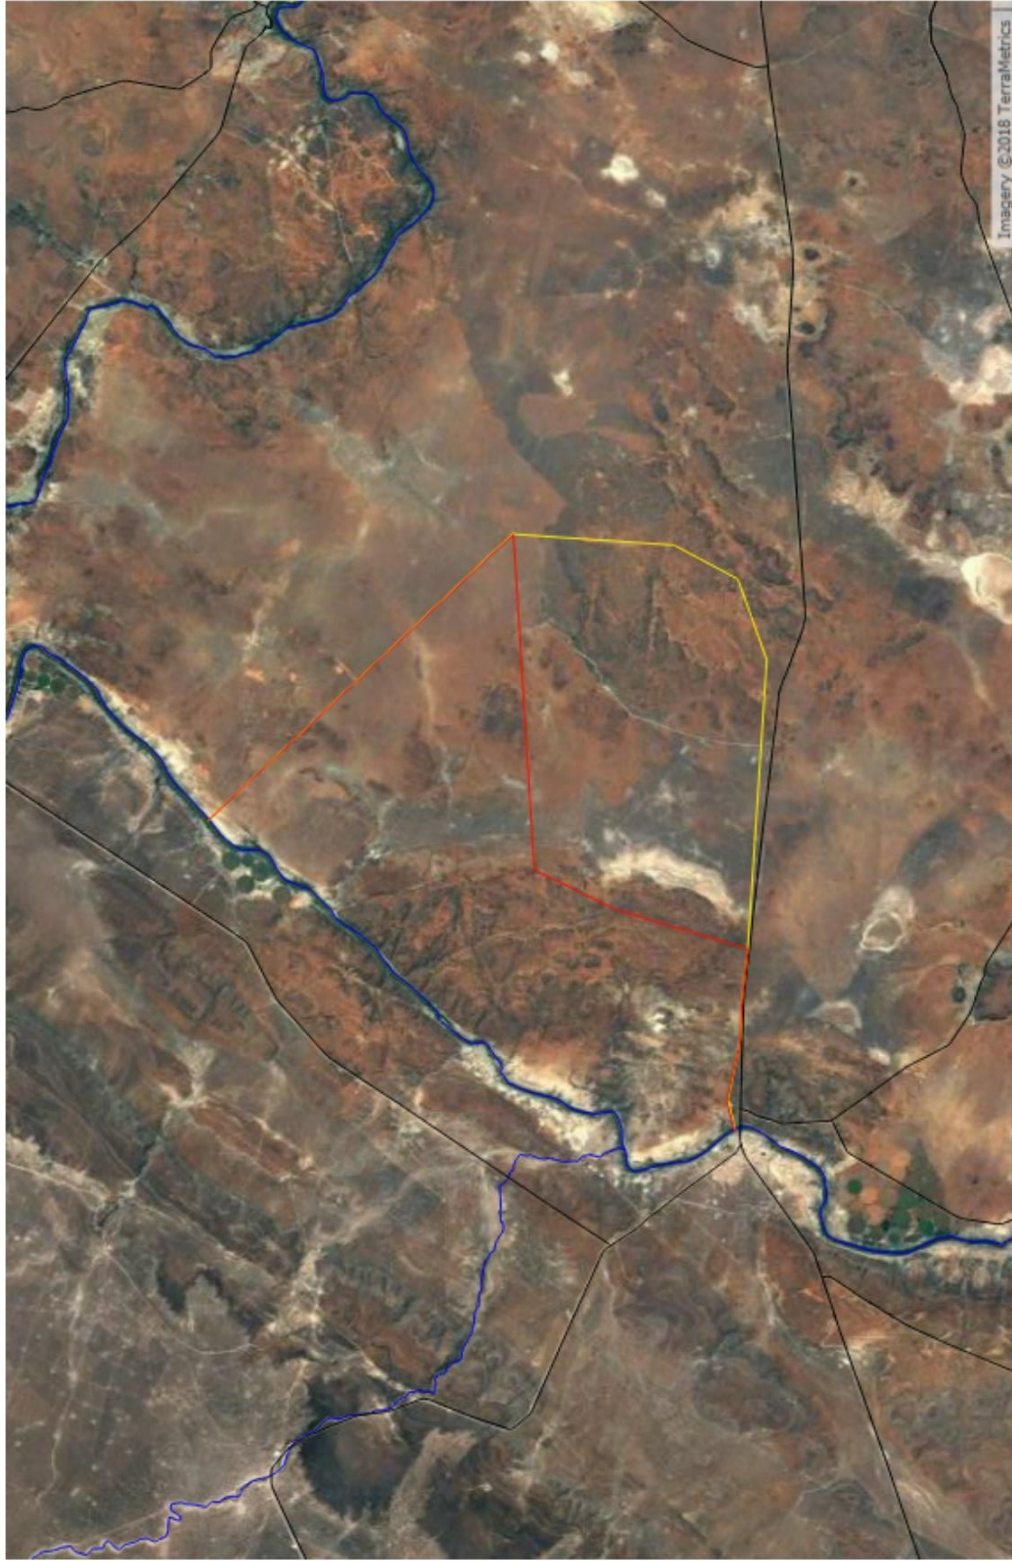
Map 1: Locality map for the proposed Rooipoort mining operations near Schmidtsdrif, Northern Cape Province. The application area and the mining area has both been indicated. Note also that the Vaal River forms the western border of the mining area.

study area is located on the eastern banks of the Vaal River to the east of the town of Schmidtsdrif and approximately 60 km to the west of Kimberley. The extent of the study is approximately 40 000 ha with the portions where mining will mostly take place covering 25 000 ha (Map 1).
