***Report to NAC JV on a Geotechnical Investigation on Sector K  
and Sector L (Duffs Road to Phoenix 2 Reservoir) of the  
Proposed Northern Aqueduct Pipeline Augmentation***

**Reference : 11-107**

**Dated : August 2012**

**MOORE SPENCE JONES (PTY) LTD**

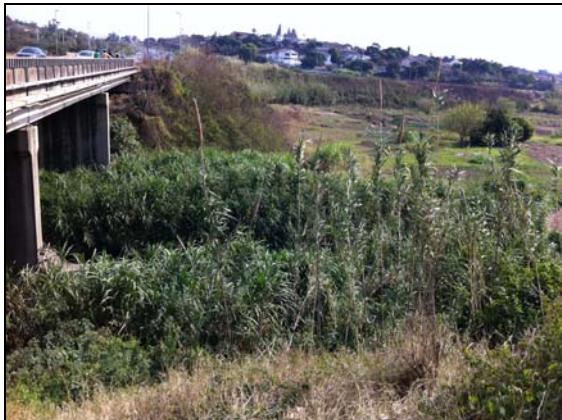
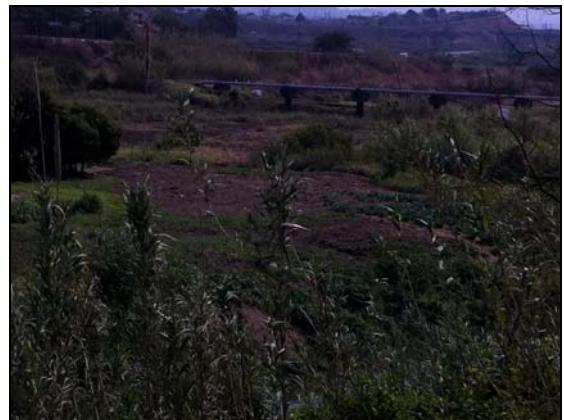
**Photos 1 and 2: Preferred route for crossing the Piesang River (see Figure 1).  
Note existing water pipeline bridge over the river**

The proposed pipeline route for sector K commences at the offtake located in the median of the M25. It crosses over the Piesang River on the area between northern side of the Duffs Road bridge and south of the existing water pipeline bridge crossing, as shown in Photos 1 and 2. It then curves northwards with the Phoenix 6 reservoir and Phoenix 1 reservoir to the west and east of the pipeline respectively. The initial alignment of the pipeline is on the floodplain, west of the Piesang River, with the R102 to the south. Subsistence farming was observed on the floodplain.

direction at the intersection of Eleka Road and Simunye Avenue and heads northward following Simunye Avenue up until it joins the line of the original pipeline route running in the powerline servitude (Photos 1 and 2).

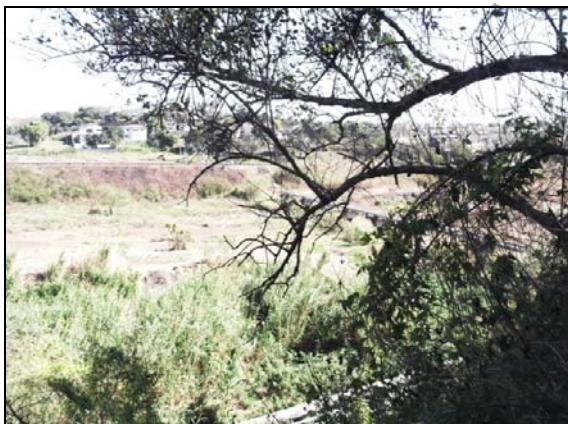
**Photo 3: Northwest view overlooking the floodplain Of Piesang River where the pipeline will commence (at EWS water trunk mains shown at the background On right-hand side). Also the M25 is at the far background**

- ii. The second alternative starts at the offtake on the M25 and the turn off heading south east through the floodplain to the edge of the R102, then east past the river (bridge overpass), then east on a foot track at the corner of the R102 and Mount Moriah Drive. It then heads approximately northwest on the line of the original route near the dead end of Eleka road, or starting the bottom of the slope approximately 50m from the intersection up along a foot track to the end of Eleka Road (Photos 3 & 4).

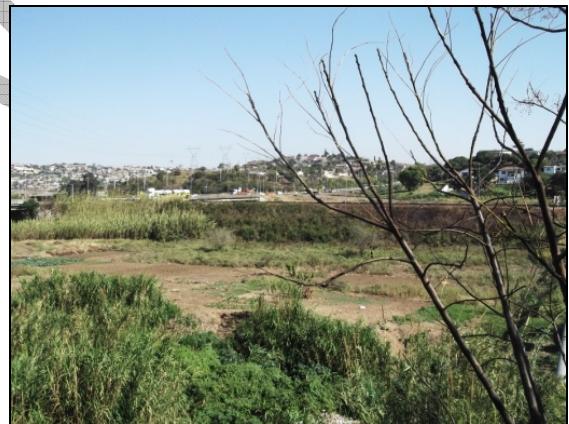
**Photo 4: West view overlooking the sand flood-plain where the pipeline bends in an east direction. The M25 is at the far background**

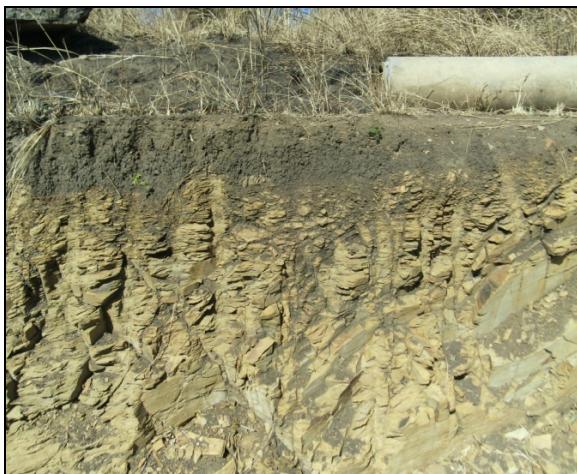
**Photo 5: Shale cutting near Phoenix 1 reservoir  
(part of an off-shoot of Sector K approximately 500m  
east of proposed pipeline)**

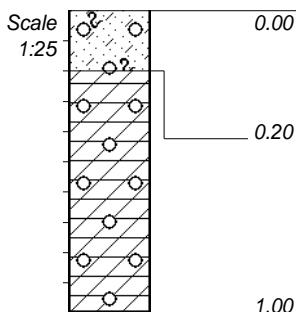
ELEVATION :  
X-COORD :  
Y-COORD :  
**HOLE No: Cutting 1**

Dry greyish brown to dark brown medium dense to dense shattered gravelly clayey SAND. Gravel consists of angular to subangular shale fragments with roots. Colluvium.

Dry light greyish speckled orange loose to medium dense intact gravelly CLAY. Gravel consists of SHALE fragments. Residual Shale.

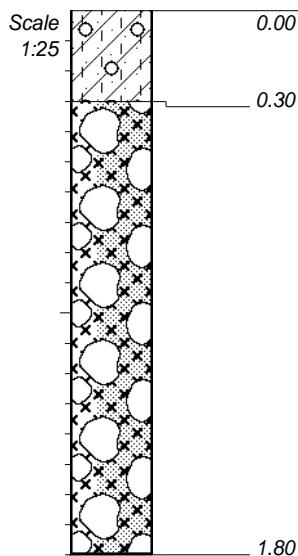
ELEVATION :  
X-COORD :  
Y-COORD :  
**HOLE No: Cutting 2**

Dry to slightly moist dark greyish brown to yellowish brown medium dense gravelly silty sandy CLAY. Colluvium.

Light greyish brown completely weathered medium hard ROCK with reddish brown boulders (20mm-10m diameter) SOFT ROCK dolerite.

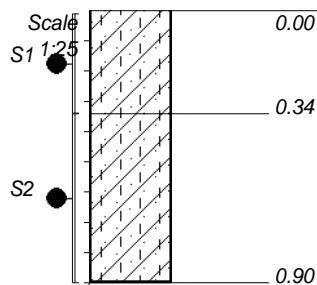
**HOLE No: AH 24**

Slightly moist dark greyish brown speckled light brown slightly silty sandy clay. Colluvium.

Slightly moist greyish brown silty sandy CLAY lenses.

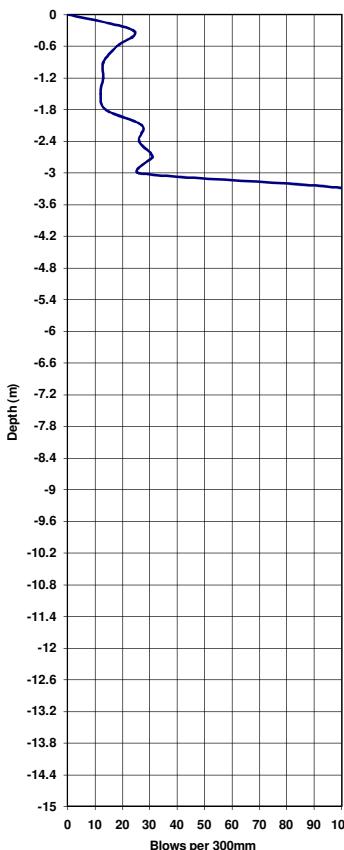
Light Dynamic Penetrometer Probe ..... **Test No.DPL 21**

Hammer: 10kg falling 550mm  
Cone: 25mm diameter with 60 degree apex angle

Depth metres	Blows per 300mm	Inferred Consistency
0	24	Med.Dense
0.6	18	Med.Dense
0.9	13	Loose
1.2	13	Loose
1.5	12	Loose
1.8	14	Loose
2.1	27	Med.Dense
2.4	26	Med.Dense
2.7	31	Med.Dense
3	26	Med.Dense

Refusal

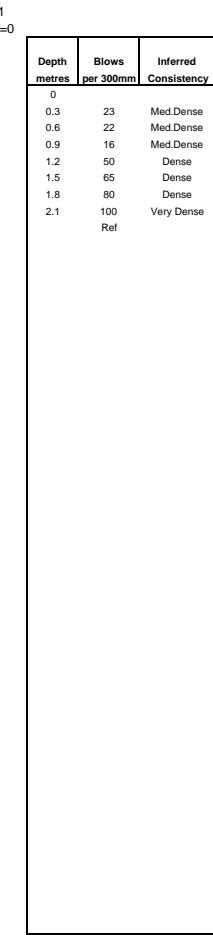
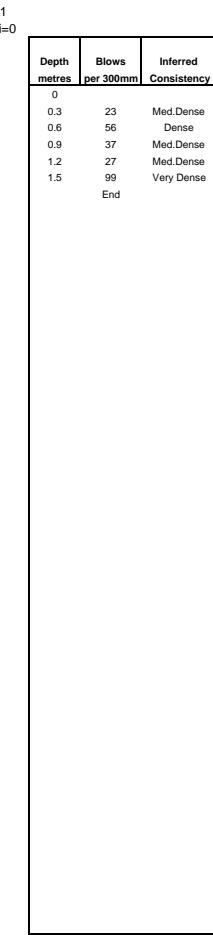
Light Dynamic Penetrometer Probe ..... Test No. DPL 41

THE INSITU STRENGTH DEPENDS ON SOIL MOISTURE CONTENT AND GRAIN STRUCTURE WHICH HAVE NOT BEEN ASSESSED AND MAY CHANGE. THE VALUES GIVEN ARE THEREFORE INDICATIVE ONLY AND SHOULD BE VERIFIED BY TEST OR OBSERVATION
