1 SAHRA PERMIT APPLICATION

PROPOSED RESTORATION TO O R TAMBO DWELLING
&
POST CONSTRUCTION LANDSCAPING

OR Tambo Homestead,
Mdikiso Village,
Mbizana Local Municipality,
Oliver Tambo District Municipality,
Eastern Cape Province, South Africa

PERMIT APPLICATION
RESTORE & UPGRADE
O R TAMBO TWO BEDROOMED DWELLING

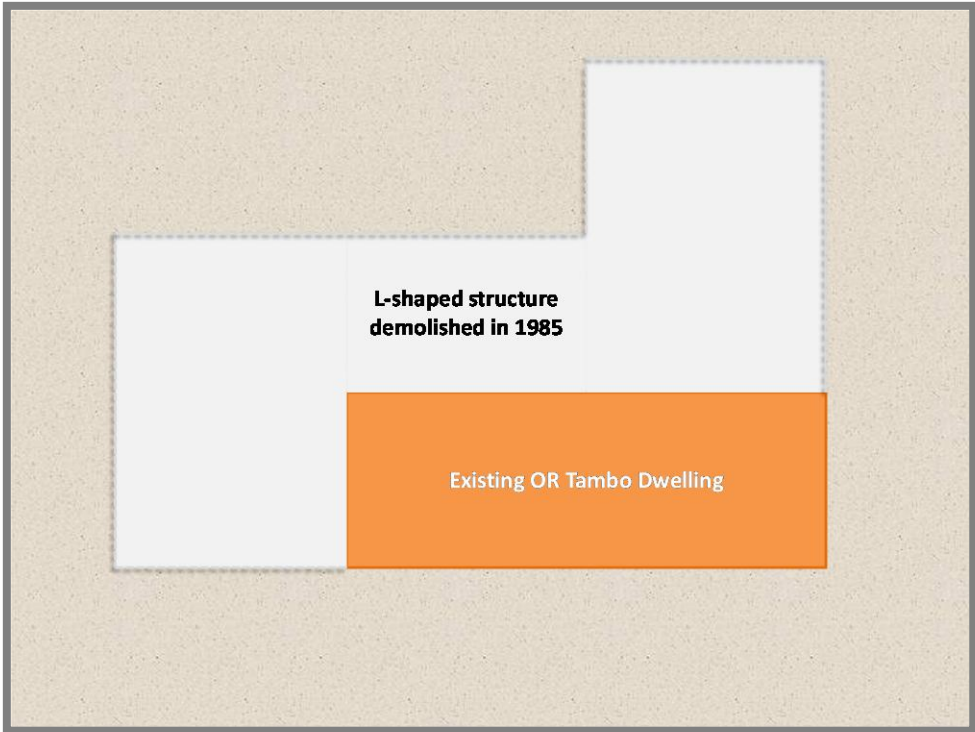
FIGURE 2 POSITION OF OR TAMBO DWELLING RELATIVE TO EARLIER STRUCTURE

The homestead constructed in 1942 included a large L-shaped building comprising four rooms: three bedrooms and a dining room. This building was demolished in 1985. The existing OR Tambo Dwelling was constructed on part of the foundations of this building in 1989 by the late Mr Lalamntwini Mpingana Zulu (Figure 2). Mrs Gerty Tambo and her sister commissioned and paid for the construction.

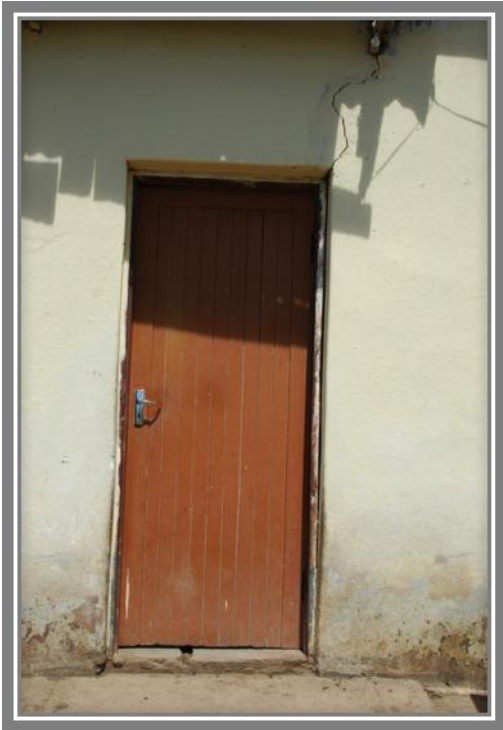
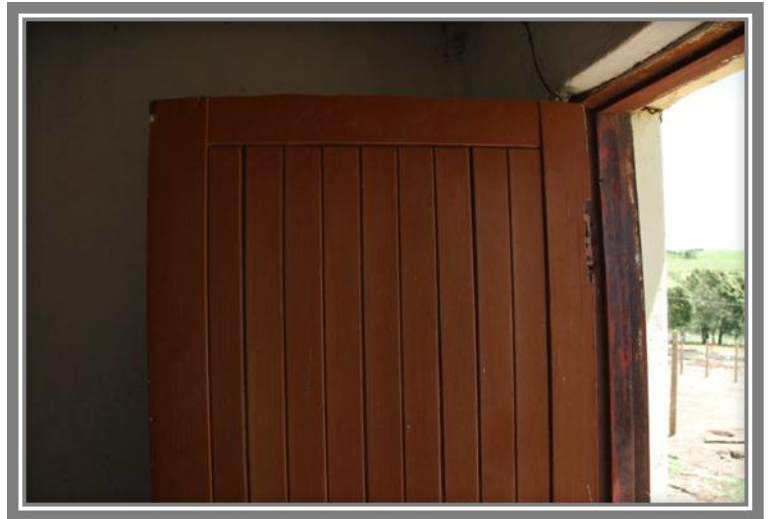
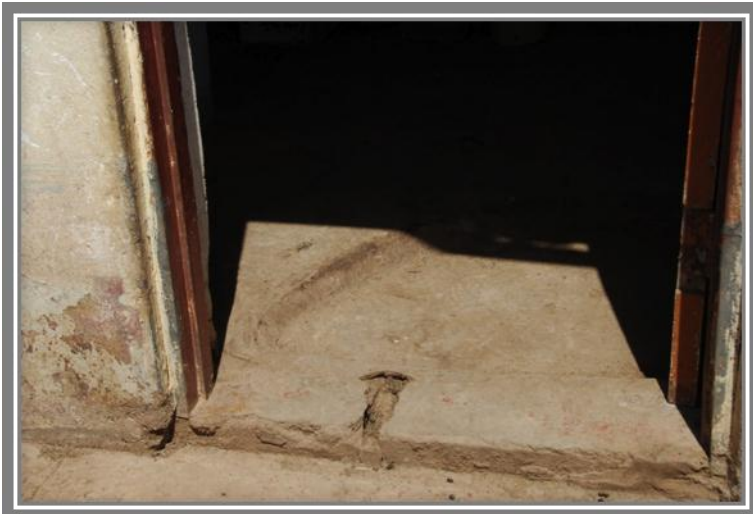
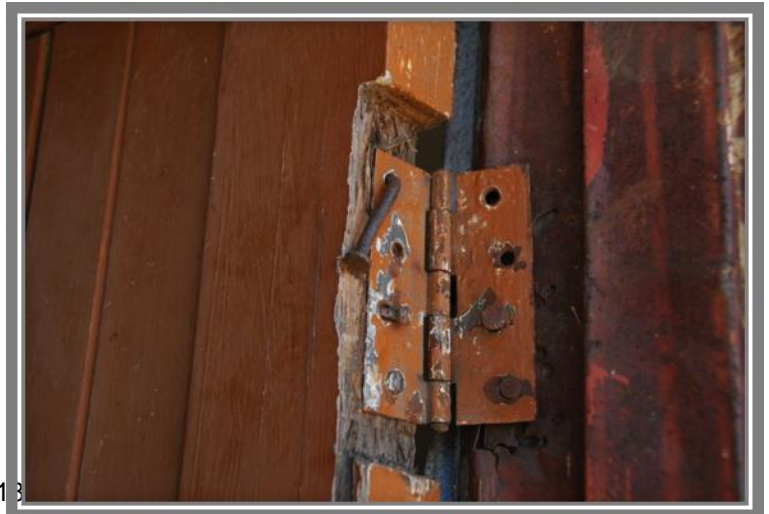
FIGURES 15-18 FRONT DOOR WITH DETAIL.

The wooden front door has been replaced twice and the structure has been repainted twice. The original interior wall colour was white and that of the exterior cream. The roof was painted on top with red oxide 2-3 years after construction; the interior of the roof is painted white in the entrance hall, but those of the rooms are unpainted.

- Restore and repair the existing structure and roof
- Repair walls and flooring.
- Replacement of windows and doors
- Repair and Upgrading of the existent electrical installation.

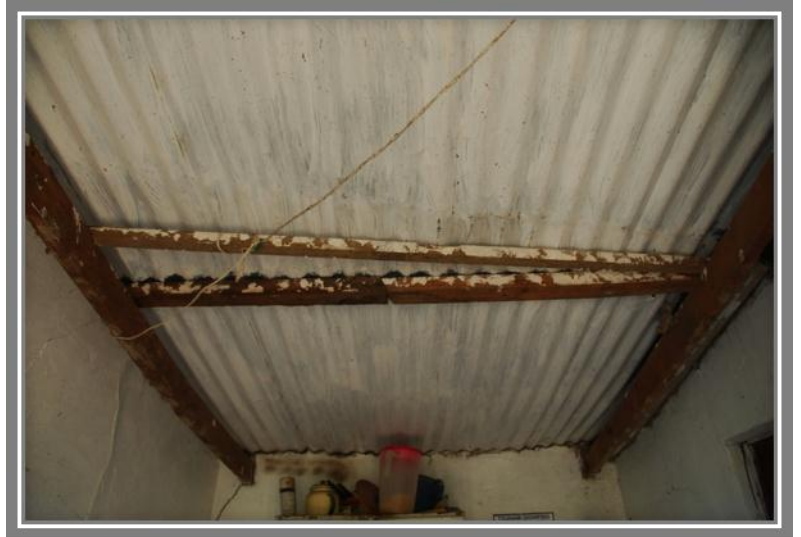
FIGURE 20 ENTRANCE FOYER ROOF INTERIOR.

holding it in place had rotted away. There is no ceiling and the corrugated iron roof; roof timbers; metal windows and window frames; metal door frame and cement floor are all original.

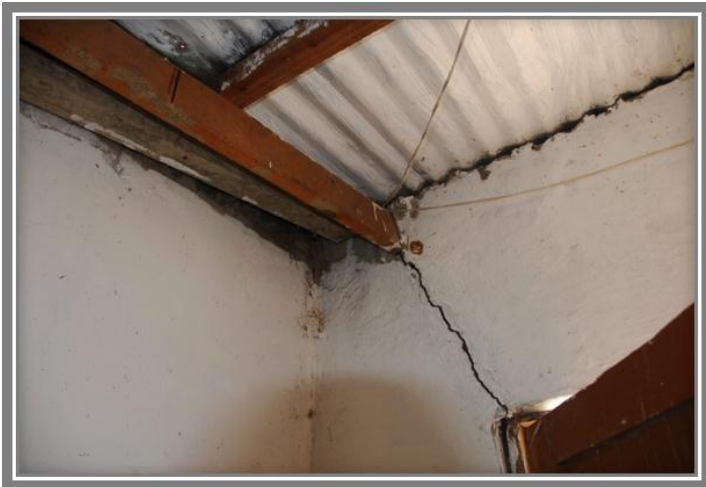
FIGURE 21 CRACK IN ENTRANCE FOYER EASTERN WALL ABOVE ENTRANCE DOOR.

This two roomed brick and mortar dwelling, construction date and source unknown, is significant as it the house in which the late OR Tambo lived upon return from exile. The dwelling displays irreparable structural damage by virtue of to the poor quality of the original construction, substantiated by a report from a structural engineer. Additionally, the roof of the dwelling has also failed, structurally.

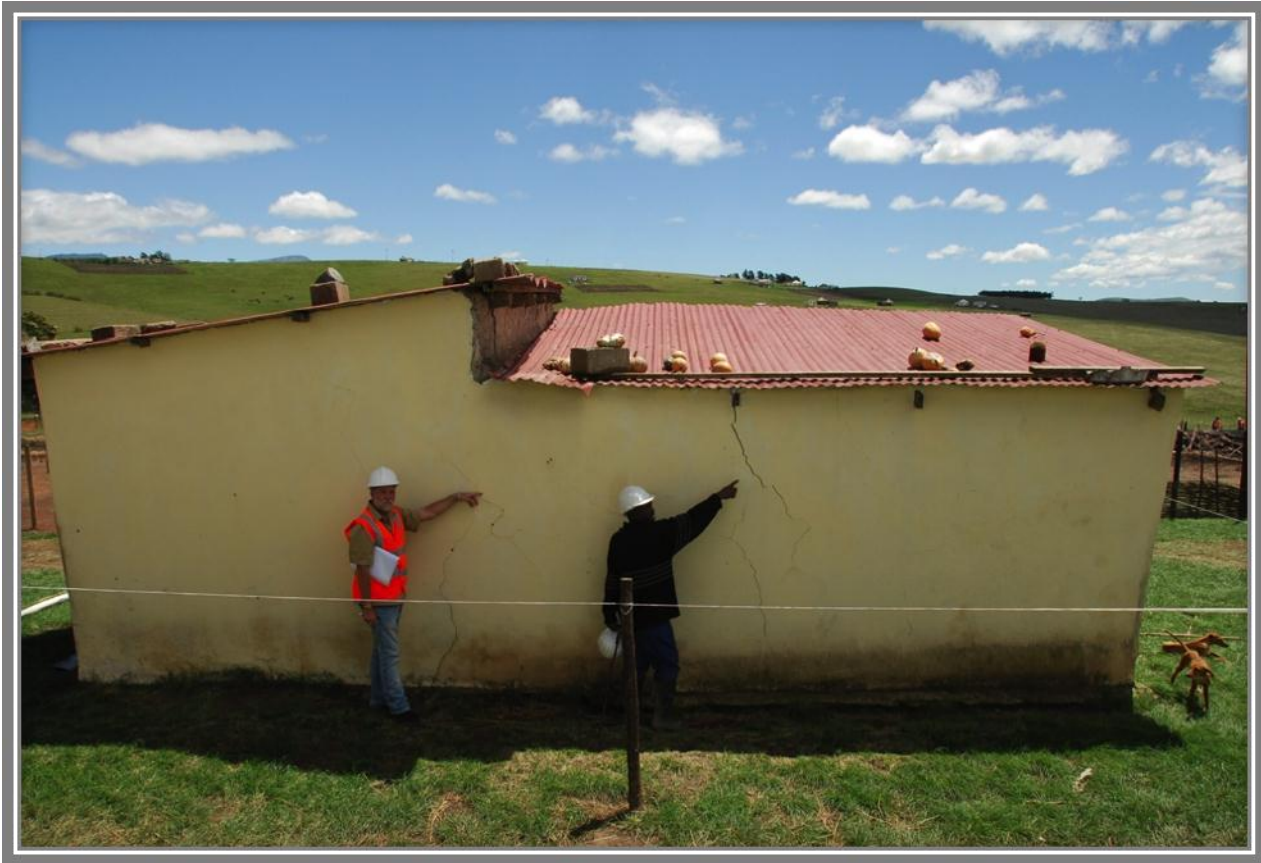
FIGURE 32 CRACKS IN WESTERN EXTERIOR WALL.

In 1999 tile windowsills were installed and large cracks in the western wall were repaired with cement and chicken wire.
