SAHRIS PERMIT APPLICATION
MAPUNGUBWE CULTURAL LANDSCAPE, NATIONAL & WORLD HERITAGE
SITE
MAPUNGUBWE NATIONAL PARK

Management Authority	South African National Parks (SANParks)
Application Name:	Upgrade & Maintenance of Mapungubwe Hill Western Staircase
Application by:	Aletta Maria (Letsie) Coetzee (<i>B.Tech Nature Conservation</i>) P.O. Box 383 MUSINA 0900 e-mail: letsie.coetzee@sanparks.org cell: 078 893 3598
On behalf of:	South African National Parks
Application Date:	10 November 2020

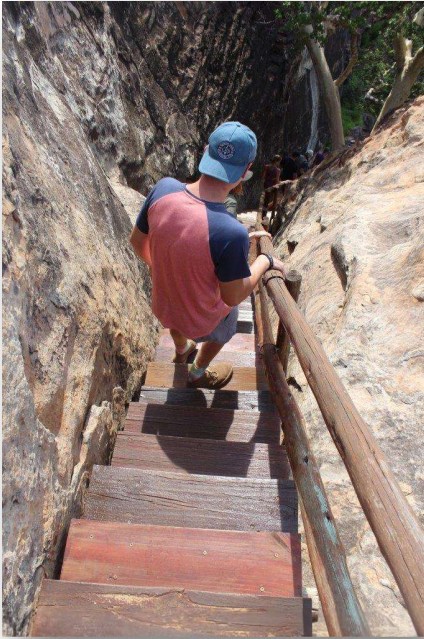
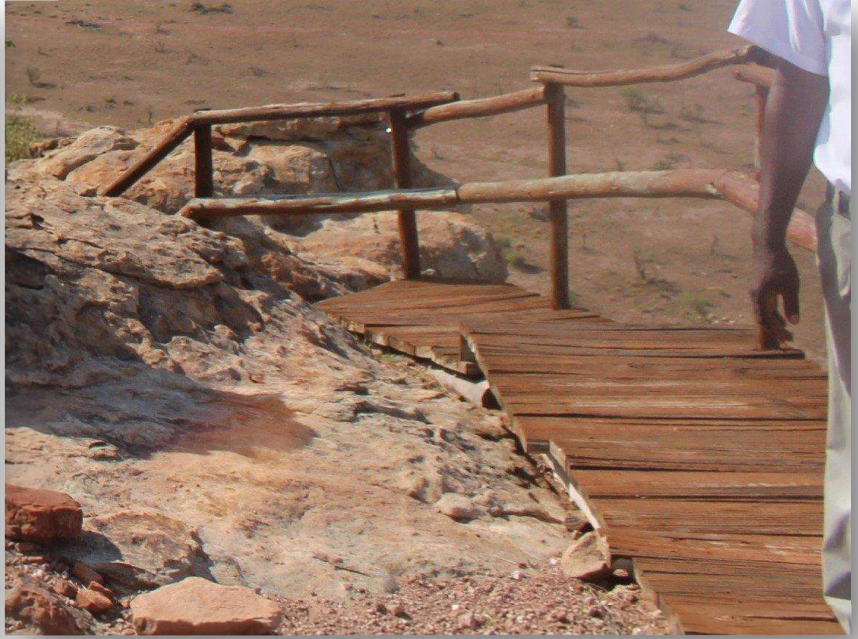
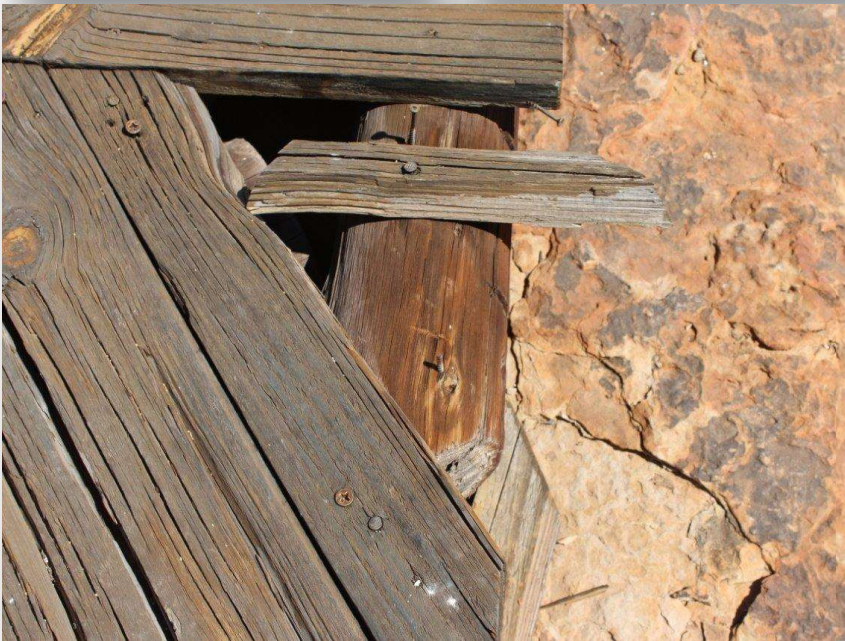
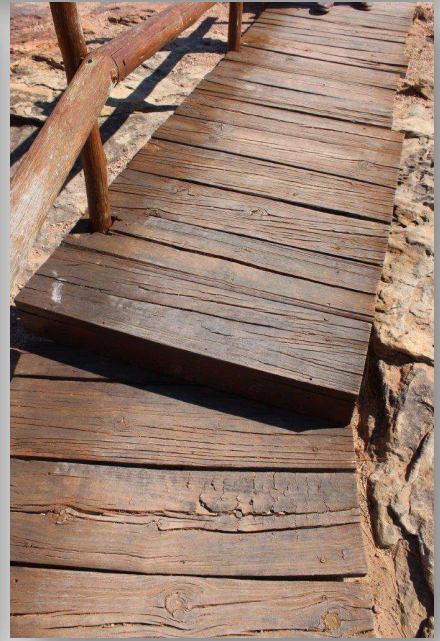
Annexure B

Views of dilapidated structures before upgrade

The work to be undertaken is upgrading (by the use of more durable wood) and maintenance of the complete Western staircase and associated structures, which provides access to Mapungubwe Hill for interpretation purposes.

- No changes should be made to layout or visual aspects of any of the current structures to be upgraded.
- Wood, cement and stone will be used on all surfaces to be maintained, and no variation from the current materials used in the different sections.
- Wood treatment must be completed off site and only final coating will be done on site.

- Oven dried (clear/semi-clear) **saligna** planks; 95mm x 21mm
- Must have rounded edges on top and two stress grooves on bottom.
- Must be solid wood with no joints.
- Treat wood all around with two layers of **Ristix Timbercare Exterior Penetrating Oil**.
- Treat wood with a third layer of **Ristix Timbercare Exterior Penetrating Oil** after screwed on, on top and sides.
- Sub-structure repairs should be done with **cca treated** ex 38 x 114 / 38 x 152 adult wood without any joints (solid wood)
- Planks should be screwed to sub-structure with wood deck 4.2 x 60mm **stainless steel screws**.
- Broken concrete stairs should be fixed with cement and natural stone without any deviations from the current structure.
