TECHNICAL MEMORANDUM

WETLAND VERIFICATION AS PART OF THE WATER USE AUTHORISATION PROCESS FOR THE PROPOSED MAMATWAN MINE PROJECT NEAR KATHU, NORTHERN CAPE PROVINCE.

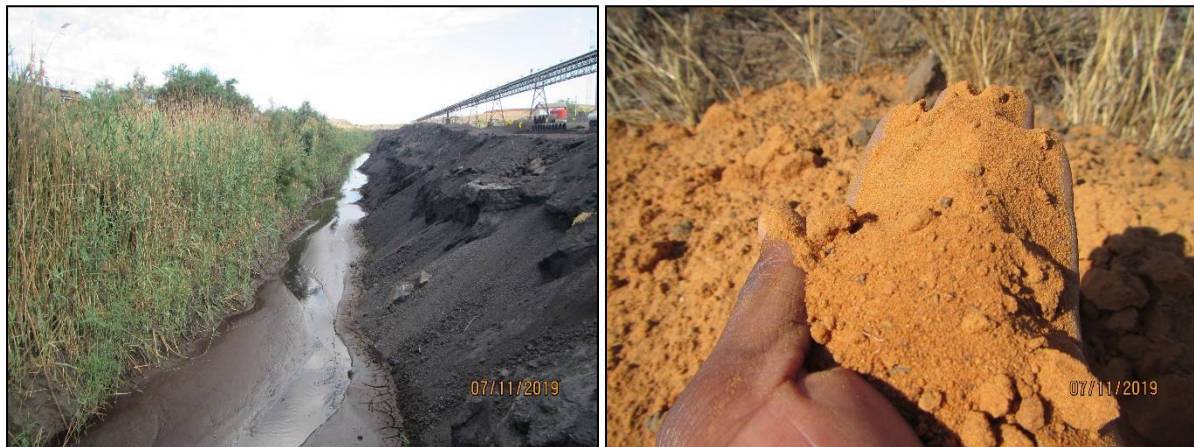
Terrestrial soil characterised by yellow brown (high chroma) coloured soils were found within the undisturbed areas of the proposed Mamatwan expansion activities. Due to the physical properties (i.e. well-drained and single soil structure) of these soils no signs of wetness (iron (Fe) and manganese (Mn) oxides) were observed and further confirm the absence of wetland conditions. Upon investigation of these soils, by means of hand auguring within 50cm of the soil surface within the Mamatwan expansion activities, wetland indicators such as mottling, gleying or other redoximorphic characteristics were not present (Figure 1).

Figure 1: (left) Runoff associated with mine operations and (right) soils within the proposed Mamatwan expansion activities showing no signs of wetness within the first 50cm.

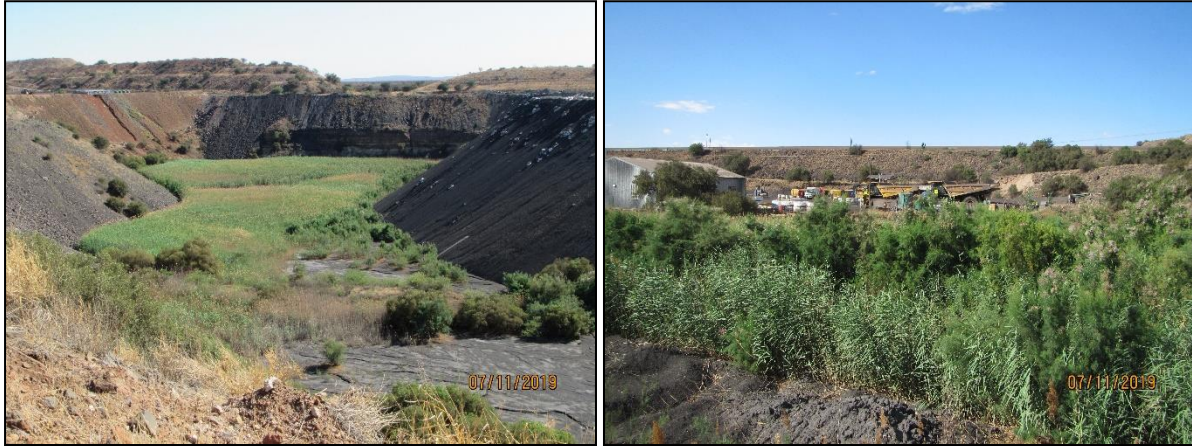
Using digital satellite imagery, it was observed that the robust vegetation response within the upgradient portion of Adams pit, within the investigation area is as a result of the mining activities taking place in the area. Prior to these activities no wetness signatures are observable in the satellite imagery. It therefore evident that as a result of altered natural flow patterns linked to the activities within the investigation area, the wet response is artificial and is entirely driven by regular water inflow into the upgradient portion of the Adams pit. This portion of Adams pit receives surplus water from the mine storage dams and from the ore processing plant regularly. Furthermore, the Adams pit is used as a stormwater storage dam as part of the mine stormwater management system.

Figure 2: Artificially driven freshwater feature identified within the Mamatwan expansion activities.

Therefore, this artificial wet response is unlikely to persist under “normal circumstances” in accordance with the definition provided by the National Water Act, 1998 (Act No. 36 of 1998) as when the mining activities cease, the hydrological driver of this anthropogenically derived freshwater feature will cease.
