**AQUATIC ECOLOGICAL ASSESSMENT AS PART OF THE
ENVIRONMENTAL ASSESSMENT AND AUTHORIZATION
PROCESS FOR THE PROPOSED CONSTRUCTION OF A
FERROCHROME SMELTER, LIMPOPO PROVINCE**

January 2016

Prepared by: Scientific Aquatic Services
Report authors: L. Jonker
S. van Staden (Pr. Sci. Nat.)
Report Reference: SAS 215138
Date: January 2016

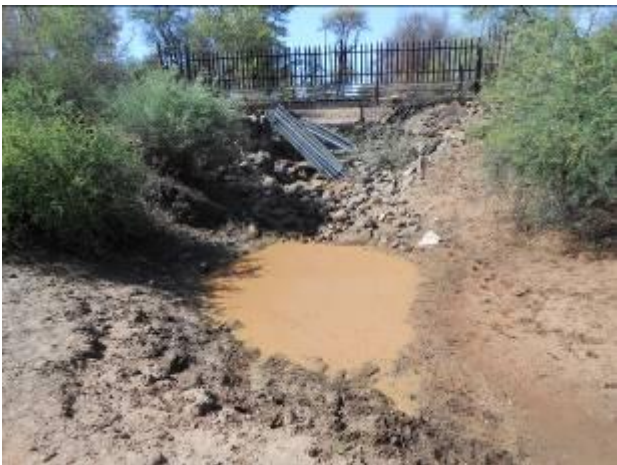
Site SC4 is located on the Phufane stream and will be crossed by the proposed powerline.

Water Quality		
pH	7.45	
Conductivity (mS/m)	16.0	
Temperature (° C)	20.7	
DO (mg/L)	6.19	
Aquatic Macro-invertebrate community assessment		
Dickens & Graham (2001)	Class F	
Dallas (2007)	Class E/F	
SASS5 Score	23	
ASPT Score	3.8	
MIRAI score	37.9 (Class E)	
Habitat Integrity Assessment		
IHAS Score	33 (Inadequate)	
IHIA Score	57.6 (Class D)	
VEGRAI Score	45.7 (Class D)	
Current impacts and comments		
Reduced instream flow due to impoundments and water abstraction within the system along with a nationwide drought experienced at the time of the assessment.

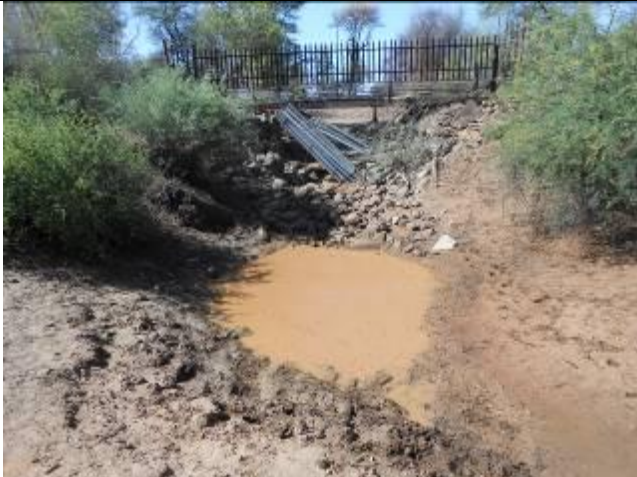
Site SC4		In situ physico-chemical water quality		Aquatic macro-invertebrate community integrity		Habitat Integrity

pH	7.45	SASS5 score	23	Instream Category 66.5 Moderately Modified Riparian Zone Category 48.7 Largely Modified Overall Category 57.6 Largely Modified (Class D)																																																		
	EC (mS/m)	16.0	Number of taxa	6																																																			
	DO (mg/L)	6.19	ASPT score	3.8																																																			
	DO (% sat)	72.6	MIRAI score	37.9																																																			
	Temp (°C)	20.7	IHAS score	33 (Inadequate)																																																			
Site specific temporal water quality variations (% var)		Site specific temporal aquatic invertebrate community variations (% var)																																																					
Parameter	% Var from baseline data	Parameter	% Var from ref ecoregion data (SASS5)	% Var from baseline data																																																			
pH	-5.9	SASS5	-80.8	-11.5																																																			
EC	-33.3	ASPT	-32.1	-23.3																																																			
DO	+9.9	IHAS	NA	-8.3																																																			
Temp	+2.0																																																						
Figure 3: General view of the SC4 site at the time of the assessment.																																																							
Algal proliferation	None observed.	Riparian Vegetation Assessment																																																					
Depth profiles	Very shallow. Generally < 1/2 m.

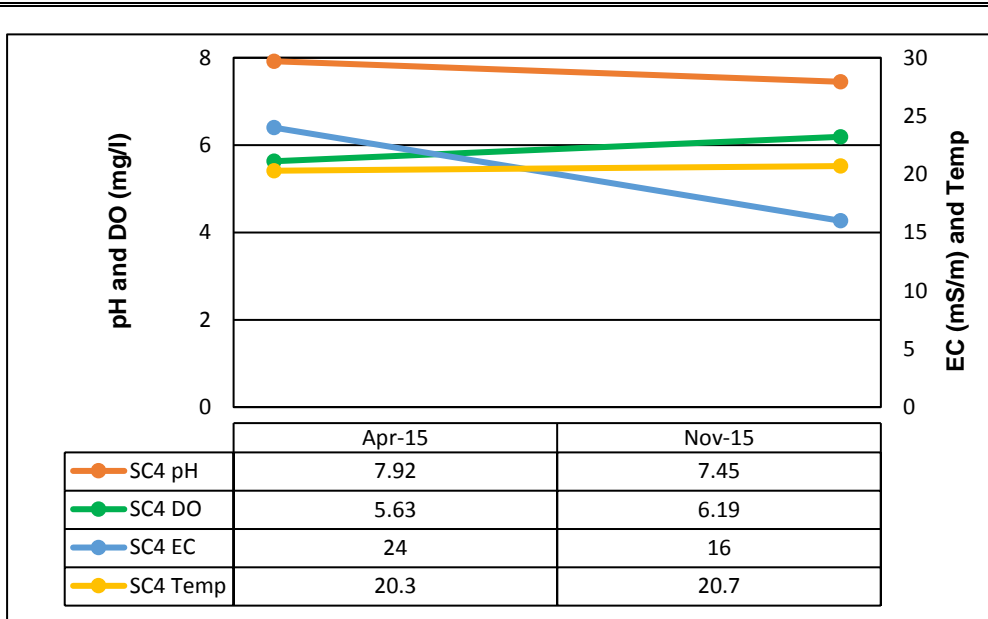
Figure 4: Site specific temporal water quality variation at site SC4.

- Electrical conductivity (EC) variation over time, exceeds the DWS target water quality guidelines (DWAF, 1996) (Table 2), which advocates that seasonal and temporal changes should not exceed 15%;

- EC has decreased significantly when compared to the baseline assessment and can be seen as an improvement in the system;
- When compared to the baseline assessment, pH has decreased slightly and exceeds the DWS target water quality guidelines (DWAF, 1996) (Table 2), which advocates that seasonal and temporal changes should not exceed 5%. No impact on the aquatic community is likely at the time of the assessment as the absolute value is considered as largely natural;

- Dissolved oxygen (DO) saturation can be considered as inadequate in supporting a diverse and sensitive aquatic community, and falls below the 80% saturation requirement (DWAF, 1996);

- DO concentrations are relatively low over time, and can be attributed to the lack of flowing water and the high turbidity due to the dominant muddy substrate at the site;

- The temperature can be regarded as natural for the time of year and time of day during which sampling took place;
- Ongoing monitoring at this point will need to continue to establish any trends.

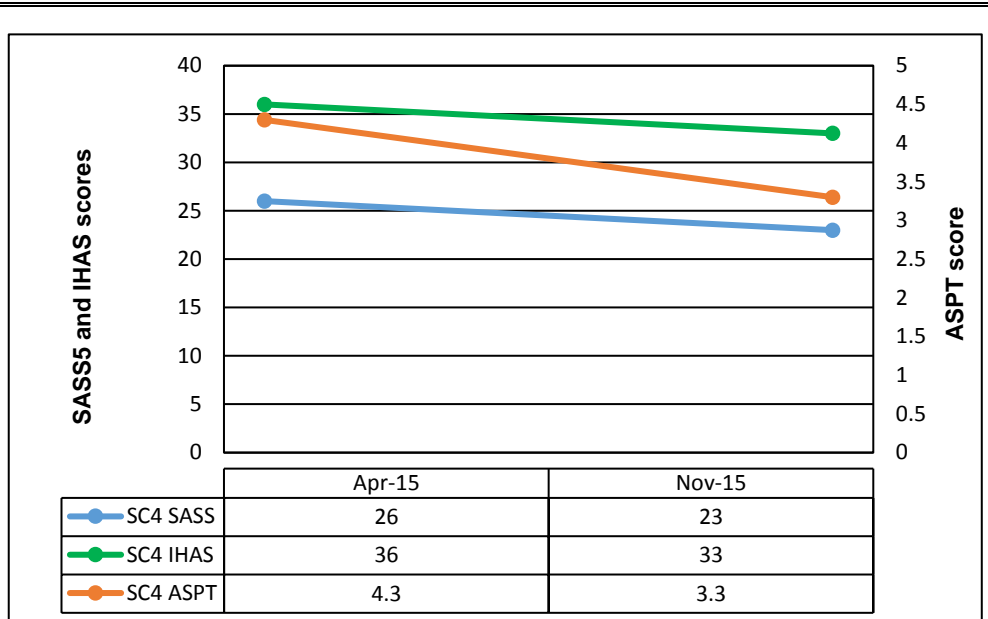
Figure 5: Site specific temporal macro-invertebrate community integrity at site SC4.

- When compared to the baseline assessment the SASS5 score has decreased by 11.5%, the ASPT score has decreased by 23.3% and the IHAS score has decreased by 8.3% (Table 2);
- The decrease in SASS5 and ASPT scores are likely related to the change in IHAS score along with the nationwide drought experienced at the time of the assessment;
- Ongoing monitoring at this point will need to continue to establish any trends.
