EMP Consolidation for Thubelisha, Trichardtfontein and Vaalkop

Aquatic Baseline & Impact Assessment Report

SAS3869

September 2017

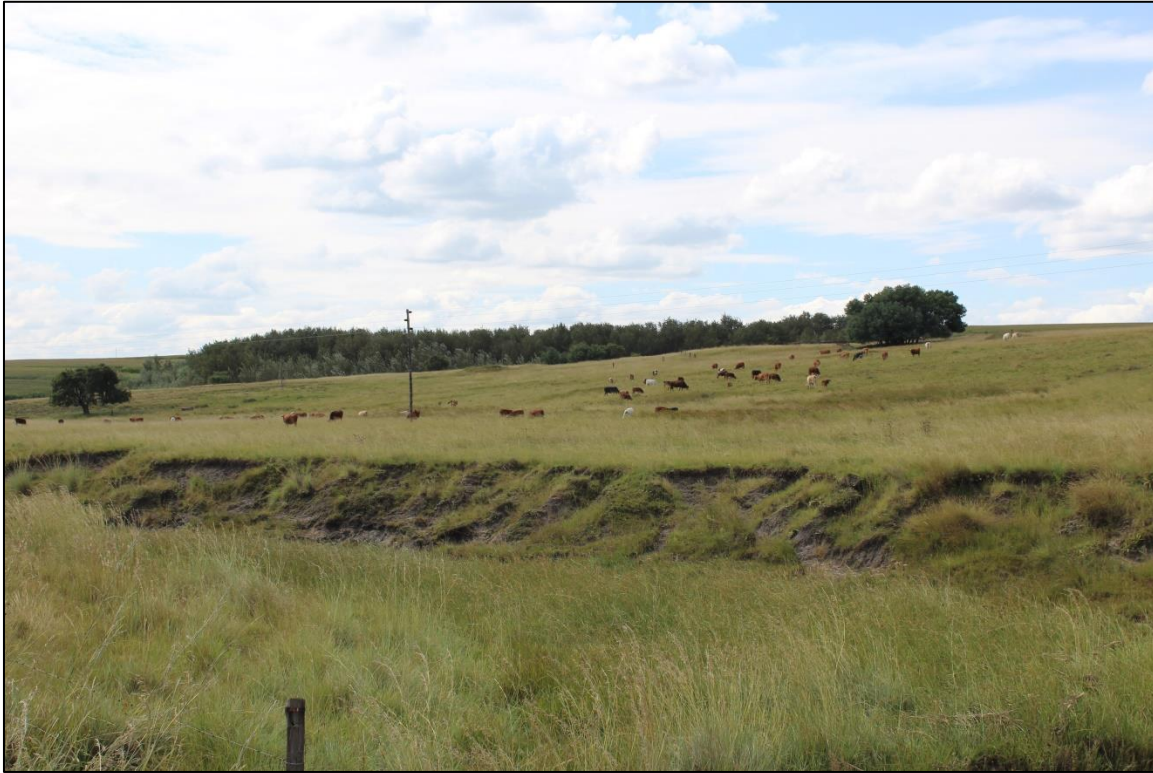
Figure 8-1: Livestock present along the Piekespruit SQR

The land use in upper reaches of the Piekesspruit and Steenkoolspruit consisted mainly of agricultural activities comprised of cultivation and livestock. Thus, knowing this and observing the runoff during the study, it is most likely that these agricultural activities are resulting in the higher than normal conductivity and pH values recorded. It is also possible that the geology of the Project area may be playing a role in these high values but further investigation into this is required to make any concise conclusions.

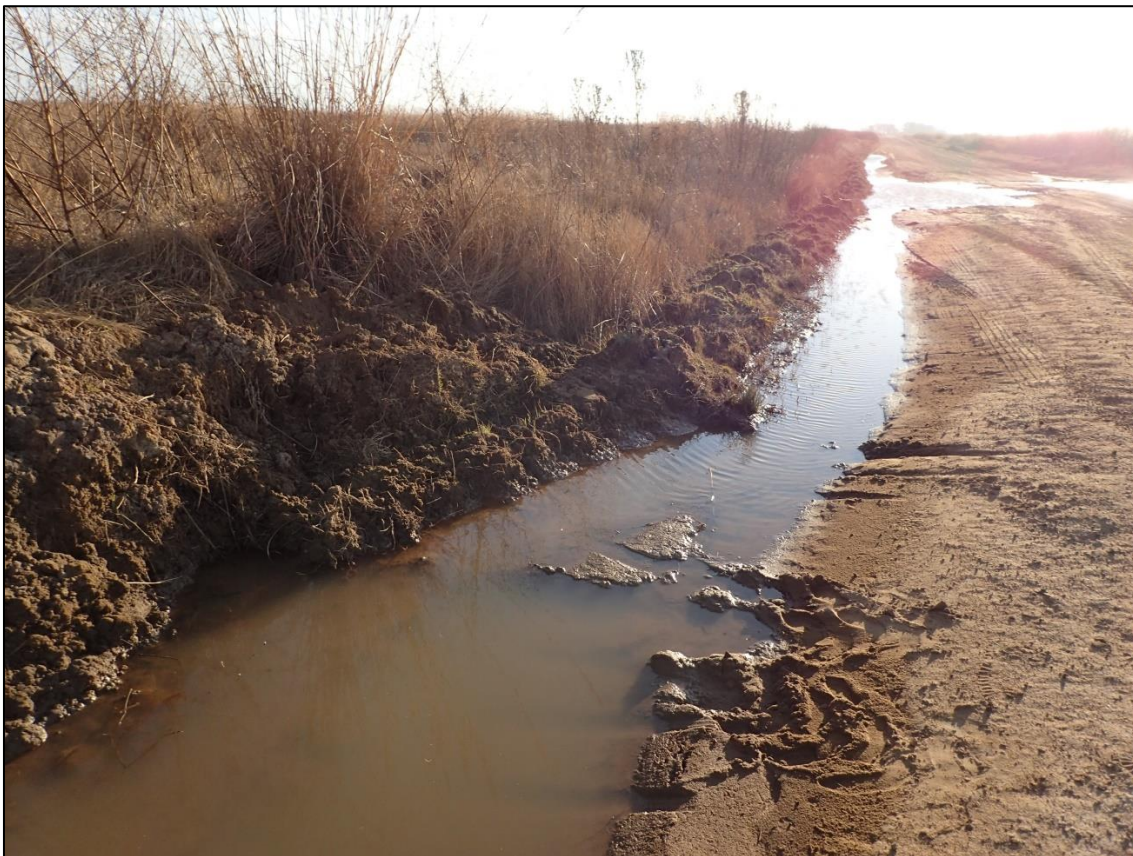
Figure 8-2: Farm effluent observed during the low flow survey (June 2017)

The conductivity at P1 remained above the threshold effect value of 700 µS/cm during the low flow survey with the conductivity at P3, S1 and S2 also exceeding this value. A large amount of algae was visible at these sites. This is most likely caused by the large abundance of livestock observed throughout the study at a majority of sites as illustrated in the figure below (Figure 8-1) compounded by the impacts of possible agricultural runoff entering the aquatic systems. Agricultural runoff was physically observed adjacent to the Piekesspruit reach near P1 as illustrated in Figure 8-2.

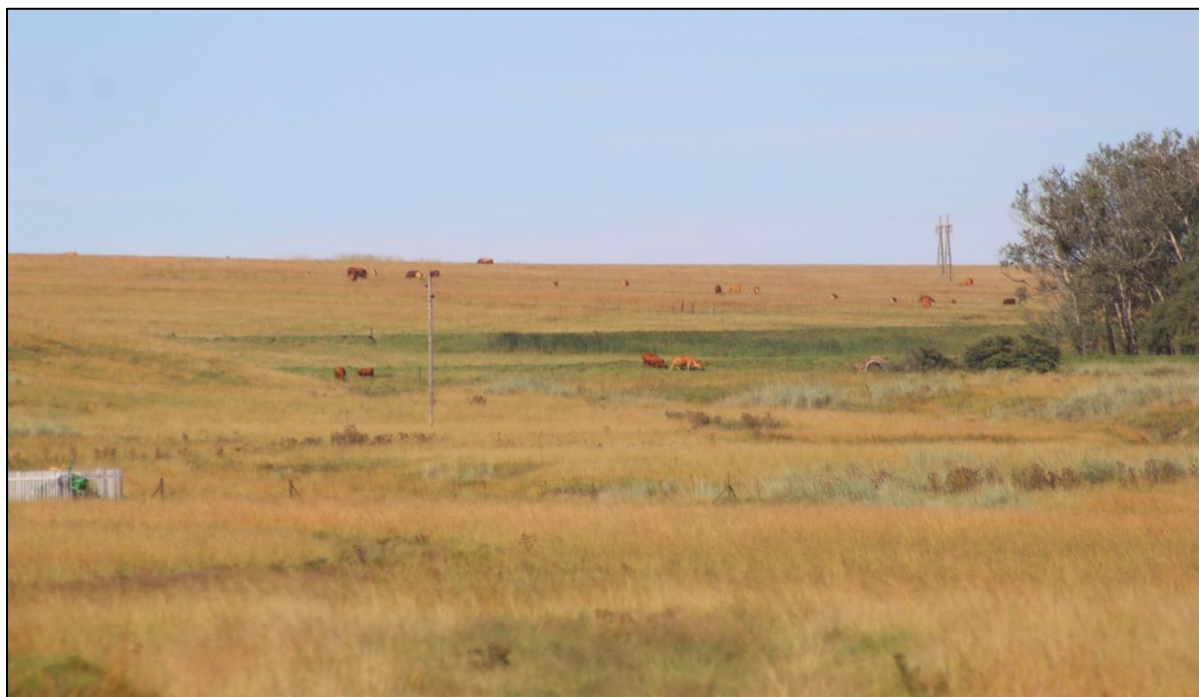
Figure 8-3: Livestock presence near the Steenkoolspruit SQR of concern

Major impacts appear to be related to a few farm dams situated in the upper reaches of the SQR as well as large amounts of erosion observed throughout the SQR. Water quality at the monitoring site (S1) was also fairly poor, especially during the low flow survey. Large amounts of algae was also observed at the site which is possibly a result of livestock being present along the SQR as illustrated in Figure 8-3 below which also compound the effects of erosion on the system.

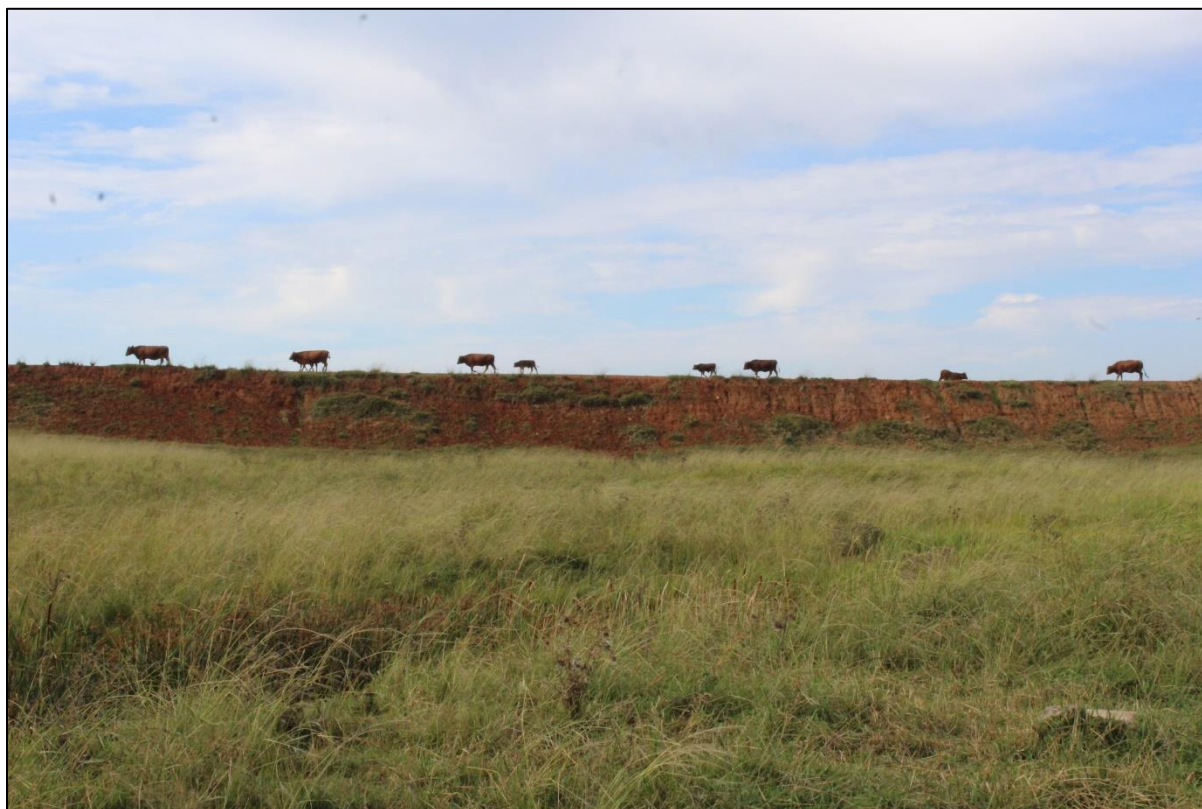
Figure 8-4: Livestock present at S2 during the high flow survey (March 2017)

The presence of the large impoundment, located approximately in the middle of the tributary, appears to have a larger impact due to the tributary's short length (approximately 8km). Thus, a fairly high modification score was allocated to the flow modification metric. Large numbers of livestock were also observed at the monitoring site, S2, during the high flow survey as illustrated (Figure 8-4) further contributing to the modified IHIA categorisation.

The PES determined for the Steenkoolspruit Tributary was based solely on the IHIA. Macroinvertebrate and fish sampling were not possible due to the low conditions of the monitoring site (S2). Therefore, it is assumed that the ecostatus of the Steenkoolspruit Tributary is category C or in a moderately modified state. Modifications appear to be directly associated with agricultural activities taking place in proximity to the tributary. This was especially noted with the number of livestock present, even at the monitoring site during sampling (Figure 8-4).
