Sasol Mining Sigma Colliery Ash Backfilling Project, Sasolburg, Free State Province

Aquatic Biodiversity Assessment Report

SAS5184

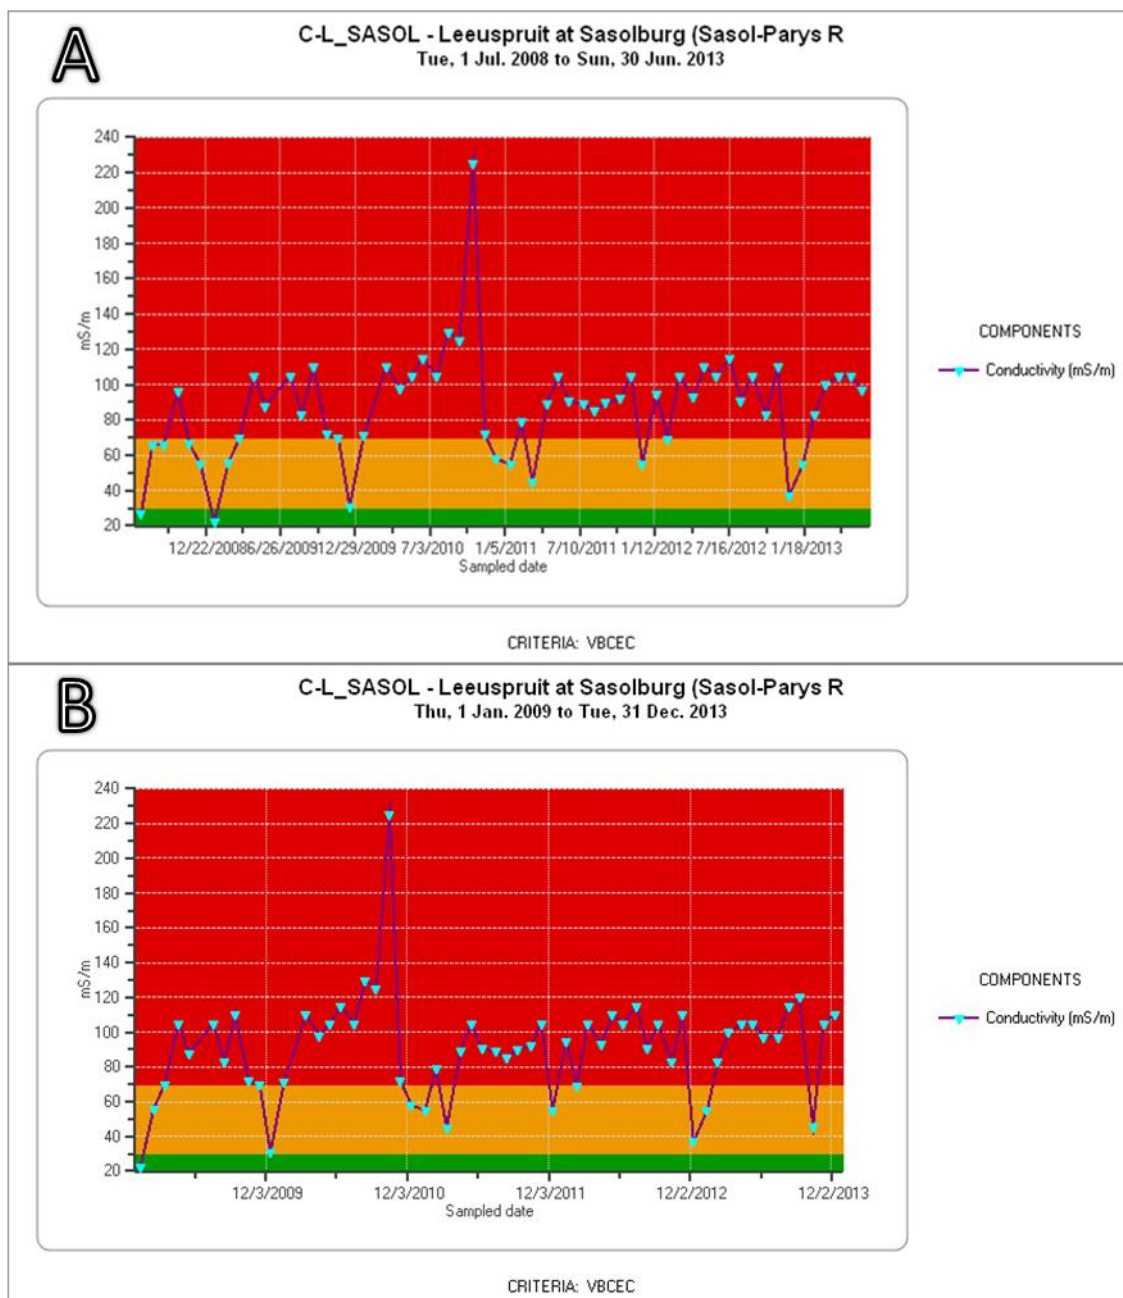
Figure 8-1: Conductivity (mS/m) changes from (A) 1 July 2008 to 30 June 2013 and (B) 1 January 2009 to 31 December 2013

Temporal data of the conductivity of the Vaal Barrage above the Leeuspruit confluence is presented in Figure 8-1. The pH levels in the Vaal Barrage at the Leeuspruit confluence are presented in Figure 8-2.

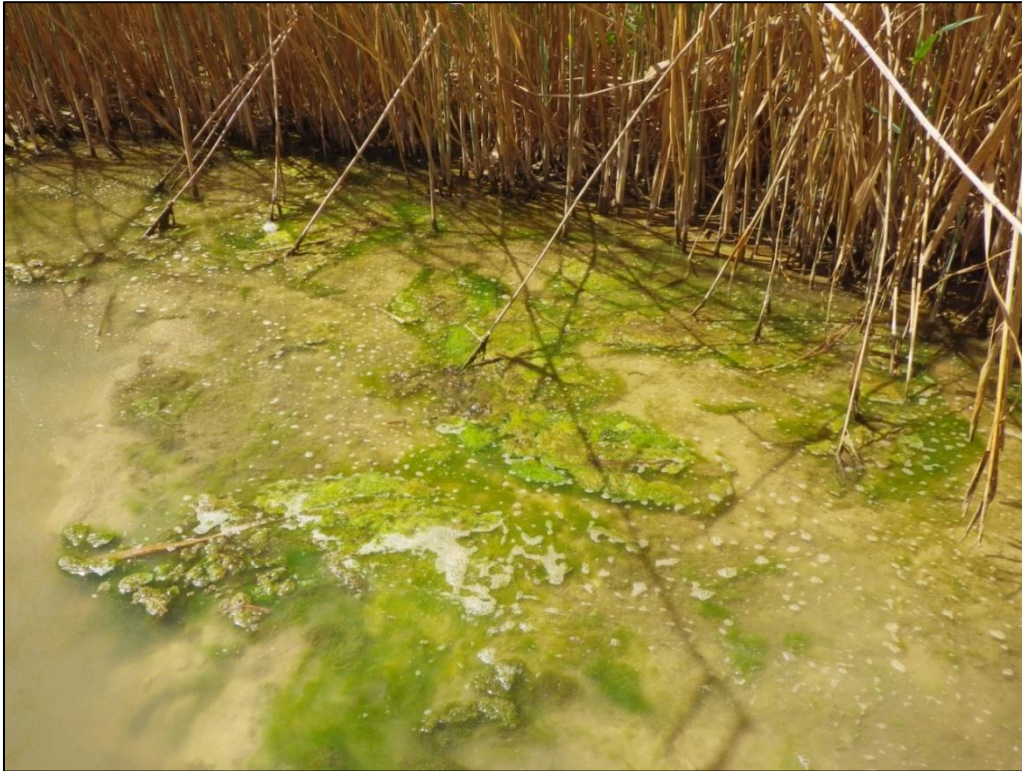
Figure 8-3: Eutrophication

Some of the factors considered for the IHI and the project area are given in the below figures (Figure 8-3, Figure 8-4, Figure 8-5).

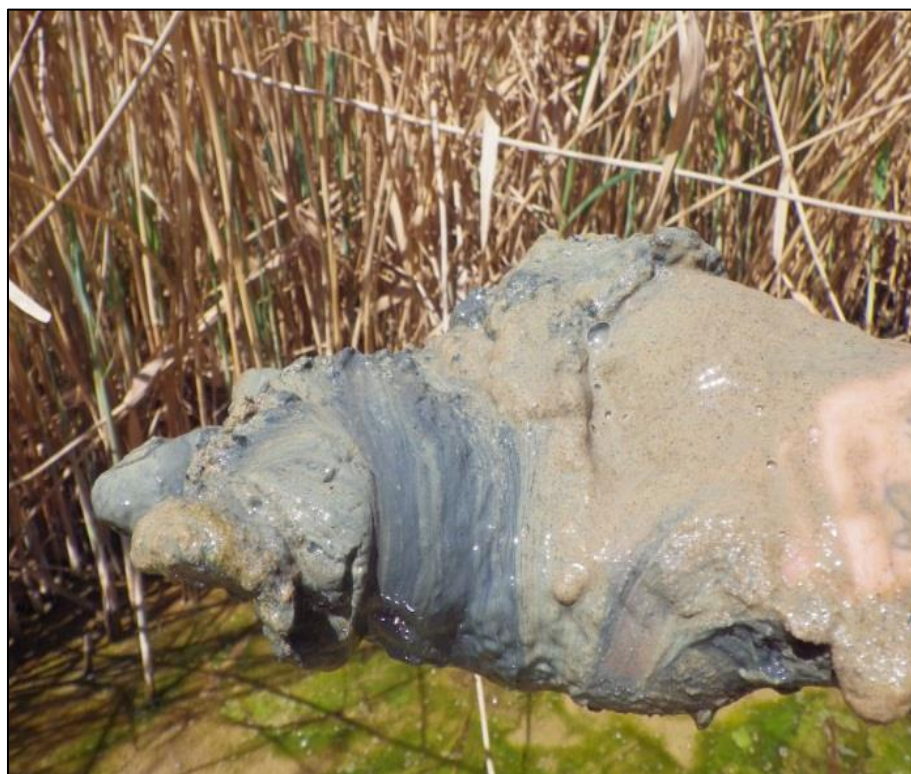
From the IHI for the reach of the Leeuspruit assessed it can be noted that the instream habitat is in a largely modified condition. The modified instream habitat is a result of habitat modification with most sites assessed affected by eutrophication and severe sedimentation. At Site SAS5, the instream habitat was completely modified through sedimentation of ash and/or sand from the local sand mining operation and industrial activities within the catchment area. The siltation is partially linked to the ash spill that occurred in the area during the 2009-2012 ash backfilling project (Figure 8-6).

Figure 8-6: Photograph depicting the Nature of Siltation at Site SAS5

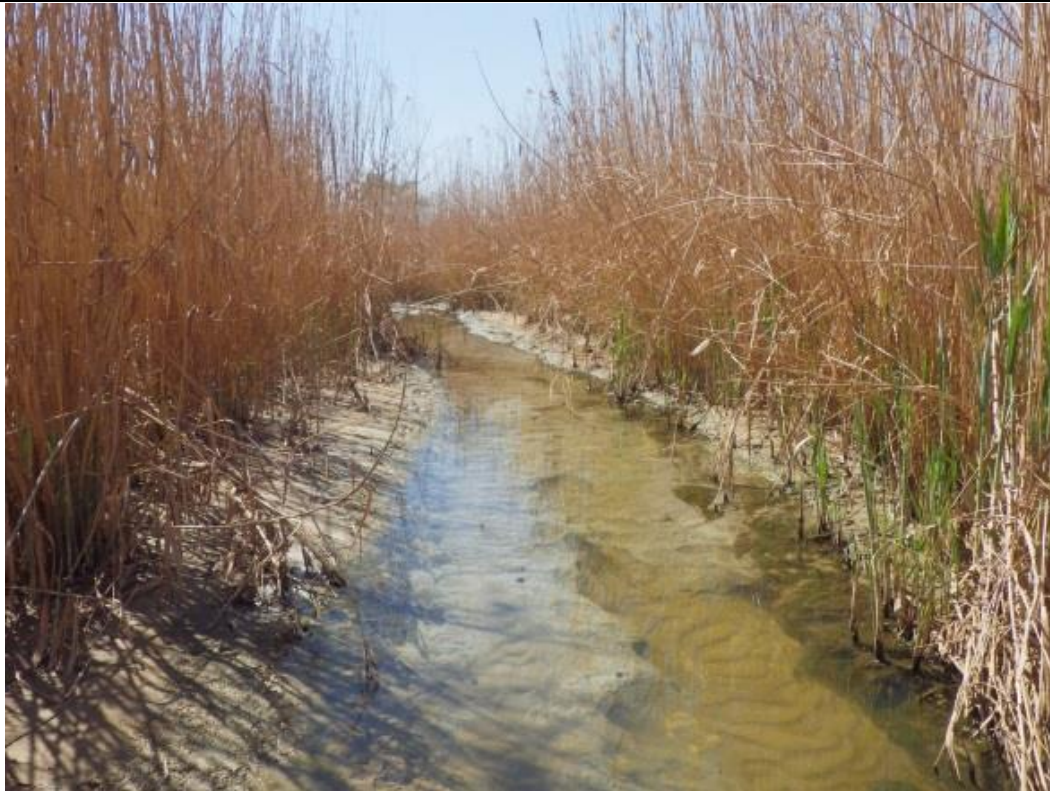
It should be noted that conditions at site SAS5 were altered to such an extent that no fish were sampled from this site in the low flow. However, during the high flow assessment fish were observed in the stream channel. *Cyprinus carpio* and *Micropterus sp.* were observed. Available habitat was covered with fine particulate sediment which covered most available habitat and provided limited cover for aquatic organisms.

Findings of the fish assessment indicate that the community structure of the fish population in the associated sites is in a poor condition due to impacted water quality. Sensitive species such as *Enteromius cf. neefi* which were expected to be present within the water course were not captured during the assessment indicating modified conditions. Additionally, habitat at site SAS5 and downstream from site SAS5 was covered in fine particulate matter.

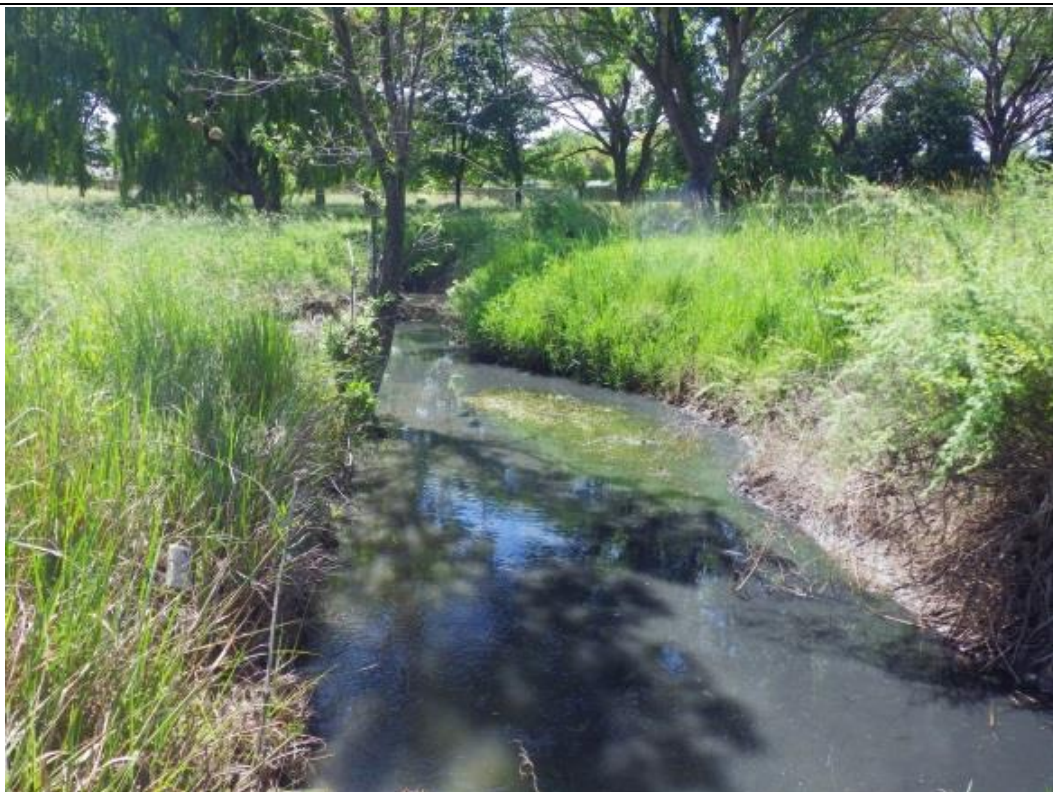
SAS10	26°48'37.04"S 27°48'03.28"E	This is believed to be the site where an ash spill entered the Leeuspruit. Evidence of ash mixed with sediment was found at this location
SAS11	26°47'32.11"S 27°47'02.46"E	Confluence of the Leeuspruit and the Vaal River. Lots of riparian vegetation. Only accessible by boat. Water level artificially elevated due to presence of the barrage.
The Rietspruit		
SAS6	26°50'15.13"S 27°45'18.65"E	This site is located within the upper reaches of the Rietspruit adjacent a cattle farm. The site was completely dry during the low flow survey.
SAS7	26°49'42.36"S 27°45'11.39"E	This site is situated at the R59 bridge crossing and was completely dry during the current low flow survey.
SAS8	26°48'59.46"S 27°44'45.46"E	This site is located within a game farm area. The site was completely dry during the low flow survey.
SAS9	26°48'02.75"S 27°44'35.52"E	This site is located within a game farm area. The site was completely dry during the low flow survey.

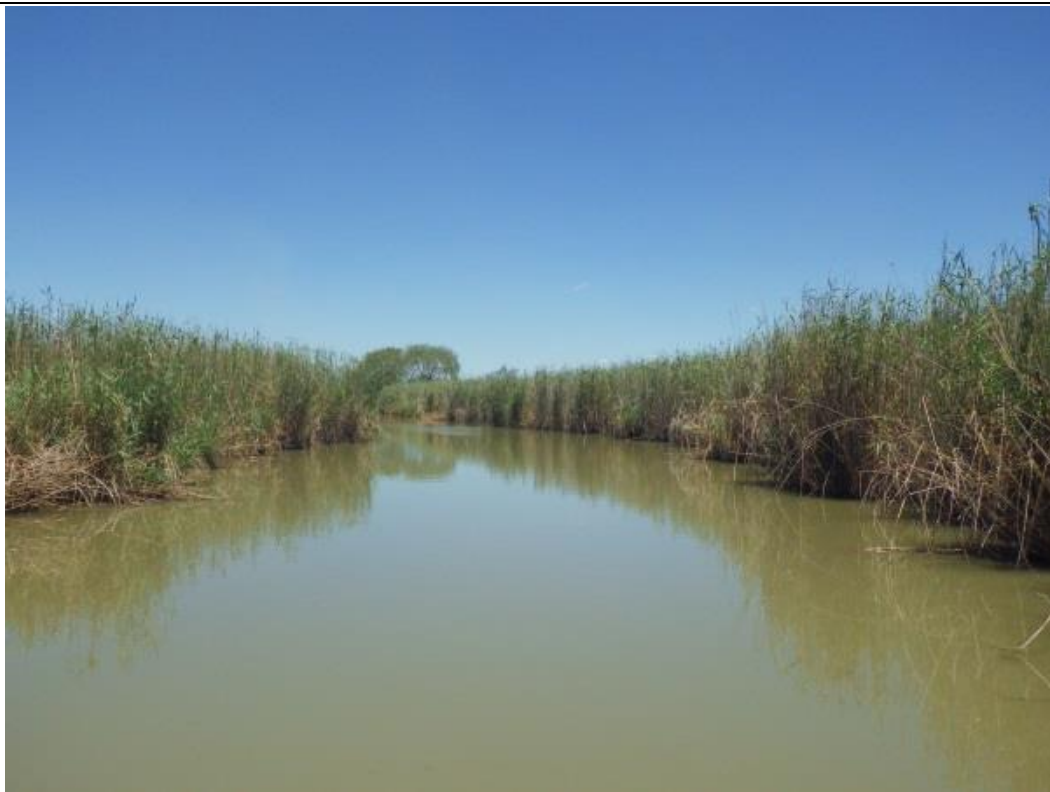
SAS12	26°46'41.00"S 27°44'28.34"E	Confluence of the Rietspruit and the Vaal River. Lots of riparian vegetation (<i>Phragmites australis</i>). Only accessible by boat. Water level artificially elevated due to presence of the barrage.
