Sasol Mining Sigma Colliery Ash Backfilling Project, Sasolburg, Free State Province

Surface Water Assessment Report

SAS5184

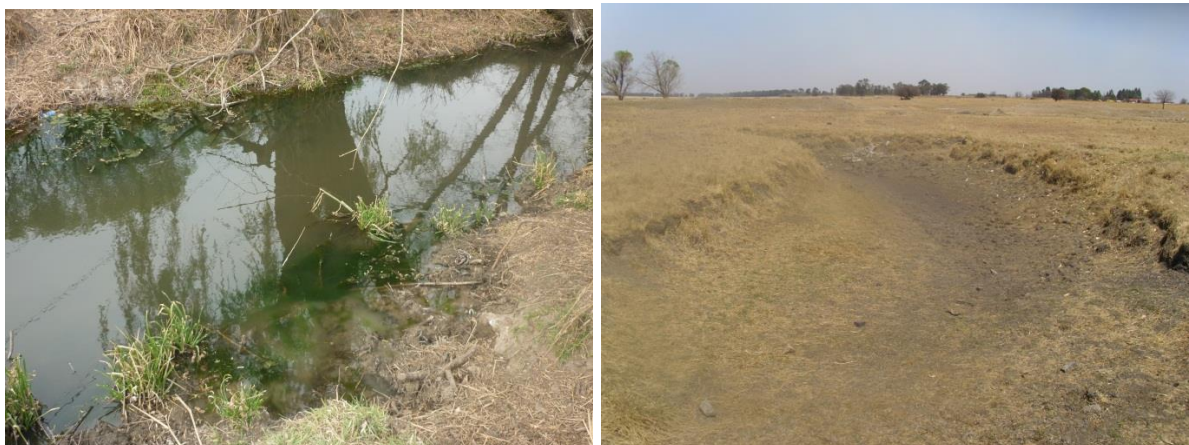
Figure 6-1: Photographs of the Leeuspruit (Left) and the Rietspruit (Right) River Channels

The Taaibos Spruit drains the area to the east of Sasolburg and is not influenced by the Colliery. At the time of the site visit the Rietspruit was dry whilst the Leeuspruit was flowing. Photos presented in Figure 6-1 below show some sections of the Rietspruit and Leeuspruit during site visit. The Rietspruit presented well-defined dry river channels whilst the Leeuspruit was slow flowing with varying channel shapes. The Kromelmsboogspruit flows outside of the project boundary to the west.

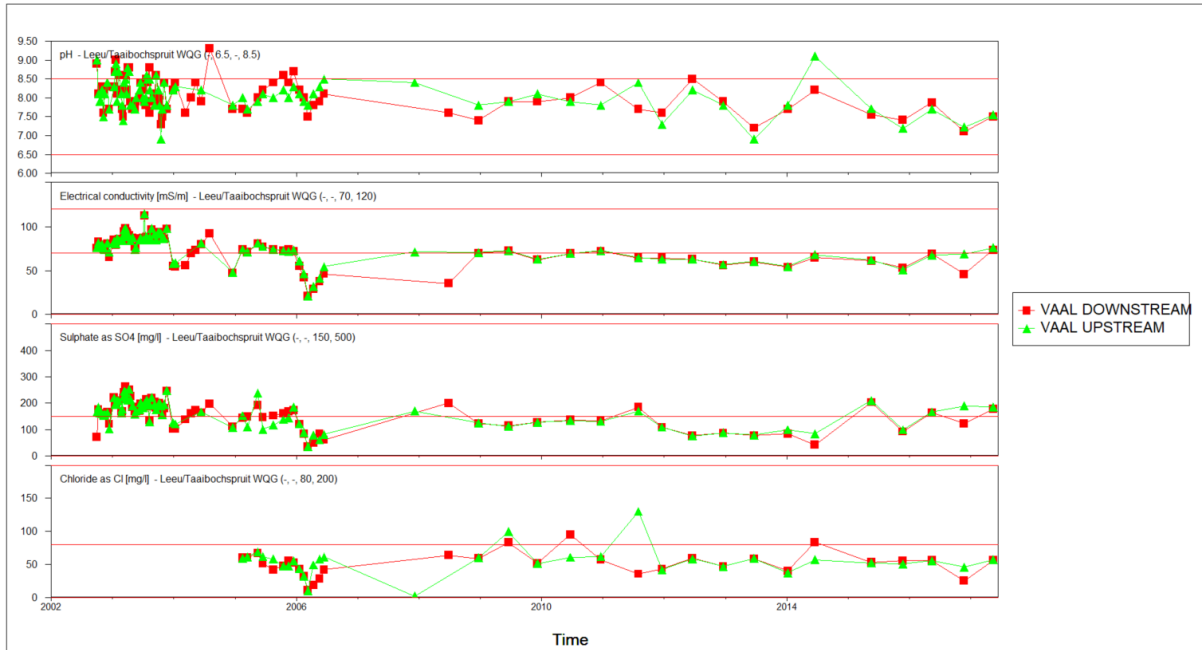
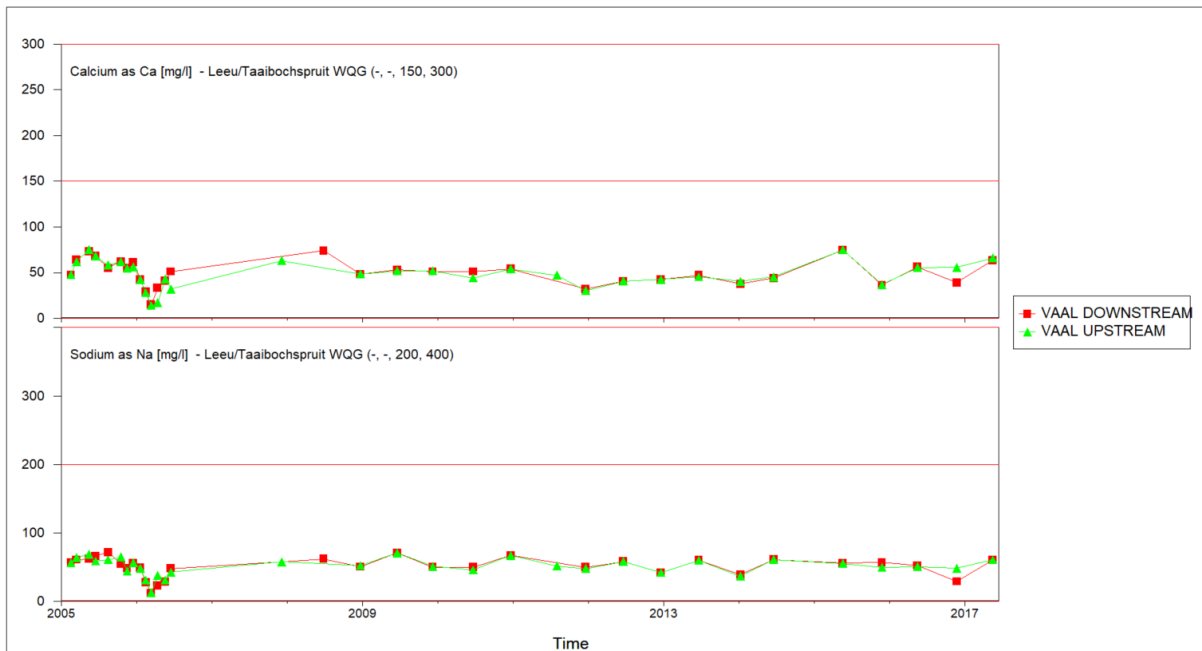
Figure 6-14: Major Cation, Anion and Electrical Conductivity Time Graphs of the Vaal River Upstream and Downstream

The historic water quality data as shown in Figure 6-14 reveals the current calcium sulphate signatures from the latest data. The time series Stiff diagrams (Figure 6-15) indicate that the water quality downstream varies between calcium sulphate and sodium bicarbonate water.

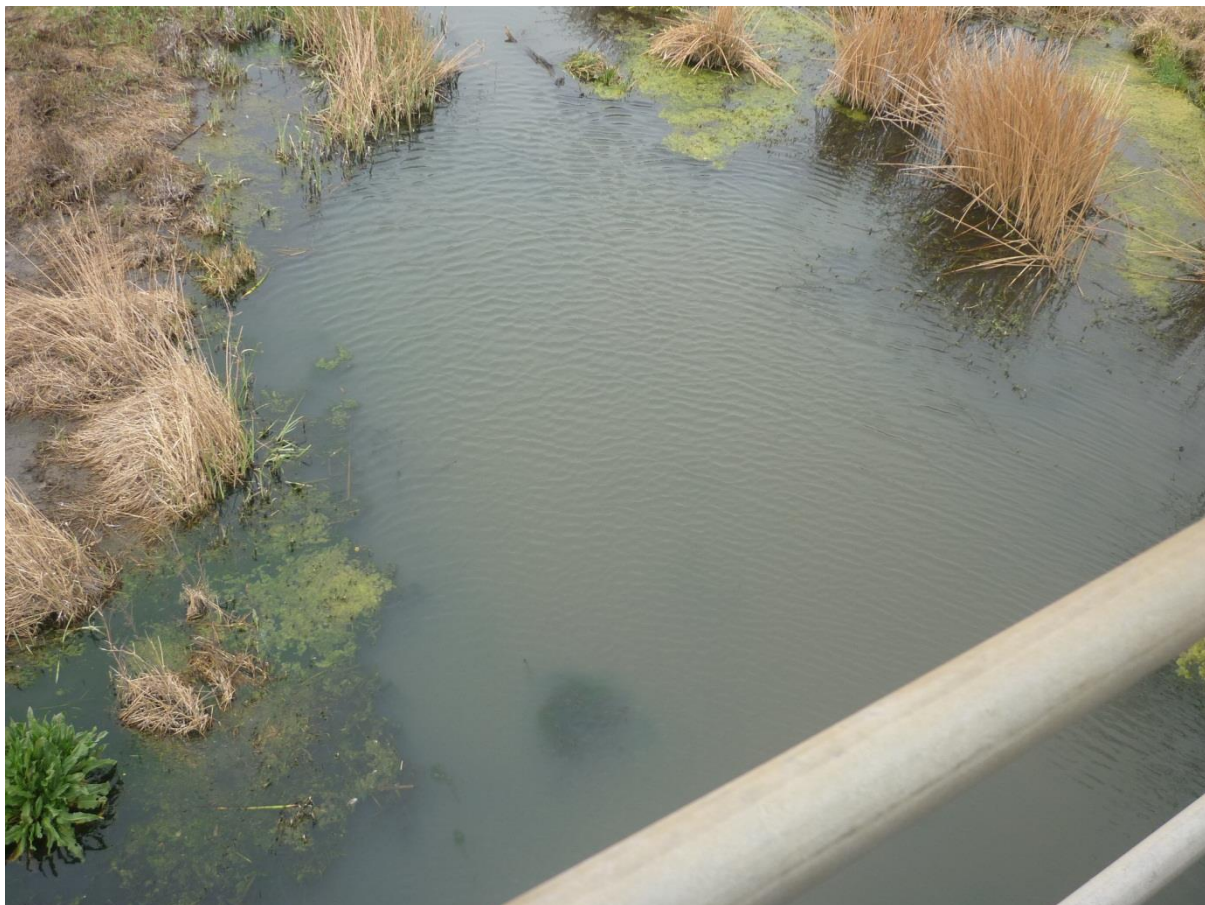
Figure 7-1: Location on Leeuspruit Downstream of the Sand Mining and Agricultural Activities at the Pipeline Stream Crossing

Downstream impacts of the sand mining are already evident as indicated in Figure 7-1, shown by the murky water with evidence of algal growth. The algal growth can be attributed to the impacts from agricultural activities and sewage bursts in the vicinity and upstream.
