Environmental Authorisation Process to Decommission the Conveyor Belt Servitude, Road and Quarry at Twistdraai East Colliery, Secunda, Mpumalanga Province

Surface Water Report

SAS5544

April 2019

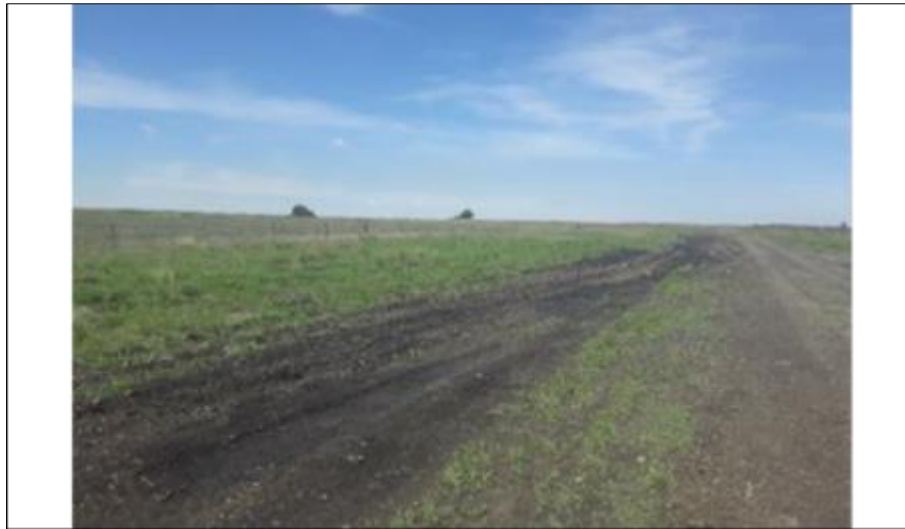
The conveyor belt infrastructure had been removed for most (approximately 17 km) of the route (Photograph 5-1). In some parts along the route, the conveyor belt was still lying on the ground during site assessment on the 3rd of December 2018 as indicated in Photograph 5-2.

Photograph 5-1: Conveyor belt removed from 17 km of the conveyor route

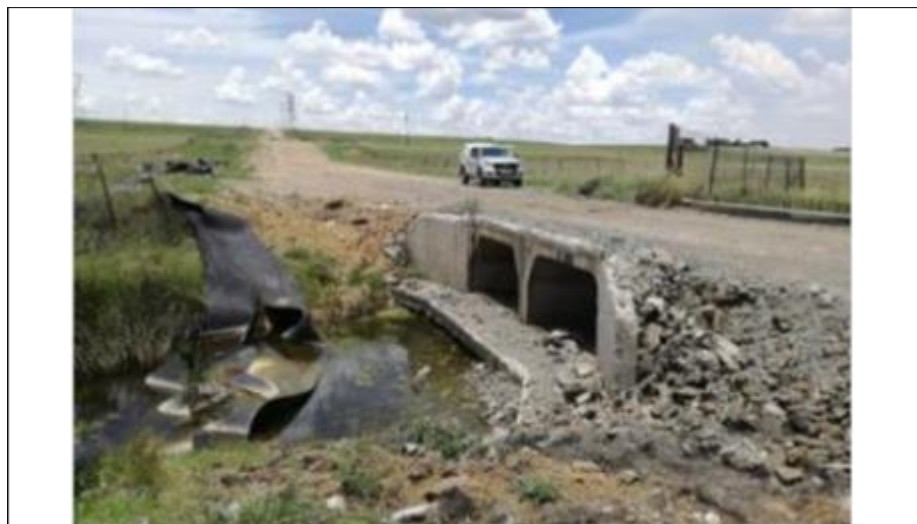
Photograph 5-2: Conveyor belt lying on the ground at a river crossing

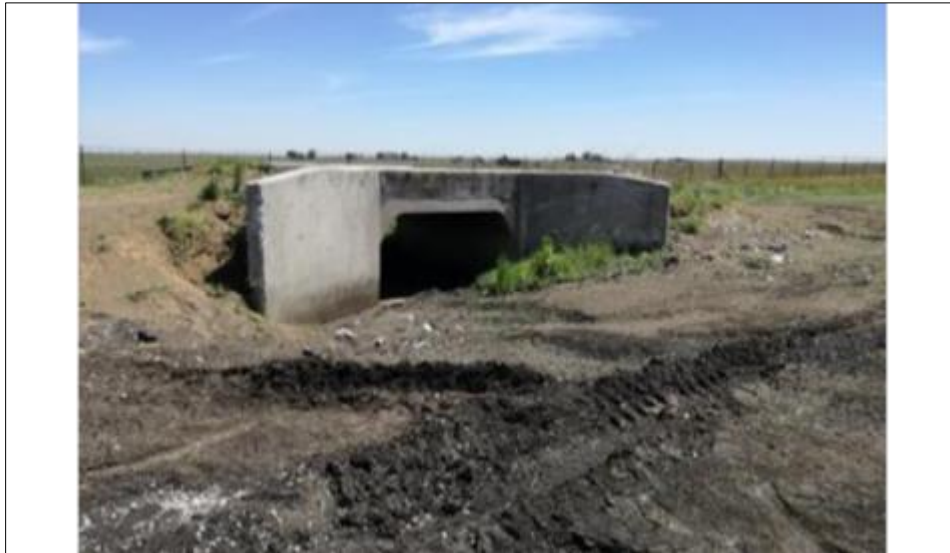
The stream channel geometry is observably altered in most river crossings along the conveyor belt route as can be seen in Photograph 5-3 and Photograph 5-4.

Photograph 5-3: Altered stream channel geometry and silted river at a crossing

Vehicle movement through watercourses at river crossings should be limited to minimise damage to channel geometry.

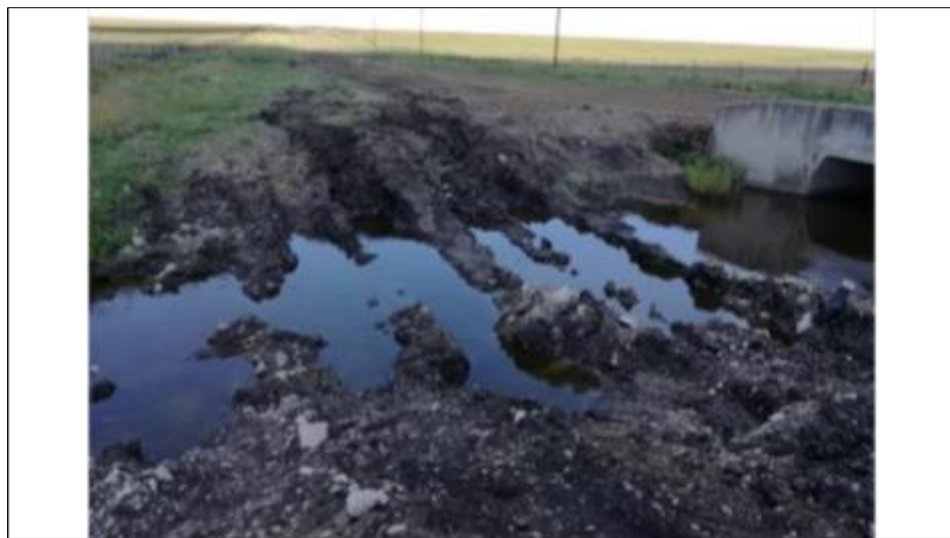
Photograph 5-4: Altered stream channel geometry and silted river at a crossing

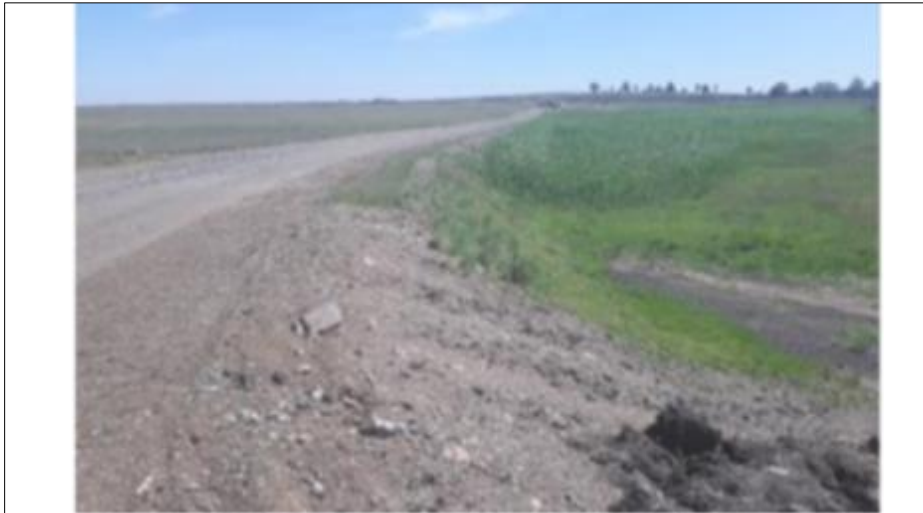
The Twistdraai gravel road, quarry and the pipeline daylight points to be decommissioned and rehabilitated were also assessed during the site visit. These facilities are presented in Photograph 5-5 and Photograph 5-7. Coordinates of the pipeline daylighting points are presented in Table 5-1. As mentioned, the pipeline will be cut-off at these daylighting positions while the embedded sections underground will not be removed.

Photograph 5-5: Gravel road from Mynpad to the Twistdraai East Shaft area

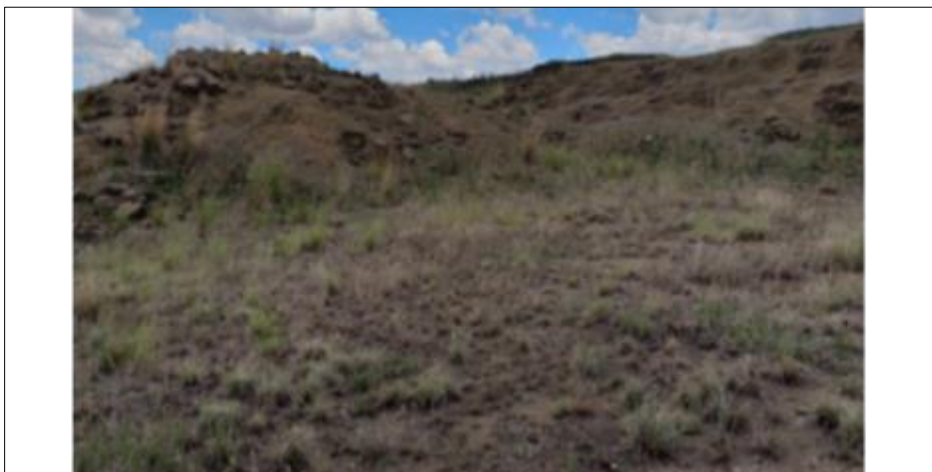
Photograph 5-6: Quarry area to be rehabilitated

The decommissioned quarry should be infilled, top-soiled and re-vegetated to reduce chances of soil erosion, sedimentation, siltation and contamination of nearby watercourses. Re-profiling of the infilled quarry and road surfaces prior to re-vegetation must be undertaken to ensure surface profiles that allow free drainage mimicking pre-mining conditions as much as practically possible. This will ensure improvement of catchment runoff yield benefitting aquatic ecosystems and downstream water users.

The decommissioned quarry should be infilled, top-soiled and re-vegetated to reduce chances of soil erosion, sedimentation, siltation of nearby watercourses. Re-profiling of the infilled quarry and road surfaces prior to re-vegetation must be undertaken to ensure surface profiles that allow freely draining runoff mimicking pre-mining conditions as much as practically possible. This will ensure improvement of catchment runoff yield benefitting aquatic ecosystems and downstream water users.

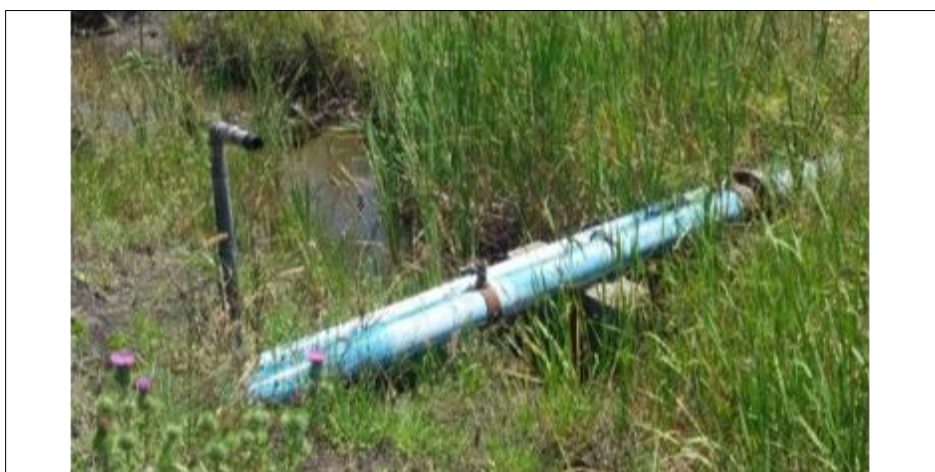
Photograph 5-7: Water pipeline to be decommissioned

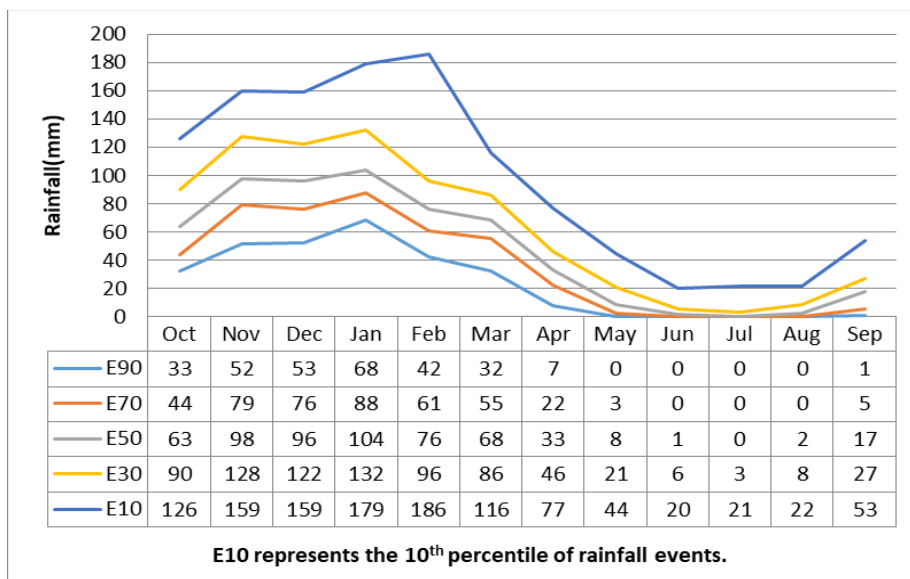
Figure 6-2: Rainfall distribution for quaternary catchment C12D

The MAP for quaternary catchment C12D in which the Twistdraai East Colliery conveyor belt and road are located is 667 mm. This MAP is likely to be distributed as indicated in Figure 6-2. 90 % of the most frequent rainfall events in the wettest month of January did not exceed 68 mm, while 10 % of the extreme rainfall events will likely be below 179 mm. The potential MAE for the region is in the order of 1 580mm which is more than twice as much as the MAP for the area (Figure 6-3). This indicates the existence of seasonal rainfall in this quaternary catchment with more rainfall being received from October to March and less rainfall from April to September.
