## **Environmental Authorisation Process to Decommission a Conveyor Belt Servitude, Road and Quarry at Twistdraai East Colliery, Secunda, Mpumalanga Province**

### **Baseline Aquatic Biodiversity and Impact Assessment**

SAS5544

January 2019

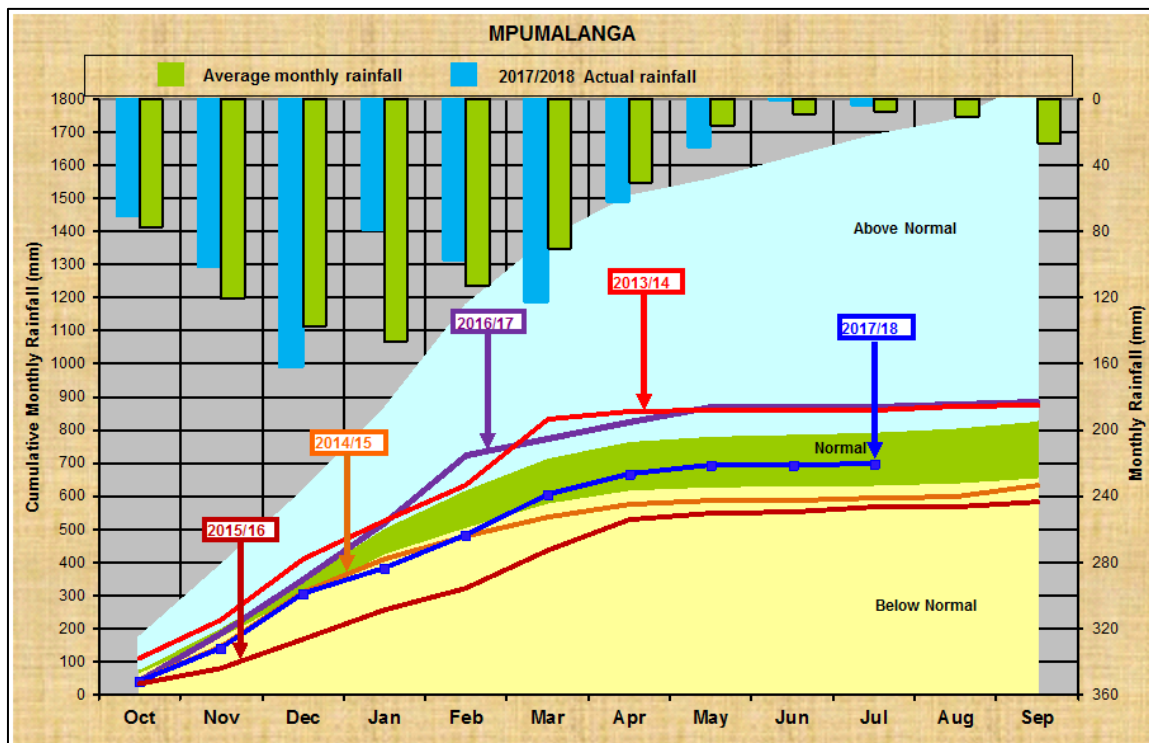
Figure 4-2: Annual Rainfall Trend for the Mpumalanga Province (DWS, 2019)

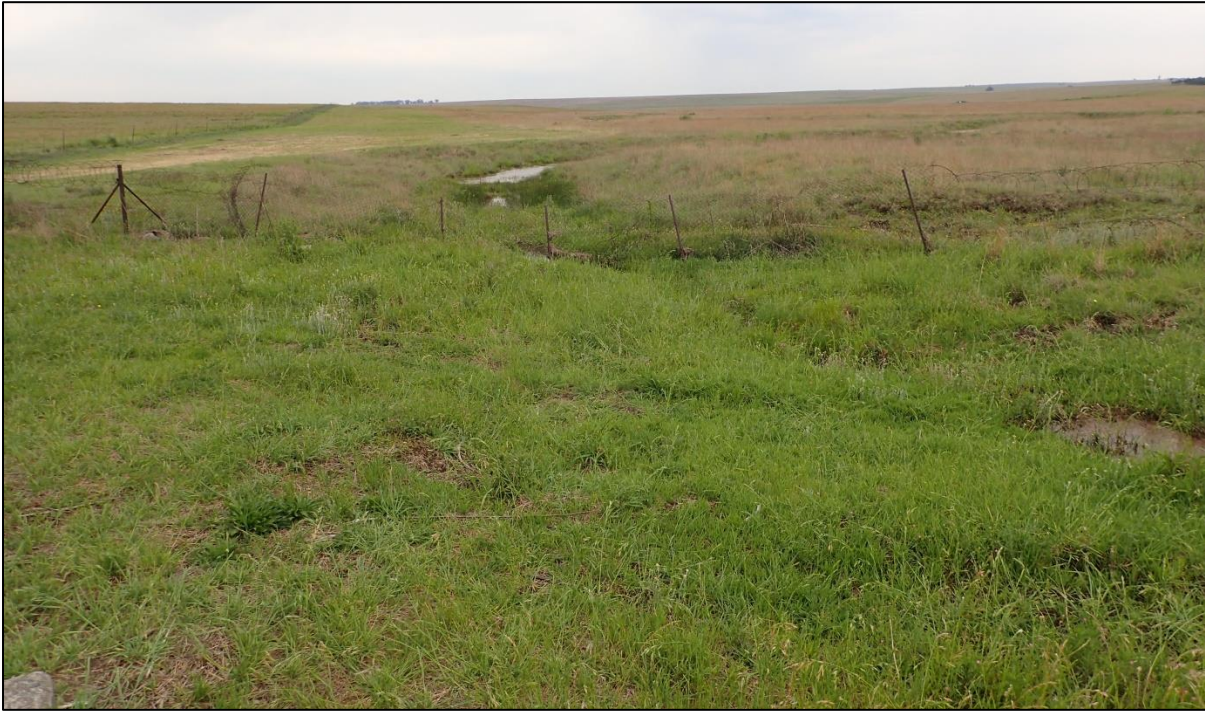
The study area consists predominantly of typical Highveld grasslands with watercourses comprising mainly of wetland systems, lacking defined riparian zones (Figure 5-1). These watercourses are further characterised by incised channels with grassy edges and muddy substrate. The systems are also ephemeral and may have seasonal flow. Notable aquatic related impacts associated with this system vary, consisting of impacts such as road and conveyor crossings, lack of flows, agriculture and instream dams (DWS, 2018). These impacts have the potential to increase sediment content in associated aquatic systems and, in cases of instream dams, result in severe hydrological and morphological changes. Additionally, agricultural practices have the potential to increase nutrient content into associated aquatic systems which in turn, has the potential to alter the chemistry and quality.

**Figure 5-1: Sampling site downstream from the road and conveyor of concern**

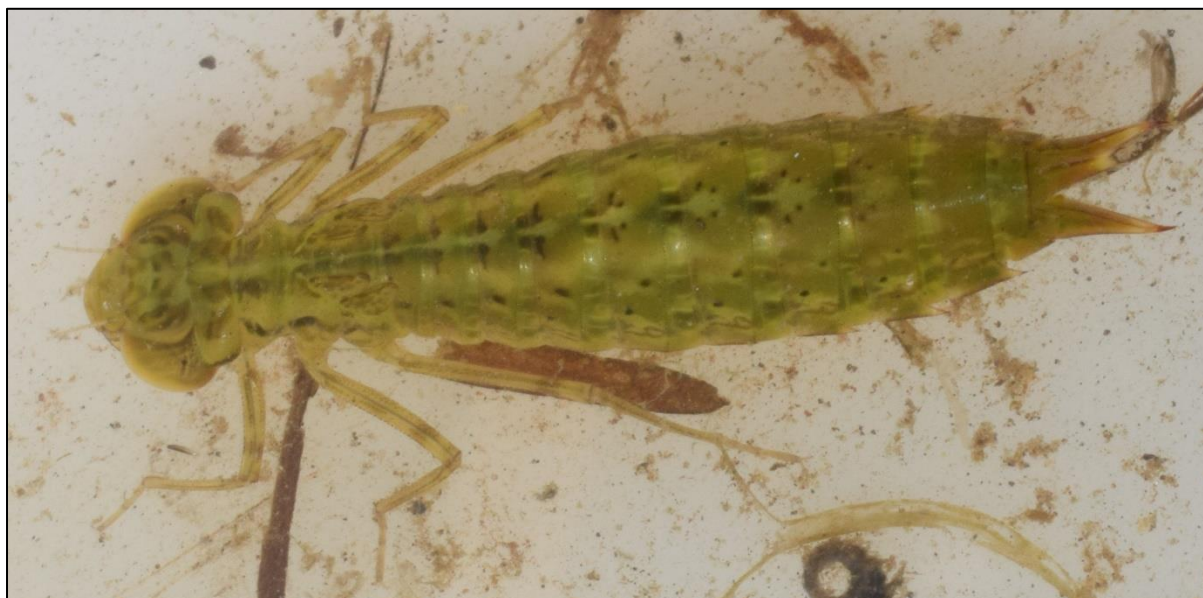
A total of 14 different taxa were sampled at Site 11B, comprising of mainly air breathing, tolerant families (i.e. sensitivity score < 8). However, a single individual Aeshnid was sampled at the site (Figure 7-1). These invertebrates belong to the Odonata order (Dragonflies and Damselflies) and have a moderate requirement for unmodified physio-chemical conditions, providing some indication of fair water quality at the site.

**Figure 7-1: Aeshnidae nymph sampled at Site 11B**

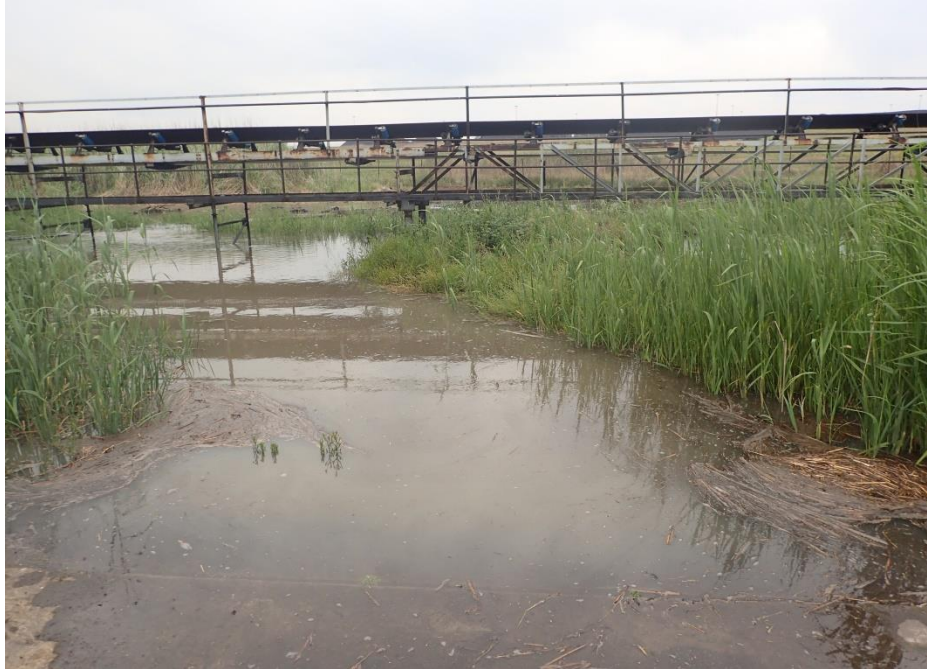
Site Name	Coordinates	Description
<b>Major Tributaries</b>		
Site 9	26°34'24.51"S 29°11'25.00"E	Site located along the Bossiespruit downstream from a large dam. As a result, a large quantity of water was entering from the dam into the site at the time of the survey. The site was split by a road crossing, where the upstream section was comprised of a deep pool which resulted in churning water downstream unsafe for sampling.
Site 1	26°34'32.89"S 29°14'07.02"E	Site impounded, forming a small pool after the servitude of concern. Road crossing is heavily eroded with large amounts of litter in the form of copper cables hidden under the crossing point in the flow pathway of the watercourse. A rubber conveyor belt was also observed to be lying across and in the channel.
Site 3	26°34'11.04"S 29°15'13.44"E	A large farm dam was developed just below the monitoring point which has resulted in the attenuation of flow at the site. Furthermore, silt and sediment have smothered the site as a result, creating a mud like substrate allowing no marginal vegetation growth.

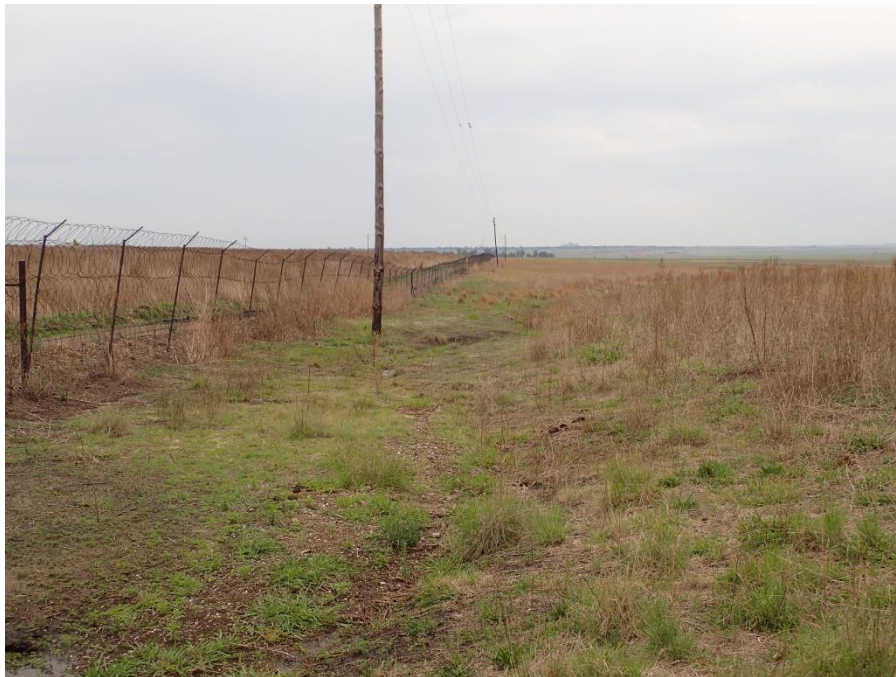
Site 11B	26°33'04.29"S 29°18'37.87"E	
<b>Unclassified Drainage Lines</b>		
Site 8	26°34'31.14"S 29°12'35.16"E	The site was observed as dry at the time of the survey. It barely forms a channel after the road crossing but, becomes incised further downstream running along a fenced off area adjacent to the Twistdraai Export Plant.
Site 2	26°34'37.68"S 29°13'35.62"E	This site is situated below a road crossing in an incised channel. There was sufficient water at the site at the time of the survey to form a pool which contained sections of gravel and large cobbles.
Site 7	26°34'33.59"S 29°12'59.05"E	This site is situated between the aforementioned drainage lines. No channel was observed however, the site had sufficient water and vegetation for diatom sampling (see wetlands report for more information).

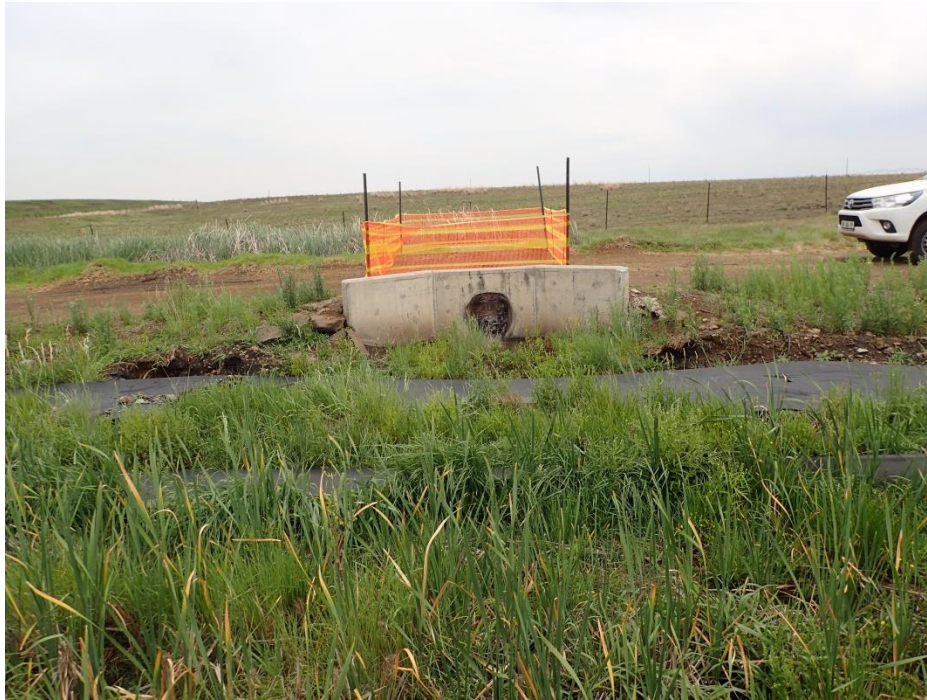
Site 7

- All concrete structures, slabs and any concrete remains;
- Culverts;
- Conveyor belt remains;
- Copper cables (especially noted at Site 1);
- Fence lines within the pathway of the crossing points (observed to be accumulating vegetation and blocking flow); and
- Any final waste material after decommissioning such as eroded rubble and plastic safety barriers (see Appendix A, Site 7).

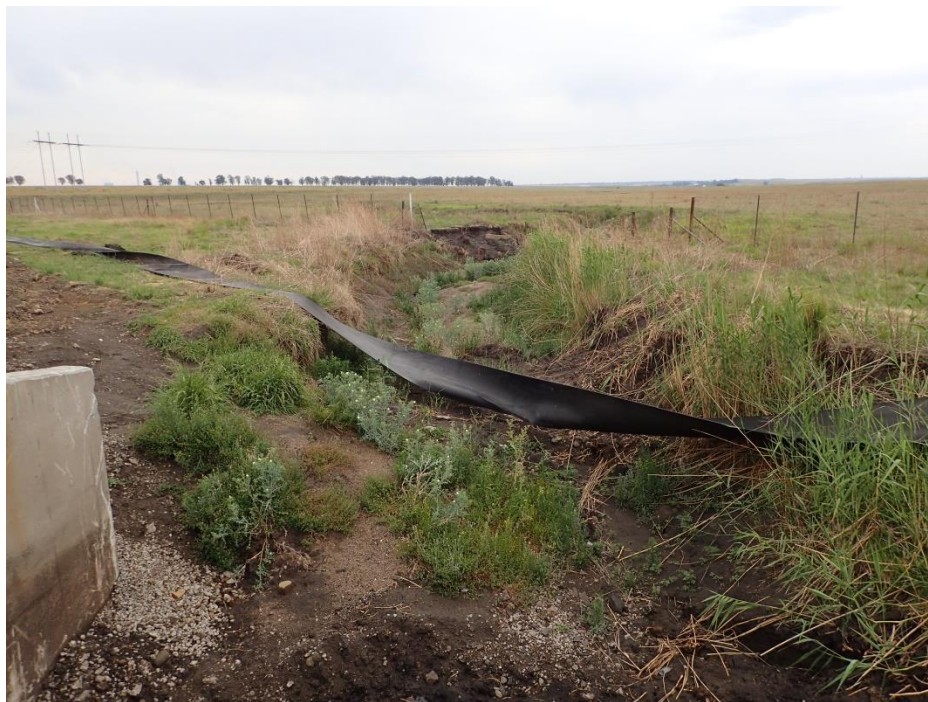
Site 4	26°33'47.85"S 29°16'24.56"E	The site was observed as dry at the time of the survey, consisting of an incised channel with grassy edges below a road crossing. Rubble from the crossing was also observed within the pathway of the channel.
Site 0	26°33'25.39"S 29°17'32.68"E	The site was observed as dry at the time of the survey. It is situated after a road crossing, between a fenced off farmland. The substrate of the site consists of compacted sand and gravel and is surrounded by fairly dense wetland vegetation.
Site 11A	26°33'04.96"S 29°18'35.19"E	These sites are both situated along an unnamed tributary flowing under a road and conveyor crossing point. The tributary splits just before the conveyor crossing point and merges again approximately 100 m afterwards. Site 11A is made up of a small trickle of water insufficient for macroinvertebrate sampling. However, Site 11B was receiving a large amount of water from a burst dam wall situated upstream from the site.
