Basic Assessment Report and Environmental Management Programme

for decommissioning of an access road, conveyor belt servitude and the rehabilitation of a quarry at Twistdraai East Shaft, Twistdraai Colliery, Mpumalanga

Report Type:	BAR and EMP
Project Name:	Basic Assessment Report for the Decommissioning of an Access Road, Conveyor Belt Servitude and the Rehabilitation of a Quarry at Twistdraai East Shaft, Mpumalanga Province
Project Code:	SAS5544

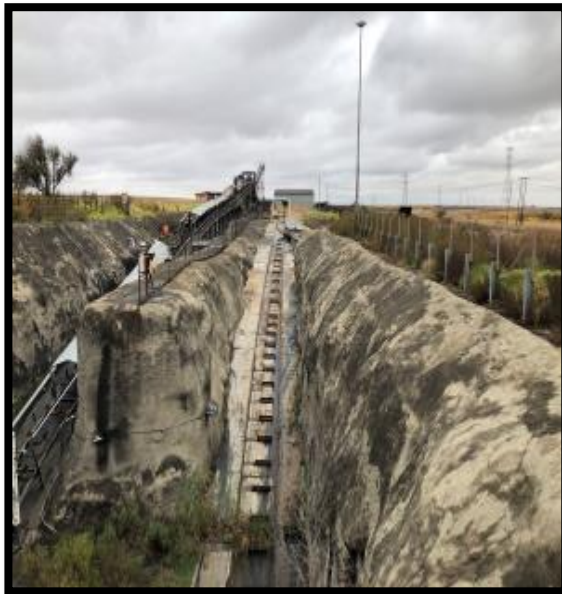
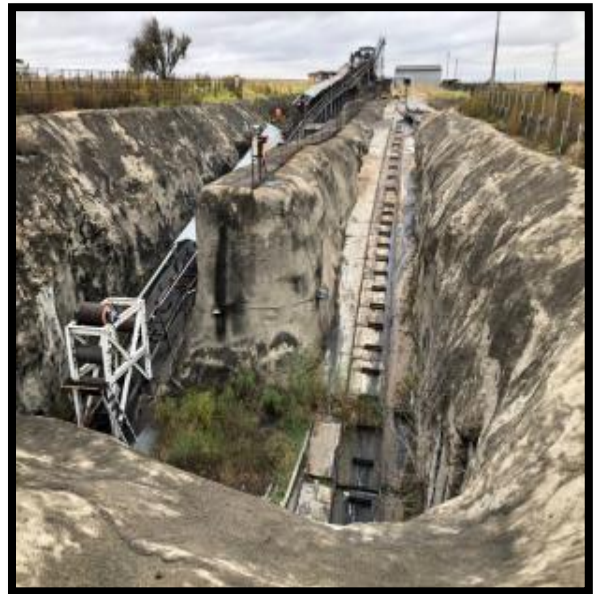
Figure 5-5: Incline Shaft prior to decommissioning

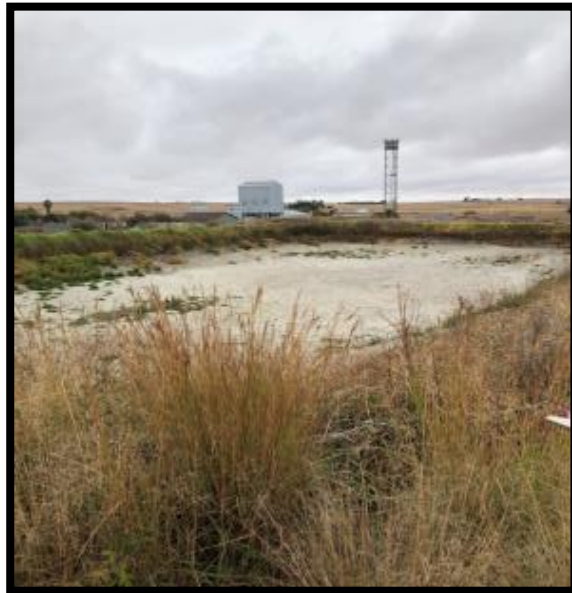
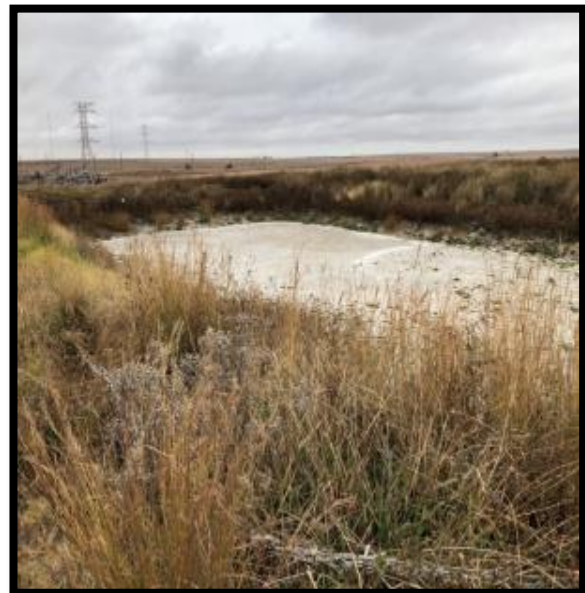
Figure 5-7: PCD A prior to decommissioning

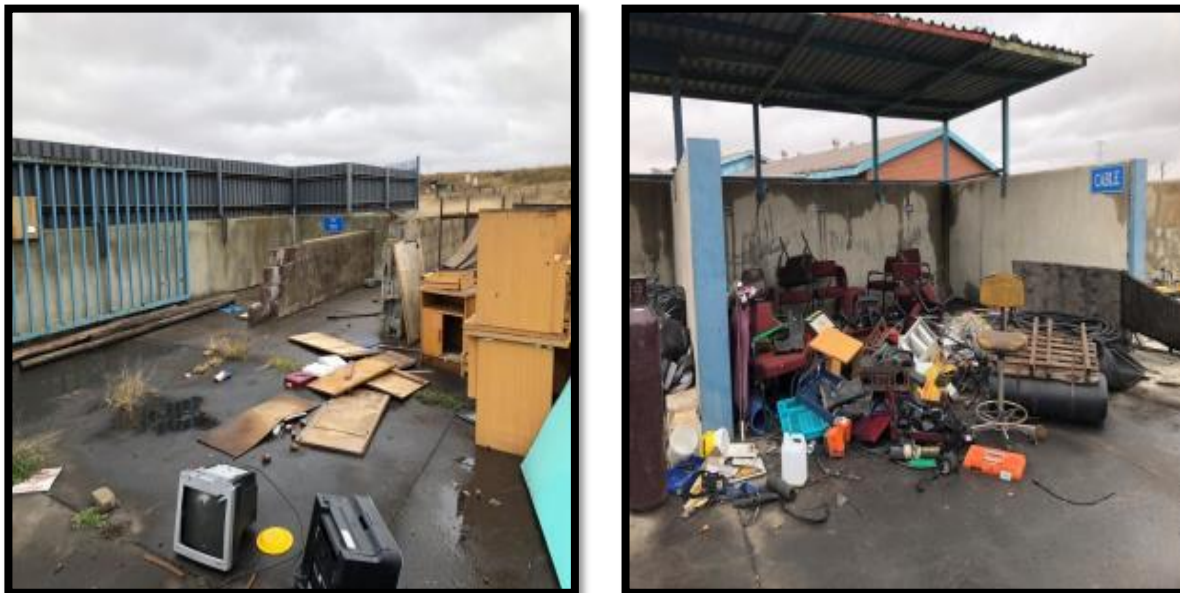
Figure 5-12: Waste Storage Area prior to decommissioning

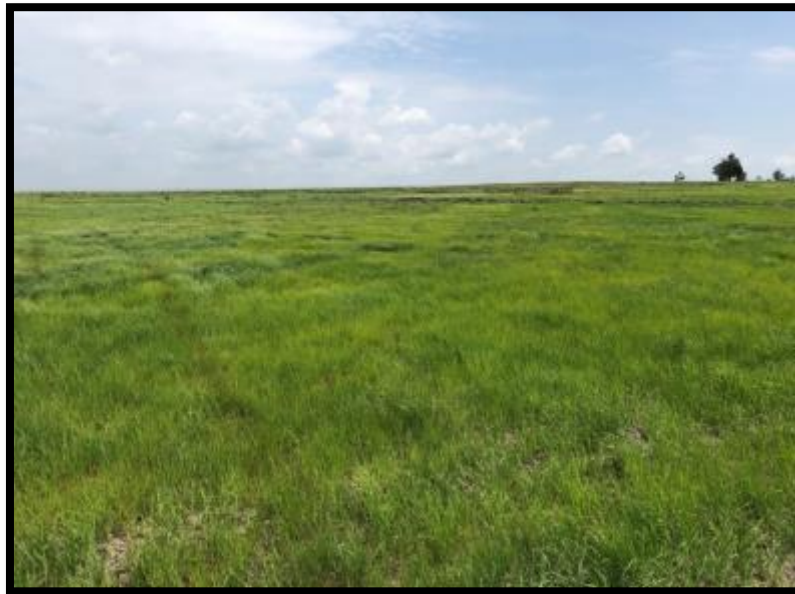
Figure 5-13: Rehabilitated Waste Storage Area

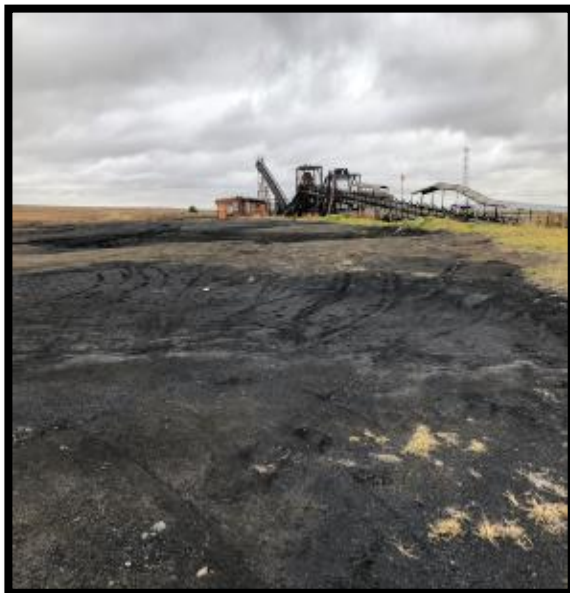
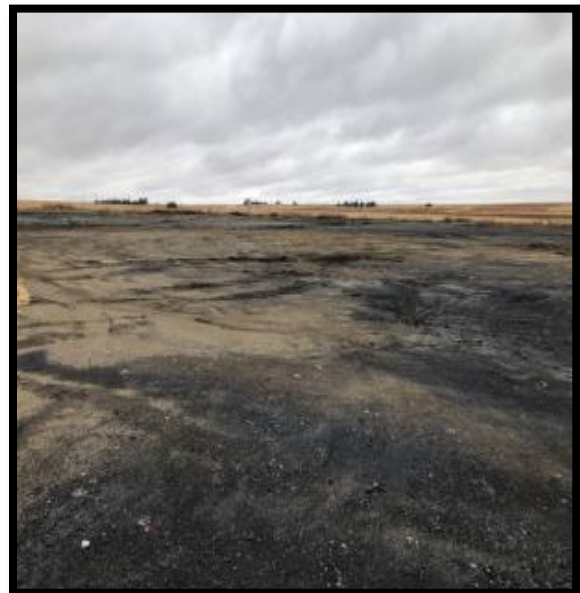
Figure 5-14: Emergency Coal Stockpile Area prior to decommissioning

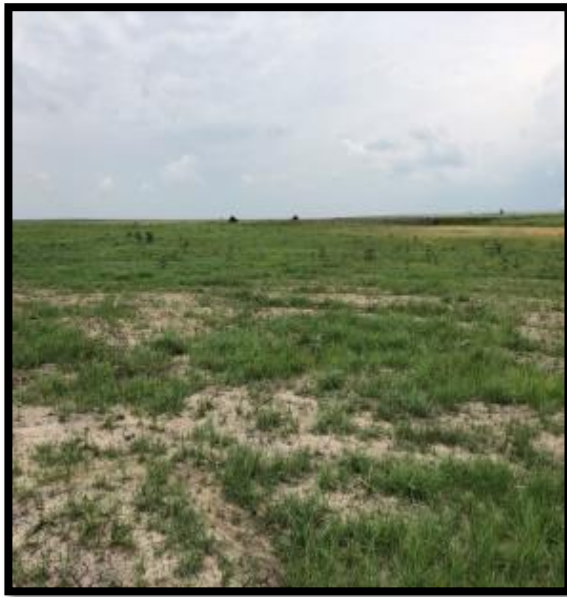
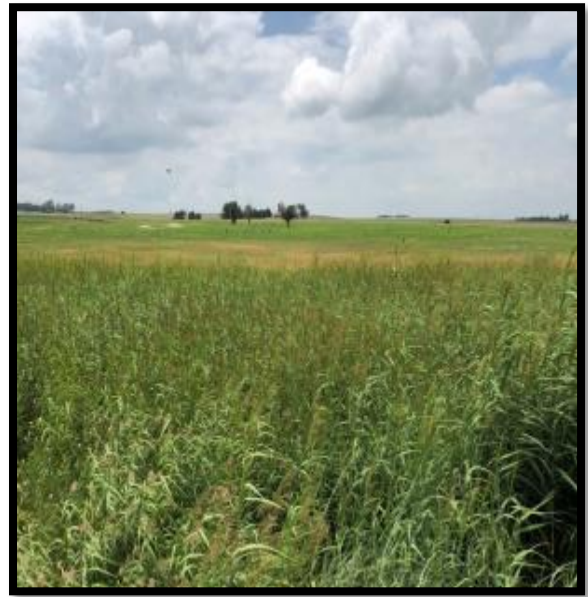
Figure 5-15: Rehabilitation of the Emergency Stockpile Area

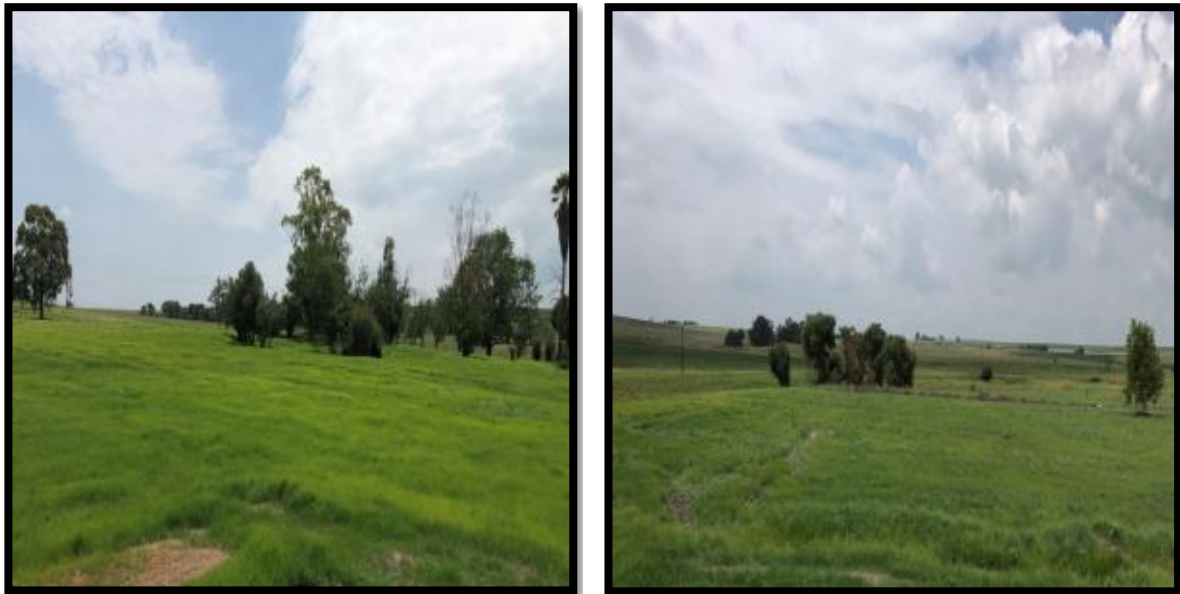
Figure 5-16: Rehabilitation of the remaining mining area

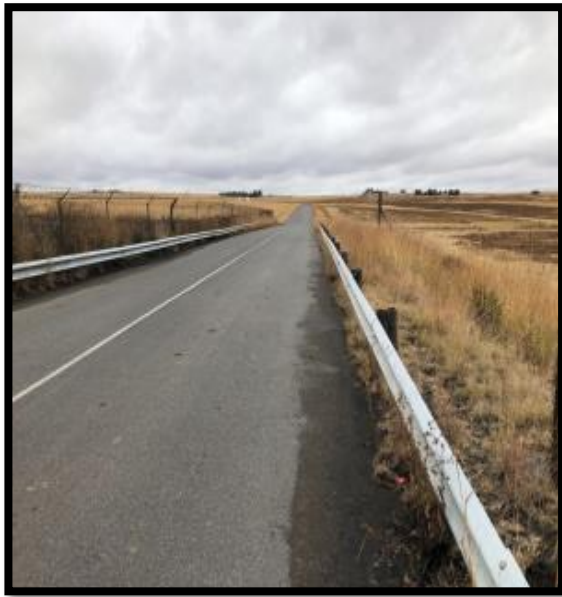
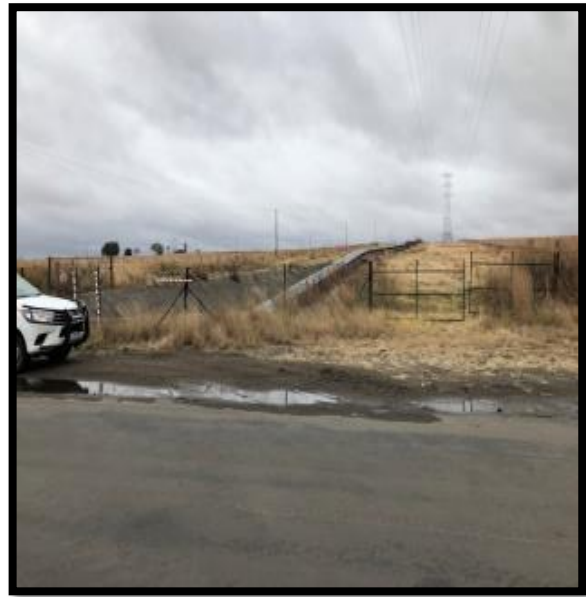
Figure 5-18: Access road to Twistdraai East Shaft (Between Mynpad Road and the Twistdraai East Shaft) before tar removal

The conveyor belt and the road crosses several watercourses as illustrated in Figure 5-17 and Plan 4 in Appendix B. Each of these crossings contains a box culvert that must be removed. Figure 5-18 to Figure 5-23 shows some of the culverts located within the

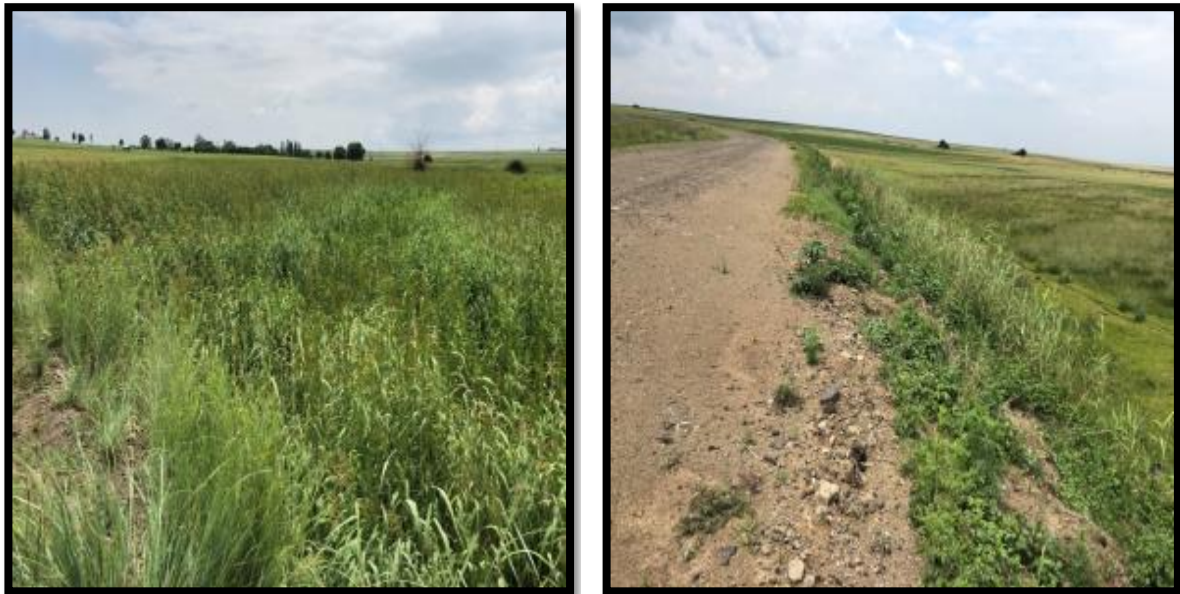
Figure 5-19: Access road to Twistdraai East Shaft (Between Mynpad Road and the Twistdraai East Shaft) after tar removal

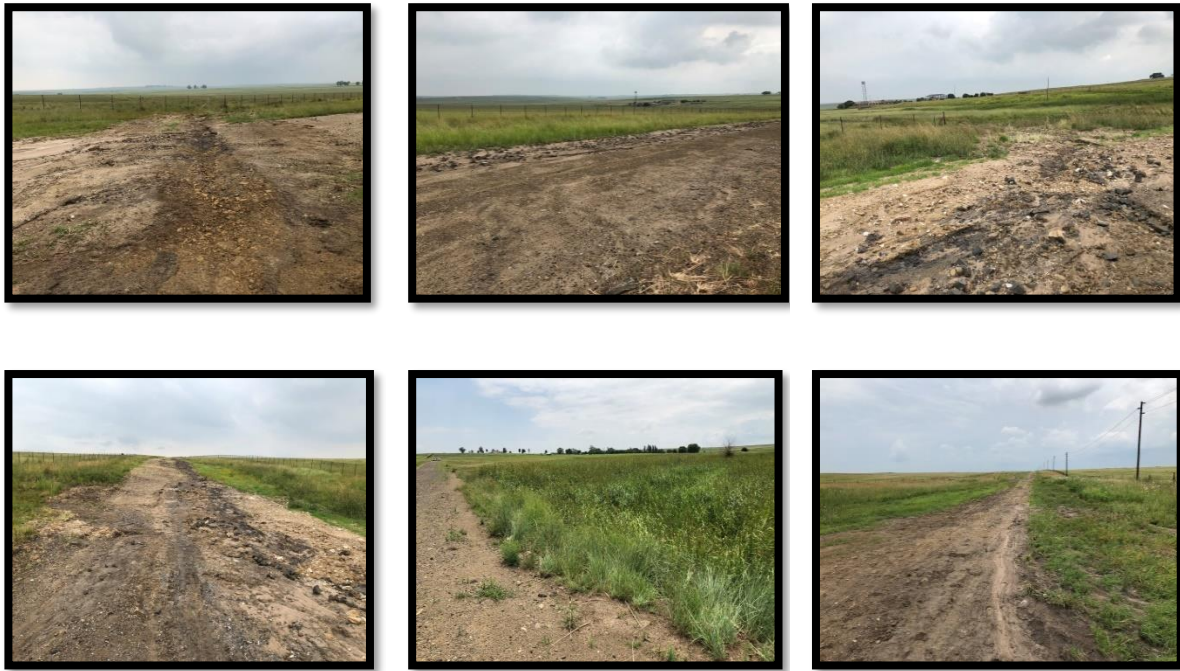
Figure 5-21: Road to be rehabilitated

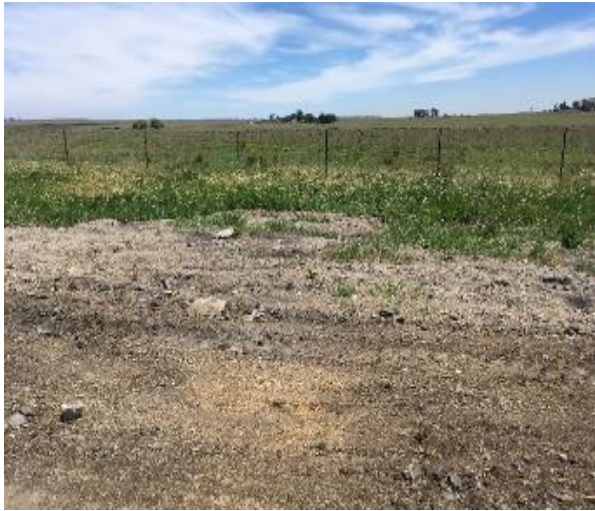
Crossing	Photo	Current state
TD27

PES
		C
		EIS
		Moderate
		Dominant Species
		<i>Bromus catharticus, Setaria sphacelata, Typha capensis, Helichrysum sp., Paspalum dilatatum, Andropogon appendiculatus.</i> Invasive species: <i>Cirsium vulgare</i>
TD26

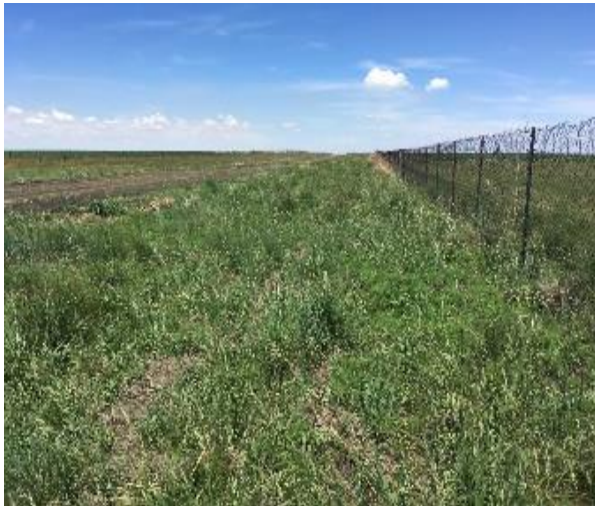
PES
		D
		EIS
		Low
		Dominant Species
		<i>Bromus catharticus, Setaria sphacelata, Typha capensis, Helichrysum sp., Paspalum dilatatum, Eragrostis chloromelas.</i> Invasive species: <i>Cirsium vulgare, Cosmos bipinnatus.</i>
TD25

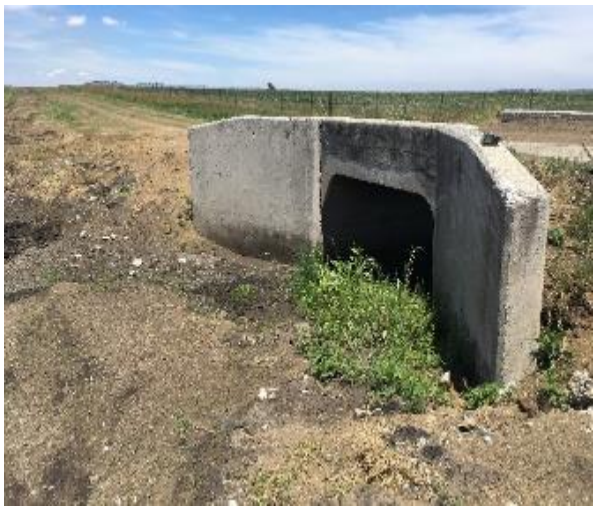
PES:
		D
		EIS
		Moderate
		Dominant Species
		<i>Bromus catharticus, Cynodon dactylon, Themeda triandra, Paspalum dilatatum.</i> Invasive species: <i>Cosmos bipinnatus.</i>

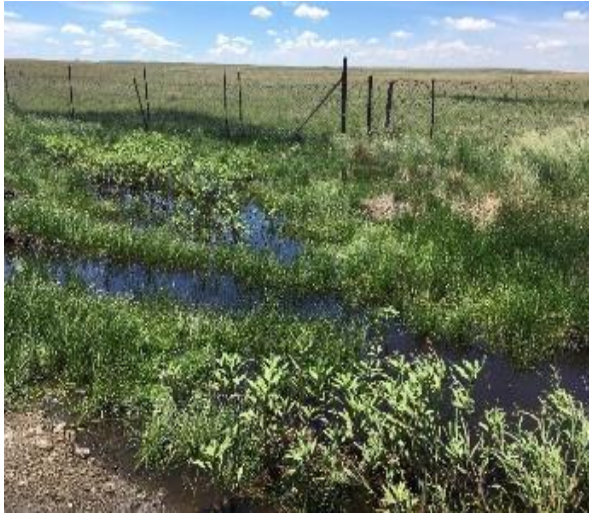
Crossing	Photo	Current state
TD24

PES
		D
		EIS
		Moderate
		Dominant Species
		<p><i>Bromus catharticus, Setaria sphacelata, Agrostis lacnantha, Helichrysum sp., Paspalum dilatatum, Eragrostis chloromelas, Eleocharis sp., Persicaria sp., Oenothera rosea, Hypoxis sp., Cyperus sp., Schoenoplectus sp.</i></p> <p>Invasive species: <i>Cirsium vulgare, Cosmos bipinnatus, Argemone ochroleuca.</i></p>
TD23

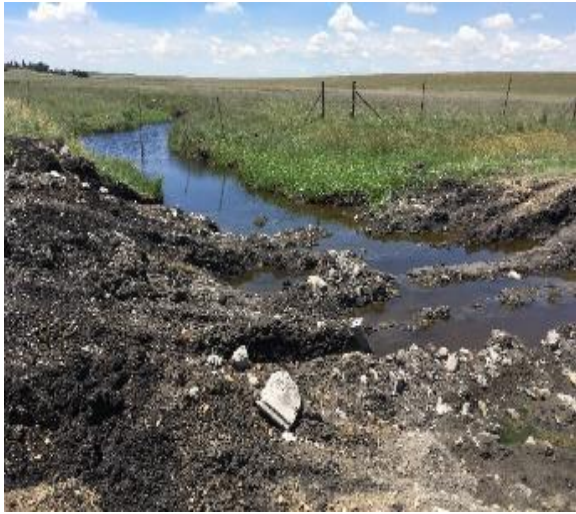
PES
		D
		EIS
		Moderate
		Species
		<p><i>Bromus catharticus, Typha capensis, Setaria sphacelata, Agrostis lacnantha, Oenothera rosea, Crinum bulbispermum.</i></p> <p>Invasive species: <i>Cirsium vulgare, Cosmos bipinnatus.</i></p>
TD22		PES
		C
		EIS
		Moderate
		Dominant Species

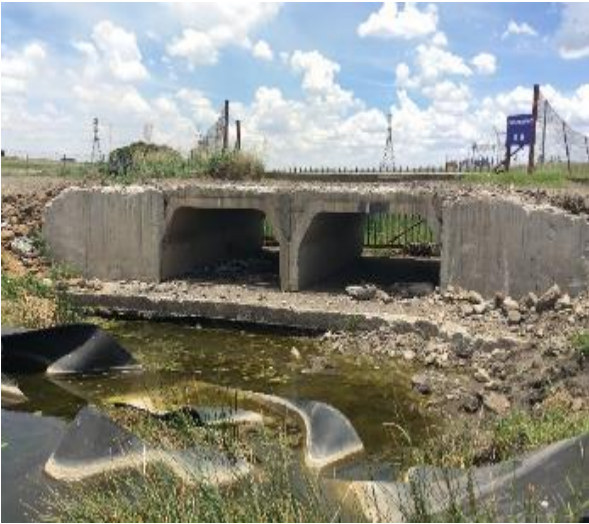
Crossing	Photo	Current state
TD18

PES
		D
		EIS
		Moderate
		Dominant Species
		<p><i>Bromus catharticus, Juncus effusus, Typha capensis, Eragrostis chloromelas, Andropogon appendiculatus.</i></p> <p>Invasive species: <i>Cirsium vulgare.</i></p>
TD 16 17

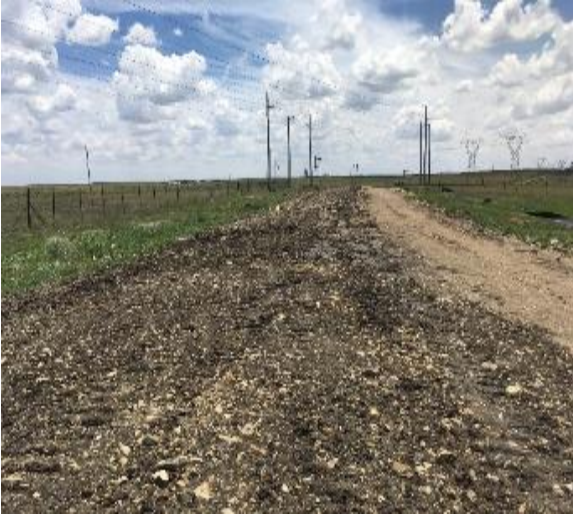
PES
		Artificial
		EIS
		Low/Marginal
		Dominant Species
		<p><i>Typha capensis, Setaria sphacelata, Helichrysum sp., Paspalum dilatatum, Eragrostis chloromelas, Andropogon appendiculatus. Alloteropsis semialata, Berkheya rigida.</i></p> <p>Invasive species: <i>Cosmos bipinnatus</i></p>
TD14		PES
		Artificial
		EIS
		Low/Marginal
		Dominant Species

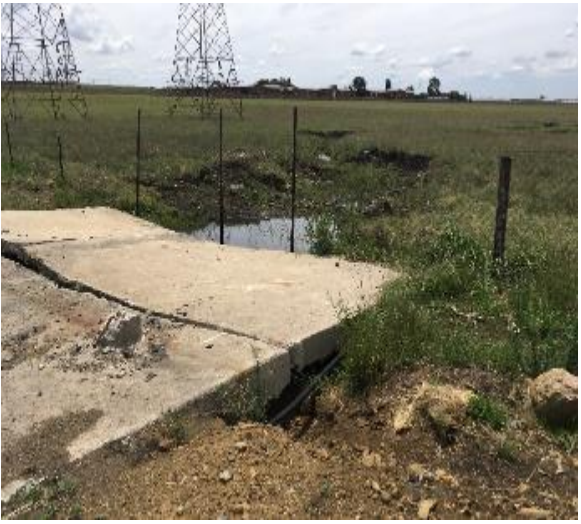
<p>PES</p> <p>D</p> <p>EIS</p> <p>Moderate</p> <p>Dominant Species</p> <p><i>Bromus catharticus, Phragmites mauritianus, Juncus dregeana, Typha capensis, Paspalum dilatatum, Eragrostis chloromelas, Oenothera rosea.</i></p> <p>Invasive species: <i>Cirsium vulgare, Argemone ochroleuca</i></p>
TD9

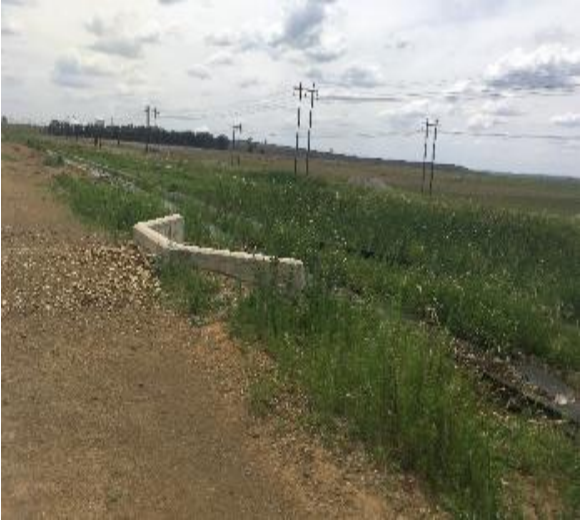
<p>PES</p> <p>C</p> <p>EIS</p> <p>Low/Marginal</p> <p>Dominant Species</p> <p><i>Typha capensis, Imperata cylindrica, Agrostis lacnantha.</i></p>

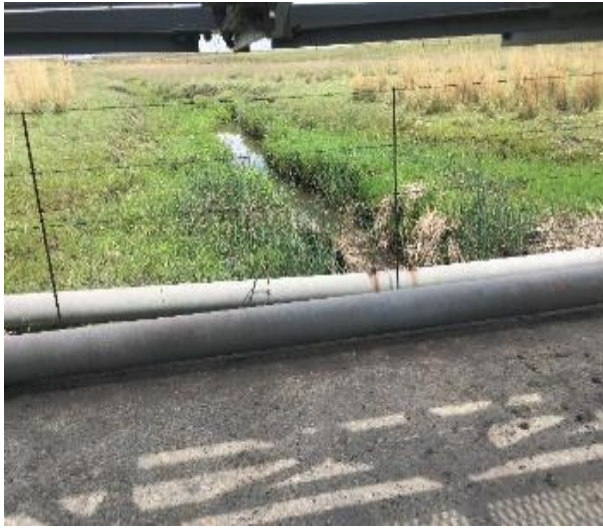
Crossing	Photo	Current state
TD3

PES
		F
		EIS
		Moderate
		Dominant Species
		<i>Bromus catharticus, Phragmites mauritianus, Juncus effusus, Typha capensis, Lemna minor.</i> Invasive species: <i>Cosmos bipinnatus, Datura stramonium.</i>
TD2

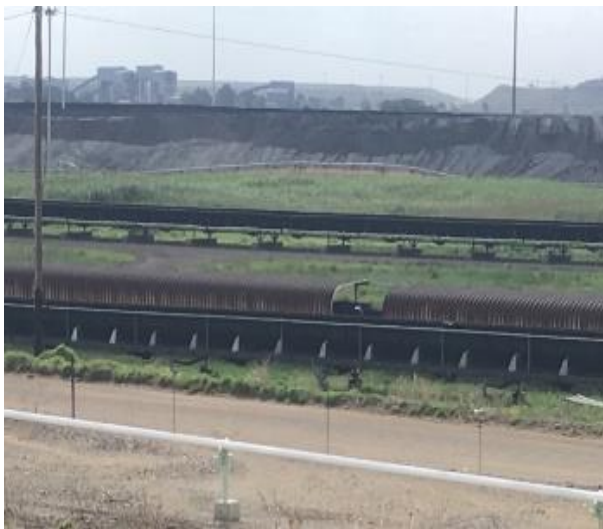
PES
		D
		EIS
		Moderate
		Dominant Species
		<i>Phragmites mauritianus.</i> Invasive species: <i>Cosmos bipinnatus.</i>
TD1 (Road)

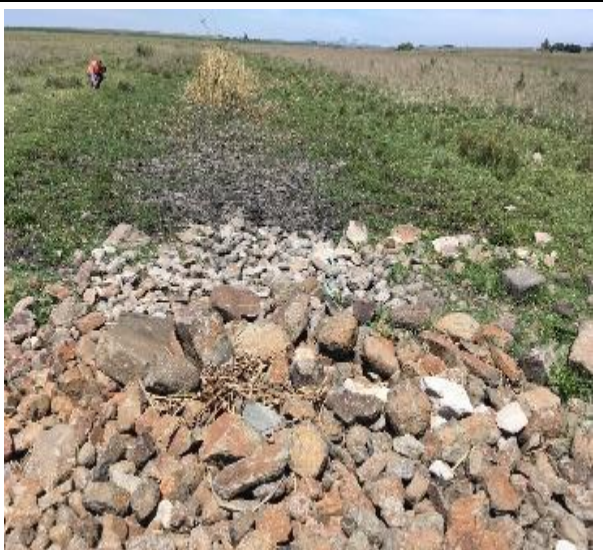
PES
		D/C
		EIS
		Moderate/High
		Dominant Species
		<i>Setaria sphacelata, Phragmites mauritianus, Paspalum dilatatum, Cynodon dactylon,</i> Invasive species: <i>Cirsium vulgare, Datura stramonium</i>

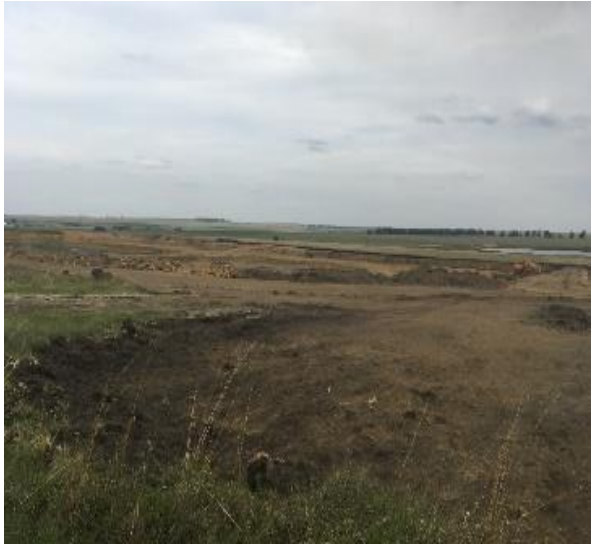
Crossing	Photo	Current state
Quarry

<p data-bbox="986 371 1396 421">Dominant Species</p> <p data-bbox="986 636 1380 707"><i>Hyparrhenia tamba</i>, <i>Hyparrhenia hirta</i>, <i>Cynodon dactylon</i>.</p>

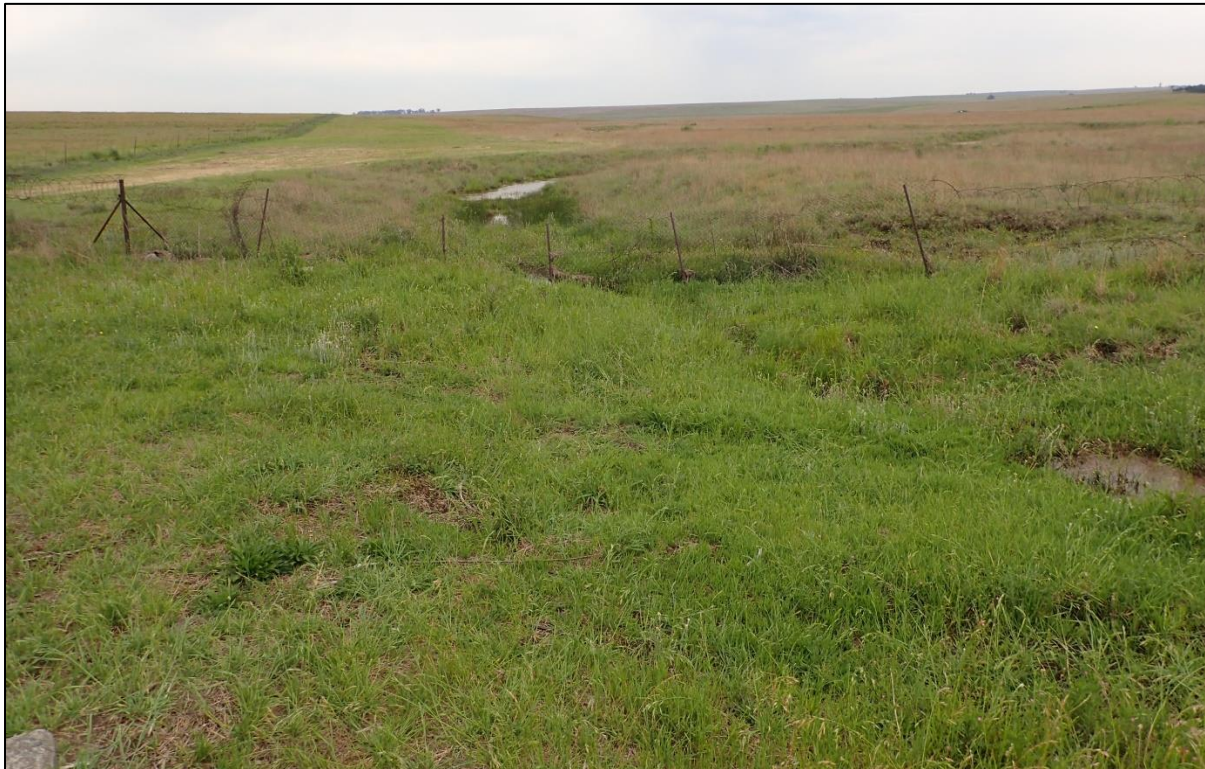
Figure 11-2: Sampling site downstream from the road and conveyor of concern

The Project area is located within the Vaal Water Management Area 5 (WMA 5), in the C12D quaternary catchment. This place the watercourses considered for assessment within the Highveld freshwater ecoregion. Six tributaries and two unclassified drainage lines intersecting the servitude and conveyor of concern are of focus for the assessment. These watercourses drain into the Klipspruit, which ultimately joins with the Waterval River (also referred to as Sub-Quaternary Reach (SQR) C12D-01685) approximately 17.76 km from the most downstream tributary under assessment (DWS, 2018). The watercourses associated with the Project area has been included in Plan 10 in Appendix B . The Project area consists predominantly of typical Highveld grasslands with watercourses comprising mainly of wetland systems, lacking defined riparian zones (Figure 11-2).

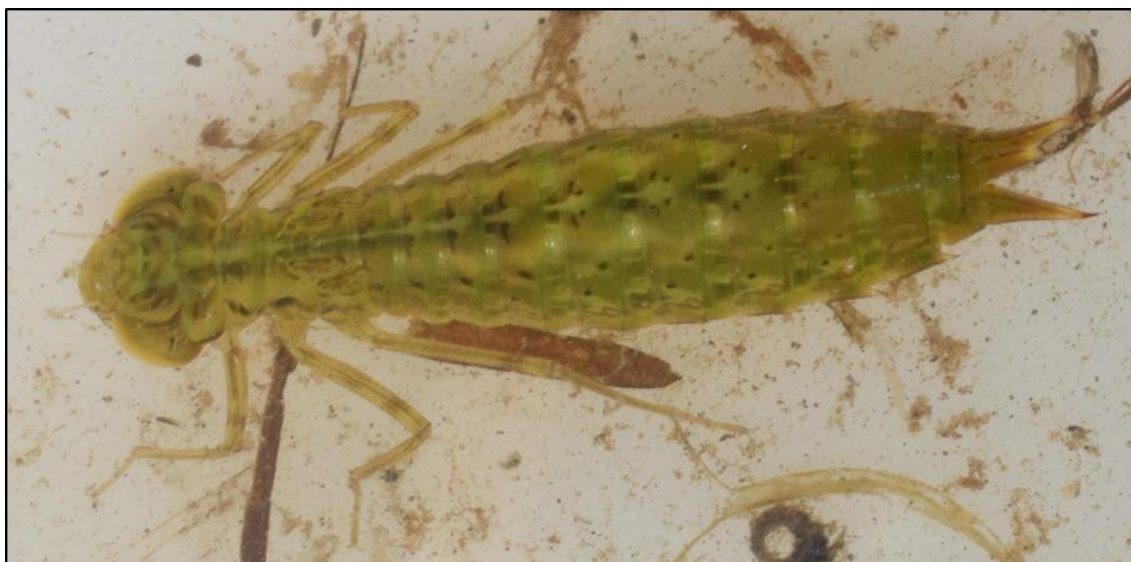
A total of 14 different taxa were sampled at Site 11B, comprising of mainly air breathing, tolerant families (i.e. sensitive score < 8). However, a single individual Aeshnid was sampled at the site (Figure 11-3). These invertebrates belong to the Odonata order and have a moderate requirement for unmodified physiochemical conditions, providing an indication of fair water quality at the site.

Figure 11-3: Aeshnidae nymph samples at Site 11B

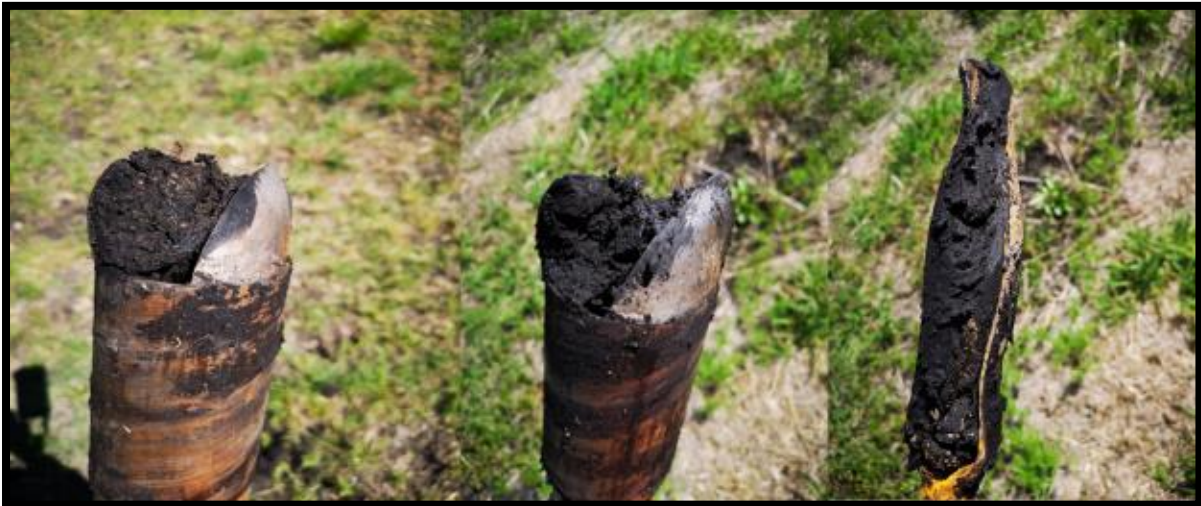
Land Type	Soil Forms	Geology	Characteristics
Ea17 & Ea20	Arcadia and Rensburg forms	Alluvium, dolerite, sandstone and shale of the Ecca Group	Consists of soil with significant accumulation of smectitic (swelling) clay (vertic horizon).

Figure 11-4: Examples of swelling structured black soils

Although the black clay is potentially difficult to work with because of unfavourable consistence, it has the advantage of a self-mulching habit meaning that clods will weather to a fine crumb structure due to shrinking and swelling with changes in water content. Also, the shrink-swell behaviour could potentially have a favourable effect in counteracting mechanical compaction caused by heavy machinery employed for rehabilitation. Vertic soils can be used successfully for crop and pasture production if managed judiciously (Fey *et al.*, 2010).

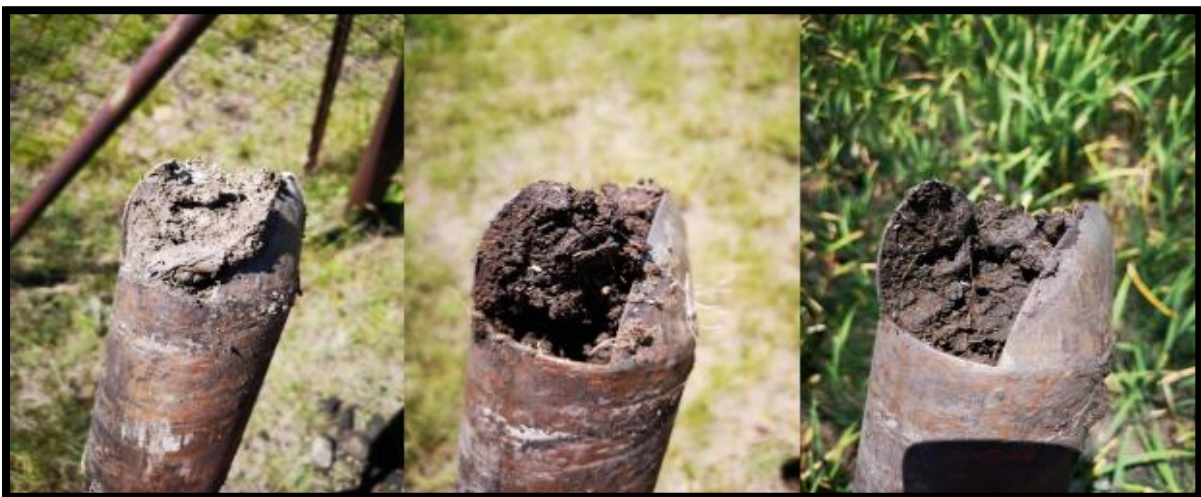
Figure 11-5: Examples of apedal soils

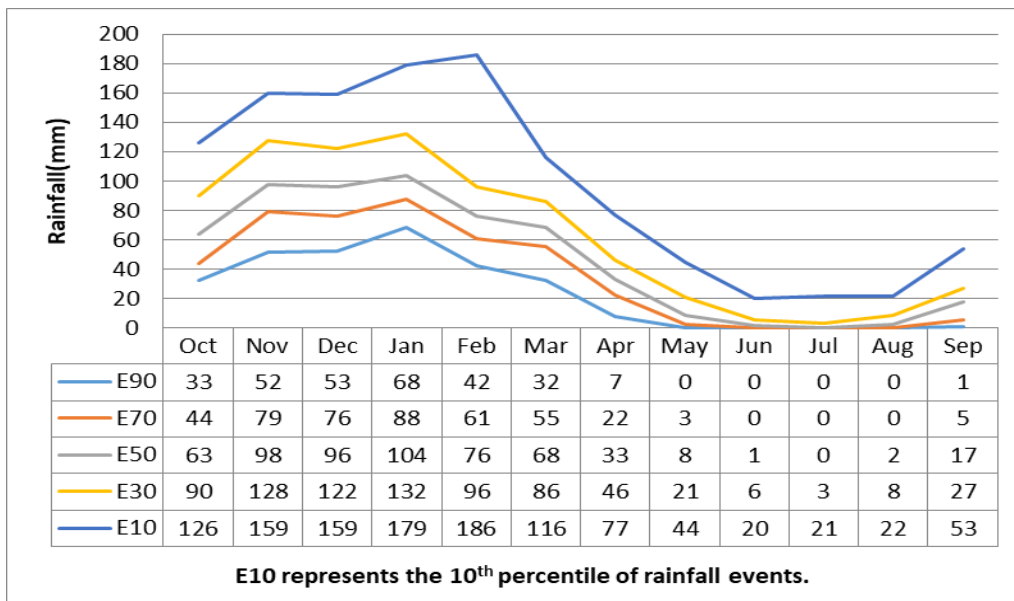
The Mean Annual Precipitation (MAP) for quaternary catchment C12D in which the Twistdraai East Shaft conveyor belt servitude, quarry and road are located is 667 mm. This MAP is likely to be distributed as indicated in Figure 11-7. 90% of the most frequent rainfall events in the wettest month of January did not exceed 68 mm, while 10% of the extreme rainfall events will likely be below 179 mm. The potential Mean Annual Evaporation (MAE) for the region is in the order of 1 580 mm which is more than twice as much as the MAP for the area (Figure 11-8). This indicates the existence of seasonal rainfall in this quaternary catchment with more rainfall being received from October to March and less rainfall from April to September.

Figure 11-7: Rainfall distribution for quaternary catchment C12D

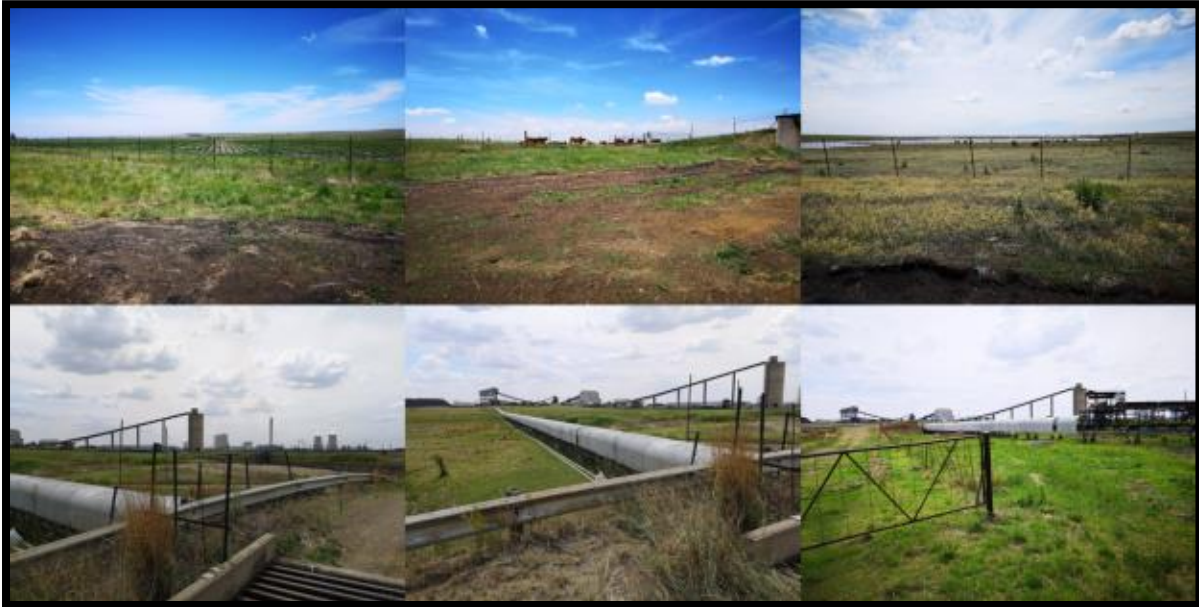
Figure 11-11: Land Use at Twistdraai Colliery and surrounding

The present land use was identified using satellite images and visual observations. The main land uses in the area are cultivated land and veld for grazing, as illustrated in Figure 11-11 and in Plan 13 in Appendix B. A large amount of agricultural activities is taking place within the Project area and surroundings. The area is underlain by underground mining.
