# Choje Windfarm Preliminary Geotechnical Investigation

**Document No.:** PP224951-PE-R-02-A

Preliminary Geotechnical Investigation for the proposed Choje Windfarm, Eastern Cape, South Africa

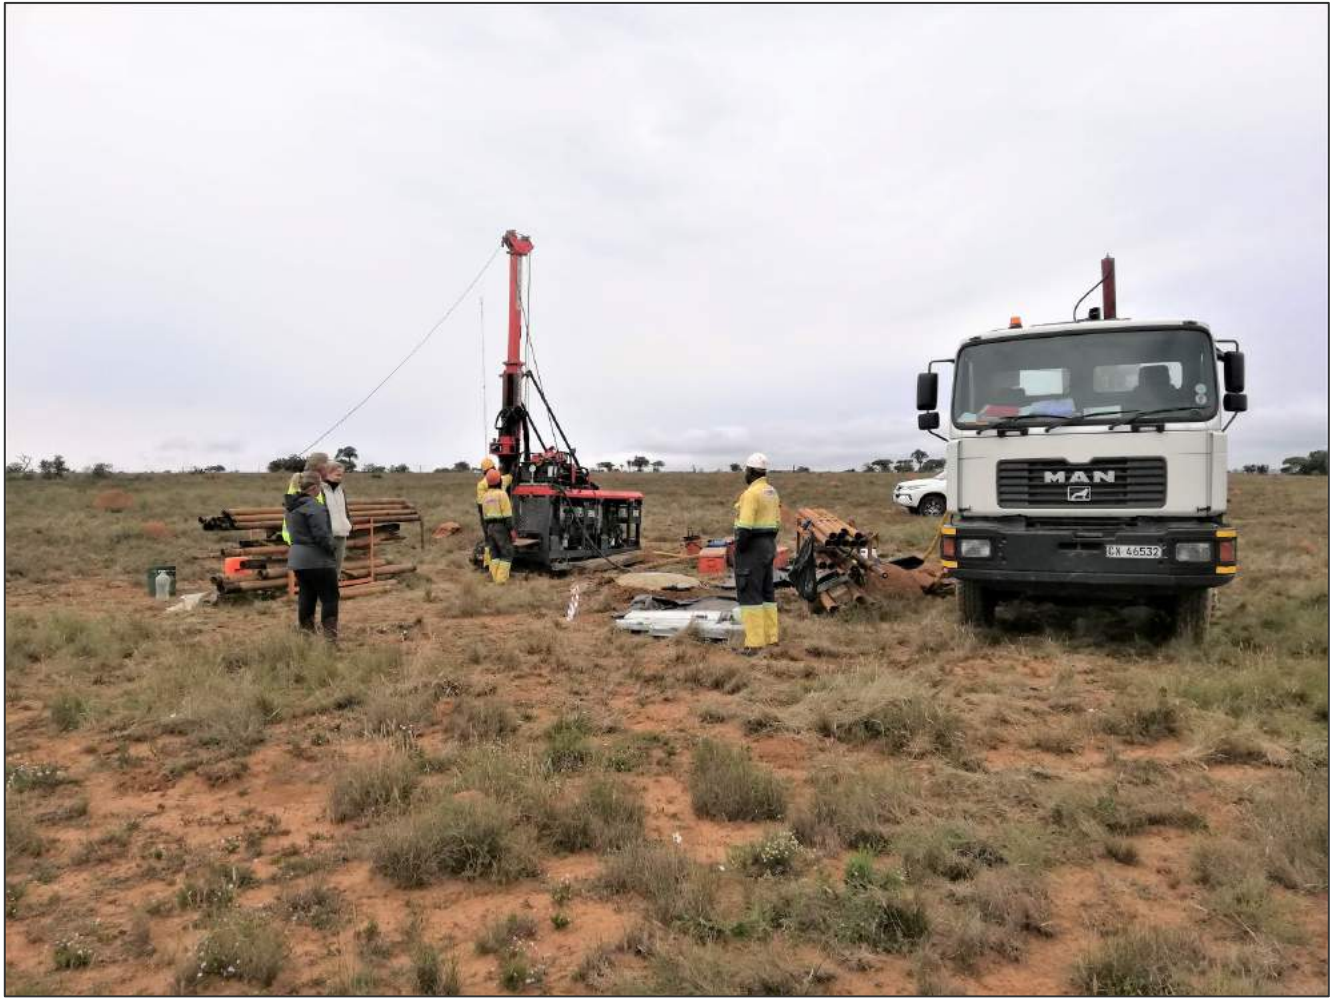
**Plate 1: Rotary core drilling at borehole position E64**

Nine (9) boreholes were drilled at predetermined WTG positions utilising rotary core drilling methods, on a HQ3 drill-string size by the drilling Contractor *EarthTech Geotechnical Services*. Sampling during the exploration was performed using Standard Penetration Test (SPT) where possible, although SPTs widely refused across the site owing to dense residual soils and weathered rock. Split spoon tube sampling was also attempted, however geological conditions did not cater for any successfully being retrieved. The positions of all WTG boreholes are illustrated in Figure 1. The soil conditions and rock strata described using standard methods and terminology outlined by *Jennings et al. (1973)* and the *Core Logging Committee of South Africa (1976)*. Borehole logs and photographic plates are included in Annexure B.

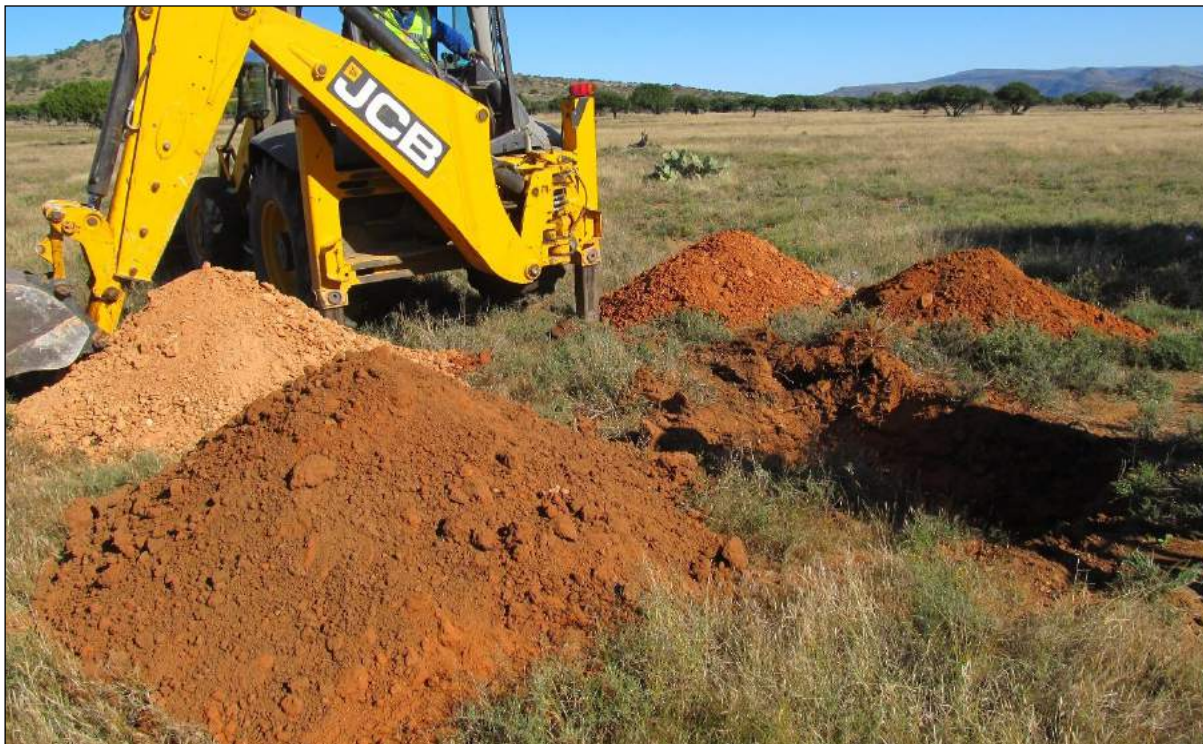
**Plate 2: Trial pit excavation at W417 position** (photo credit: Outeniqua Geotechnical Laboratory)

All trial pits were profiled by and the soil conditions described using standard methods and terminology outlined by Jennings et al. (1973) Representative soil samples retrieved from trial pits were subjected to Modified AASHTO moisture/density, California Bearing Ratio (CBR), Foundation Indicator, Moisture Content, Relative Density and Thermal Resistivity. Representative samples of various soil types were collected for pH and electrical conductivity (EC) to determine the potential aggressiveness (corrosivity) of the soil towards buried structures and underground electrical services.

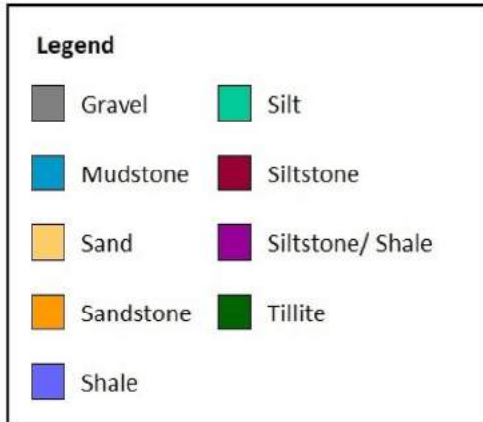
Figure 13: Boreholes Profiles West Block

The measured orientation of bedding planes varies between horizontal to ~45° (compare E100 to W521). Dominant joint orientation varies from subvertical to ~45°. Joints tend to be narrow to wide, rough to slightly rough, and stained with minimal clay infill, indicating a partial opening of the joint structures. Drawing a correlation for continuity between strata is problematic across such marked distances as between boreholes at Choje WF, as demonstrated by the illustrative cross-section depicted in Figures 13 and 14 overleaf, showing the Western and Eastern block borehole sections respectively. The variation in rock type

and condition is a function to the inclined nature of regional strata in the area, which dips away from the horizontal. It is also a function of the depositional history of the sedimentary strata, showing repeating cycles of sandstone and mudstone with then regional metamorphism altering to shale and quartzitic sandstones. The glacial actions and deposition of tillite equally have affected this strata distribution. Lastly, the variation is a function of localized topography and ensuing chemical alteration at each borehole position.

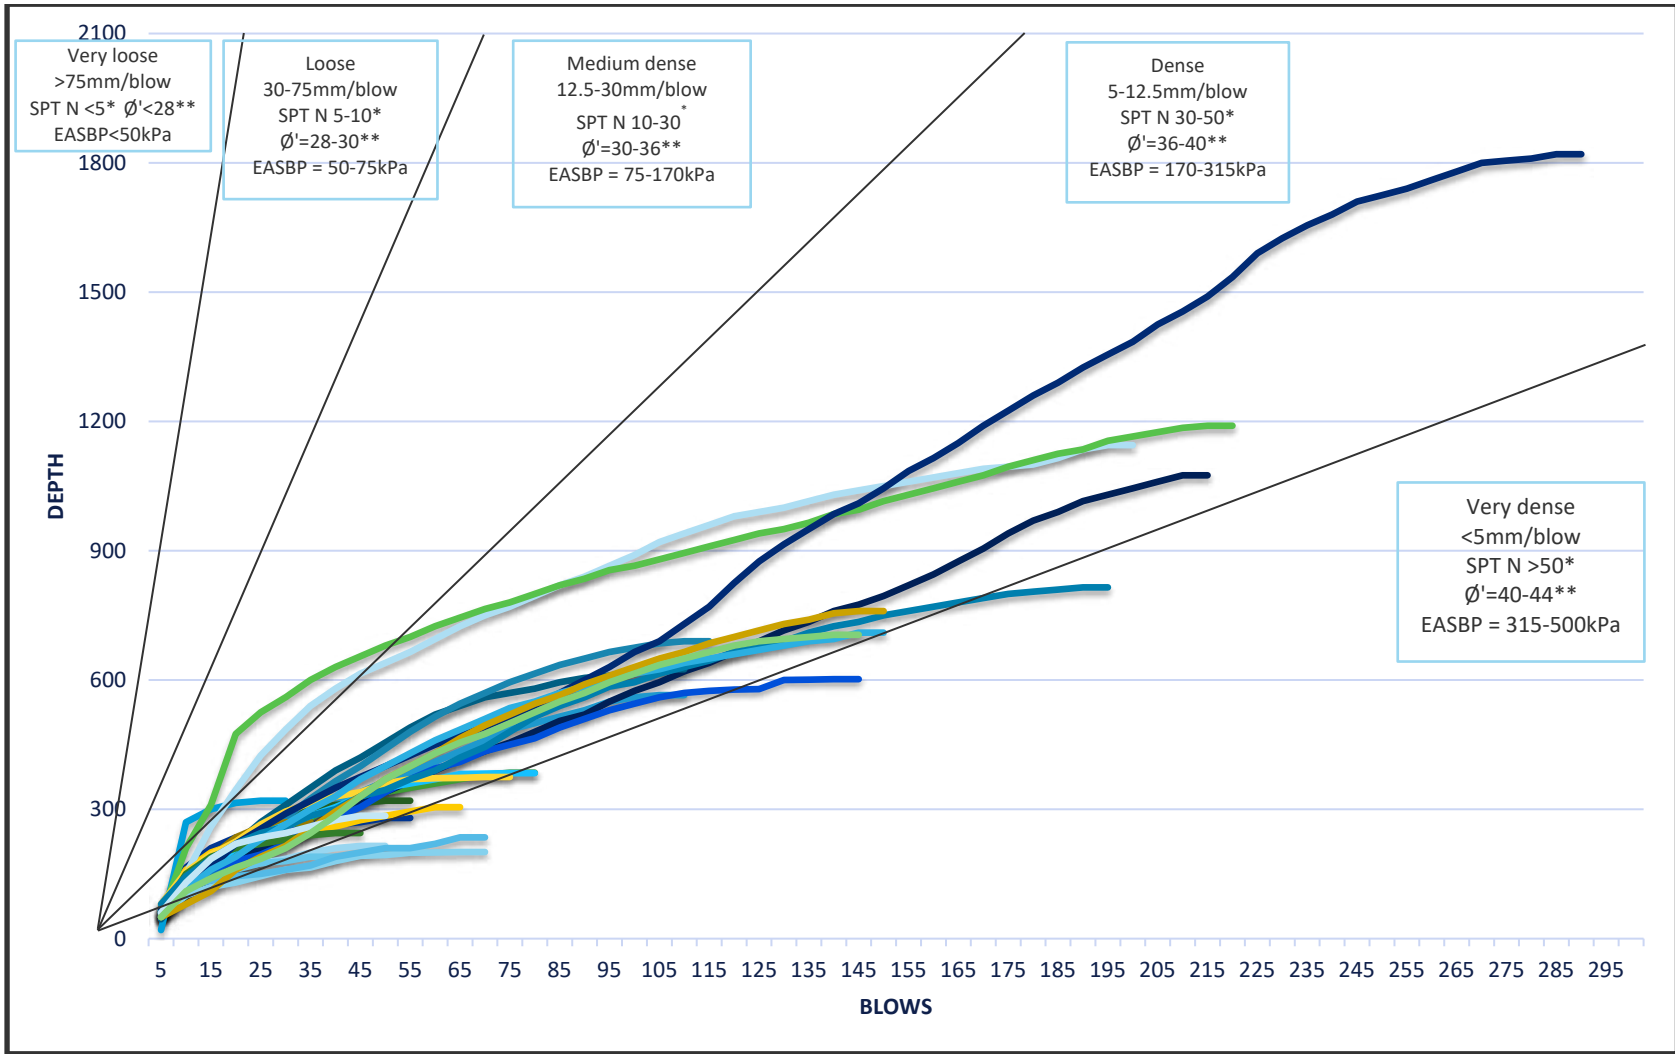
**Chart 6-1: DCP Penetration Results**

Results of the DCP testing illustrated a picture of generally competent soil conditions for lightly loaded structures at shallow depths across the site. DCPs mostly refused within 1.0m of surface, with many refusing within the upper 0.5m. Refusal was broadly due to dense soil conditions, as well as the presence of cobbles in the profile, which are widespread throughout the transported and residual soils on the Choje site. Pedogenic accumulation of ions and the ensuing calcification of the profile is also widespread in arid conditions such as these, and further “weakly cements” the soil profile, leading to increased density and resistance to the DCP probe.

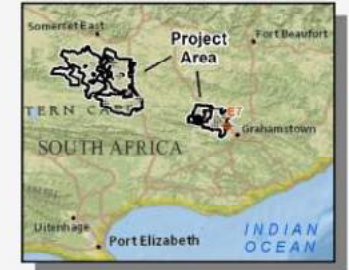
**Figure 5: Borehole E7**

**E7**  
**Latitude: -33.262219**  
**Longitude: 26.456147**

Significant variation in the hardness of the tillite was observed between boreholes (compare logs from E7 and E64), associated with the degree of weathering the tillite has been subjected to under the influence of groundwater. Significant core loss was recorded in a number of the boreholes at shallow founding depth of

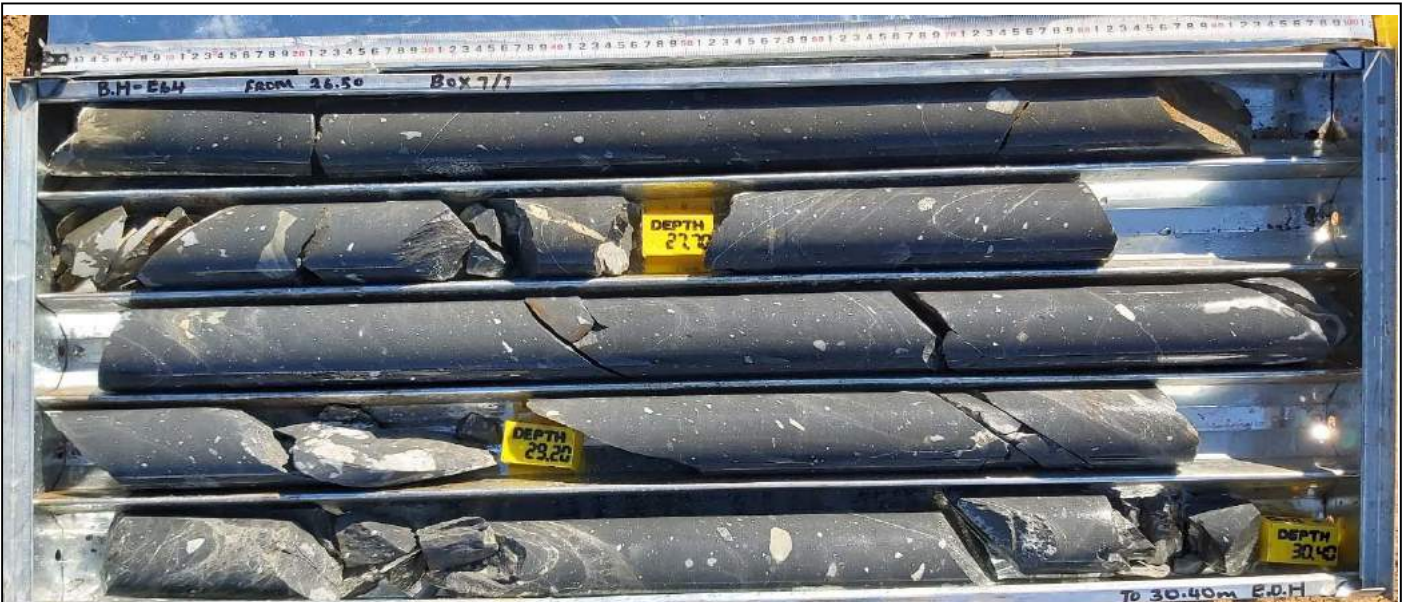
<b>CONTRACT: CHOJE WIND FARM, EASTERN CAPE</b>	<b>BOREHOLE NO: BH E64 SHEET 3/3</b>
<b>CLIENT: DNV GL/WIND RELIC</b>

Core size	% Mat. recov.	% Core recov.	RQD%	Frac. Freq.	SPT
HQ3	87	0	0	0	1
HQ3	142	68	0	>20	2
HQ3	90	70	0	8	3
HQ3	115	115	0	9	4
HQ3	72	51	0	>20	5
HQ3	91	24	0	>20	6
HQ3	69	67	0	>20	7
HQ3	103	87	0	>20	8
HQ3	79	55	0	>20	9
HQ3	71	56	7	>20	10
HQ3	73	37	9	>20	11
HQ3	81	63	20	>20	12
HQ3	23	7	0	>20	13
HQ3	68	0	0	>20	14
HQ3	64	64	64	1	15
HQ3	56	56	53	3	16
HQ3	179	153	153	5	17
HQ3	89	89	78	3	18
HQ3	95	93	73	8	19
					20
					21
					22

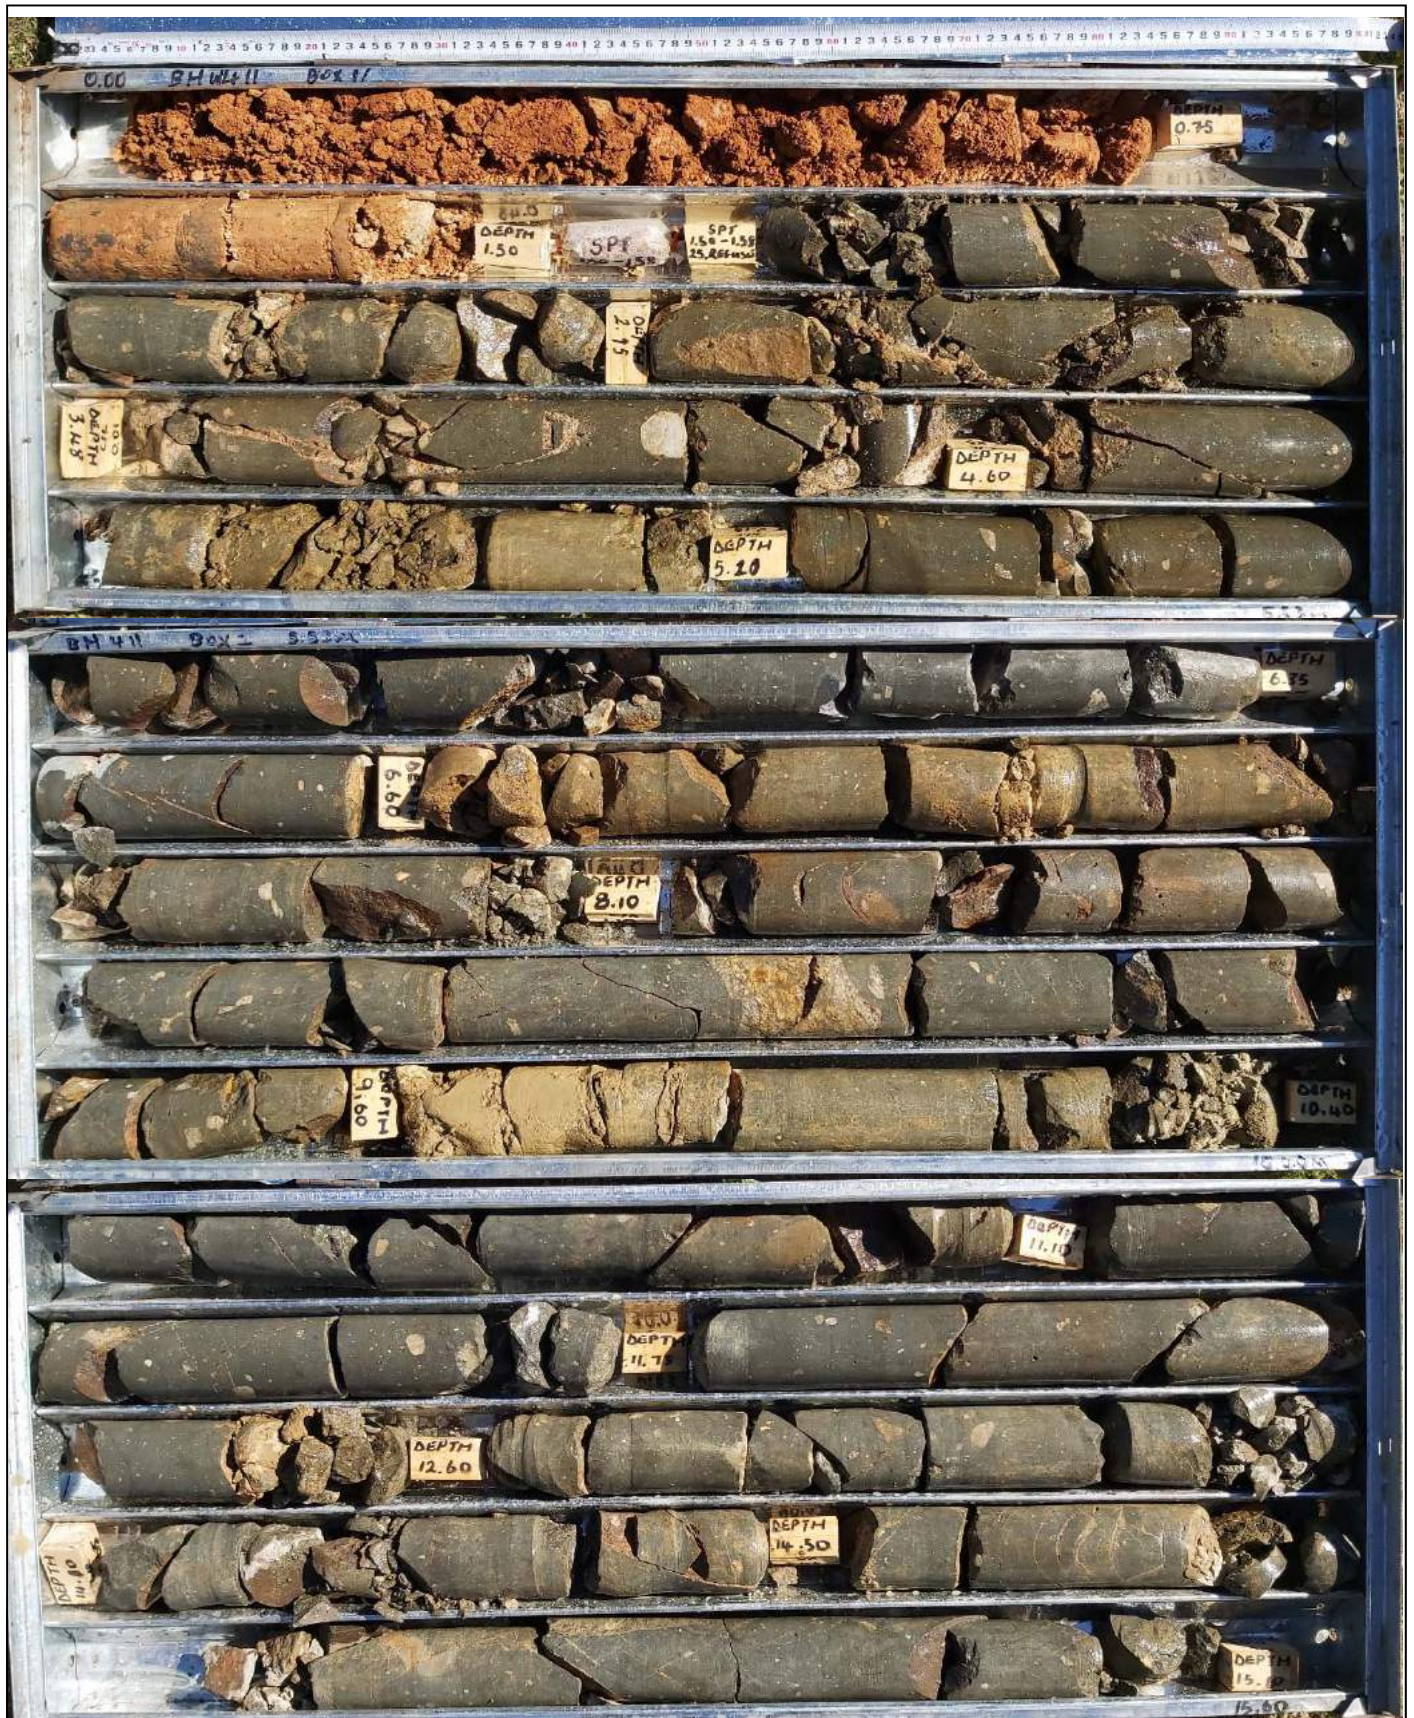
BOREHOLE NO: BH W411 SHEET 1/3

**TILLITE**  
 Dark grey, moderately weathered, fine grained, massive, very highly to moderately fractured, fractures rough, horizontal to sub-vertical, narrow to very wide, stained and filled, medium hard rock, Dwyka TILLITE.  
 Note:  
 1. Clay gauge in fractures from 9.60m-9.77m and 12.46m-12.52m

2-4m (e.g. E6, W411, W417 – See Appendix B). Core loss in calcareous soils is unsurprising (W417), as fines wash out during the drilling process, however core loss in rock is largely due to the highly fractured, highly weathered and soft nature of shallow rock at these positions.

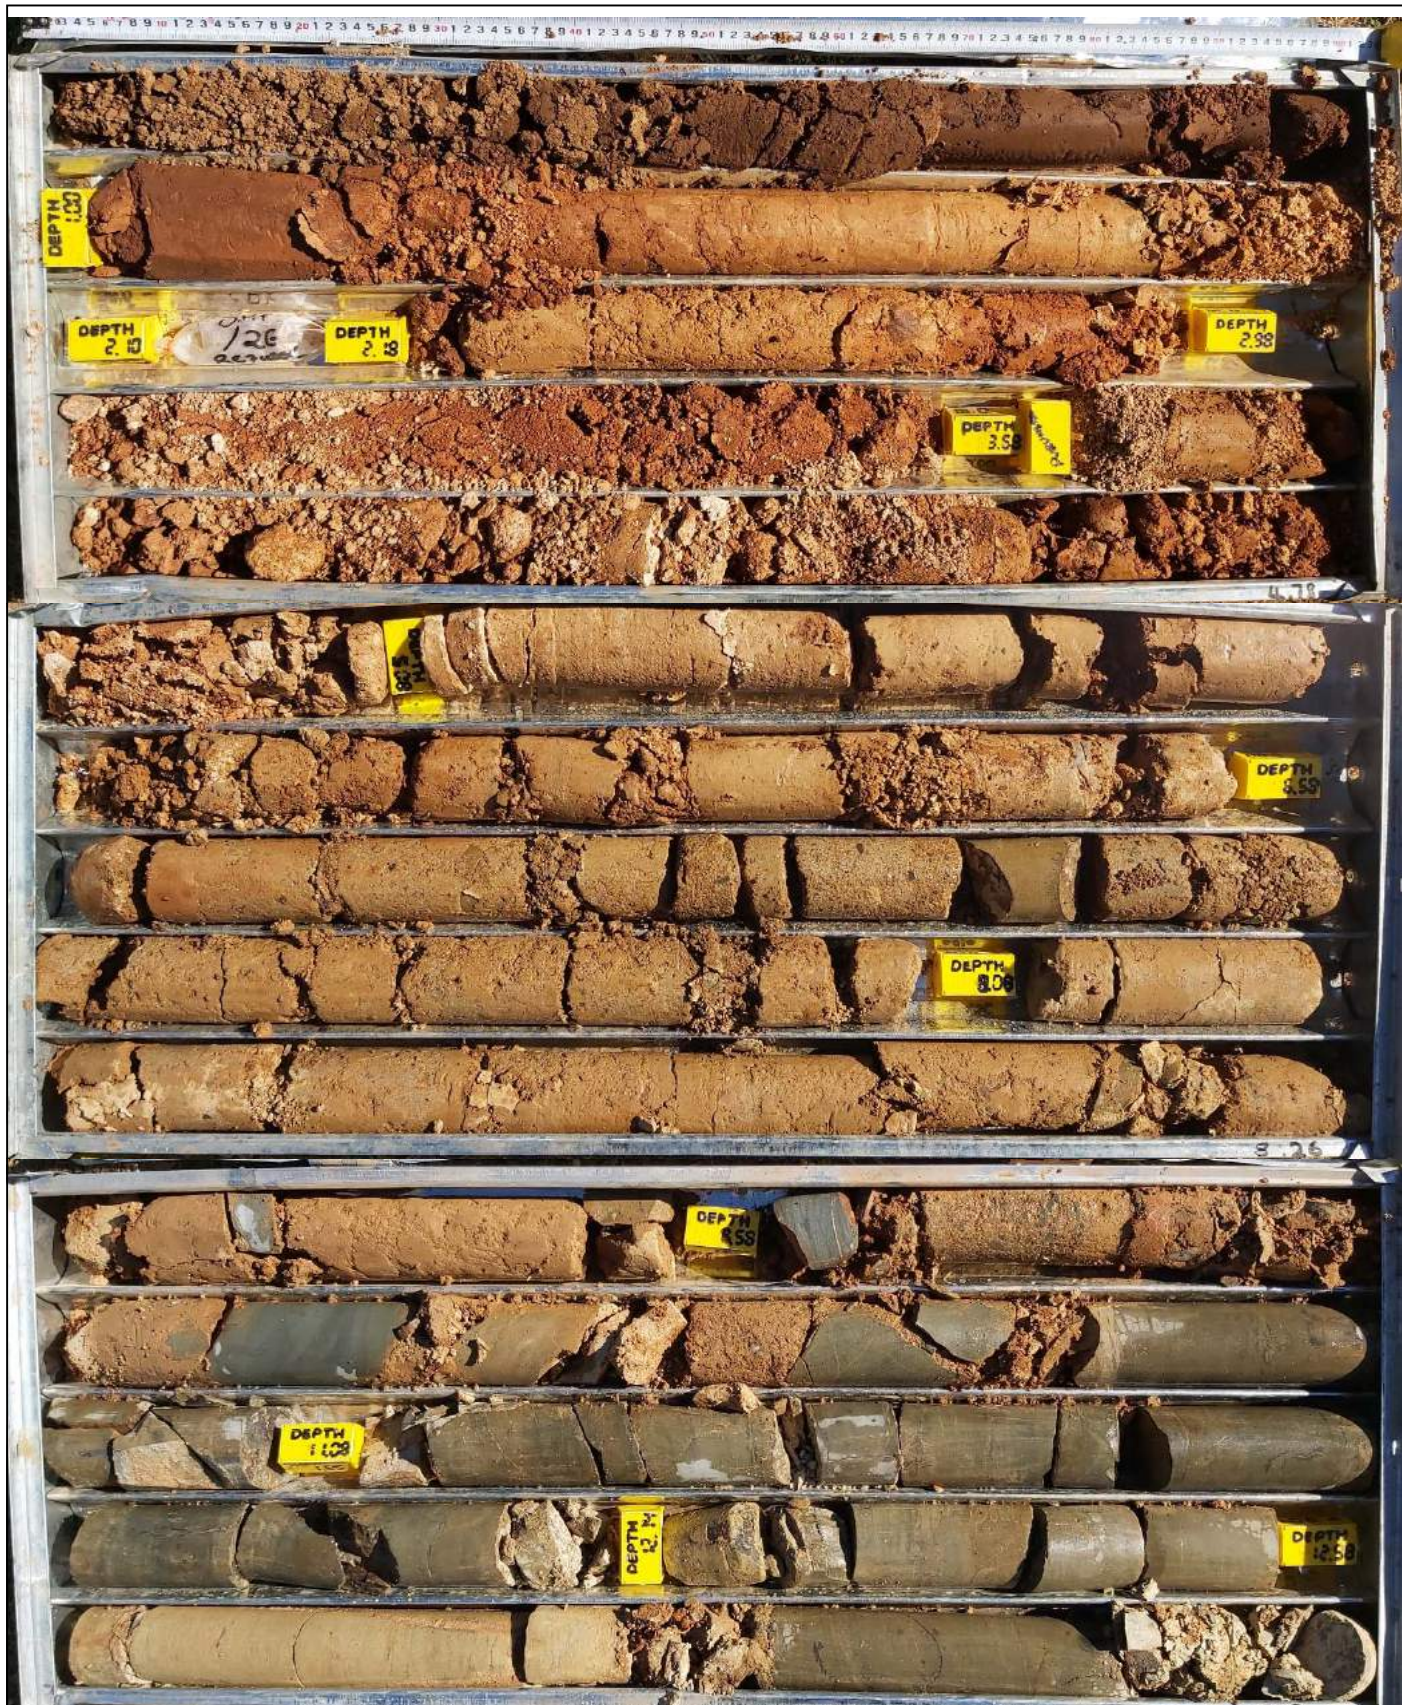
BOREHOLE NO: BH W417 SHEET 1/3

W417	Dense gravelly CALCAREOUS SILT with COBBLES, overlying dark olive SILTSTONE	<b>10.73m</b>	2.20m (R) 3.80m (R)	Highly weathered, very highly to moderately fractured, soft rock. <b>Significant core loss above 11m.</b>	Below 18.7m	23.83m
W452	Dense gravelly silty SAND, overlying dark olive to grey SANDSTONE	0.95m	-	Moderately to slightly weathered, highly to slightly fractured, medium hard to hard rock	Below 0.95m	16.54m
W521	Medium dense clayey GRAVEL, overlying dark grey SILTSTONE	0.45m	-	Highly weathered, very highly fractured, soft to medium hard rock	Below 1.5m	26.05m
W564	Medium dense silty sandy GRAVEL with sporadic BOULDERS, overlying dark olive TILLITE	2.00m	-	Highly to moderately weathered, very highly fractured, soft to medium hard rock	Below 6.8m	19.20m

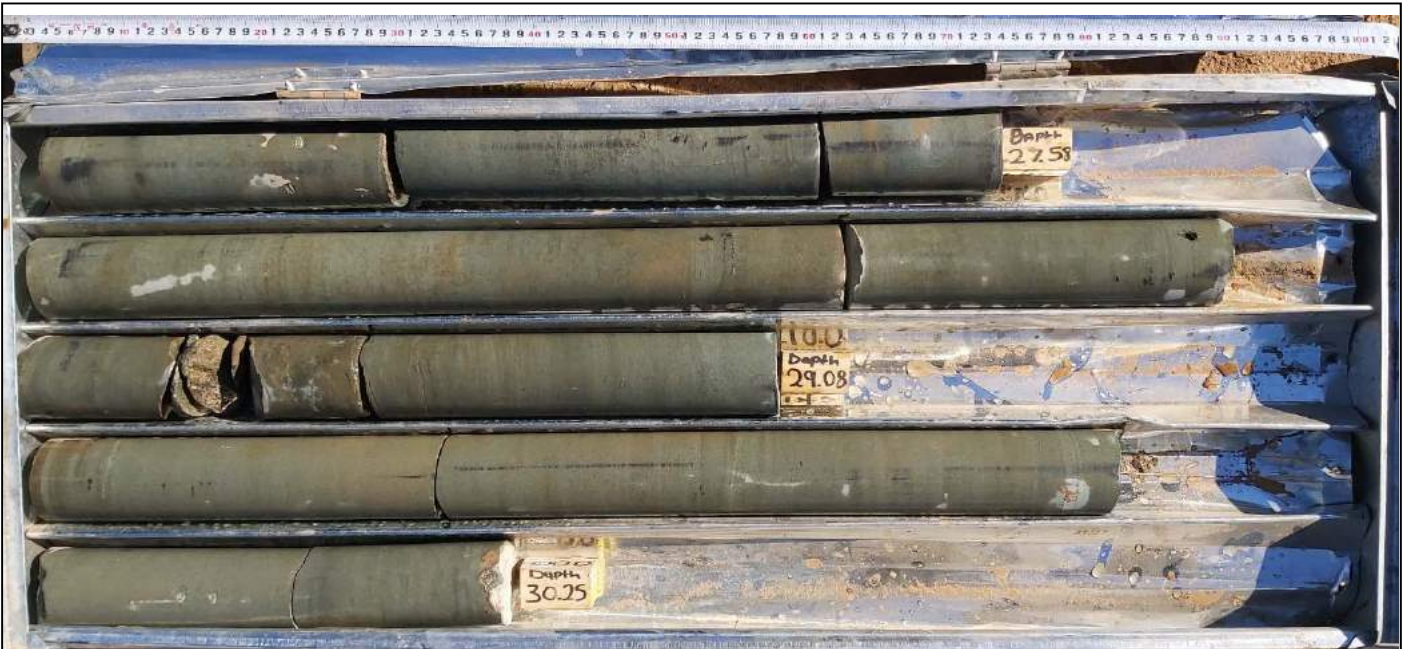
<b>CONTRACT: CHOJE WIND FARM, EASTERN CAPE</b>	<b>BOREHOLE NO: BH W417 SHEET 3/3</b>
<b>CLIENT: DNV GL/WIND RELIC</b>

Core size	% Mat. recov.	% Core recov.	RQD%	Frac. Freq.	SPT	Depth (m)	Soil Description
HQ3	98	0	0	0		0.00	<b>CLAYEY SILTY SAND</b> Dark reddish brown, CLAYEY SILTY SAND, transported.
HQ3	91	67	61	7		0.22	
HQ3	101	101	101	4		0.95	<b>CLAYEY GRAVELLY SILTY SAND</b> Dark reddish orange to light brown, CLAYEY GRAVELLY SILTY SAND, residual.
HQ3	102	93	88	5			
HQ3	98	91	91	2			<b>SANDSTONE</b> Dark olive to light grey, moderately to slightly weathered, fine grained, medium to thinly bedded, highly to slightly fractured, fractures rough, horizontal to sub-vertical, narrow, stained, medium hard to hard rock, horizontally bedded Middleton FM SANDSTONE.
HQ3	101	91	84	9			
HQ3	97	97	97	0			
HQ3	100	84	66	9			
HQ3	76	76	63	1			
HQ3	105	98	79	8			
HQ3	58	58	44	7		10.90	
HQ3	96	96	87	7			
HQ3	100	91	91	3			
HQ3	53	49	35	6		16.54m	
HQ3	91	91	91	0			<b>SANDSTONE</b> Dark grey, slightly weathered, fine grained, thinly bedded, highly to moderately fractured, fractures rough, horizontal to sub-vertical, narrow, stained, medium hard to hard rock, horizontally bedded Middleton FM SANDSTONE with minor shale lenses.

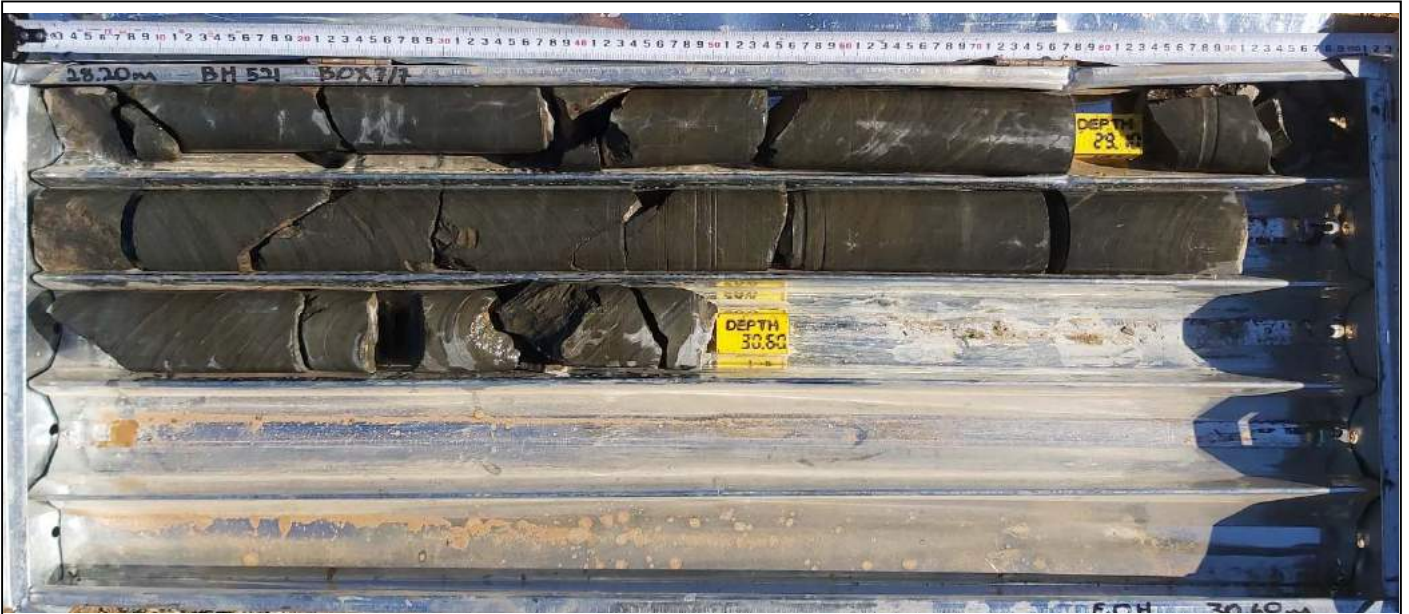
<b>CONTRACT: CHOJE WIND FARM, EASTERN CAPE</b>	<b>BOREHOLE NO: BH W521 SHEET 3/3</b>
<b>CLIENT: DNV GL/WIND RELIC</b>

Core size	% Mat. recov.	% Core recov.	RQD%	Frac. Freq.	SPT	Depth (m)	Soil Description
HQ3	100	0	0	0		0.00	<b>CLAYEY SILTY SAND</b> Dark reddish orange, CLAYEY SILTY SAND, transported.
HQ3	100	0	0	0		1	
HQ3	65	0	0	0		2	
HQ3	98	60	47	10		3	<b>CLAYEY SILTY SANDY GRAVEL</b> Light reddish orange, CLAYEY SILTY SANDY GRAVEL, transported.
HQ3	75	60	20	13		4	
HQ3	74	51	17	16		5	<b>CLAYEY SILTY SANDY GRAVEL with BOULDERS</b> Dark olive stained light reddish orange, CLAYEY SILTY SANDY GRAVEL with BOULDERS, transported.
HQ3	34	27	7	>20		6	
HQ3	98	91	43	6		7	<b>CLAYEY SILTY SANDY GRAVEL</b> Dark olive stained light reddish orange, CLAYEY SILTY SANDY GRAVEL, residual.
HQ3	63	61	24	6		8	
HQ3	102	85	37	>20		9	
HQ3	84	115	15	>20		10	
HQ3	84	70	32	15		11.43	<b>TILLITE</b> Dark olive, highly to moderately weathered, fine grained, massive, very highly fractured, fractures slightly rough, horizontal to sub-vertical, narrow to wide, stained, soft to medium hard rock, Dwyka TILLITE.

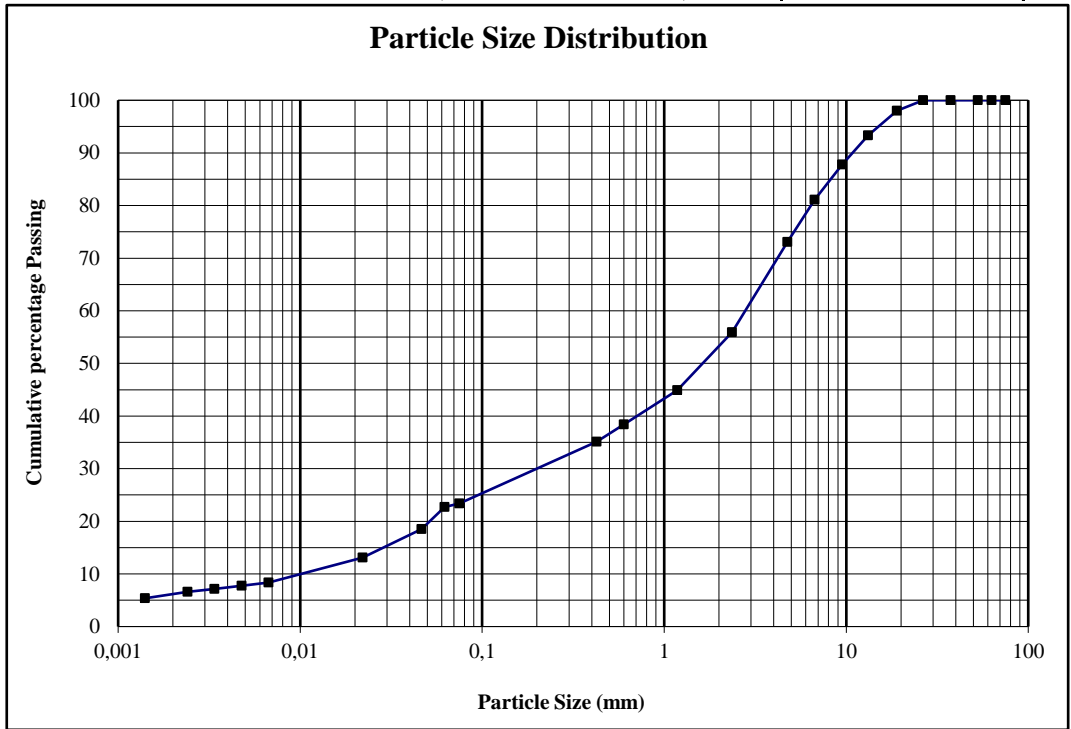
Sieve Size(mm)	% Passing
75,0	100
63,0	100
53,0	100
37,5	100
26,5	100
19,0	98
13,2	93
9,5	88
6,7	81
4,75	73
2,36	56
1,18	45
0,600	38
0,425	35
0,075	23
0,0623	23
0,0464	19
0,0221	13
0,0067	8
0,0048	8
0,0034	7
0,0024	7
0,0014	5

% Clay	6	% Silt	16	% Sand	31	% Gravel	47
Unified Soil Classification		GC		PRA Soil Classification		A-2-7
