**GREAT KAROO WIND FARM AND GRID CONNECTION, NORTHERN CAPE
PROVINCE**

ECOLOGICAL WALKDOWN REPORT

5 July 2021

REVISION 1

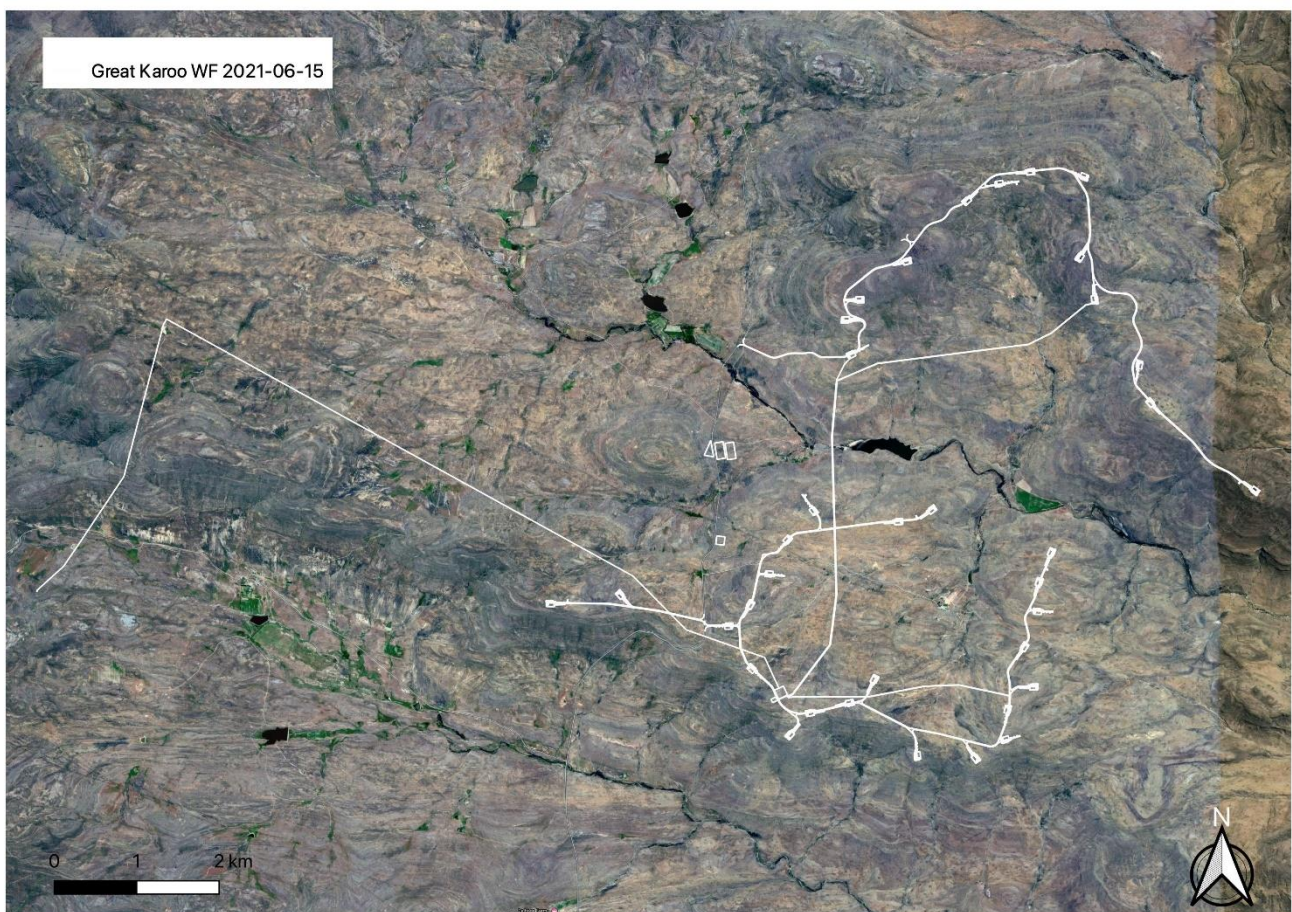
Figure 1: The proposed project layout used in the walk down assessment conducted in June 2021

As part of the Wind Farm Environmental Authorization and permitting conditions for the development, a pre-construction walk-through of the facility and grid connection is required before construction can commence. This also assisted with any micro-siting of any of the currently proposed wind farm and associated infrastructure, including wind turbines, turbine hardstands, internal access roads, underground MV cables alongside roads, overhead MV cables, temporary laydown areas, batch plants and construction camps as well as permanent Office and Maintenance Buildings, Substation, Switchyard, 132kV overhead powerline (Figure 1) and Battery Energy Storage System (BESS). This walkdown also considered the ~12.5 km x 300m wide grid connection corridor that extends from the Great Karoo Wind Farm Substation to the Hidden Valley Substation on the Karusa Wind Farm site (also Figure 1).

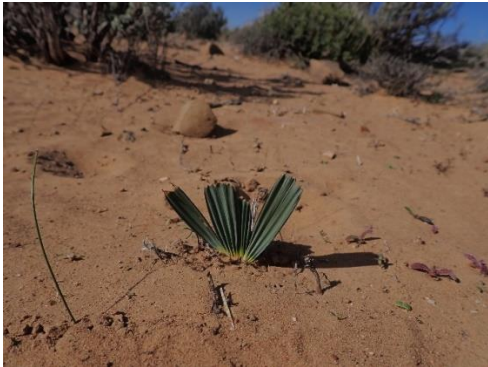
Structure	Observation	Comment & ID Photo
Wind farm entrance Road 1 & 2, Turbine 1 & 42		
Roads, turbine, hardstands and underground cables	8 – 10 Irises (<i>Moraea miniata</i>) 30 -40 <i>Babiana spp</i> >40 <i>Gethyllis spp</i> 20 <i>Drimia capensis</i>	All listed species can be easily relocated

<i>Babiana spp</i>

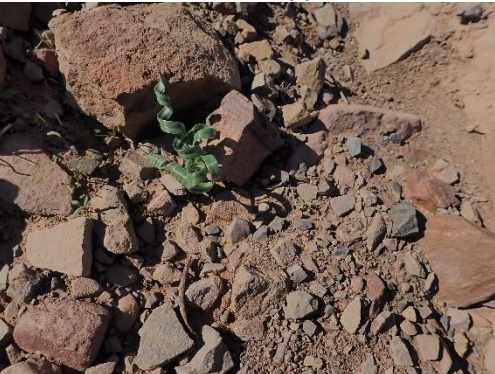
<i>Gethyllis spp</i>

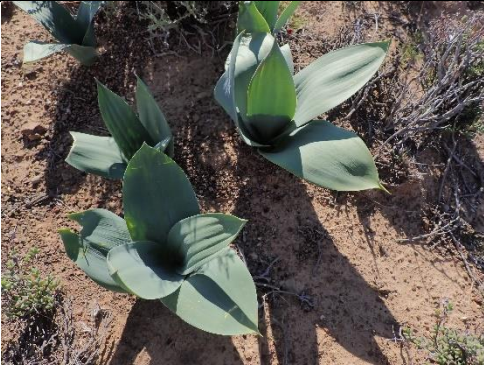
<p data-bbox="1608 563 1798 598"><i>Drimia capensis</i></p>
Site camp, Road 3a, 4a, b, c, d, e, f and g, 5a, 6a and Turbines 22, 21, 7, 5, 4, 3 and 2		
<p>Roads, turbine, hardstands and underground cables. A significant ridgeline occurs directly west of Road 5a, and this must be protected from any secondary disturbance as it is currently outside of any footprint areas.</p> <p>Note the site camp / laydown is within 10m of the LOW sensitivity drainage line buffer and will require a specific water use authorisation (Possibly under a GA)</p>	<p>6 Irises (<i>Moraea miniata</i>) 80 <i>Babiana spp</i> >40 <i>Gethyllis spp</i> 5 <i>Drimia capensis</i> >1000 <i>Antimima spp</i></p>

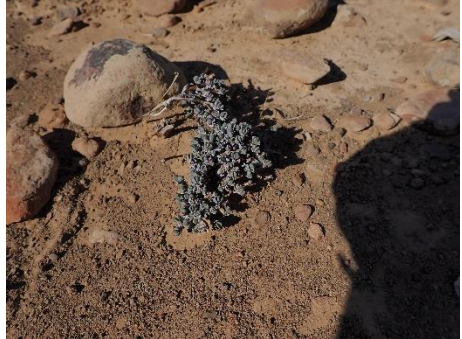
<p data-bbox="1597 978 1809 1013"><i>Antimima pumila</i></p>
Substation (BESS) & OM Buildings		
	<p>10 <i>Babiana spp</i> >20 <i>Gethyllis spp</i> >1000 <i>Antimima spp</i></p>	<p>Extensive rock pavement area near substation</p>

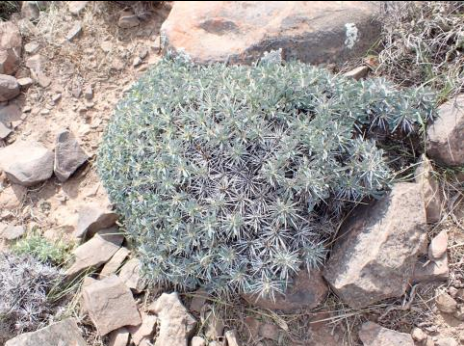
Structure	Observation	Comment & ID Photo
Roads 4 i to t, 7a, 8a, 9a 10a, 11a, 12a, 13a, Turbines 8, 9, 10, 11, 12, 13, 14, 15, 16, 17, 18, 19, 20		
<p>This portion of the layout covers very similar terrain, up on a ridge line, which has avoided large dolerite outcrops and / or sensitivity areas. Similarly extensive cut and fill areas will also be limited to most of road 4t and 4s.</p>	<p>Species are represented by all the Aizoaceae and those listed above, ranging from 100-1000s of plants. The only unique species observed along the portion of the alignment include the 2 x <i>Euphorbia multifolia</i> near Road 13a but will be avoided by the road alignment</p>

<p><i>Euphorbia multifolia</i></p>
Northern wind farm entrance, Roads 14a to m, 15a, 16a, 17a, 18a, 21a, 22a, 20a. Turbines 41, 40, 23, 24, 36, 37, 25, 26, 45 and 29		
<p>This portion of the site cover a northern ridgeline, similar in aspect and slope, with a similar suite of plant species.</p> <p>Note the underground cable around Turbine 40 is within 12m of the LOW sensitivity drainage line buffer and will require a specific water use authorisation (Possibly under a GA). Similarly the blade finger area for Turbine 36 is located 10m into drainage line buffer (LOW sensitivity).</p>	<p>Species include all those previously listed above, but due to drier / sunnier conditions on these slopes, the following additional species were also observed</p> <p>>50 <i>Euphorbia hamata</i> 20- 30 <i>Brunsvigia josephinae</i></p>

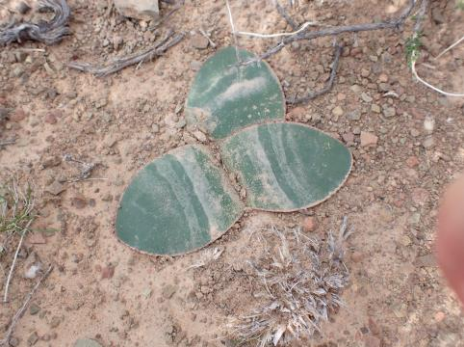
<p><i>Brunsvigia spp</i></p>

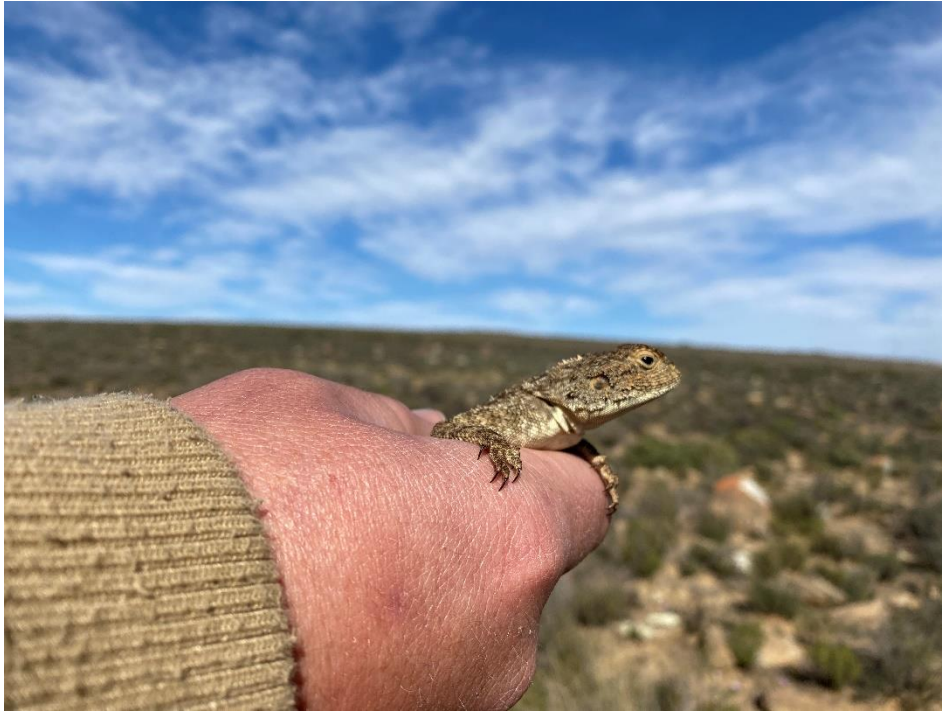
Girdled lizard (*Karusasaurus polyzonus*; Karoo Girdled Lizard) found near the Southern site entrance

With the exception of the tortoises, lizards and snakes, the species listed above typically leave the area once construction commences, thus permits for the relocation of lizards, snakes and tortoises must be obtained.
