Report on the ecological and wetland assessment for the proposed Harmony 1 Plant PV solar development situated in Welkom, Free State Province.

July 2022

Darius van Rensburg

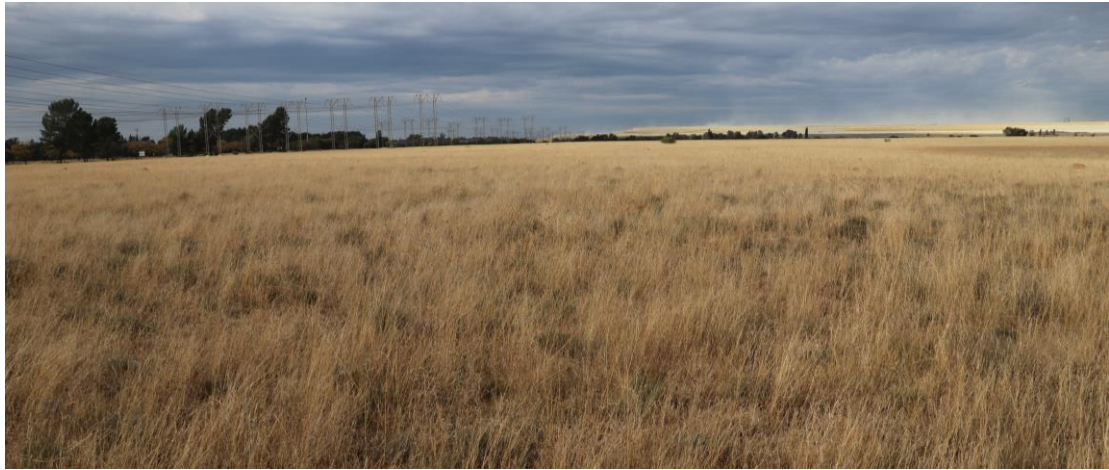
The north western portion of the study area consists of a fairly large area of remaining natural grassland. Some disturbance is also present here though in general this portion is a good representation of the natural grassland in this area, Vaal-Vet Sandy Grassland. This vegetation type is listed as Endangered (EN) and any remaining areas such as this, will be essential to meeting the conservation targets for it (Appendix A: Map 1 & 2). The conservation value of this area will be very high and should be excluded from development.

Figure 3: The remaining natural grassland in the north western portion of the site is fairly extensive and a good representation of the natural vegetation type.

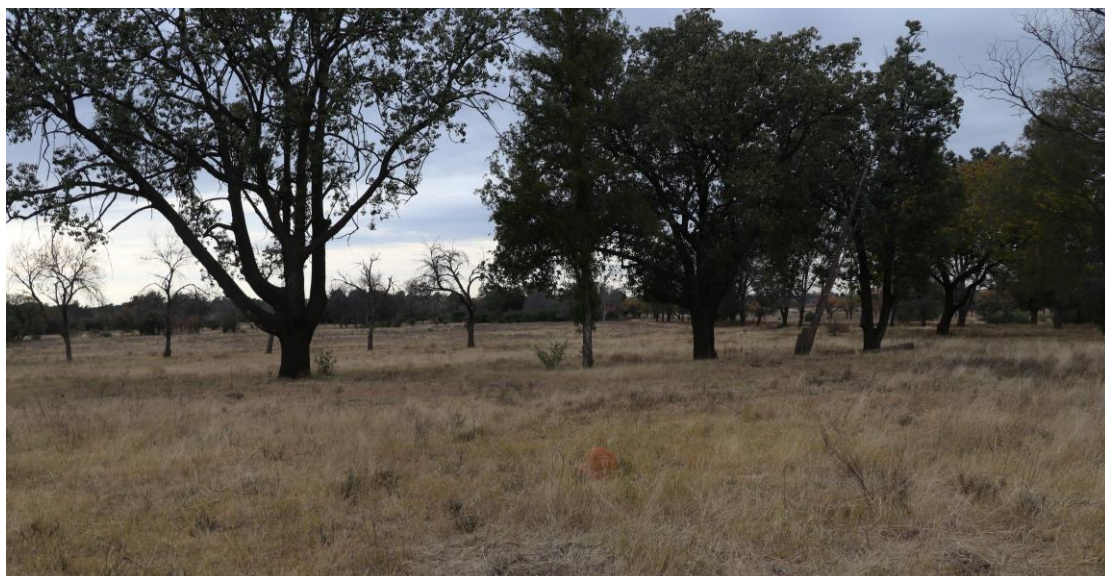
Figure 7: The eastern portion of the site is dominated by a pioneer grass layer with extensive plantings of exotic and invasive trees.

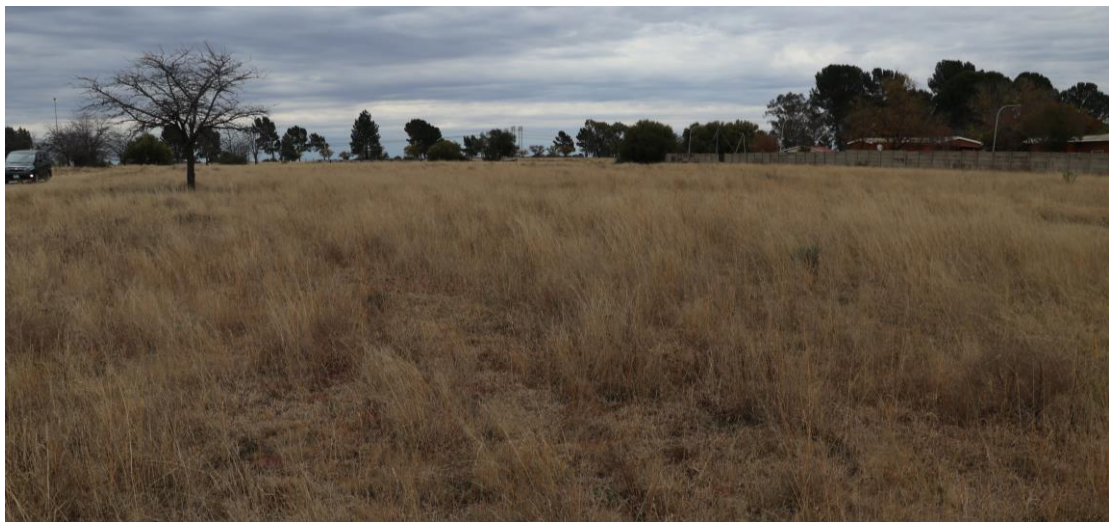
Figure 10: The north eastern portion of the site contains grassland still representative of the natural vegetation type though the proximity of urban areas do cause significant disturbance.

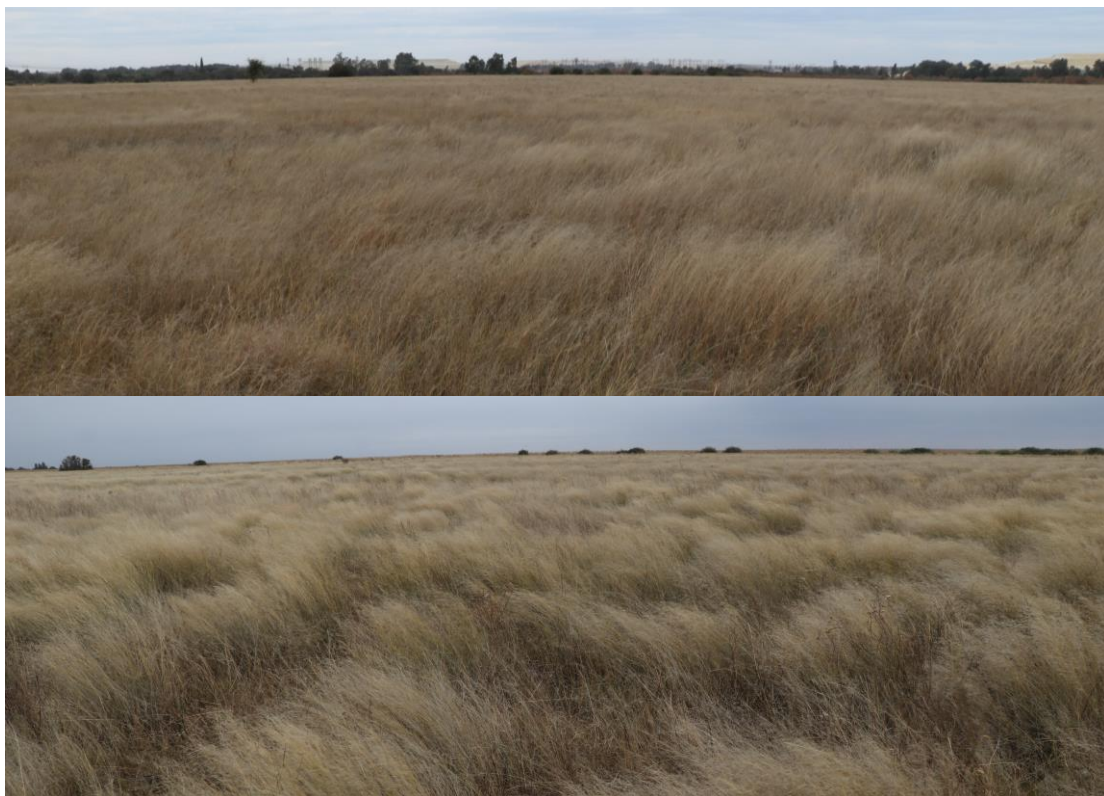
Figure 14: Though the southern still consists of indigenous grassland it is dominated by pioneer species which is not representative of Vaal-Vet Sandy Grassland.

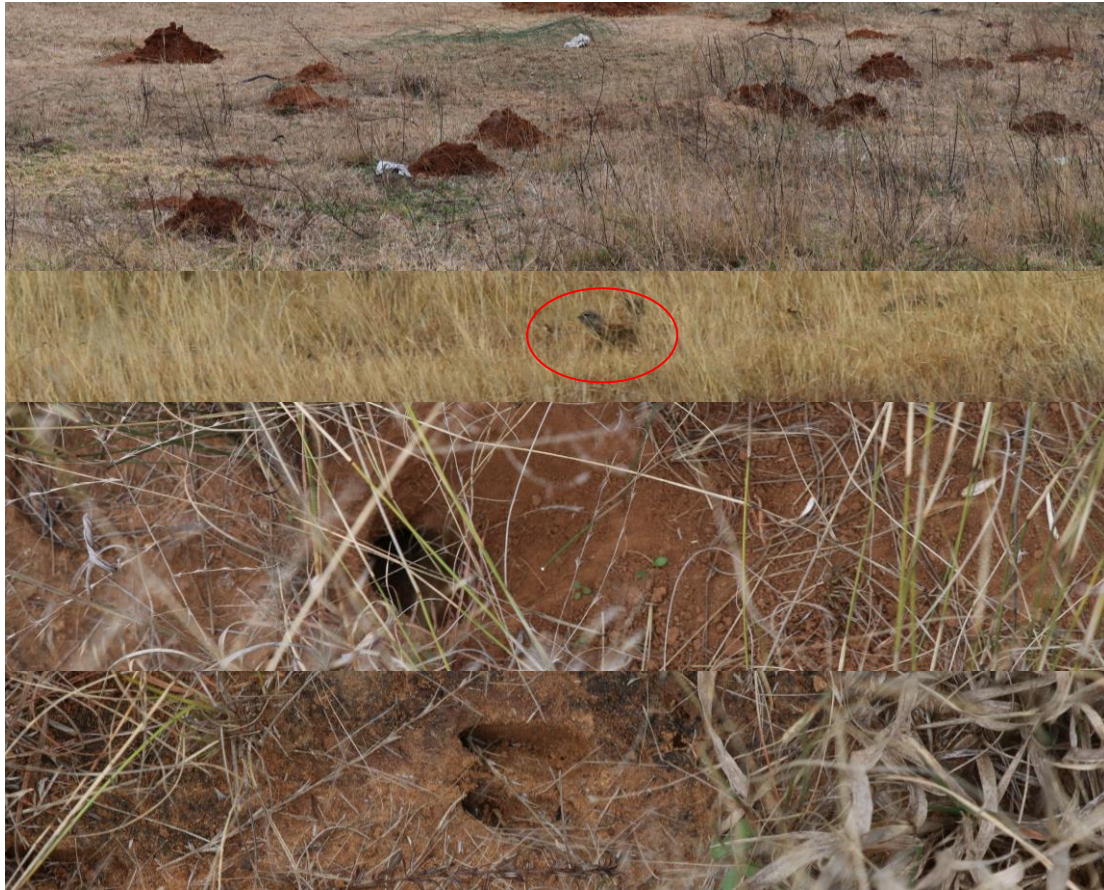
Figure 16: Tracks and signs of mammals on the site include from top to bottom; soil mound of the Common mole rat (*Cryptomys hottentotus*), Ground squirrels (*Xerus inauris*), Burrow of an unidentified small rodent and Spoor of either a Steenbok (*Raphicerus campestris*) or Common Duiker (*Sylvicapra grimmia*).

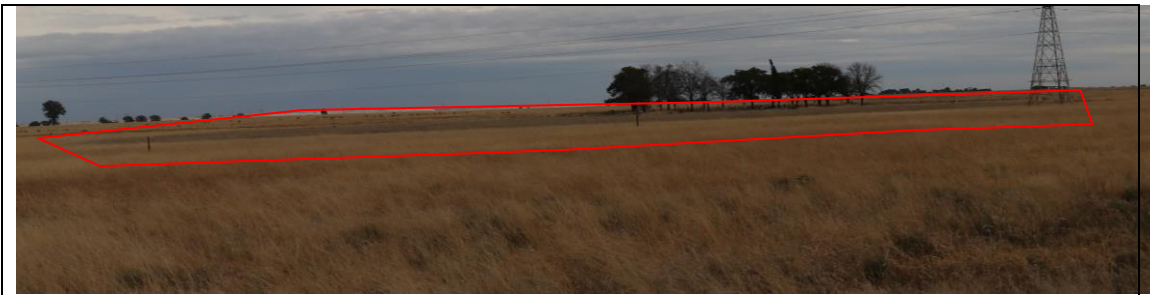
The pan system is clearly differentiated within the landscape.

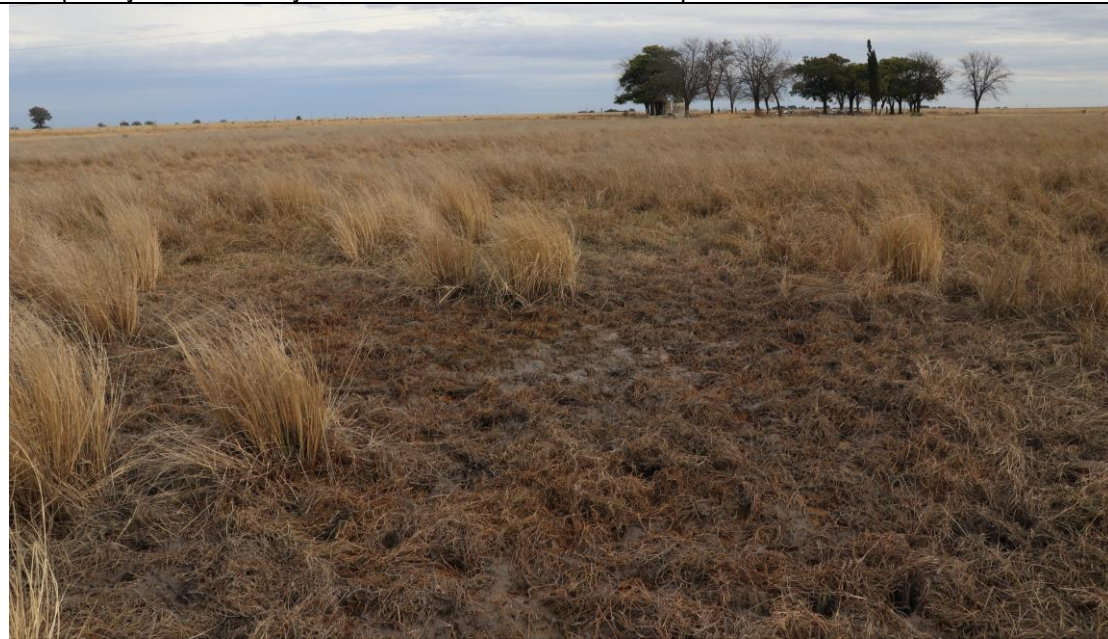
Dense wetland vegetation and saturated soils clearly indicate the presence of wetland conditions. Note also high levels of trampling by domestic livestock.

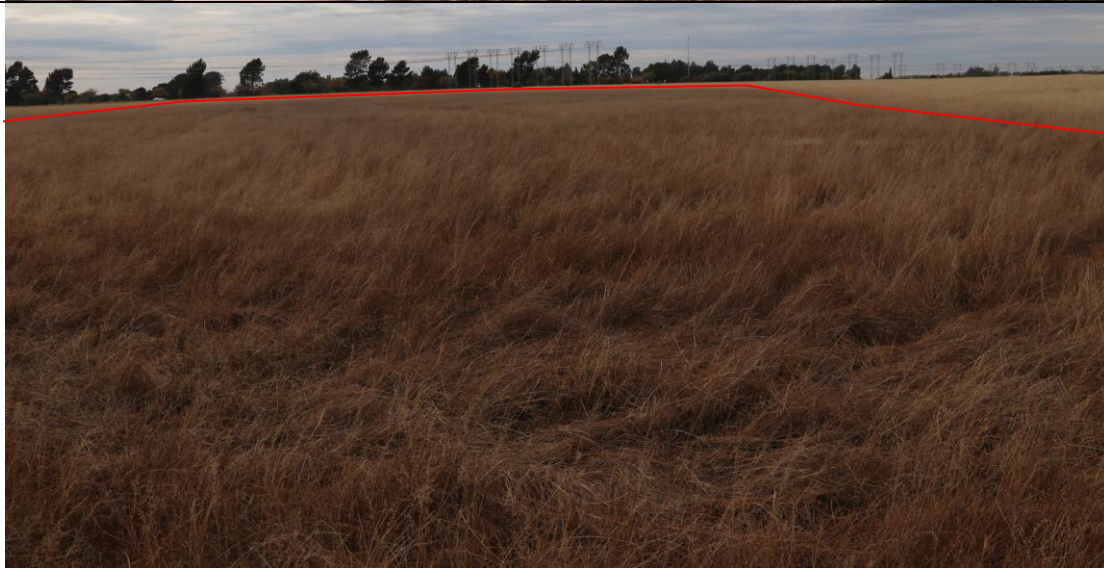
The wetland is somewhat less prominent in terms of wetland conditions, though is still clearly discernible within the landscape.

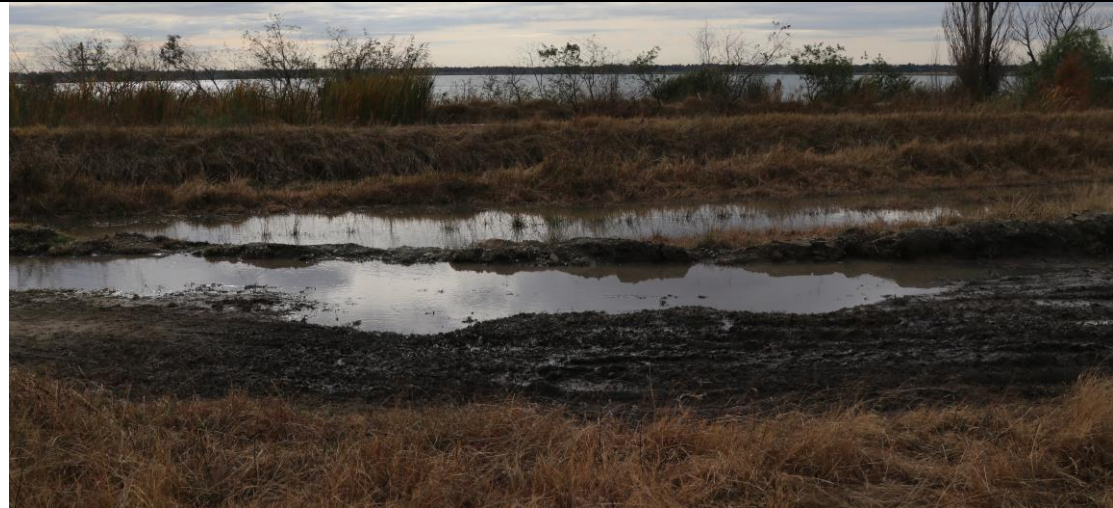
The Witpan is a large waterbody but which is clearly heavily modified from the natural condition.

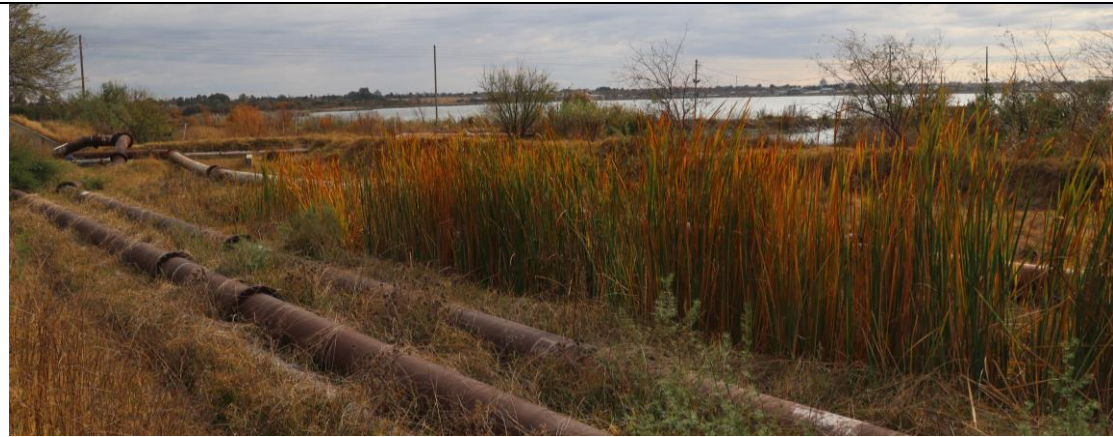
Modifications and sever degradation is evident along the shores of the Witpan.

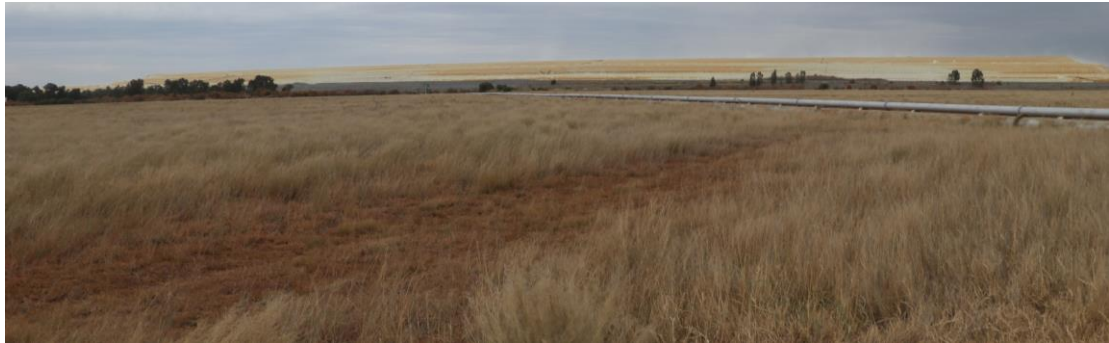
Figure 18: Various structures and infrastructure in the catchment of the pan act as obstructions to surface flow and impact on the hydrology of the pan.

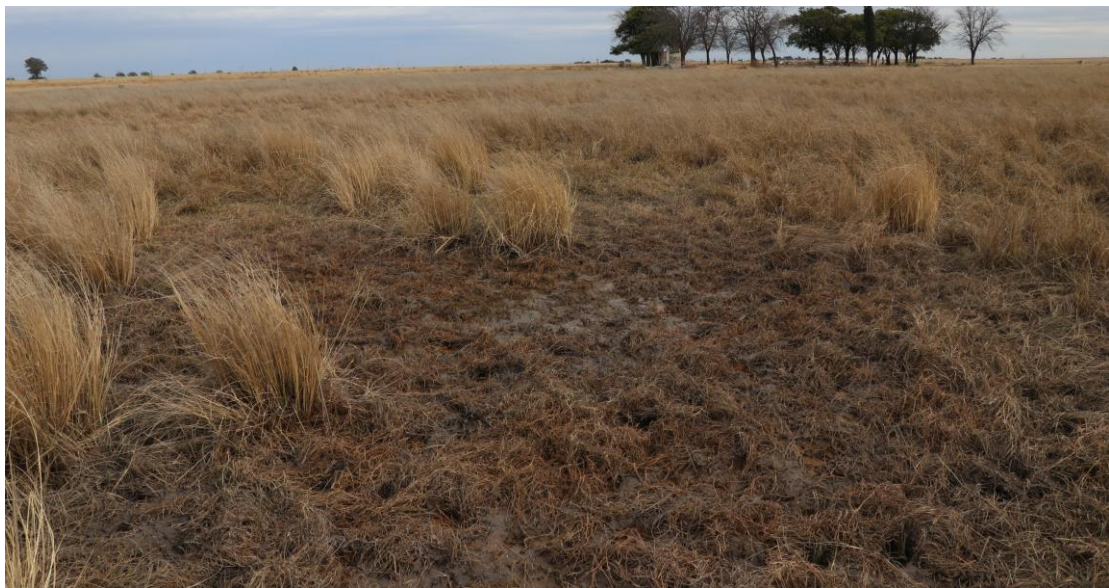
The pan itself is largely intact though is also affected to a significant extent by high level of overgrazing and trampling by domestic livestock. This results in elevated nutrient levels caused by manure. Trampling and overgrazing also decreases the percentage vegetation cover while also causing disturbance of the soil surface. This all leads to some modification of the wetland hydrology and vegetation cover.

Figure 19: Trampling by domestic livestock within the pan is quite high and visibly contributes toward a decrease in vegetation cover, an increase in soil disturbance and modification of the surface roughness of the wetland.

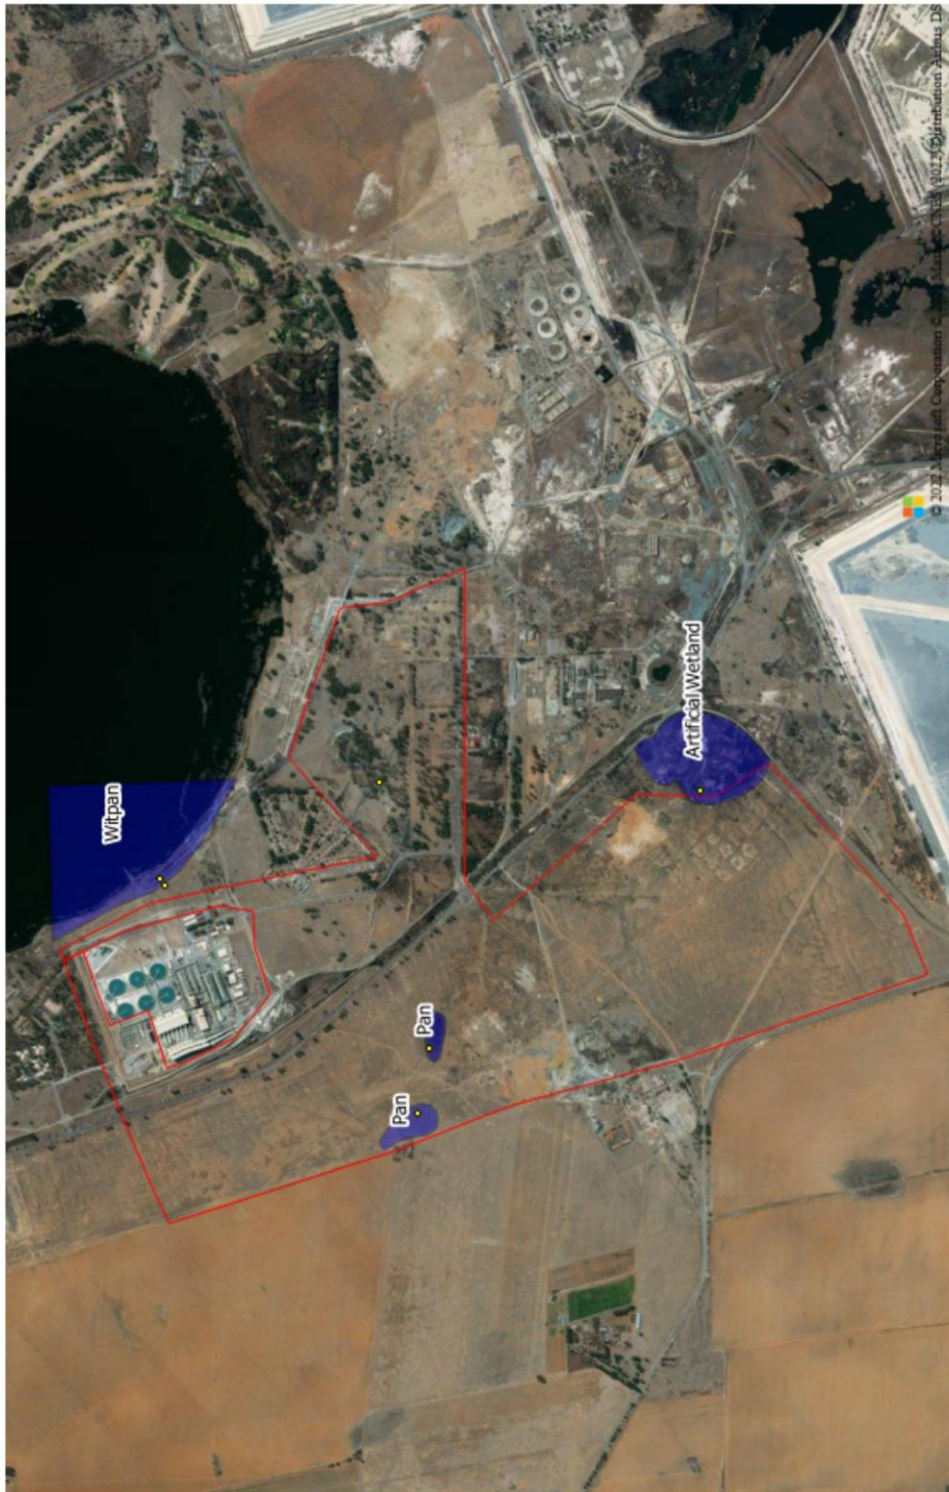
Wetland delineation map for the proposed Harmony 1 Plant PV solar development situated in Welkom, Free State Province.

Map 3: Wetland delineation map of the proposed Harmony 1 Plant PV solar development near the town of Welkom. The different wetland areas on and around the site are labeled and indicated. The large Witpan is situated to the north east of the site and though it does not form part of the site, it may be affected by the grid connection powerline. Two large pans are also situated in the north western portion of the site but should remain unaffected by development as long as portions of natural grassland are excluded from development. A large, but certainly artificial wetland areas is also situated in the south of the site. Being artificial is of low conservation value but since it contains saturated soils conditions, should still be taken into account by the development. The wetland sampling points are also indicated.
