Aquatic Biodiversity Compliance Statement – Carolus Solar Photo- Voltaic (PV) Solar Energy Facility and associated Grid Connection Infrastructure

**Pixley ka Seme District Municipality,
Northern Cape Province**

Report Date: August 2022

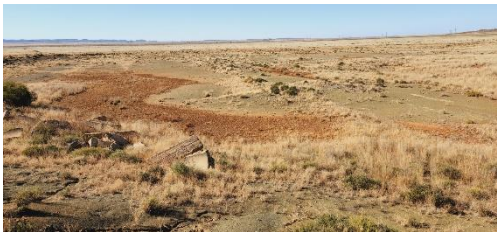
Comments	A dam located along a public road with no clear drainage lines. The dam is located adjacent to the BESS area of the PV area. The dam is considered artificial and a result of the presence of the road. The site was dry and considered to have low aquatic ecology importance or sensitivity due to its artificial nature.

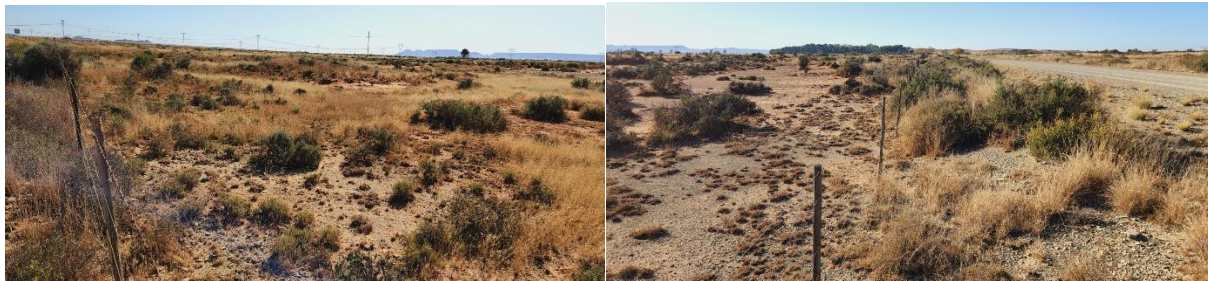
Figure 5-4 Illustration of the ephemeral habitat features of the Western tributary (June 2022)

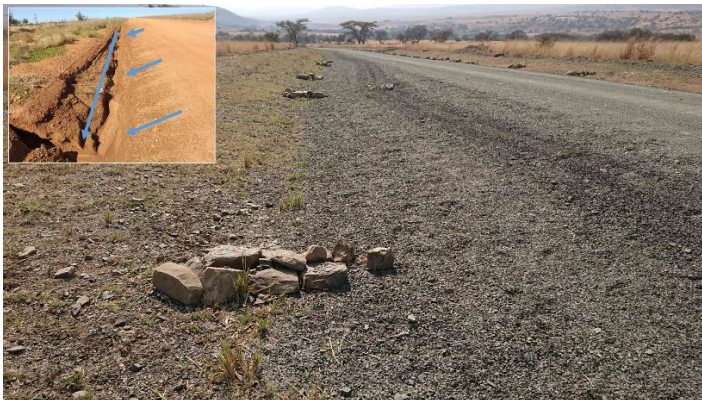
Figure 6-3 Example of road margin erosion prevention

- Energy dissipation, such as stone berms or blocks must be strategically placed along the road margins for the entire road network as surface runoff leaves the roads and enters the surrounding environment with the potential for severe erosion. The steeper the slope of the road, the more regular the berms should be spaced and can be as close as one meter apart where necessary;

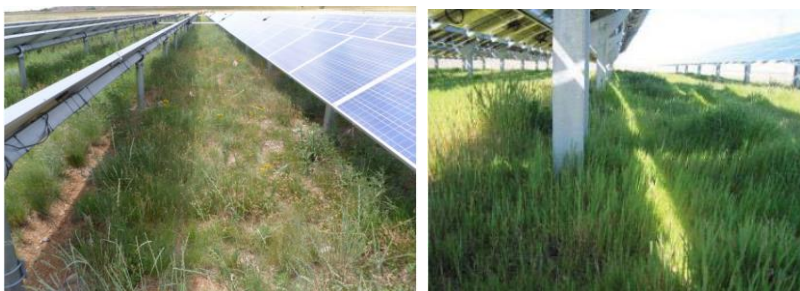
- Indigenous vegetation must be maintained under the solar panels to ensure biodiversity is maintained and to prevent soil erosion (Beatty *et al*, 2017; Sinha *et al*, 2018). This vegetation cover will maintain surface roughness which will assist in maintaining hydrological connectivity through infiltration and subsurface interflow. The photographs below are sourced from these documents;
