# **Aquatic Biodiversity Compliance Statement – Fountain Solar Photo- Voltaic (PV) Solar Energy Facility**

**Pixley ka Seme District Municipality,  
Northern Cape Province**

Report Date: June 2022

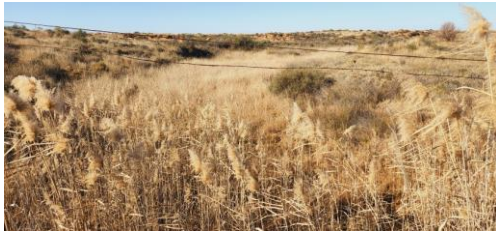
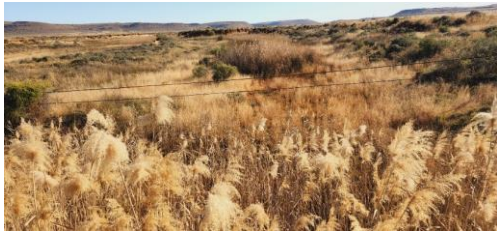
<b>Comments</b>	Upstream Brak River site, upstream and east of proposed infrastructure. The watercourse presented wetland habitat and was dry.	
<b>GPS-coordinates</b>	30°40'42.52"S 24°10'45.43"E	
<b>Brak Down</b>

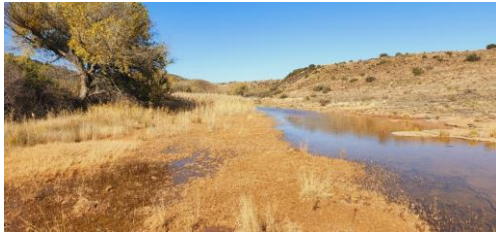
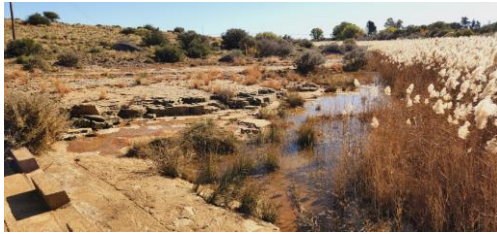
<b>Comments</b>	Downstream Brak River site, downstream of proposed infrastructure and downstream of Brak Mid. The site presented wetland habitat. The site was deemed too shallow and unsuitable for standard aquatic sampling methods and was limited to <i>in situ</i> water quality analysis only.	
<b>GPS-coordinates</b>	30°38'18.43"S 24° 8'12.64"E	
<b>Brak River tributaries</b>		
<b>East Trib Dam</b>

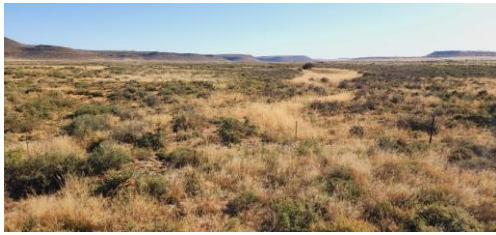
<b>Comments</b>	Located at a Dam on a Brak River tributary to the east of the project area (Eastern tributary). The site is downstream of the Fountain Solar PV1 Footprint and would drain into the Brak River upstream of Brak Mid. The dam had surface water and water quality analysis was conducted at this site.

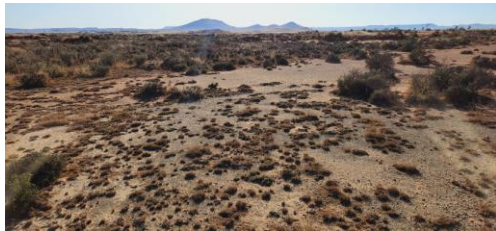
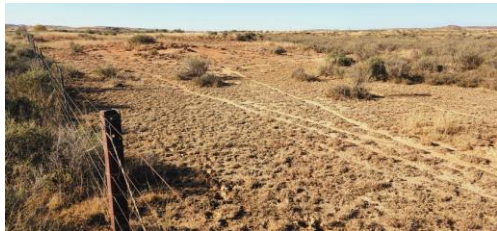
Site	Upstream	Downstream
<b>Comments</b>	Located on the major Brak River tributary within the western portion of the project area. The site assessed the upper portion of this tributary (Western Tributary) that will be traversed by the proposed linear infrastructure (powerlines). This site was presented by a wide drainage area (floodplain) with an inconspicuous channel, which was dry at the time of the survey.	
<b>GPS-coordinates</b>	30°42'39.68"S 24° 6'36.75"E	
<b>West Trib 3</b>

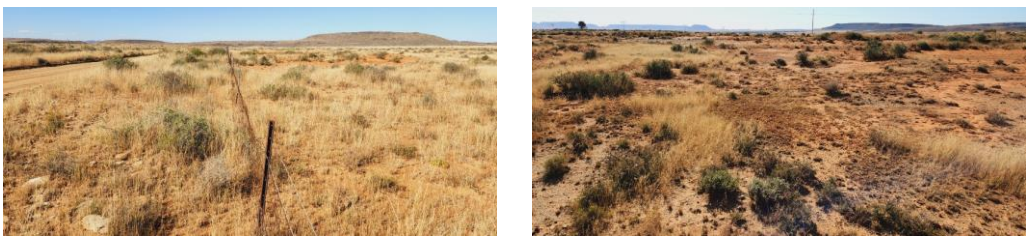
<b>Comments</b>	Located on the Western Tributary in the lower portion of this tributary that will be traversed by the proposed linear infrastructure (powerlines). This site was presented by a wide drainage area (floodplain) with an inconspicuous channel, which was dry at the time of the survey.	
<b>GPS-coordinates</b>	30°38'50.53"S 24° 6'0.03"E

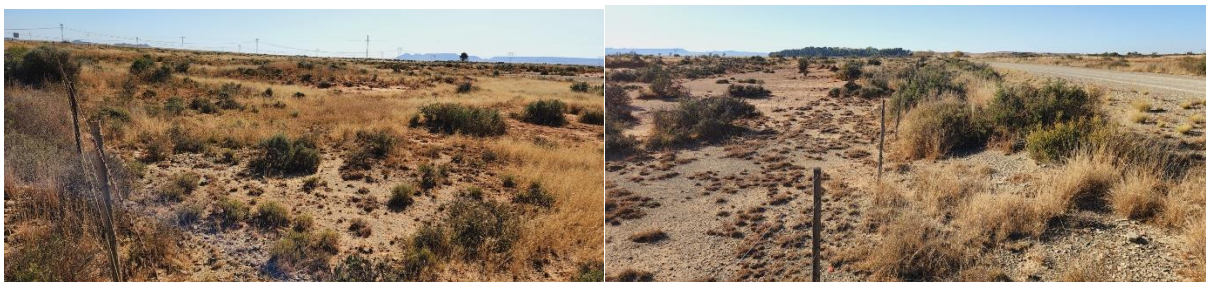
Figure 6-2 Illustration of the ephemeral habitat features of the Western tributary (June 2022)

The on-site assessment of the watercourses presented largely dry conditions, with the ephemeral systems presenting no clear banks or riparian features which is typical for watercourses in an arid region (Figure 6-3 and Figure 6-2). This together with the temporary presence of surface water within these watercourses limited the use of the IHIA method. Therefore, the baseline condition of the watercourses is presented through site photos and satellite imagery. Some level of channel habitat modification has taken place through land use activities however the ecosystems and adjacent terrestrial habitat is considered open and largely unmodified. Baseline impacts within the drainage channels and catchment include instream weirs, farm fences, livestock influence and vehicle tracks which have altered the hydro-dynamics to some degree. Despite their current level of modification and ephemeral nature, the watercourses are sensitive to further modification as these systems do provide drinking opportunities (in times of rainfall) and habitat for foraging, nesting and refugia for terrestrial biota and avifauna. Therefore, the watercourses in the project area are regarded as sensitive environments in relation to changes in habitat integrity, flow and water quality requiring avoidance from the project related disturbance activities and maintenance of baseline conditions.
