Aquatic Biodiversity Compliance Statement – Wagt Solar Photo-Voltaic (PV) Solar Energy Facility and Associated Grid Connection Infrastructure

**Pixley ka Seme District Municipality,
Northern Cape Province**

Report Date: August 2022

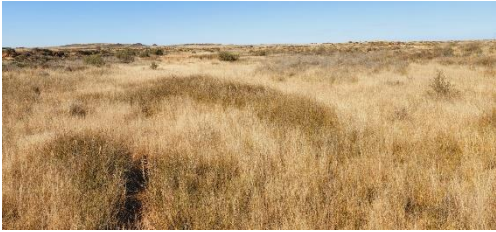
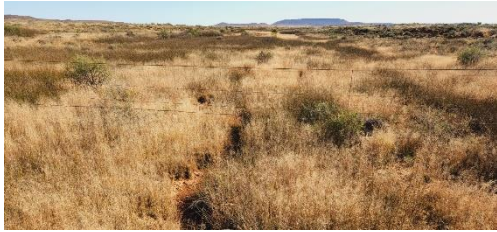
Comments	Upstream Brak River site, upstream and east of proposed infrastructure. The watercourse presented wetland habitat and was dry.	
GPS-coordinates	30°43'18.49"S 24°12'14.13"E	
East Trib 1

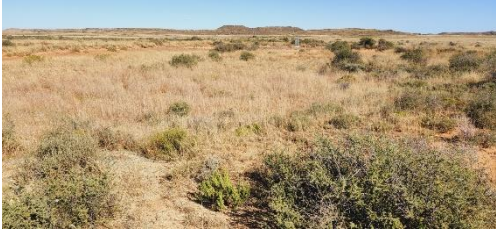
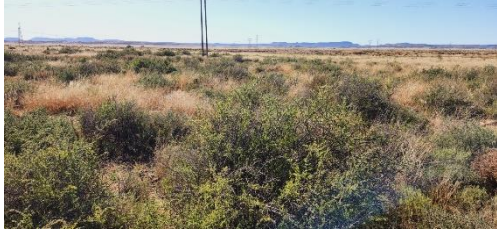
Comments	The site was located on a tributary of the Brak River to the east of proposed PV1 area. The tributary drains the south eastern perimeter portion of the PV1 area. The tributary joins the Brak River downstream of Brak Up. The watercourse presented wetland habitat and was dry.	
GPS-coordinates	30°42'26.34"S 24°10'49.02"E	
Brak Mid

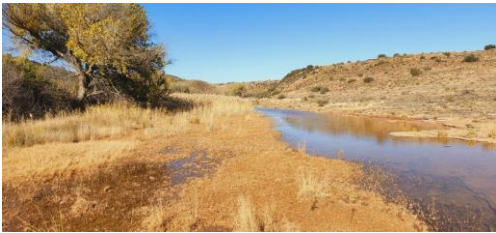
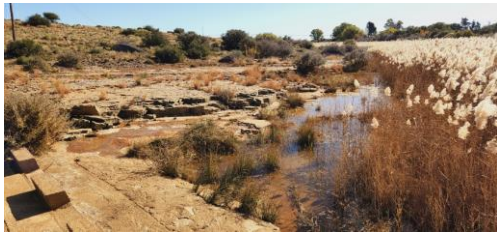
Comments	Downstream Brak River site, downstream of proposed infrastructure and downstream of Brak Mid. The site presented wetland habitat. The site was deemed too shallow and unsuitable for standard aquatic sampling methods and was limited to <i>in situ</i> water quality analysis only.

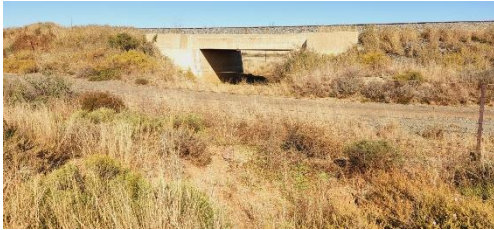
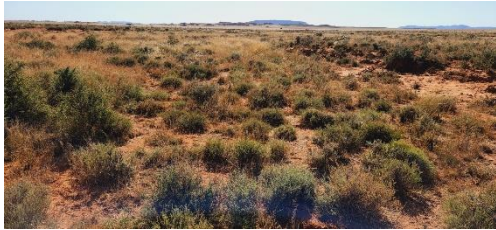
Comments	Located on the major Brak River tributary within the western portion of the project area (Western Tributary). The site serves as an upstream reference site upstream of the western portion of the PV1 area. This site was presented by a wide drainage area (alluvial floodplain), which was dry at the time of the survey.	
GPS-coordinates	30°44'12.82"S 24° 8'44.55"E	
West Trib 2

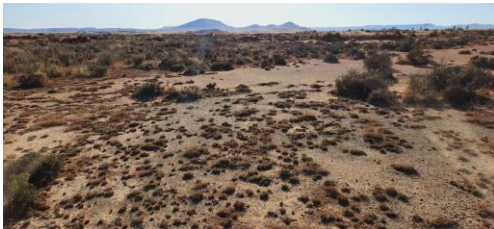
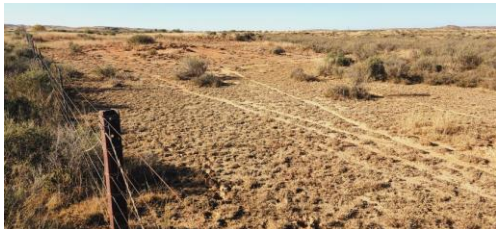
Comments	Located on the Western Tributary within the western portion of the project area and downstream of site West Trib 1. The site is directly west of the PV1 area and receives water from the PV1 drainage network. The site assessed the upper portion of the Western Tributary that will be traversed by the proposed linear infrastructure (powerlines and roads). This site was presented by a wide drainage area (alluvial floodplain) with an inconspicuous channel, which was dry at the time of the survey.

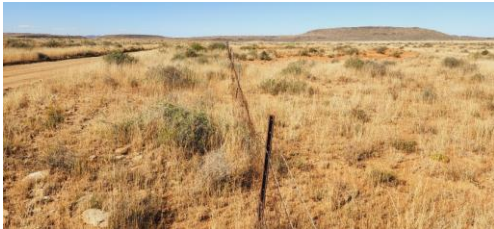
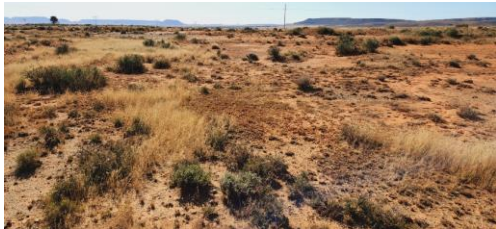
Comments	Located on the Western Tributary in the lower portion of this tributary that will be traversed by the proposed linear infrastructure (powerlines and roads). This site was presented by a wide drainage area (alluvial floodplain) with an inconspicuous channel, which was dry at the time of the survey.	
GPS-coordinates	30°38'50.53"S 24° 6'0.03"E	
Artificial Dam

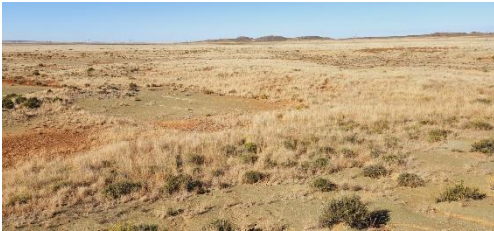
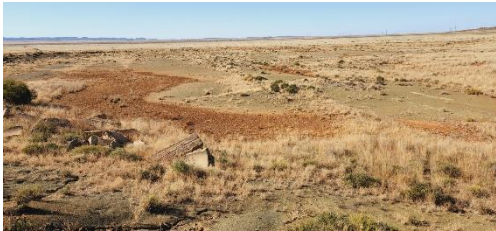
Comments	A dam located along a public road with no clear drainage lines. The dam is located adjacent to the BESS area of the PV area. The dam is considered artificial and a result of the presence of the road. The site was dry and considered to have low aquatic ecology importance or sensitivity due to its artificial nature.	
GPS-coordinates	30°41'20.69"S 24° 8'52.01"E

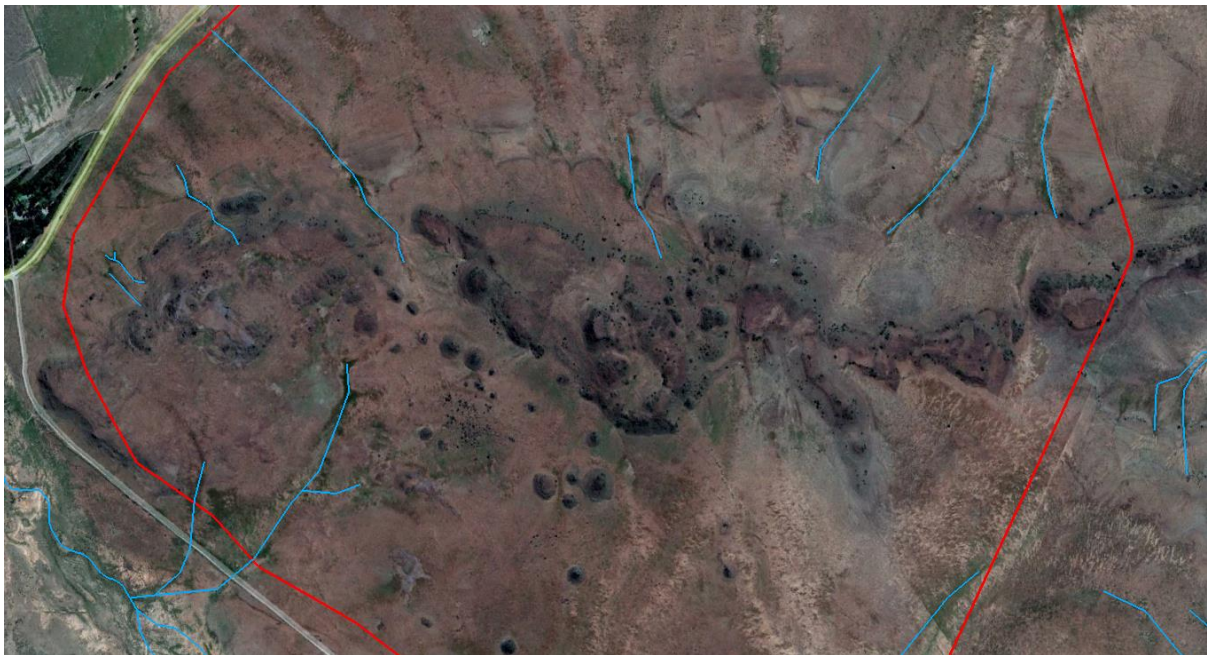
Figure 5-2 Illustration of the alluvial fans (green areas) in wet periods (Google Earth 3/2017)

The on-site assessment of the watercourses presented largely dry conditions, with the numerous ephemeral systems presenting no clear banks or riparian features which is typical for watercourses in an arid region (Figure 5-5 and Figure 5-4). Many of the drainage features presented as alluvial fans that have formed in the low laying areas below mountain slopes or gorges due to the flat topography and low water energy that has resulted in the accumulation of alluvial sediment. These areas are broad presenting as wide floodplain-like features which are difficult to observe in-field and are best seen from satellite imagery (Figure 5-3, Figure 5-5 and Figure 5-4). These drainage areas are highlighted in times of good rainfall when the vegetation cover is greatest from inundated soils, with an example from March 2017 imagery highlighting the extent of these saturated areas (Figure 5-2). The areas are prone to flooding during large storm events and may remain saturated for several days to weeks, depending on the permeability of the soils and climate conditions. These areas are important for groundwater recharge.

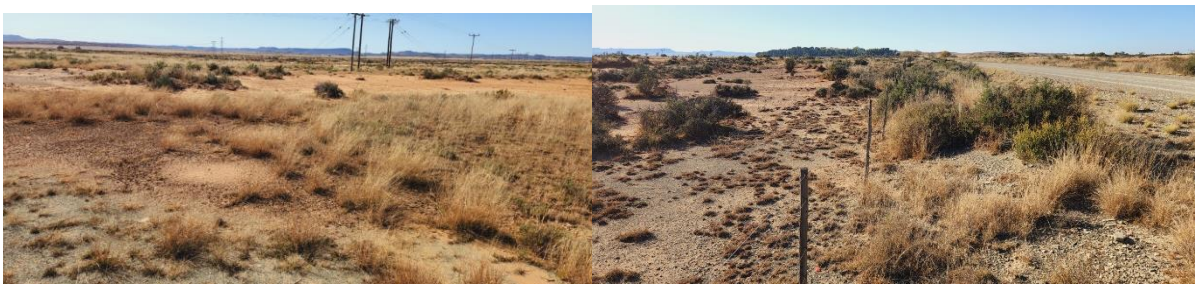
Figure 5-4 Illustration of the ephemeral habitat features of the Western tributary (June 2022)

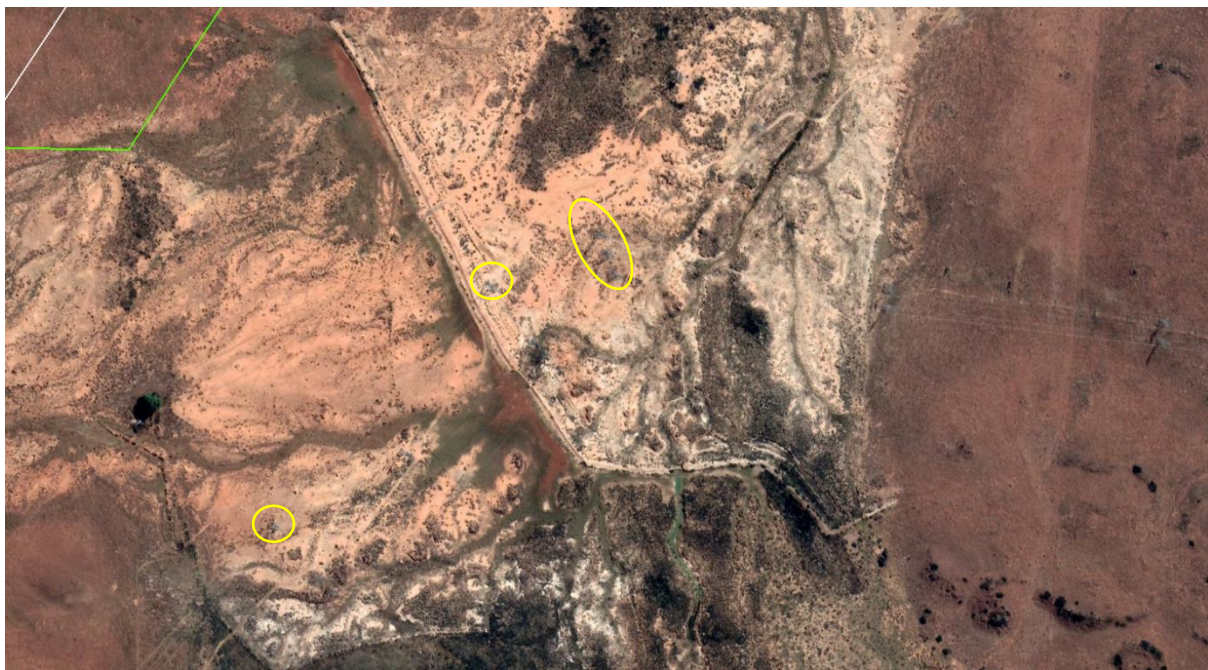
Figure 5-6 Illustration of existing instream weirs structures and powerline pylons (yellow circles) within the drainage features (Google Earth)

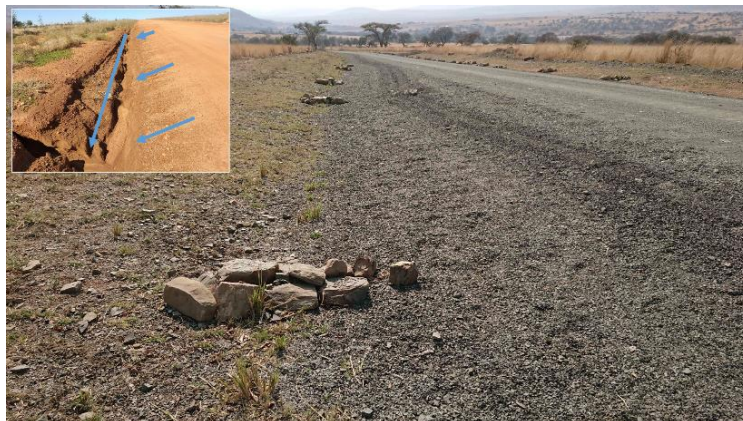
Figure 6-3 Example of road margin erosion prevention

- Energy dissipation, such as stone berms or blocks must be strategically placed along the road margins for the entire road network as surface runoff leaves the roads and enters the surrounding environment with the potential for severe erosion. The steeper the slope of the road, the more regular the berms should be spaced and can be as close as one meter apart where necessary;

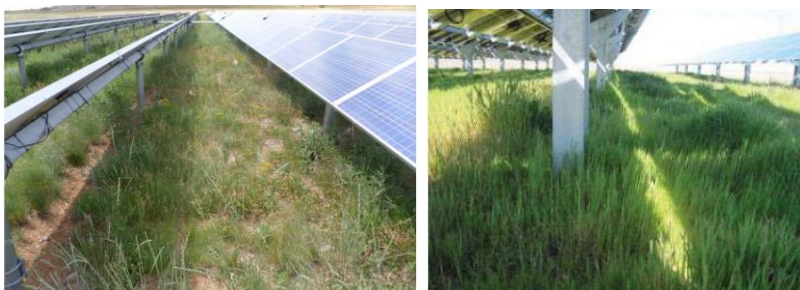
- Indigenous vegetation must be maintained under the solar panels to ensure biodiversity is maintained and to prevent soil erosion (Beatty *et al*, 2017; Sinha *et al*, 2018). This vegetation cover will maintain surface roughness which will assist in maintaining hydrological connectivity through infiltration and subsurface interflow. The photographs below are sourced from these documents;
