**REPORT TO THE INZUZO YE-SIZWE DEVELOPMENT CONSULTANTS CC  
ON THE RESULTS OF A GEOTECHNICAL DESKTOP INVESTIGATION FOR  
PROPOSED CEMETERY SITES IN GREATER KOKSTAD MUNICIPALITY,  
KWAZULU-NATAL**

**REPORT REFERENCE: SGE-165-2019.REP01**

**Date: 19 June 2019**

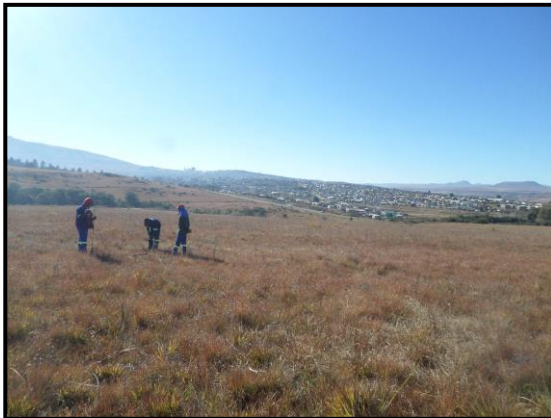
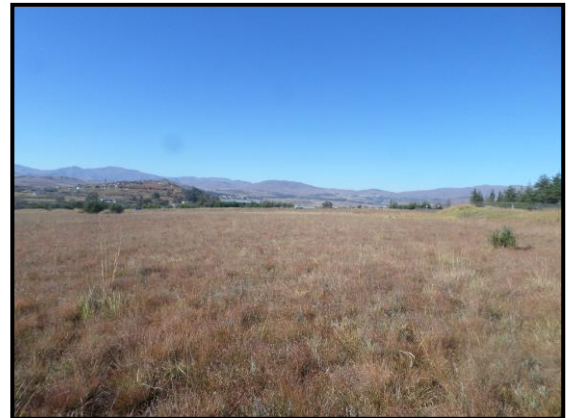
Plates 1 and 2: General views of the study area

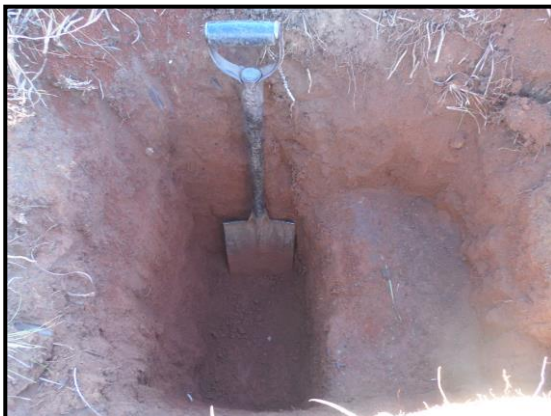
The area underlain by Beaufort Group – Adelaide Formation mudstone bedrock, is characterised by moderate brown, clayey SAND to sandy silty CLAY (colluvium) and orange brown to reddish brown, moderately clayey sandy SILT (residual). Weathered bedrock was not visually observed but inferred (from DCP test results) to occur at depths typically in the range 1.5 to 2.0 metres below EGL.

Plate 3: IP4

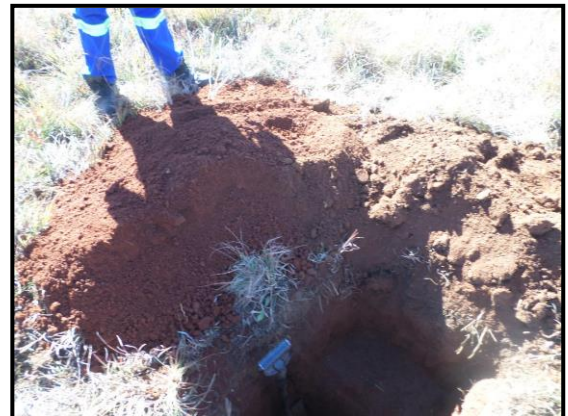
Plate 4: Spoil from IP4

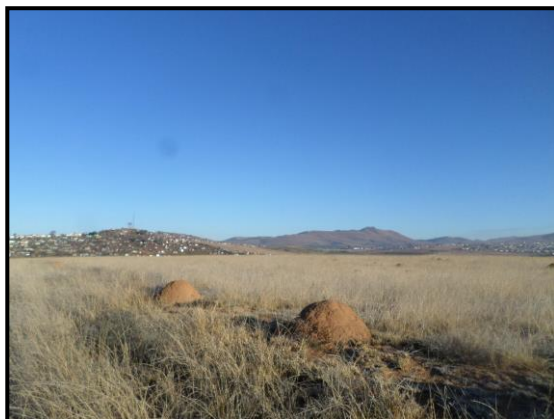
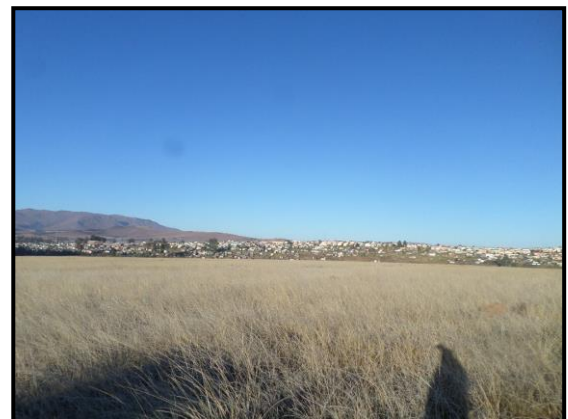
Plates 5 and 6: General views of the study area

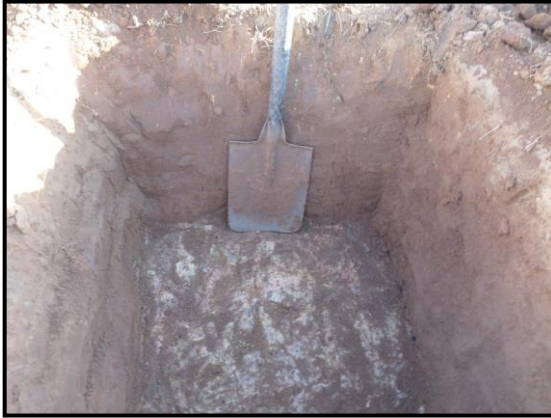
The area underlain by Beaufort Group – Adelaide Formation mudstone bedrock, is characterised by moderate brown, clayey SAND to sandy silty CLAY (colluvium) and orange brown to reddish brown, moderately clayey sandy SILT (residual). Karoo-age dolerite intrudes the mudstone bedrock in the form of sills, predominantly along the eastern portion of the study area. Bedrock occurs at depths typically less than 1.0 metre below EGL across the study area.

Plate 7: IP1

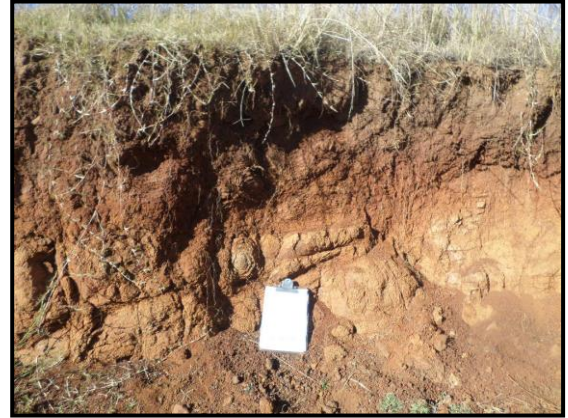
Plate 8: Dolerite exposed in cutting

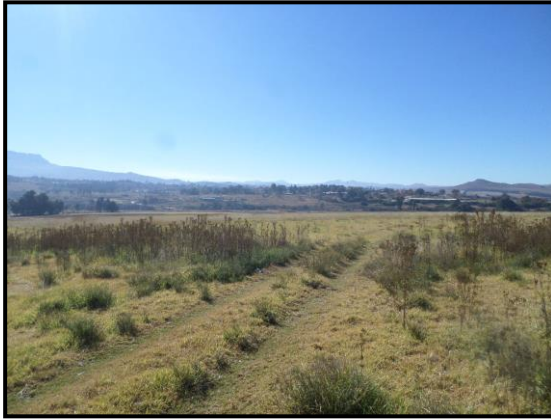
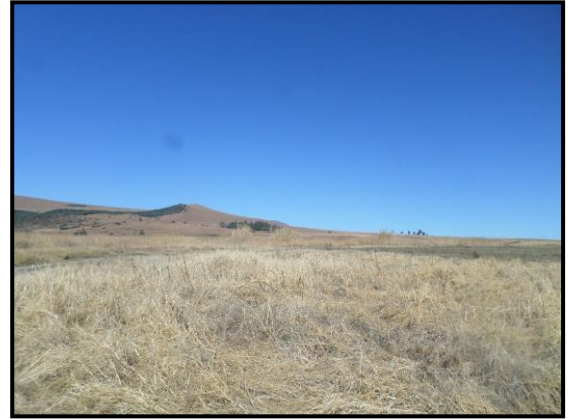
**Plates 9 and 10: General views of the study area**

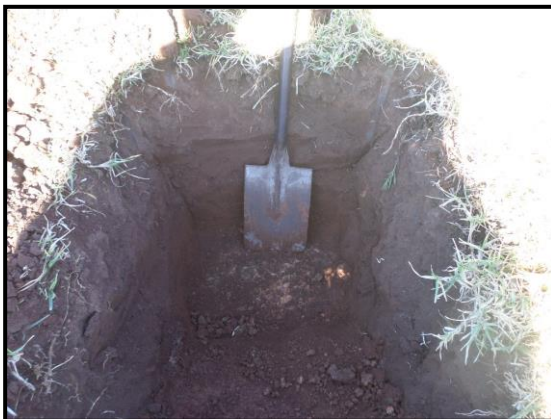
The area underlain by Beaufort Group – Adelaide Formation mudstone bedrock, is characterised by moderate brown, clayey SAND to sandy silty CLAY (colluvium) and orange brown to reddish brown, moderately clayey sandy SILT (residual).

Thick, dark grey alluvial clay (which extends to depths in excess of 1.5 metres below EGL) was encountered in the northern portion of the site, closer to the Mzintlava River.

**Plate 11: IP5**

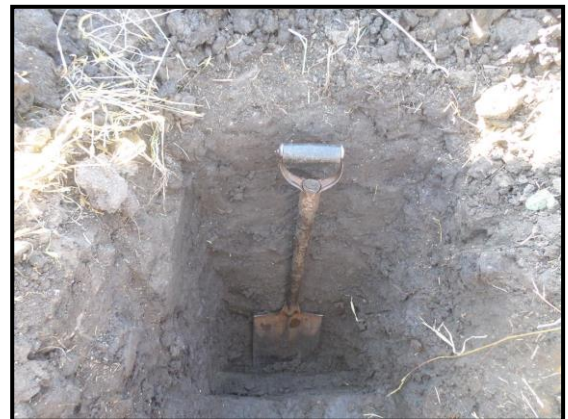
**Plate 12: IP6**

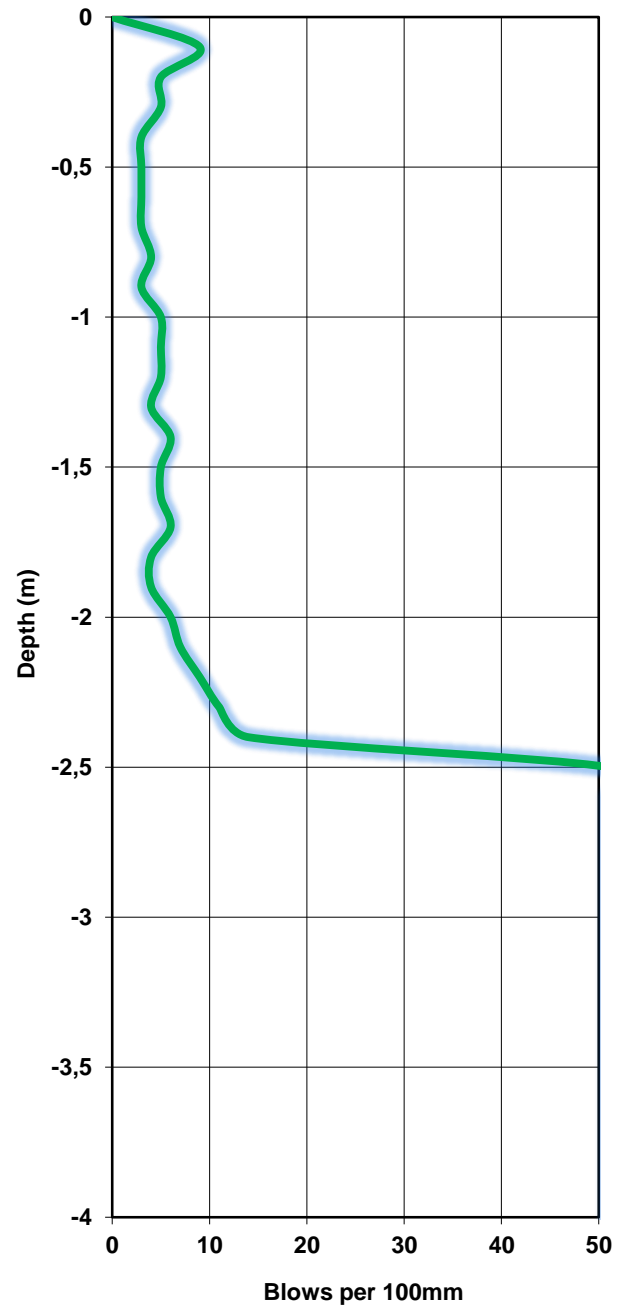
**Dynamic Cone Penetrometer (DCP) TEST NO: DCP2**

Depth metres	Blows per 100mm	Inferred Consistency	Shear Strength	CBR %
0				
0,1	9	Stiff	75 kPa	15
0,2	5	Firm	40 kPa	8
0,3	5	Firm	40 kPa	8
0,4	3	Soft	25 kPa	5
0,5	3	Soft	25 kPa	5
0,6	3	Soft	25 kPa	5
0,7	3	Soft	25 kPa	5
0,8	4	Soft	35 kPa	7
0,9	3	Soft	25 kPa	5
1	5	Firm	40 kPa	8
1,1	5	Firm	40 kPa	8
1,2	5	Firm	40 kPa	8
1,3	4	Soft	35 kPa	7
1,4	6	Firm	50 kPa	10
1,5	5	Firm	40 kPa	8
1,6	5	Firm	40 kPa	8
1,7	6	Firm	50 kPa	10
1,8	4	Soft	35 kPa	7
1,9	4	Soft	35 kPa	7
2	6	Firm	50 kPa	10
2,1	7	Firm	60 kPa	12
2,2	9	Stiff	75 kPa	15
2,3	11	Stiff	90 kPa	19
2,4	14	Stiff	115 kPa	25
	Refusal

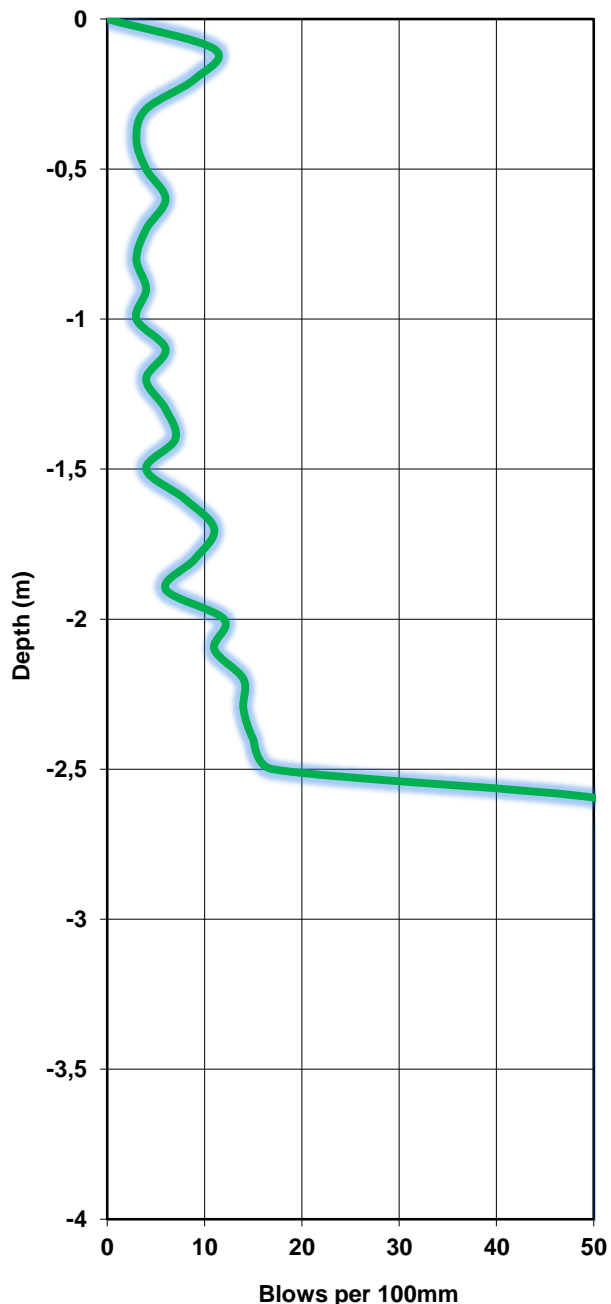
**Dynamic Cone Penetrometer (DCP) TEST NO: DCP5**

Depth metres	Blows per 100mm	Inferred Consistency	Shear Strength	CBR %
0				
0,1	11	Stiff	90 kPa	19
0,2	9	Stiff	75 kPa	15
0,3	4	Soft	35 kPa	7
0,4	3	Soft	25 kPa	5
0,5	4	Soft	35 kPa	7
0,6	6	Firm	50 kPa	10
0,7	4	Soft	35 kPa	7
0,8	3	Soft	25 kPa	5
0,9	4	Soft	35 kPa	7
1	3	Soft	25 kPa	5
1,1	6	Firm	50 kPa	10
1,2	4	Soft	35 kPa	7
1,3	6	Firm	50 kPa	10
1,4	7	Firm	60 kPa	12
1,5	4	Soft	35 kPa	7
1,6	8	Firm	65 kPa	14
1,7	11	Stiff	90 kPa	19
1,8	9	Stiff	75 kPa	15
1,9	6	Firm	50 kPa	10
2	12	Stiff	100 kPa	21
2,1	11	Stiff	90 kPa	19
2,2	14	Stiff	115 kPa	25
2,3	14	Stiff	115 kPa	25
2,4	15	Stiff	125 kPa	27
2,5	17	Stiff	140 kPa	31

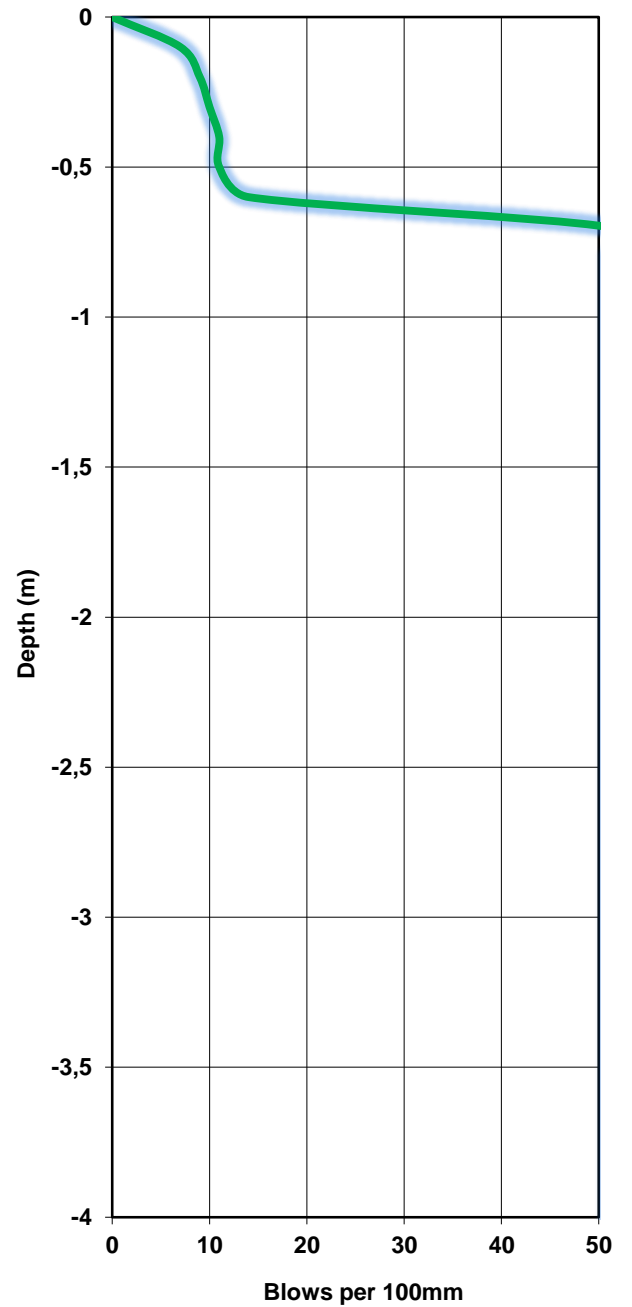
***Dynamic Cone Penetrometer (DCP)      TEST NO:      DCP7***

Depth metres	Blows per 100mm	Inferred Consistency	Shear Strength	CBR %
0				
0,1	7	Firm	60 kPa	12
0,2	9	Stiff	75 kPa	15
0,3	10	Stiff	85 kPa	17
0,4	11	Stiff	90 kPa	19
0,5	11	Stiff	90 kPa	19
0,6	14	Stiff	115 kPa	25
	Refusal

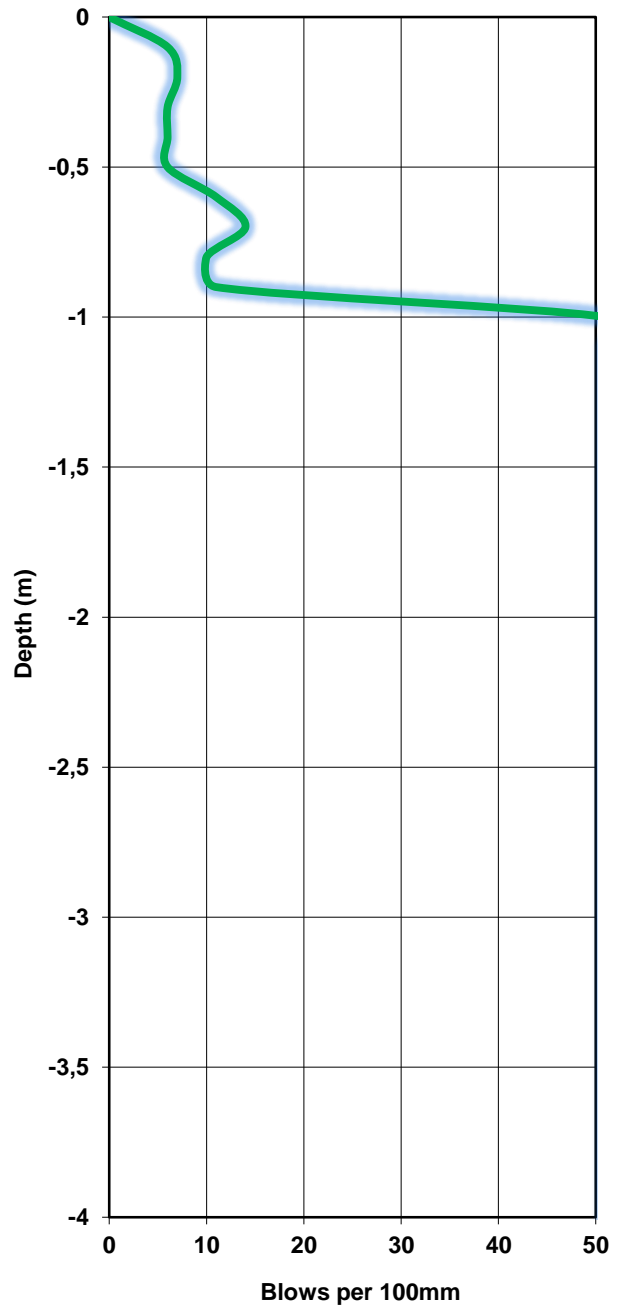
***Dynamic Cone Penetrometer (DCP)      TEST NO:      DCP8***

Depth metres	Blows per 100mm	Inferred Consistency	Shear Strength	CBR %
0				
0,1	6	Firm	50 kPa	10
0,2	7	Firm	60 kPa	12
0,3	6	Firm	50 kPa	10
0,4	6	Firm	50 kPa	10
0,5	6	Firm	50 kPa	10
0,6	11	Stiff	90 kPa	19
0,7	14	Stiff	115 kPa	25
0,8	10	Stiff	85 kPa	17
0,9	11	Stiff	90 kPa	19

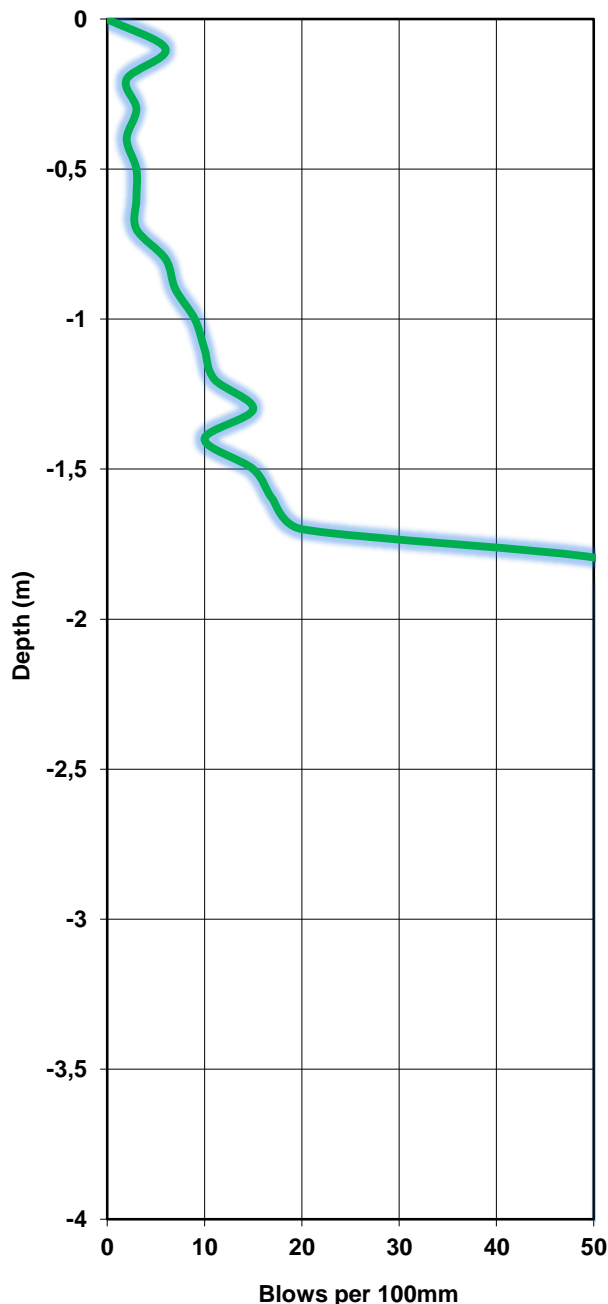
**Dynamic Cone Penetrometer (DCP) TEST NO: DCP9**

Depth metres	Blows per 100mm	Inferred Consistency	Shear Strength	CBR %
0				
0,1	6	Firm	50 kPa	10
0,2	2	Soft	20 kPa	3
0,3	3	Soft	25 kPa	5
0,4	2	Soft	20 kPa	3
0,5	3	Soft	25 kPa	5
0,6	3	Soft	25 kPa	5
0,7	3	Soft	25 kPa	5
0,8	6	Firm	50 kPa	10
0,9	7	Firm	60 kPa	12
1	9	Stiff	75 kPa	15
1,1	10	Stiff	85 kPa	17
1,2	11	Stiff	90 kPa	19
1,3	15	Stiff	125 kPa	27
1,4	10	Stiff	85 kPa	17
1,5	15	Stiff	125 kPa	27
1,6	17	Stiff	140 kPa	31
1,7	20	Very Stiff	>150 kPa	37
	Refusal

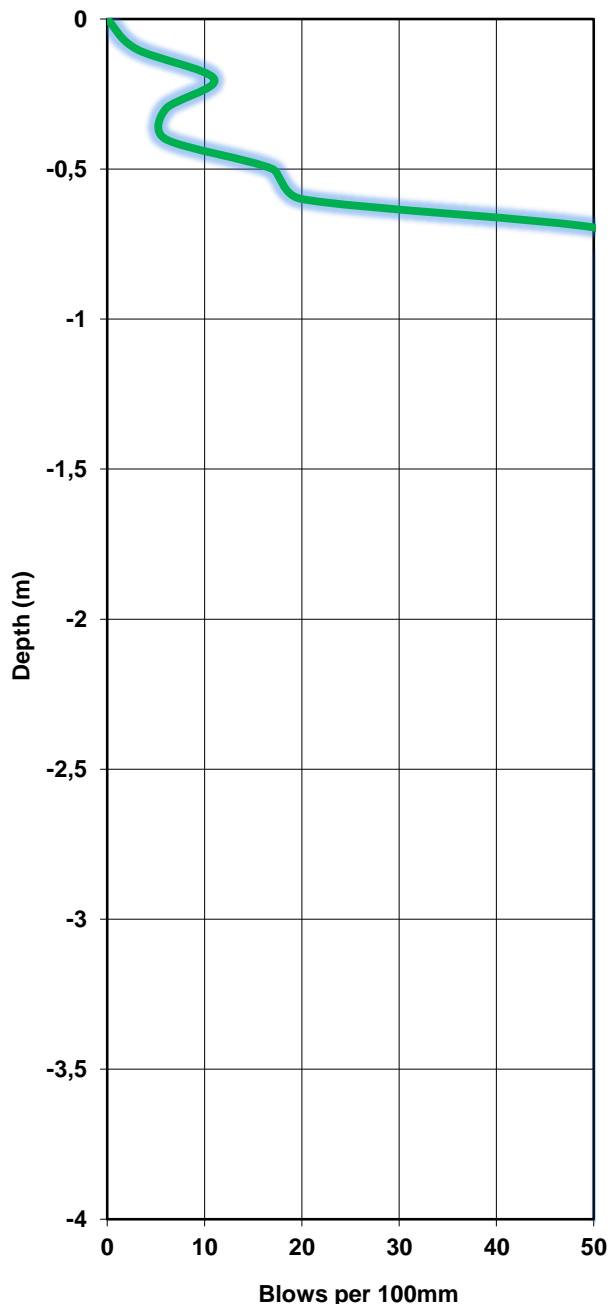
***Dynamic Cone Penetrometer (DCP)***      **TEST NO:**      **DCP10**

Depth metres	Blows per 100mm	Inferred Consistency	Shear Strength	CBR %
0				
0,1	3	Soft	25 kPa	5
0,2	11	Stiff	90 kPa	19
0,3	6	Firm	50 kPa	10
0,4	6	Firm	50 kPa	10
0,5	17	Stiff	140 kPa	31
0,6	20	Very Stiff	>150 kPa	37
	Refusal
