SIYANQOBA WETLAND ASSESSMENT REPORT

WETLAND ASSESSMENT FOR THE PROPOSED RESIDENTIAL
DEVELOPMENT OF SIYANQOBA EXTENSIONS ON THE FARM TWEEDAM
AND LEEUWPOORT

REPORT TITLE: Wetland Assessment Report

REPORT REF NO: W13/07/26

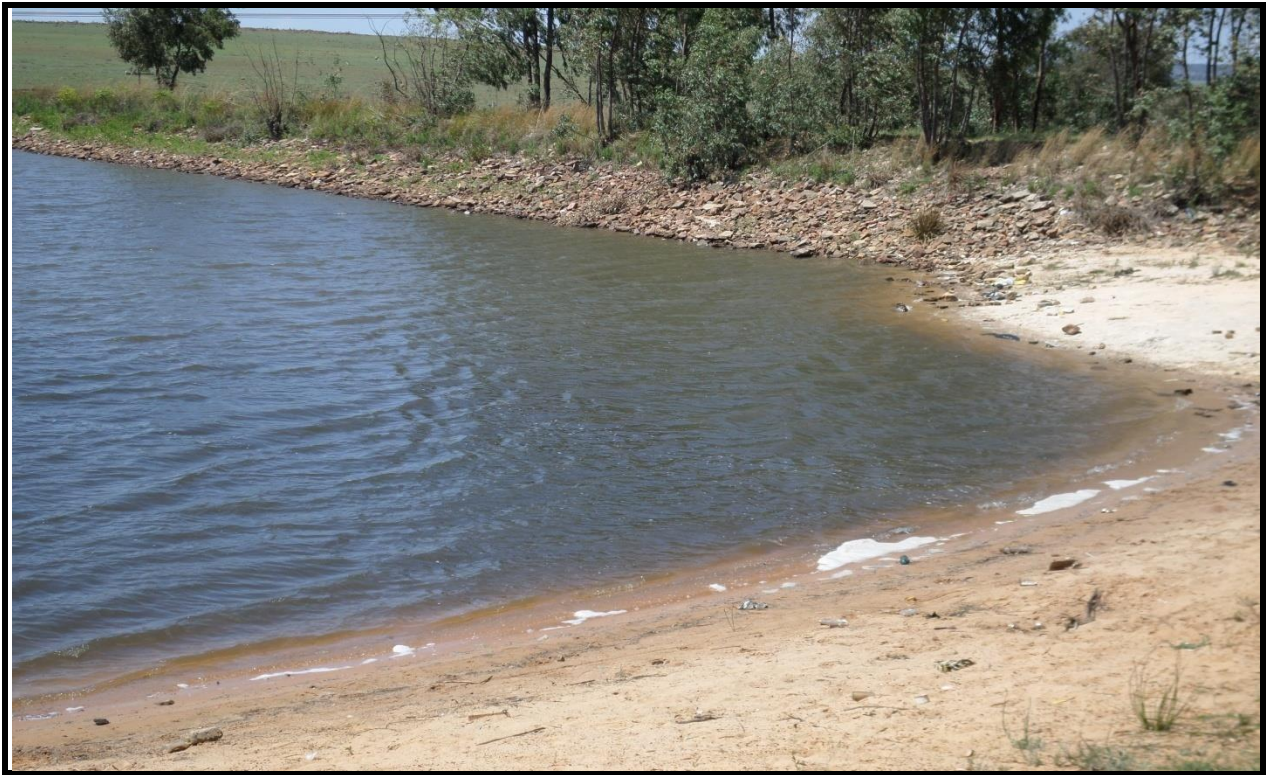
Figure 3: A farm dam that was observed within the study area in Tweedam 377 J.S farm.

sensitive (No-Go) zones. A number of manmade impoundments (farm dams) are also present, especially in the remainder of portion 0 of Tweedam 377 J.S farm (figure 3)

- No inspection or other vehicles to drive through drainage lines, along the bank margin of streams except where there are existing crossovers.
- It is recommended that the farm dams on the Tweedam 377 J.S have to be protected by fence and monitored. This is a means to offset any negative impact the construction might have.

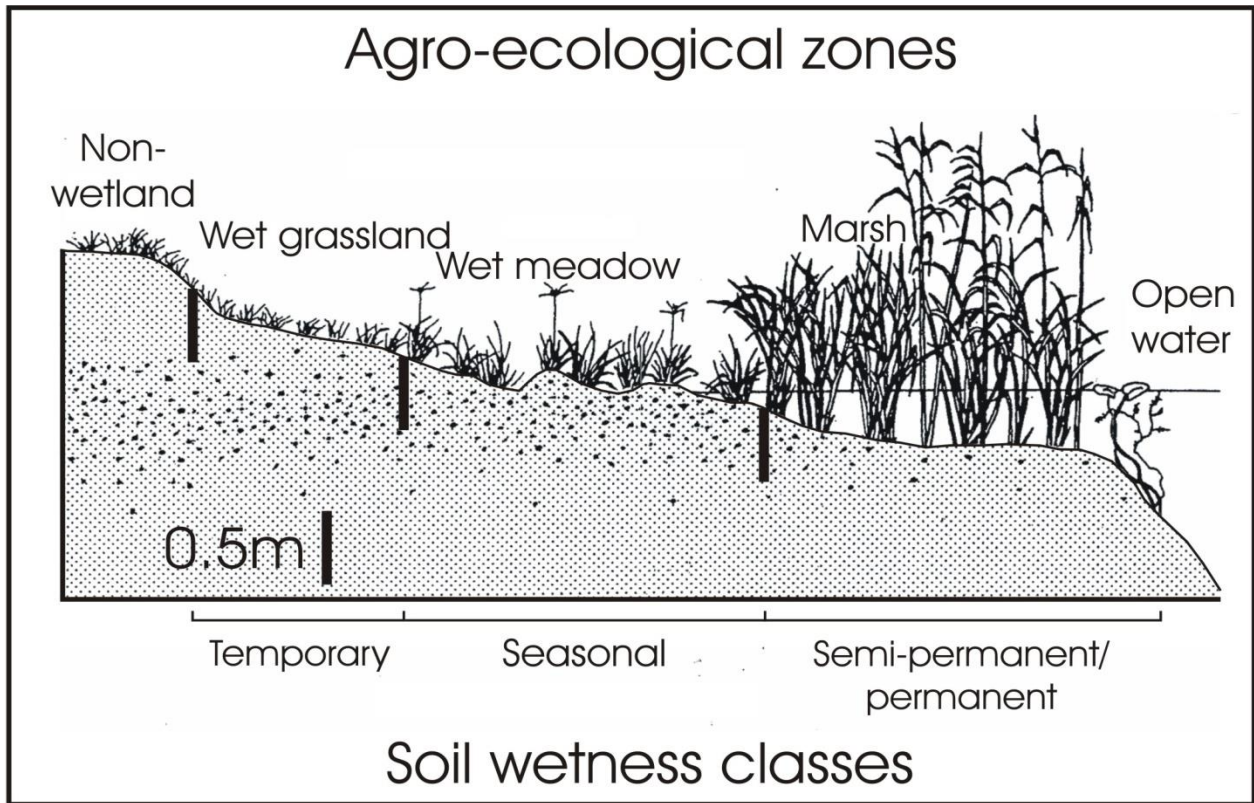
Figure 4: Illustrates the soil wetness classes.

This wetland indicator identifies the morphological “signatures” developed in the soil profile as a result of prolonged and frequent saturation. According to DWAF guidelines, soil wetness is the most important indicator of wetland occurrence. This is because, compared to the vegetation indicator, soil wetness is not seasonally dependant. Wetland indicators remain in the soil as ‘markers’ of wetness even during the drought periods. The soil wetland indicator identifies the signatures which develop in the soil due frequent or prolonged saturation. The different zones of the wetland are delineated by the change in colour of the soil. The permanent zone has few mottles and gleyed; the seasonal zone has many mottles and gleying within 0.5 m depth of the soil profile; the temporary zone has few mottles and gleying of soil within 0.5 m depth of the soil profile. See diagram below for soil wetness classes (figure 4).

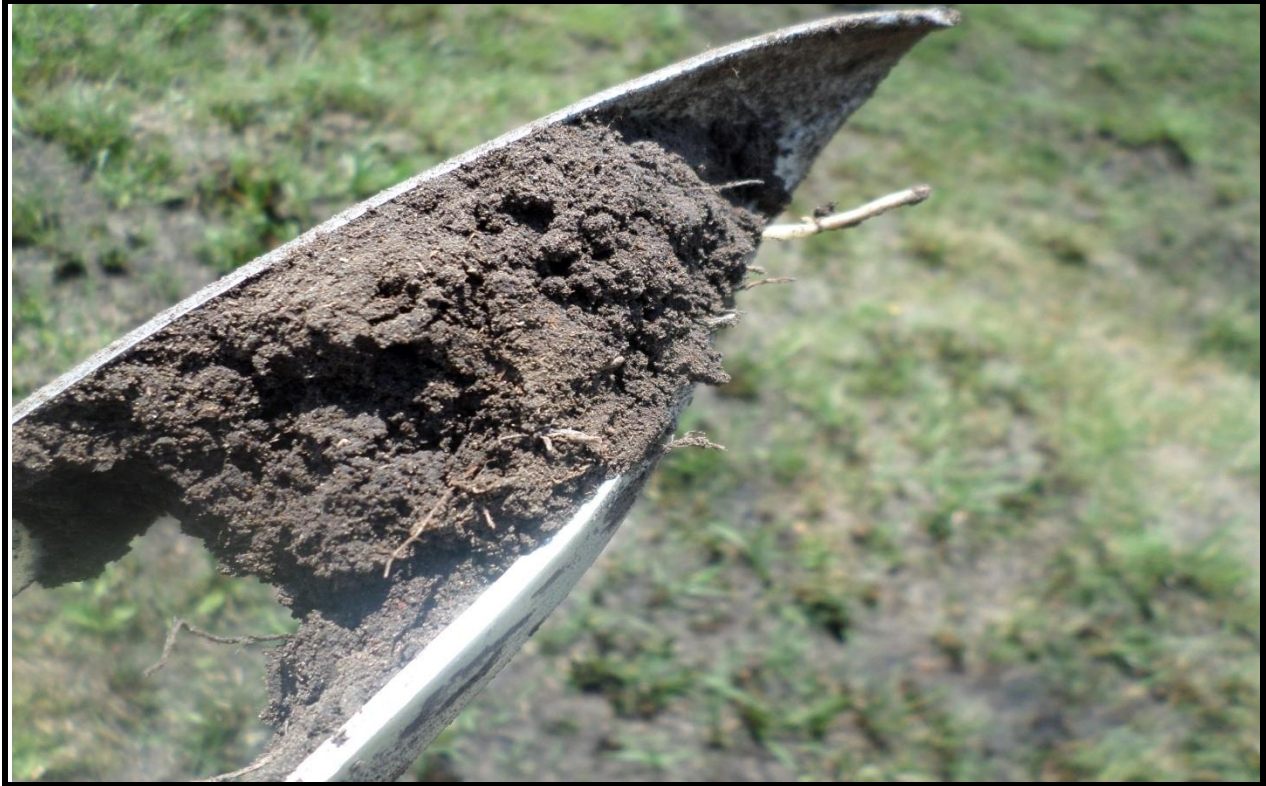
Figure 5: Indicates soil samples taken for soil wetness indicator during field study.

All sampled sites along the stream did not present the soil marker indicators that are typically associated with wetland soils (figure 5). This wetland indicator alone suggests that; no functional wetland found around the study area. The findings suggest that what was observed in the study area can be identified as semi-perennial stream or channel. The proposed development of residential area shows to have little negative impacts on the surrounding soils and water courses; however mitigation measures were implemented to minimize the impact.

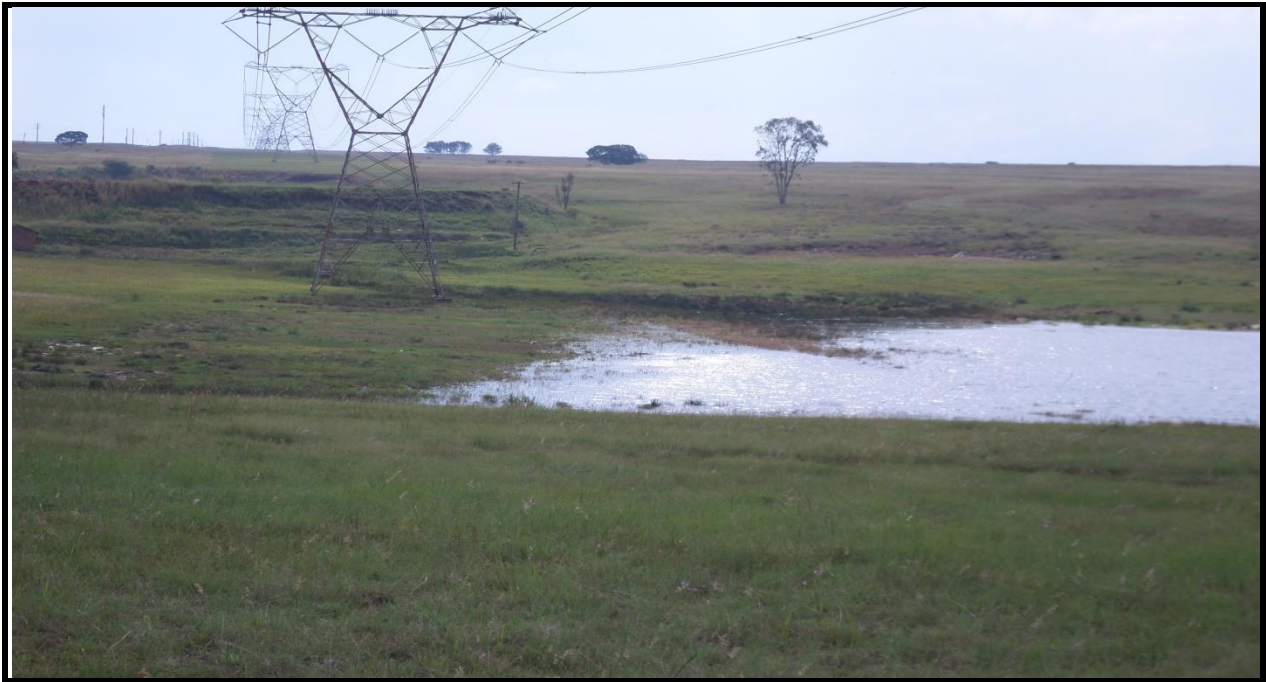
Photo plate 1: A farm dams in potion 0 of Tweedam 377 J.S farms.

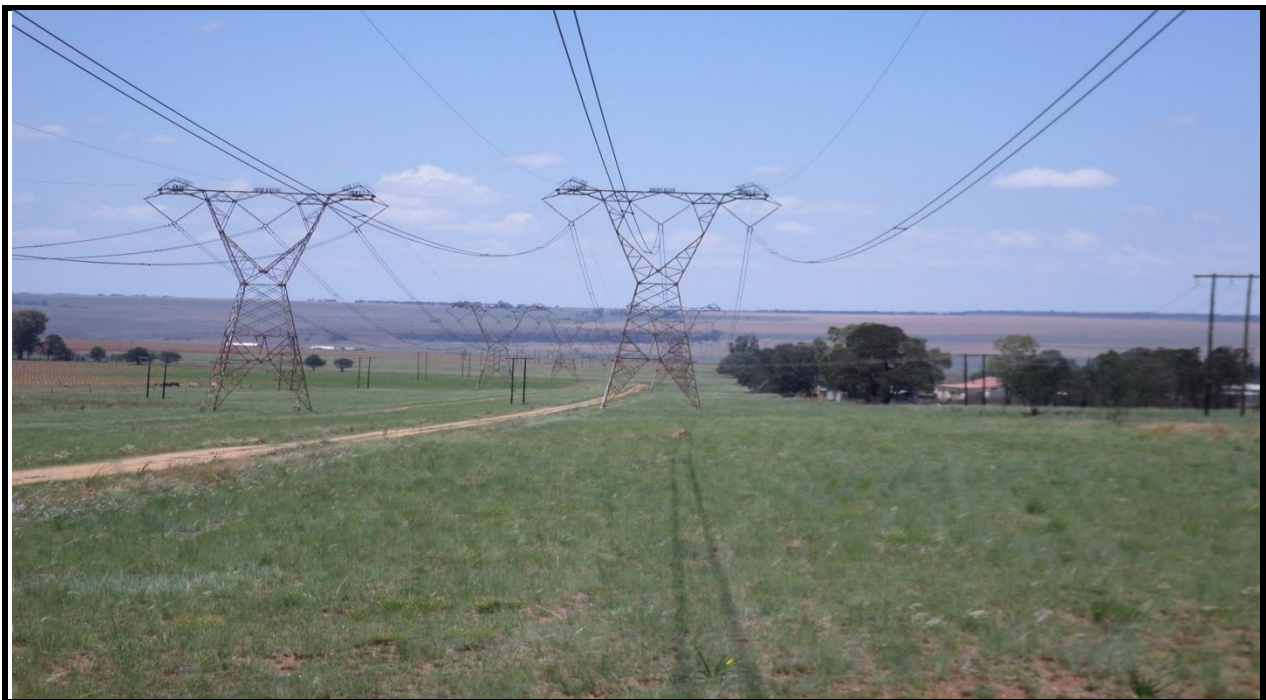
Photo plate 2: Electrification as typical example of land use of the study area in Leeuwpoort 283 J.S farm.

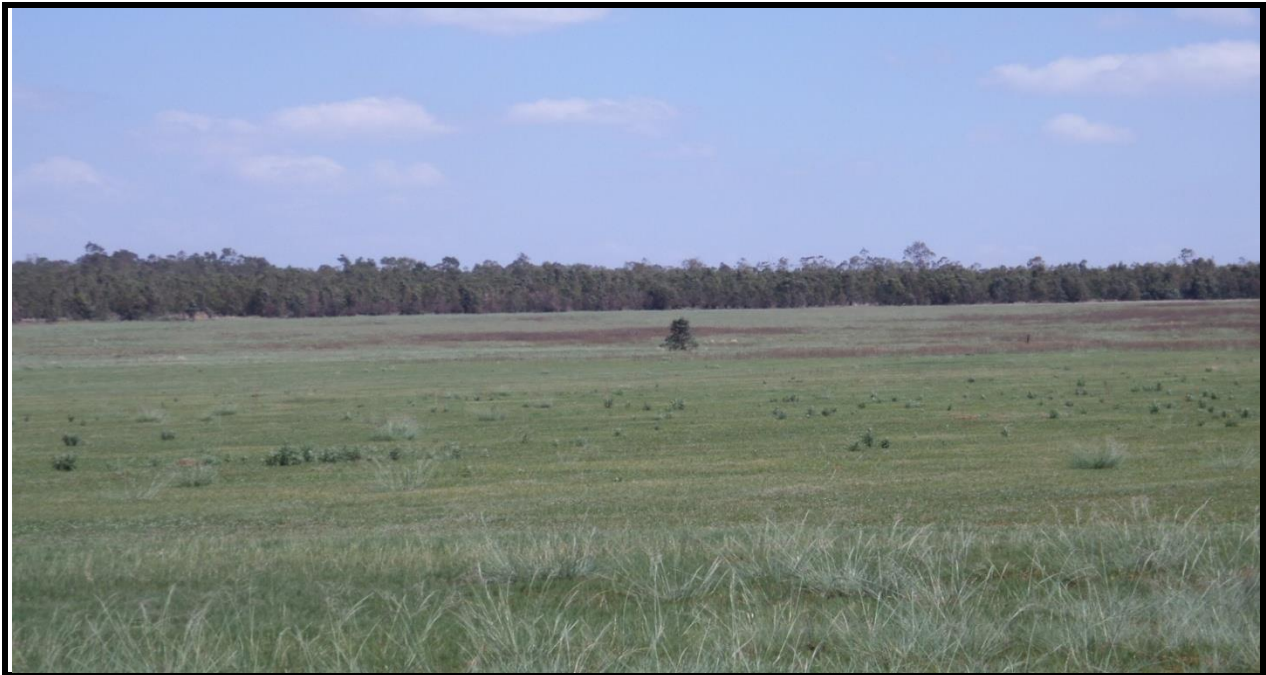
Photo plate 3: A previously cultivated land in the study area, in Leeuwpoort 283 J.S farm.

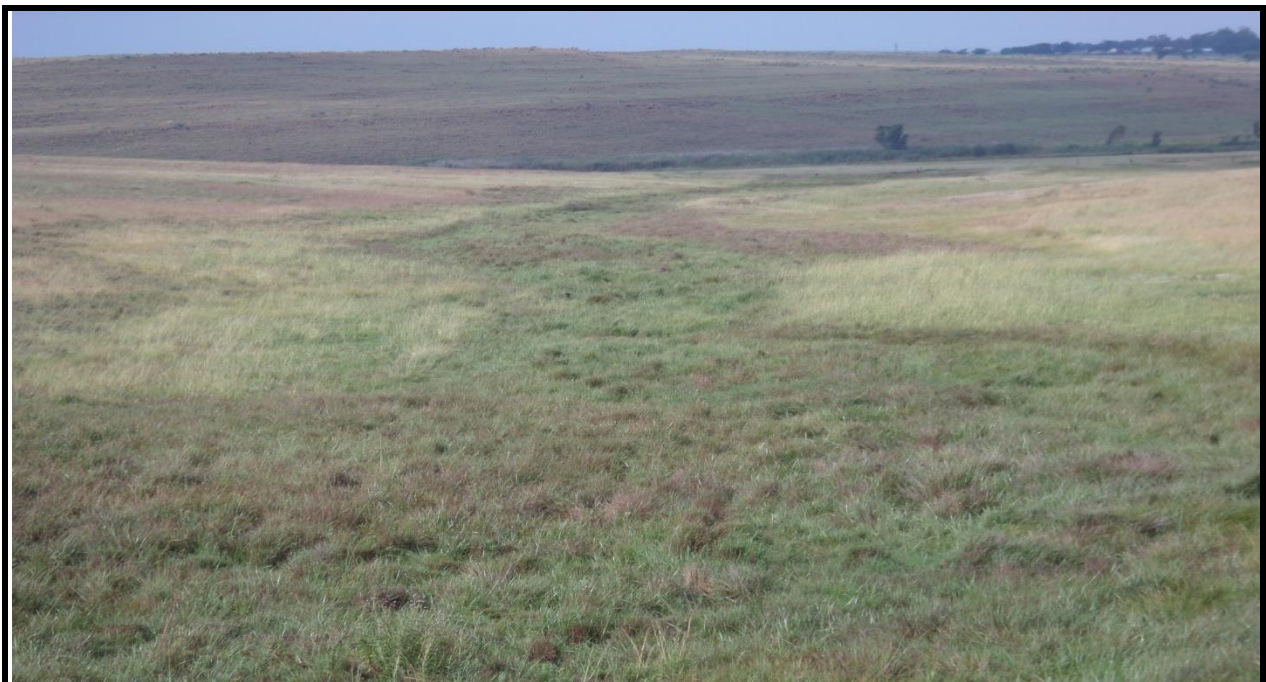
Photo plate 4: A Valley bottom wetland observed in the study area.
