**FINAL BASIC
ASSESSMENT REPORT
FOR MULTIPLE PROJECT
ON RAVENSCOURT
257KU AND CASTLETON
260KU, SINGITA, SABI
GAME RESERVE**

Final Basic Assessment Report for multiple projects at Singita, Sabi Sands Game Reserve, Bushbuckridge Local Municipality (MP325), Mpumalanga.

June 2019.

1/3/1/16/1E-213

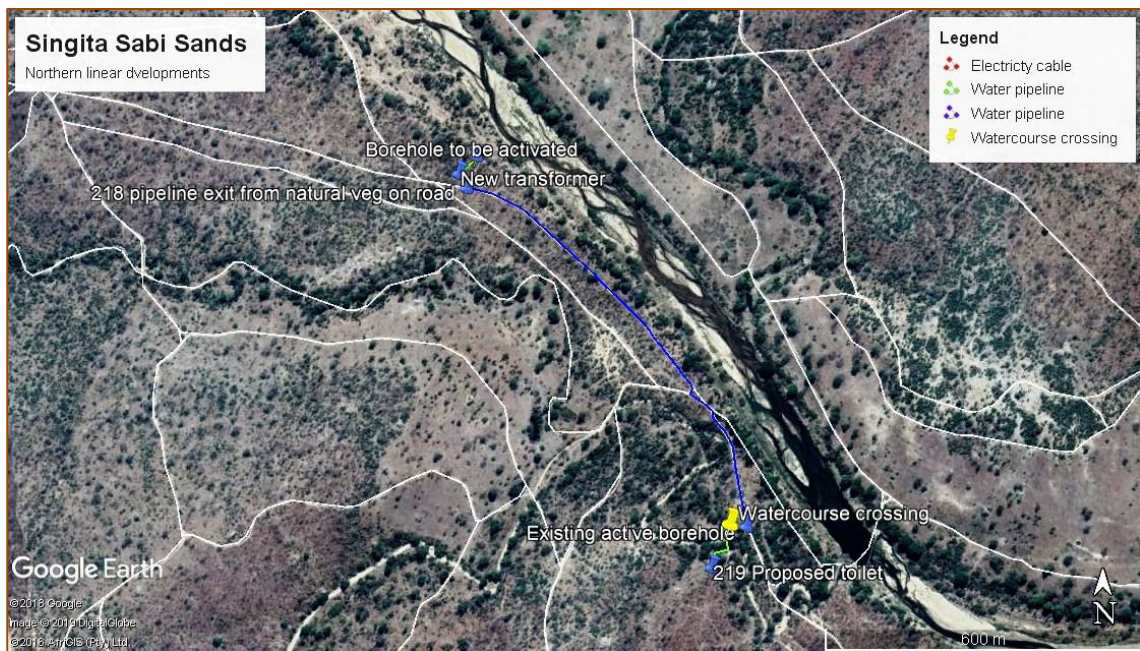
Figure 6: The position of the northern linear developments and related components on Ravenscourt 257KU.

The localities of the development components described above are illustrated in Figure 6 to Figure 9. Note that due to the electricity cable being laid in the same trench as the water pipeline, it is not visible in the illustration but is between the borehole and the new transformer.

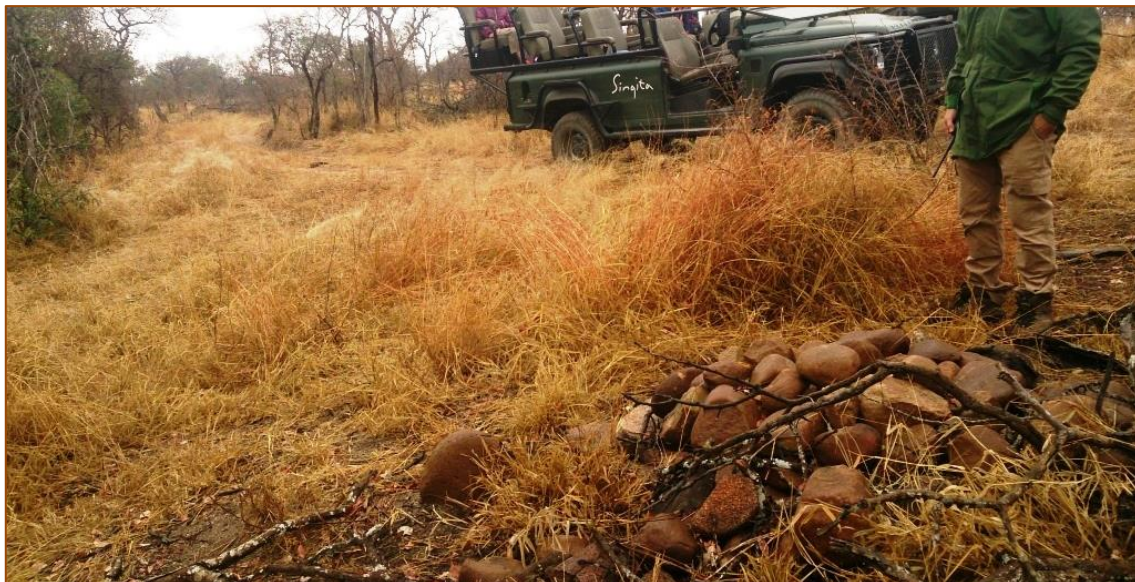
Figure 7: The existing borehole to be activated (© K Zunckel).

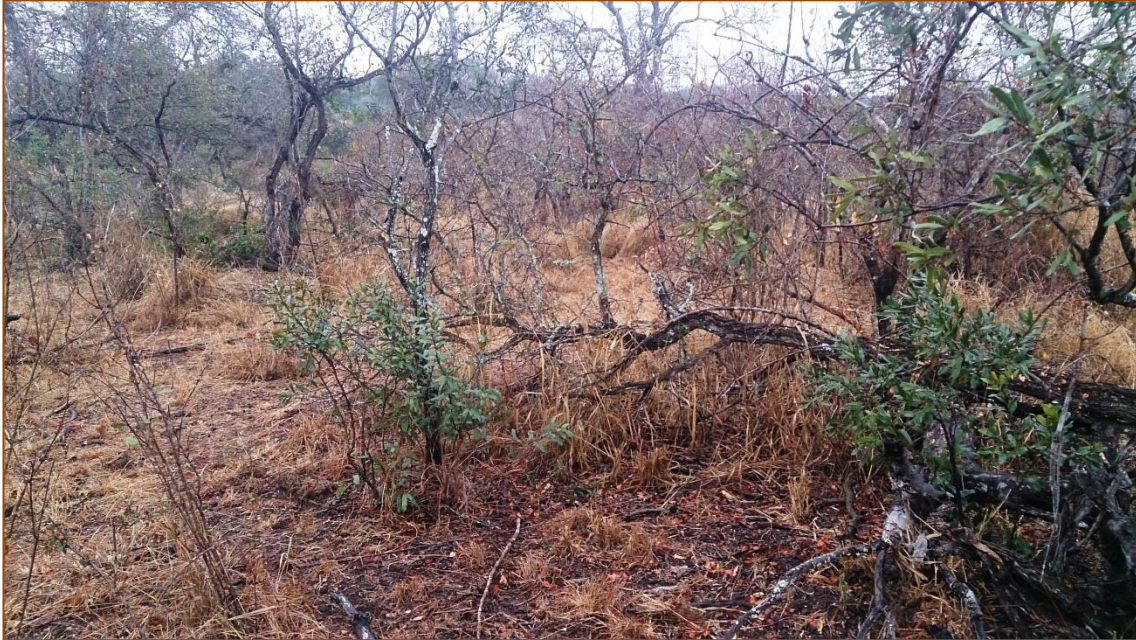
Figure 8: Position for the new transformer and where the electricity cable will be trenched through untransformed indigenous vegetation (© K Zunckel).

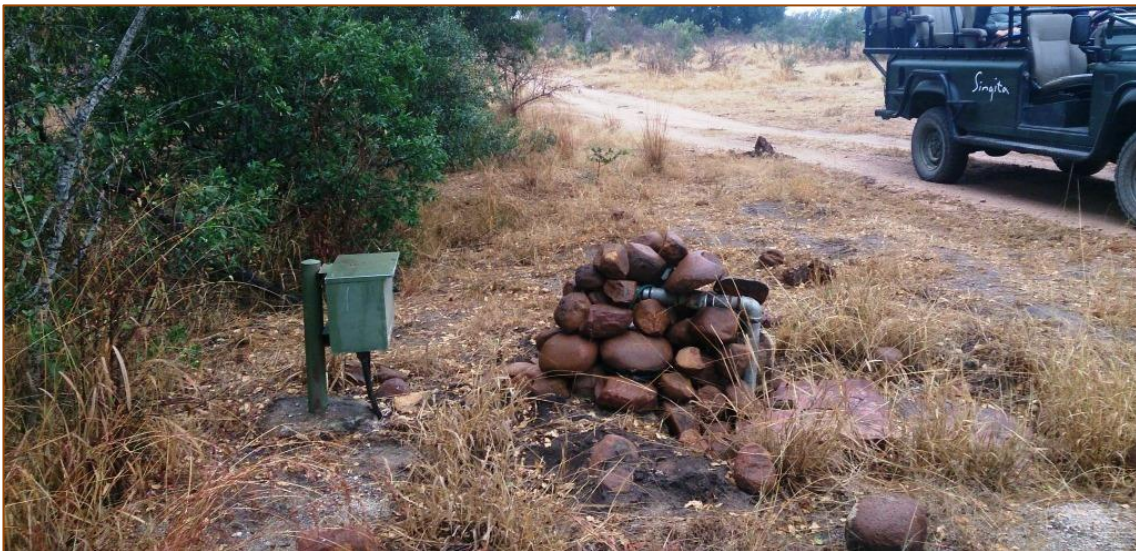
Figure 9: The existing and active borehole at the end of the proposed new water pipeline (© K Zunckel).

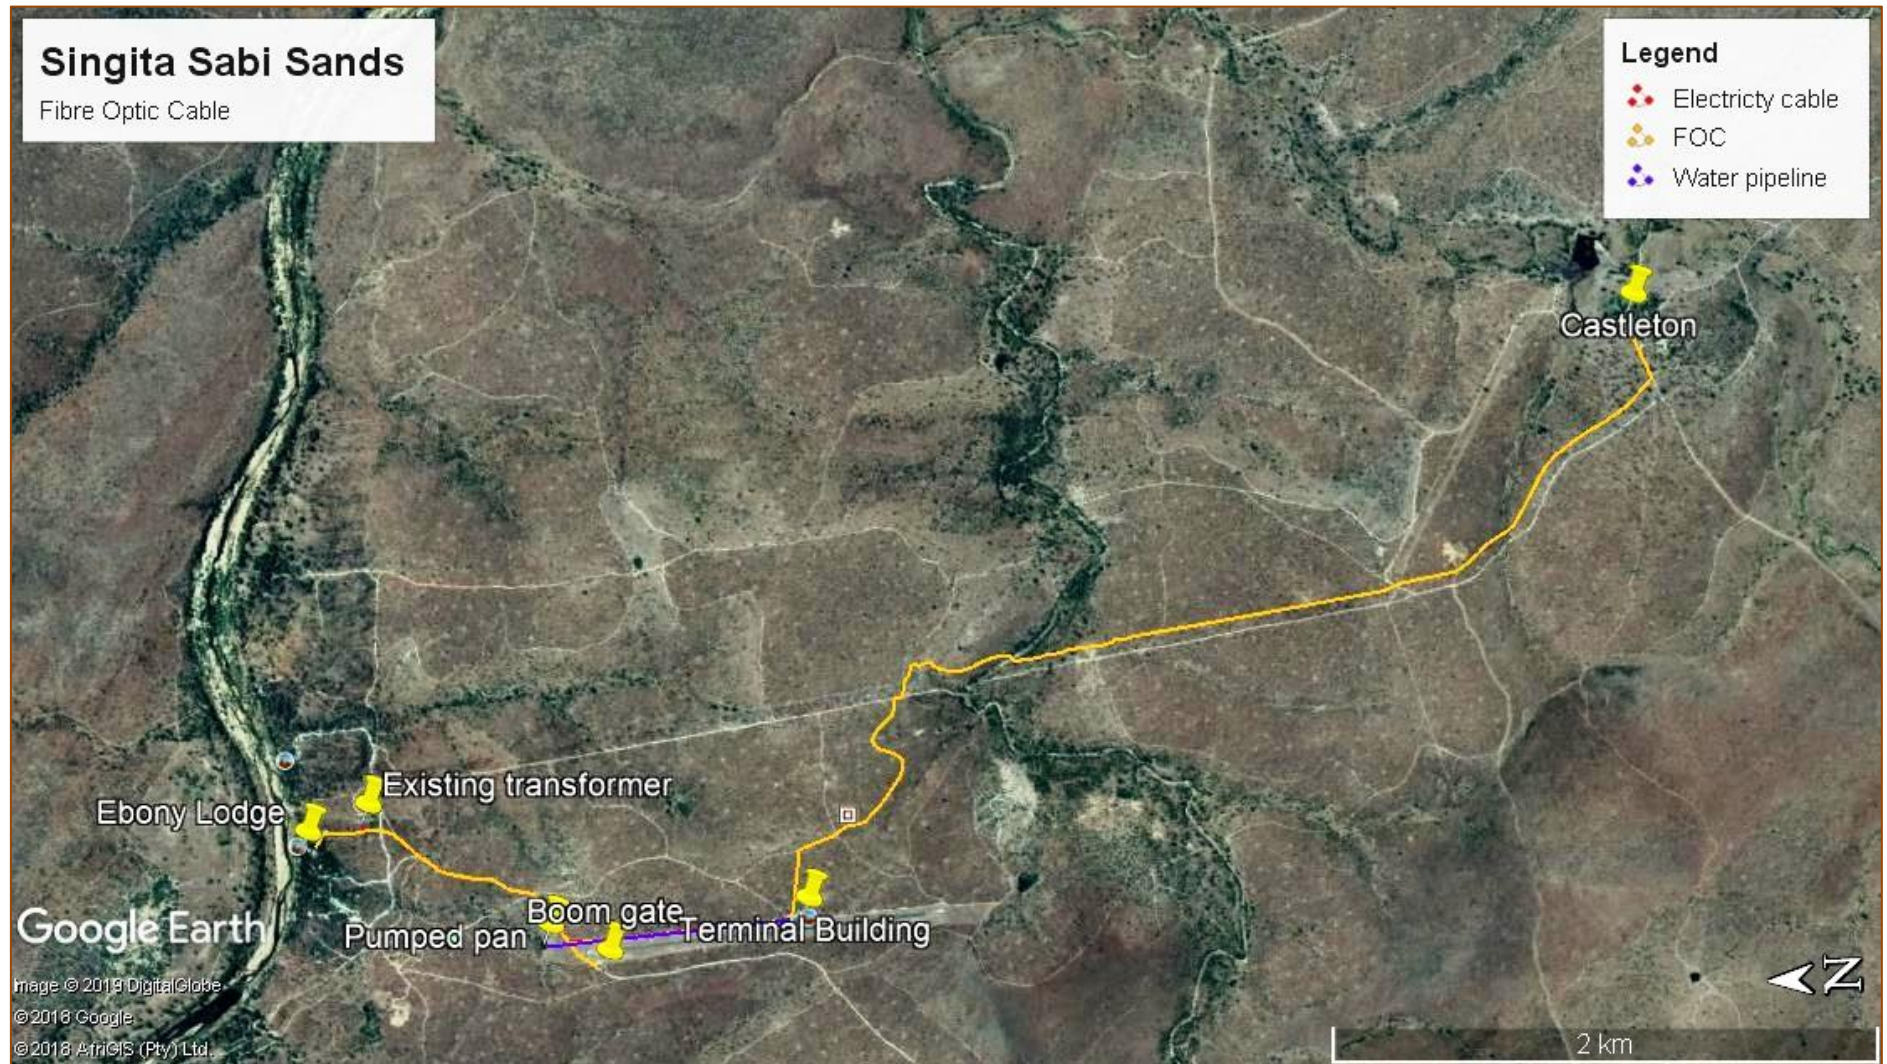
Figure 10: The FOC route from Ebony to Castleton inclusive of the electricity cable and water pipeline.

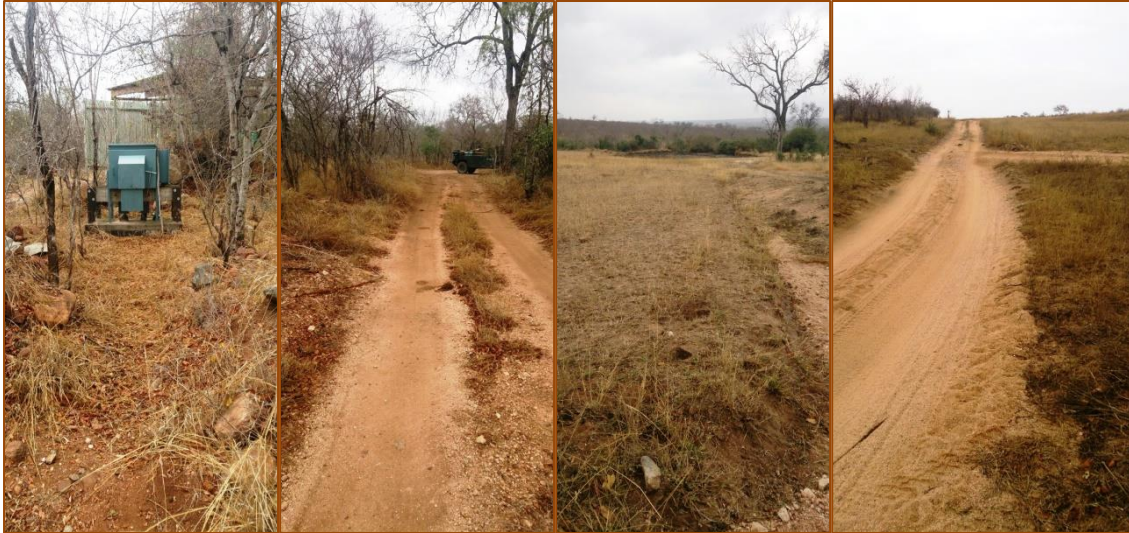
Figure 11: From left to right the existing transformer, the access road to the guest drop-off at the lodge, looking north from the junction point to the pumped pan and looking south along the eastern service road adjacent to the airstrip (© K Zunckel).

boom gate access control point. Illustrations of key points described here are provided in Figure 10 to Figure 14.

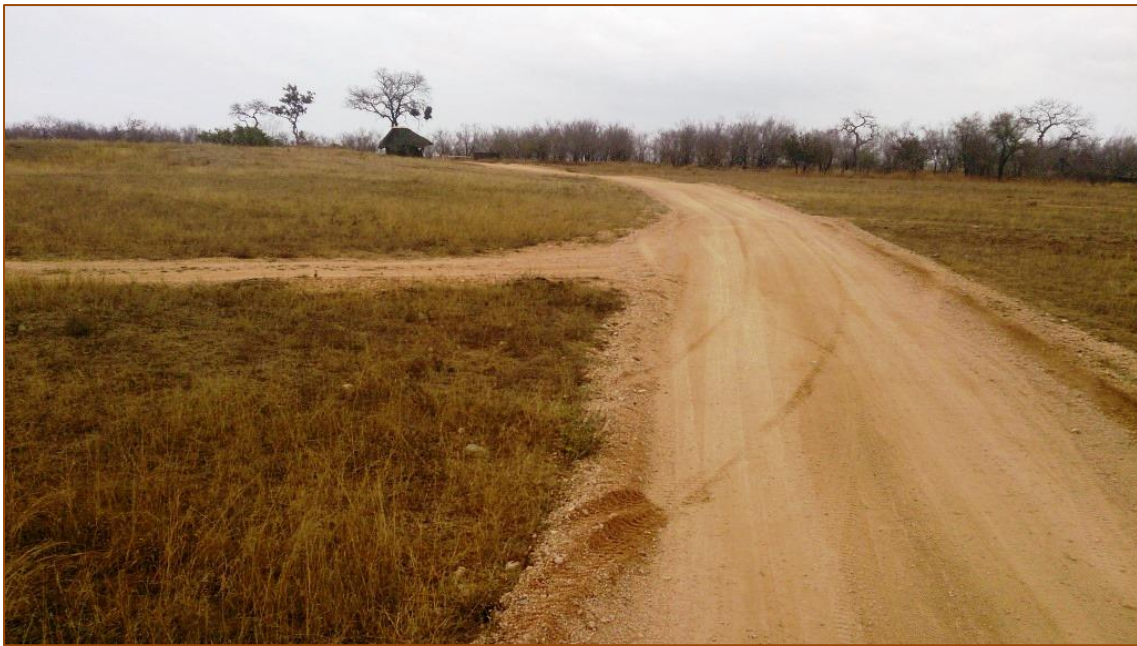
Figure 12: View to the south west from the junction point to the boom gate (© K Zunckel).

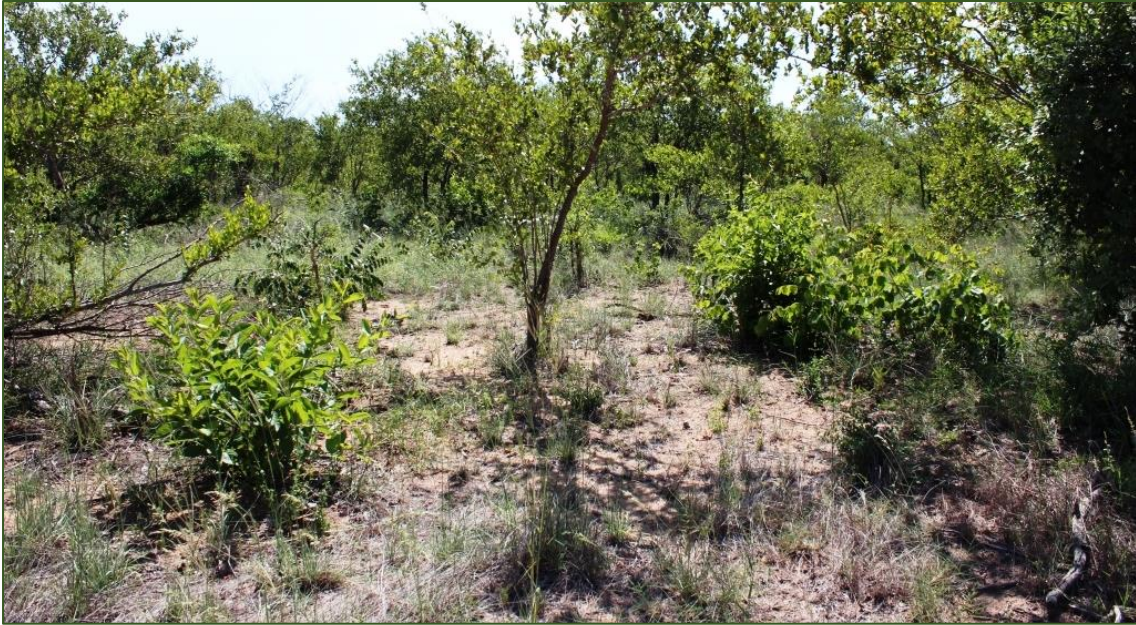
Figure 13: The view looking west from the Pangolin North Road towards the terminal building (© K Zunckel).

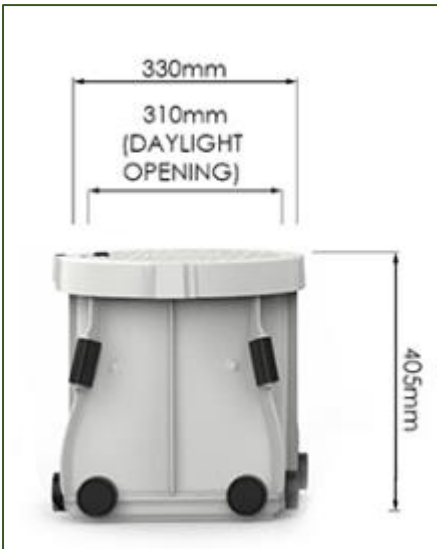
Figure 14: The design and dimensions of the manholes that will be inserted approximately every 100m into the trench for the FOC.

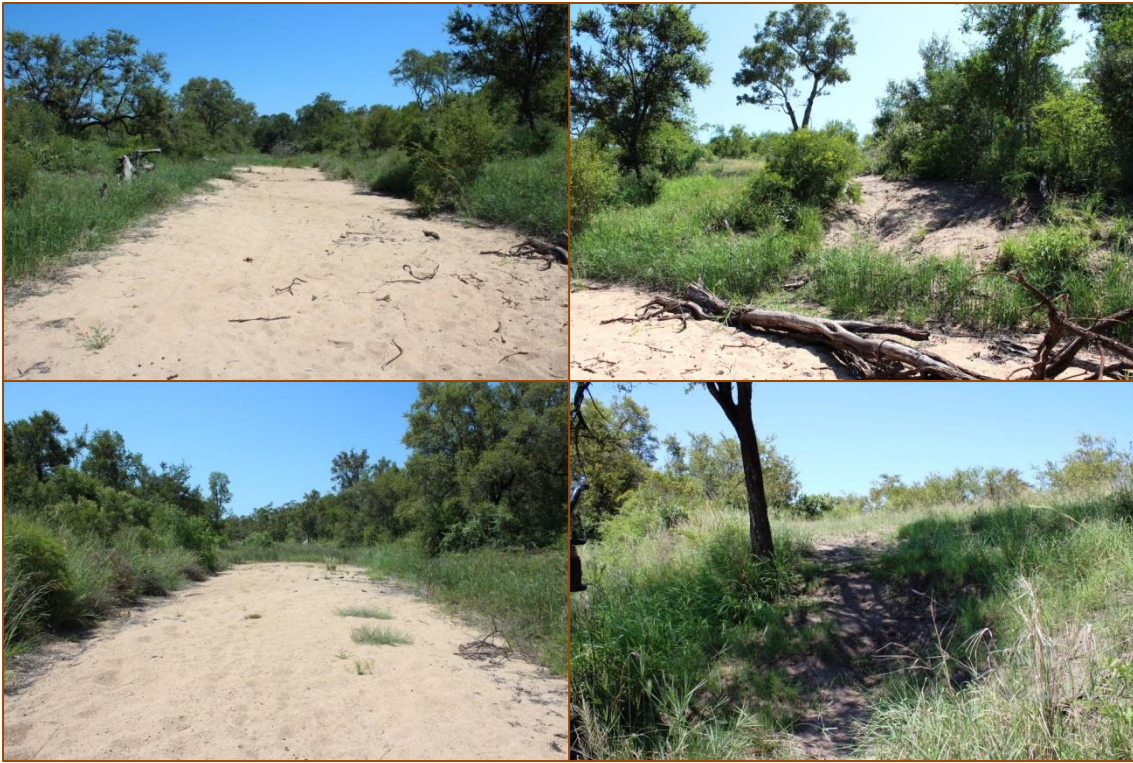
Figure 15: Clockwise from top left is the major watercourse looking upstream, looking to the northern access point, looking downstream and looking to the southern access point (© K Zunckel).

Within approximately 400m moving south in the tracer belt, the FOC trench crosses a significant but non-perennial watercourse at 24°48'38.24"S and 31°25'53.56"E, another 1st order non-perennial watercourse just less than 400m further on at 24°48'50.90"S and 31°25'55.29"E, and another 1.5km further on at 24°49'37.97"S and 31°26'7.03"E. The watercourse crossings will be trenched to 1m depth and the conduit encasing the FOC will be anchored to gabions also sunk below the surface of the watercourse. These crossing

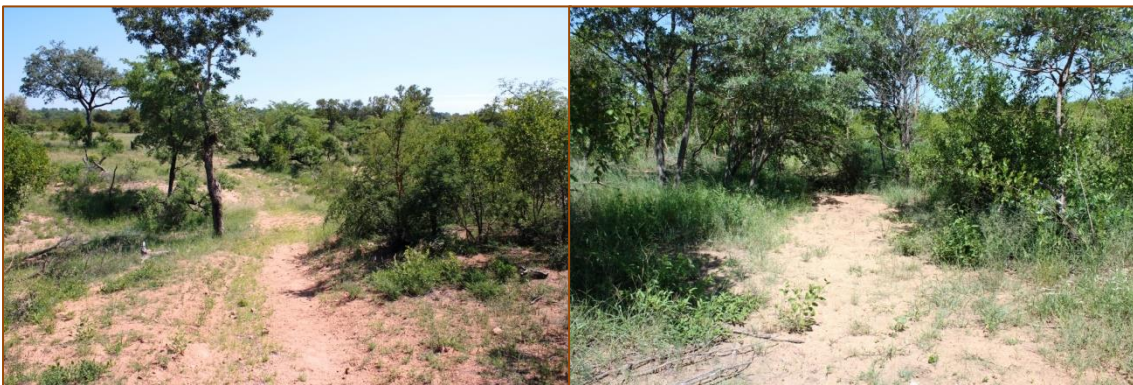
Figure 16: From left to right approaching the 2nd watercourse crossing from the south and looking upstream within the 3rd watercourse crossing (© K. Zunckel).

are illustrated in Figure 15 and Figure 16.

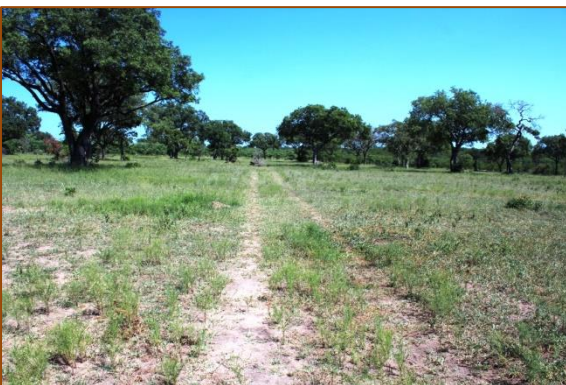
Figure 17: Looking north up the tracer belt from the point at which the FOC route emerges just before Castleton (© K Zunckel).

Approximately 800m further to the south east the route emerges from the tracer belt on to the main access road to Castleton at 24°49'56.50"S and 31°26'26.36"E. Figure 17 provides a view of this portion of the route looking north from this point. Here it can be seen that the tracer belt has retained its untransformed character despite the annual mowing and scarification.

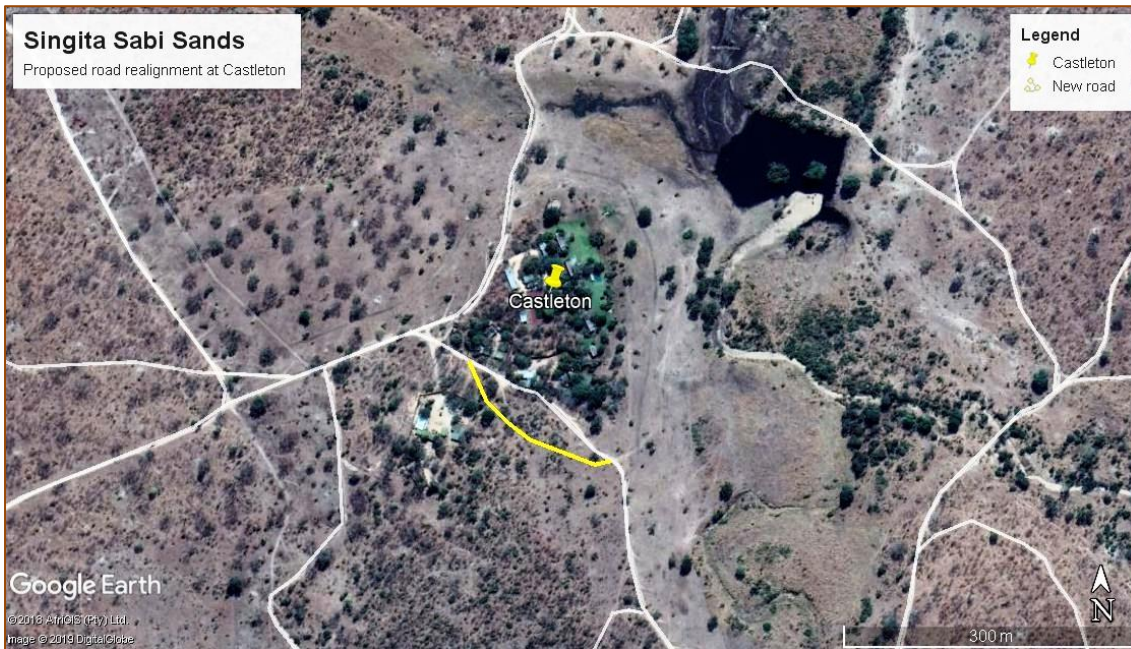
Figure 18: The proposed road realignment at Castleton.

The road realignment at Castleton involves approximately 200 meters of twin track and the rehabilitation of the existing road as illustrated in Figure 18. The coordinates for the route of the proposed new road from the north west to south east are as follows:

- Start point: 24°49'56.25"S and 31°26'31.99"E;
- Mid-point: 24°49'58.70"S and 31°26'33.96"E; and
- End point: 24°49'59.50"S and 31°26'37.11"E.

The new road will be constructed simply by driving over the route repeatedly to create the twin tracks. The route will be carefully placed to avoid all threatened and protected plants. Where avoidance is not possible, the plants will be removed and transplanted as part of the rehabilitation of the existing road. The existing road surface will be broken up, seeded with a mix of indigenous grass seed and covered with brush.

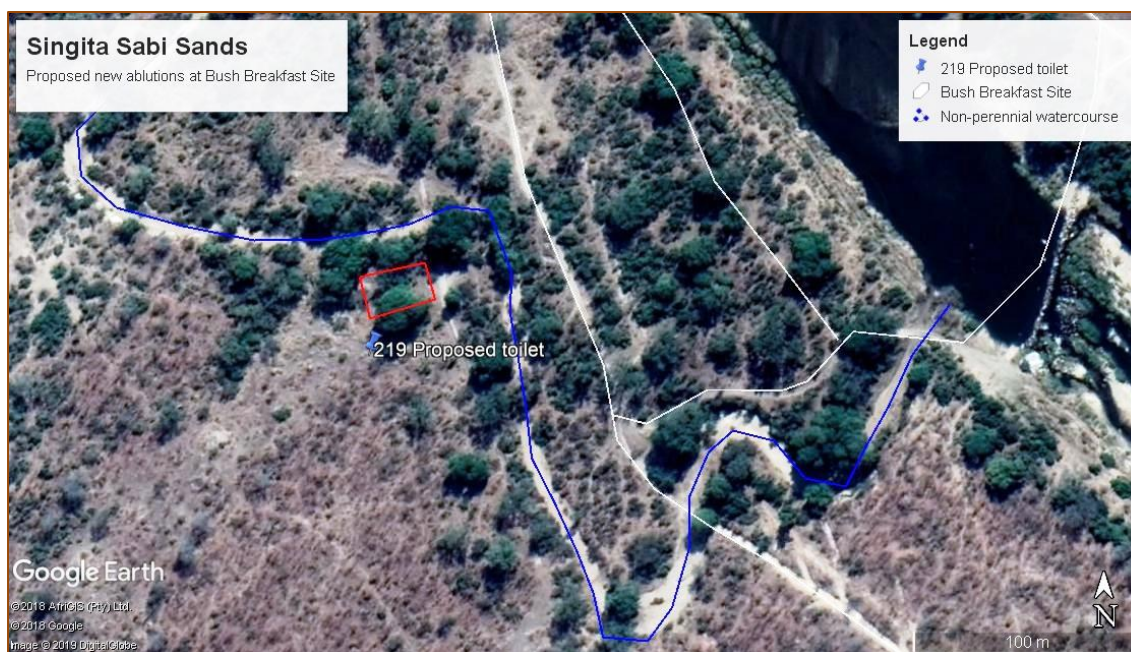
Figure 19: The locality of the proposed new ablutions at the Bush Breakfast Site to the west of the Sand River.

Two toilets with wash hand basins will be installed in a single block, located more than 32m from the edge of the adjacent non-perennial water course as illustrated in Figure 19 and at coordinates 24°47'3.95"S and 31°25'3.85"E. The building will be constructed of brick and mortar on a concrete slab and will be screened from the Bush Breakfast Site. Waste water will be directed via gravity to a

French drain and soak-away towards the south west and further from the water course. Water will be provided from the activated bore hole and pipeline described in Section 3.2.1.1 and will be stored in the roof of the facility.

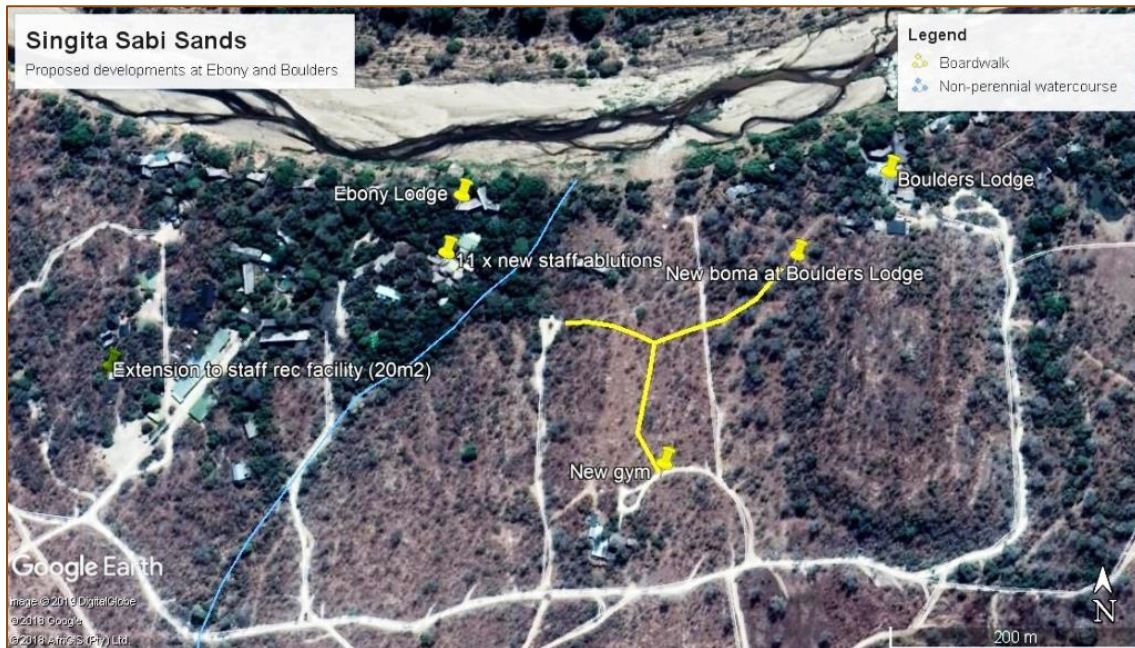
Figure 20: The proposed new developments at Ebony and Boulders Lodges

The details related to the proposed new developments at the Ebony and Boulders Lodges are captured in Table 2 working from the west to the east. Figure 20 shows the localities of these sites relative to each other and the existing infrastructure. A total of approximately 500m² of untransformed indigenous vegetation will be disturbed by these development components.

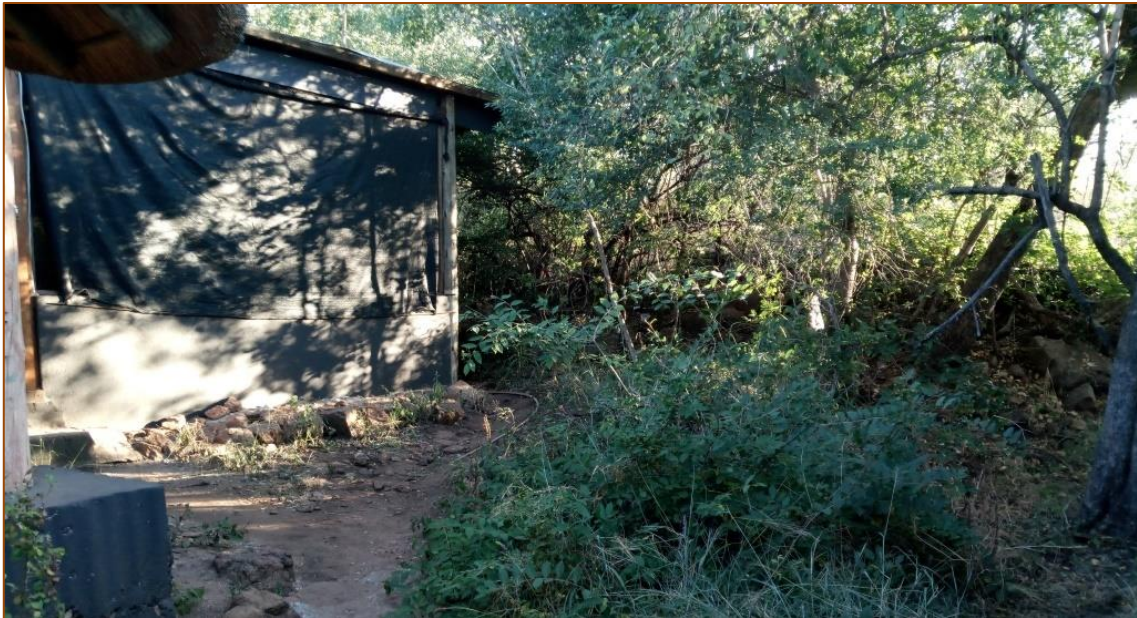
Figure 21: The area into which the existing staff recreation facility is to be extended (© K Zunckel)

DEVELOPMENT COMPONENT	DESCRIPTION	SITE CENTRAL COORDINATES
Extension to existing staff recreation facility - Ebony	A 20m ² extension to the existing staff recreation facility will require the clearing of some undisturbed indigenous vegetation (see Figure 21).	24°47'16.92"S 31°25'22.68"E
Staff ablutions - Ebony	Eleven (11) additional staff ablation facilities varying in size from 4.04m ² to 12.33m ² and totalling 44m ² to service rooms 2 to 6, 9, 10 and 17 to 20 (see Figure 22 to Figure 24). All are within 32m of an adjacent watercourse, are in close proximity to each other and in an existing development footprint in the staff village. Waste water from the new ablutions will feed into the existing reticulation and treatment works.	24°47'13.80"S 31°25'32.16"E
New gym and raised boardwalk	The existing gym and spa are to be converted to serve as a spa only. The new gym (216m ²) is proposed to be built just to the	24°47'18.84"S 31°25'37.98"E

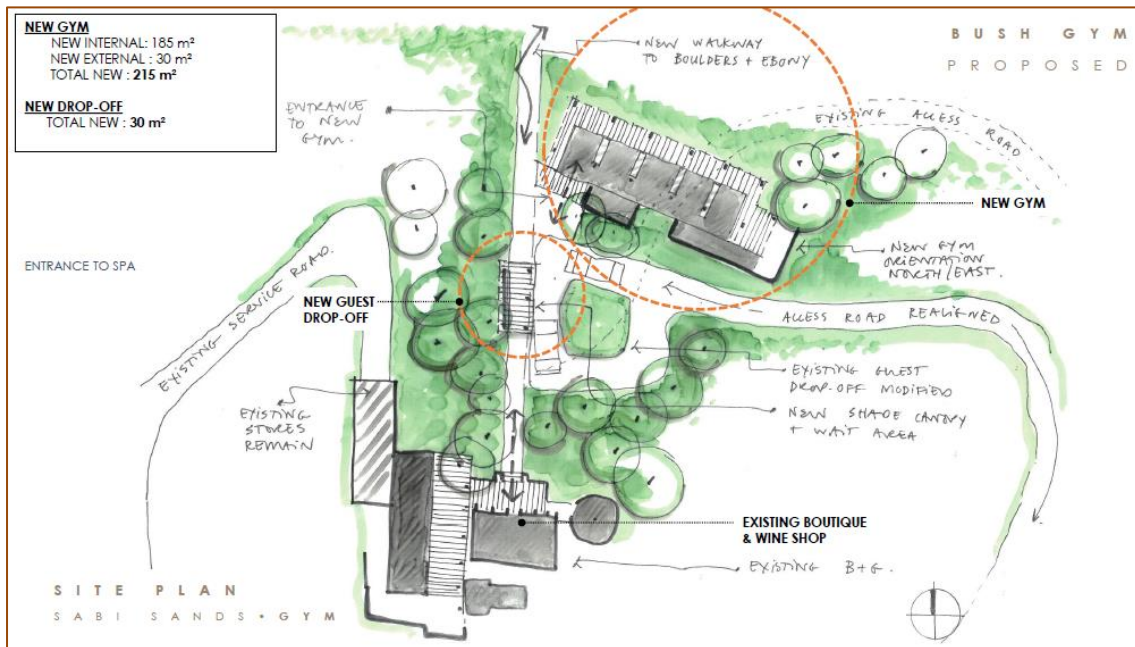
Figure 26: The proposed layout for the new gym in relation to the existing boutique and wine shop.

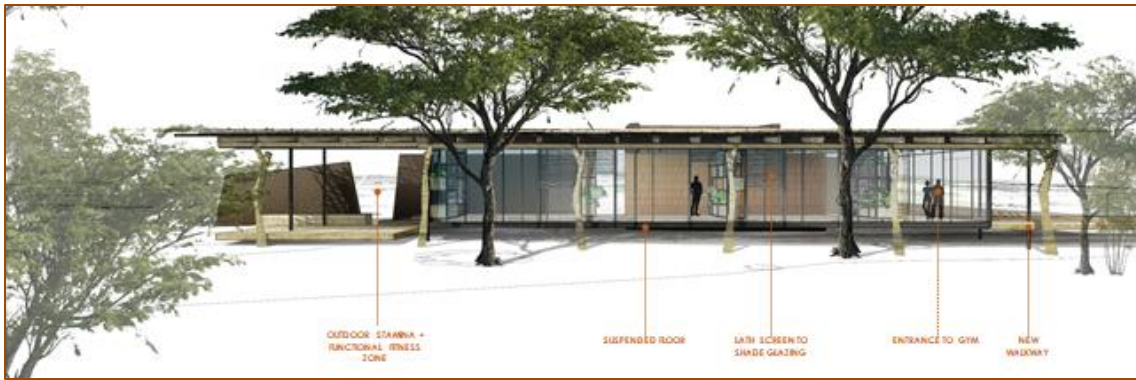
Figure 27: Artist's impression of the proposed new gym viewed from the north.

DEVELOPMENT COMPONENT	DESCRIPTION	SITE CENTRAL COORDINATES
	north of the existing boutique and wine shop over the existing access road (see Figure 25 to Figure 29). The latter is to be realigned to route behind the new gym. Ablution facilities in the new gym will be plumbed into the existing reticulation. The gym will be linked to Ebony and Boulders Lodges by a raised wooden boardwalk (see Figure 29).	
New boma at Boulders Lodge	The proposed new boma will cover an area of approximately 180m ² (see Figure 30) and will include a small scullery and gas storage area, as well as a guest toilet; which together will cover another approximately 30m ² . The waste water will be plumbed into the existing reticulation and together with other services, will be secured to the new boardwalk that will link the new boma and new gym. The old boma will be decommissioned and turned into a mix of indigenous bush and gardens.	24°47'13.50"S 31°25'41.76"E

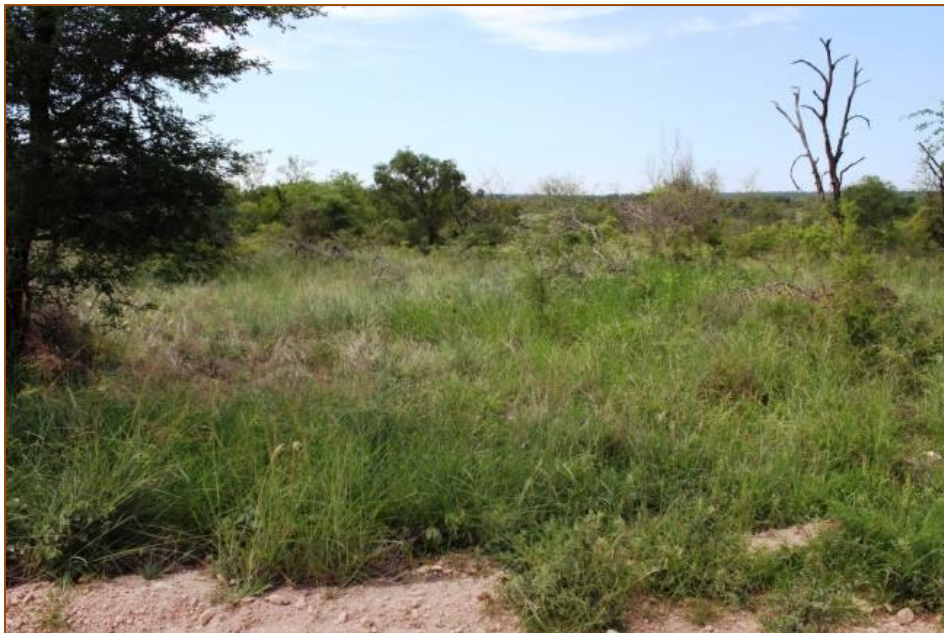
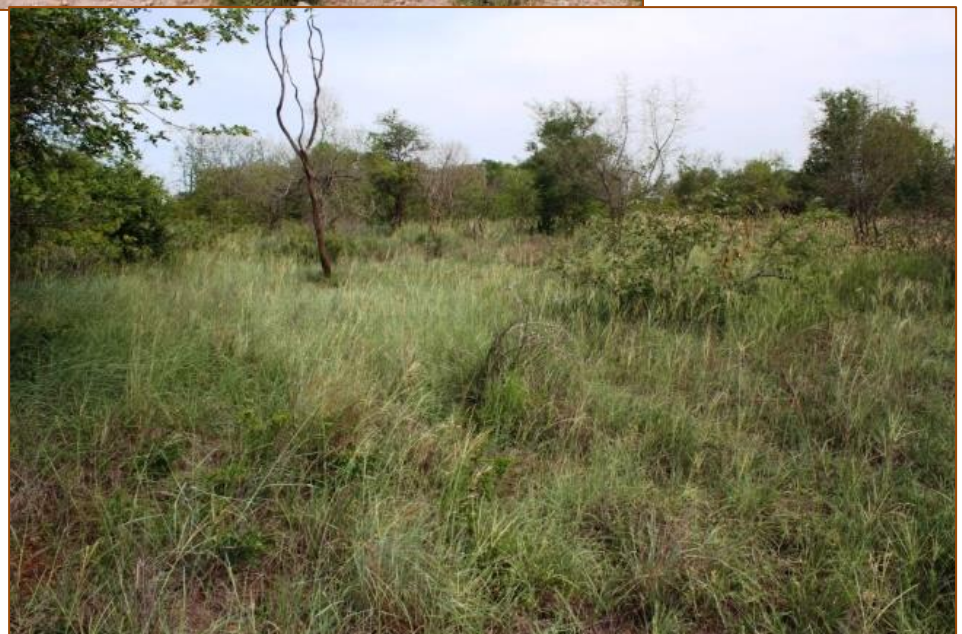
Figure 28: Views of the site for the proposed gym looking to the north west (top) and south east (bottom) of the existing road (© K. Zunckel).

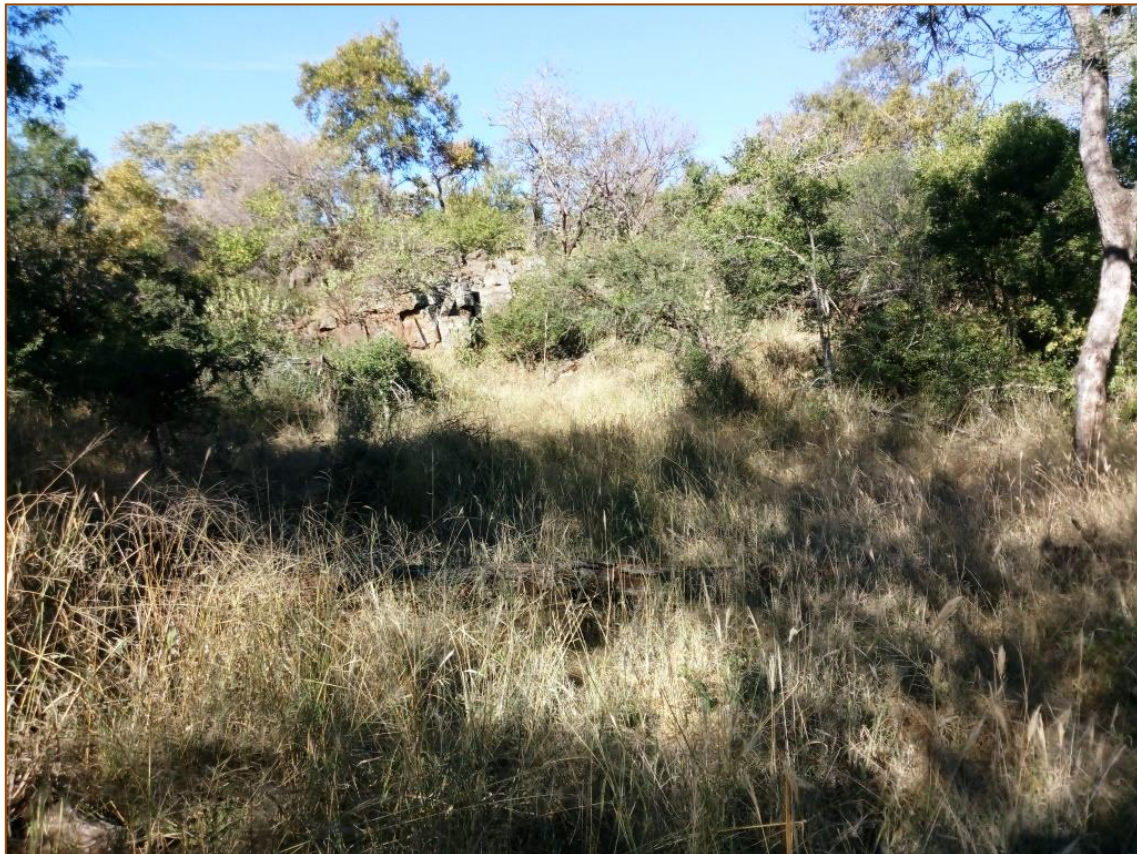
Figure 30: The site for the new boma near Boulders Lodge (© K Zunckel).

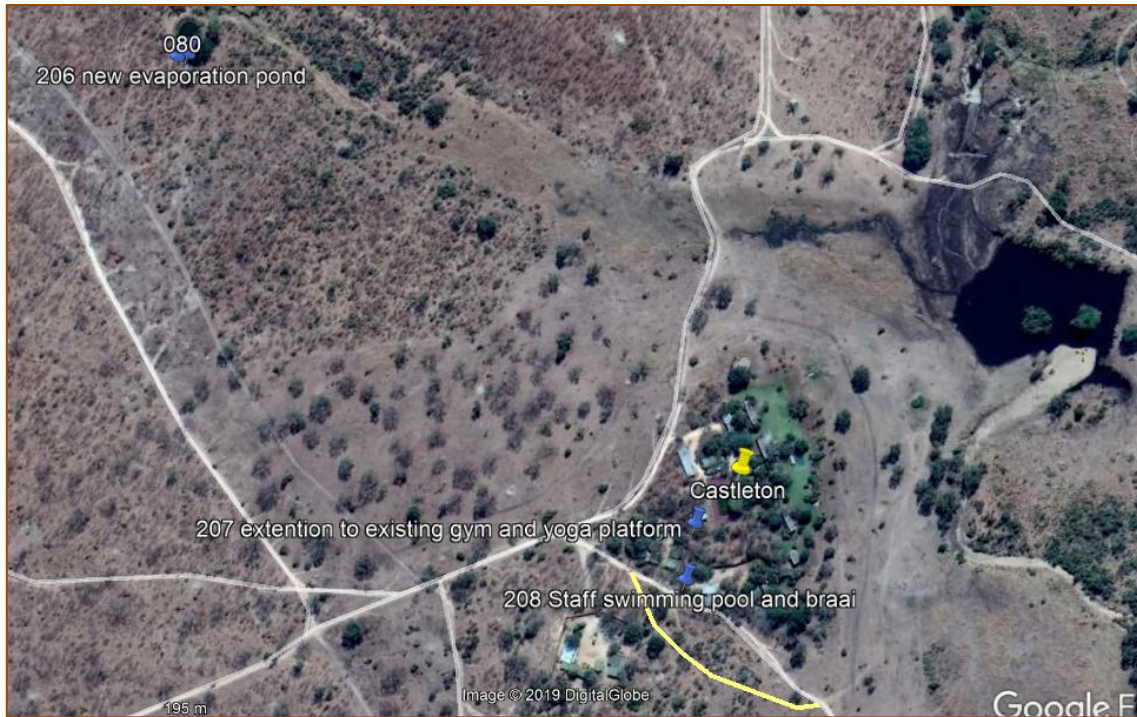
Figure 31: Castleton Camp and the locality of the various developments being proposed.

The details related to the proposed new developments at Castleton Camp are captured in Table 3 working from the north to the south. Figure 31 shows the localities of these sites relative to each other and existing infrastructure. Some detail within the camp is missing from this illustration due to scale but is described together with the coordinates in Table 3. An area of approximately 1000m² of untransformed indigenous vegetation will be disturbed by these development components.

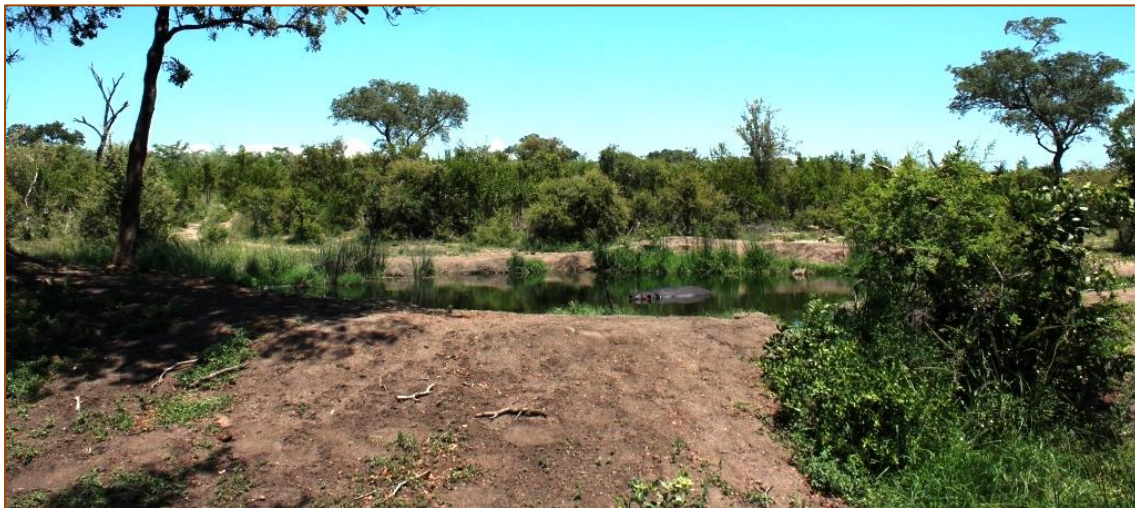
Figure 32: Looking across the existing evaporation pond up slope towards the locality of the proposed new pond (© K. Zunckel).

DEVELOPMENT COMPONENT	DESCRIPTION	SITE CENTRAL COORDINATES
New evaporation pond	<p>Due to an increase in the volume of treated waste pumped to the existing evaporation pond, it is now over flowing. A new pond measuring 30m x 30m is proposed to be located just to the south and upslope of the existing pond, outside of the 32m buffer from the adjacent non-perennial watercourse and avoiding a large Leadwood tree (<i>Combretum imberbe</i>) (see Figure 32)</p>

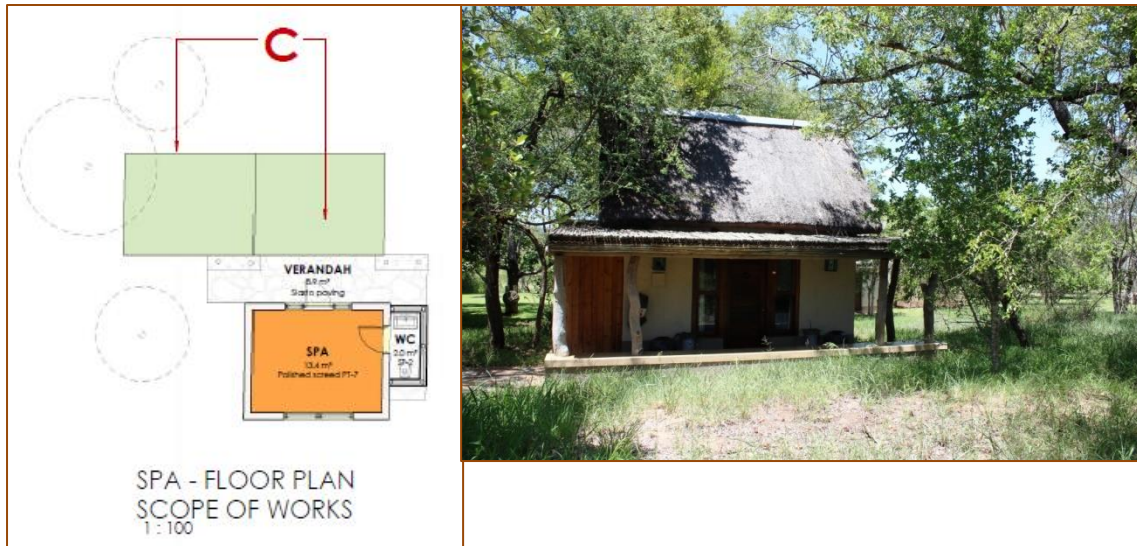
Figure 33: The floor plan showing the proposed two new treatment rooms in front of the existing spa and a front view of the spa (© K. Zunckel).

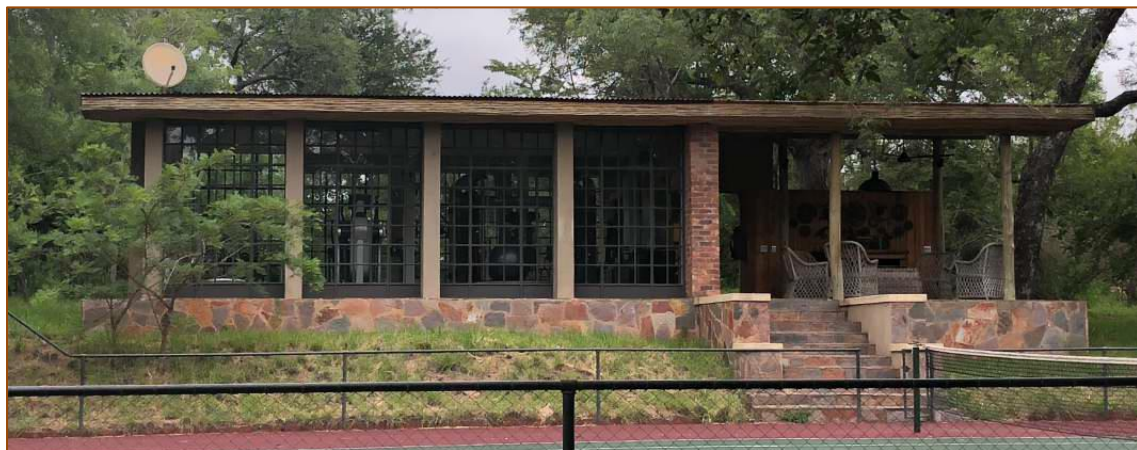
Figure 34: Front view of existing gym (© GAPP).

<p>SPA - FLOOR PLAN SCOPE OF WORKS 1:100</p> <p>). The two ponds will be linked using gabion mattress with wing walls and laying geotextile material inside.</p>	24°49'43.63"S 31°26'19.56"E
New treatment rooms	Convert existing treatment room into a reception area and store and add two additional new treatment rooms under existing trees totalling 40m ² (see Figure 33).	24°49'55.21"S 31°26'35.51"E
Extension to existing gym and new yoga platform	Extend existing gym to create additional workout space totalling 40m ² and link new gym extension to a yoga platform under trees totalling 16m ² (see Figure 34 to Figure 38).	24°49'55.20"S 31°26'33.68"E

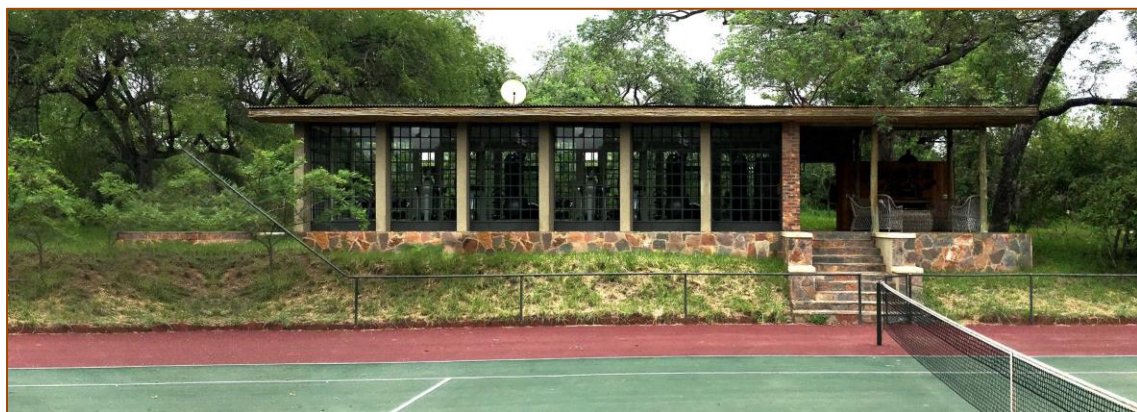
Figure 35: Simulated impression of the extended gym (© GAPP).

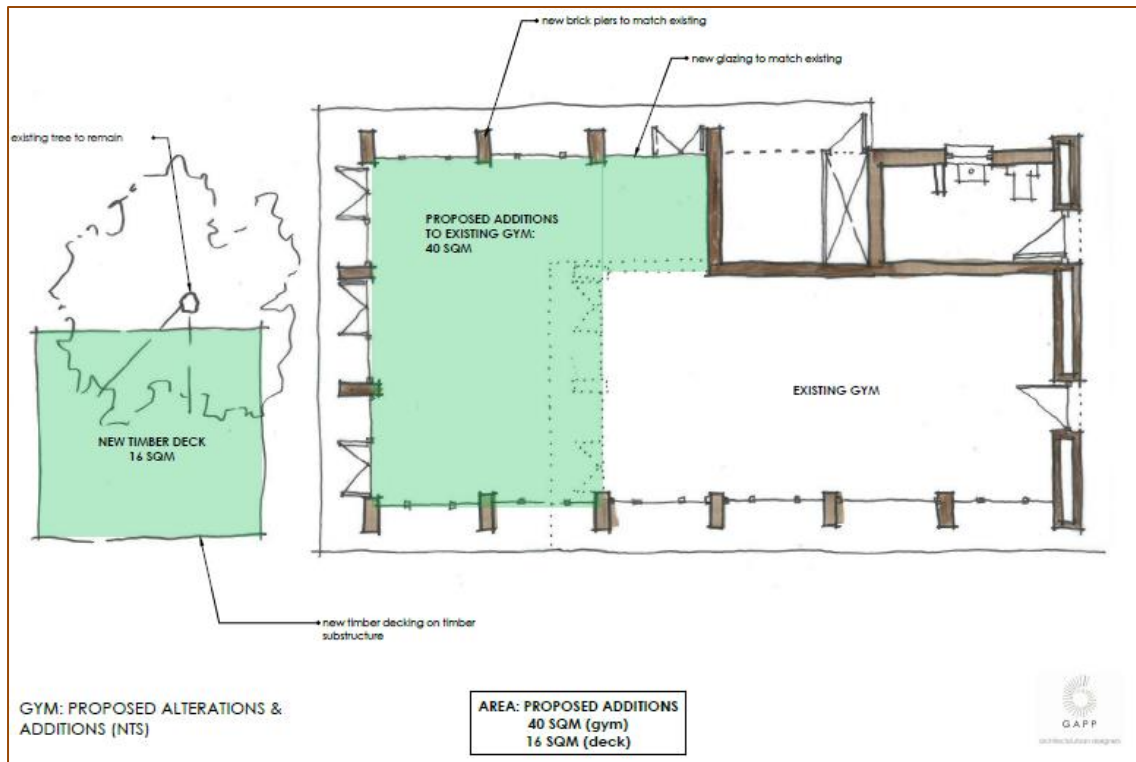
Figure 36: Plan view of proposed extension to existing gym and new yoga platform.

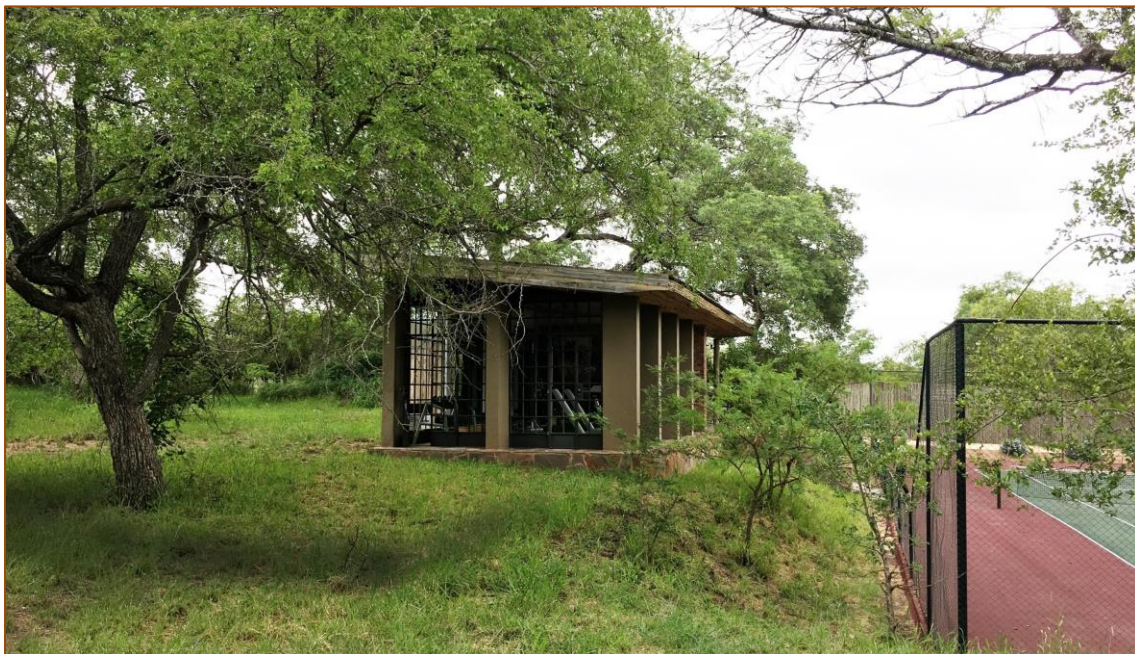
Figure 37: View of the existing gym from the south showing the area into which the extension and new yoga platform are proposed to be located (GAPP).

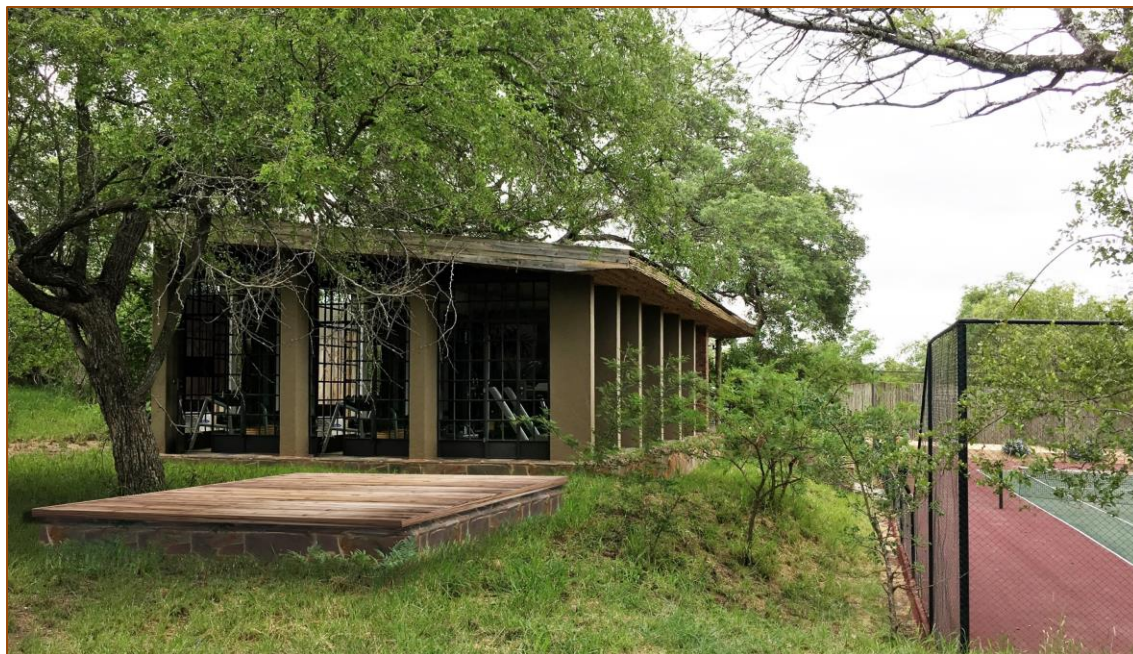
Figure 38: A simulated illustration of the extension to the existing gym and the yoga platform (© GAPP).
