**FINAL BASIC
ASSESSMENT REPORT
FOR MULTIPLE PROJECT
ON RAVENSCOURT
257KU AND CASTLETON
260KU, SINGITA, SABI
GAME RESERVE**

Final Basic Assessment Report for multiple projects at Singita, Sabi Sands Game Reserve, Bushbuckridge Local Municipality (MP325), Mpumalanga.

June 2019.

1/3/1/16/1E-213

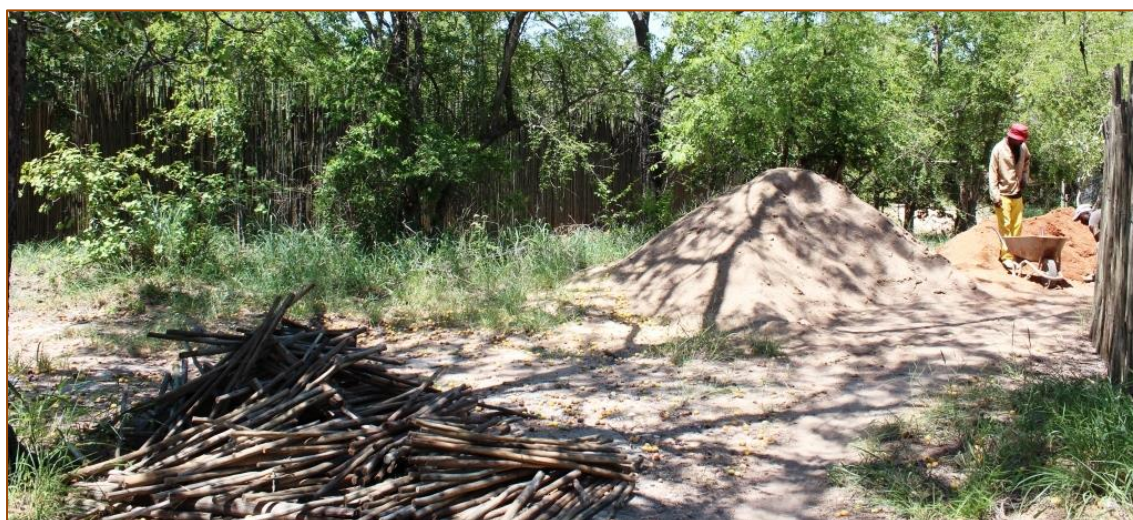
Figure 39: The disturbed site planned for the new staff pool and braai area (© K. Zunckel).

Staff swimming pool and braai area	A staff swimming pool and braai facility totalling approximately 60m ² within an area already disturbed so that vegetation clearance will be minimal (see Figure 39).	24°49'56.60"S 31°26'33.42"E

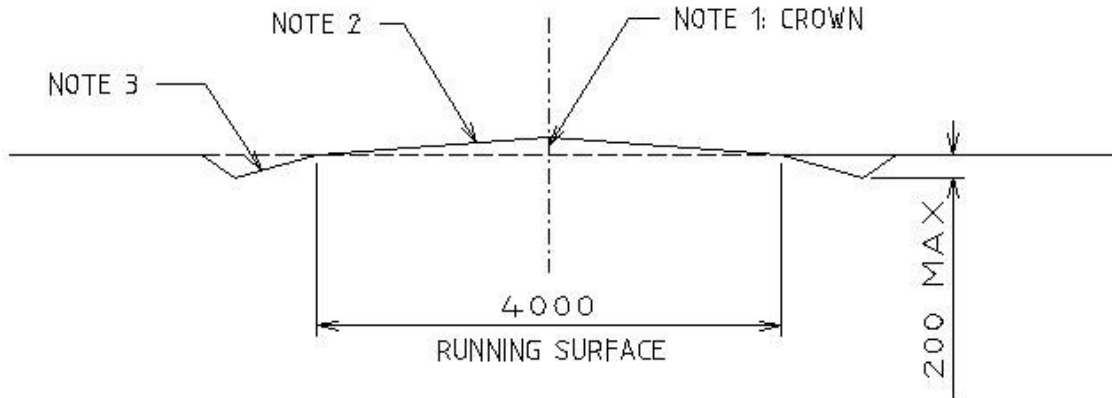
6.3.1 Crowned Surface Formation

Note (1) Normally 0.3m above natural surface after consolidation

Note (2) Nominal design crossfall of 5% after consolidation ie. \approx 7% unconsolidated

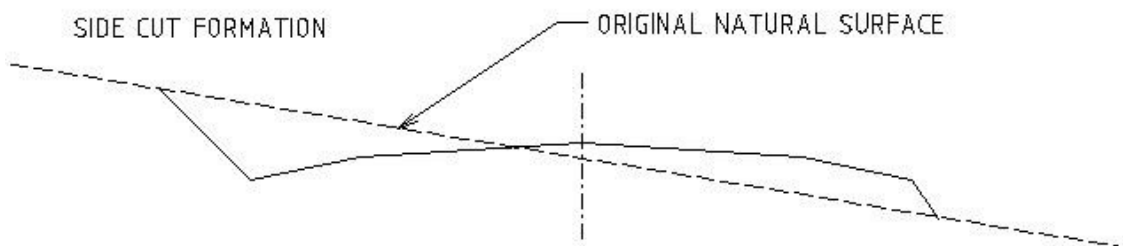
6.3.2 Crowned Side Cut and fill Formation.

Notes and dimensions as per 6.1.1

Crowned Side Cut and fill formation

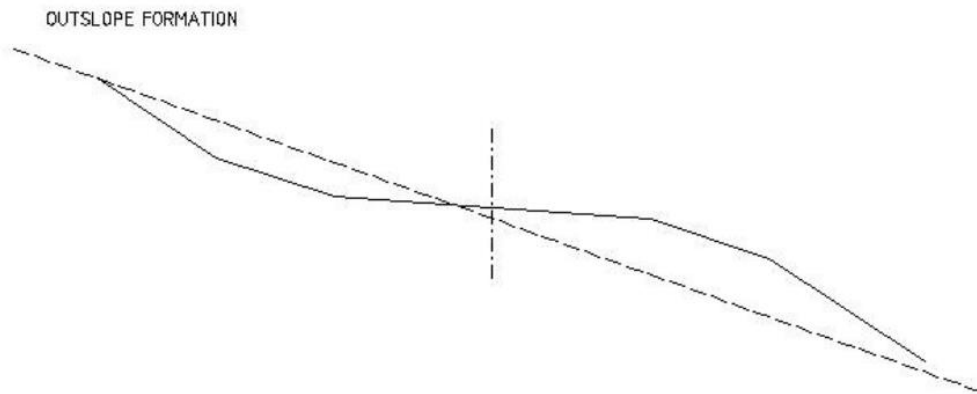
6.3.3 OUTSLOPE FORMATION

(Notes placed as per 6.1.1)

Note (1) Normally 0.3m above natural surface after consolidation

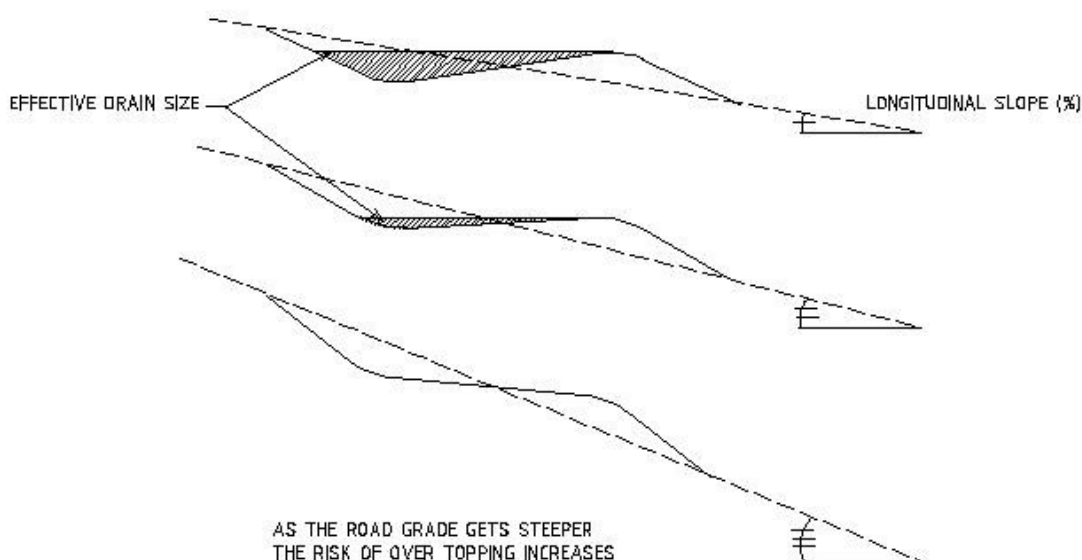
As the longitudinal slope (grade) increases so too does the risk of overtopping. A corresponding degree of care with construction is warranted to preclude any risk of the structure failing.

Generally:

For slopes <5%, materials should be sourced from the lower side of the mound.

For slopes >10%, all material should be sourced from above the mound (where possible)

In some very steep situations additional material may be required. Gravel may need to be sourced elsewhere and imported to the required hump location.
